Inspection Report

Permit Number:	C0150018
Inspection Type:	PARTIAL
Inspection Date:	Wednesday, August 15, 2012
Start Date/Time:	8/15/2012 8:15:00 AM
End Date/Time:	8/15/2012 2:00:00 PM
Last Inspection:	Wednesday, July 11, 2012

Permitee: **PACIFICORP**
 Operator: **ENERGY WEST MINING CO**
 Site: **DEER CREEK MINE**
 Address: **PO BOX 310, HUNTINGTON UT 84528**
 County: **EMERY**
 Permit Type: **PERMANENT COAL PROGRAM**
 Permit Status: **ACTIVE**

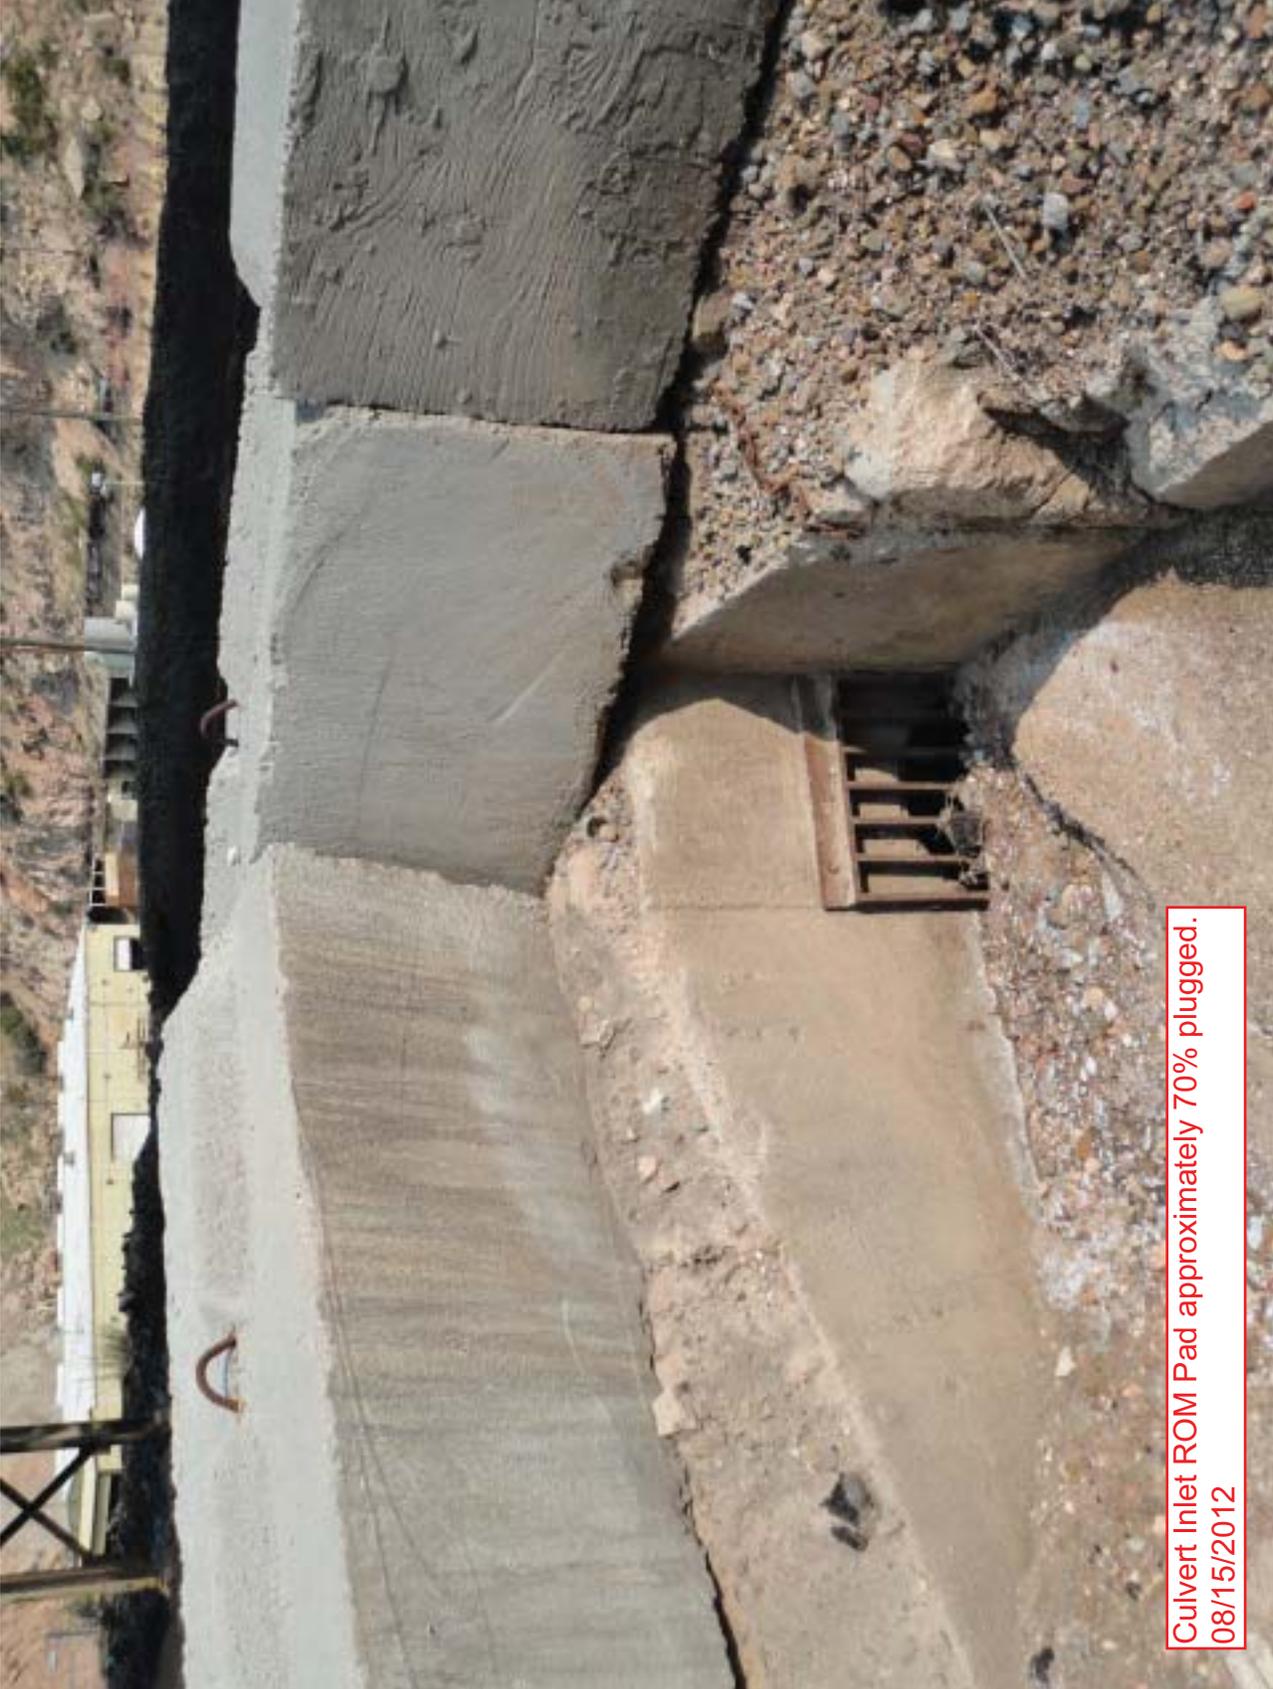
The culvert inlet located on the Run Of Mine (ROM) pad near the MCC building and old fan is approximately 70% plugged. This culvert inlet is not in compliance with the design criteria in the approved MRP or R645 Coal Rules. This culvert inlet needs to be cleaned immediately.

Culvert Inlet ROM Pad approximately 70% plugged.
08/15/2012

The Culvert Inlet on the ROM pad was cleaned on the afternoon of 08/15/2012. The Culvert Inlet at the base of the main fan access road was cleaned on the afternoon of 08/15/2012.

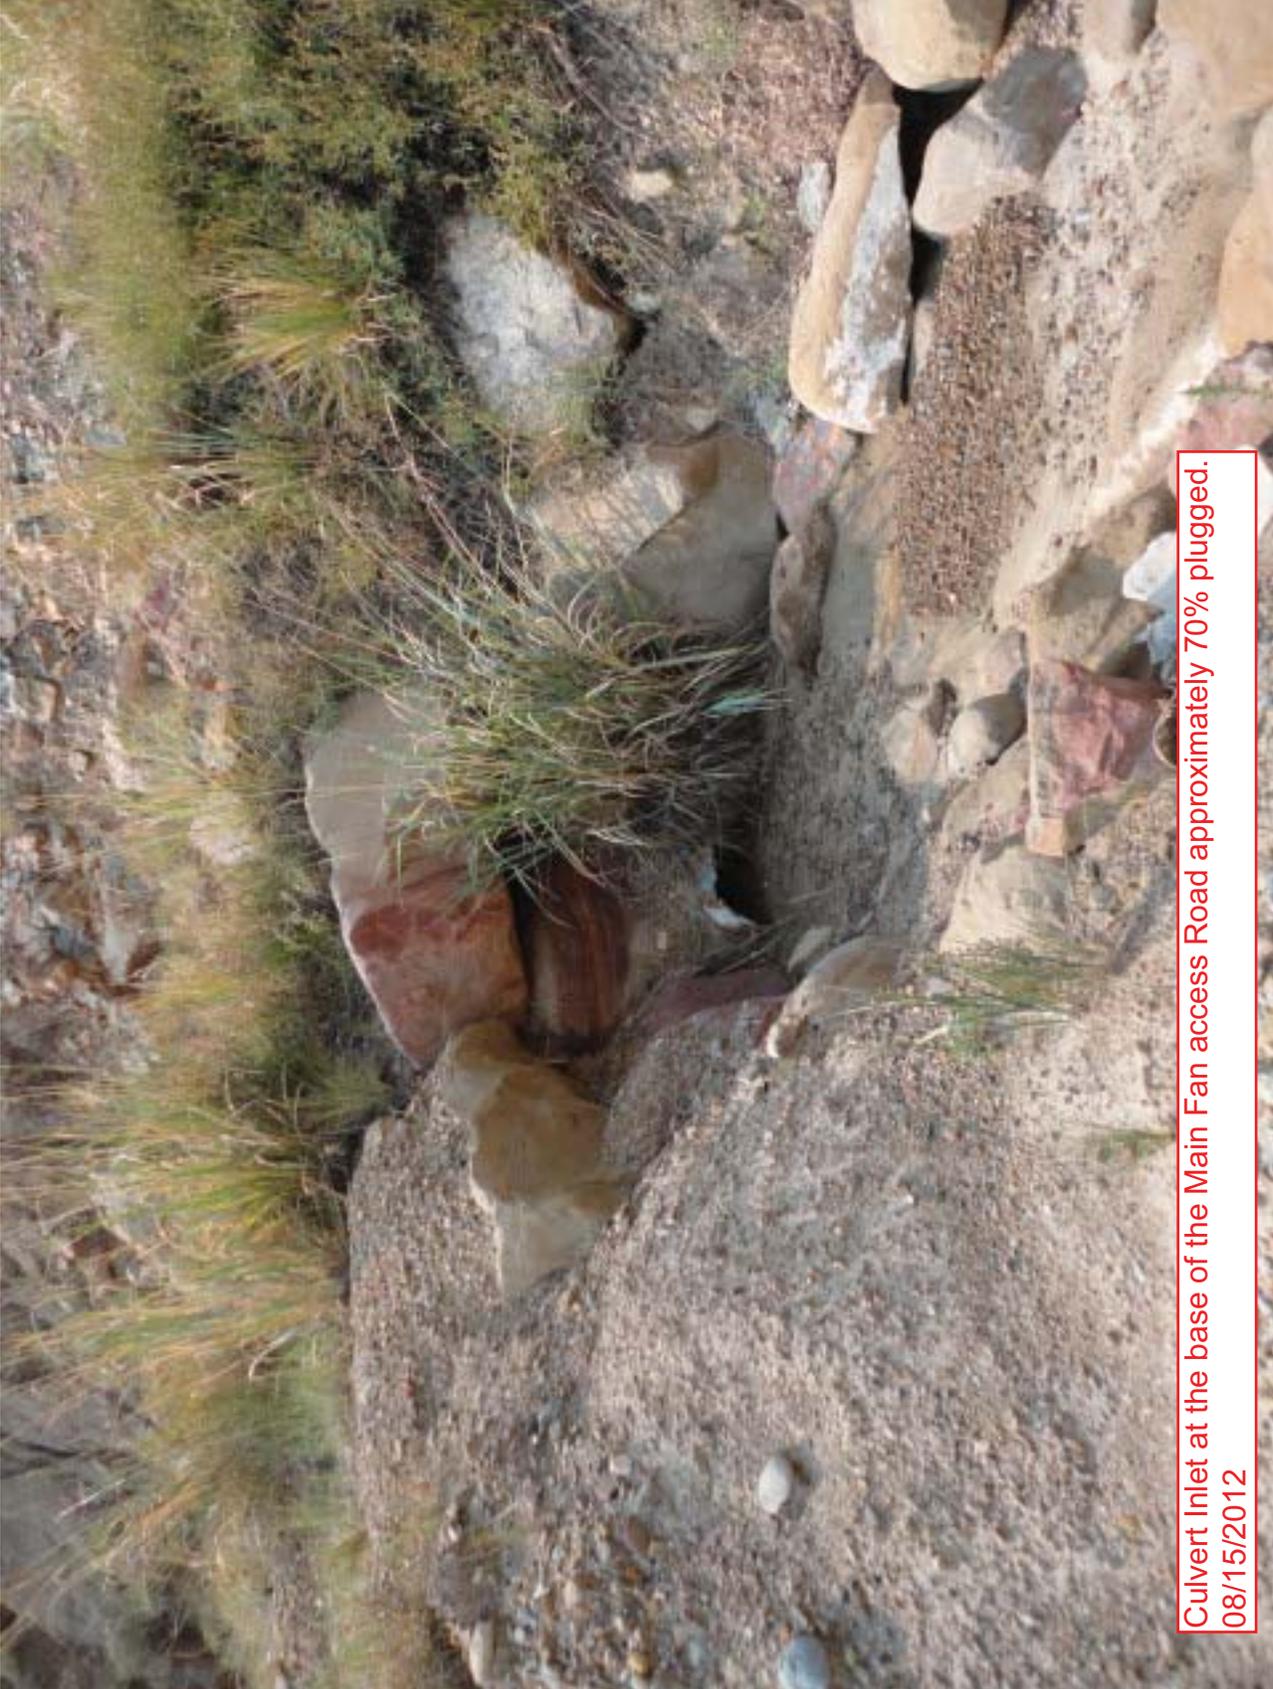
The culvert inlet located at the base of the fan access road, below the water tank and adjacent to the bath house is approximately 70% plugged with sediment. The culvert inlet is not in compliance with the design criteria in the approved MRP or the R645 Coal Rules. This culvert inlet needs to be cleaned immediately.

Culvert Inlet at the base of the Main Fan access Road approximately 70% plugged.
08/15/2012

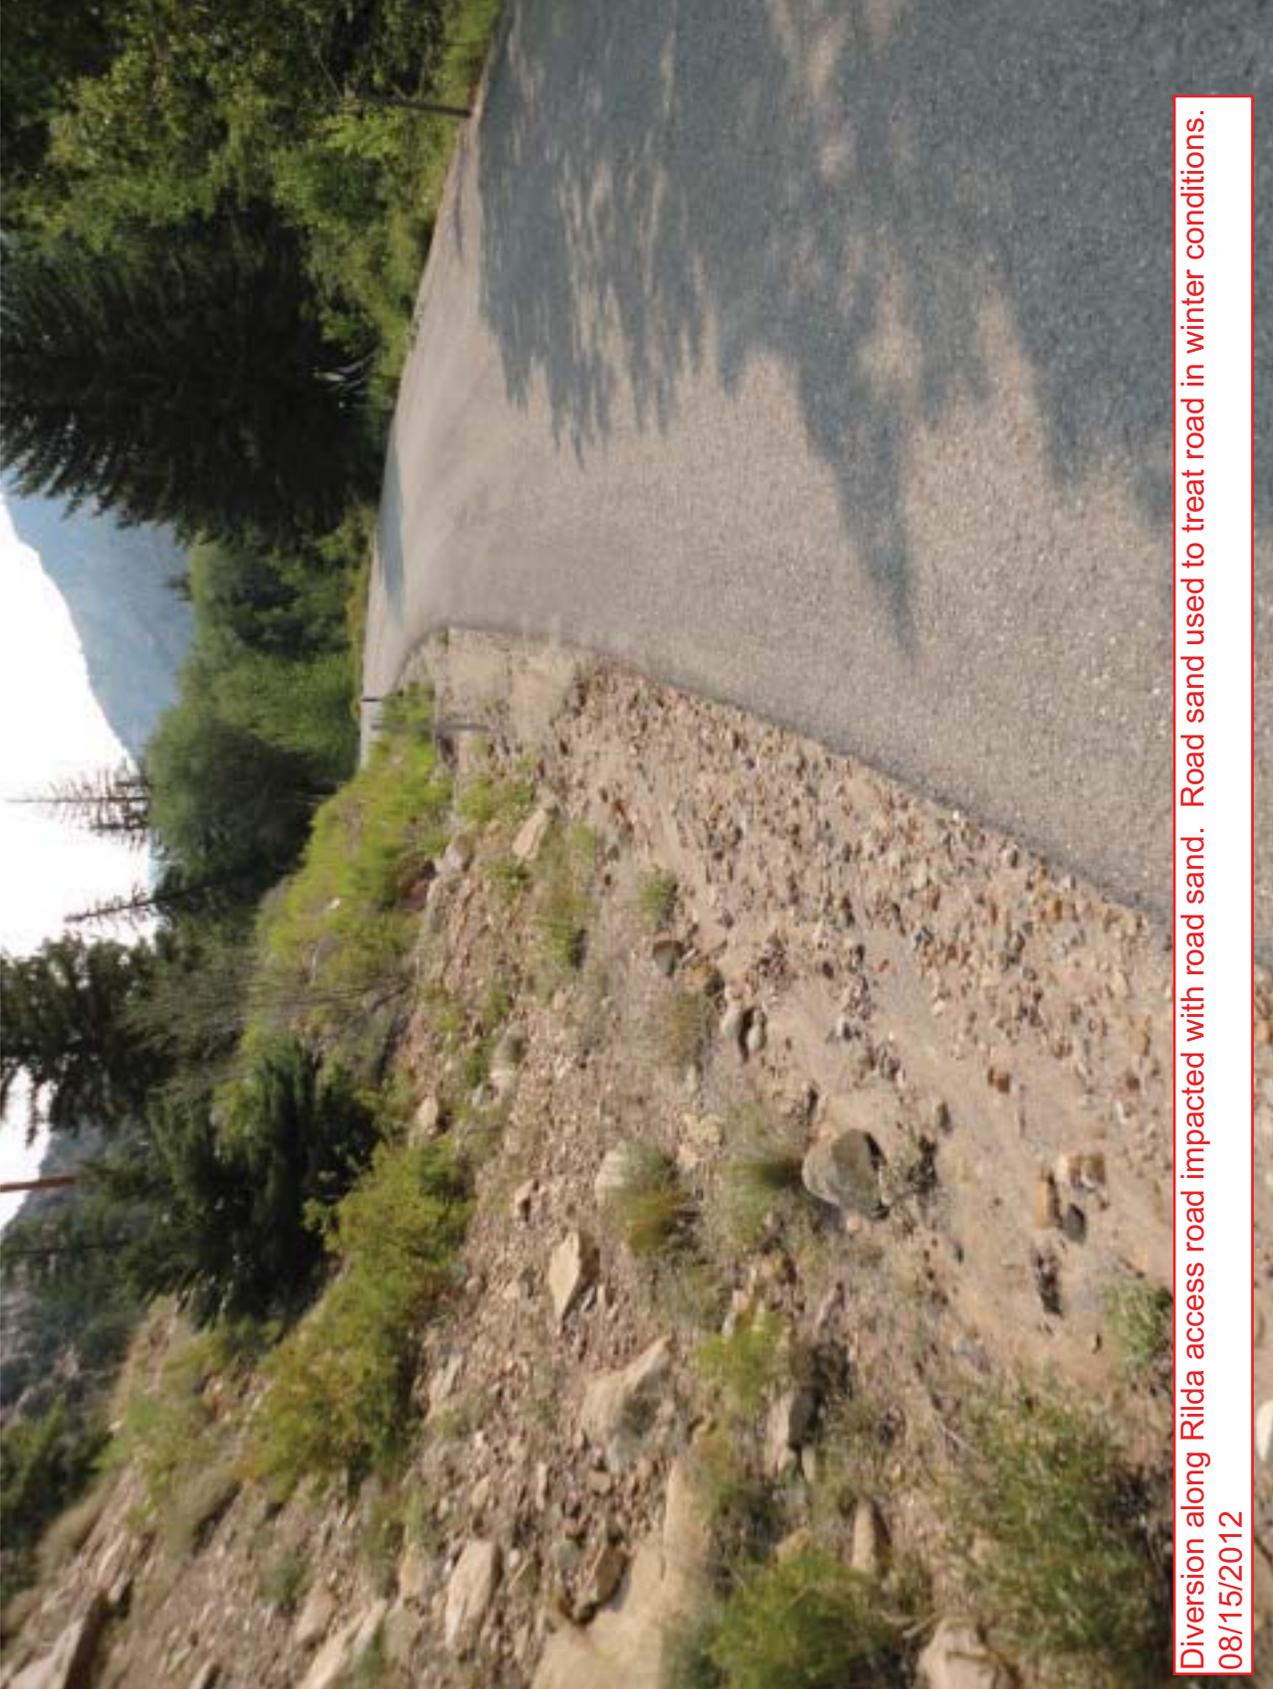
The diversion ditch from the gate entrance along the right side of the access road looking up canyon at the Rilda Facility is impacted with road sand. This sand is used during the winter as a treatment on the road for traction and to aid in snow melt. The rip rap channel is completely inundated with the road sand. Along some portions of the diversion the road sand is above the asphalt surface of the road preventing any road drainage from entering the diversion. This item has been a topic of discussion for over a year with several warnings being issued. The diversion was to be cleaned in the spring of 2012. This problem has been documented in several previous inspection reports. The cleaning has not taken place to date, This diversion needs to be cleaned immediately

Diversion along Rilda access road impacted with road sand. Road sand used to treat road in winter conditions.
08/15/2012

The Rilda diversion was being cleaned during the 08/16/2012 inspection by a track hoe and loader from Nielson Construction Co. This equipment upon completion of

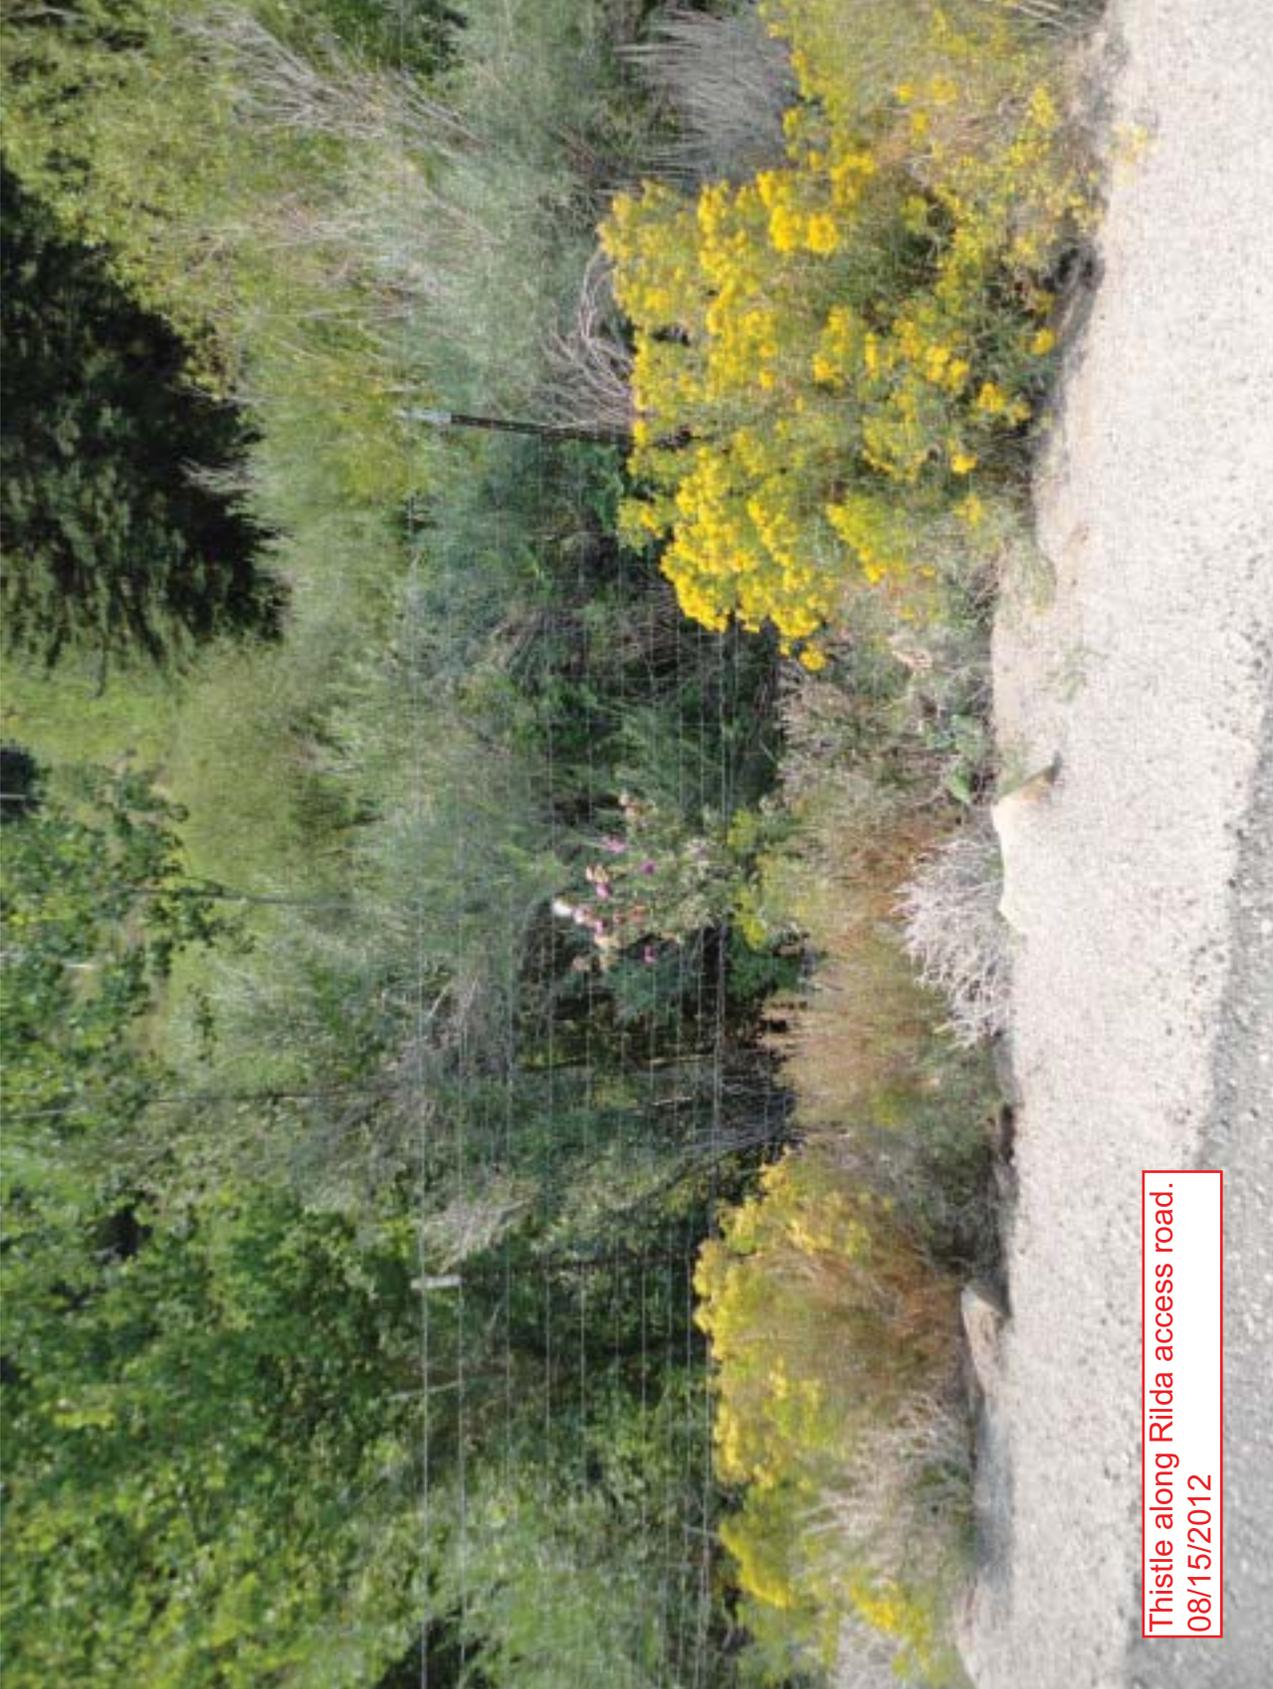
The Rilda Facility area has numerous stands of Thistle on both sides of the access road. The heaviest concentration of thistle is on the right side of the access road looking up canyon in the area that fans out toward the hillside. This area is near to the pad site in an area covered by rock. This item was identified on the July 2012 inspection. No work has been done to remove the heads and dispose of them properly and/or treat or remove the plants. The removal of the heads with proper disposal and the removal and/or treatment of the thistle needs to be done immediately to prevent further spreading of this plant.

Thistle along Rilda access road.
08/15/2012

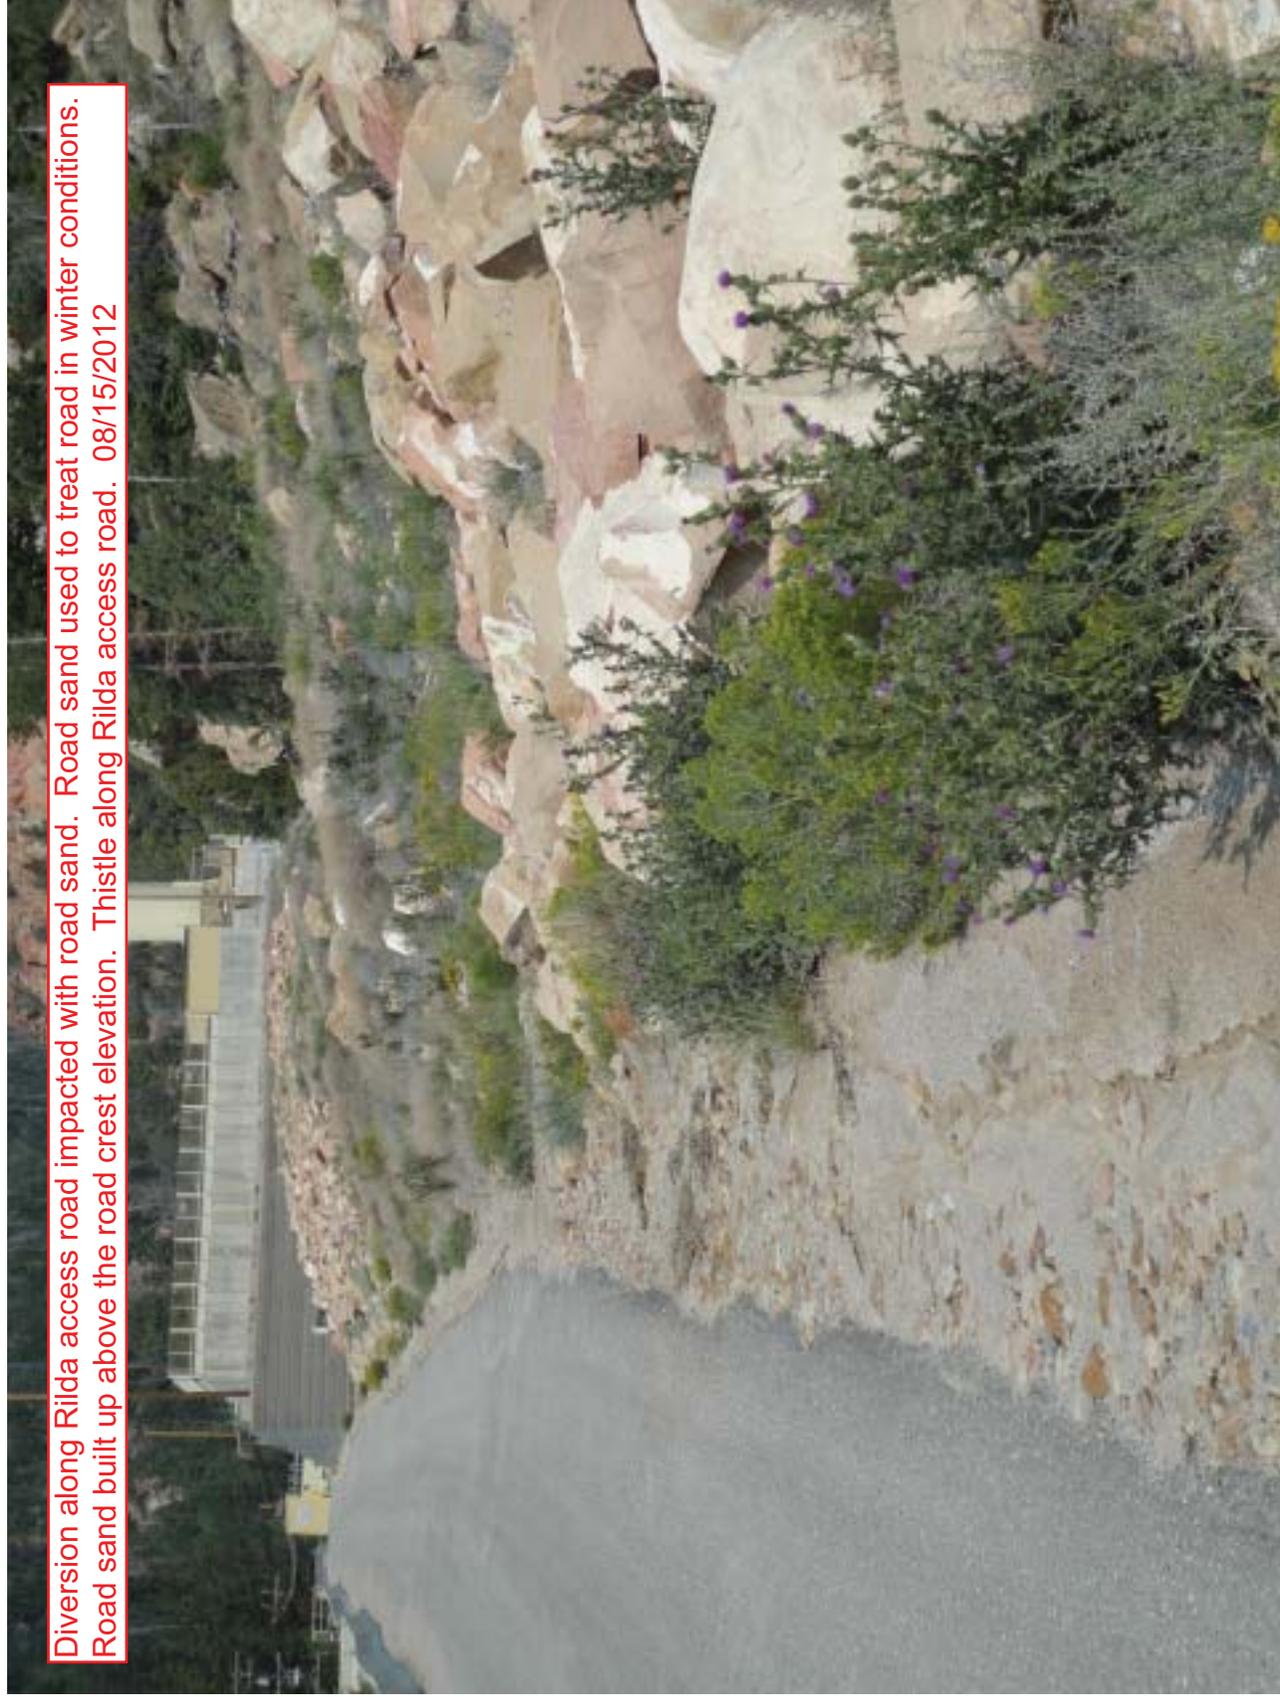
Diversion along Rilda access road impacted with road sand. Road sand used to treat road in winter conditions. Road sand built up above the road crest elevation. Thistle along Rilda access road. 08/15/2012

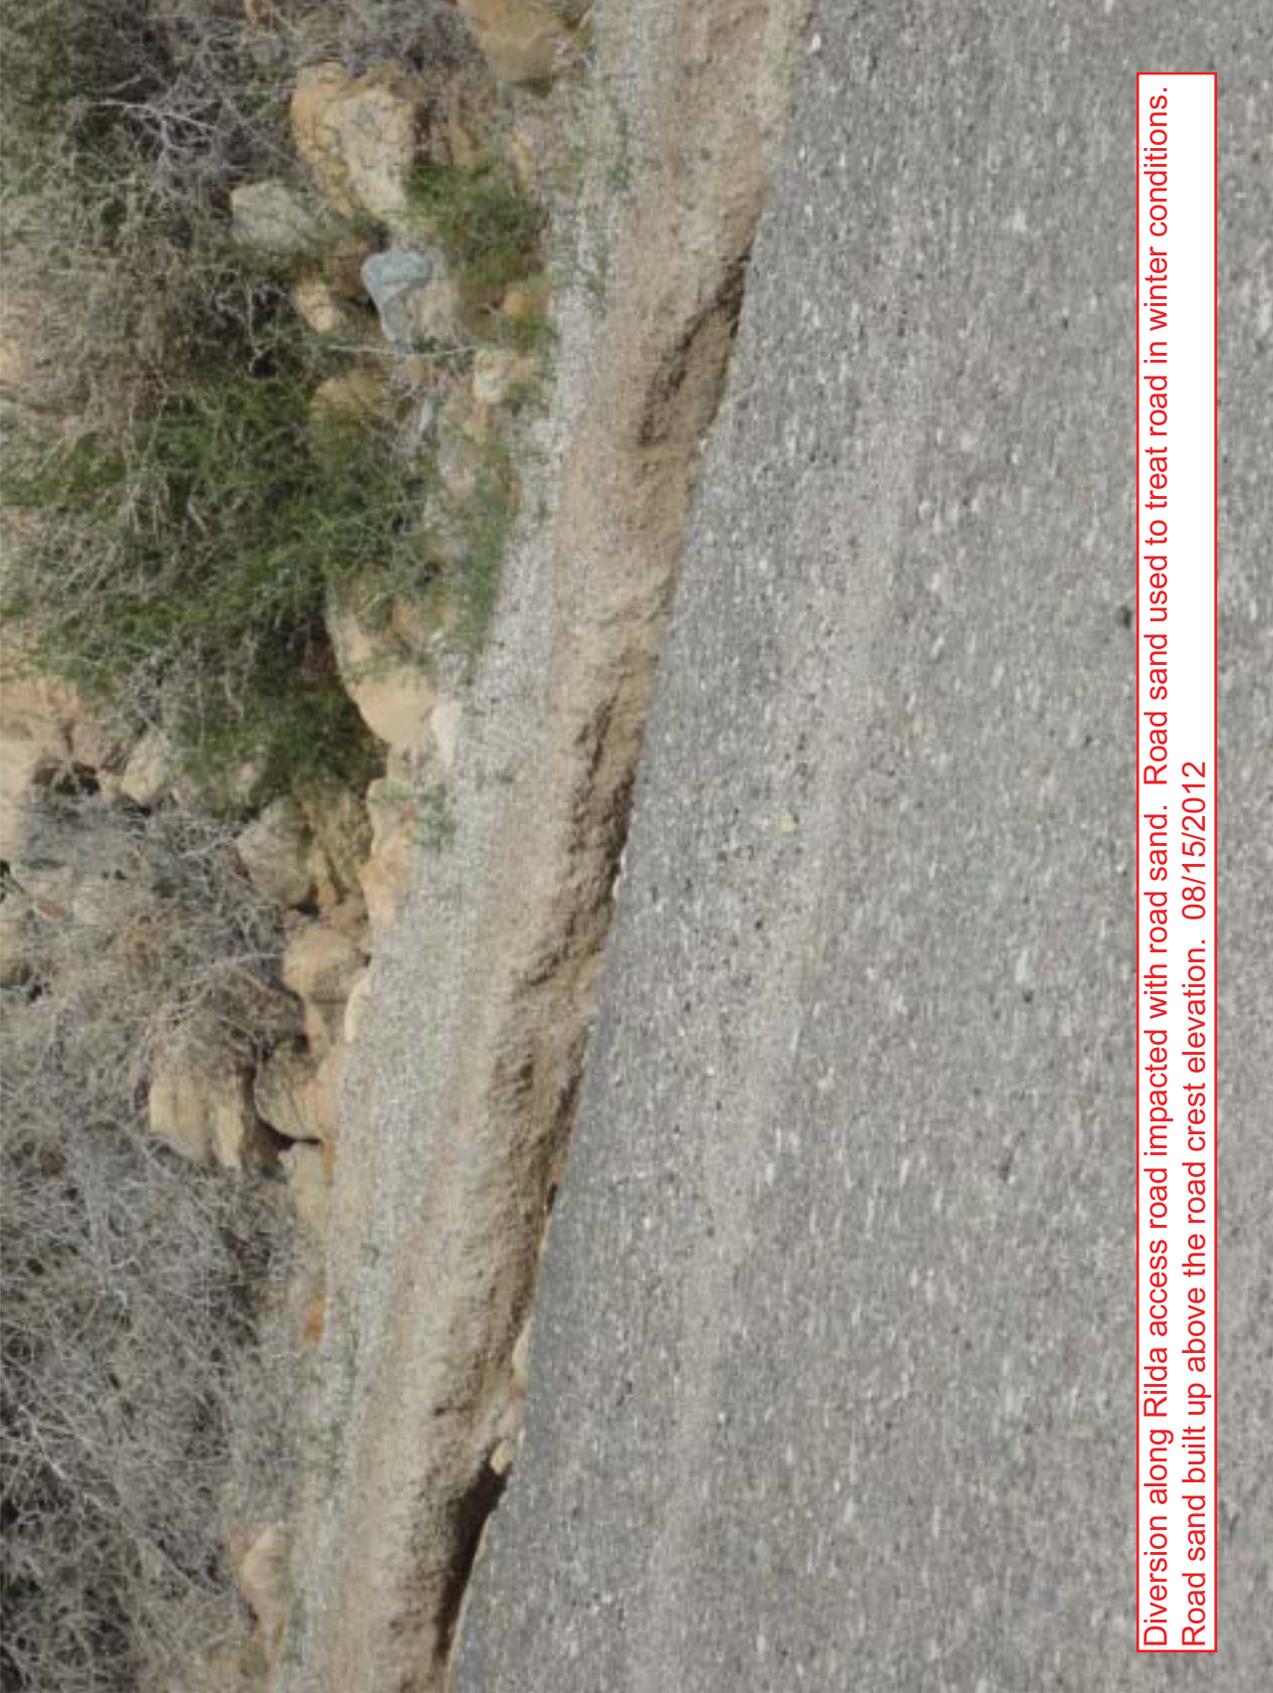
Diversion along Rilda access road impacted with road sand. Road sand used to treat road in winter conditions. Road sand built up above the road crest elevation. 08/15/2012

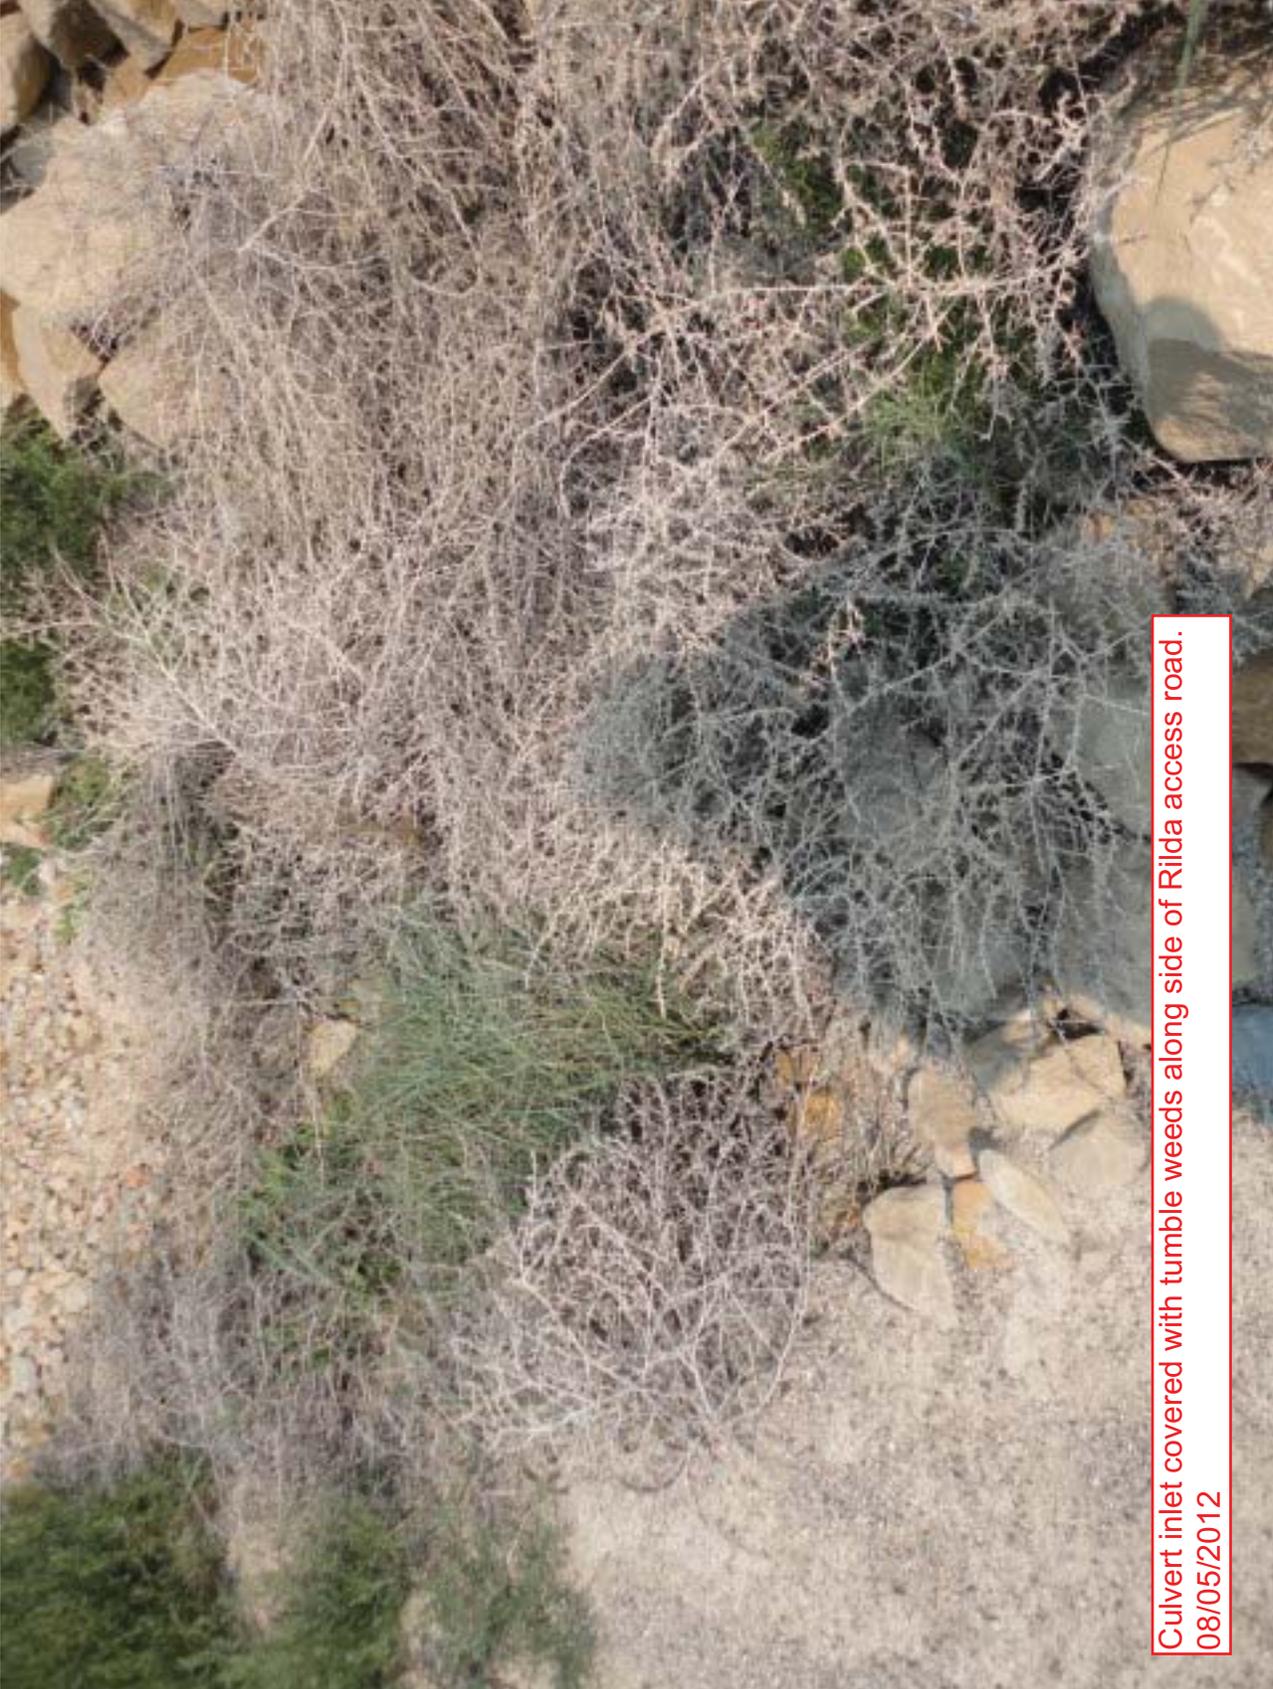
Culvert inlet covered with tumble weeds along side of Rilda access road.
08/05/2012

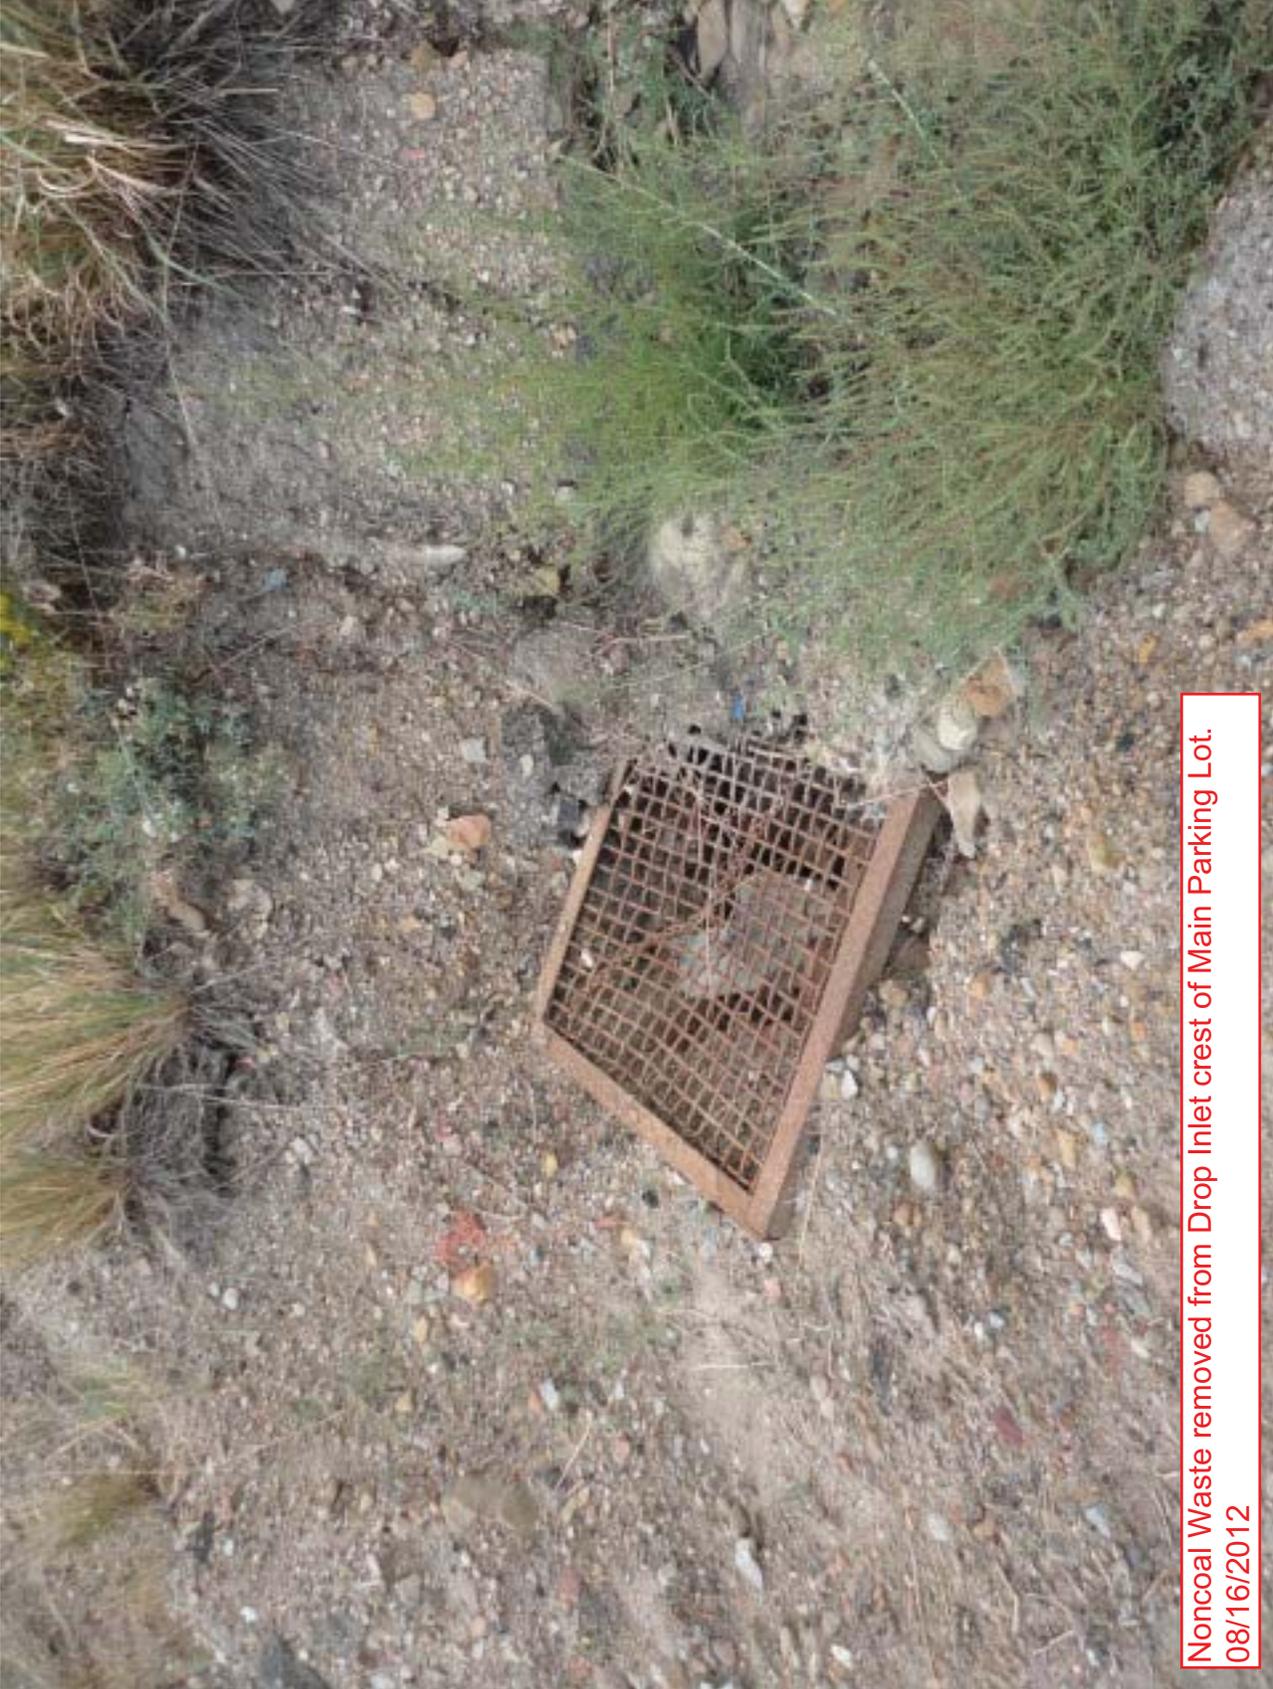
Noncoal Waste removed from Drop Inlet crest of Main Parking Lot.
08/16/2012

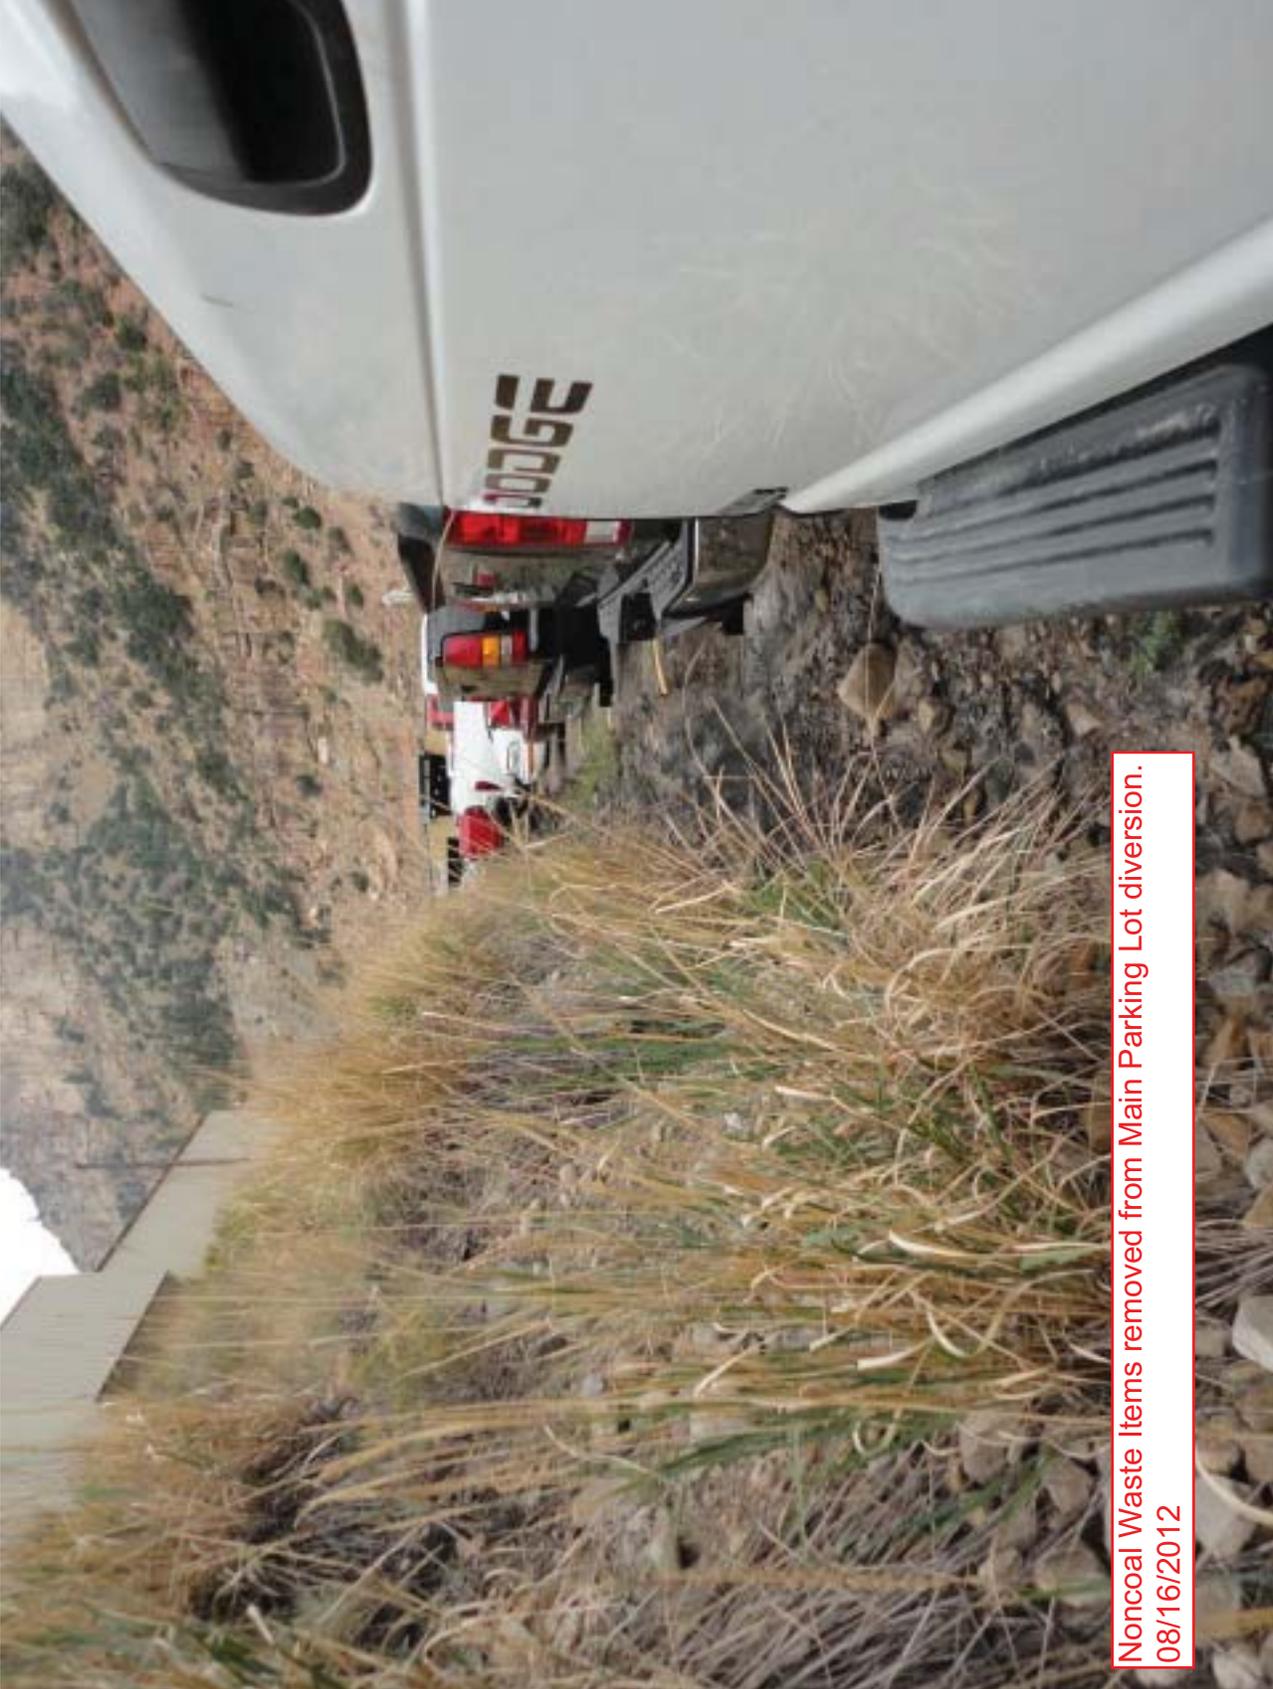
Noncoal Waste Items removed from Main Parking Lot diversion.
08/16/2012

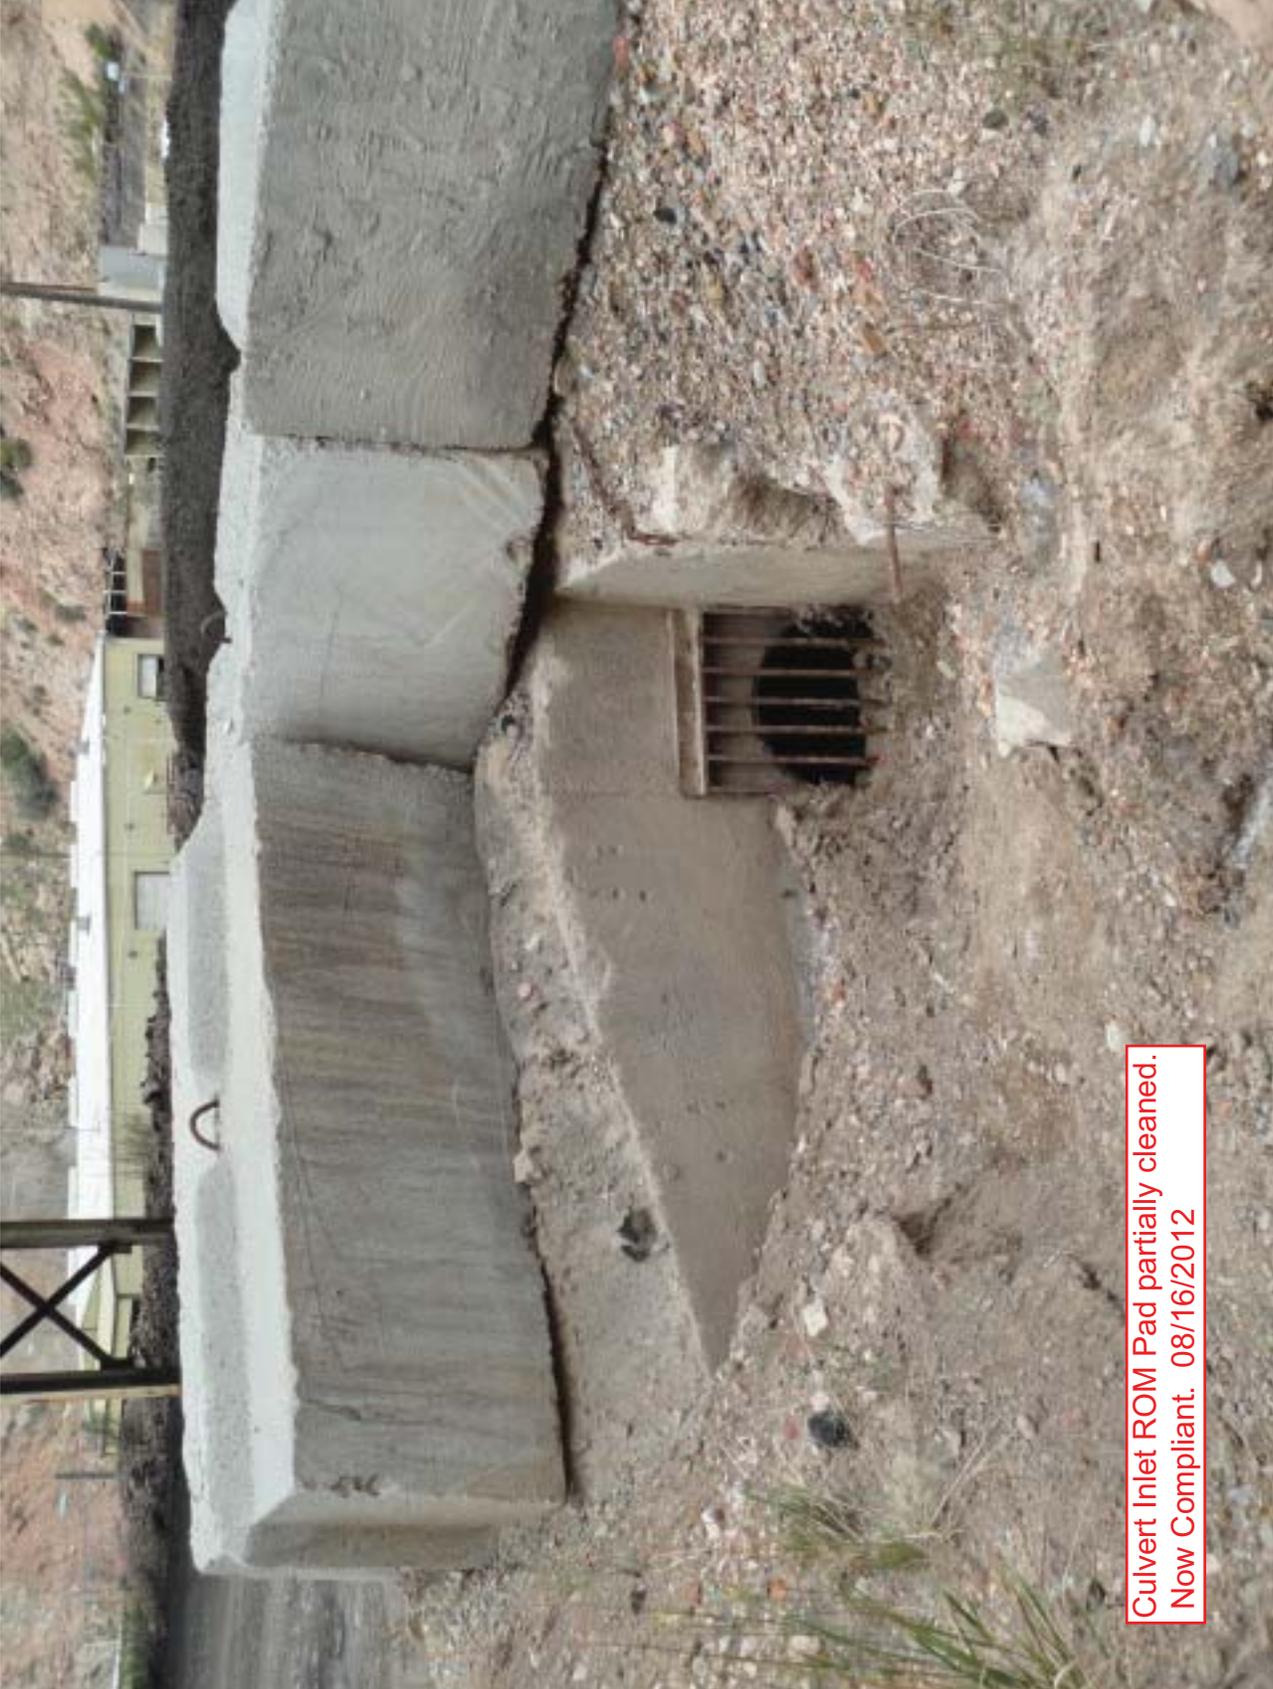
Culvert Inlet ROM Pad partially cleaned.
Now Compliant. 08/16/2012
