Inspection Report

Permit Number:	C0150018
Inspection Type:	PARTIAL
Inspection Date:	Wednesday, August 15, 2012
Start Date/Time:	8/15/2012 8:15:00 AM
End Date/Time:	8/15/2012 2:00:00 PM
Last Inspection:	Wednesday, July 11, 2012

Permitee: **PACIFICORP**
 Operator: **ENERGY WEST MINING CO**
 Site: **DEER CREEK MINE**
 Address: **PO BOX 310, HUNTINGTON UT 84528**
 County: **EMERY**
 Permit Type: **PERMANENT COAL PROGRAM**
 Permit Status: **ACTIVE**

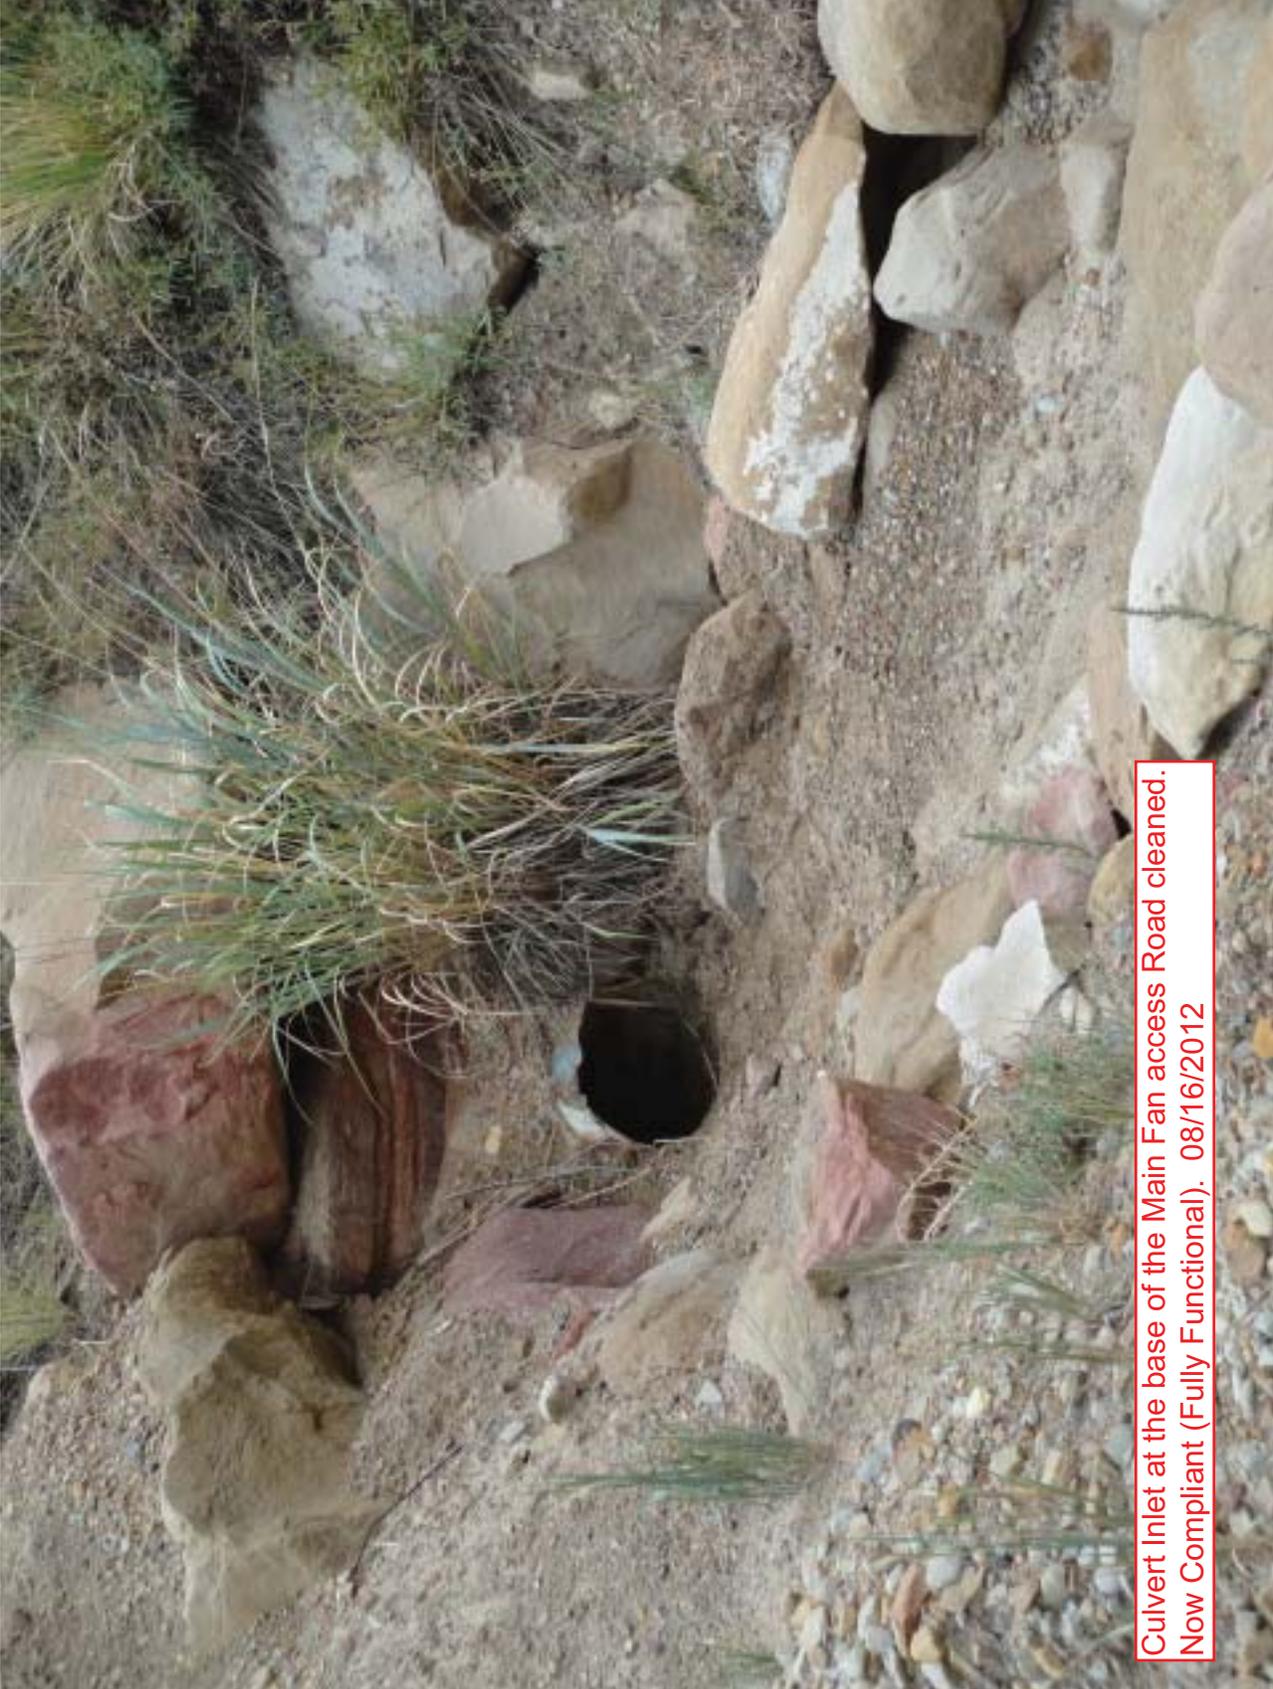
Culvert Inlet at the base of the Main Fan access Road cleaned.
Now Compliant (Fully Functional). 08/16/2012

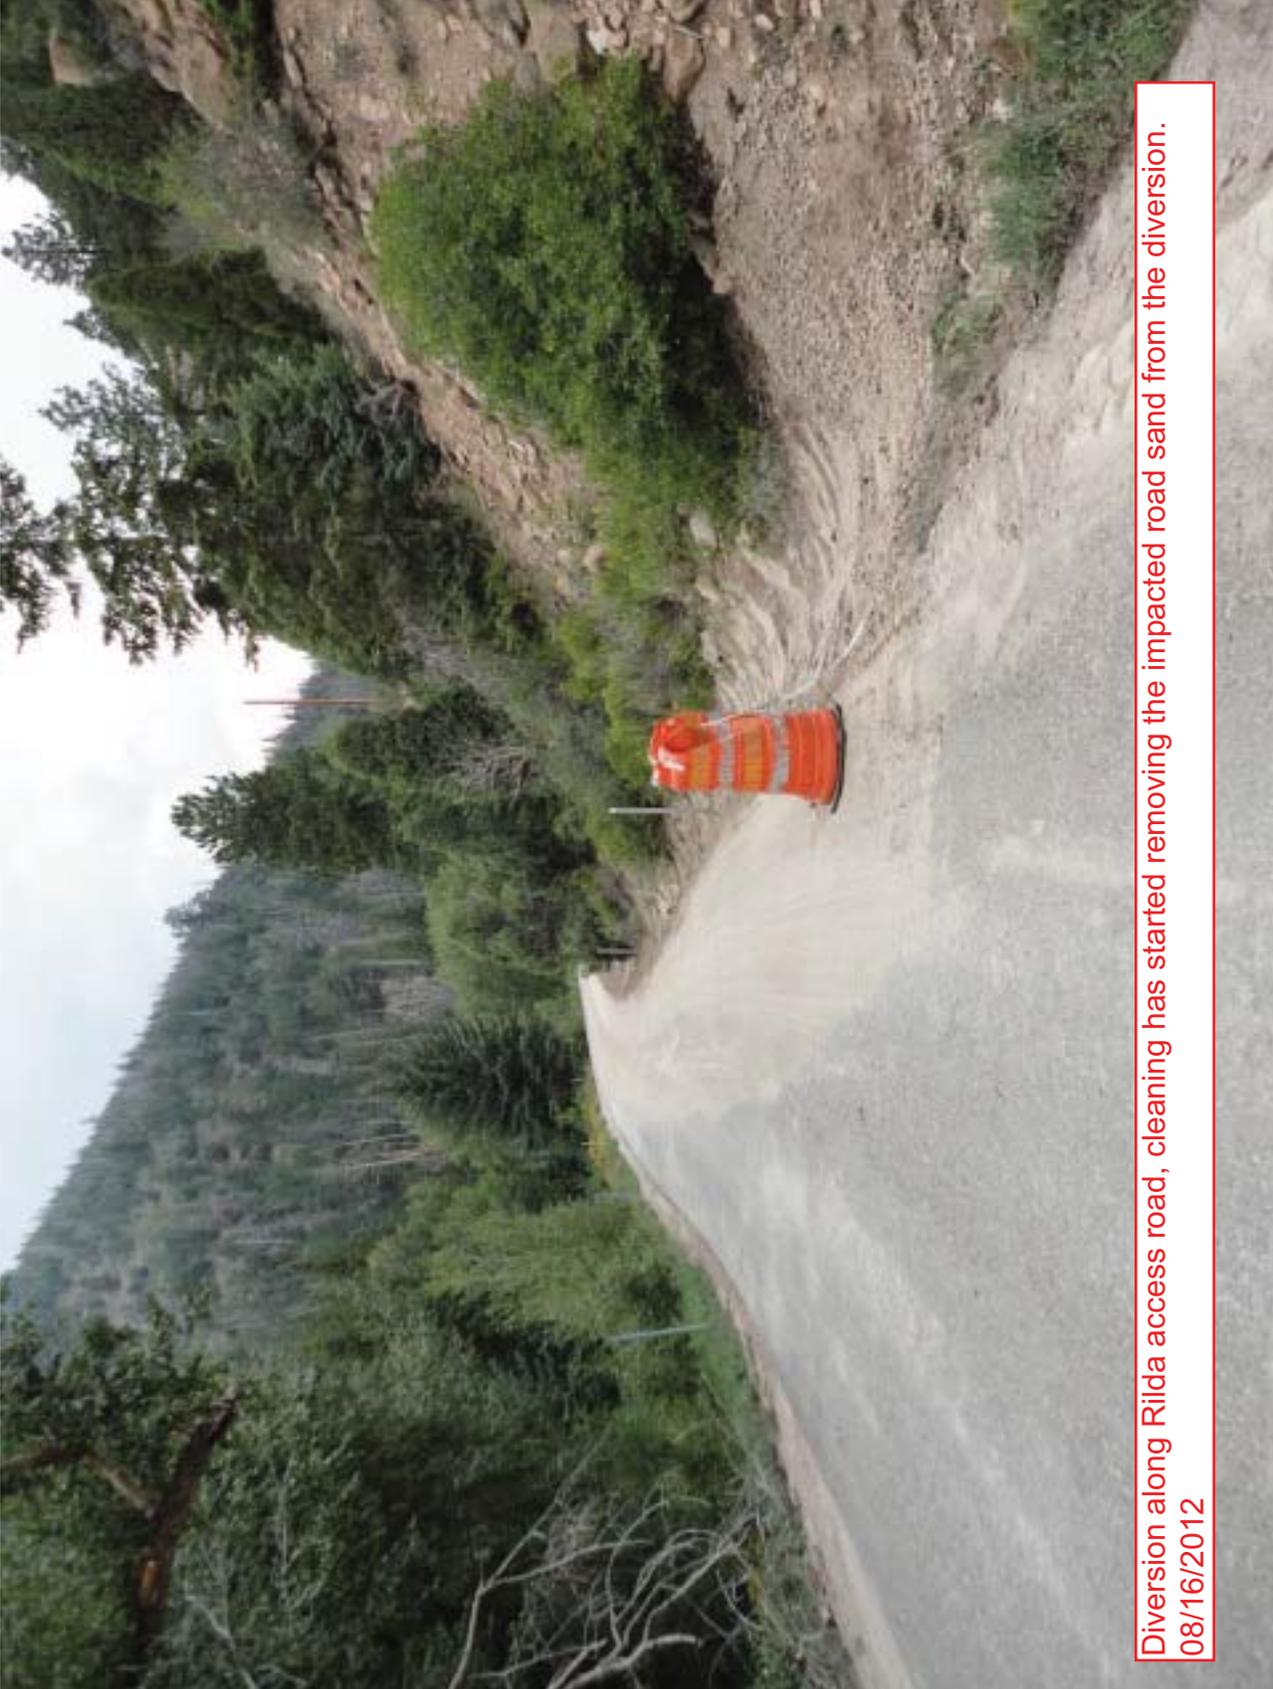
Diversion along Rilda access road, cleaning has started removing the impacted road sand from the diversion.
08/16/2012

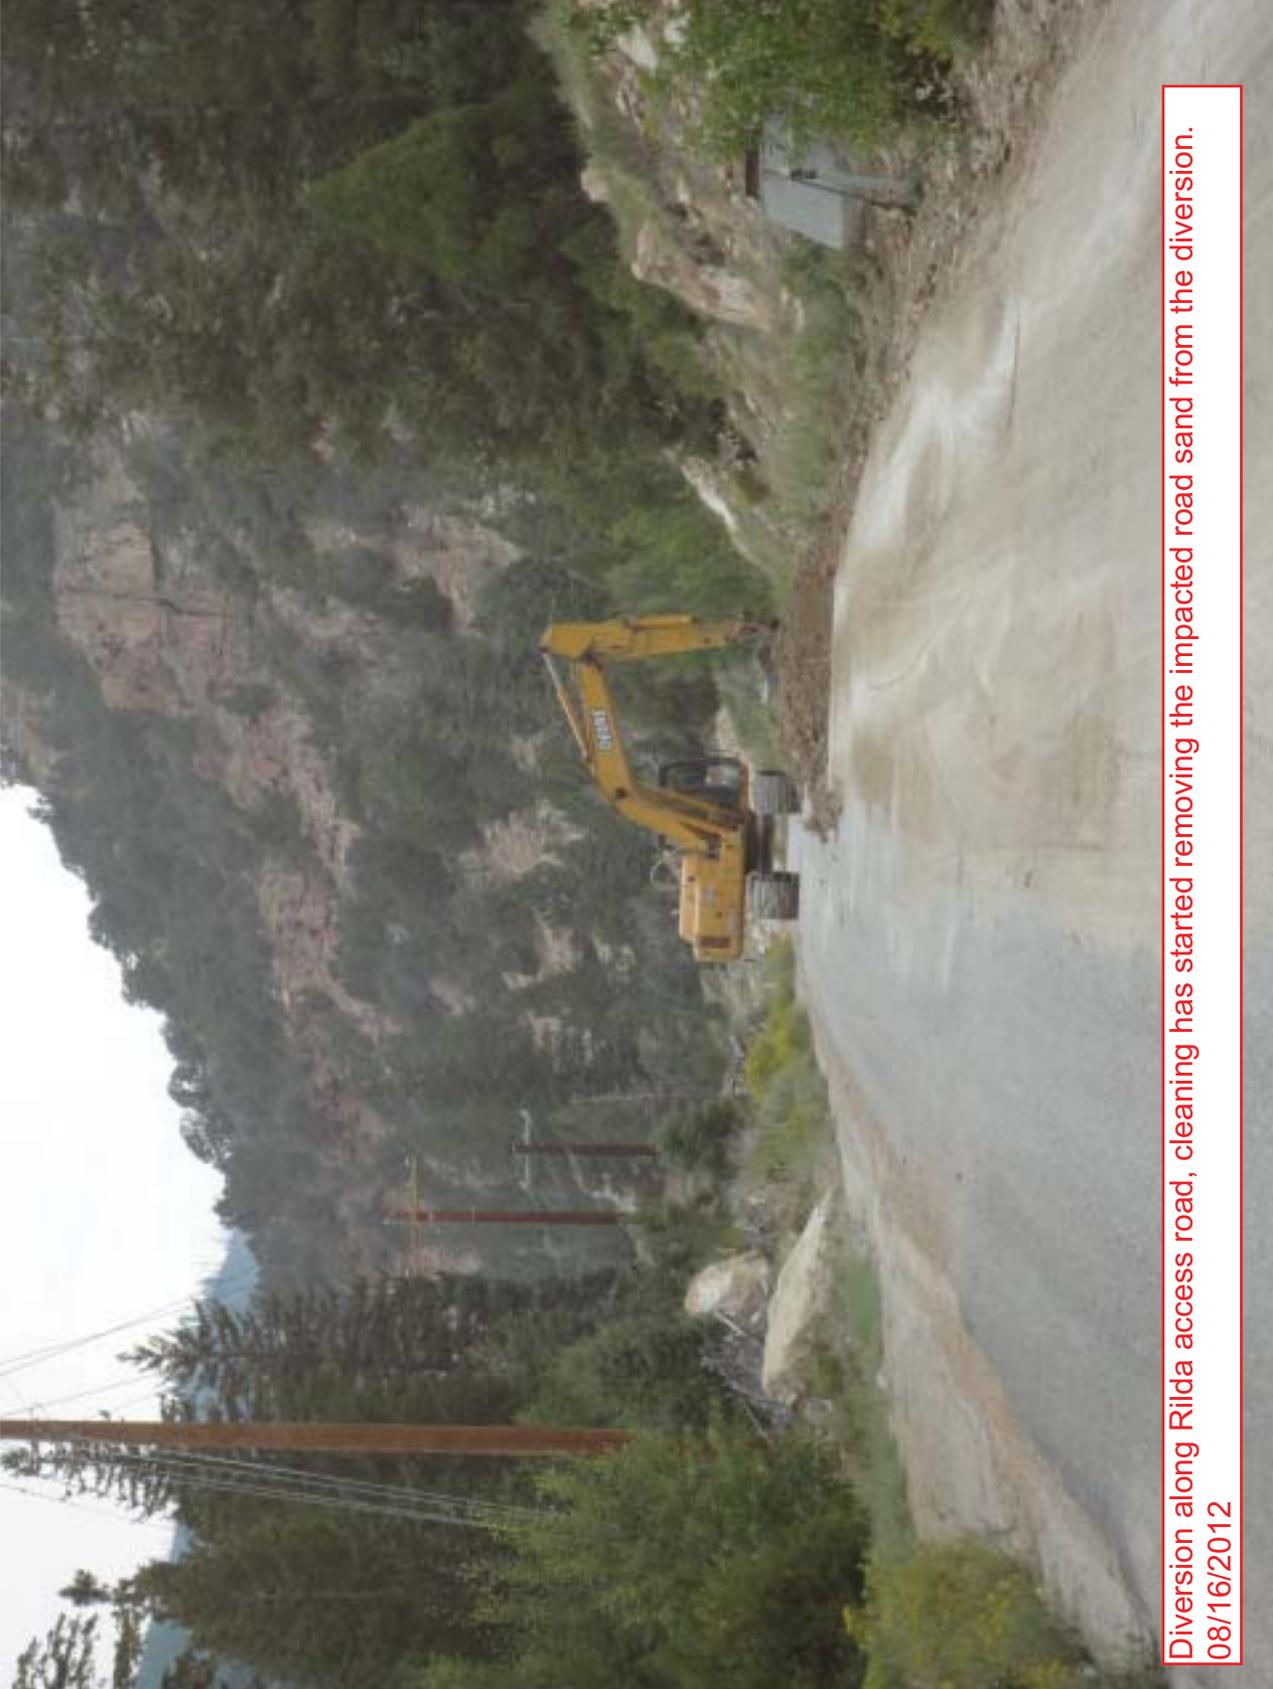
Diversion along Rilda access road, cleaning has started removing the impacted road sand from the diversion.
08/16/2012
