Subj: Deer Creek Mine Closure – 5th North Mains Stream Crossing Area, Pre-Closure Subsidence Survey of Underground Workings, PacifiCorp, Deer Creek Mine, C/015/0018, Emery County, Utah.

Subject: Geotechnical Inspection of the 5th North Blind Canyon Mains, XC- 1 – 10, Deer Creek Mine, January 30, 2015

Energy West Mining Co.
 Deer Creek Mine
 Inspection of Workings - 01/30/15
 5th North Mains - B.C. Seam

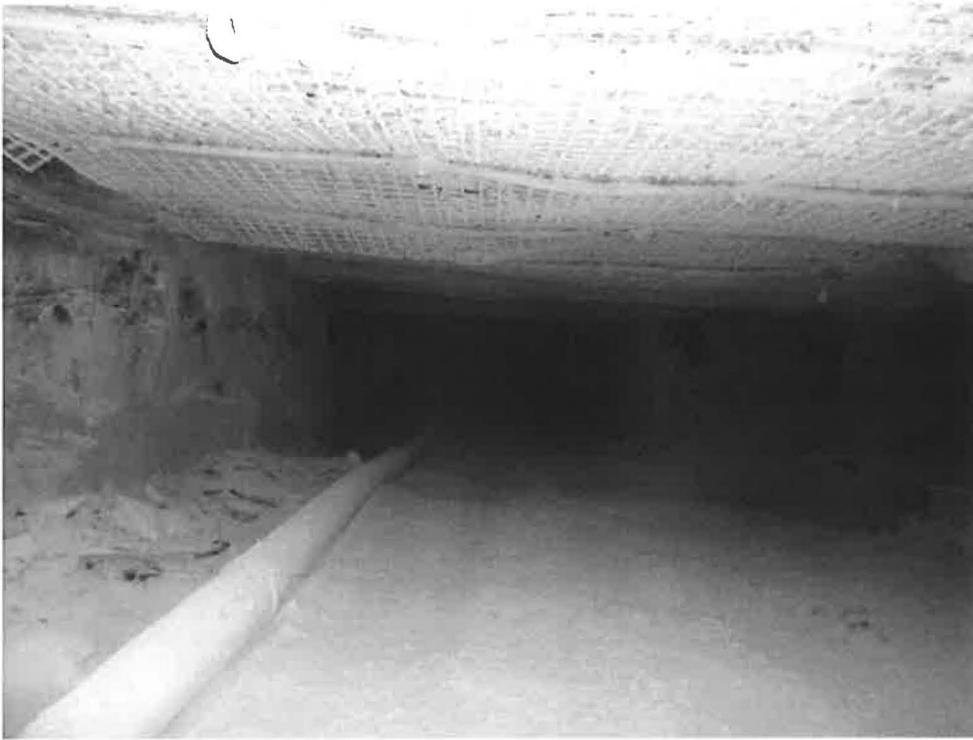
#1 - Ent 1 XC 1-2 Inby

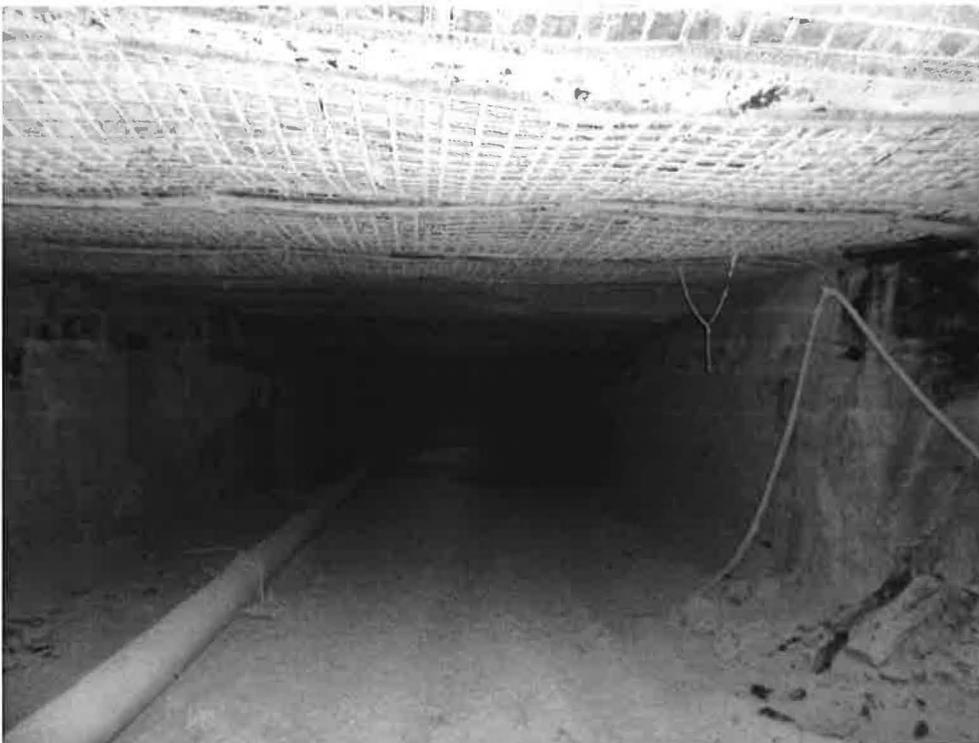
#2 - Ent 1 XC 2-3 Inby

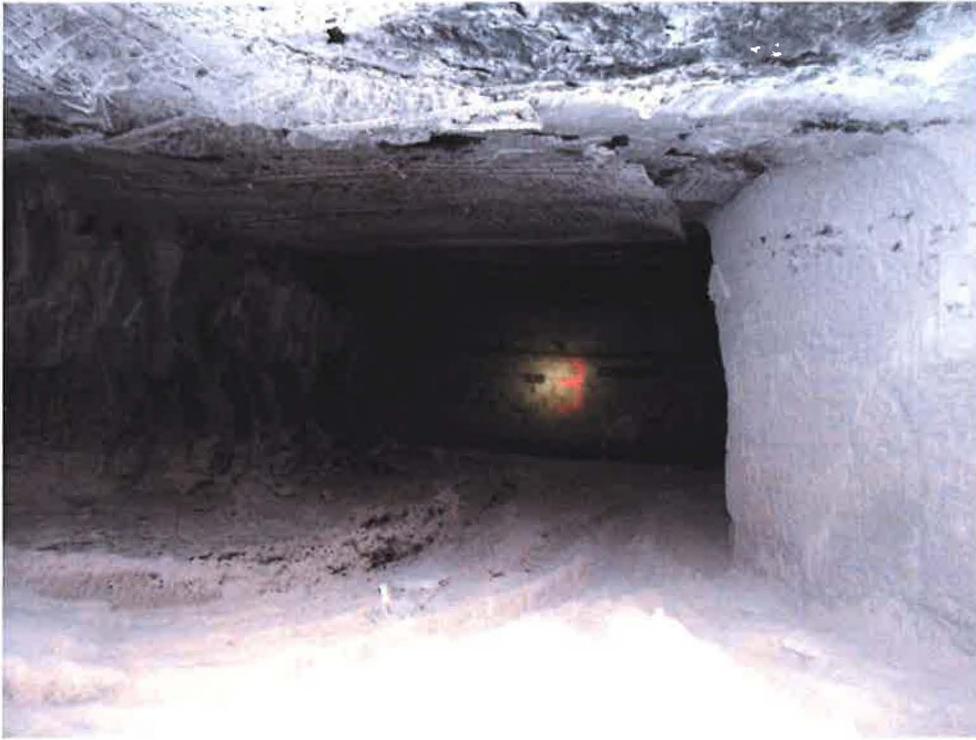
#3 - Ent 1 XC 3 Looking Right

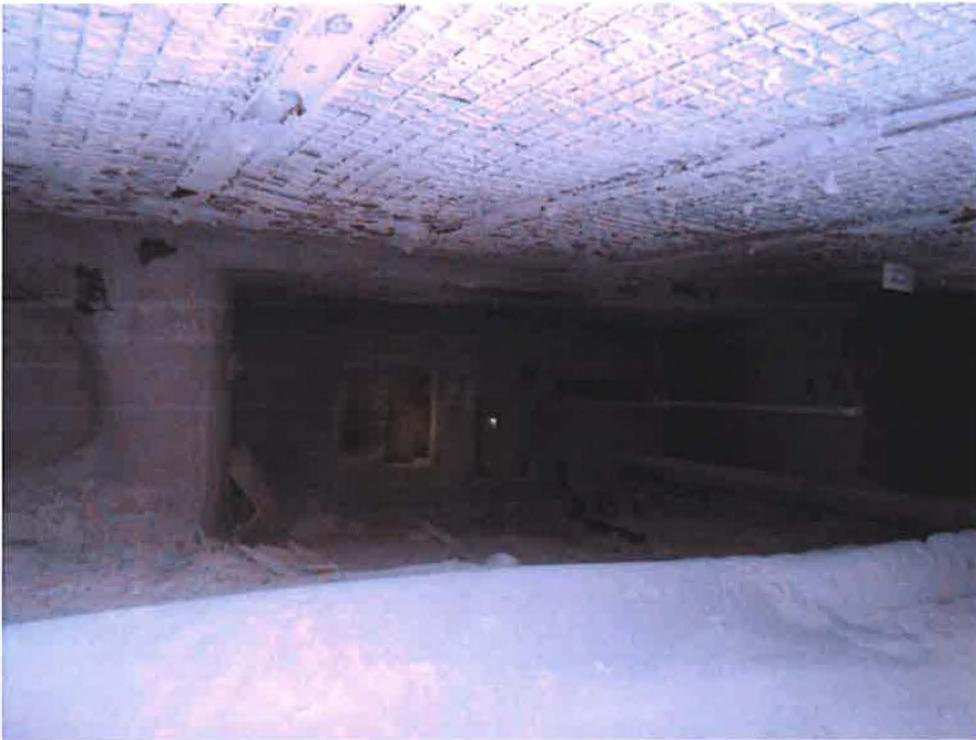
#4 - Ent 1 XC 4 Looking Left

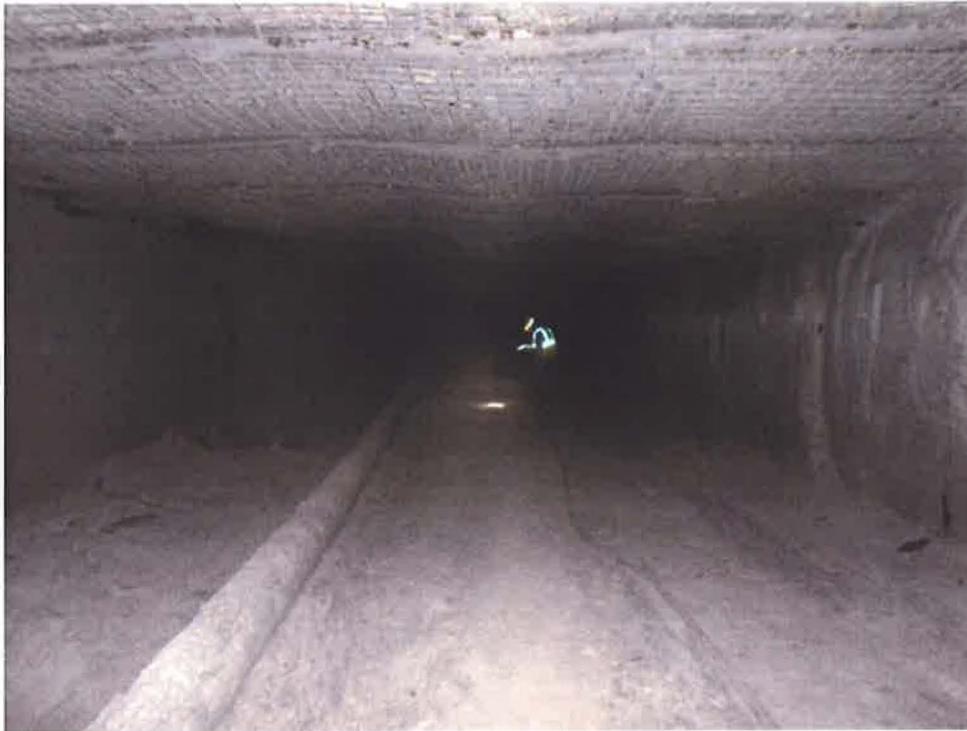
#5 - Ent 1 XC 4-5 Looking Inby

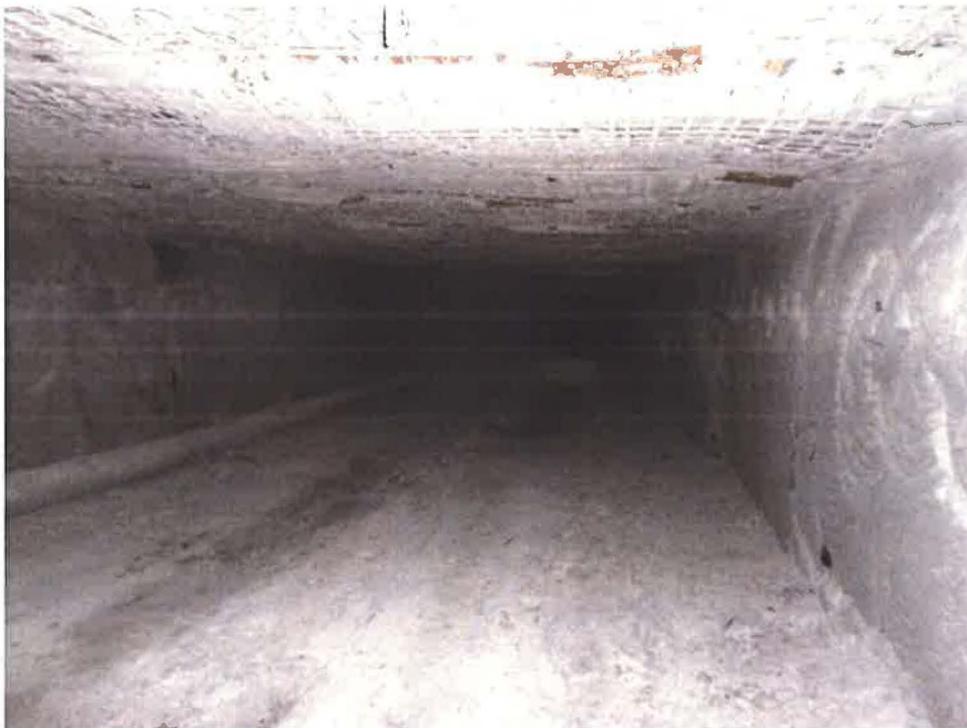
#6 - Ent 1 XC 5-6 In

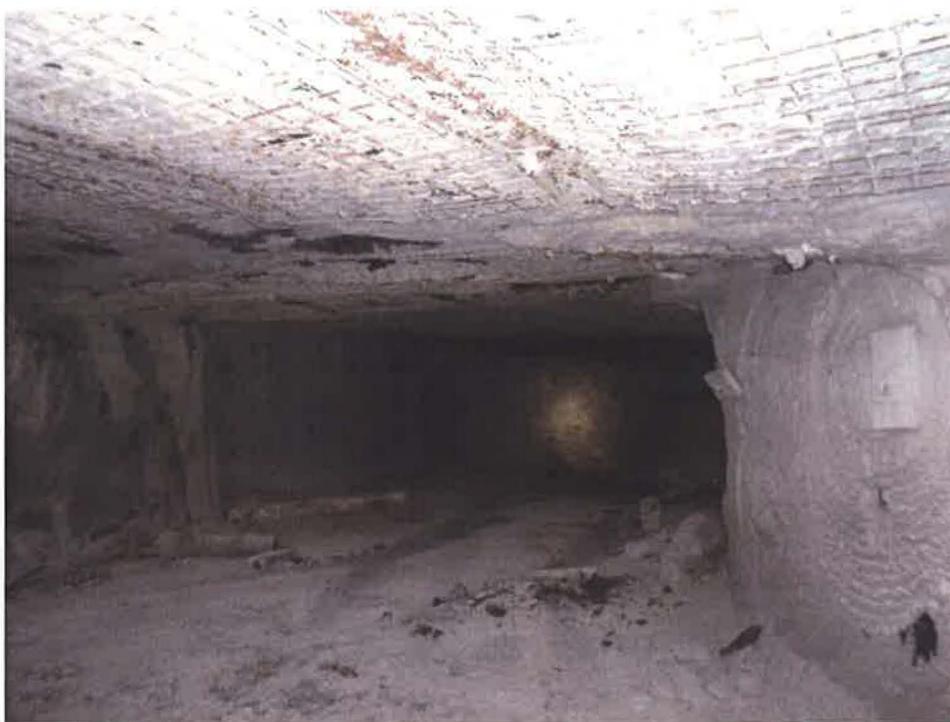
#7 - Ent 1 XC 6 Looking Right

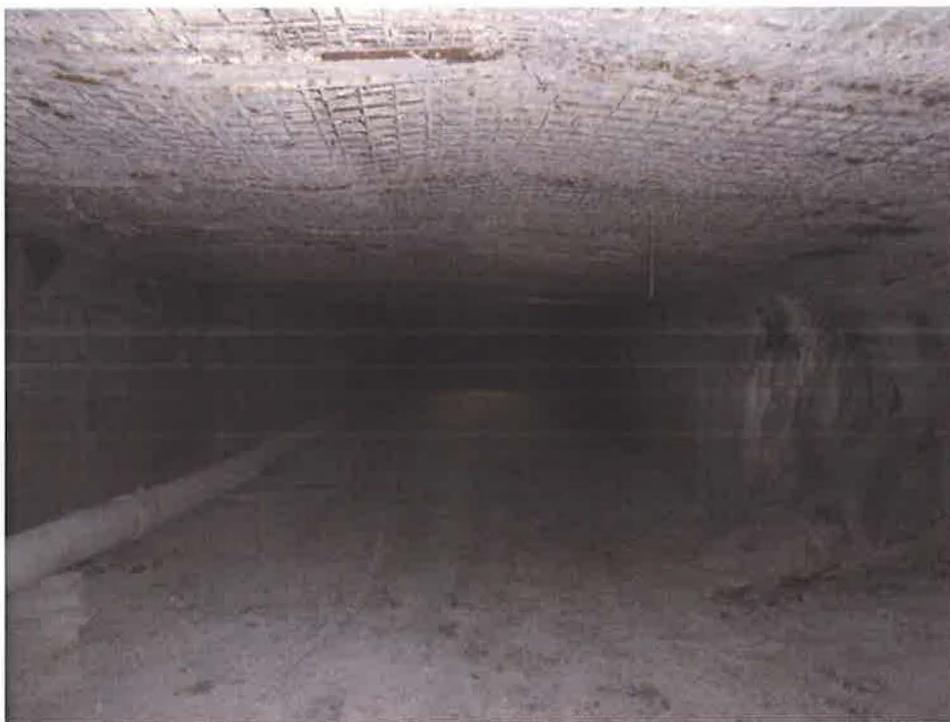
#8 - Ent 1 XC 6-7 Looking Inby

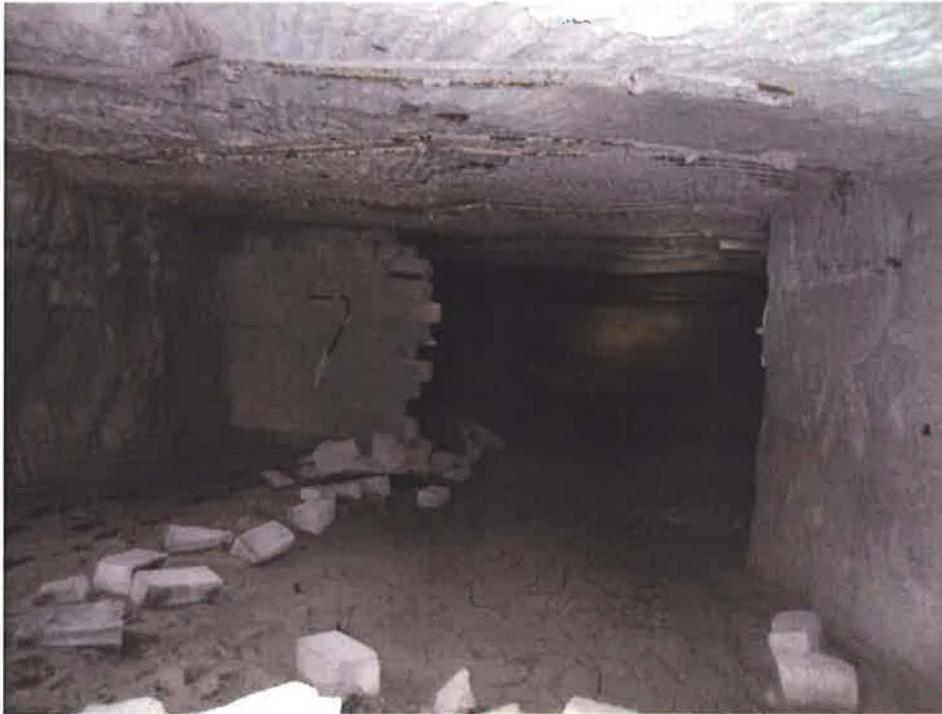
#9 - Ent 1 XC 7 Looking Right

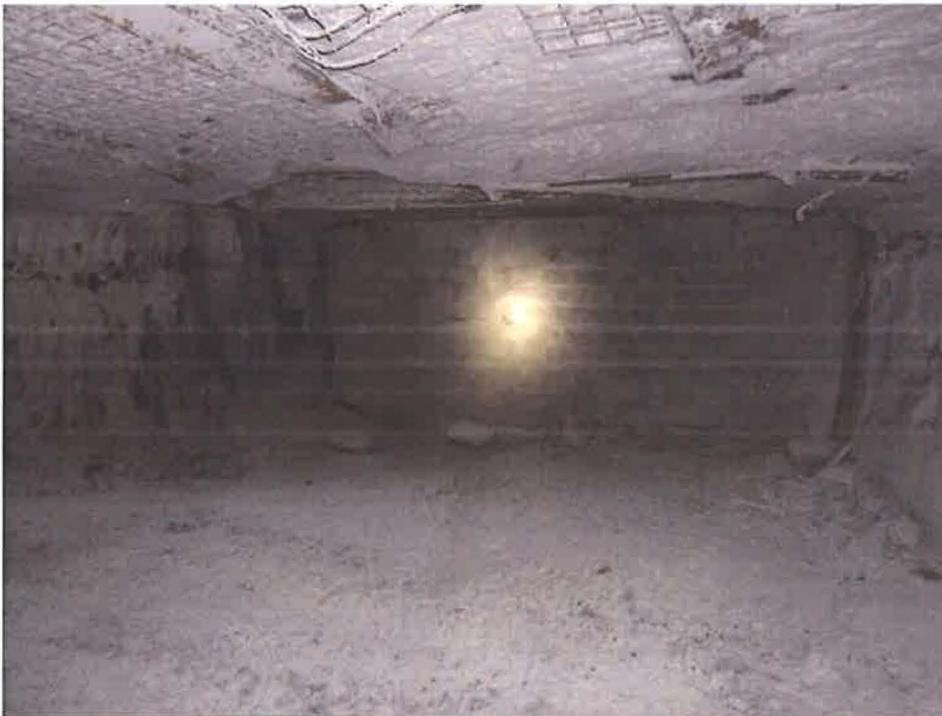
#10 - Ent 1 XC 8 Looking Right

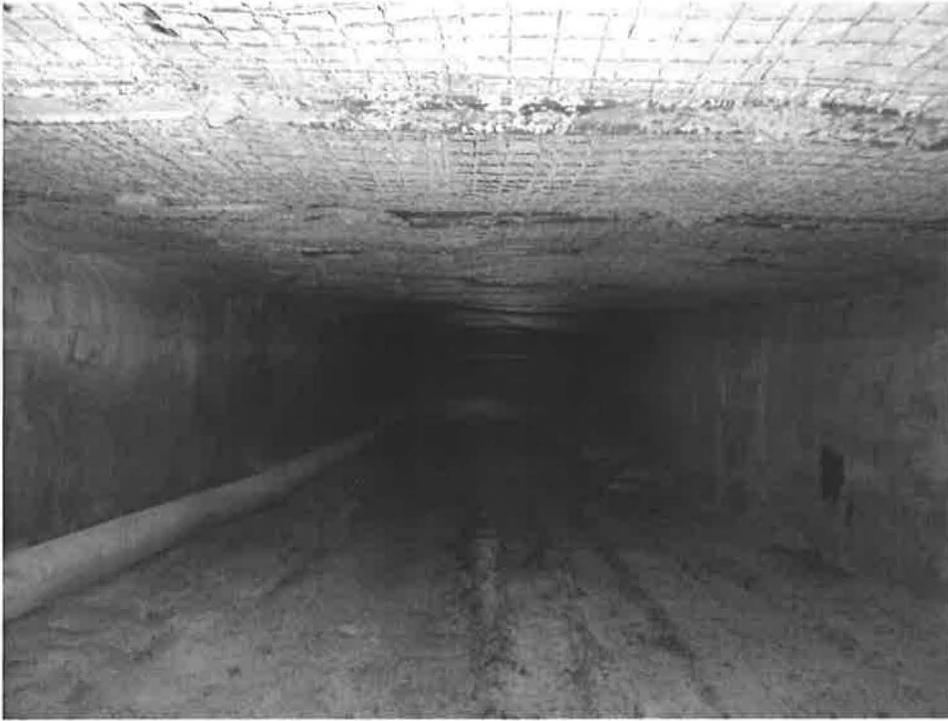
#11 - Ent 1 XC 8-9 Inby

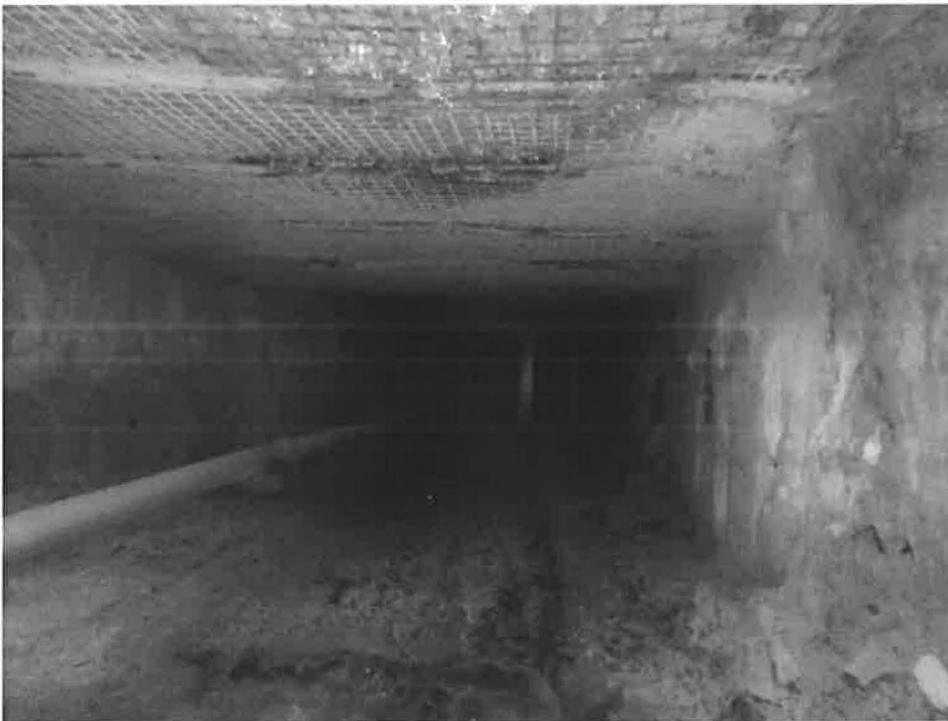
#12 - Ent 1 XC 9 Inby

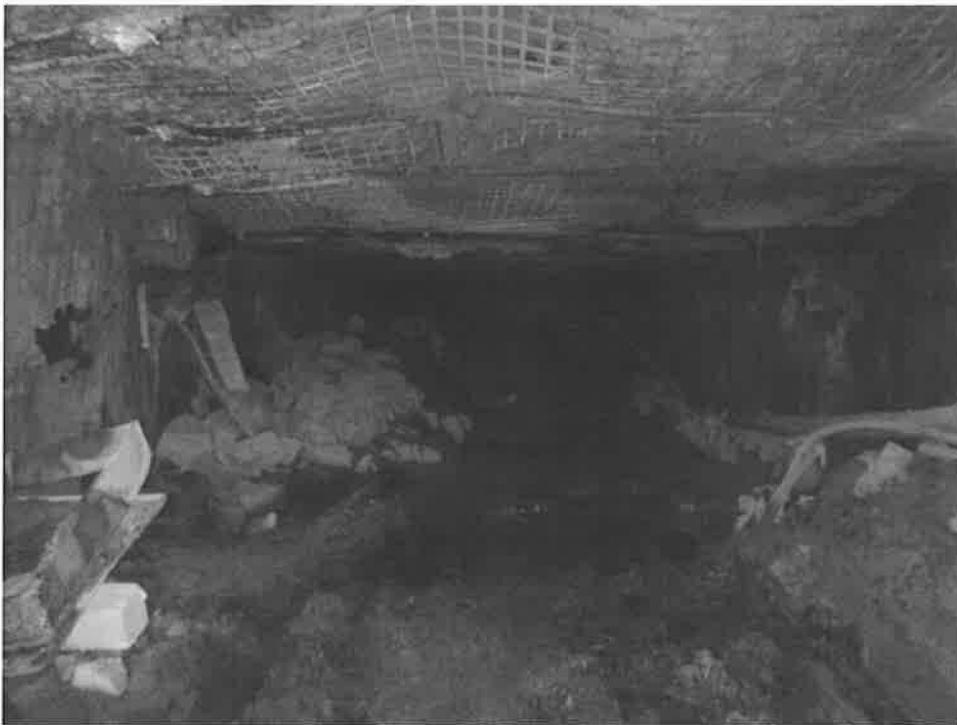
#13 - Ent 1 XC 9 Right

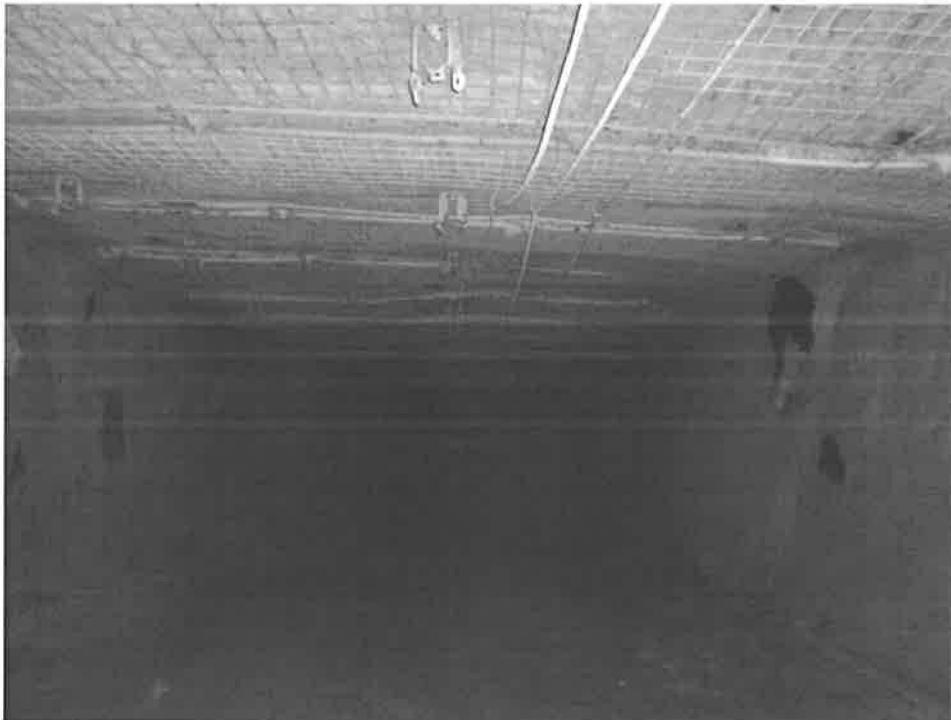
The condition of the roof, ribs and floor is stable, with minor slacking of the roof in places. The coal pillars have remained intact (no rib sloughage) and retain their full support capability after 16+ years. The roof in the belt entry, where the conveyor belt was suspended from the roof, is as stable as the rest of the entries where no load was exerted on the roof. The surface drill hole EM-161 was intercepted by the belt entry at XC-5, and is visible in the coal rib. This hole was cemented from the surface before mining and exhibits a solid cement fill with no water leakage.

#14 - Ent 3 Belt XC 9 Inby

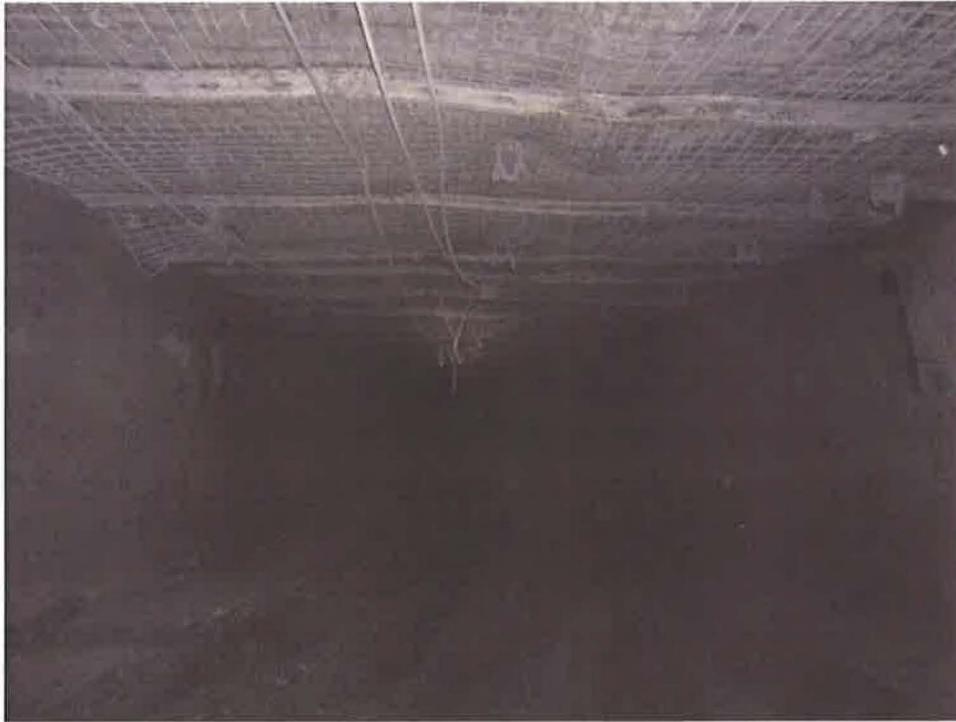
#15 - Ent 3 Belt XC 9 Outby

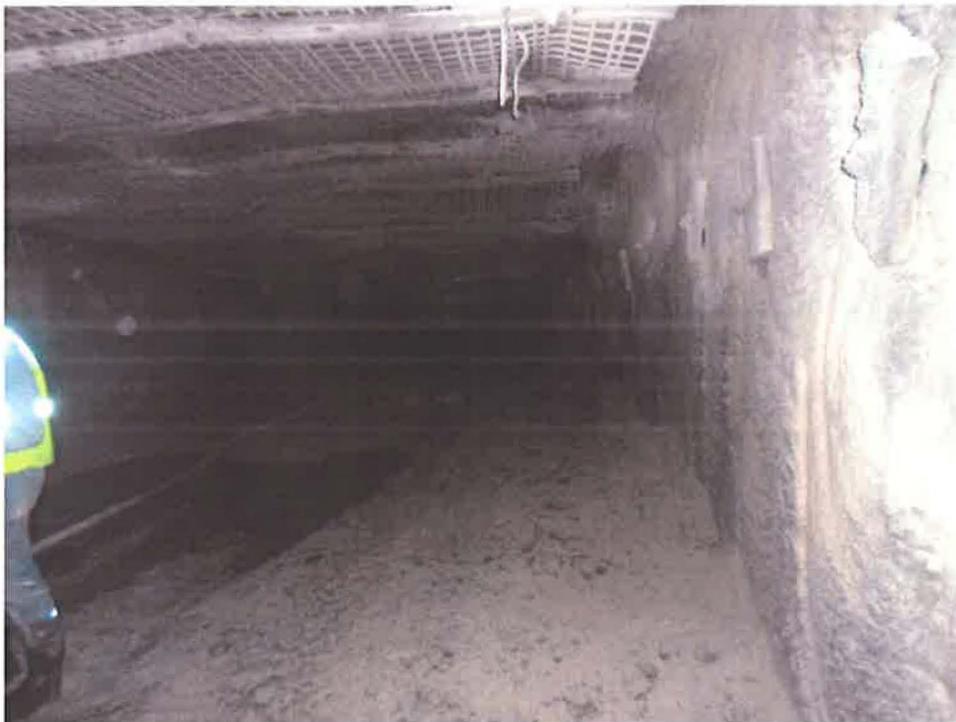
#16 - Ent 5 XC 9-8 Looking Outby

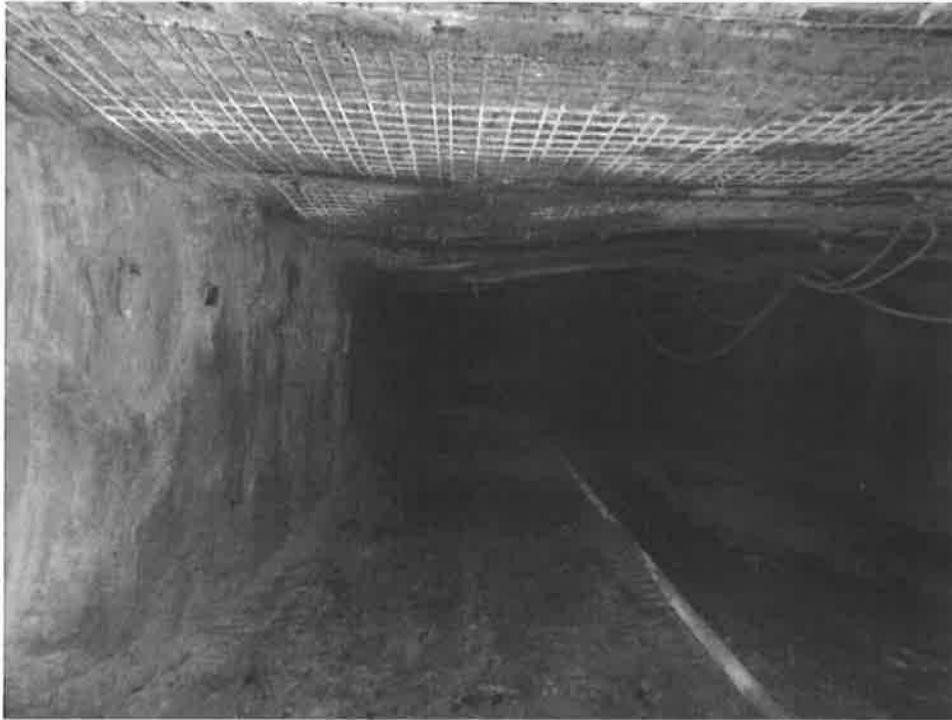
#17 - Ent 5 XC 7 Looking Outby

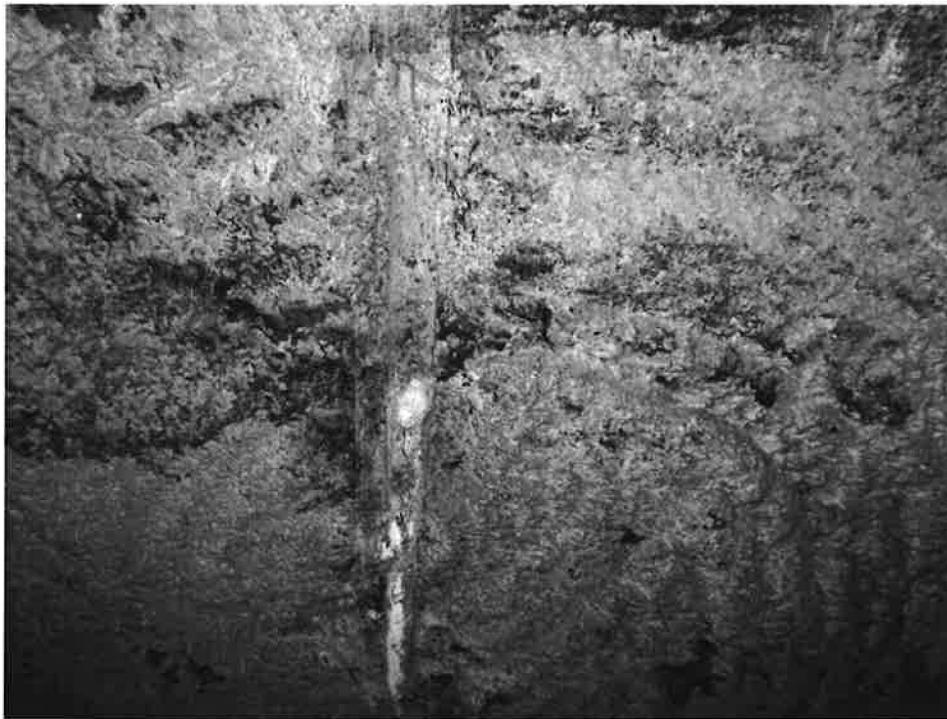
#18 - Ent 3 XC 5 Belt Drillhole EM-161 Cement and PVC Pipe

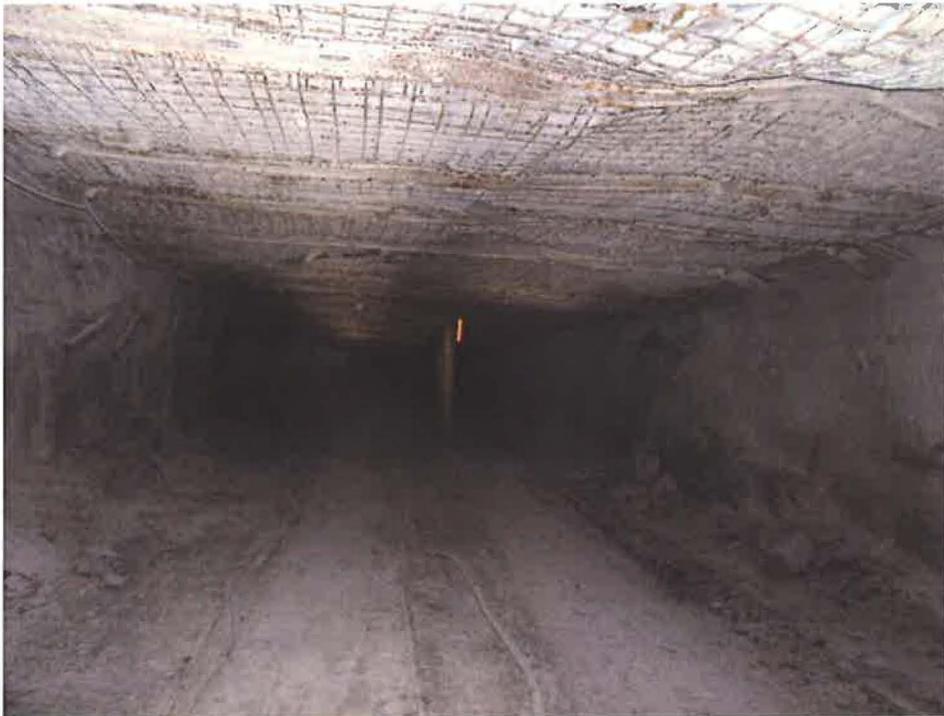
#19 - Ent 2 XC 4-5 Looking Inby

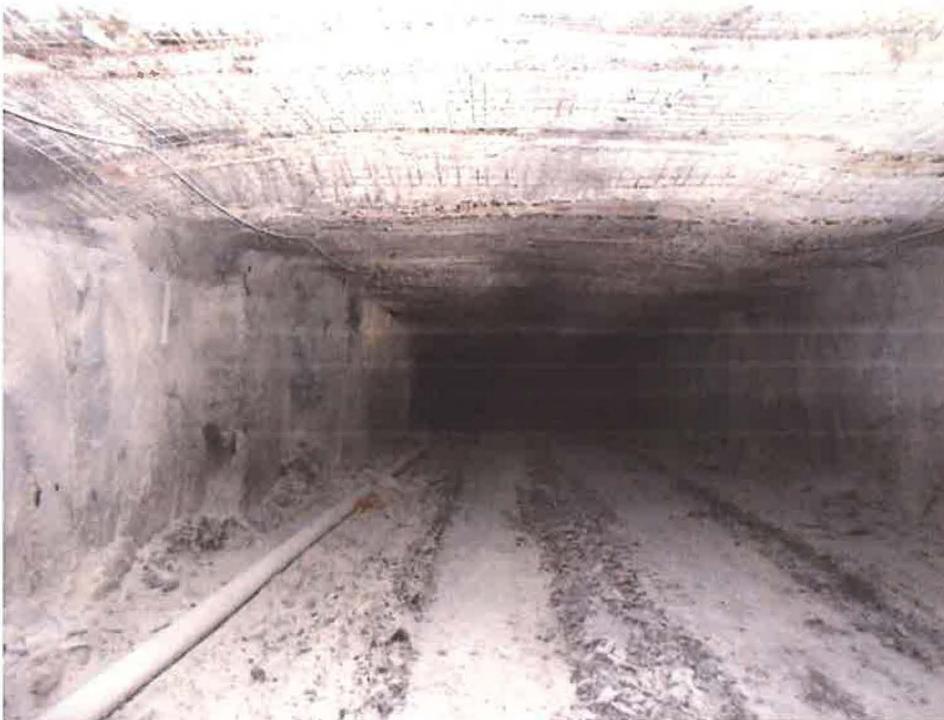
#20 - Ent 2 XC-4 Looking Outby

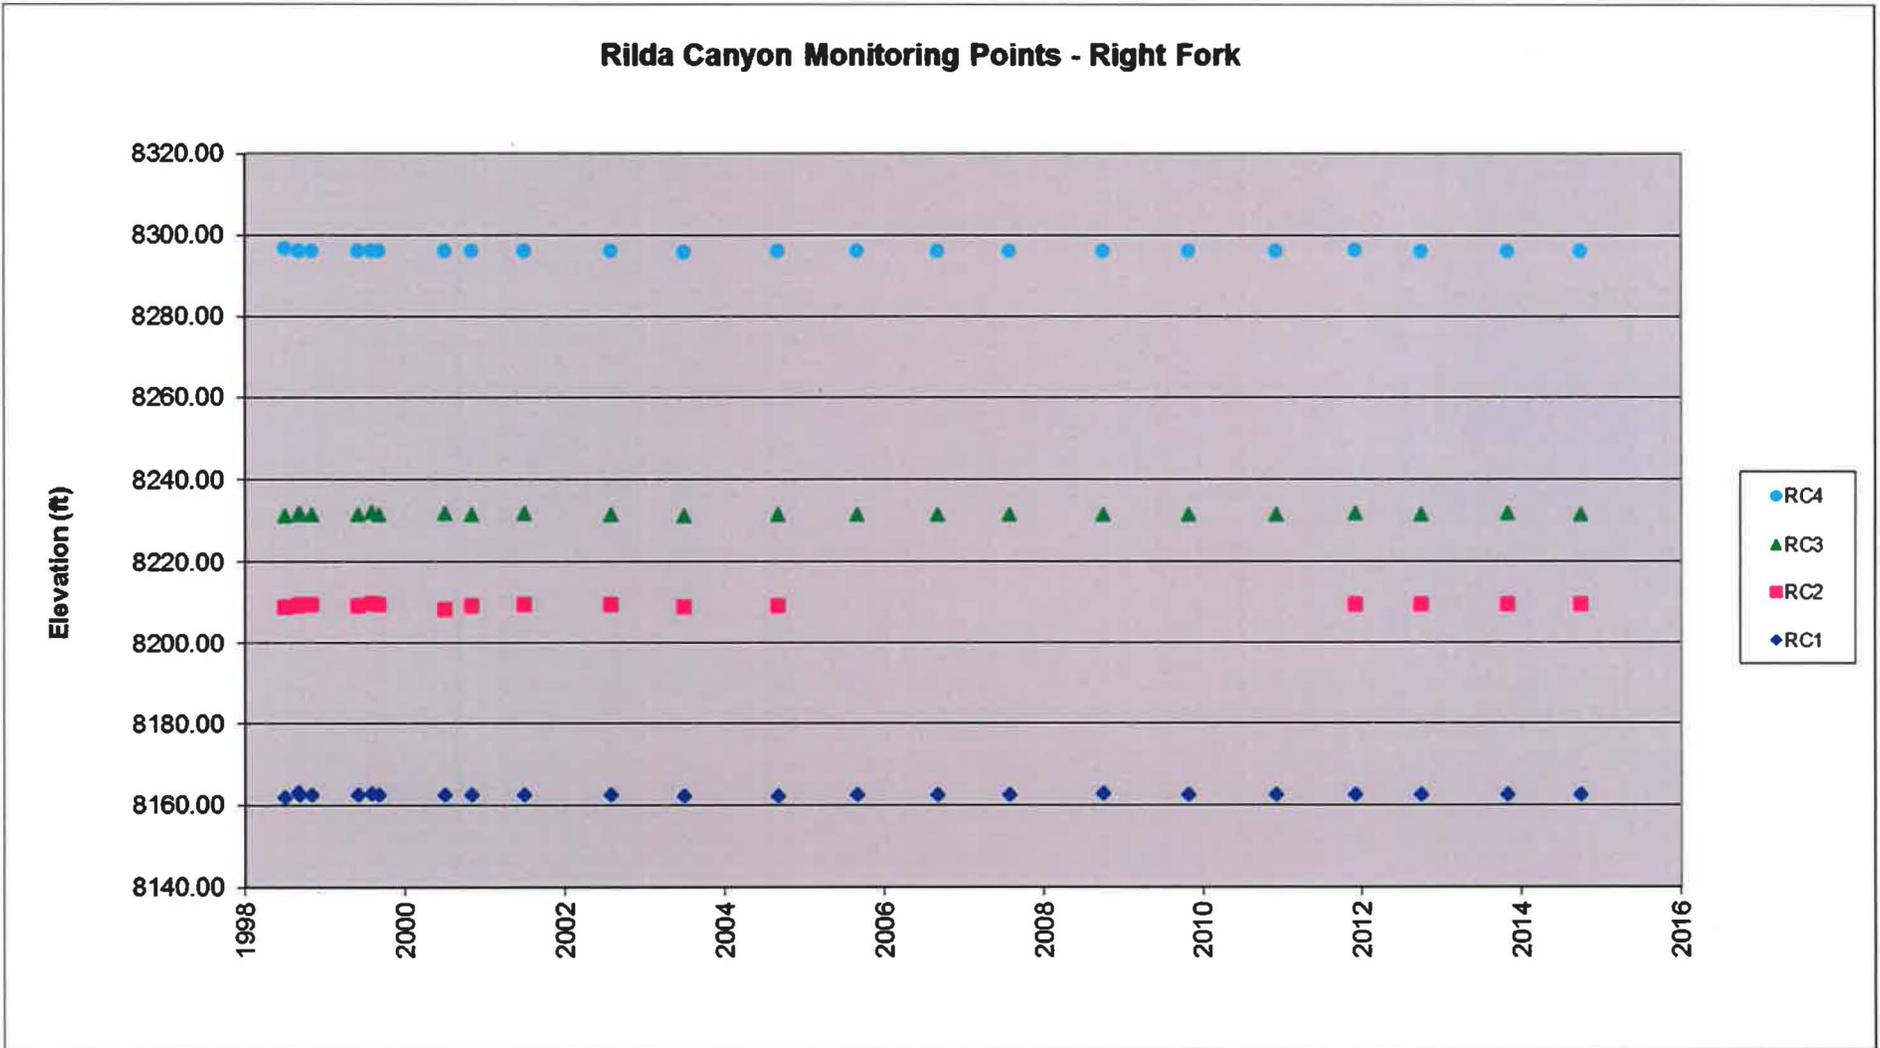
Chart 1. Graph of Rilda Canyon Right Fork Stream Crossing Area Surveyed Subsidence Monitoring Points vs. Year of Survey

Surface stability data has been generated in the form of surface monitoring points in the right fork of Rilda Canyon. A set of four points (see Map) was established on June 25, 1998 that spans the 5th North crossing area. These points have been surveyed at least annually each year since they were established (see Table and Charts). None of the points has shown any signs of subsidence, reflecting the conditions observed underground.
