Interwest Mining Company  
Huntington Office  
P. O. Box 310  
15 North Main Street  
Huntington, UT 84528

July 27, 2016

**Subj: Precipitation Event on East Mountain and Deer Creek Mine – July 19, 2016**

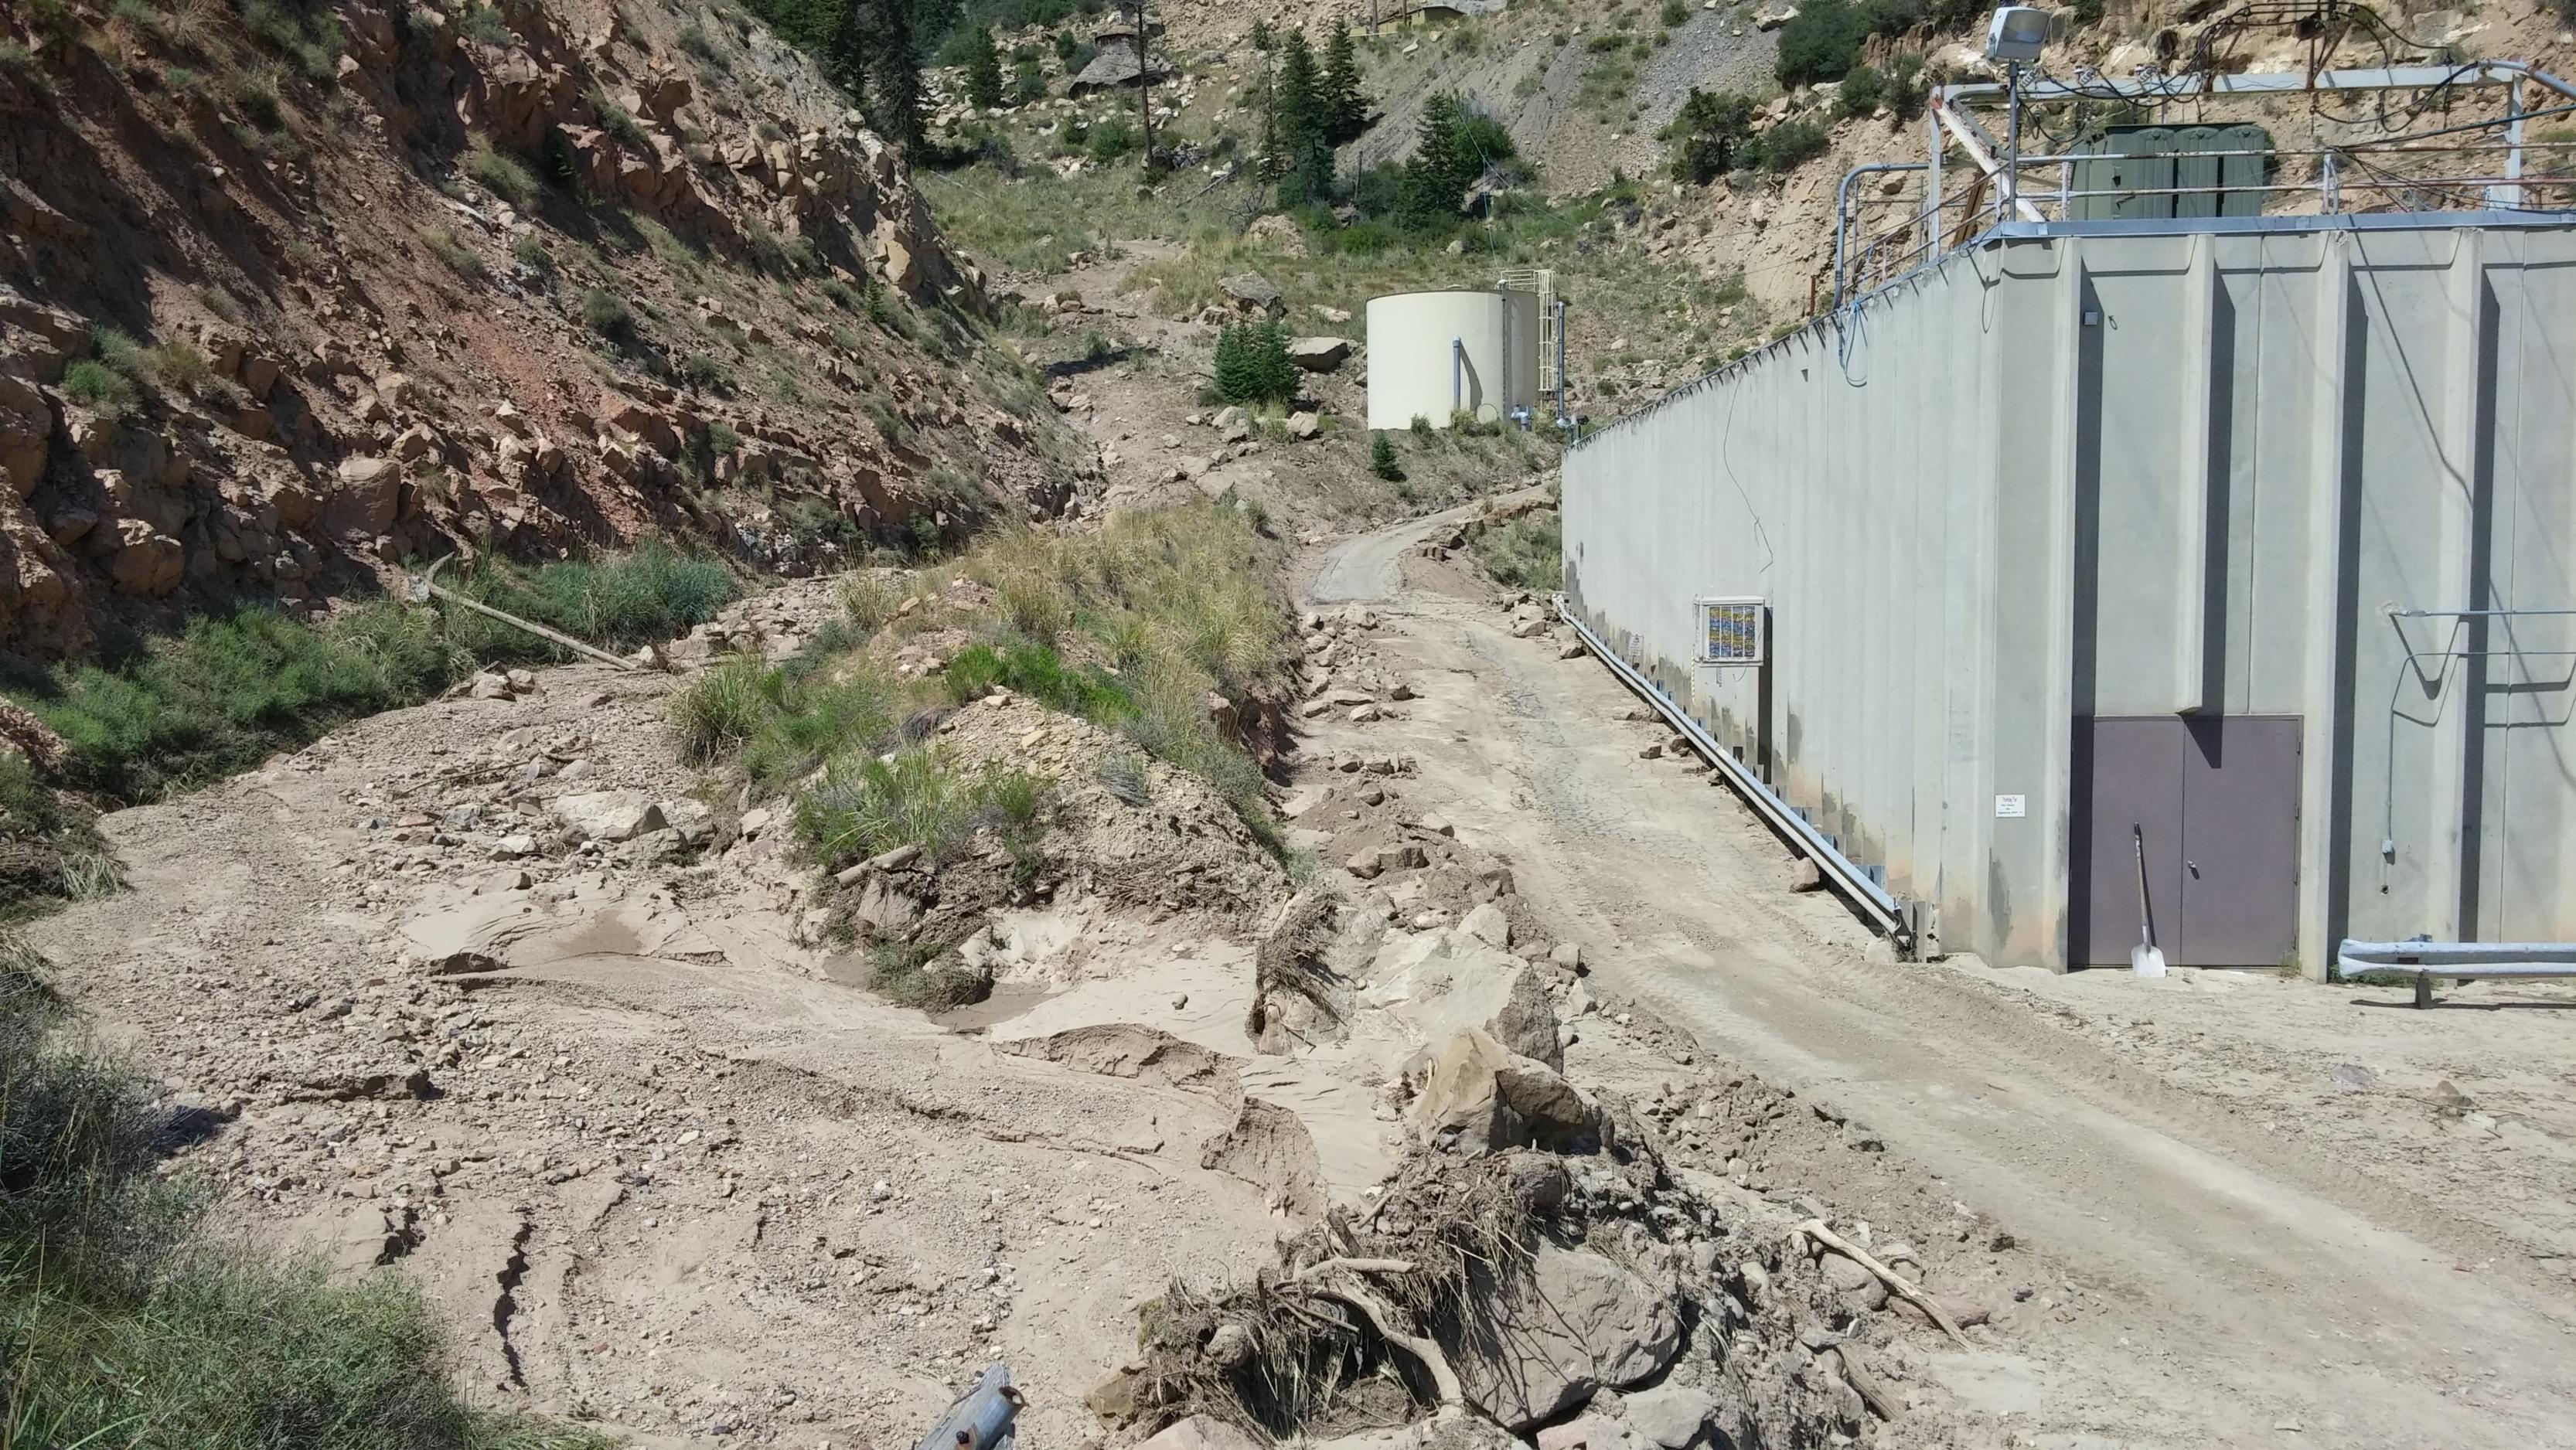
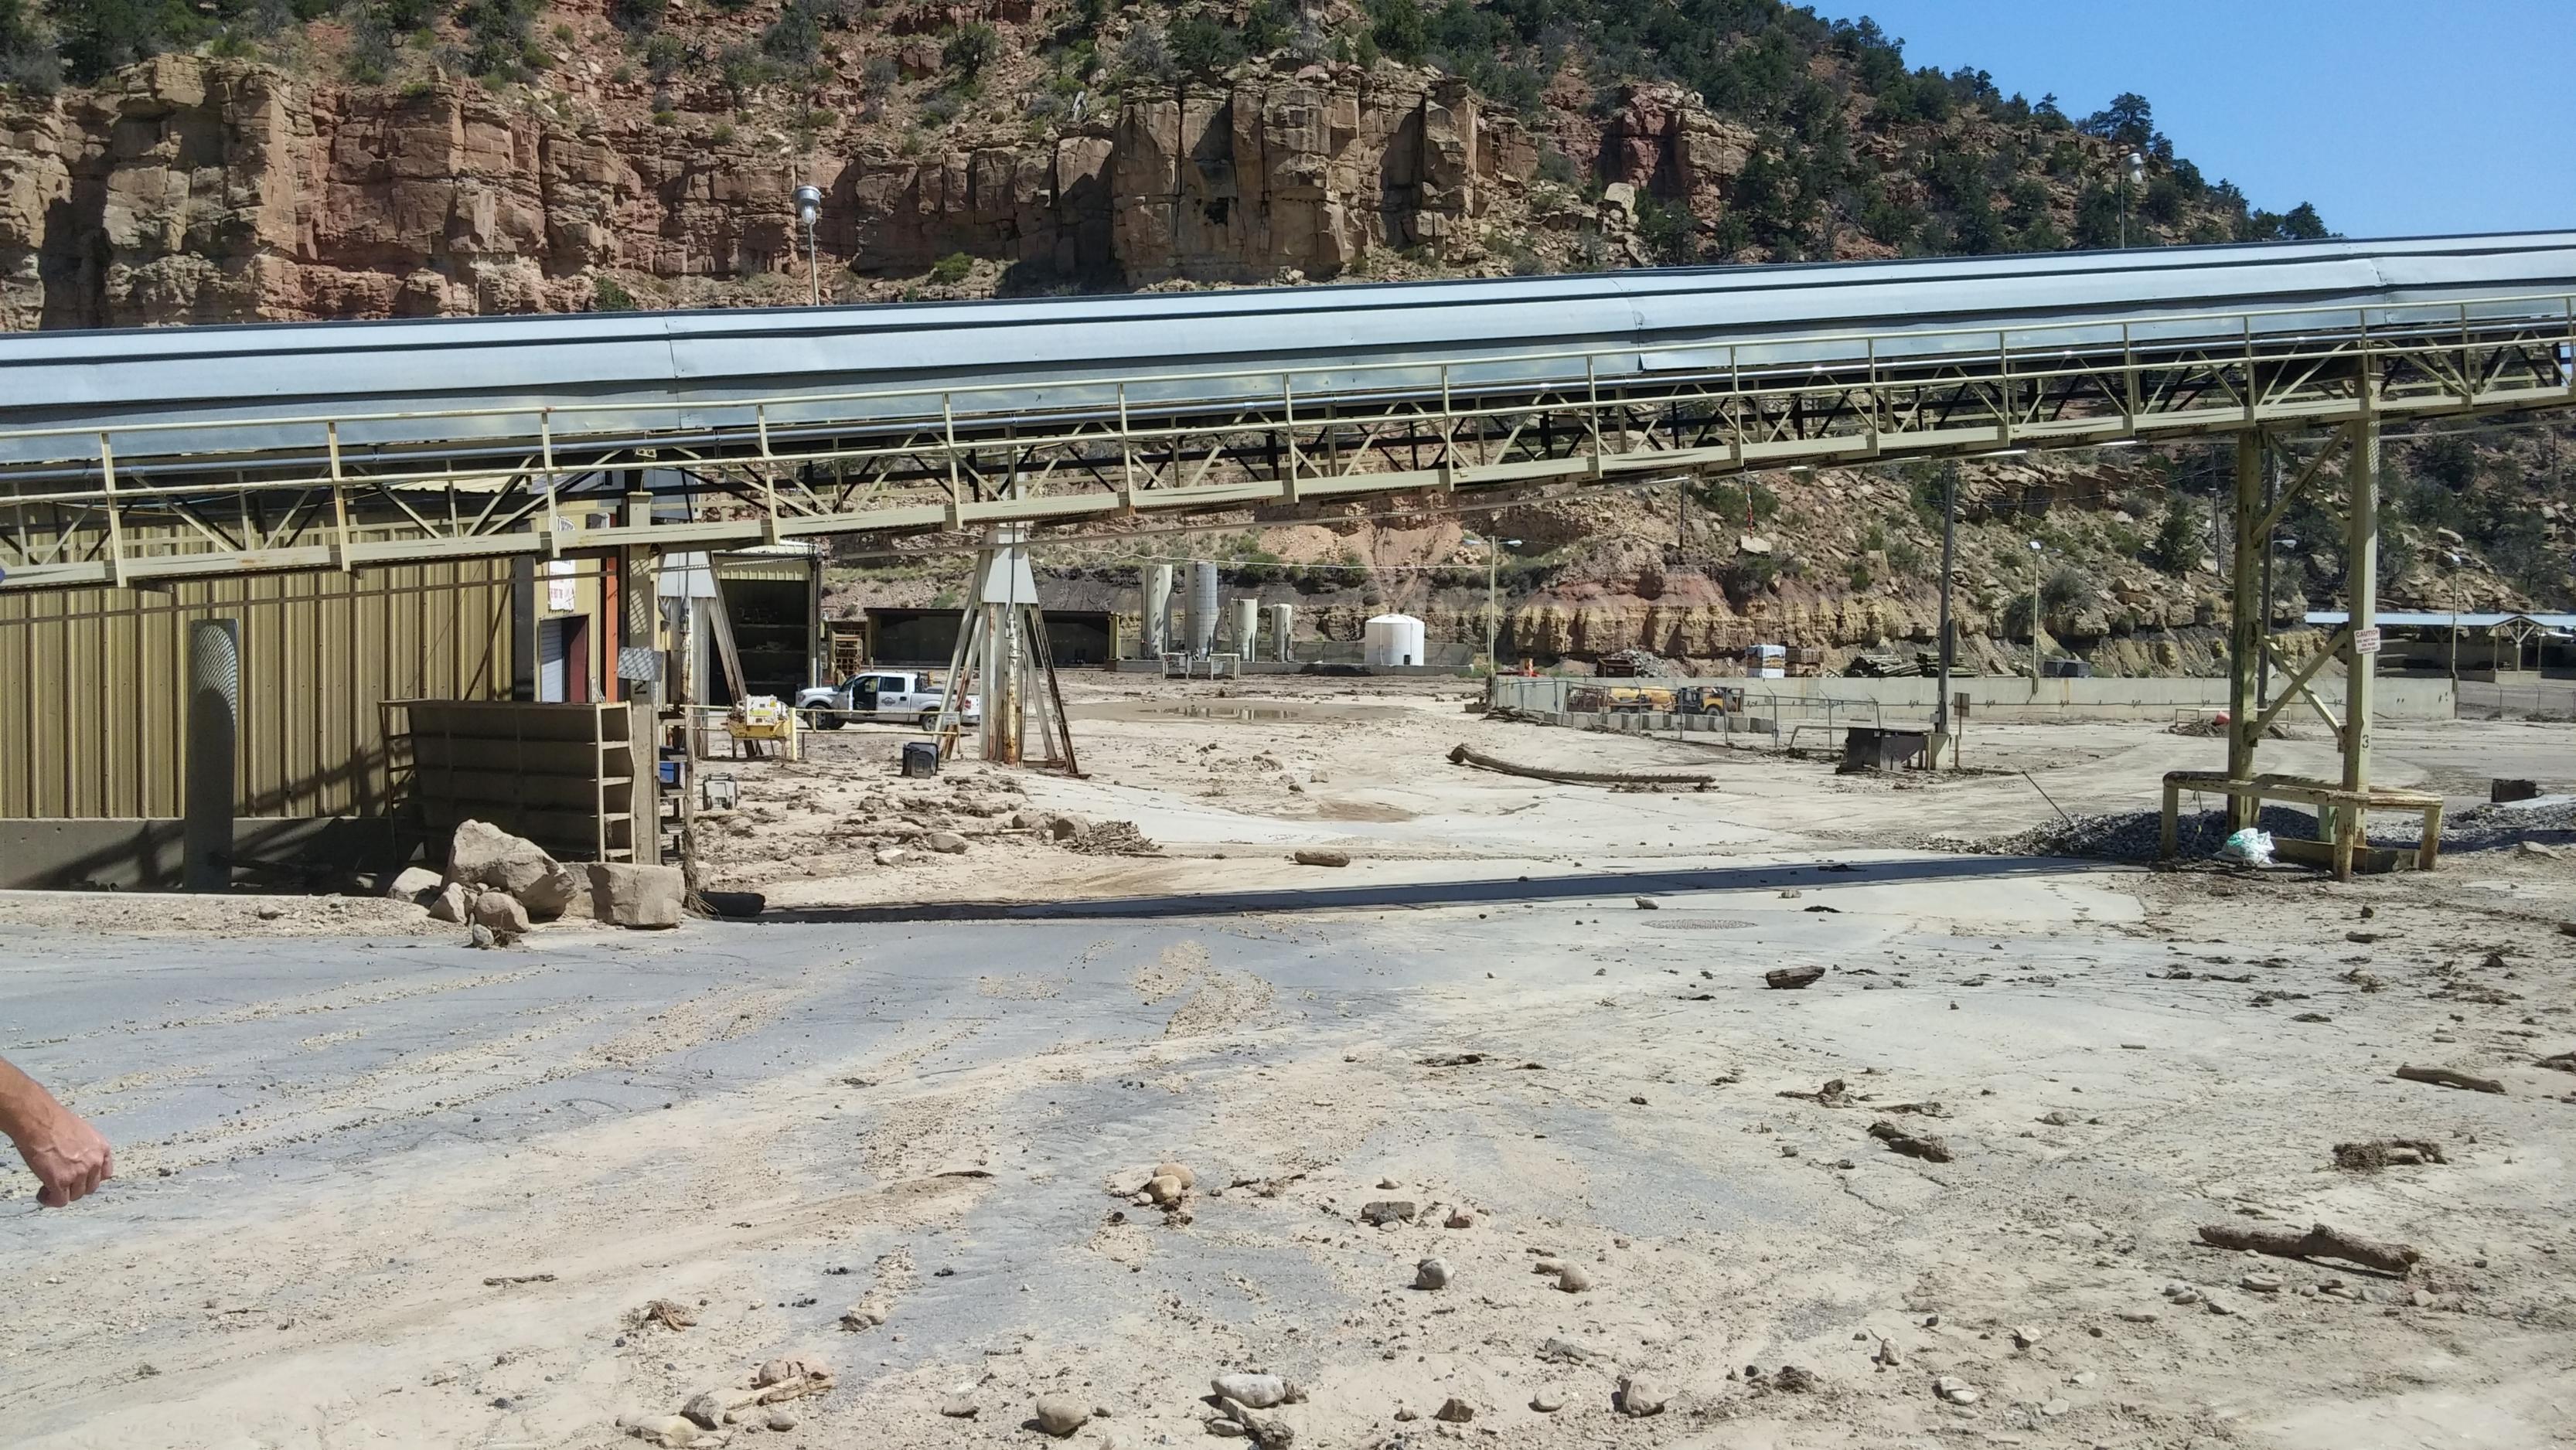
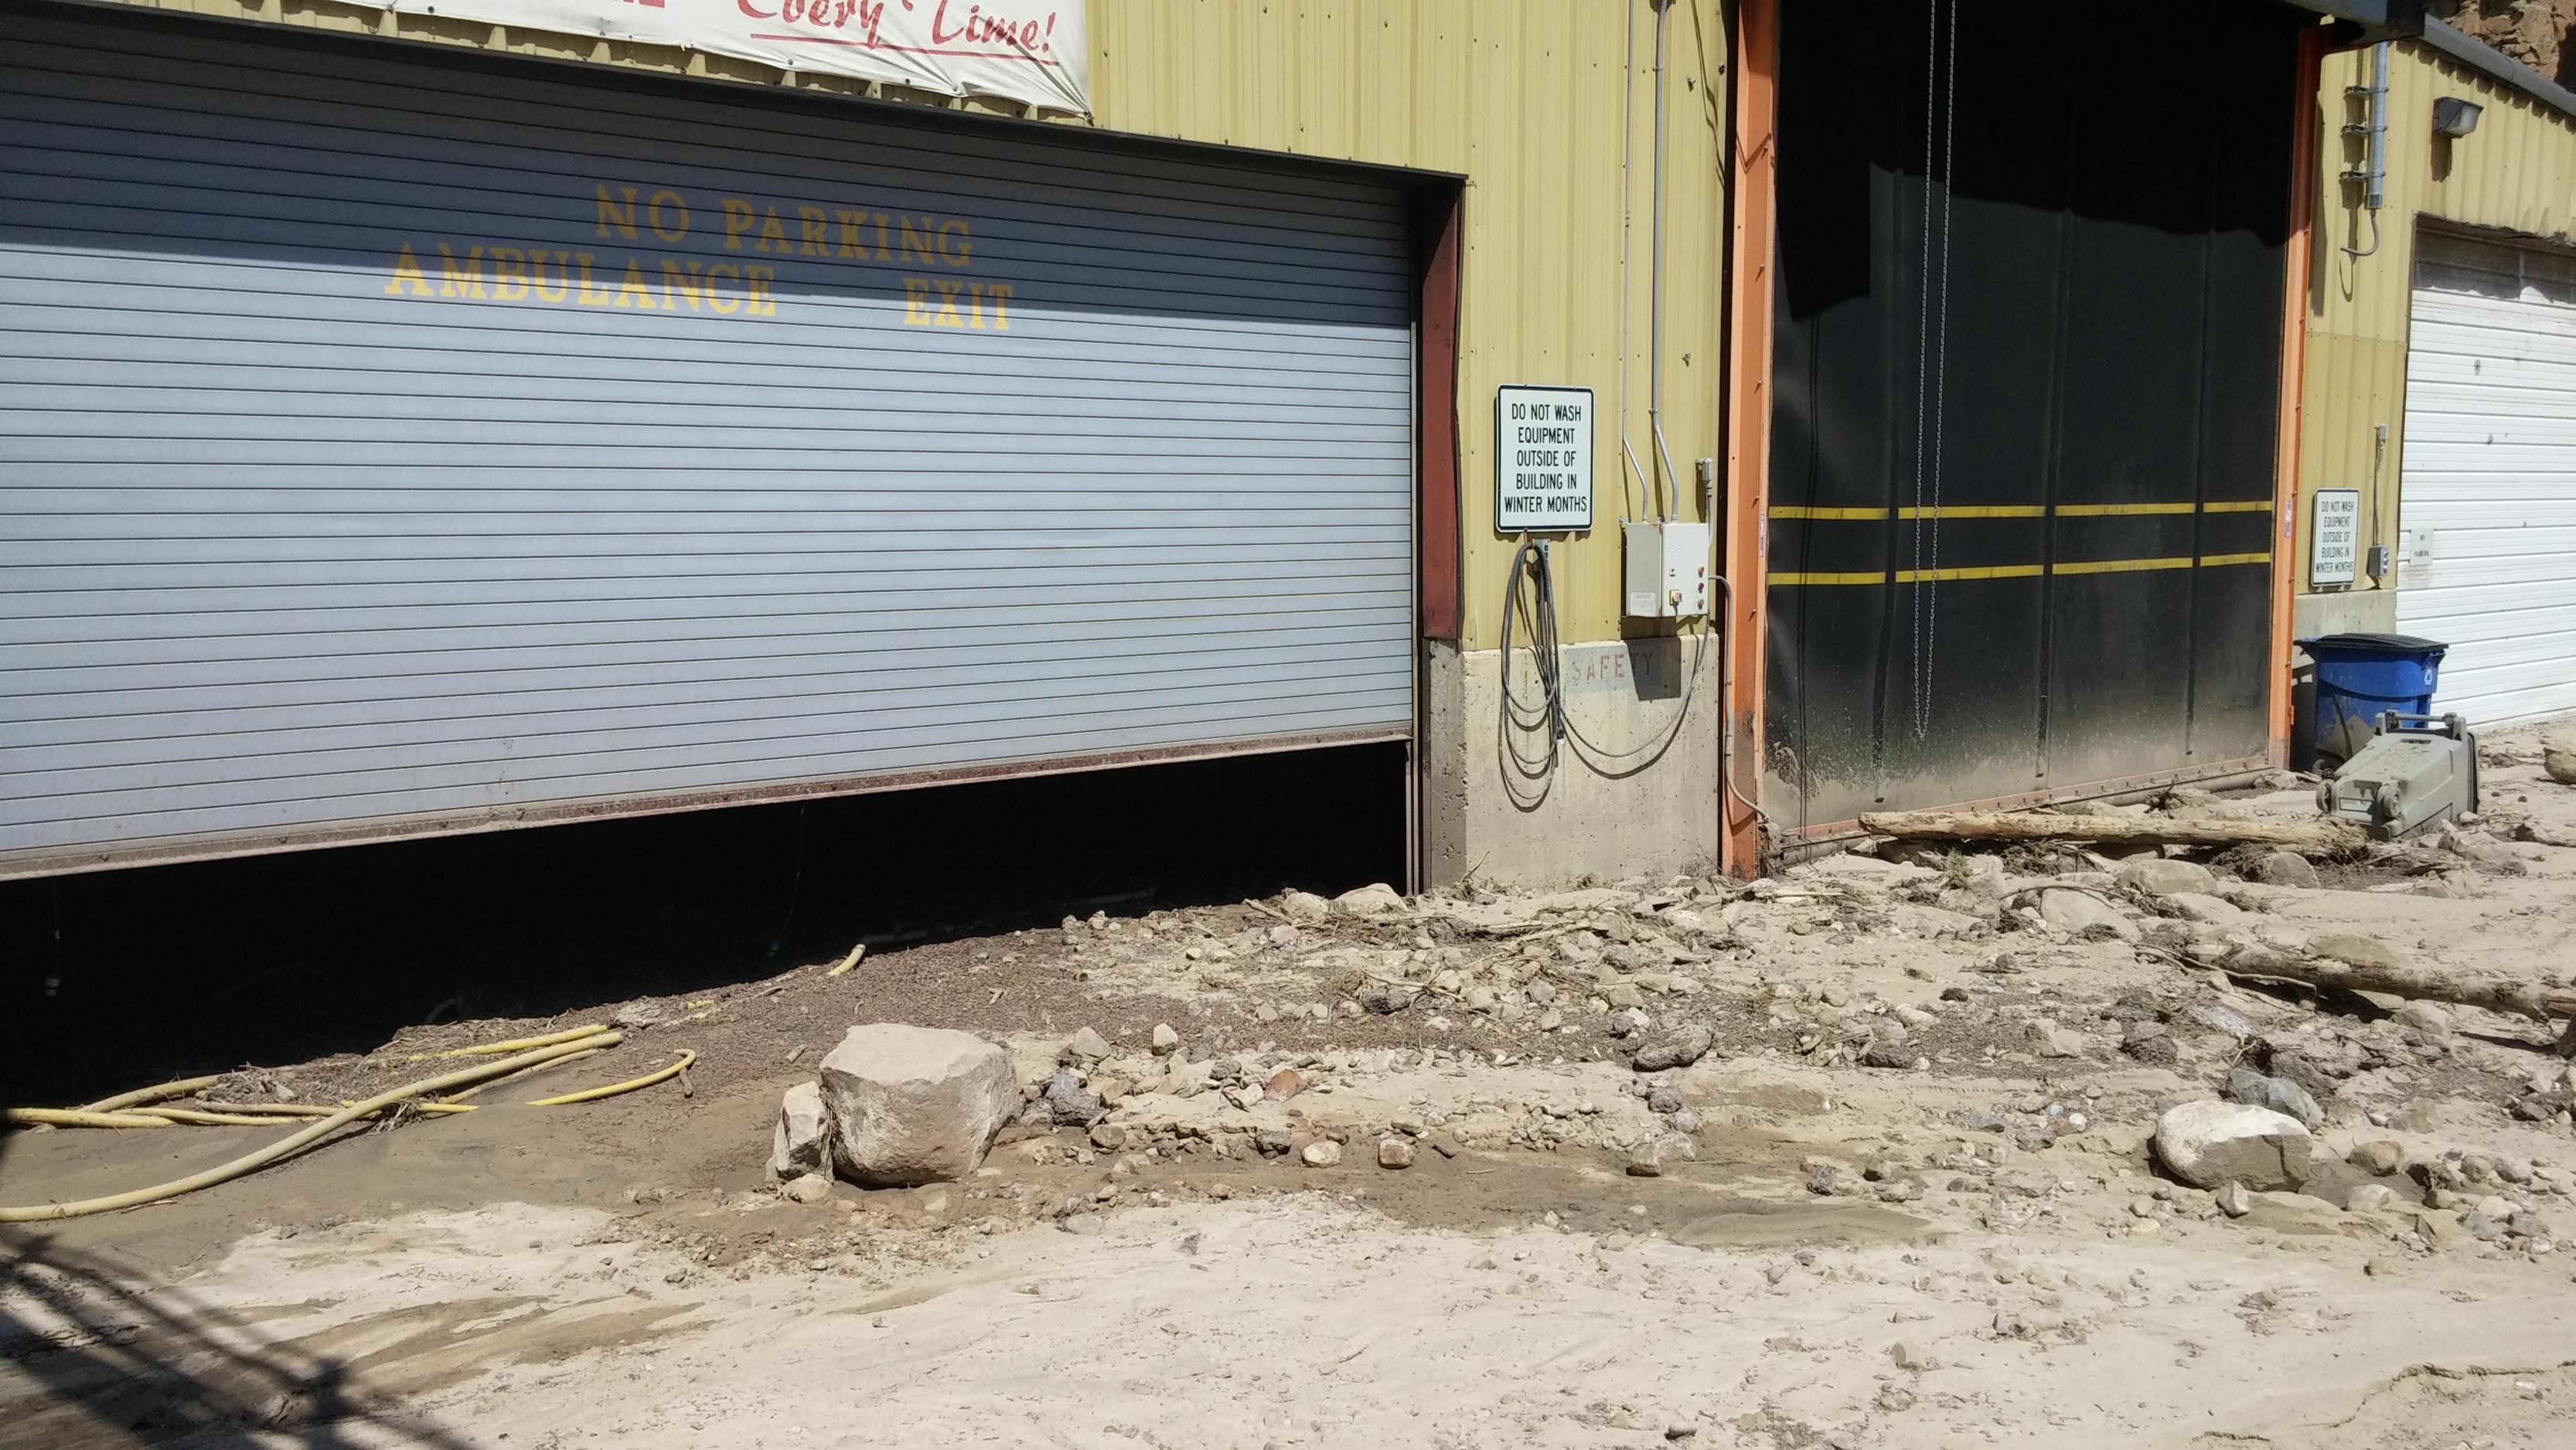
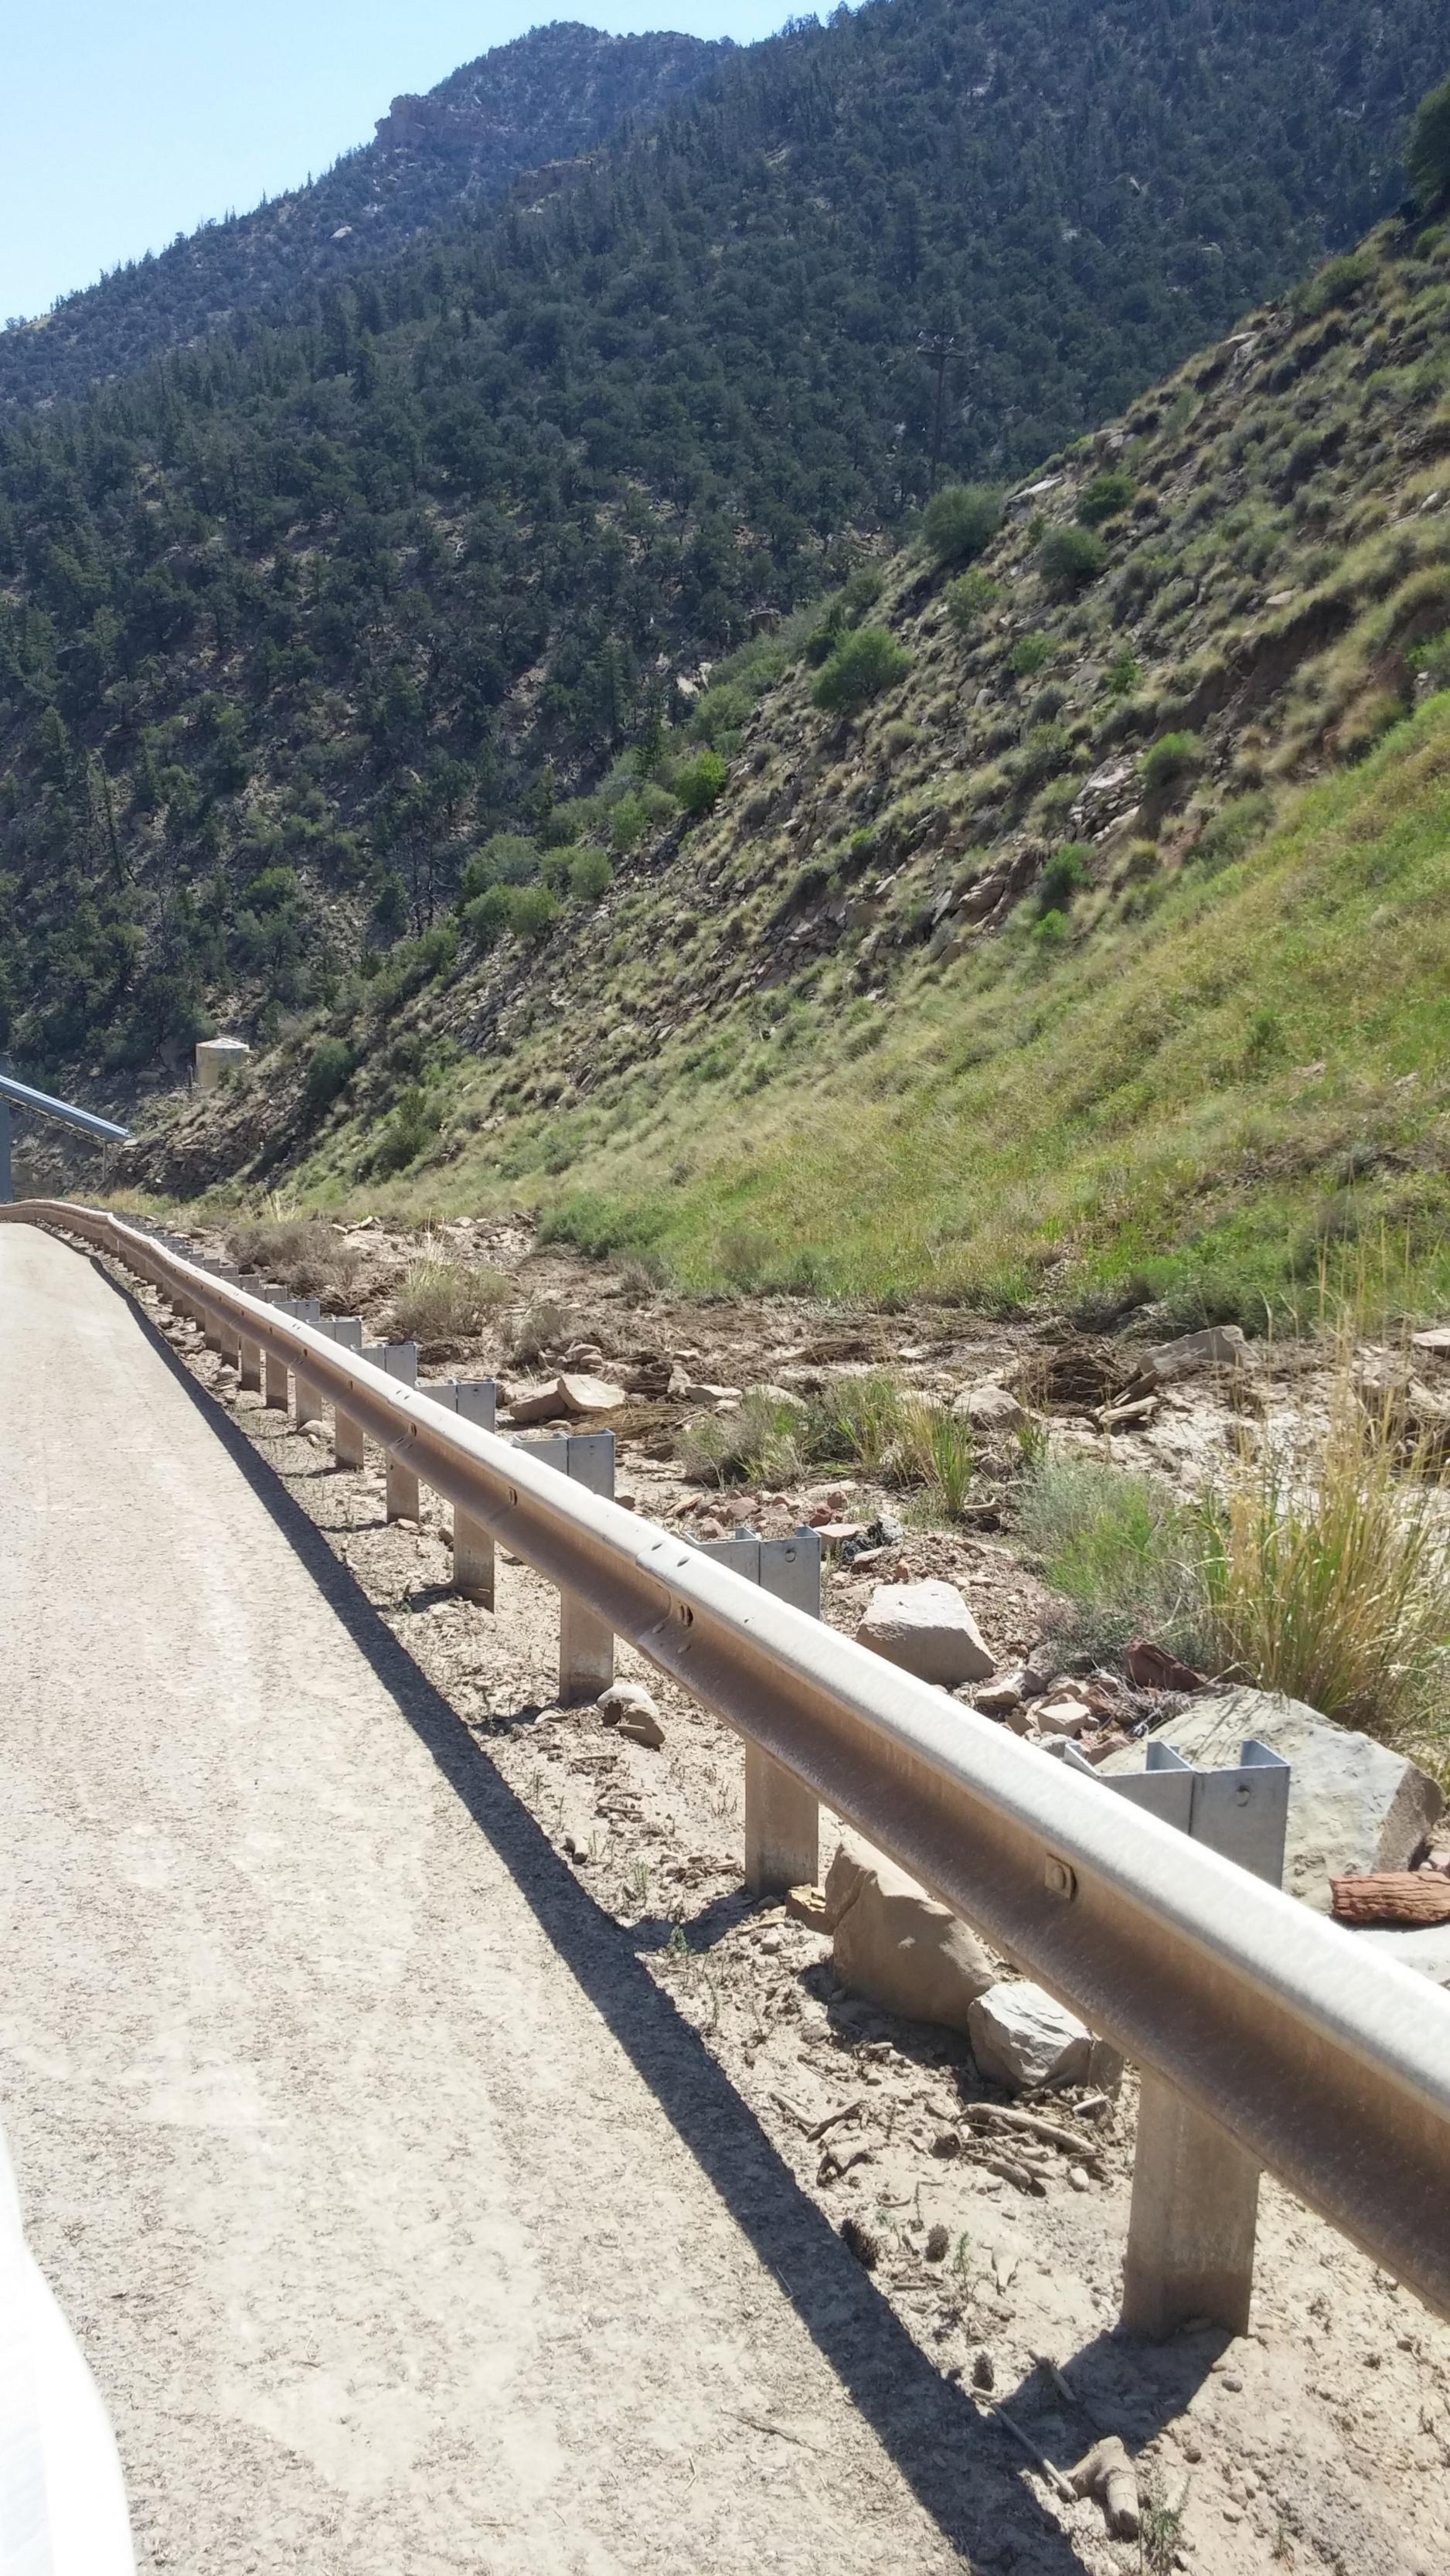
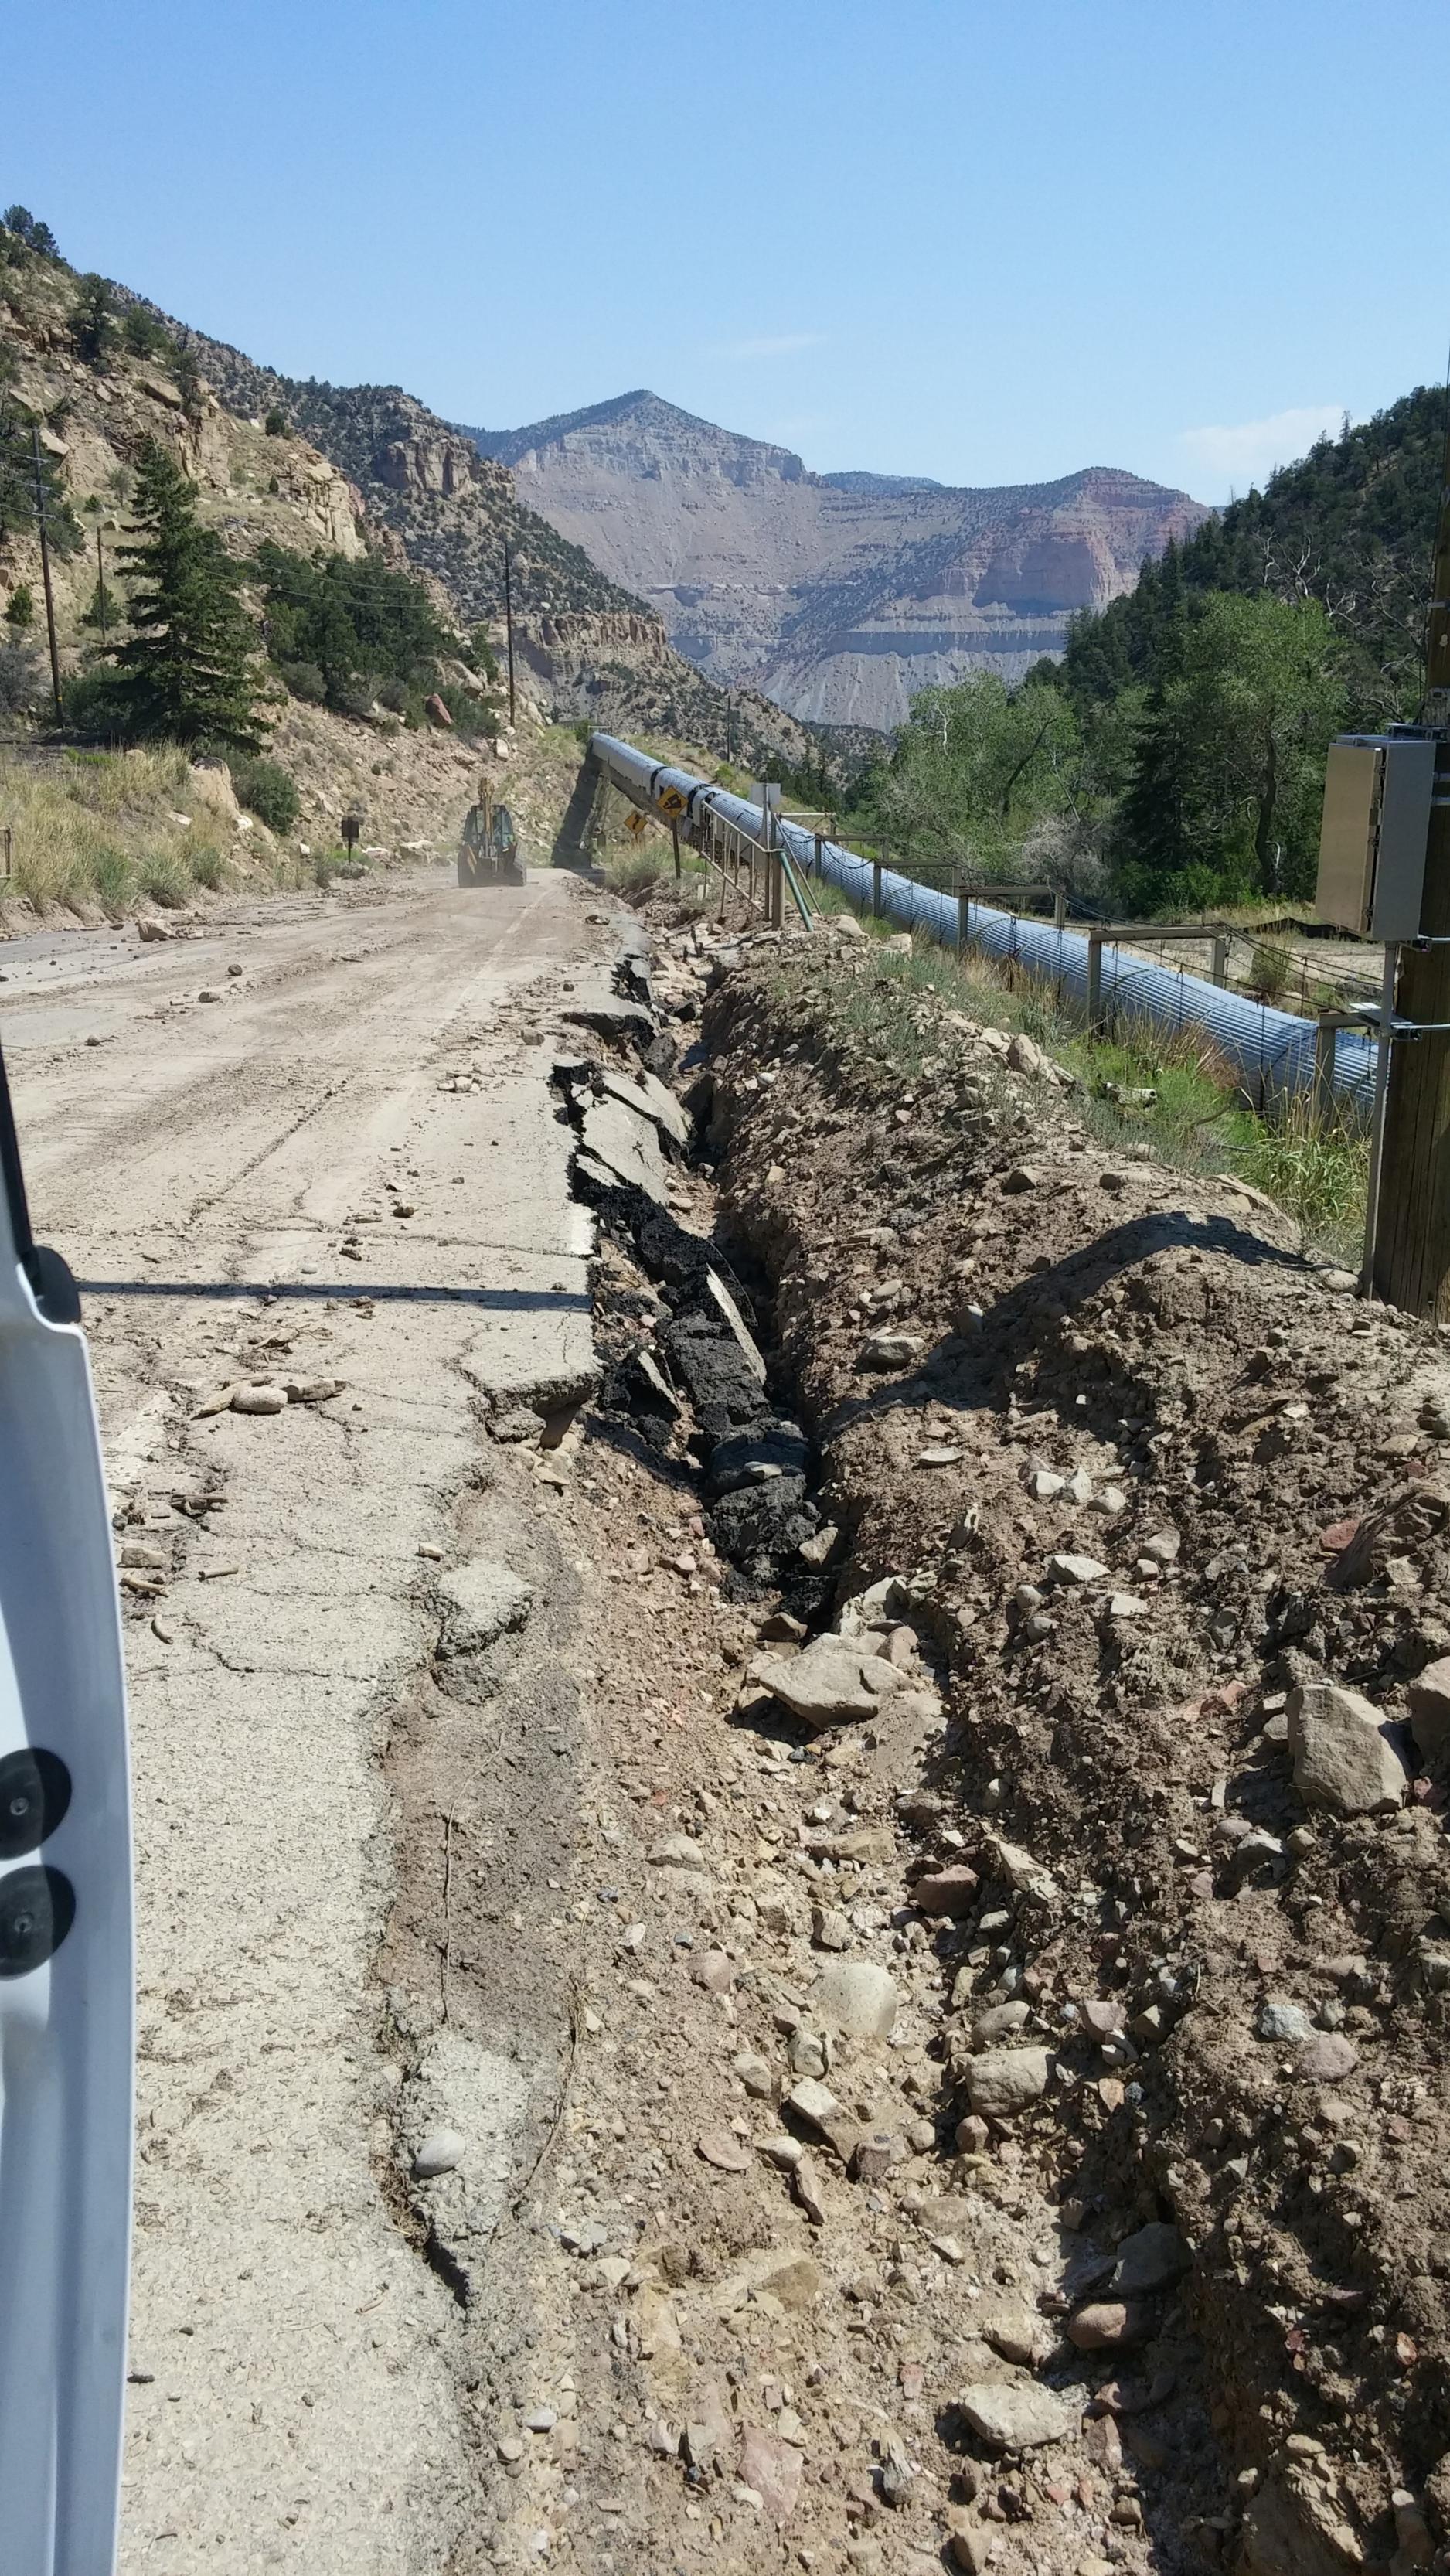
A precipitation event on East Mountain on Tuesday, July 19 caused extensive damage to the sediment controls at the Deer Creek Mine site in Deer Creek Canyon and Rilda Canyon.

There is no rain gauge at the Deer Creek site. At the Rilda canyon portals a rain gauge showed 1.25” of rain for this event and a rain gauge at Huntington Plant showed 0.79” of rain in 30 minutes for this storm. Interwest’s weather station above Des-Bee-Dove mine showed no rainfall. At the Rhino Castle Valley mine, the rain gauge showed 0.5”. These readings indicate the localized nature of the storm. The origin of this flood was on East Mountain above the uppermost structures at Deer Creek, the flow exceeded the design capacity of the bypass culvert, which has operated successfully for the last 45 years.

Operations personnel at the mine immediately contacted Nielson construction to mobilize and repair the damage. Construction equipment is already working on-site repairing the damage.
