# Inspection Report

Permit Number:	<b>C0150018</b>
Inspection Type:	PARTIAL
Inspection Date:	Wednesday, October 05, 2016
Start Date/Time:	10/5/2016 8:30:00 AM
End Date/Time:	10/5/2016 1:30:00 PM
Last Inspection:	Thursday, September 08, 2016

Permitee: **PACIFICORP**  
 Operator: **INTERWEST MINING CO**  
 Site: **DEER CREEK MINE**  
 Address: **PO BOX 310, HUNTINGTON UT 84528**  
 County: **EMERY**  
 Permit Type: **PERMANENT COAL PROGRAM**  
 Permit Status: **ACTIVE**

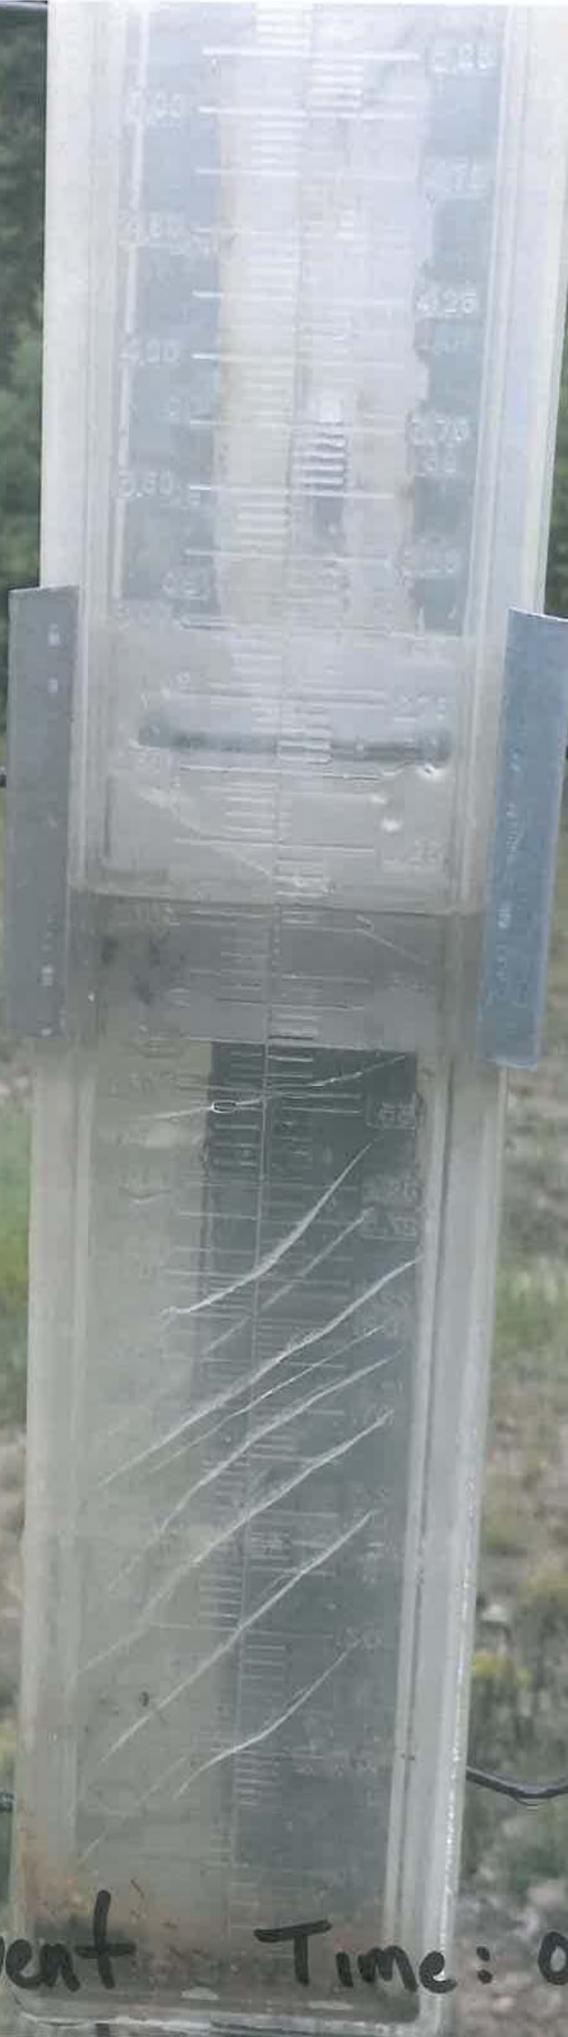
≈ 2.05"

9/22/16 Event Time: 0830

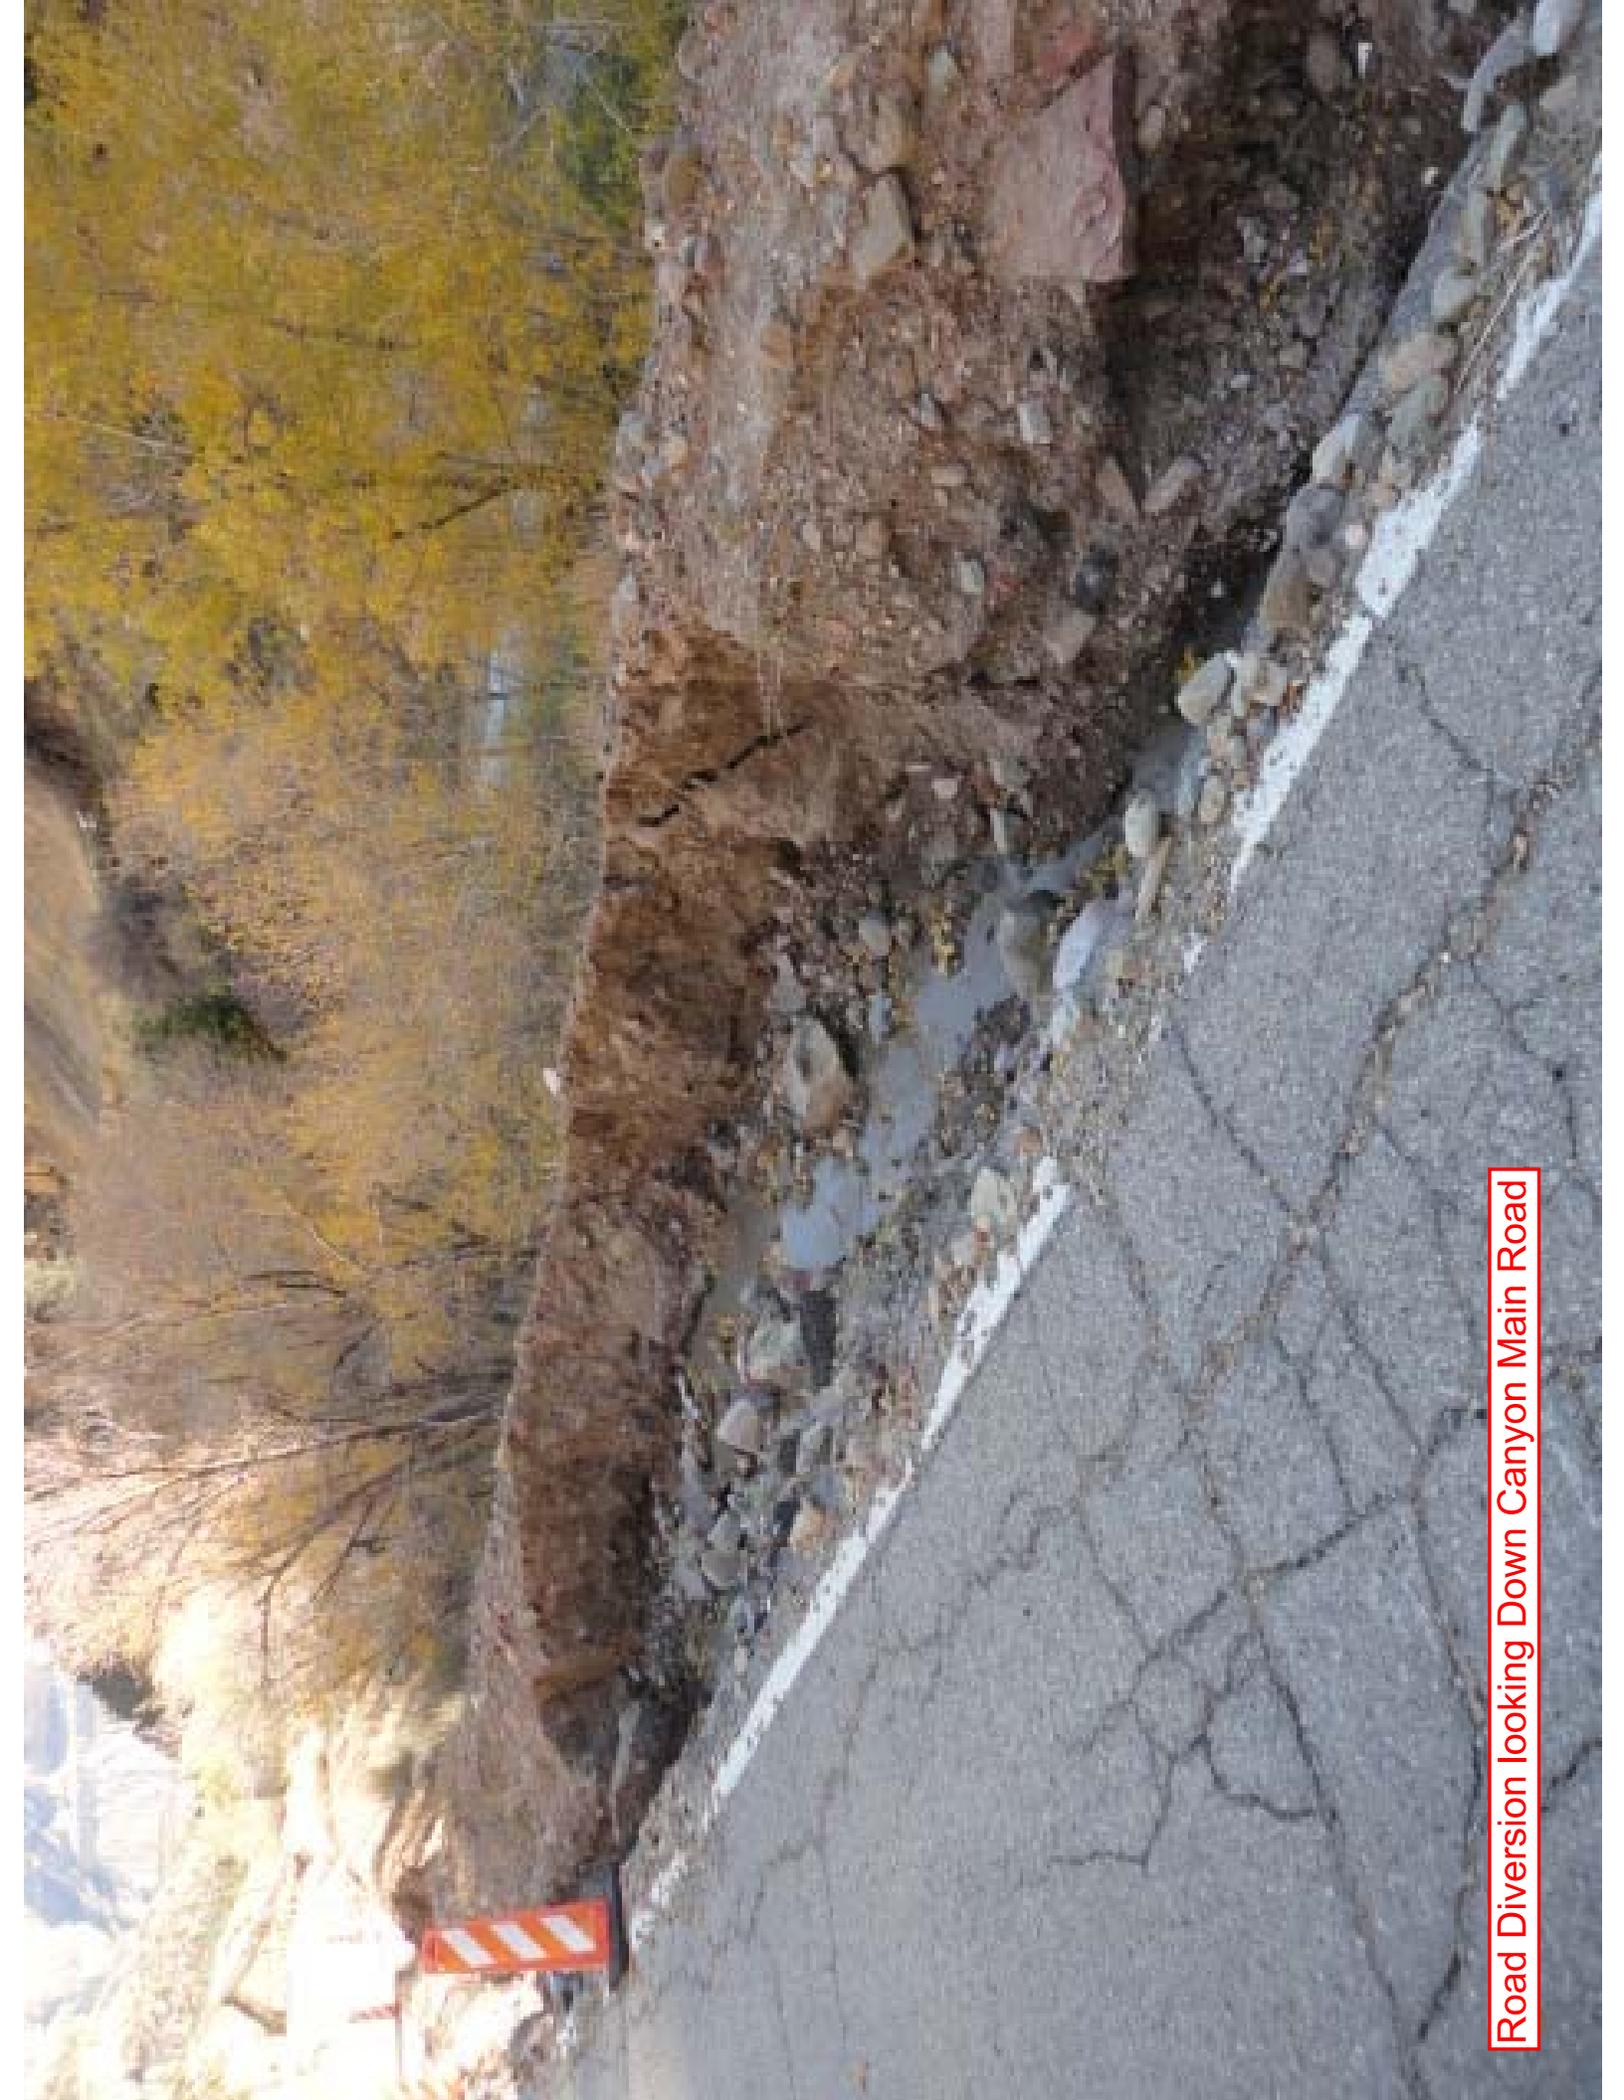
Road Diversion looking Down Canyon Main Road

Virtually all of the diversions on the main mine site have been impacted by a high intensity storm event that took place on 9/21-22/2016. Work is currently being done to restore the diversions to their approved designs.

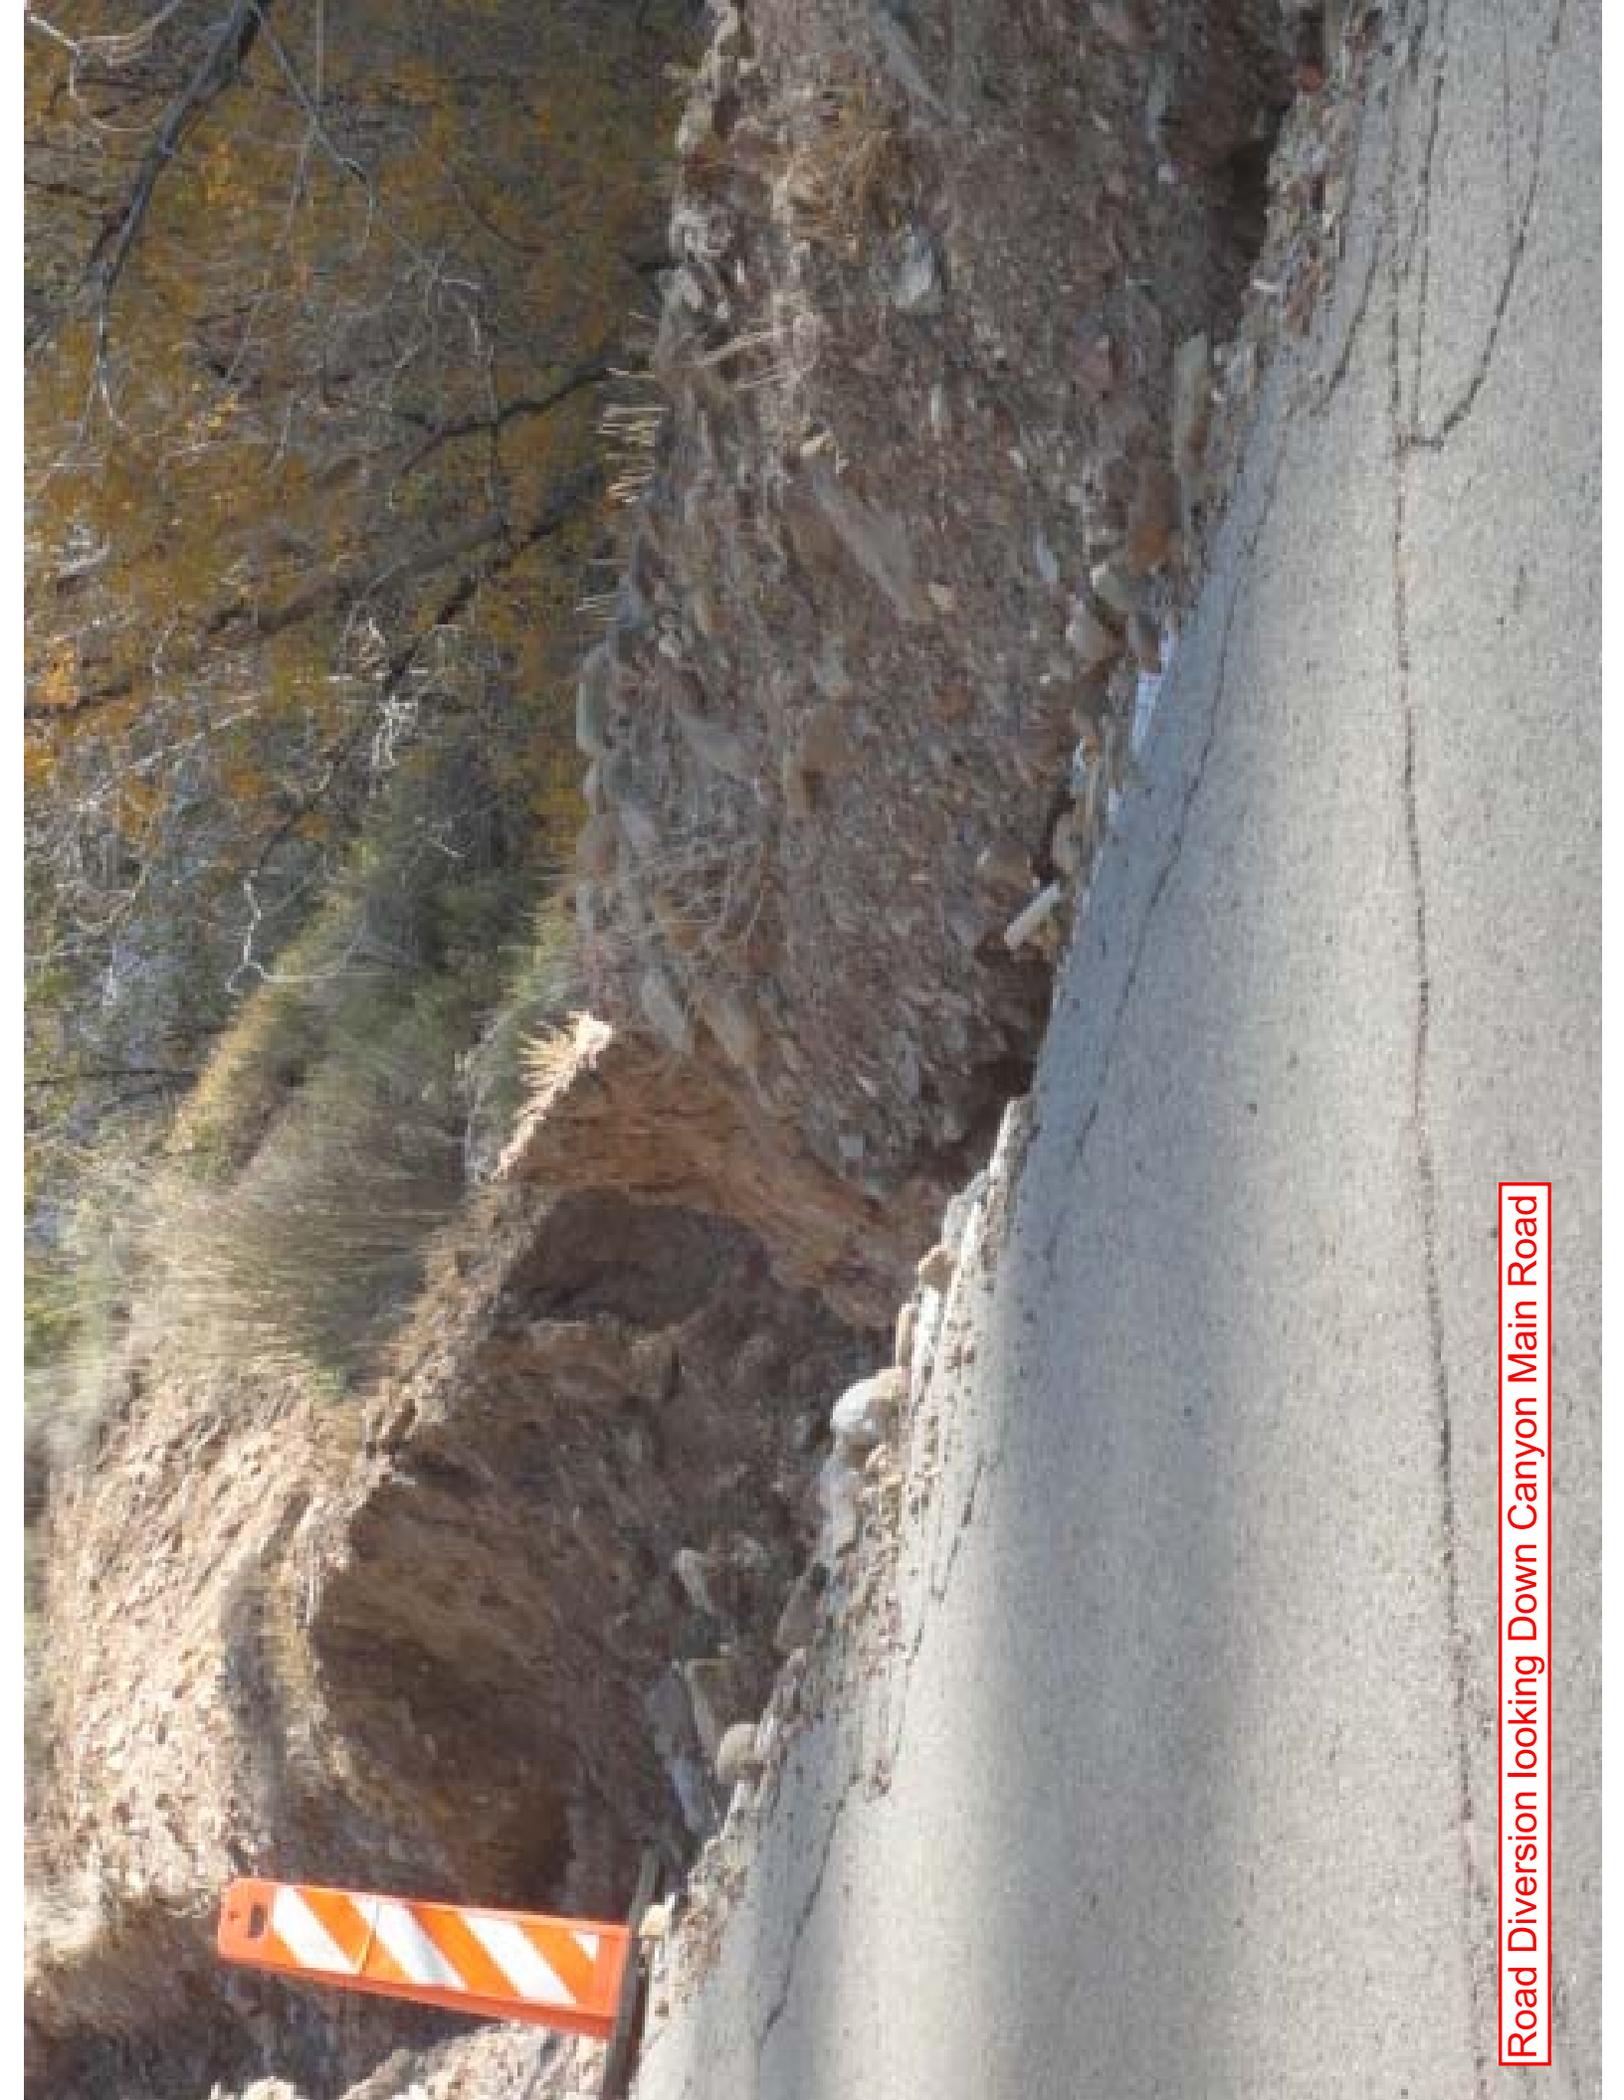
Road Diversion looking Down Canyon Main Road

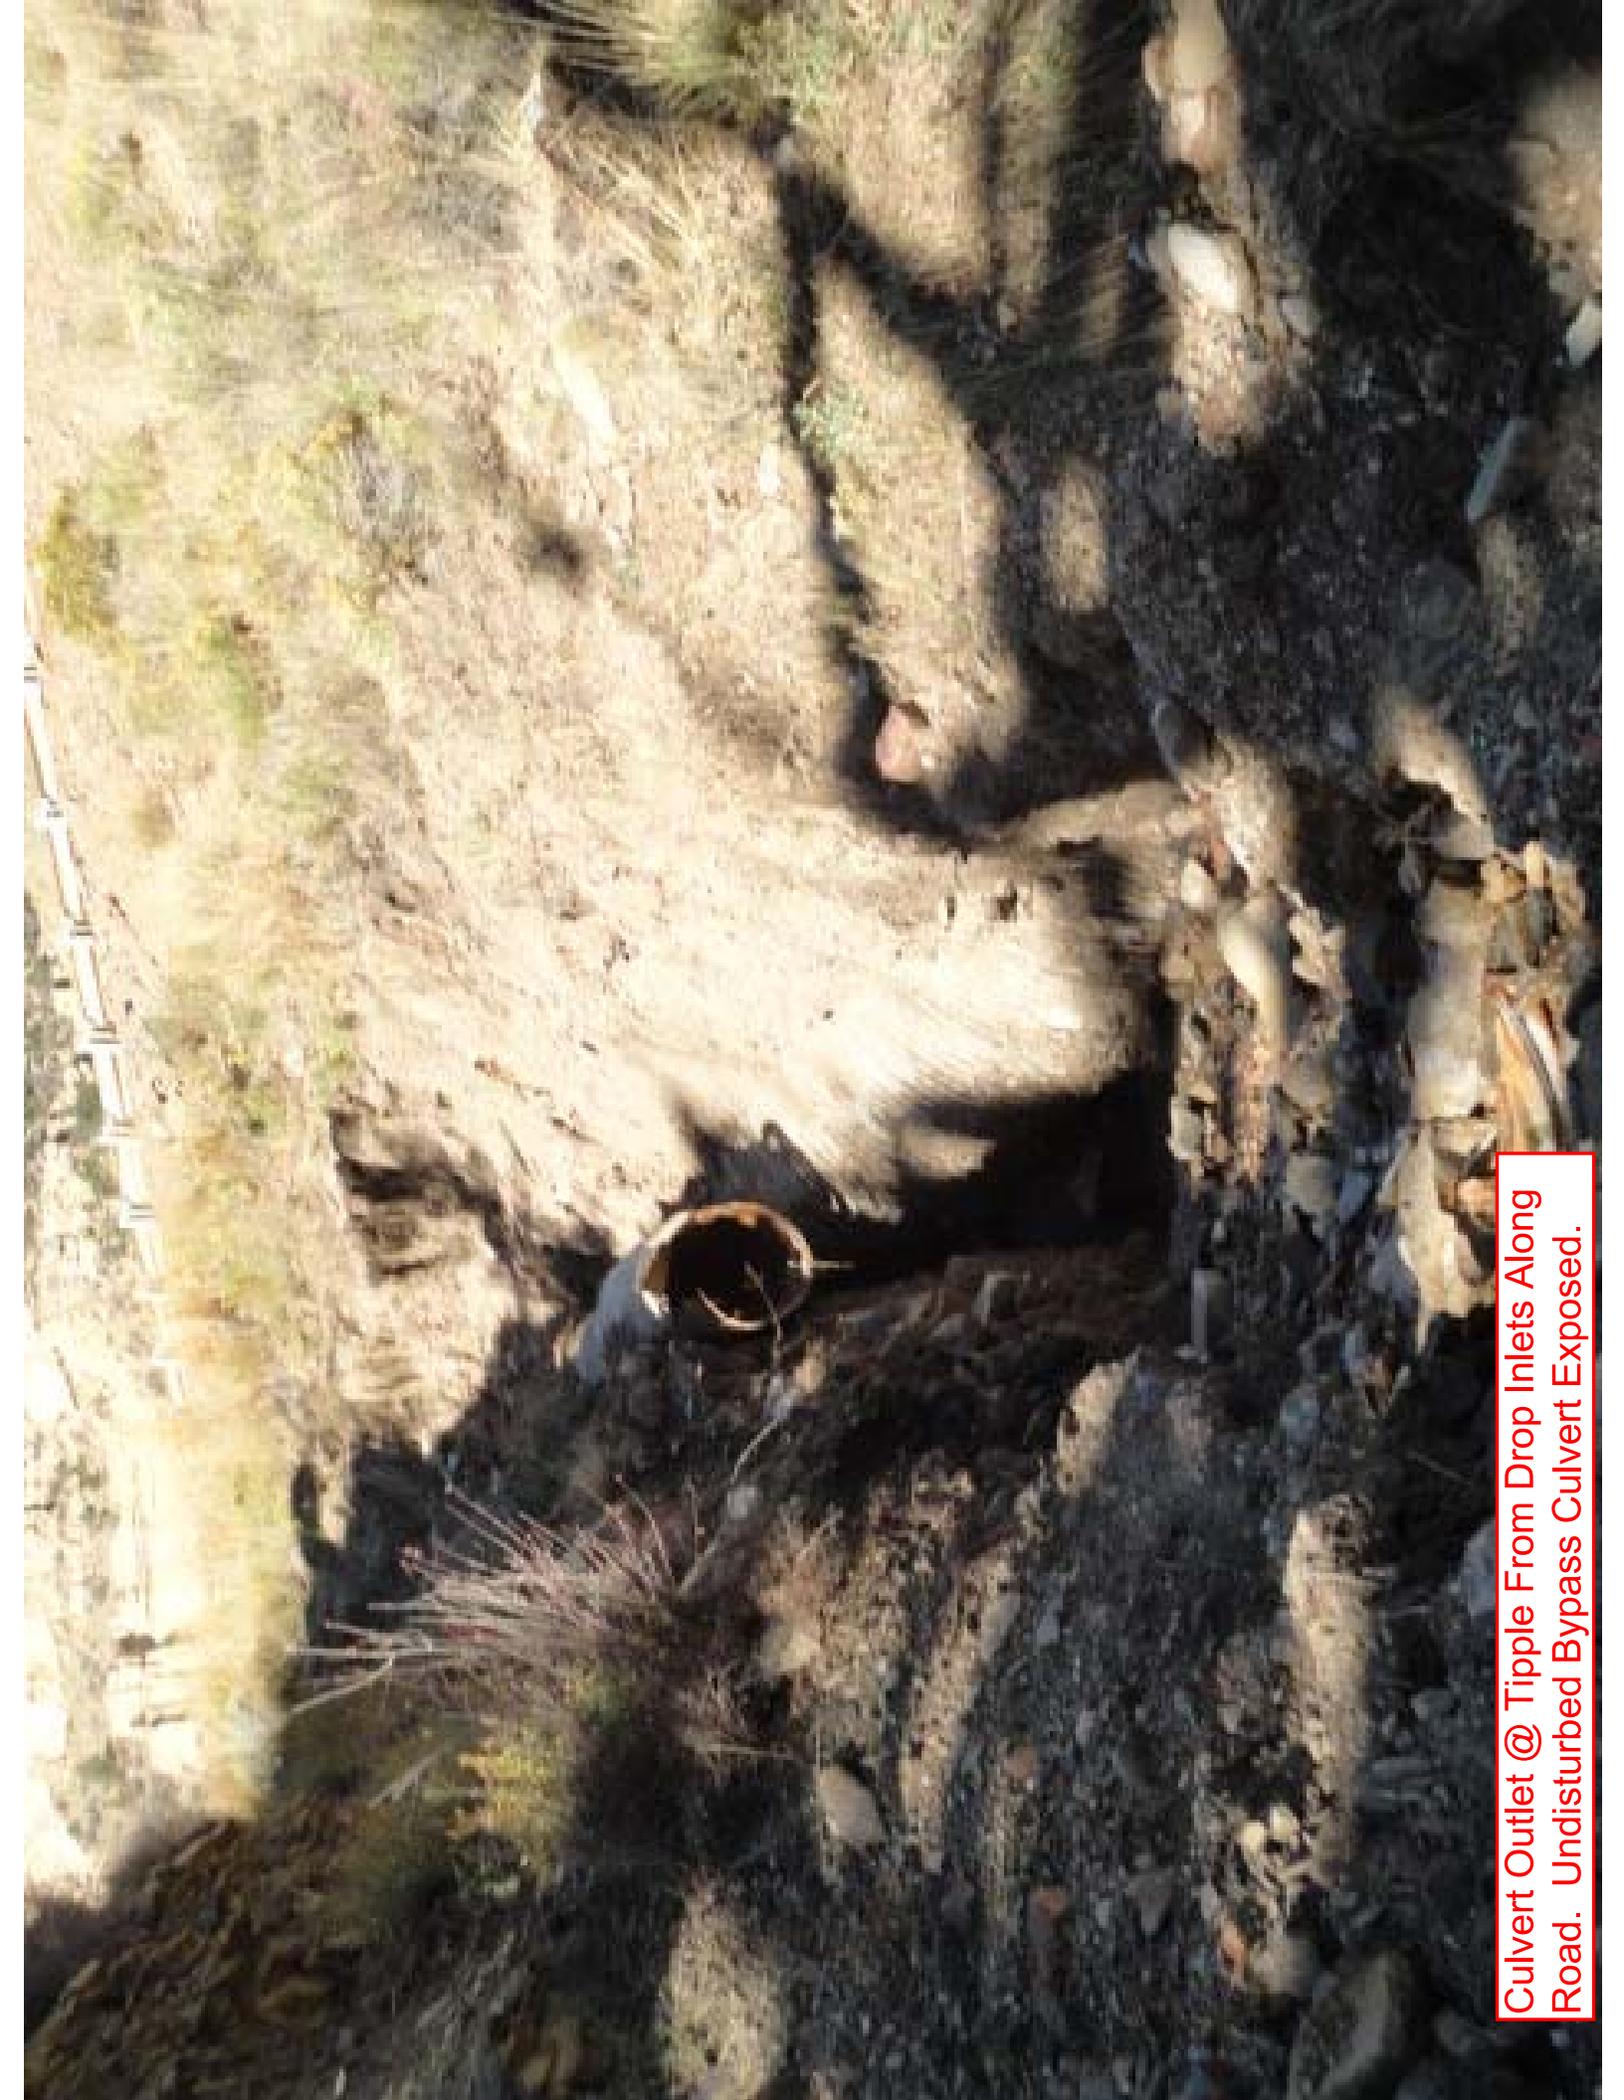
Culvert Outlet @ Tipple From Drop Inlets Along Road. Undisturbed Bypass Culvert Exposed.

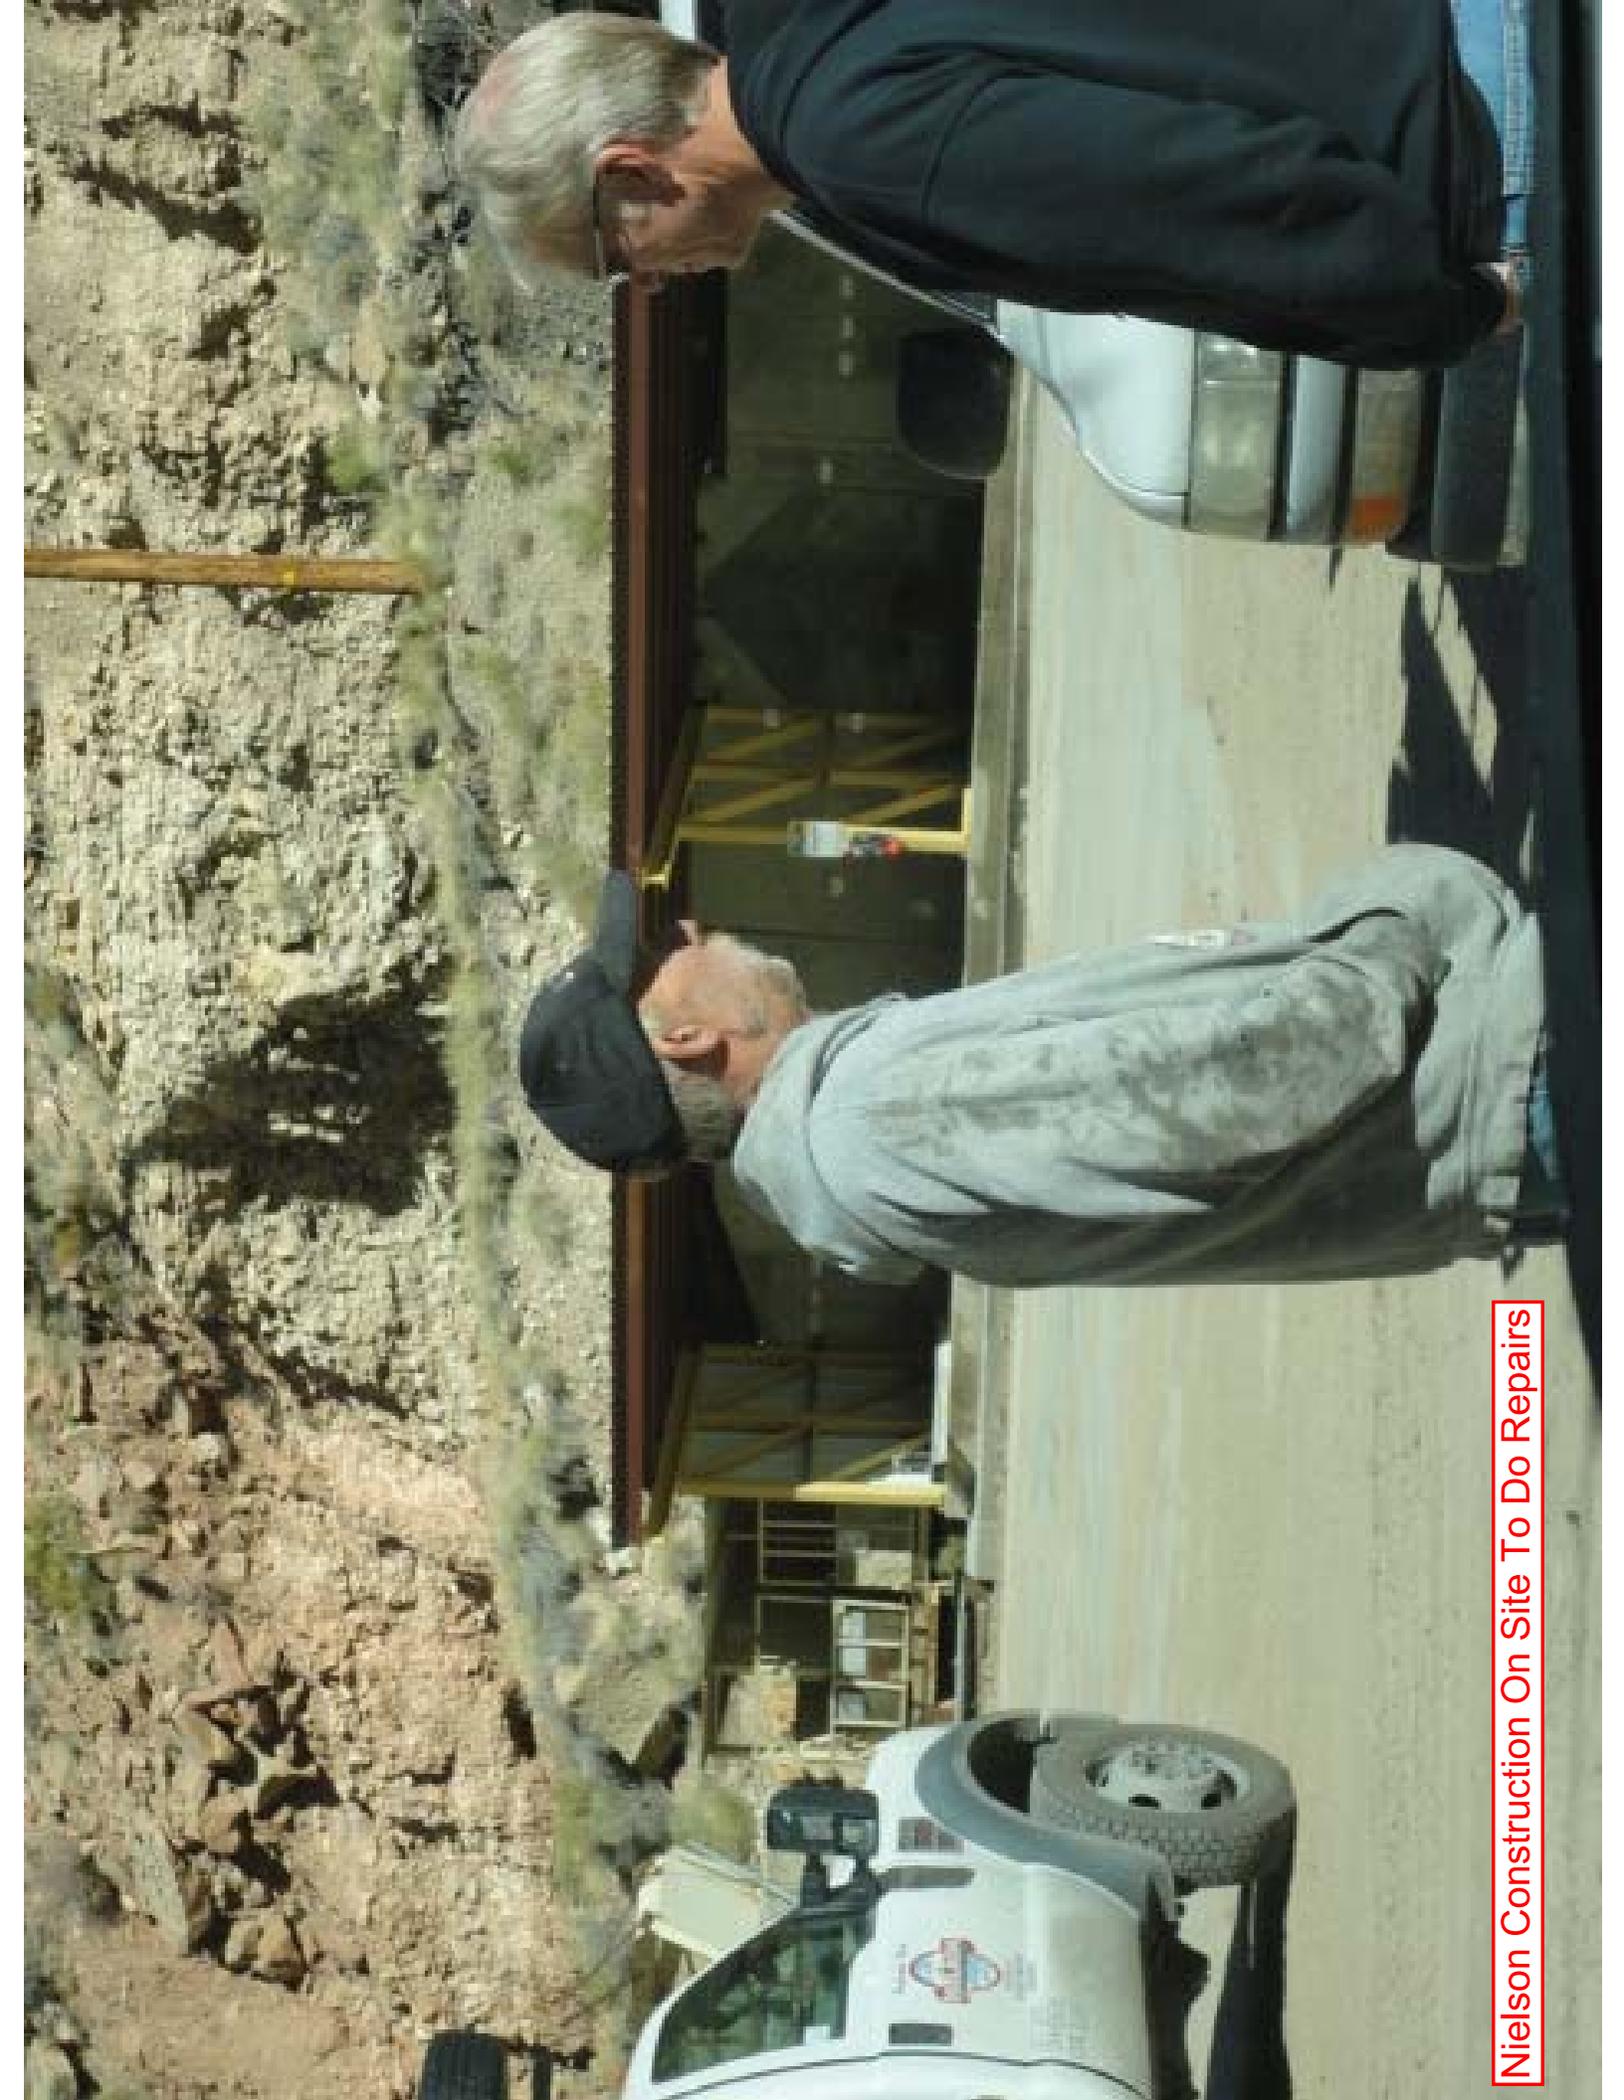
Nielson Construction On Site To Do Repairs

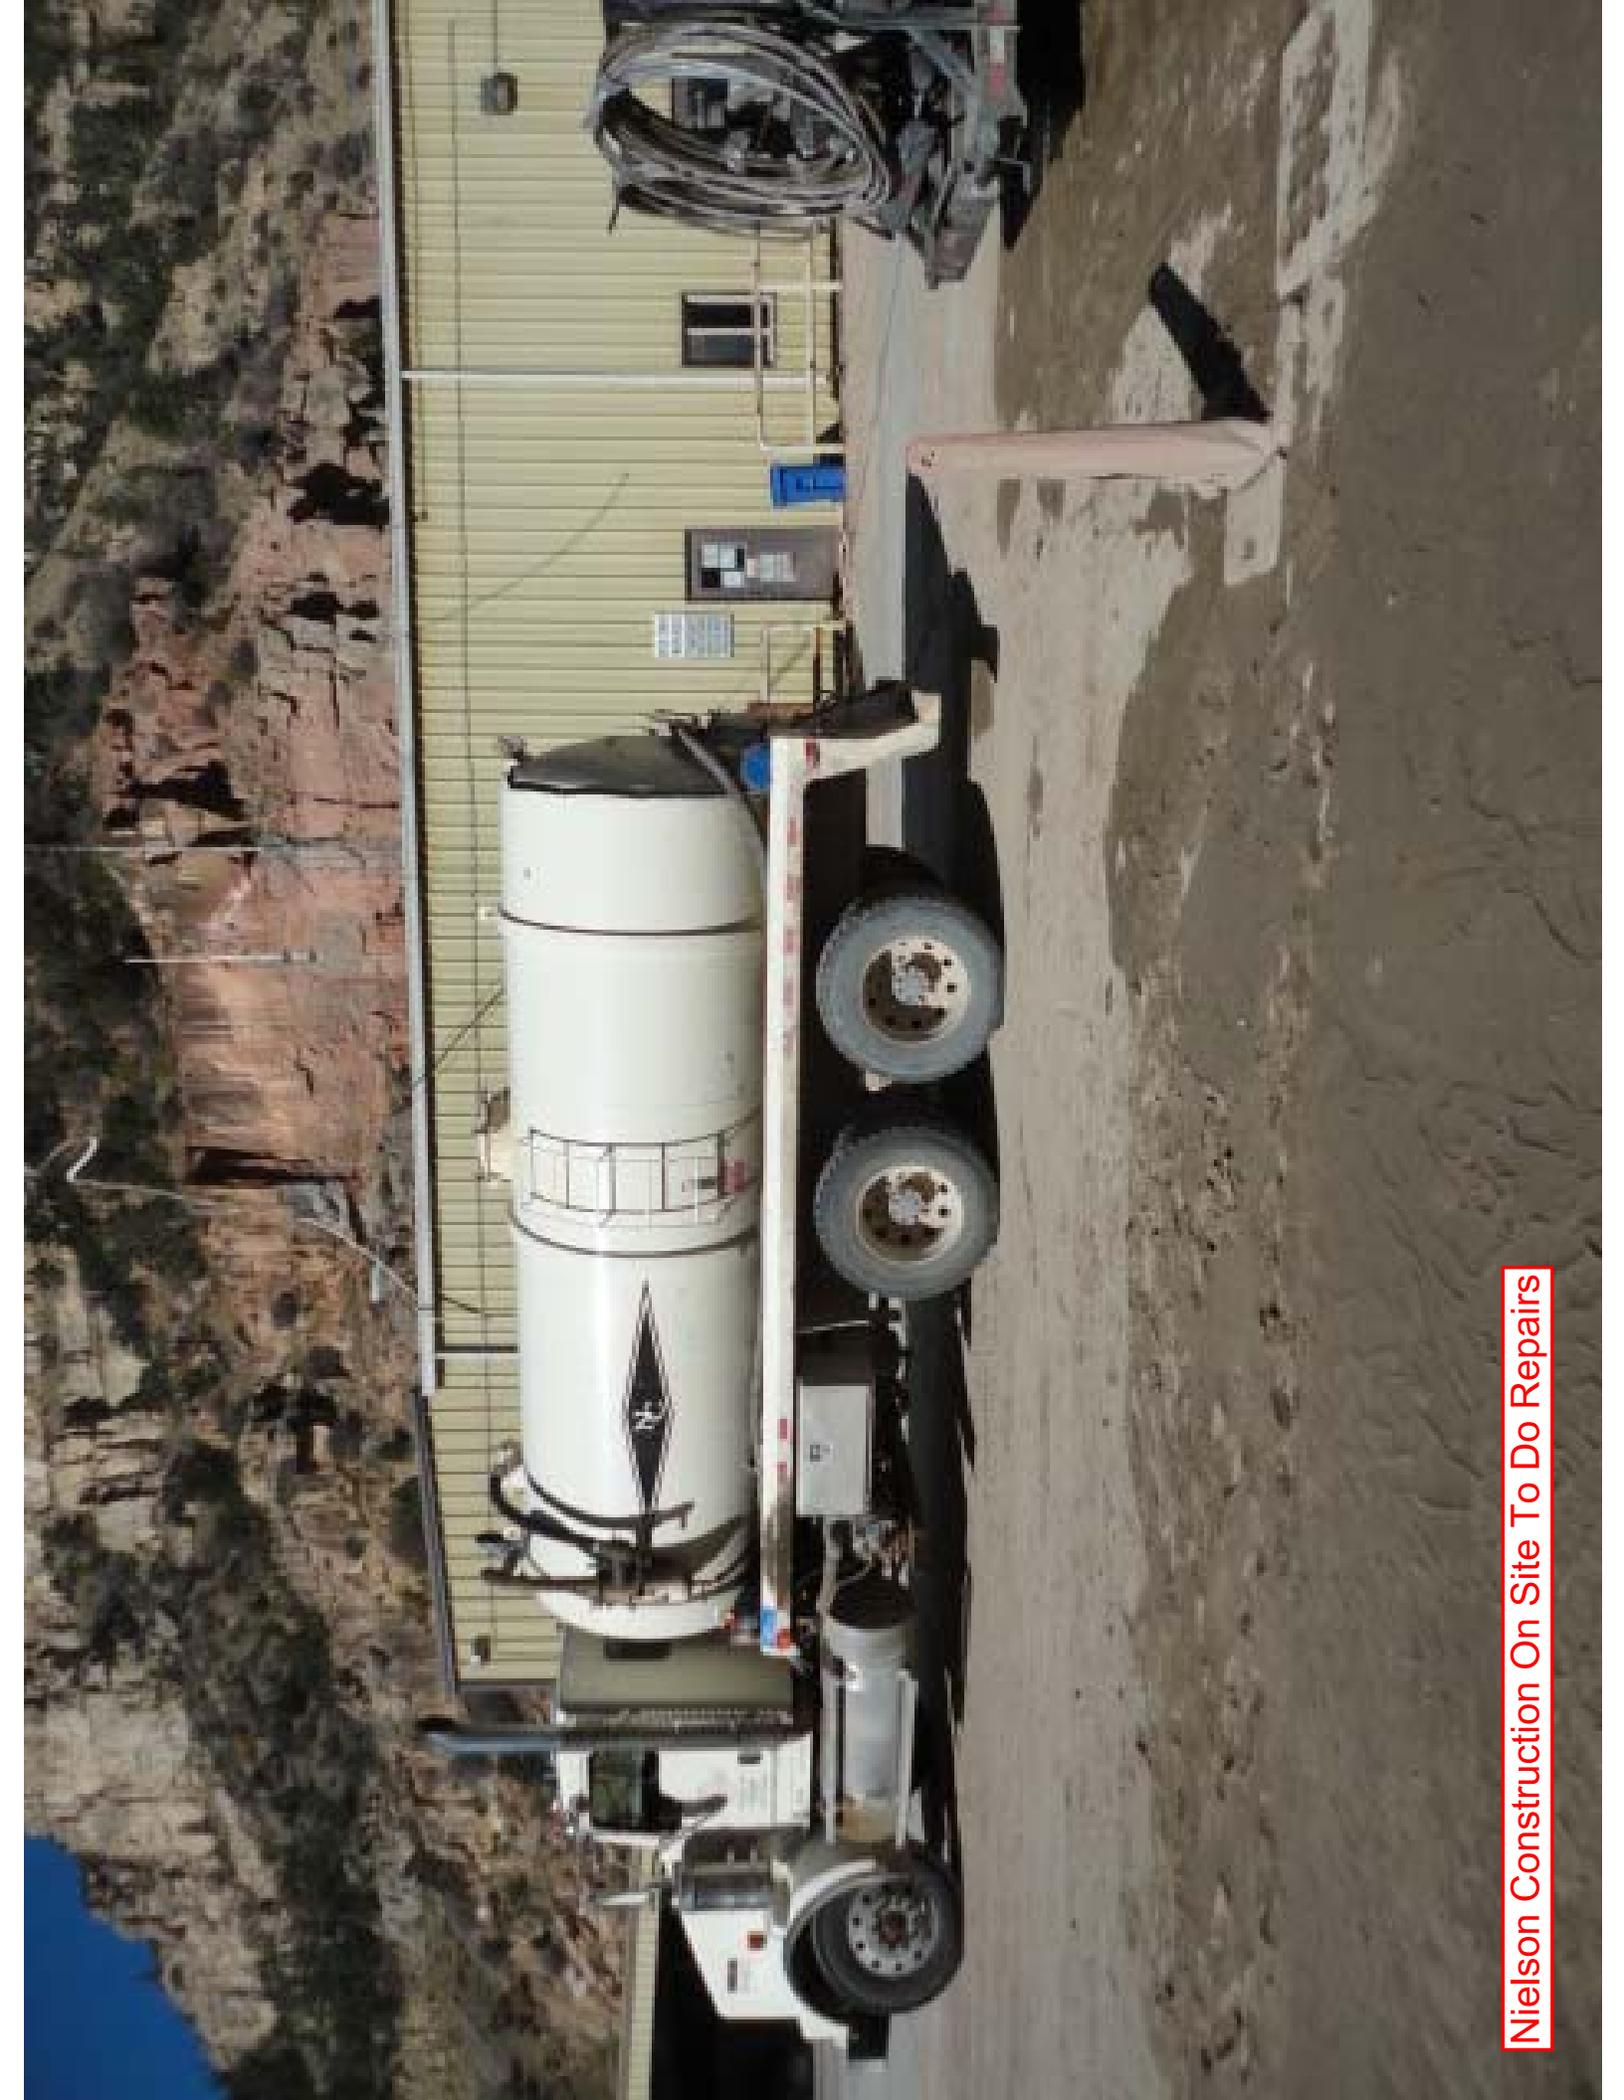
Nielson Construction On Site To Do Repairs

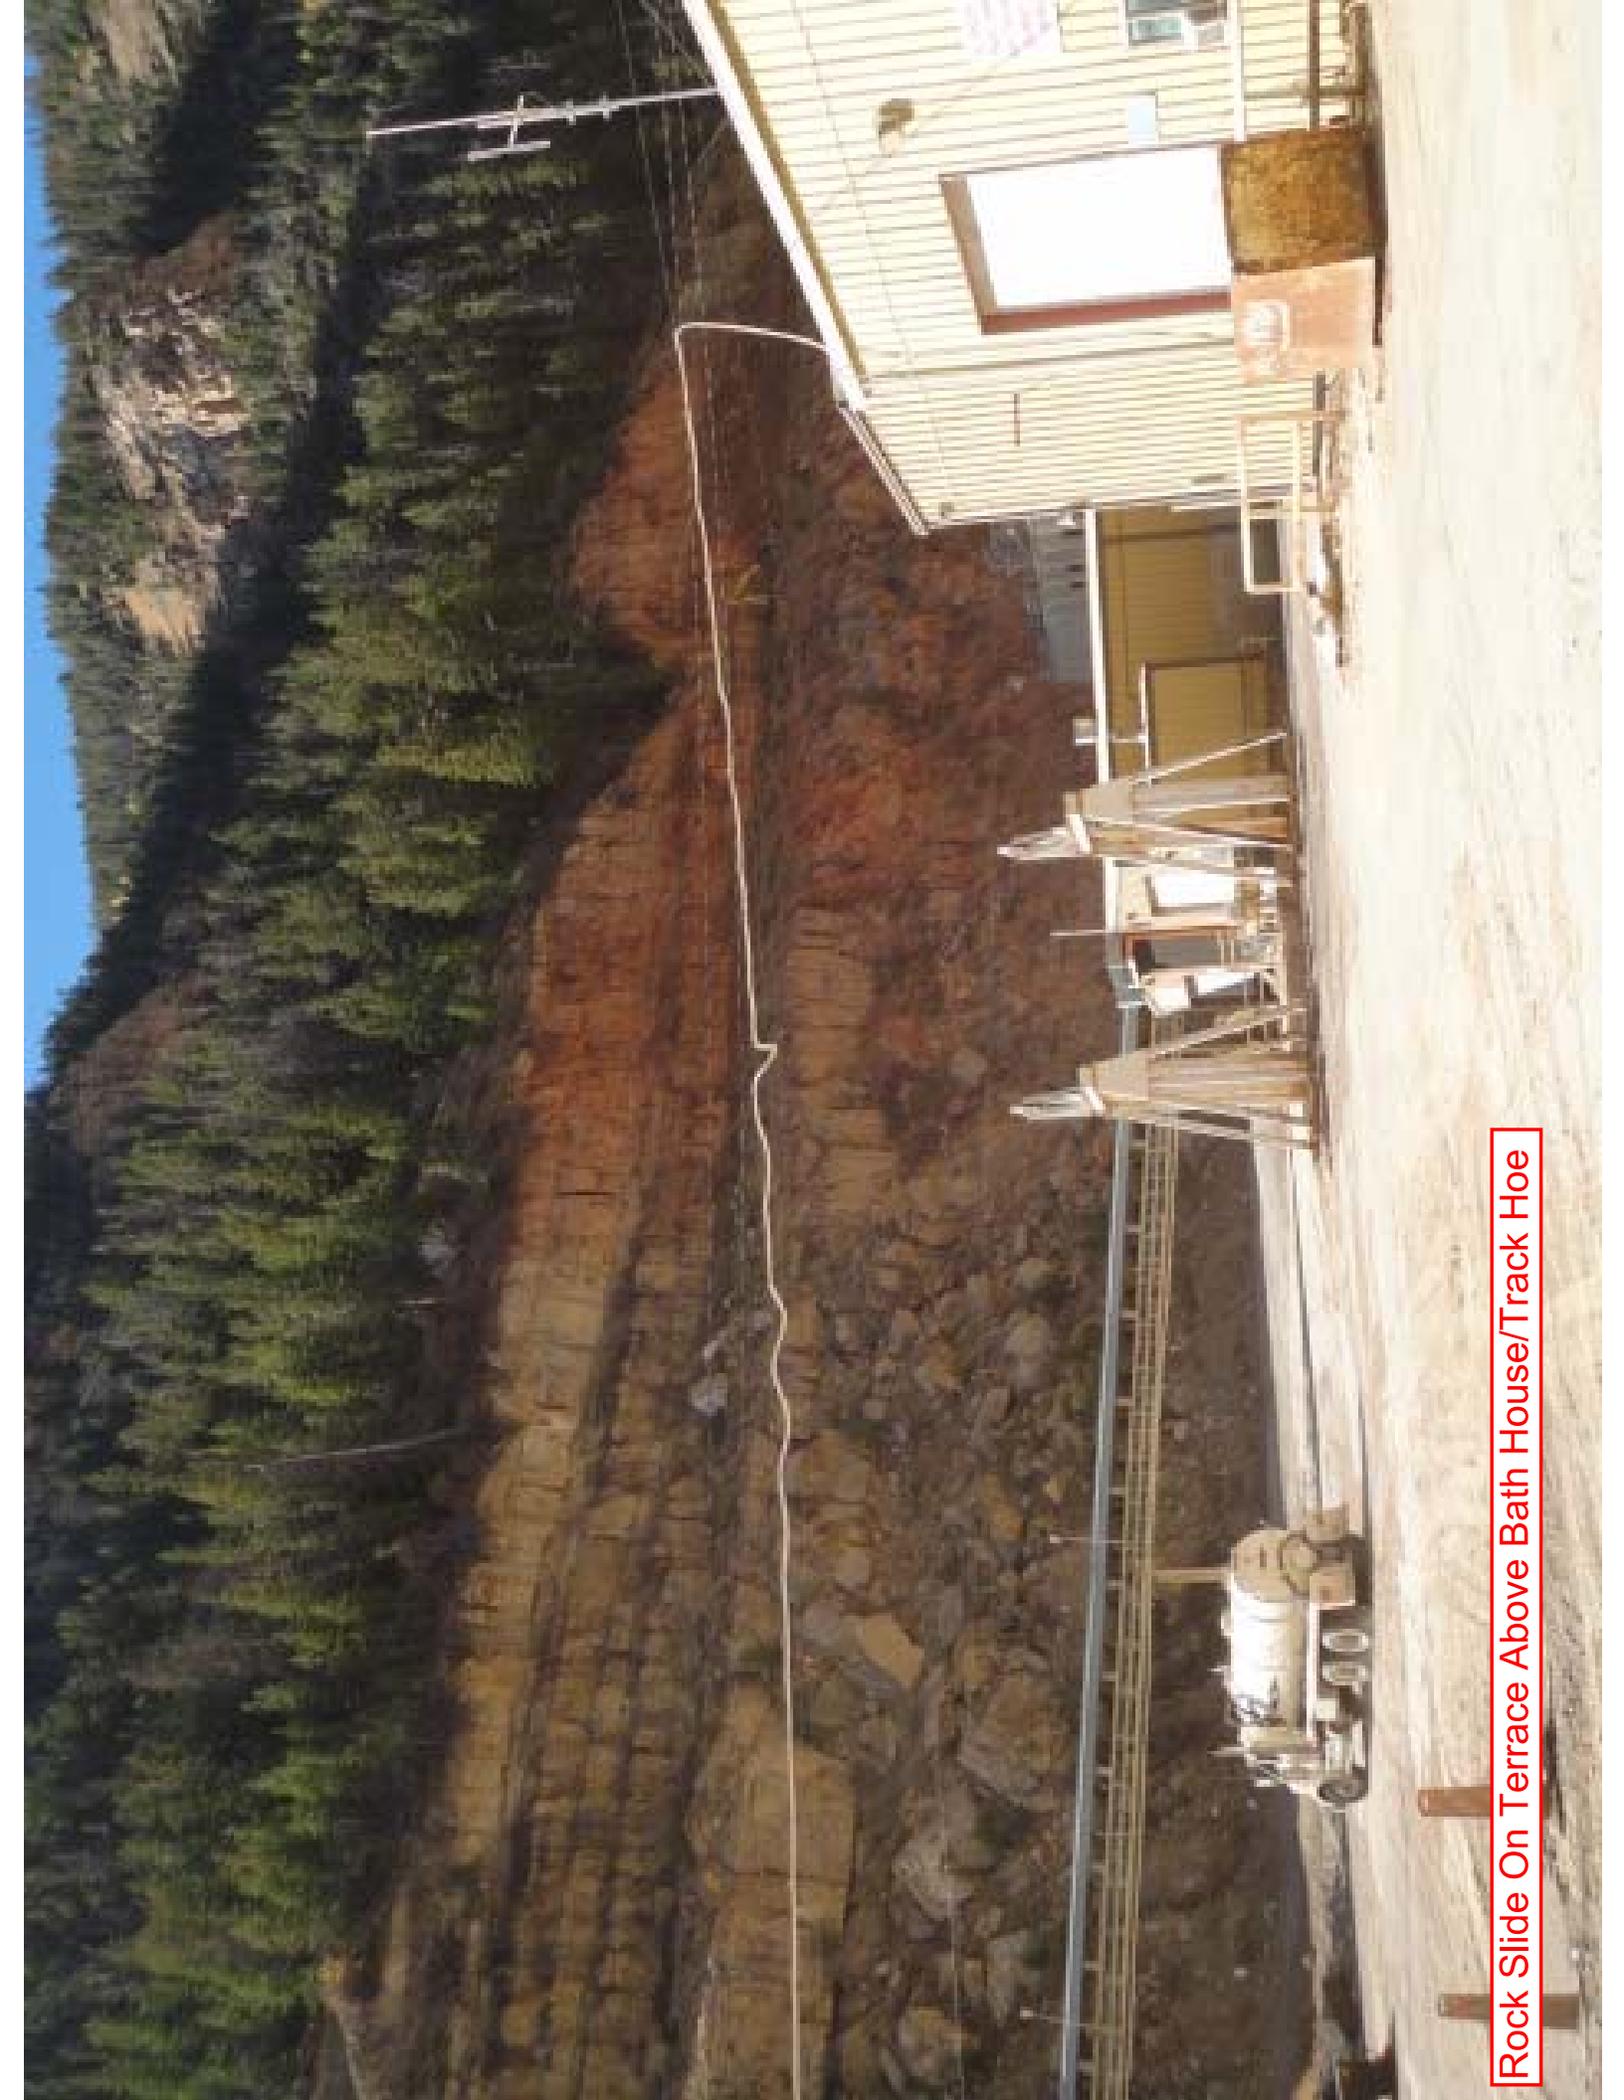
Some rocks slid during the 9/21-22/2016 storm on the terrace above the bath house. A track hoe was on the terrace during the inspection doing repair work and removing the rocks. The terrace serves as a drainage structure as well as a safety structure to protect the mine site below. From the steep escarpment and rock failures. The slide was not a reportable event. No damage occurred as a result of the rock slide.

Rock Slide On Terrace Above Bath House/Track Hoe
