# Inspection Report

Permit Number:	<b>C0150018</b>
Inspection Type:	PARTIAL
Inspection Date:	Wednesday, October 05, 2016
Start Date/Time:	10/5/2016 8:30:00 AM
End Date/Time:	10/5/2016 1:30:00 PM
Last Inspection:	Thursday, September 08, 2016

Permitee: **PACIFICORP**  
 Operator: **INTERWEST MINING CO**  
 Site: **DEER CREEK MINE**  
 Address: **PO BOX 310, HUNTINGTON UT 84528**  
 County: **EMERY**  
 Permit Type: **PERMANENT COAL PROGRAM**  
 Permit Status: **ACTIVE**

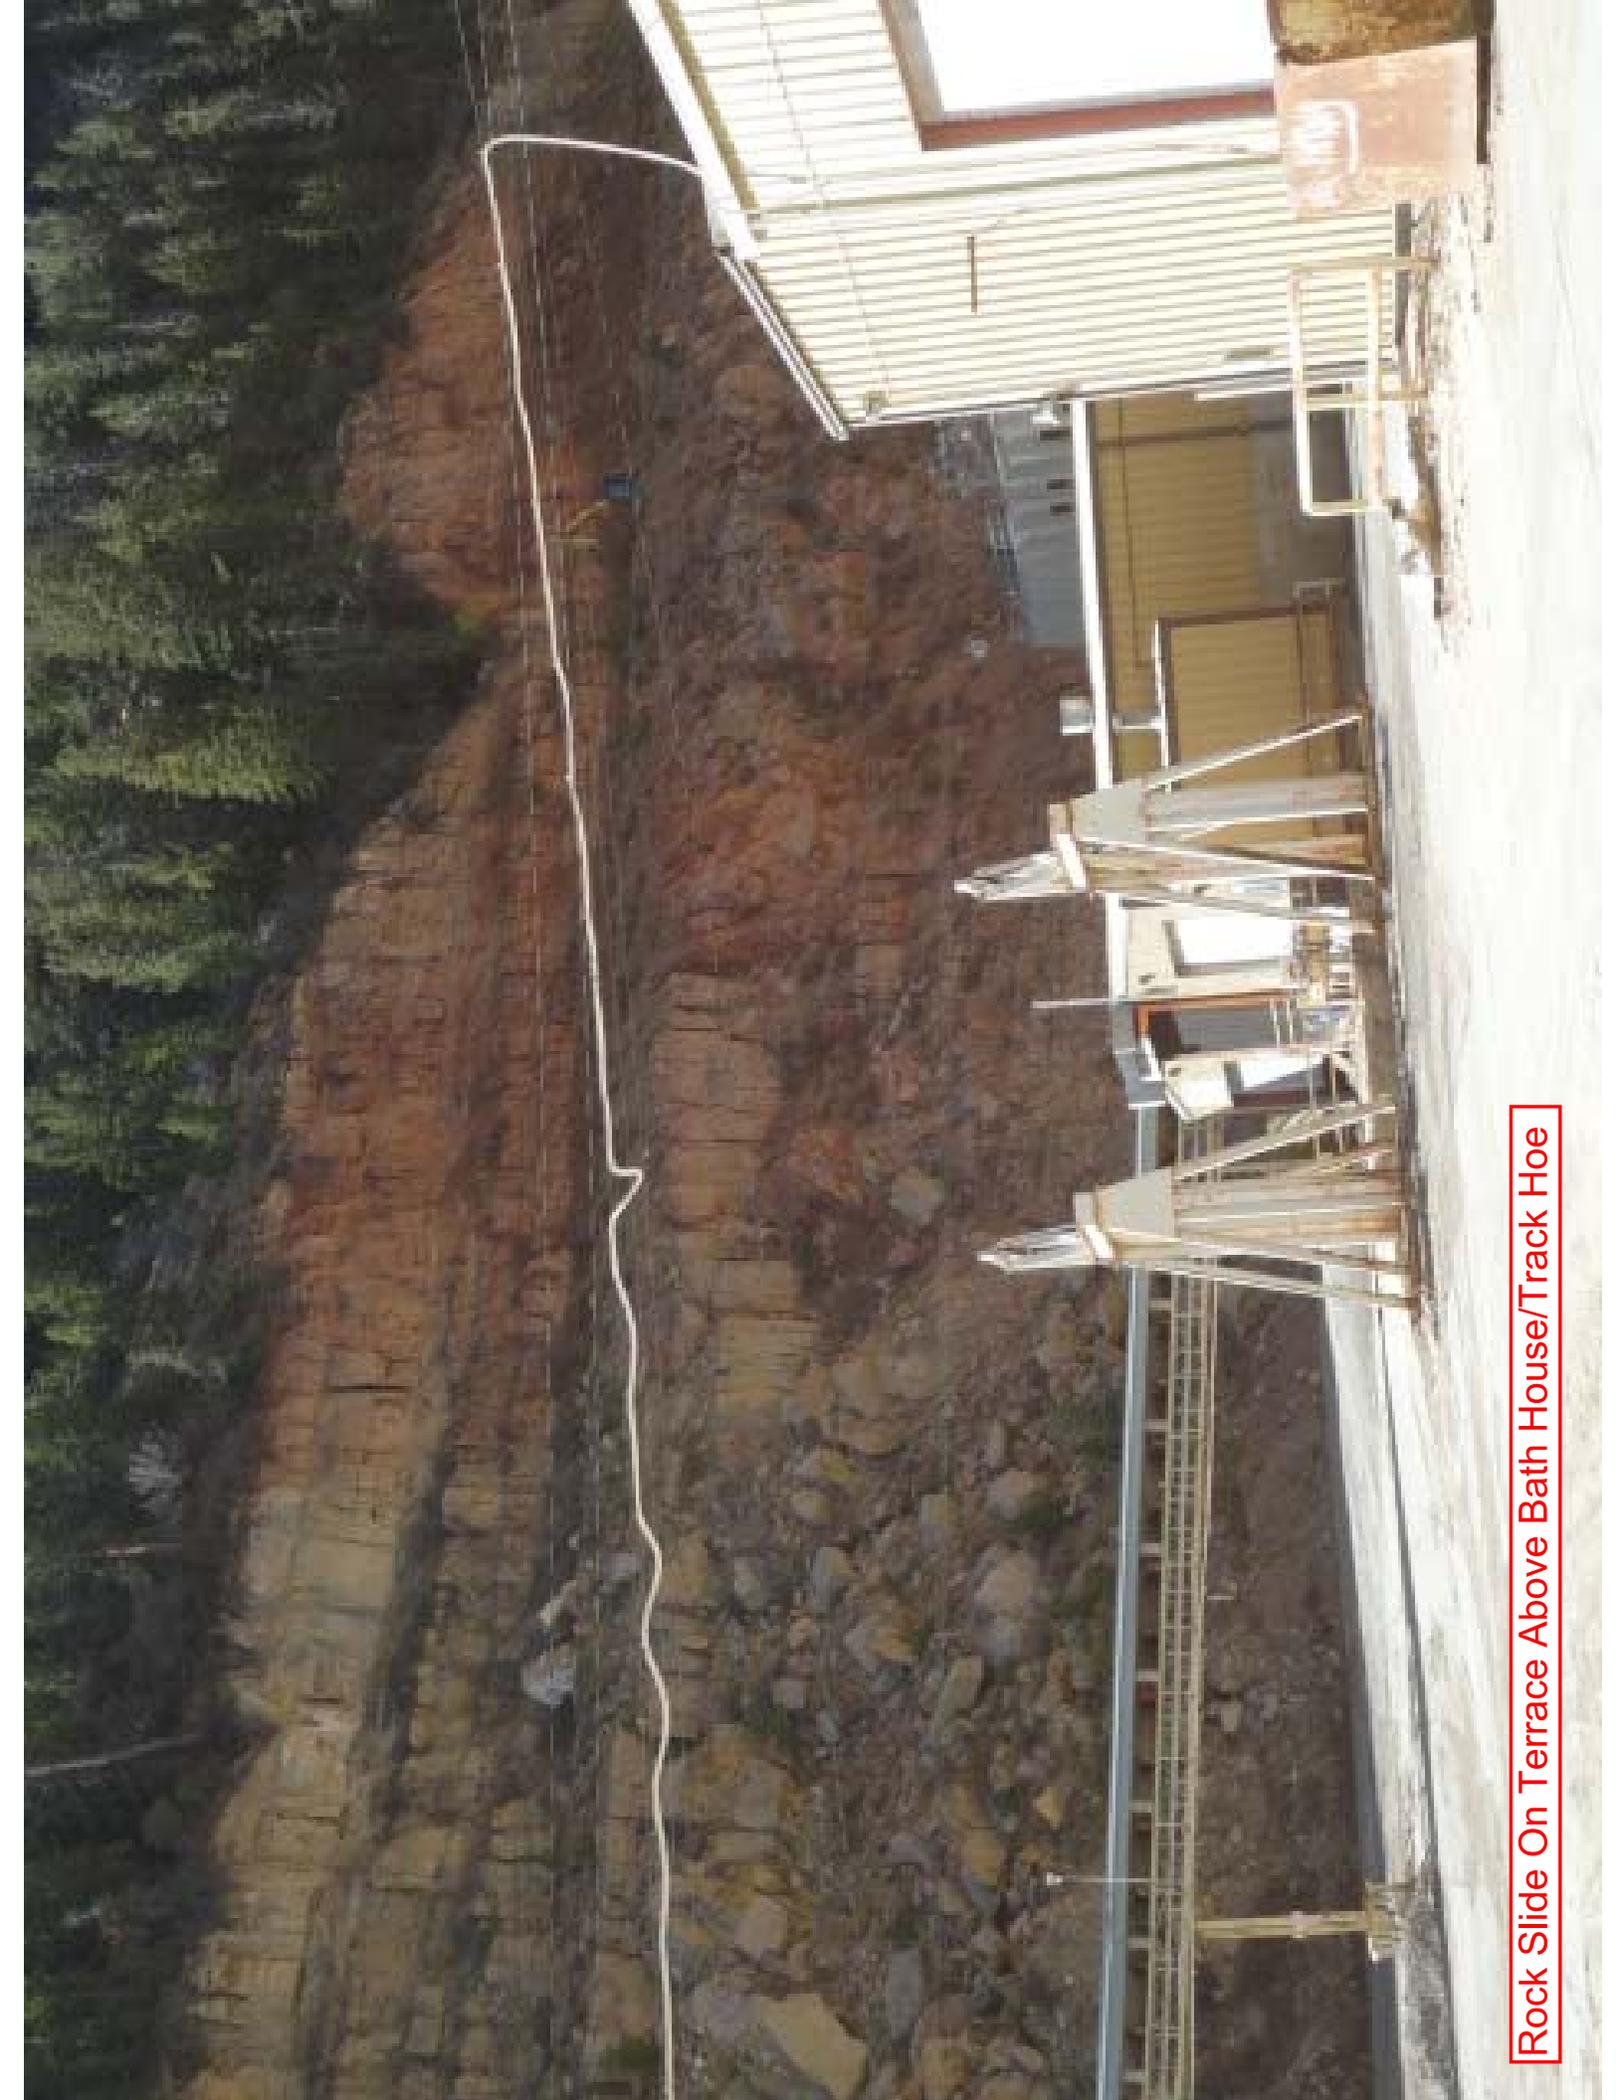
Some rocks slid during the 9/21-22/2016 storm on the terrace above the bath house. A track hoe was on the terrace during the inspection doing repair work and removing the rocks. The terrace serves as a drainage structure as well as a safety structure to protect the mine site below. From the steep escarpment and rock failures. The slide was not a reportable event. No damage occurred as a result of the rock slide.

Rock Slide On Terrace Above Bath House/Track Hoe

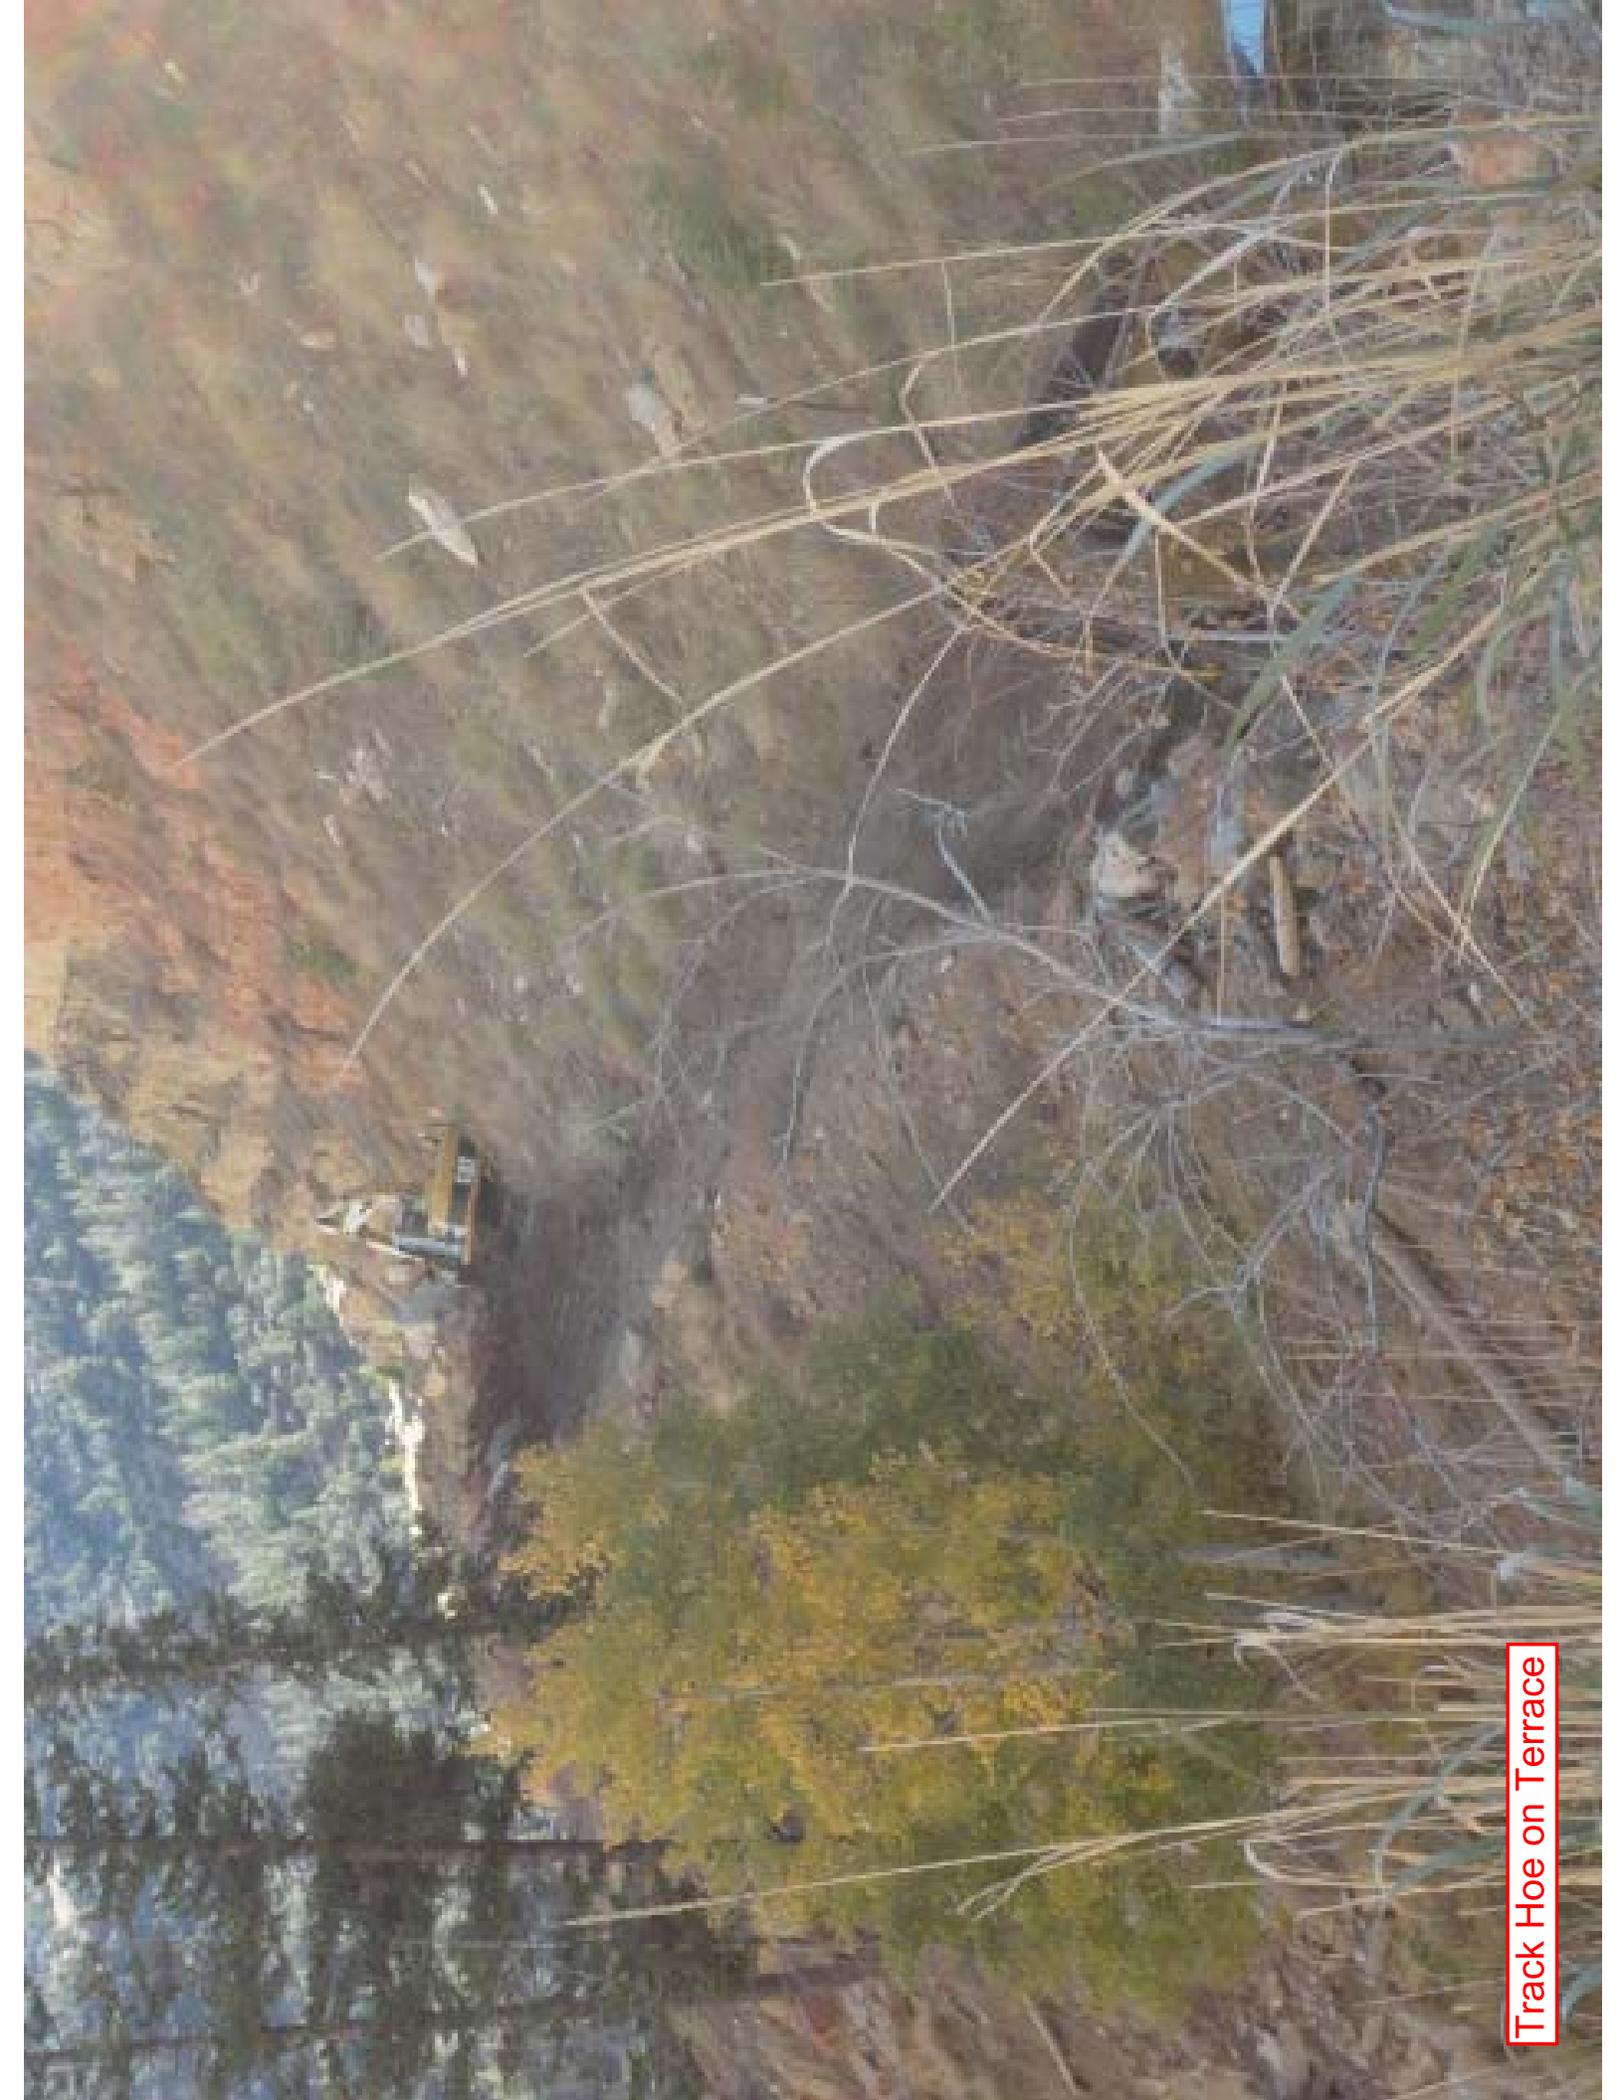
Track Hoe on Terrace
