Inspection Report

Permit Number:	C0150018
Inspection Type:	TECHNICAL
Inspection Date:	Wednesday, July 18, 2018
Start Date/Time:	7/18/2018 1:00:00 PM
End Date/Time:	7/18/2018 5:00:00 PM
Last Inspection:	Wednesday, June 13, 2018

Permitee: **PACIFICORP**
 Operator: **INTERWEST MINING CO**
 Site: **DEER CREEK MINE**
 Address: **PO BOX 310, HUNTINGTON UT 84528**
 County: **EMERY**
 Permit Type: **PERMANENT COAL PROGRAM**
 Permit Status: **ACTIVE**

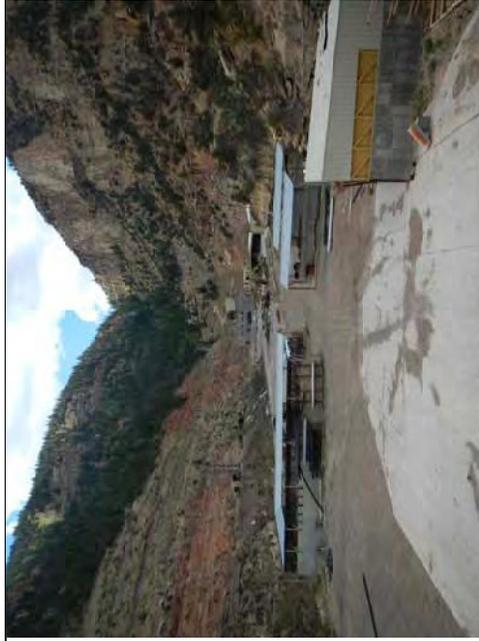
PHOTO 1

Looking upstream at Deer Creek Facilities being demolished.

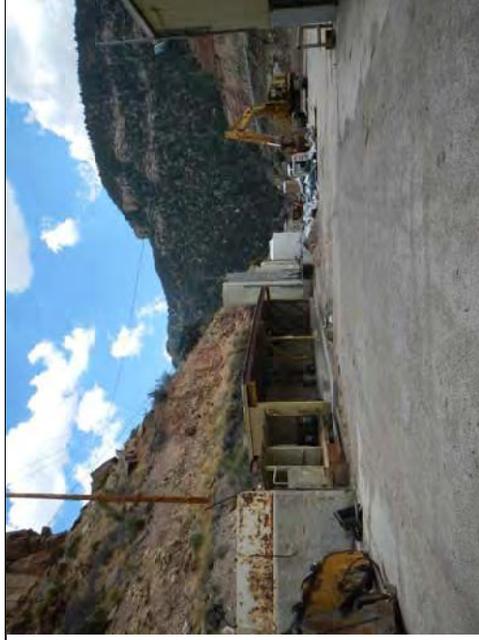
PHOTO 2

Looking down stream at the Deer Creek salt shed and fuel storage.

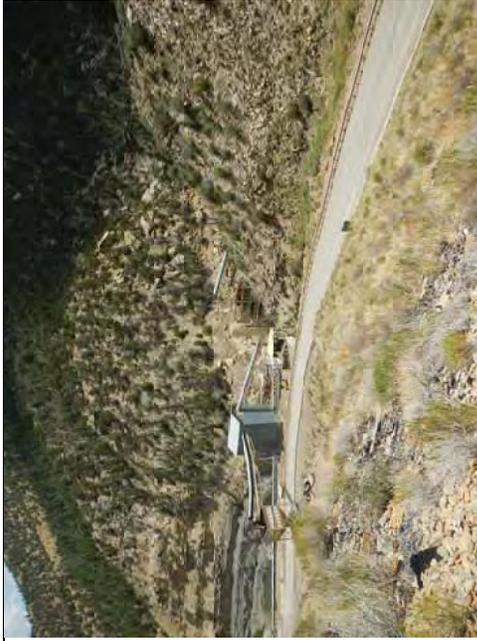
PHOTO 3 Elk Canyon. Asphalt will be removed and the drainage will be constructed to the sediment pond just below Elk Canyon.

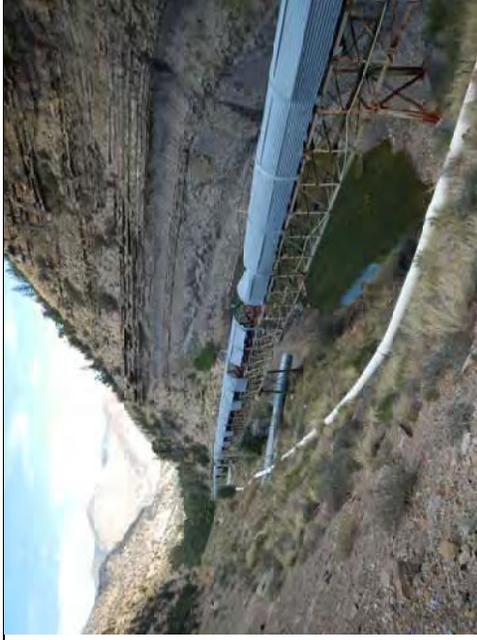
PHOTO 4

The Deer Creek pond contained a small amount of water that will be decanted prior to reclamation.

Looking downstream at the Deer Creek sediment pond and conveyor.

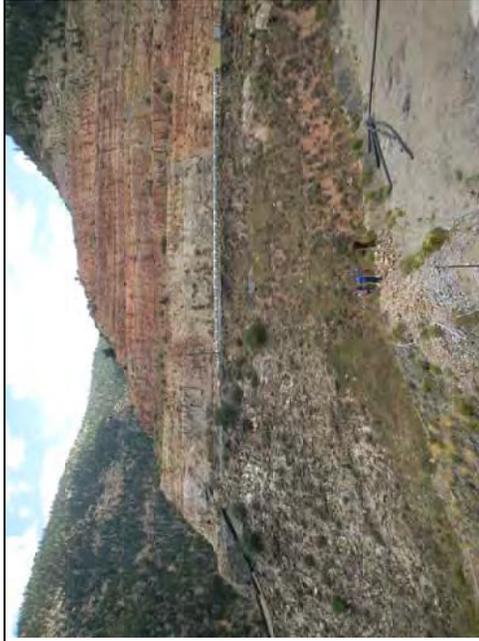
PHOTO 5

Conveyor above Elk Canyon to reclaim tunnel

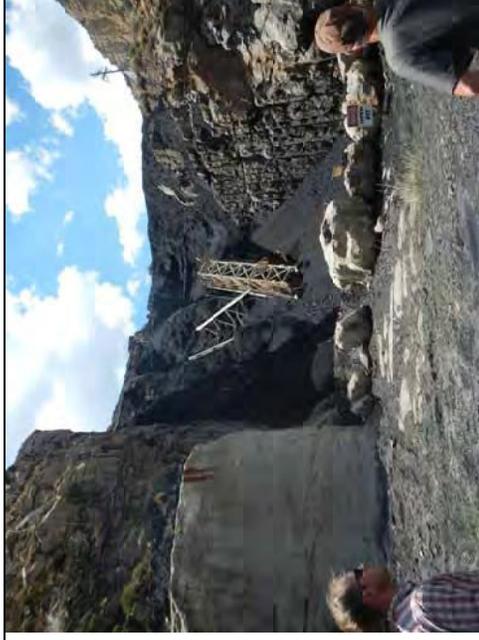
PHOTO 6

Elk canyon reclaim tunnel location

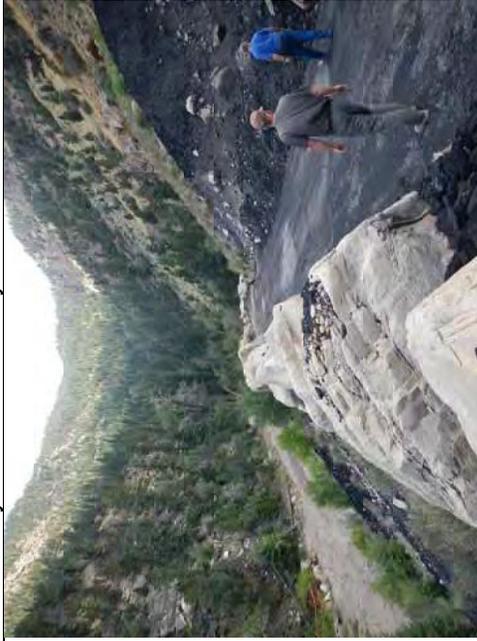
PHOTO 7

Deer Creek waste piles in Elk Cyn and the main canyon have been relinquished by MSHA. Waste piles will be graded against the cut slopes.

Elk Cyn coal refuse and reclaim tunnel access

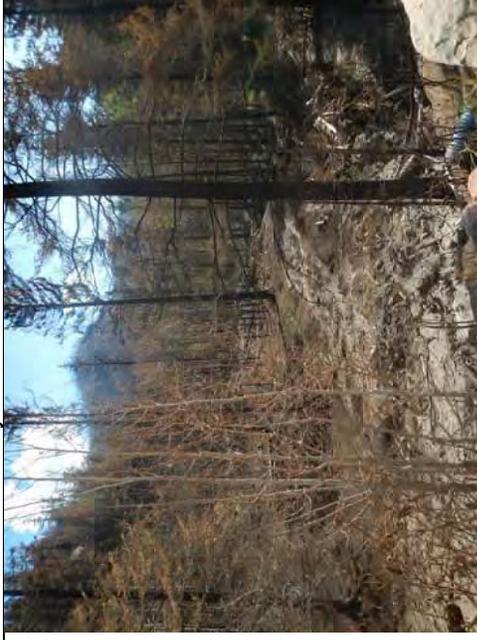
PHOTO 8

Rilda burned stream channel adjacent to portal pad
