Division of Oil, Gas and Mining

Inspection Report

Permit Number:	C0150018
Inspection Type:	PARTIAL
Inspection Date:	Thursday, November 8, 2018
Start Date/Time:	11/8/2018 8:00:00 AM
End Date/Time:	11/8/2018 2:00:00 PM
Last Inspection:

Permitee: **PACIFICORP**
 Operator: **INTERWEST MINING CO**
 Site: **DEER CREEK MINE**
 Address: **PO BOX 310, HUNTINGTON UT 84528**
 County: **EMERY**
 Permit Type: **PERMANENT COAL PROGRAM**
 Permit Status: **ACTIVE**

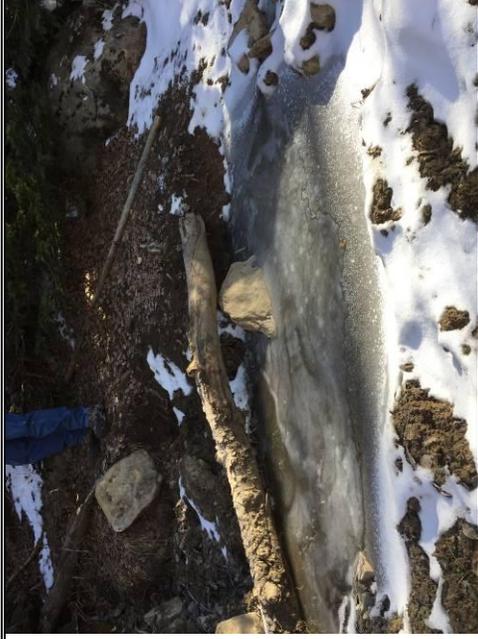
SPI-29: Spring discharge forms a small pool indicating the presence of flow (Photo 1). It is located just below the reclaimed road built during the Crandall Canyon mine disaster relief efforts.

<p>PHOTO 1 Spring site SPI-29, small pool of frozen spring discharge November 8, 2018</p>	<p>PHOTO 2 Spring site SPI-42 November 8, 2018</p>

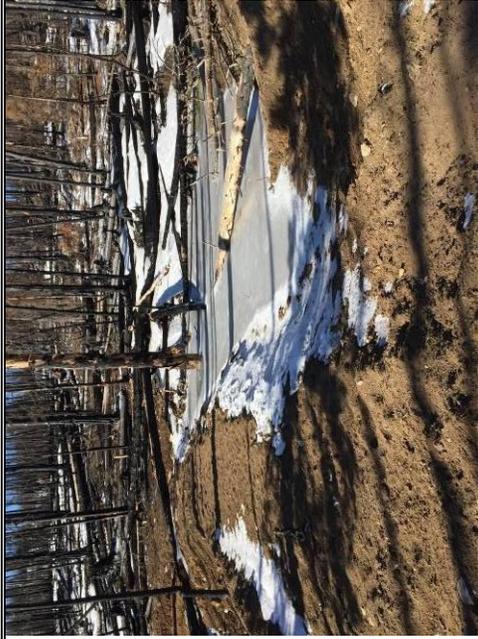
SPI-42: Spring site was full with ponded water (Photo 2). The berm had recently been worked on possibly during Trail Mountain fire suppression operations.

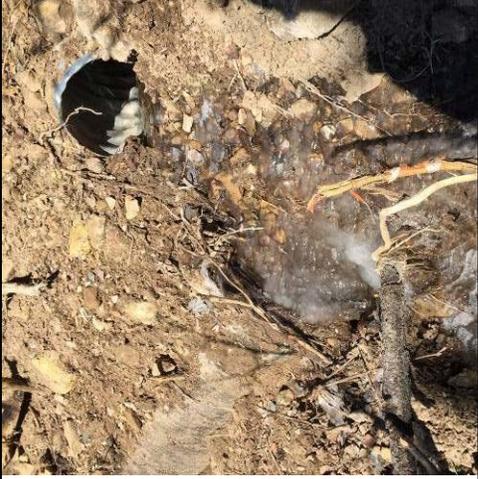
MF-217 and MF-218: Frozen seeps were spread across the surface and converged at the culvert flowing under the road (Photo 3).

<p>PHOTO 3 Spring sites MF-217 and MF-218 discharge below FS road November 8, 2018</p>	<p>PHOTO 4 Spring site MF-219 below FS road November 8, 2018</p>

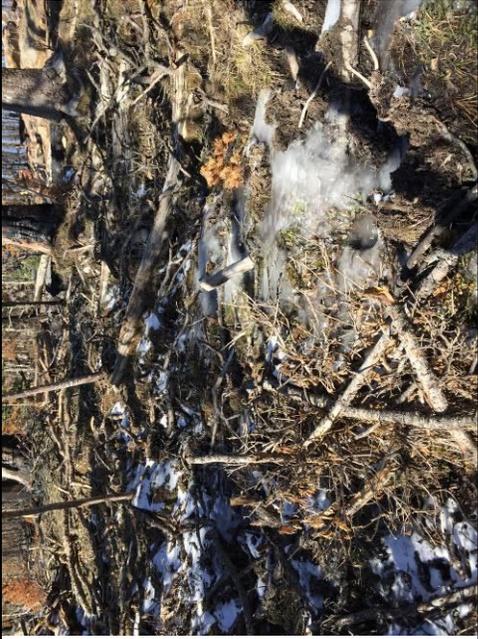
MF-219: Forest Service road appears to cut through source of spring (Photo 4). Spring flowing at the time of the inspection.

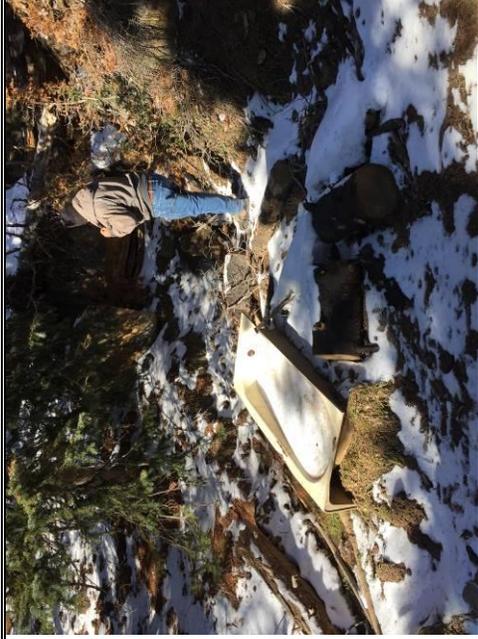
SPI-26: Also known as 'Bath Tub' spring. Discharges at three sources across hillslope (Photo 5). Flow measurements taken at two locations and summed for total discharge.

<p>PHOTO 5 Spring site SPI-26, discharge measured at two locations November 8, 2018</p>	<p>PHOTO 6 Spring site MF-10 flowing at a rate of ~4 gpm November 8, 2018</p>

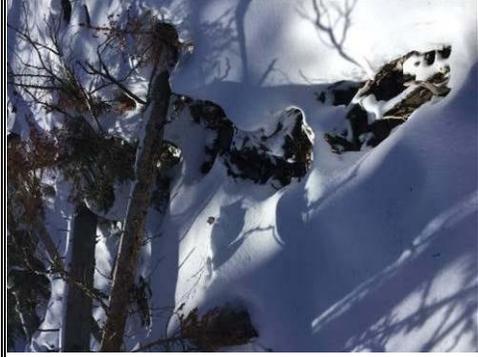
MF-10: Spring was discharging at a rate of ~4 gpm.

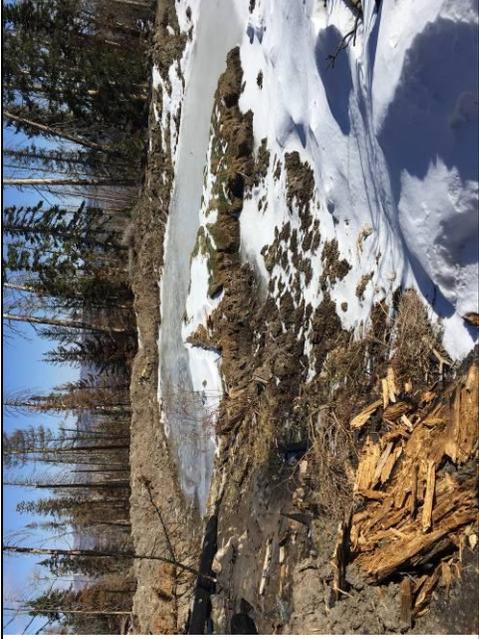
EM-Pond: Pooled water present at time of inspection and with frozen flow paths running into pond.

<p>PHOTO 7 Spring site EM-Pond, berm worked on during fire suppression efforts November 8, 2018</p>	<p>PHOTO 8 Spring site EM-216 discharging to form damp area November 8, 2018</p>

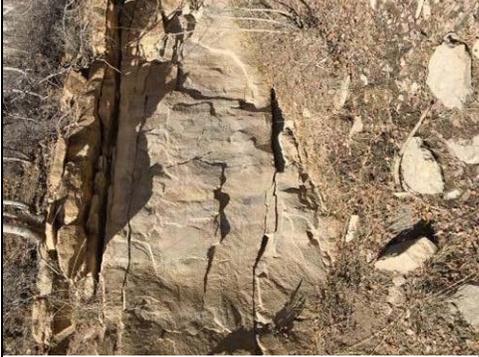
EM-216: Spring barely discharging to form damp area.

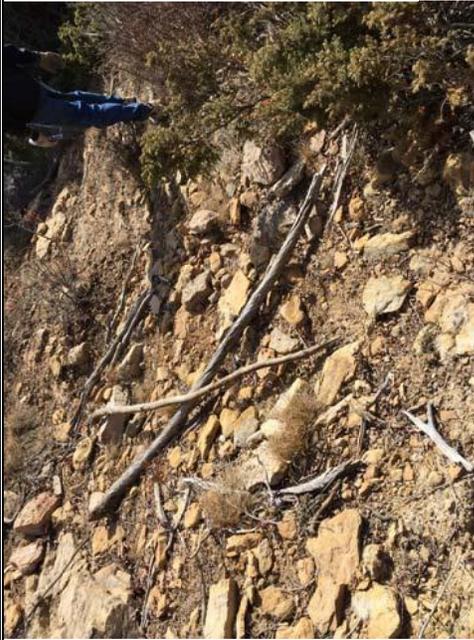
PHOTO 9

UJV-213: Spring dry. Contributing source area is an exposed west aspect, the driest of all aspects on the mountain. This is likely the reason the spring is dry much of the time.

Spring site UJV-213 dry.
November 8, 2018
