**Subject: Status of Deer Creek Mine Disturbed Area Reclamation & Upper Terrace Access Road**

Deer Creek Mine  
Final Reclamation Project  
Upper Terrace Evaluation  
May 29, 2019

Deer Creek Mine  
Upper Terrace Evaluation  
May 29, 2019

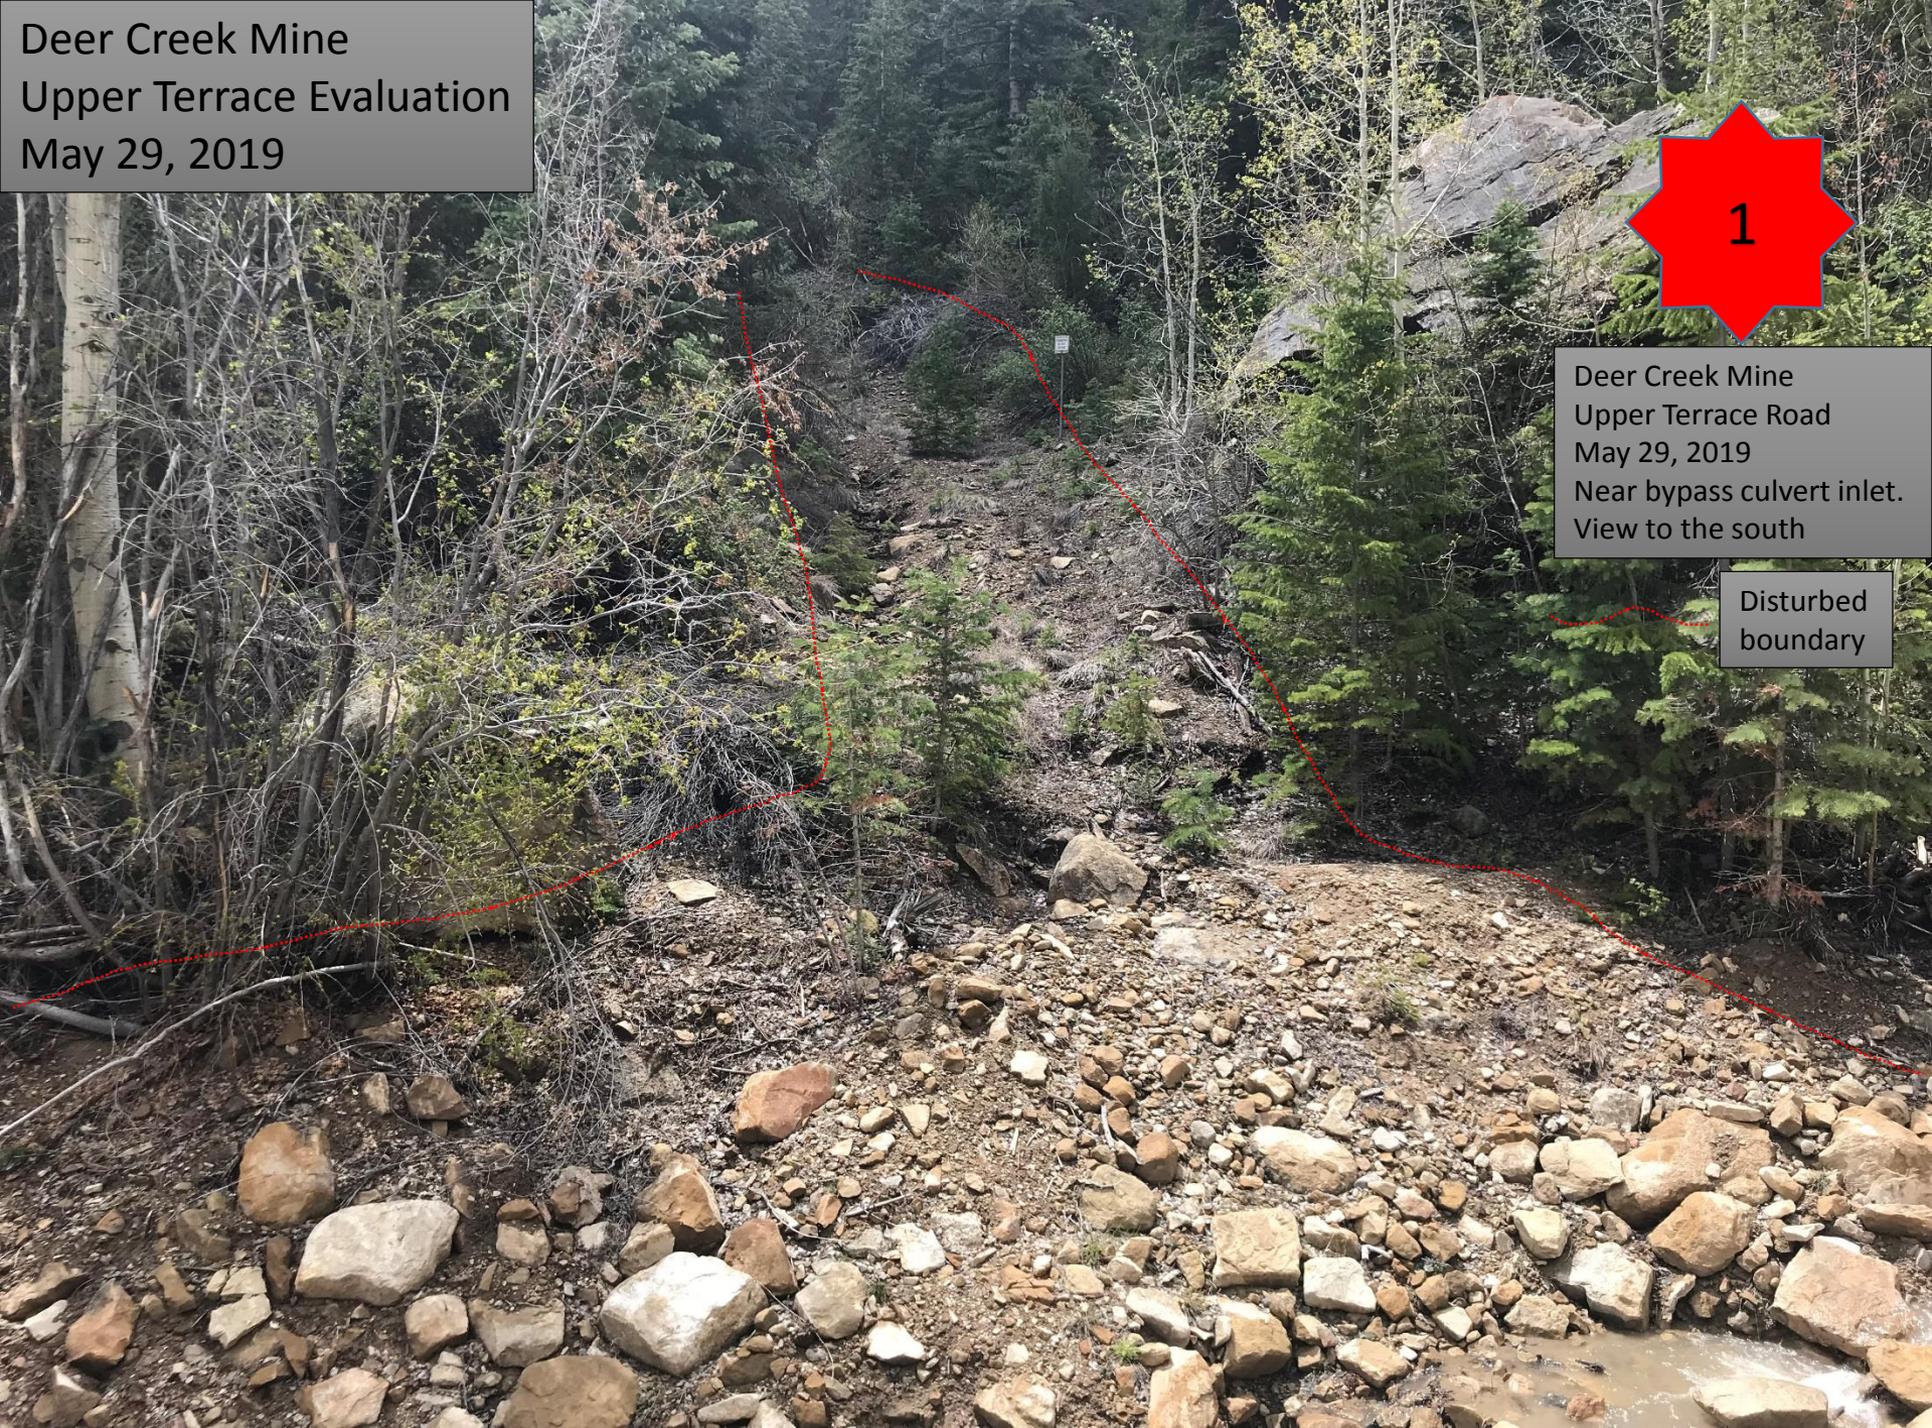
Deer Creek Mine  
Upper Terrace Road  
May 29, 2019  
Near bypass culvert inlet.  
View to the south

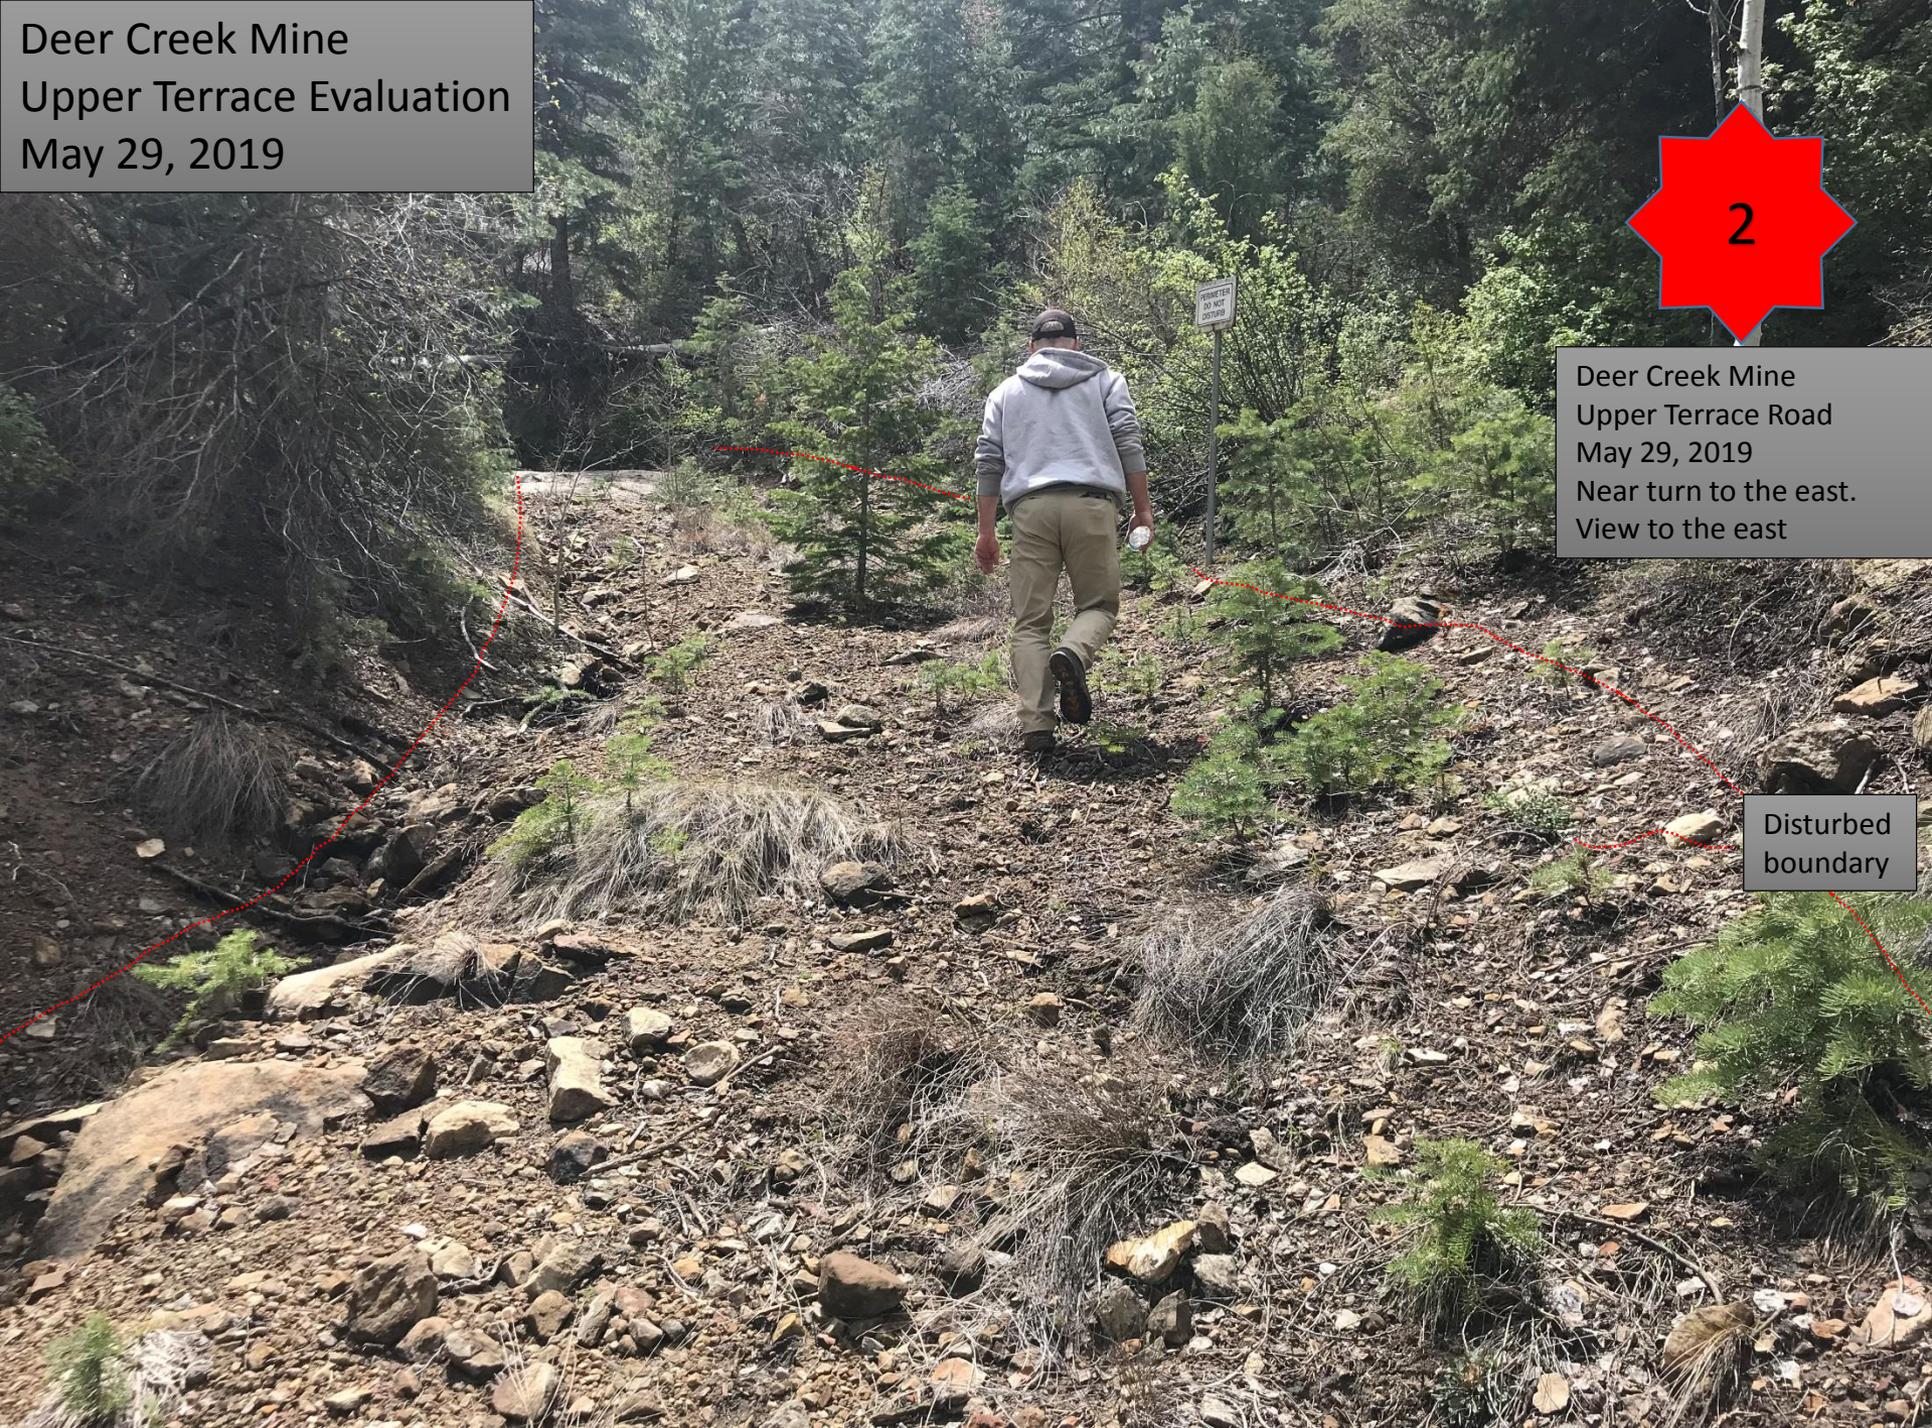
2

Deer Creek Mine  
Upper Terrace Road  
May 29, 2019  
Near turn to the east.  
View to the east

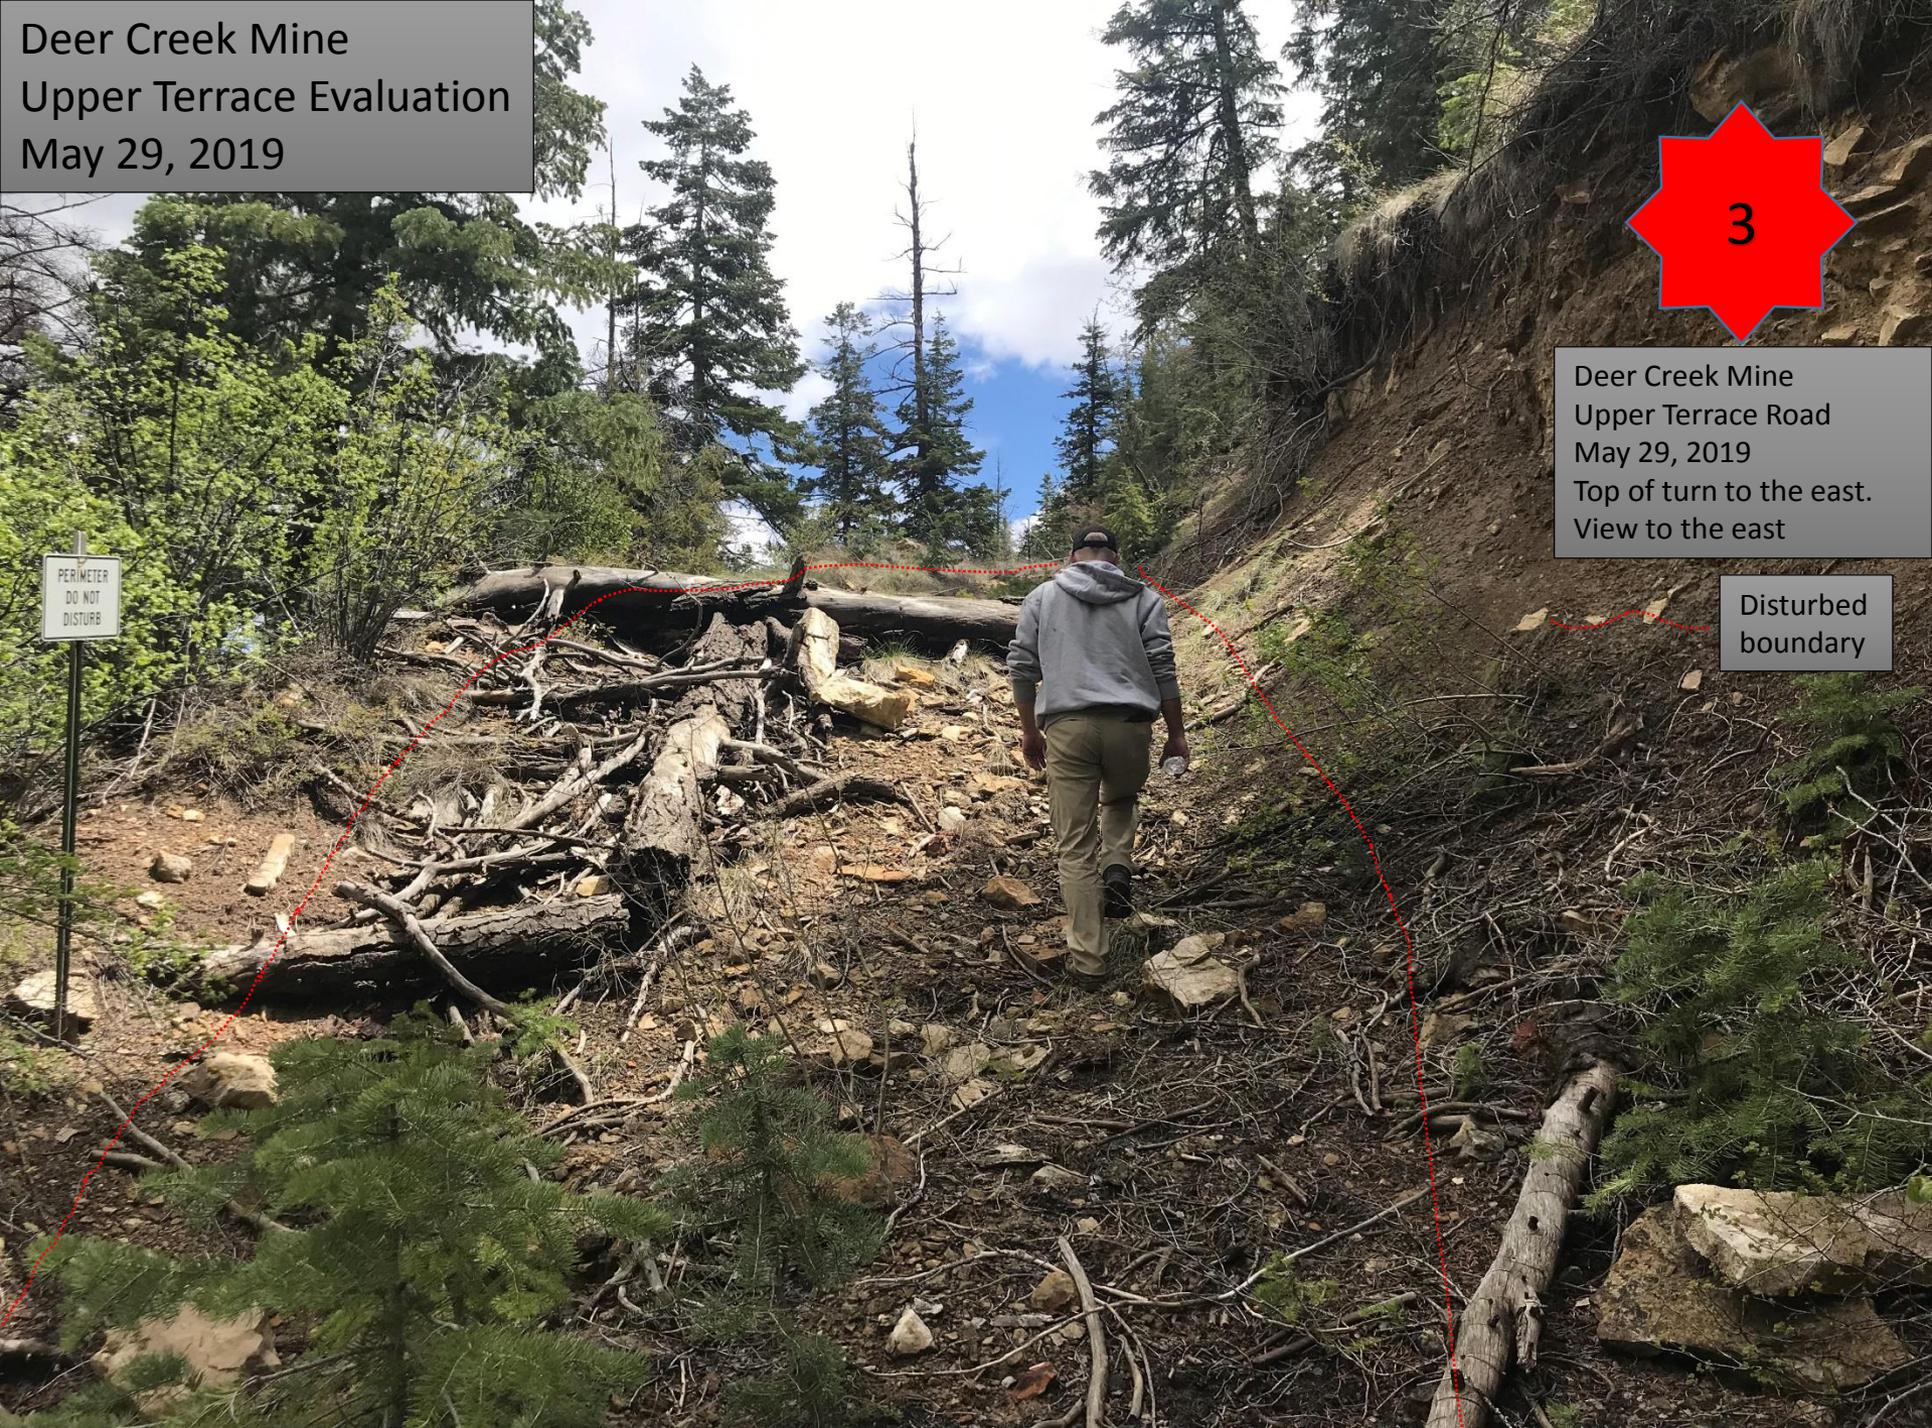
3

Deer Creek Mine  
Upper Terrace Road  
May 29, 2019  
Top of turn to the east.  
View to the east

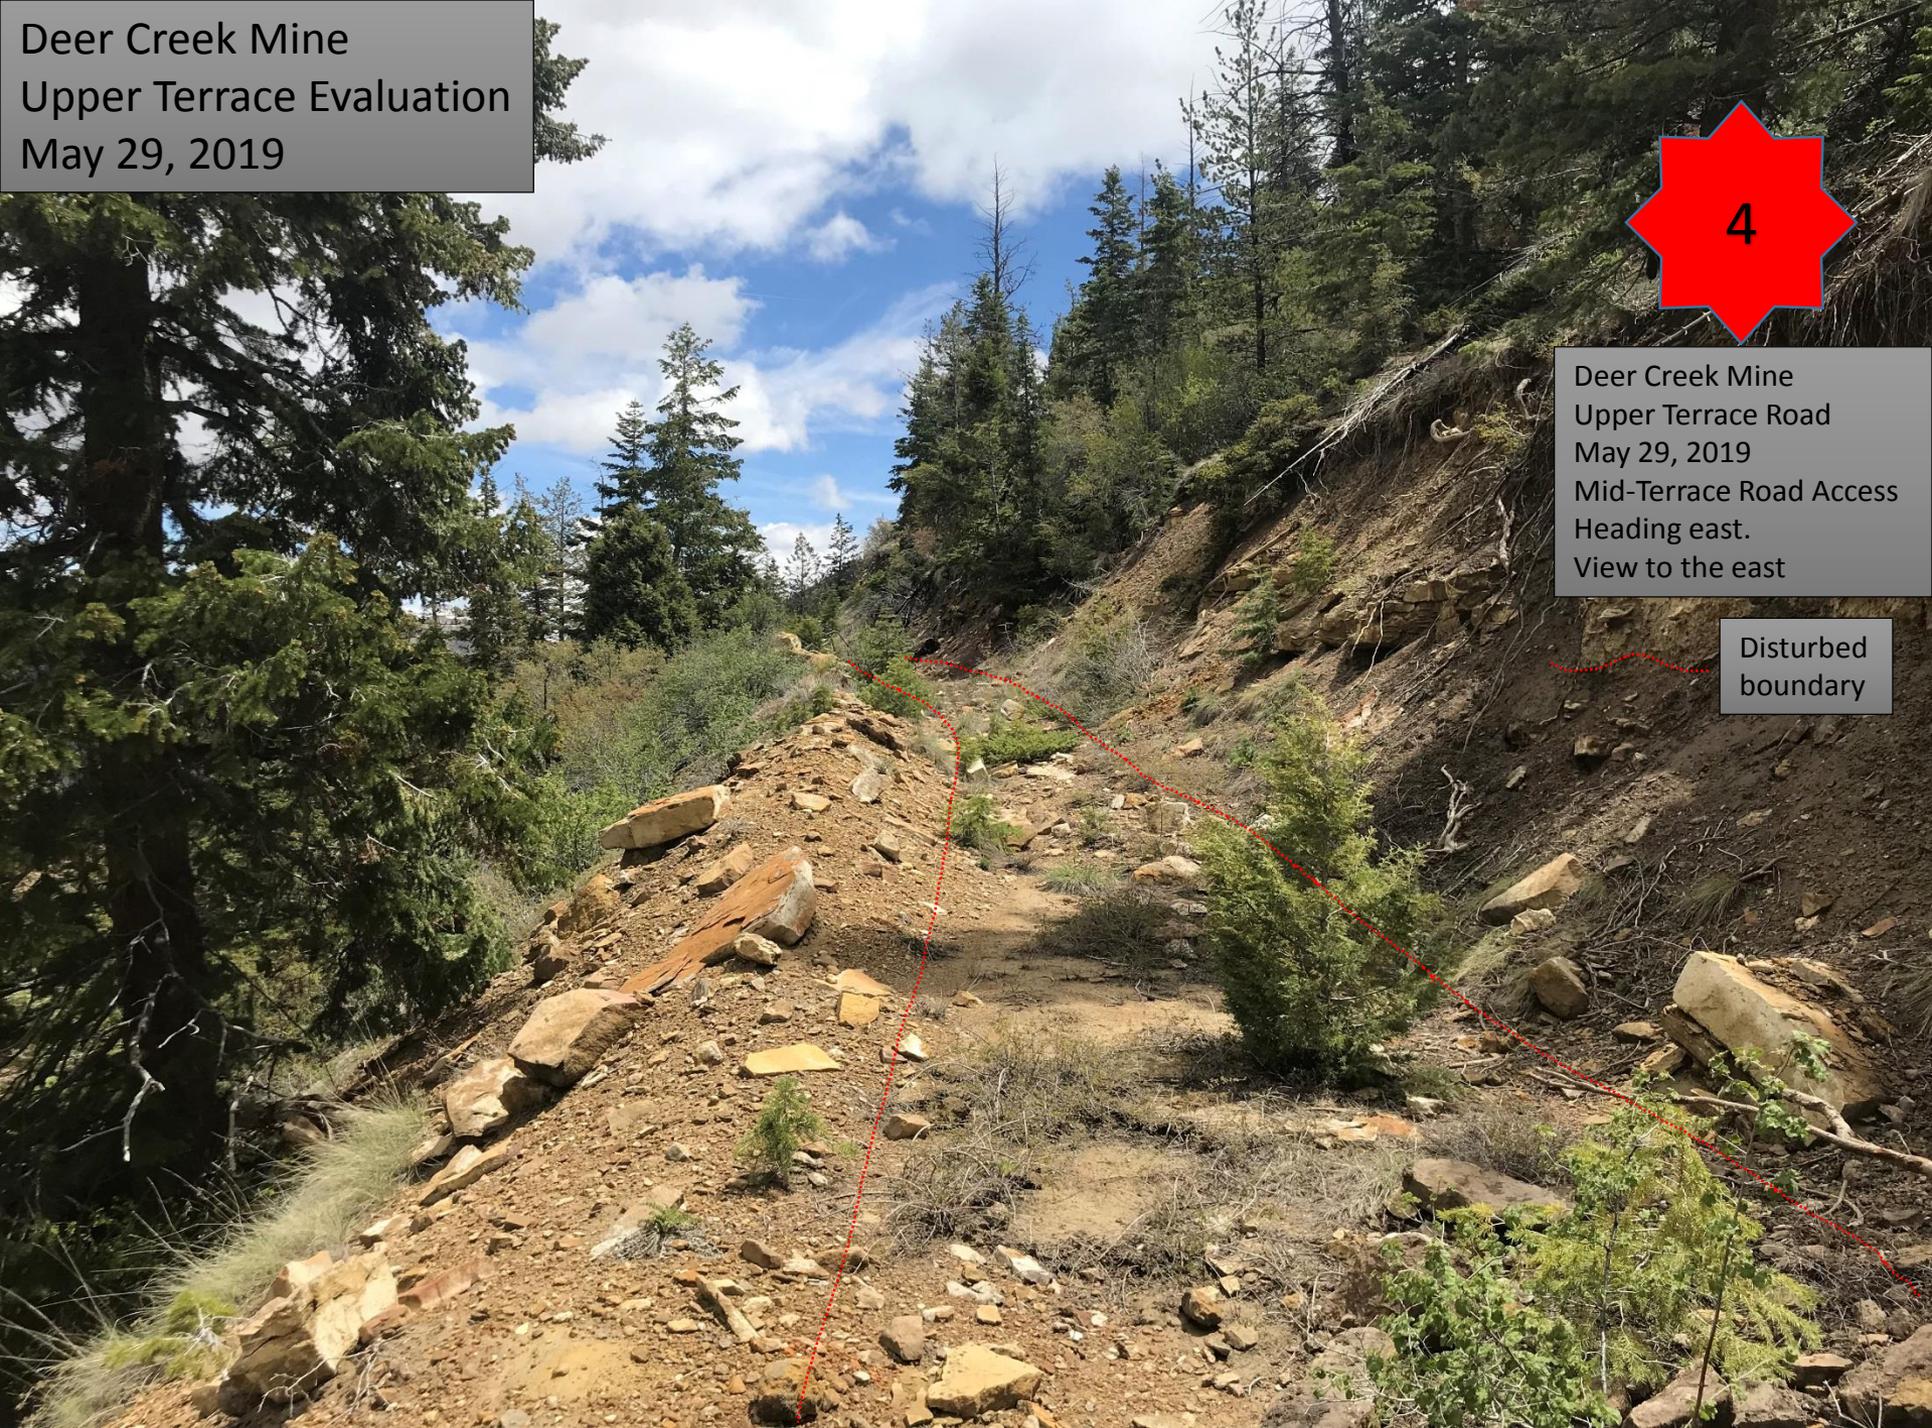
Deer Creek Mine  
Upper Terrace Road  
May 29, 2019  
Mid-Terrace Road Access  
Heading east.  
View to the east

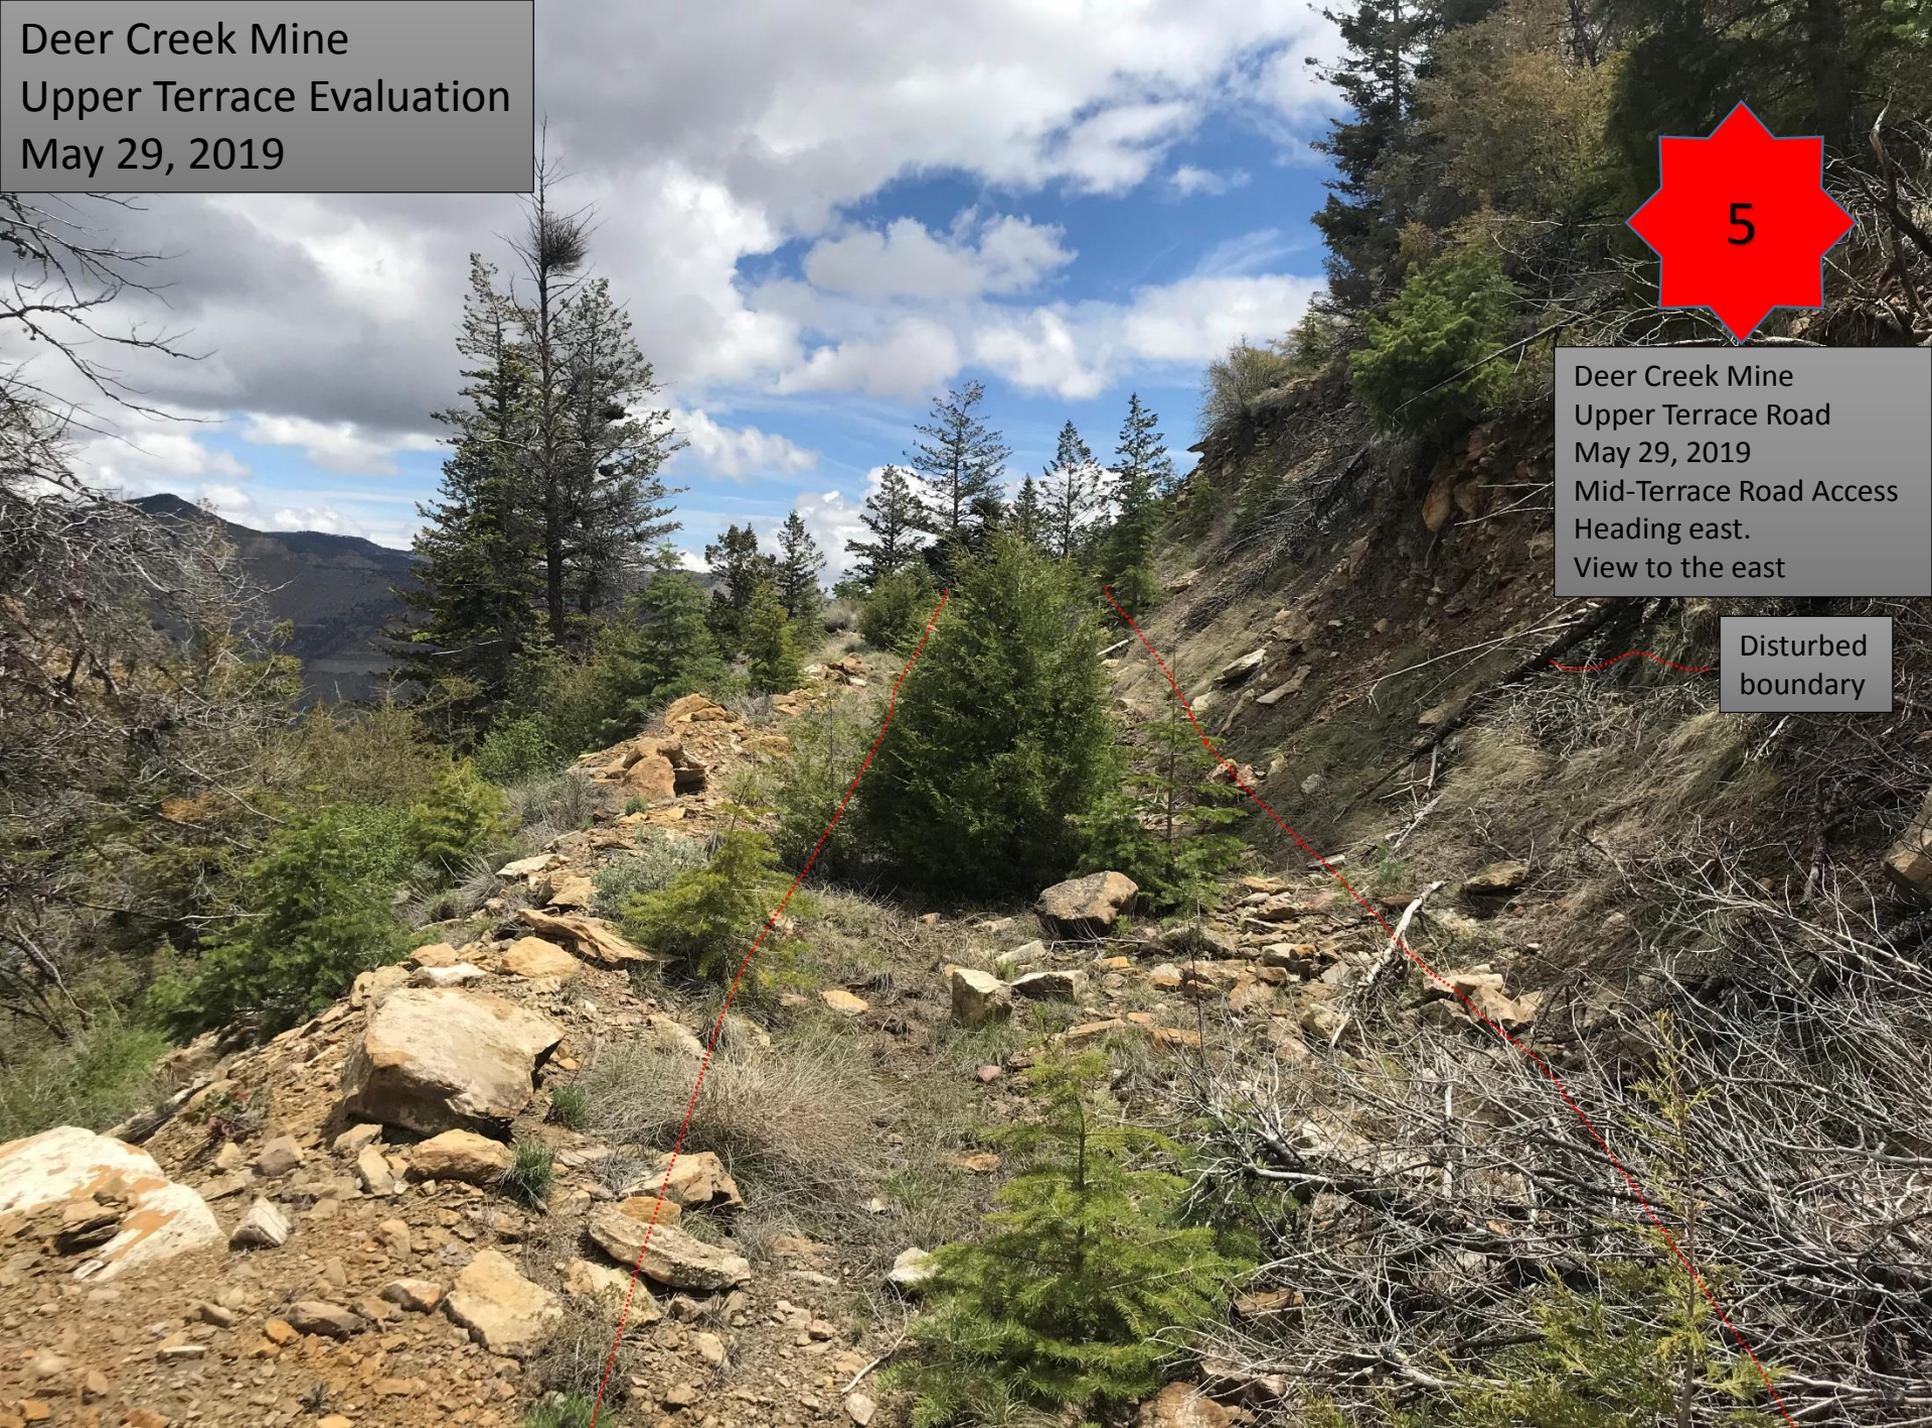
Deer Creek Mine  
Upper Terrace Road  
May 29, 2019  
Mid-Terrace Road Access  
Heading east.  
View to the east

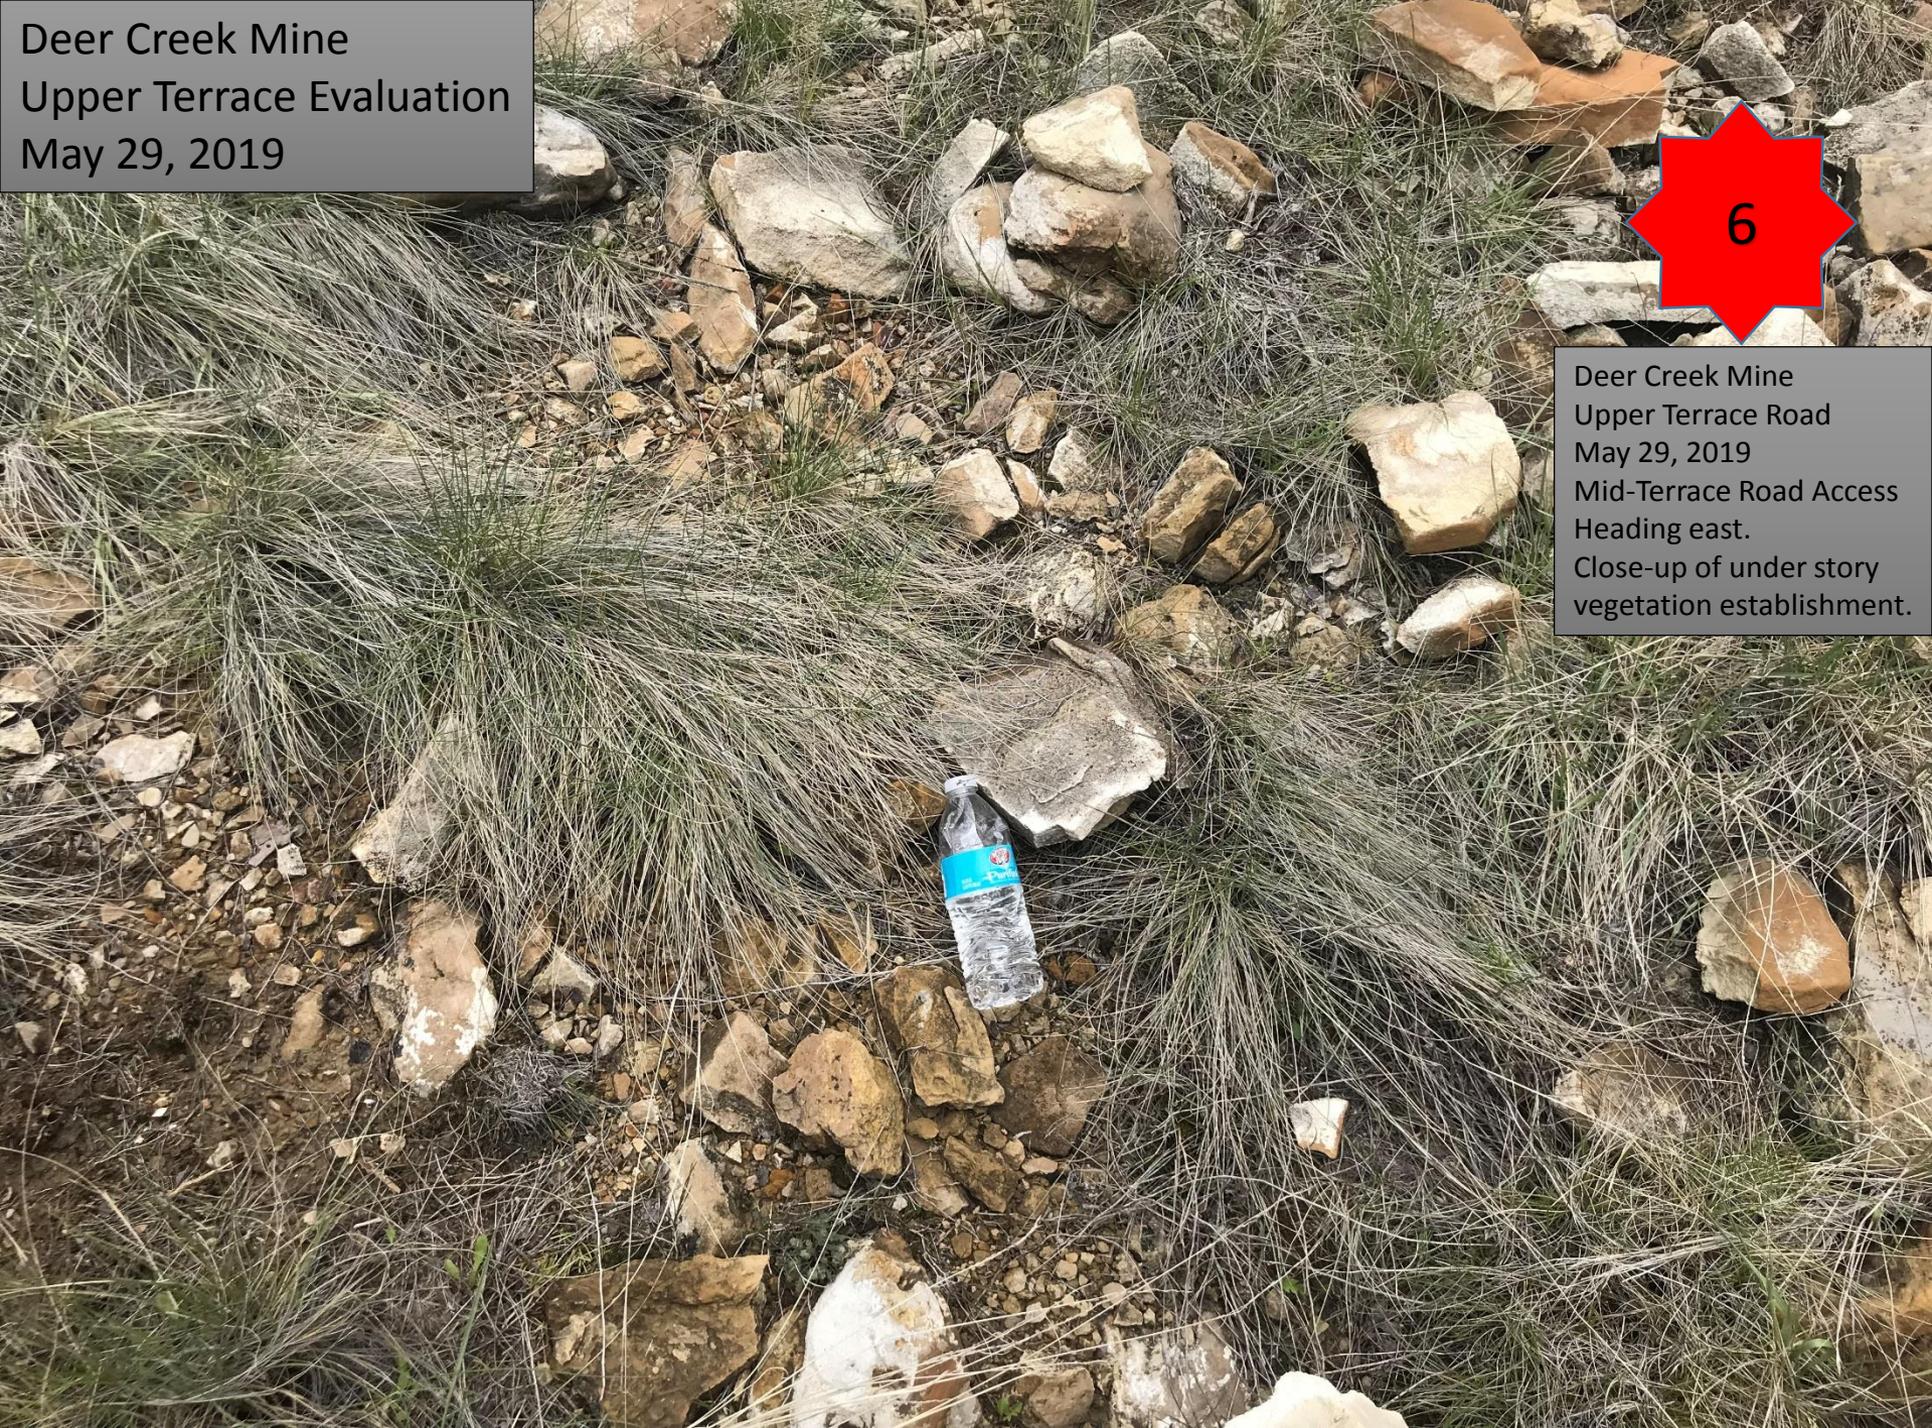
6

Deer Creek Mine  
Upper Terrace Road  
May 29, 2019  
Mid-Terrace Road Access  
Heading east.  
Close-up of under story  
vegetation establishment.

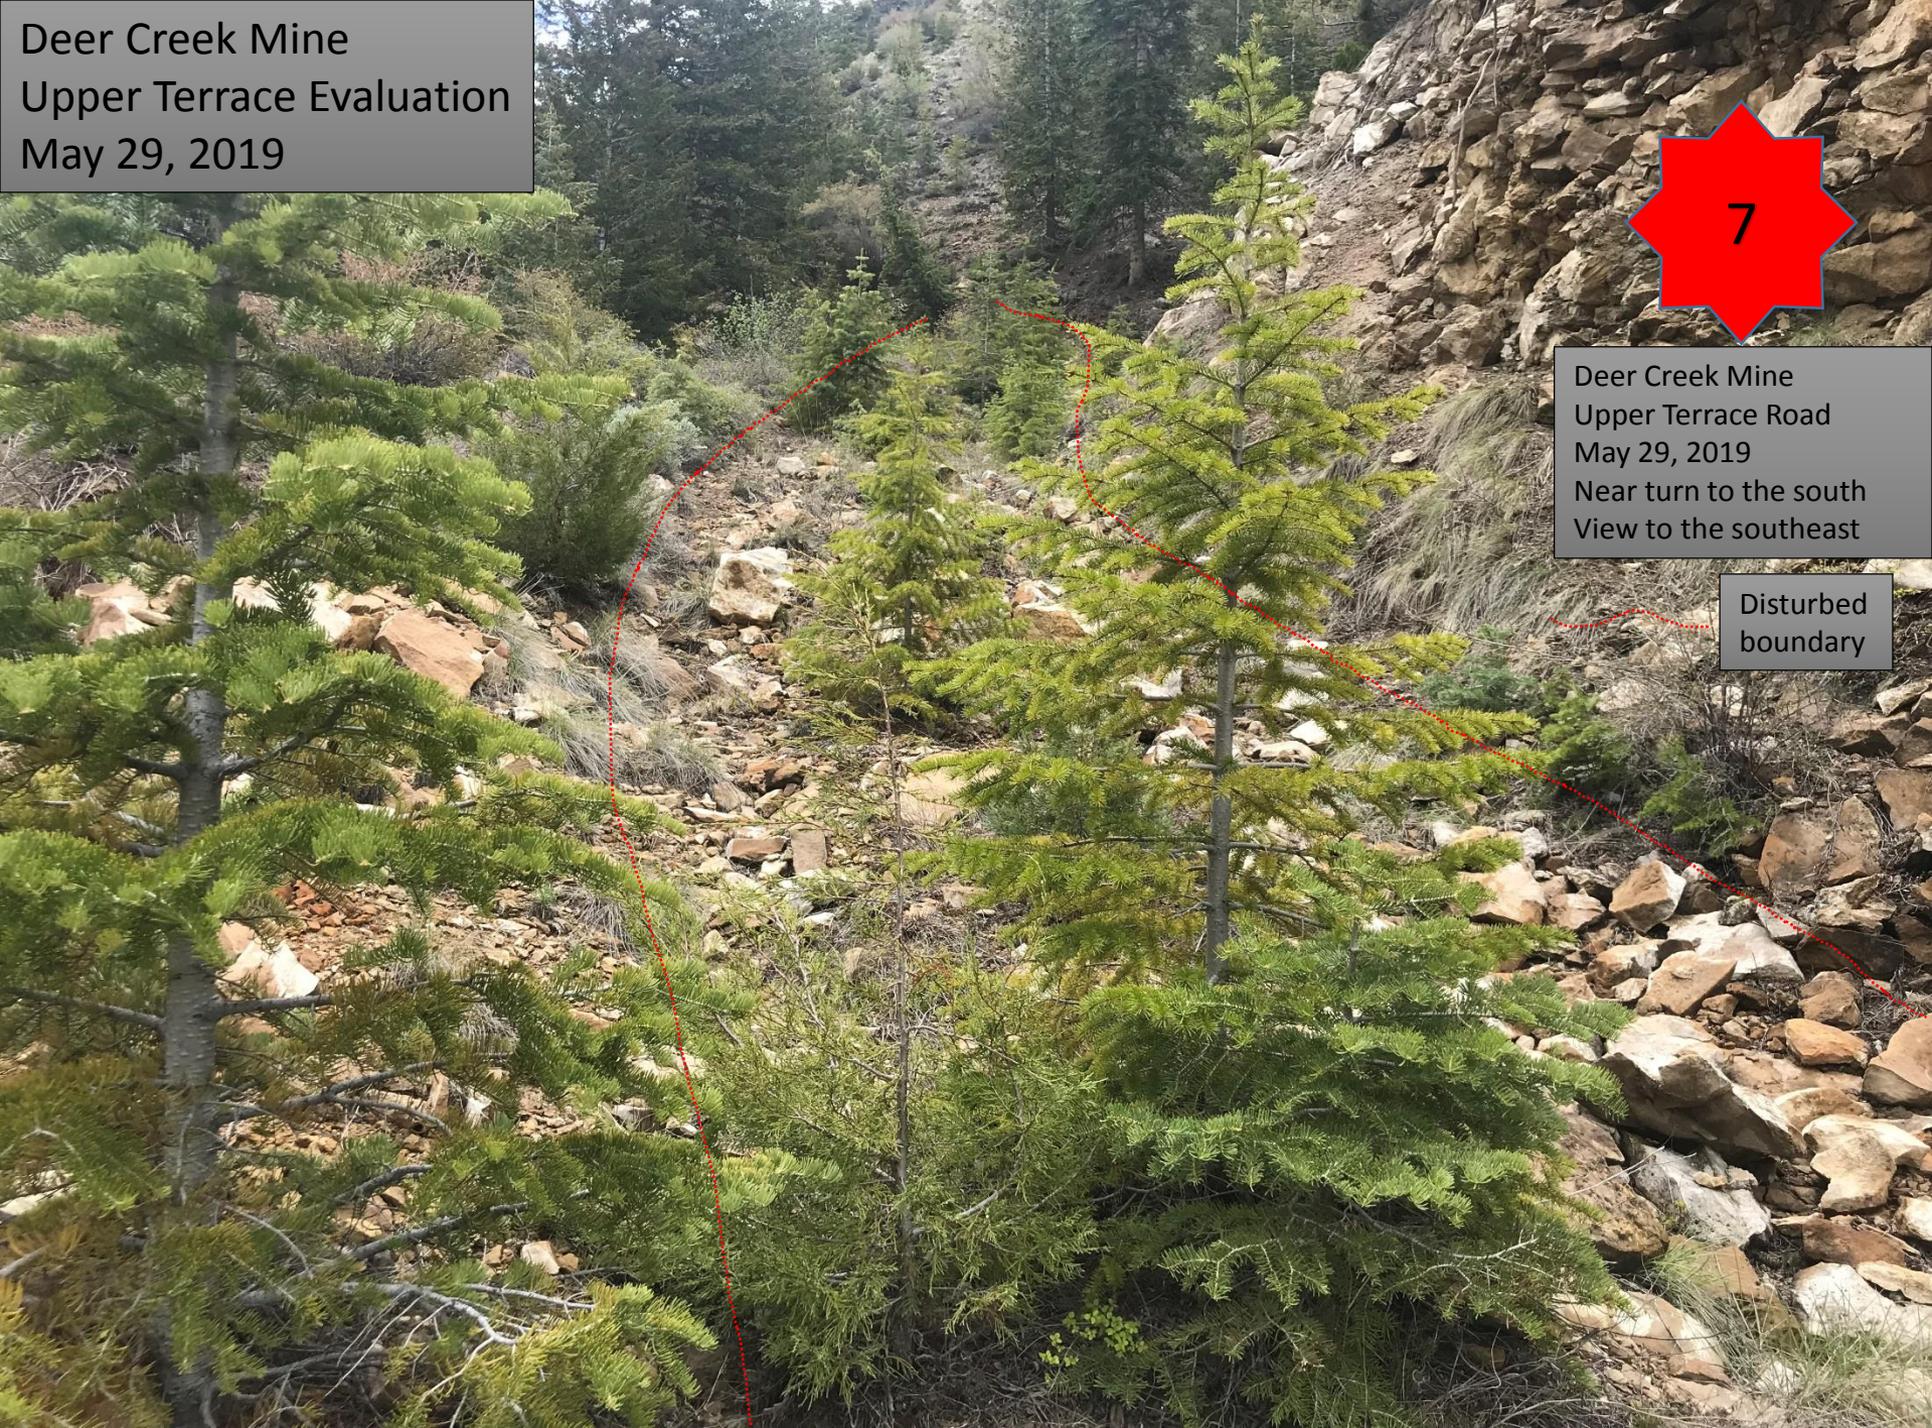
Deer Creek Mine  
Upper Terrace Road  
May 29, 2019  
Near turn to the south  
View to the southeast

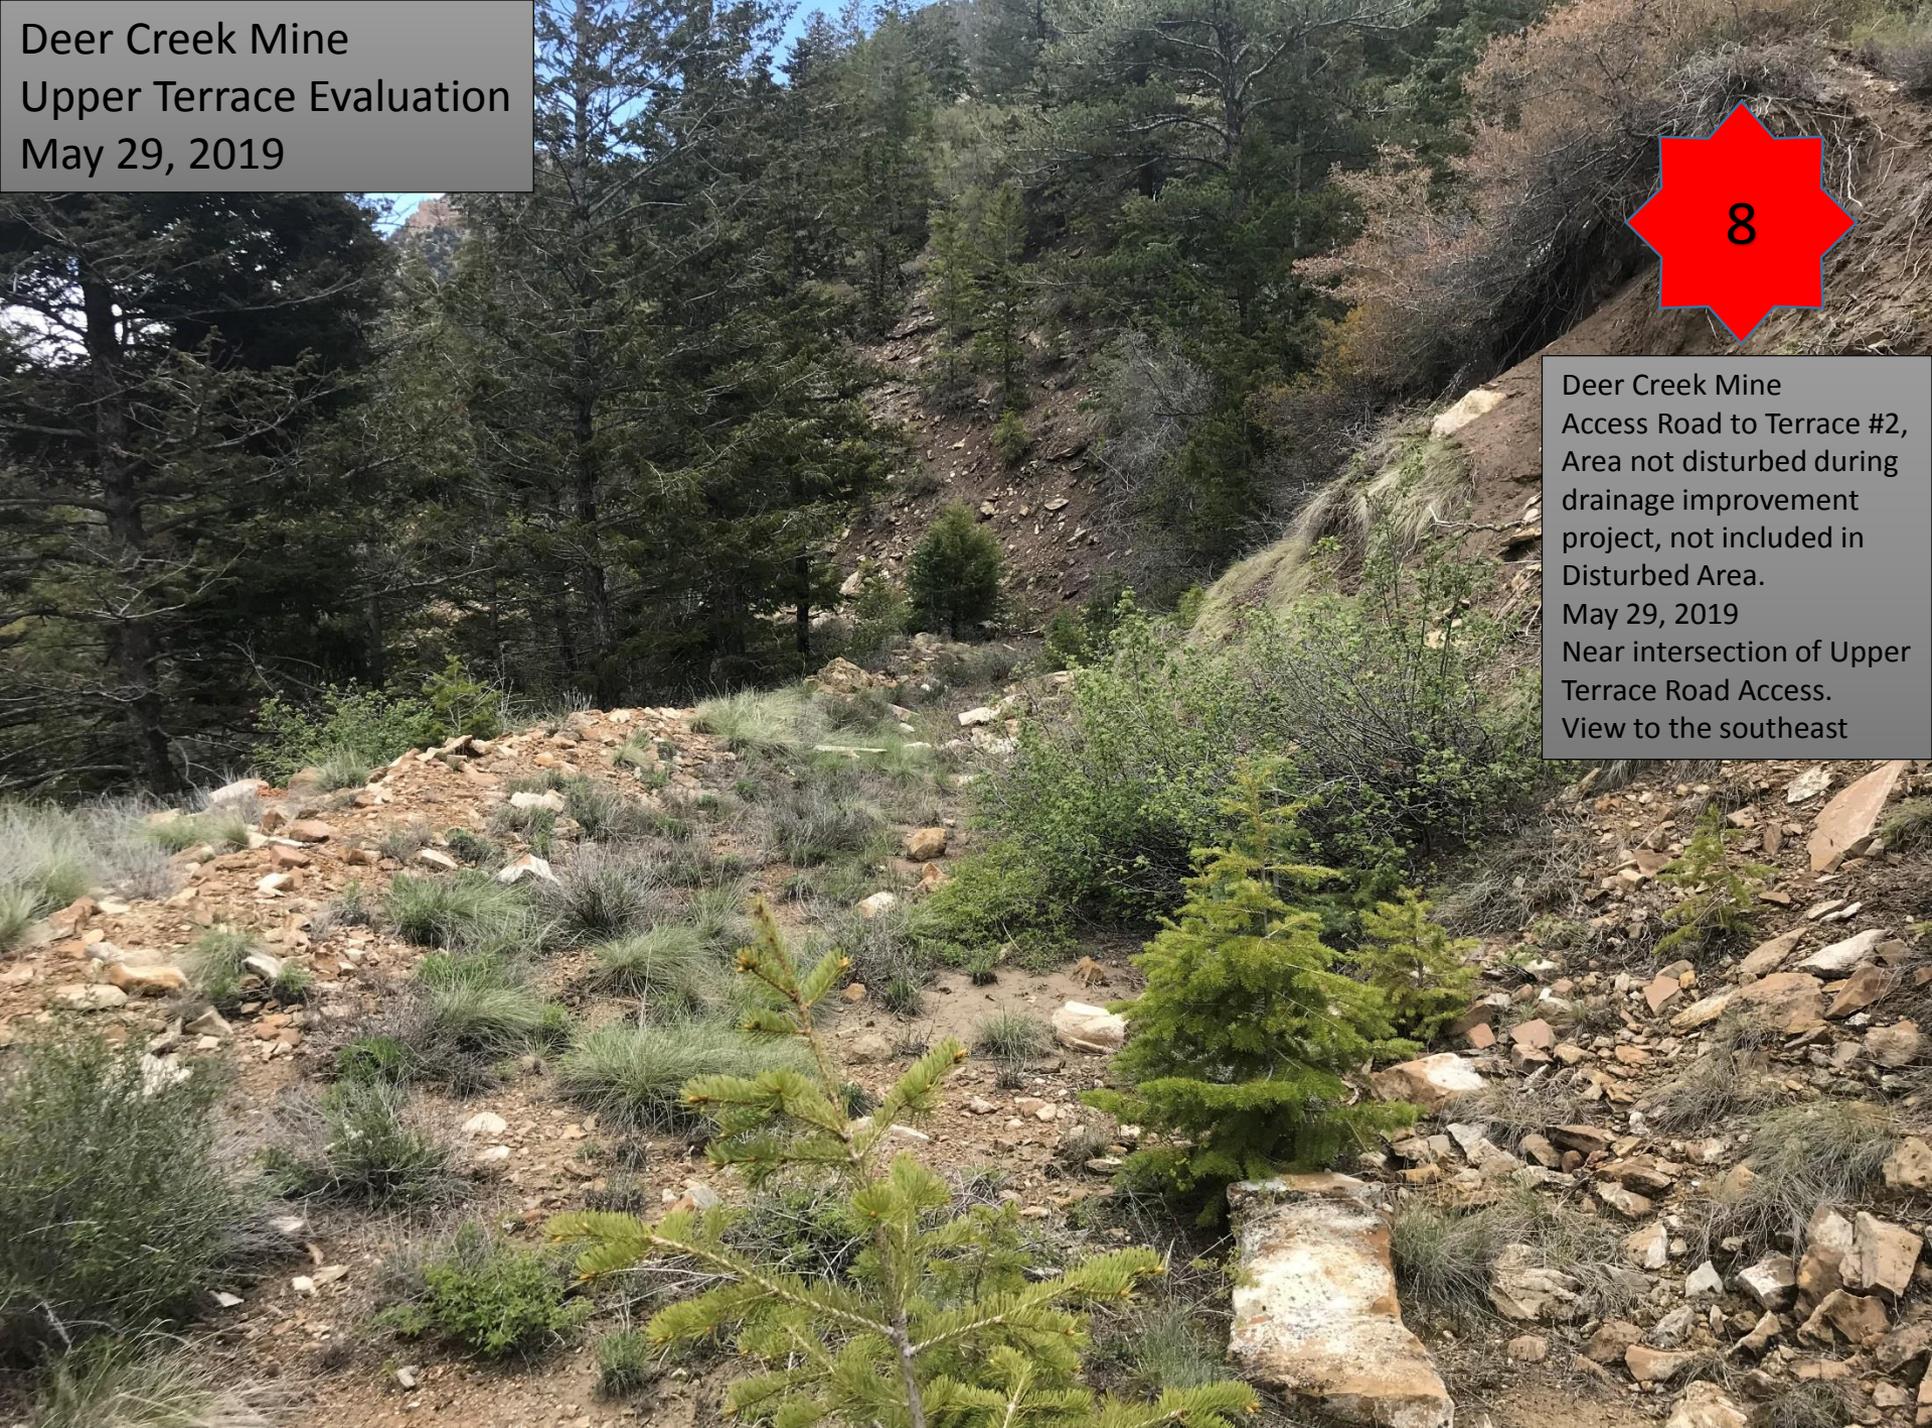
Deer Creek Mine  
Access Road to Terrace #2,  
Area not disturbed during  
drainage improvement  
project, not included in  
Disturbed Area.  
May 29, 2019  
Near intersection of Upper  
Terrace Road Access.  
View to the southeast
