**Subject: Status of Deer Creek Mine Disturbed Area Reclamation & Upper Terrace Access Road**

Deer Creek Mine  
Final Reclamation Project  
Upper Terrace Evaluation  
May 29, 2019

Deer Creek Mine  
Upper Terrace Evaluation  
May 29, 2019

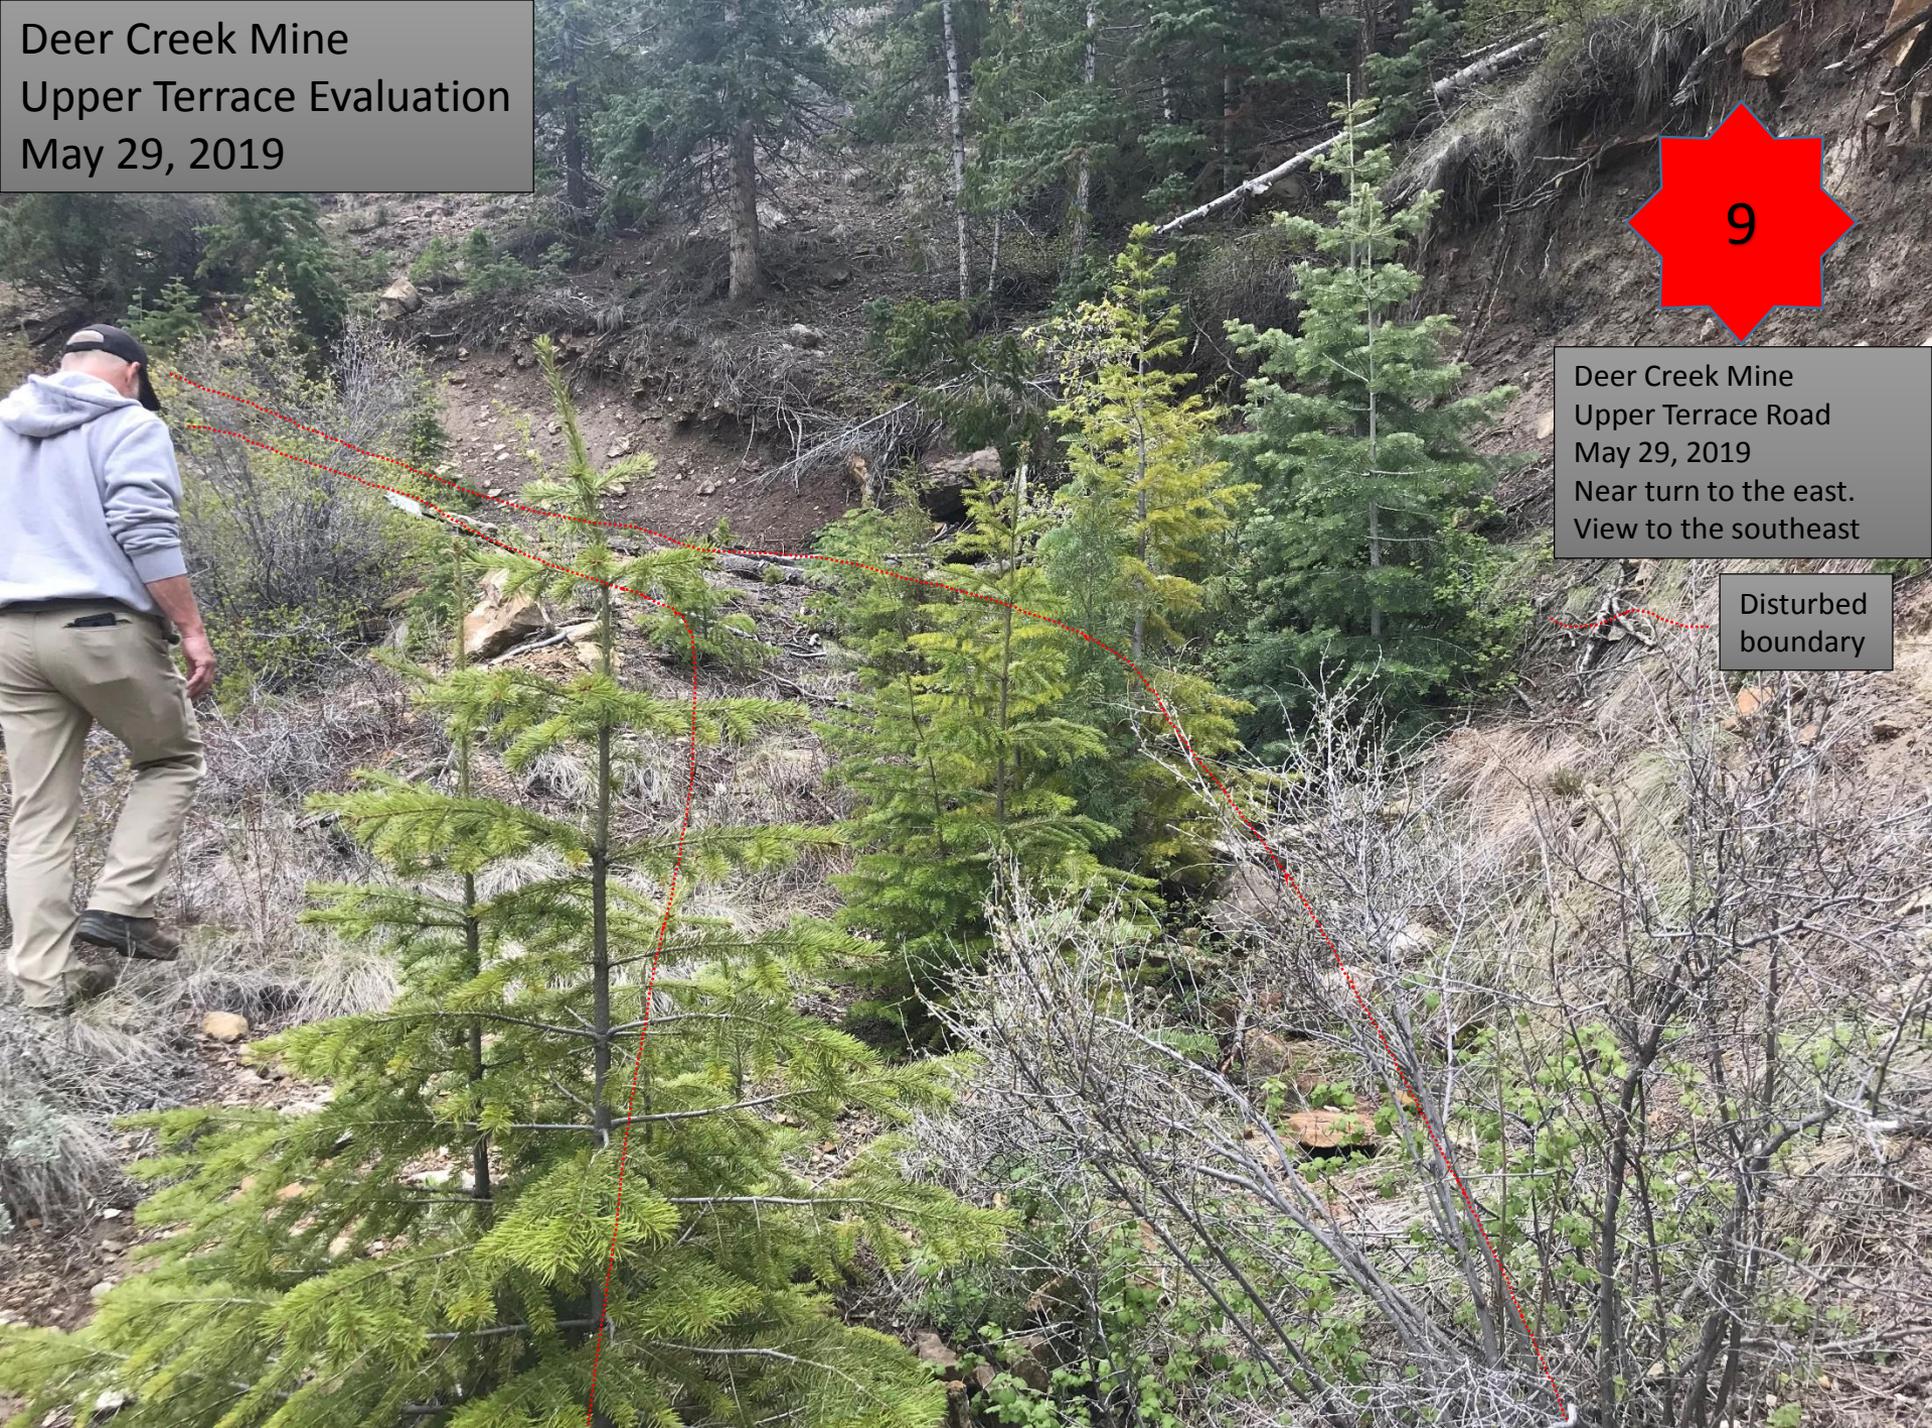
9

Deer Creek Mine  
Upper Terrace Road  
May 29, 2019  
Near turn to the east.  
View to the southeast

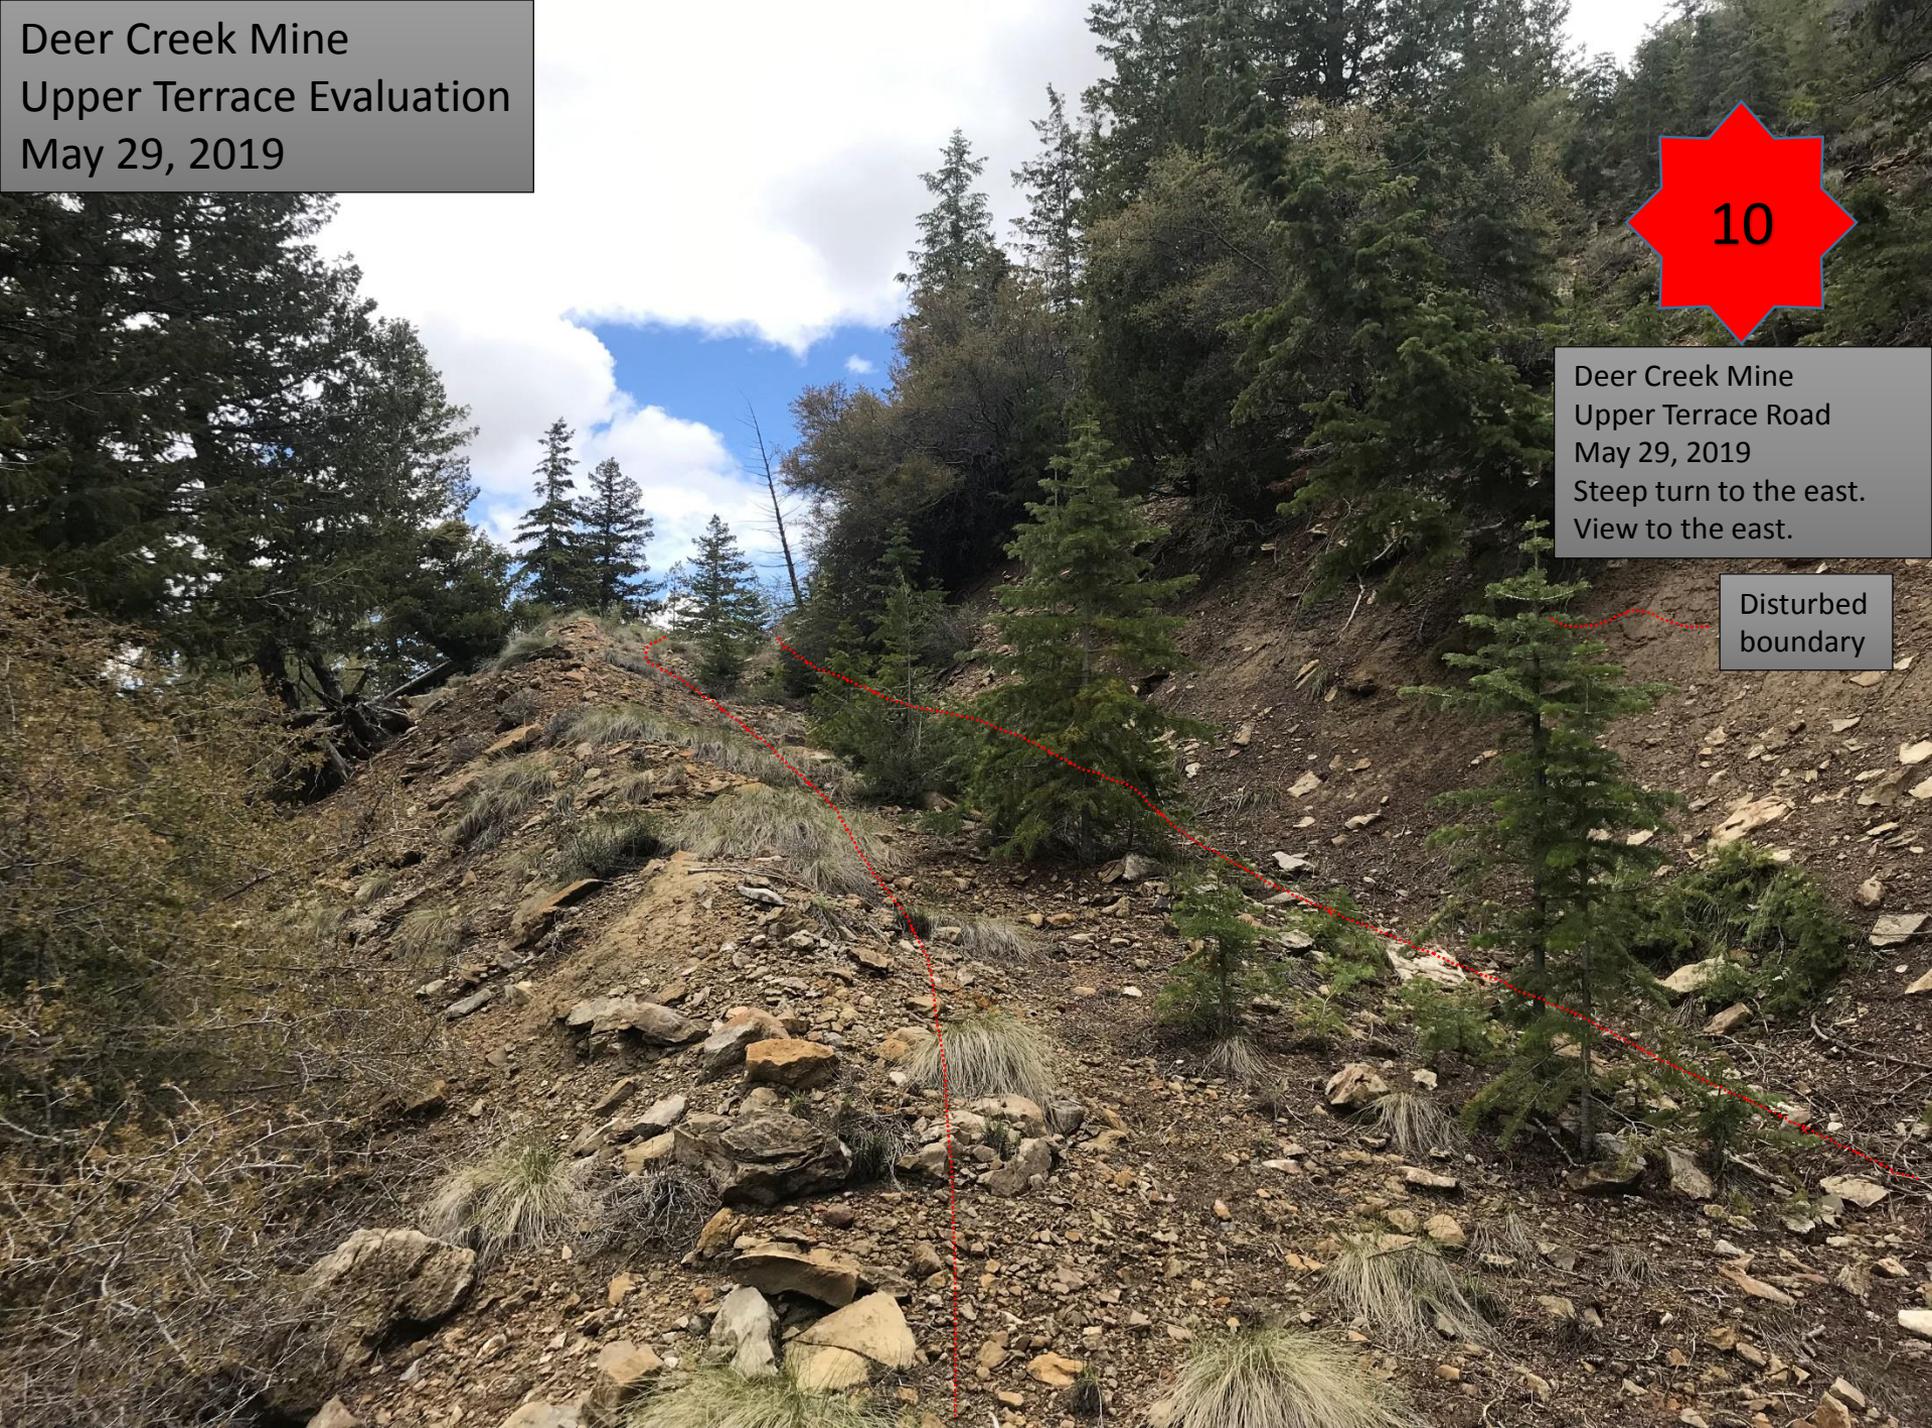
10

Deer Creek Mine  
Upper Terrace Road  
May 29, 2019  
Steep turn to the east.  
View to the east.

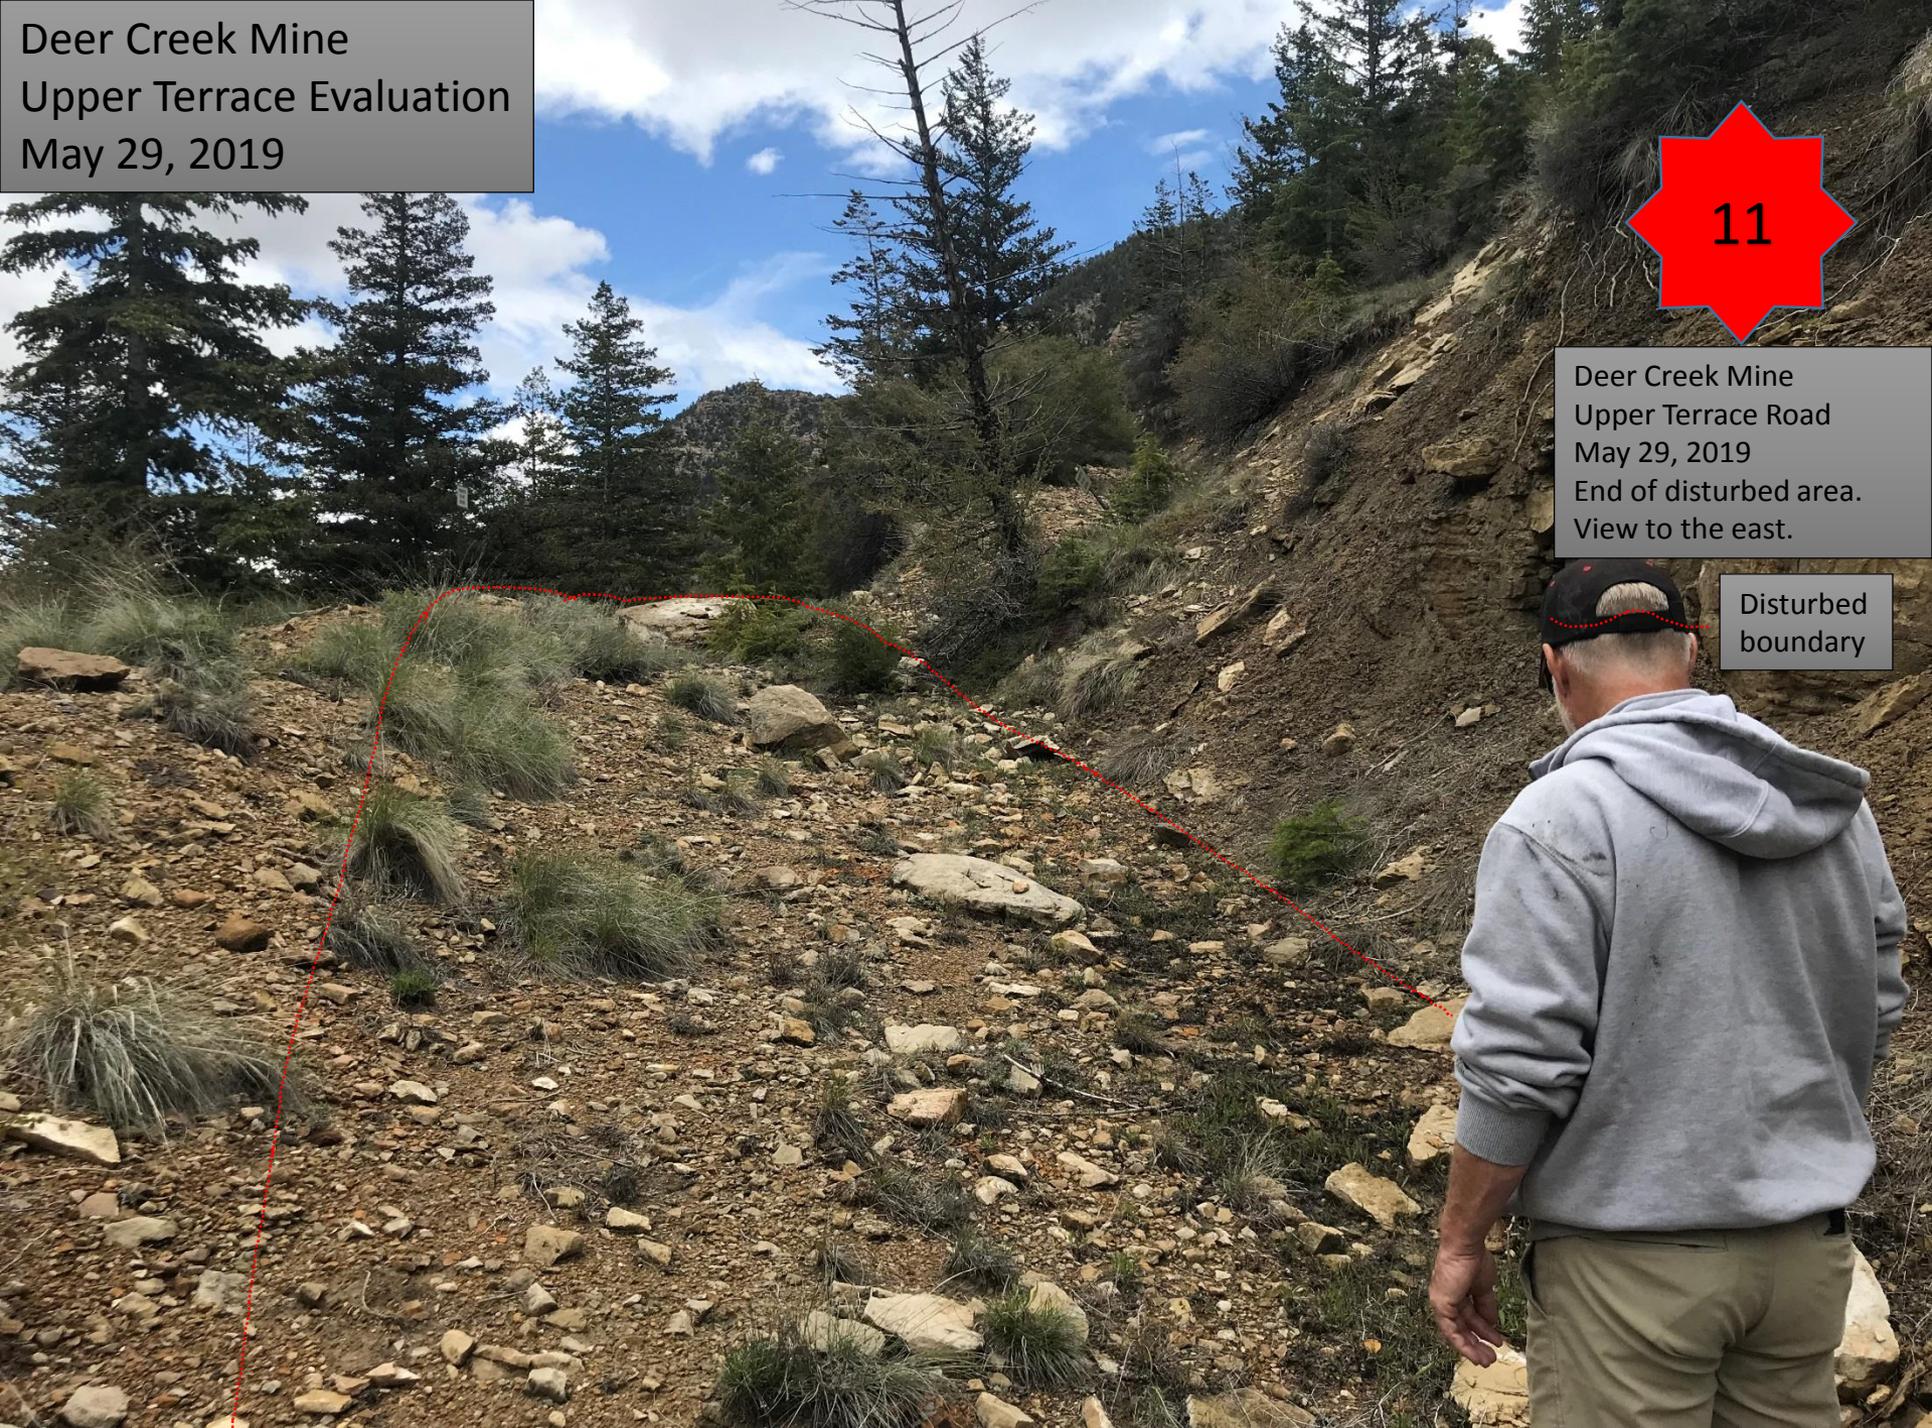
11

Deer Creek Mine  
Upper Terrace Road  
May 29, 2019  
End of disturbed area.  
View to the east.
