## Inspection Report 6468

# Inspection Report

Permit Number:	C0150018
Inspection Type:	PARTIAL
Inspection Date:	Wednesday, July 10, 2019
Start Date/Time:	7/10/2019 10:00:00 AM
End Date/Time:	7/10/2019 2:30:00 PM
Last Inspection:	Wednesday, June 26, 2019

Permitee: **PACIFICORP**  
 Operator: **INTERWEST MINING CO**  
 Site: **DEER CREEK MINE**  
 Address: **PO BOX 310, HUNTINGTON UT 84528**  
 County: **EMERY**  
 Permit Type: **PERMANENT COAL PROGRAM**  
 Permit Status: **ACTIVE**

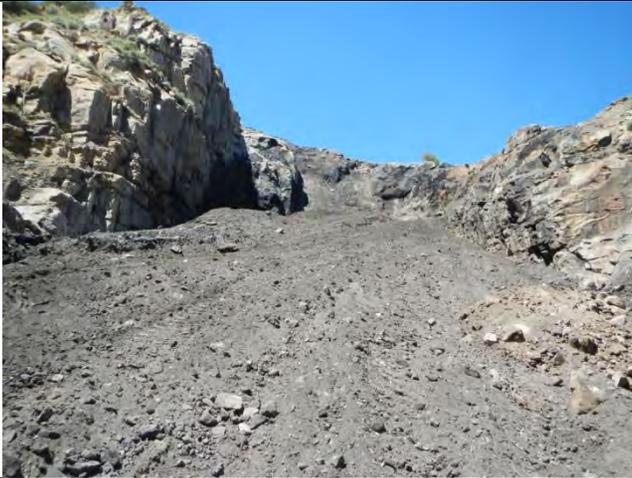
In the Elk Canyon drainage: Refuse remaining in the coal storage "chute" is being graded 2h:1v. A small grade break shown at Sta 1+65 will be extended to slow flow from the refuse chute. Grading of refuse pile #2 in Elk Cyn will be as shown on Dwg DS1782D. The upper slopes of the refuse pile will remain in tact. These slopes tie in to the undisturbed slope and are well vegetated with grass and shrubs.

**Elk Canyon coal storage chute 2h:1v slope**

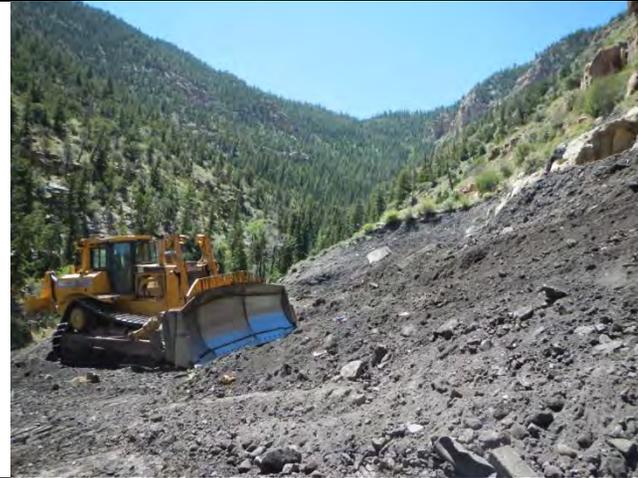
**D9 pushing refuse**

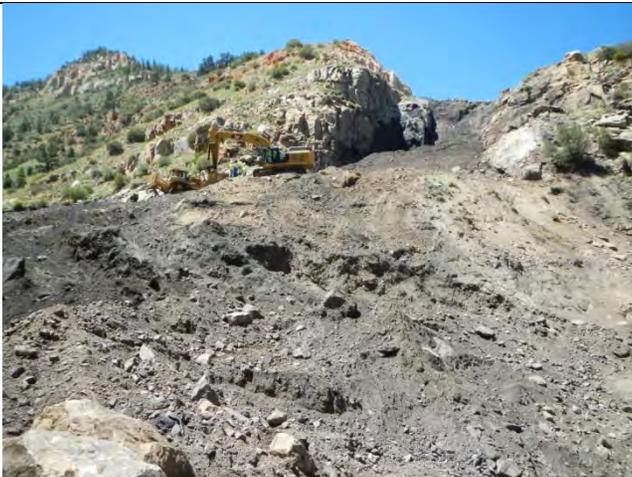
**Lower Elk Canyon coal storage & chute**

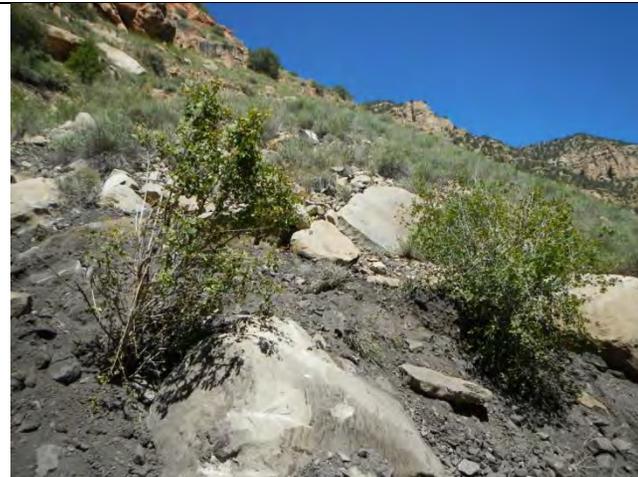
Grading of the Elk Cyn refuse will be graded so that it will not disturbed the vegetated refuse slope at the bend in the access road.

**Established vegetation on refuse in Elk Cyn**

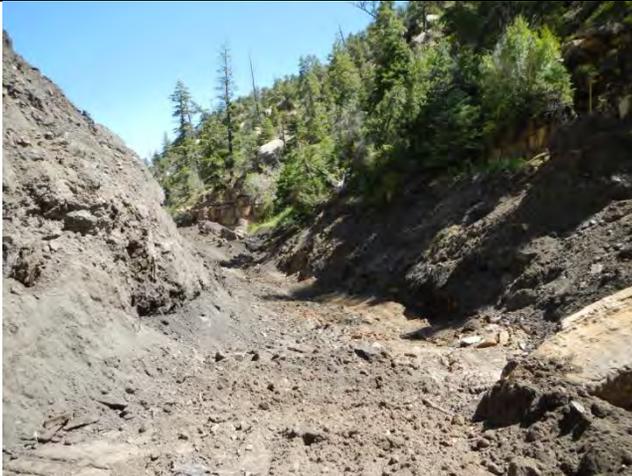
Soil was re-exposed in the main Elk Cyn channel between the two side channels. This soil was sampled for analysis and will likely be a source of substitute topsoil. It won't be possible to re-expose soil along the length of the Elk Crk channel, however, because approximately 20 feet of refuse covers the native ground at the channel transition area. The final grade of the channel would not be achieved if all this refuse was moved. So the Elk Cyn drainage will be constructed on refuse, in part, and ripped along its entirety. This is an ephemeral channel, which is overgrown with vegetation in its undisturbed reaches.

**Re-exposed soil adjacent to mine waste in main drainage in Elk Cyn**

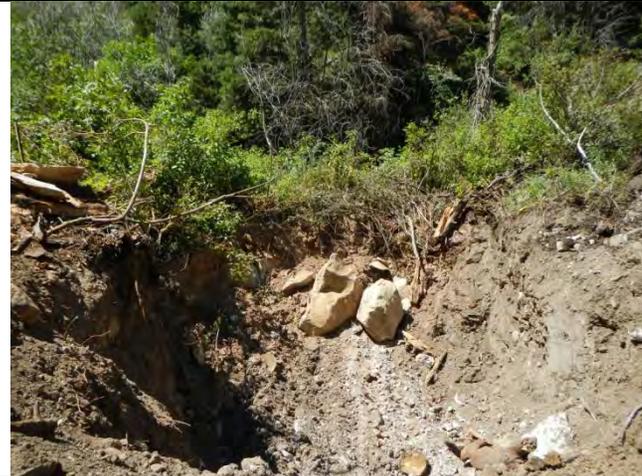
**Well vegetated Elk Cyn drainage at disturbed boundary**

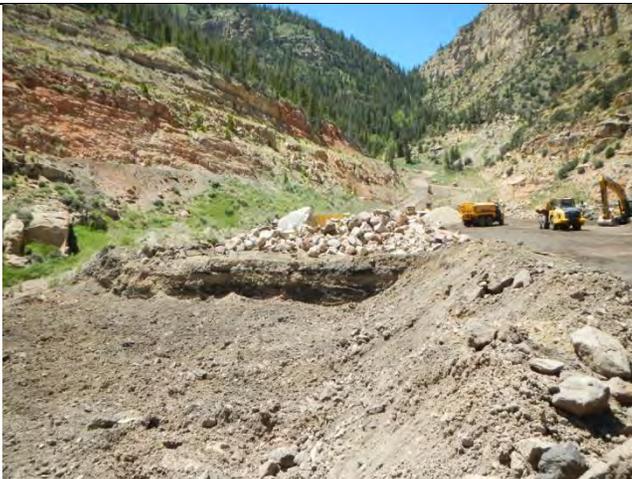
**Pad cut shows potential substitute topsoil**

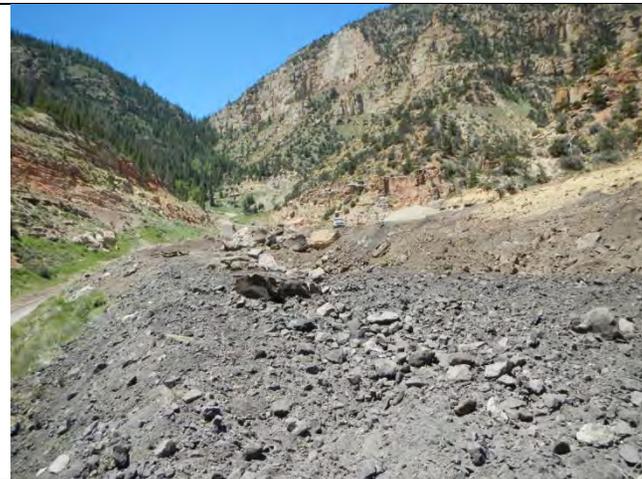
In Deer Creek Cyn: The refuse slope will be cut to achieve the final grade. Vegetation and surface soil to a depth of 12 inches is being salvaged and replaced on the graded refuse slope.

**Topsoil removed and stockpiled (right side) on Refuse Pile #1**

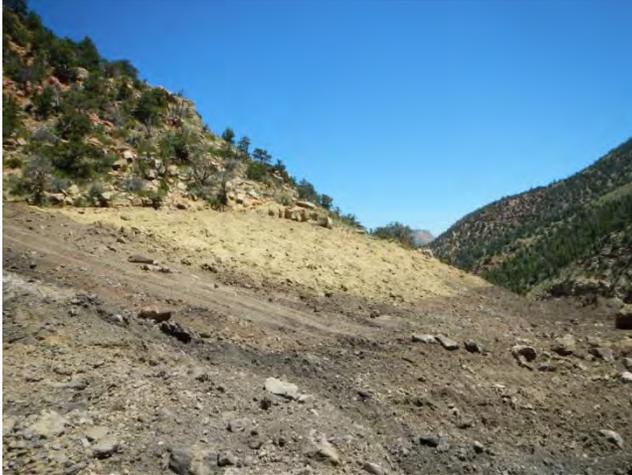
**Seeded area on final grade of refuse pile #1 in Deer Creek Cyn**

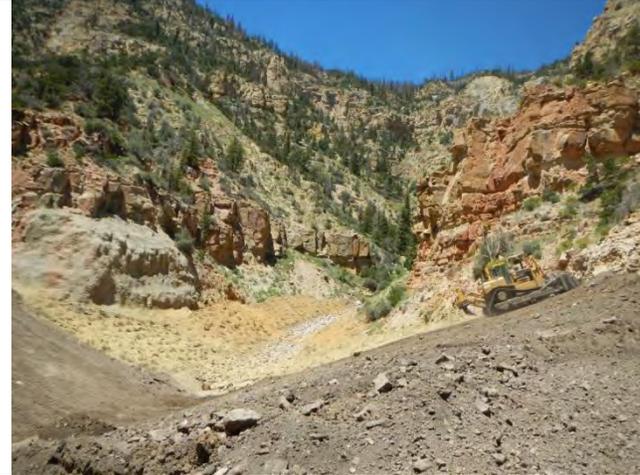
Incremental seeding and mulching is being done, before areas get out of reach of the hydro-truck. Deer Cyn and a segment of the refuse pile were seeded and mulched. The diversion ditch above the Deer Creek pad (on the southern disturbed area boundary) has also been graded out and seeded.

**Grading topsoil in Deer Canyon (foreground) and seeded mulched Deer Canyon and channel (background)**

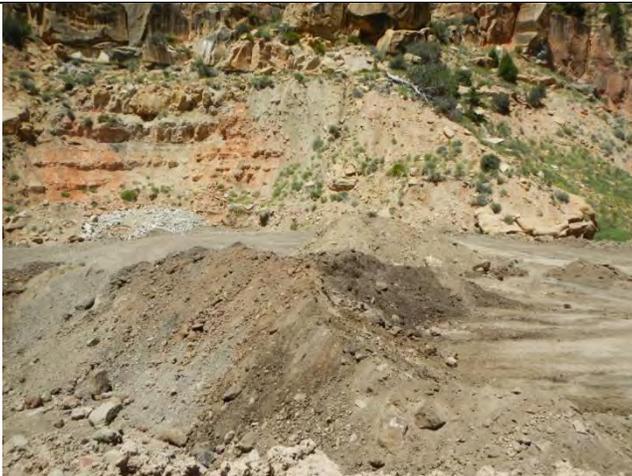
**Suitable substitute topsoil before blending**

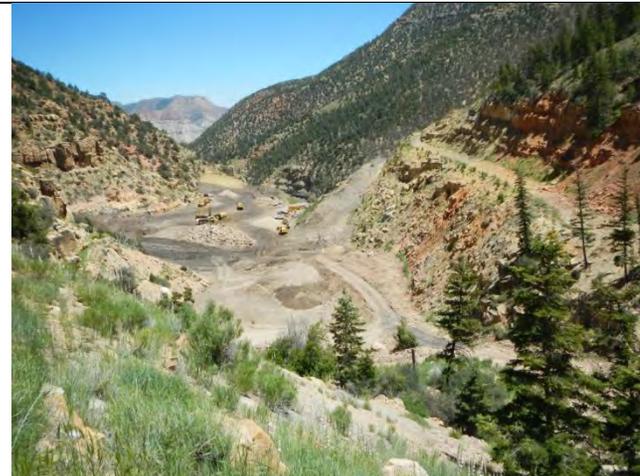
**Water tank overview. East boundary ditch at far right is seeded.**
