2019 ANNUAL REPORT

Company Name	PacifiCorp	Mine Name	Deer Creek Mine
Permit Number	C/015/0018	Permit Expiration Date	February 7, 2021
Operator Name	Interwest Mining Company	Phone Number	+1 (801) 220-4632
Mailing Address	1407 West North Temple, Suite 210	Email	dennis.oakley@pacificorp.com
City	Salt Lake City		
State	Utah	Zip Code	84116

Deer Creek Impoundment Report

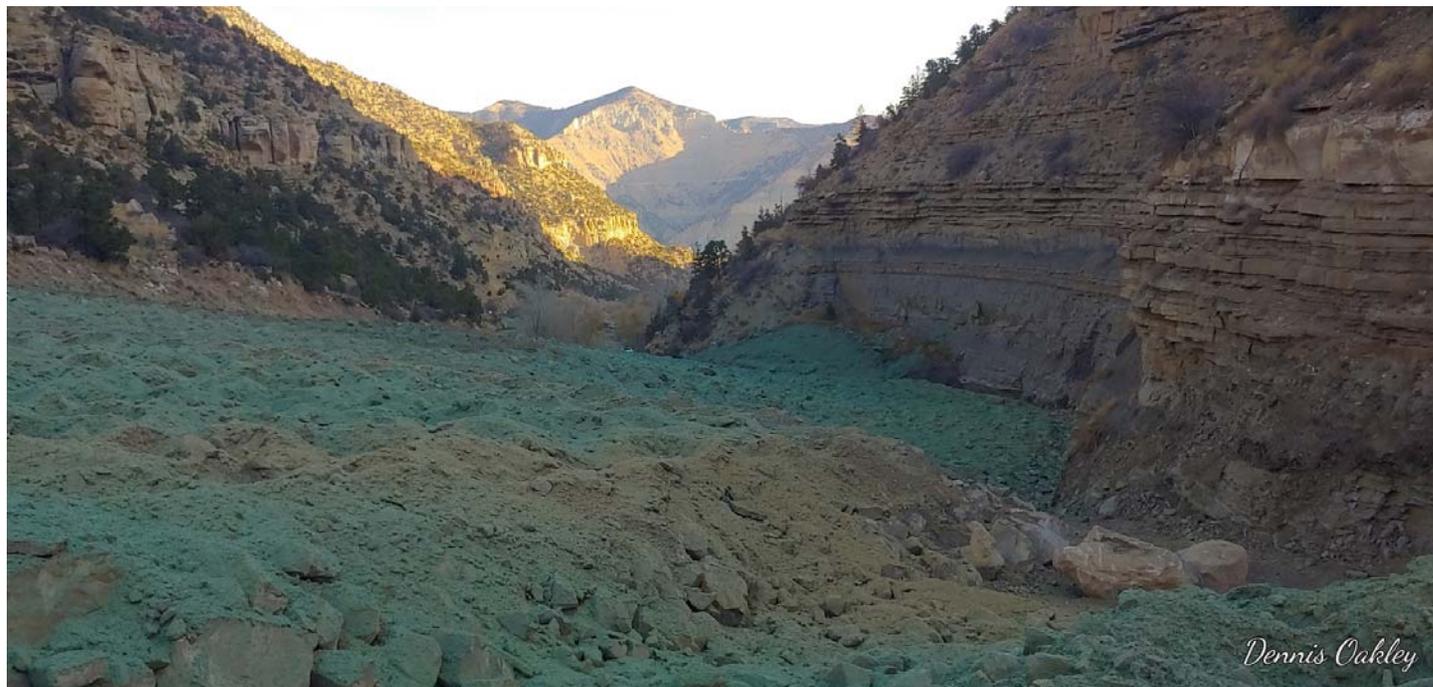
Reclaimed Deer Creek Sediment Pond looking down canyon.
