**Fwd: Deer Creek Water Issues - Action Plans**

Subject: Deer Creek Water Issues - Action Plans

**Deer Creek Piping May 23 2020.pdf**

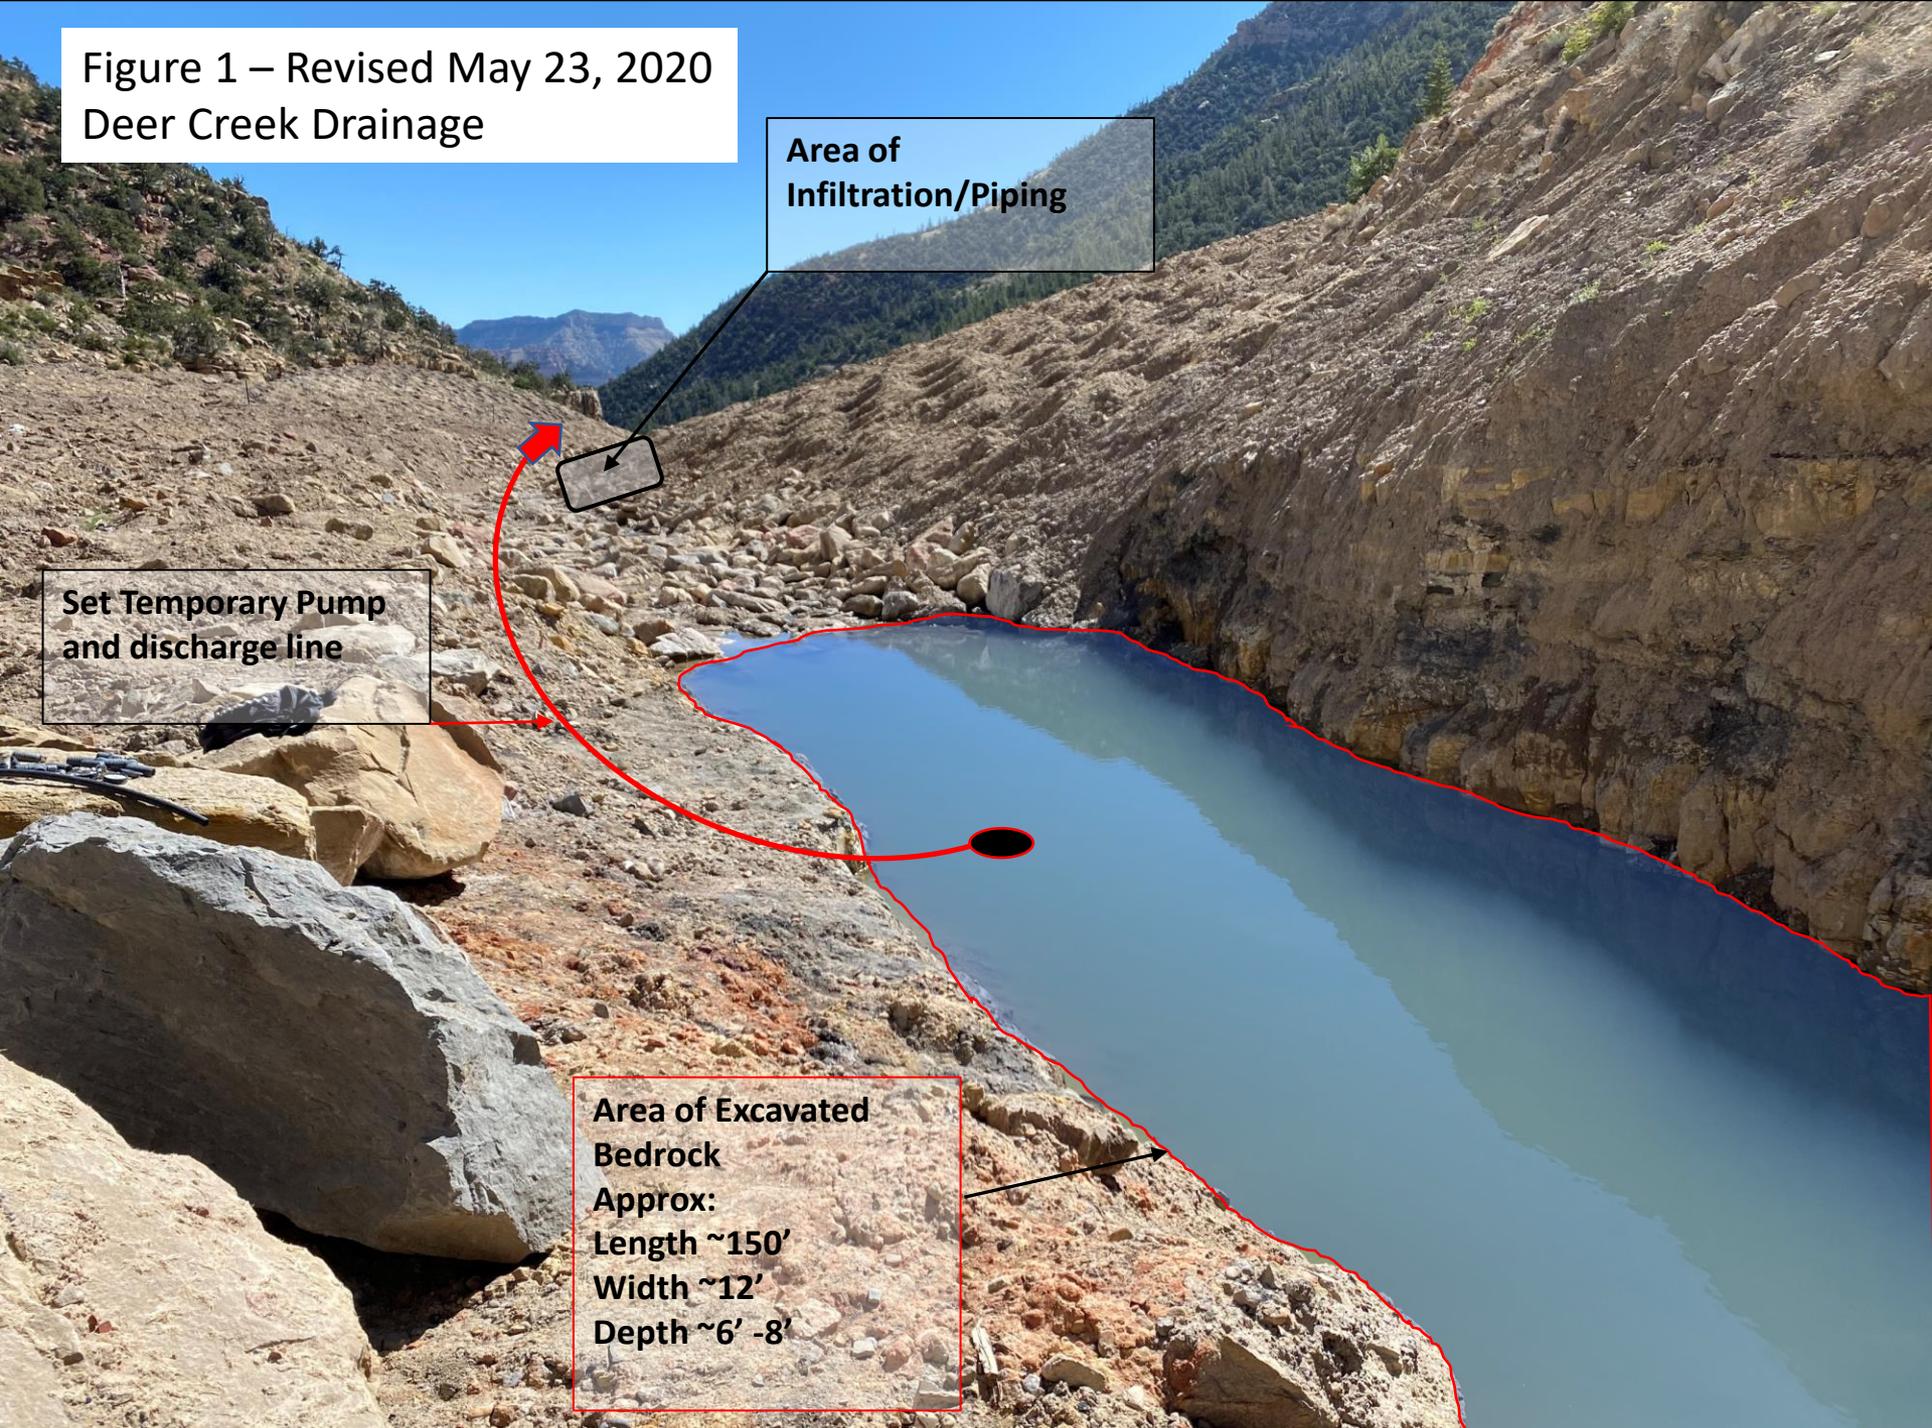
Figure 1 – Revised May 23, 2020  
Deer Creek Drainage

**Area of  
Infiltration/Piping**

**Set Temporary Pump  
and discharge line**

**Area of Excavated  
Bedrock  
Approx:  
Length ~150'  
Width ~12'  
Depth ~6' -8'**

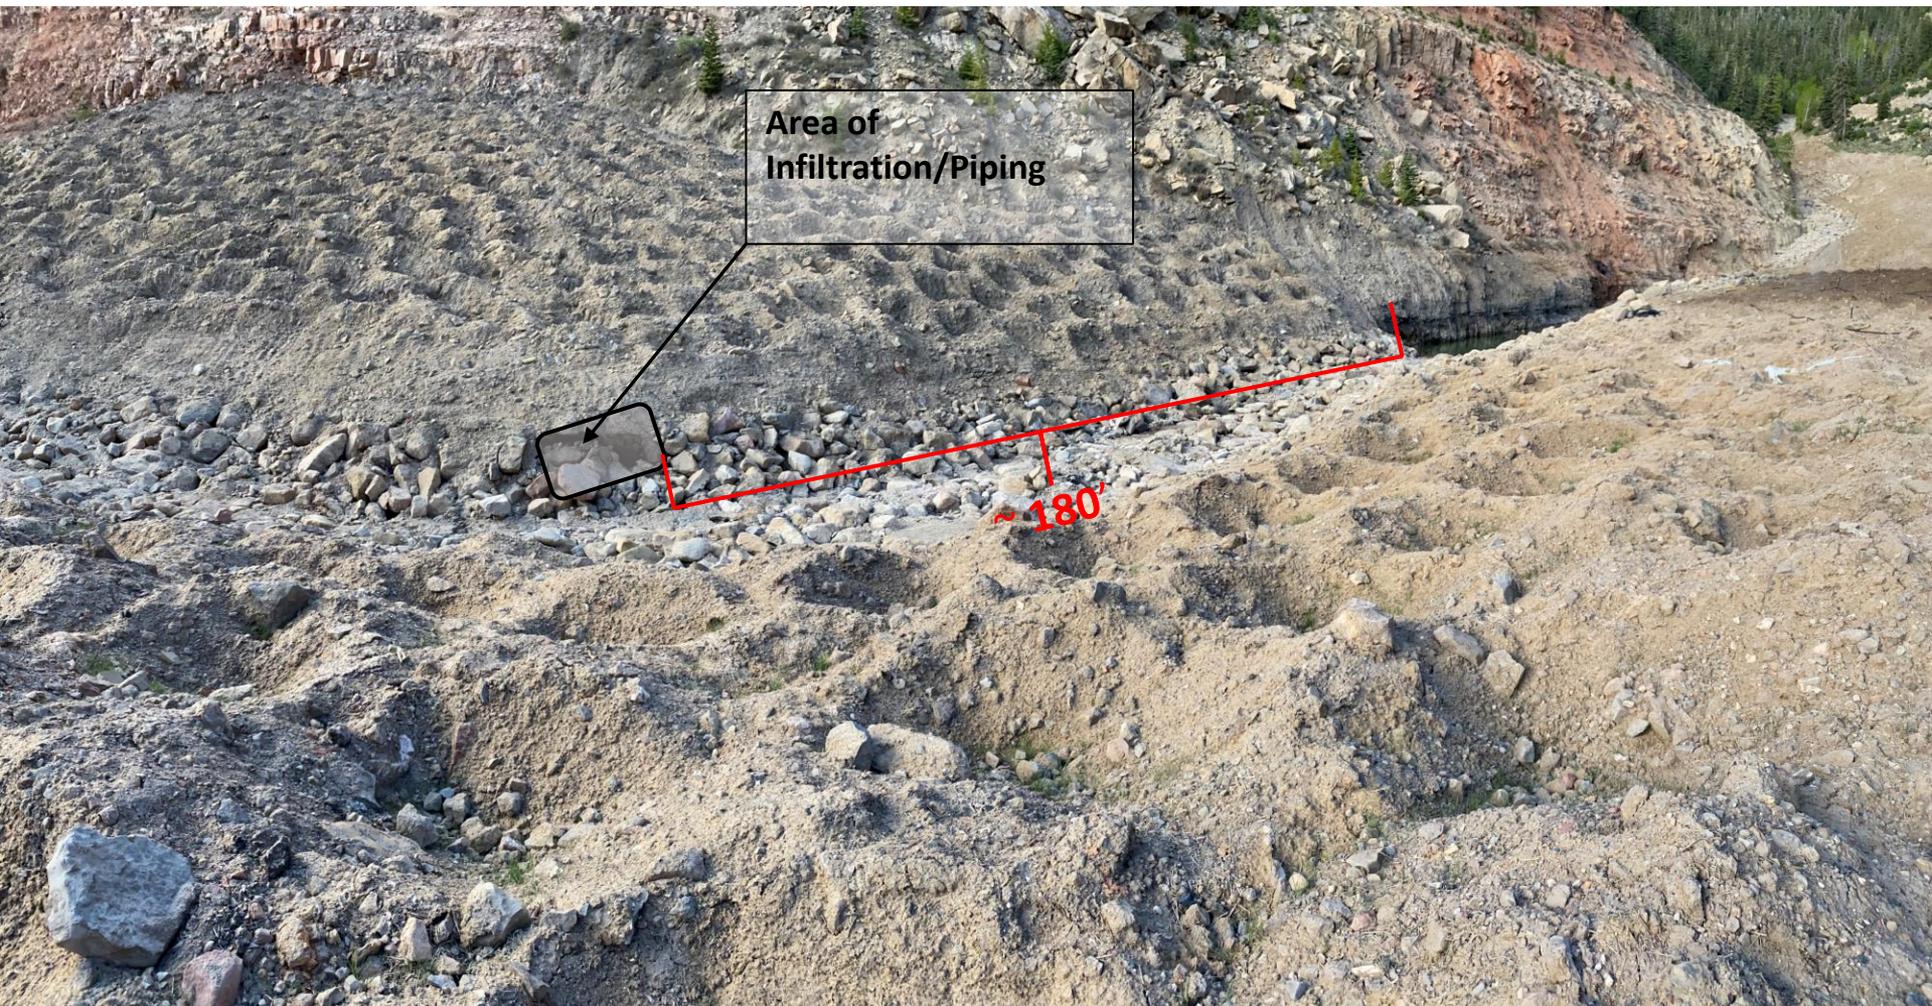
Figure 2 – May 23, 2020  
Deer Creek Drainage

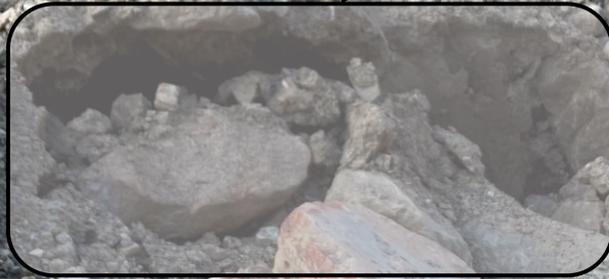
At the end of last week, a requisition was developed to supply funding for addressing the water runoff issues at the Deer Creek Mine. Our initial tactics will be to assess the area where the water infiltrates the ground. As shown in the attached photo essay, water in the channel ponds approximately 180' up channel from where it disappears into the ground. We plan to bypass this area by installing a pump in the ponded area and running a discharge hose around the infiltrations area. Once bypassed, we will begin removing riprap and filter material from the channel at the infiltration area to assess the channel bottom. The assessment should help us to ascertain whether we have man made or natural features causing the infiltration. Repair options of this area are dependent on what is found during this initial assessment.

Figure 3 – May 23, 2020  
Deer Creek  
Area of Infiltration

Area of  
Infiltration/Piping

The bypass hose connected to the pump is 600 feet in length and comes in 50' sections. We will discharge the bypassed water 600 feet from the pump checking for channel integrity below the discharge. If channel is ok, a section of hose will be removed and another nearer section of channel will be assessed. We will do this until all channel below the infiltration point has been assessed. If any part of the channel indicates piping or infiltration, the channel will be repaired.

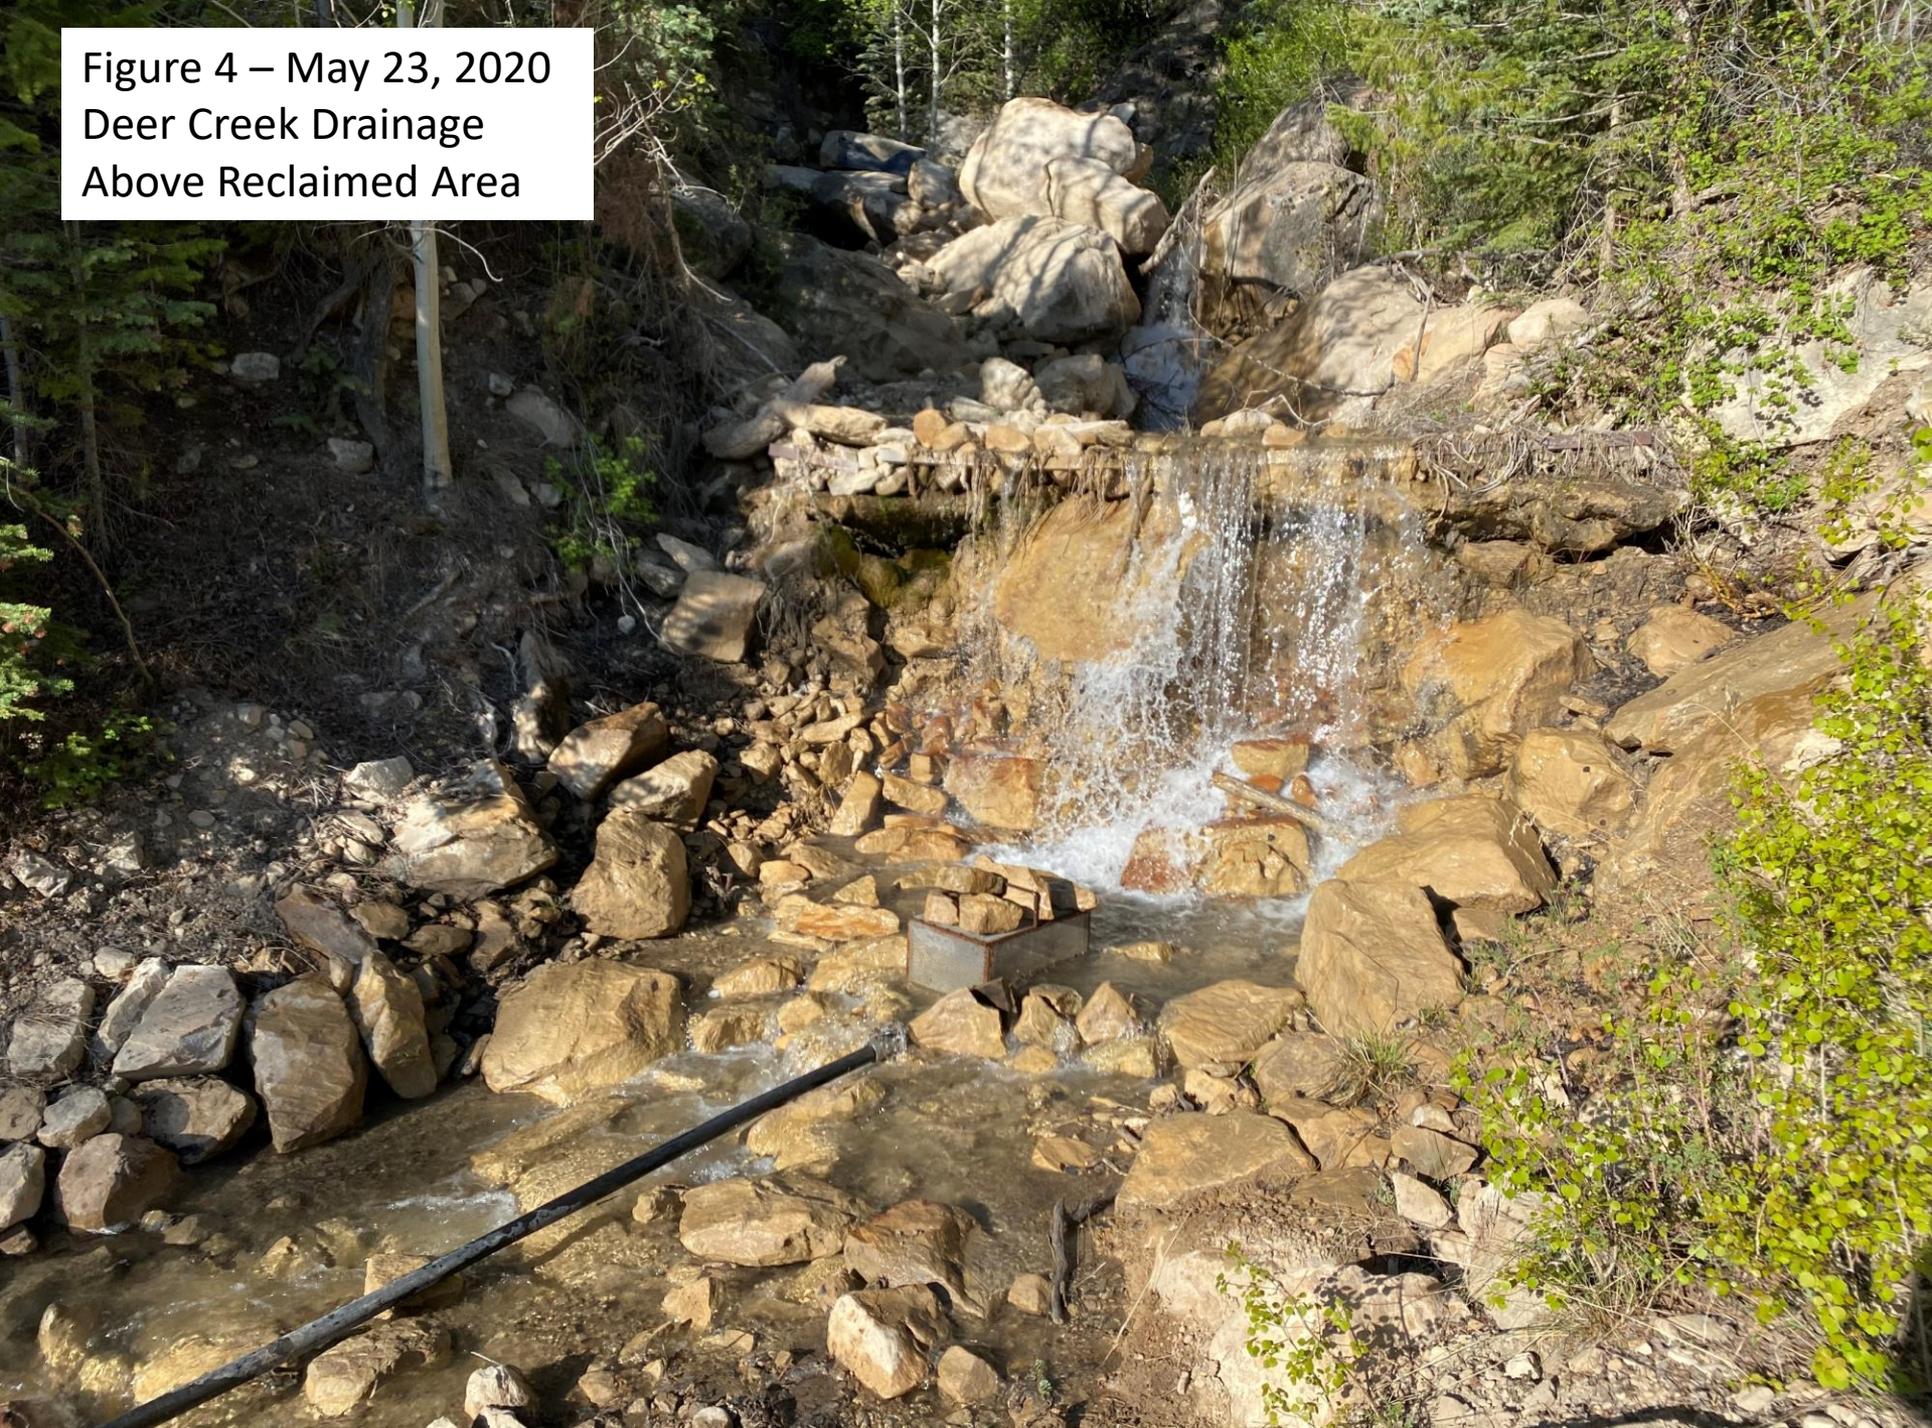
Figure 4 – May 23, 2020  
Deer Creek Drainage  
Above Reclaimed Area

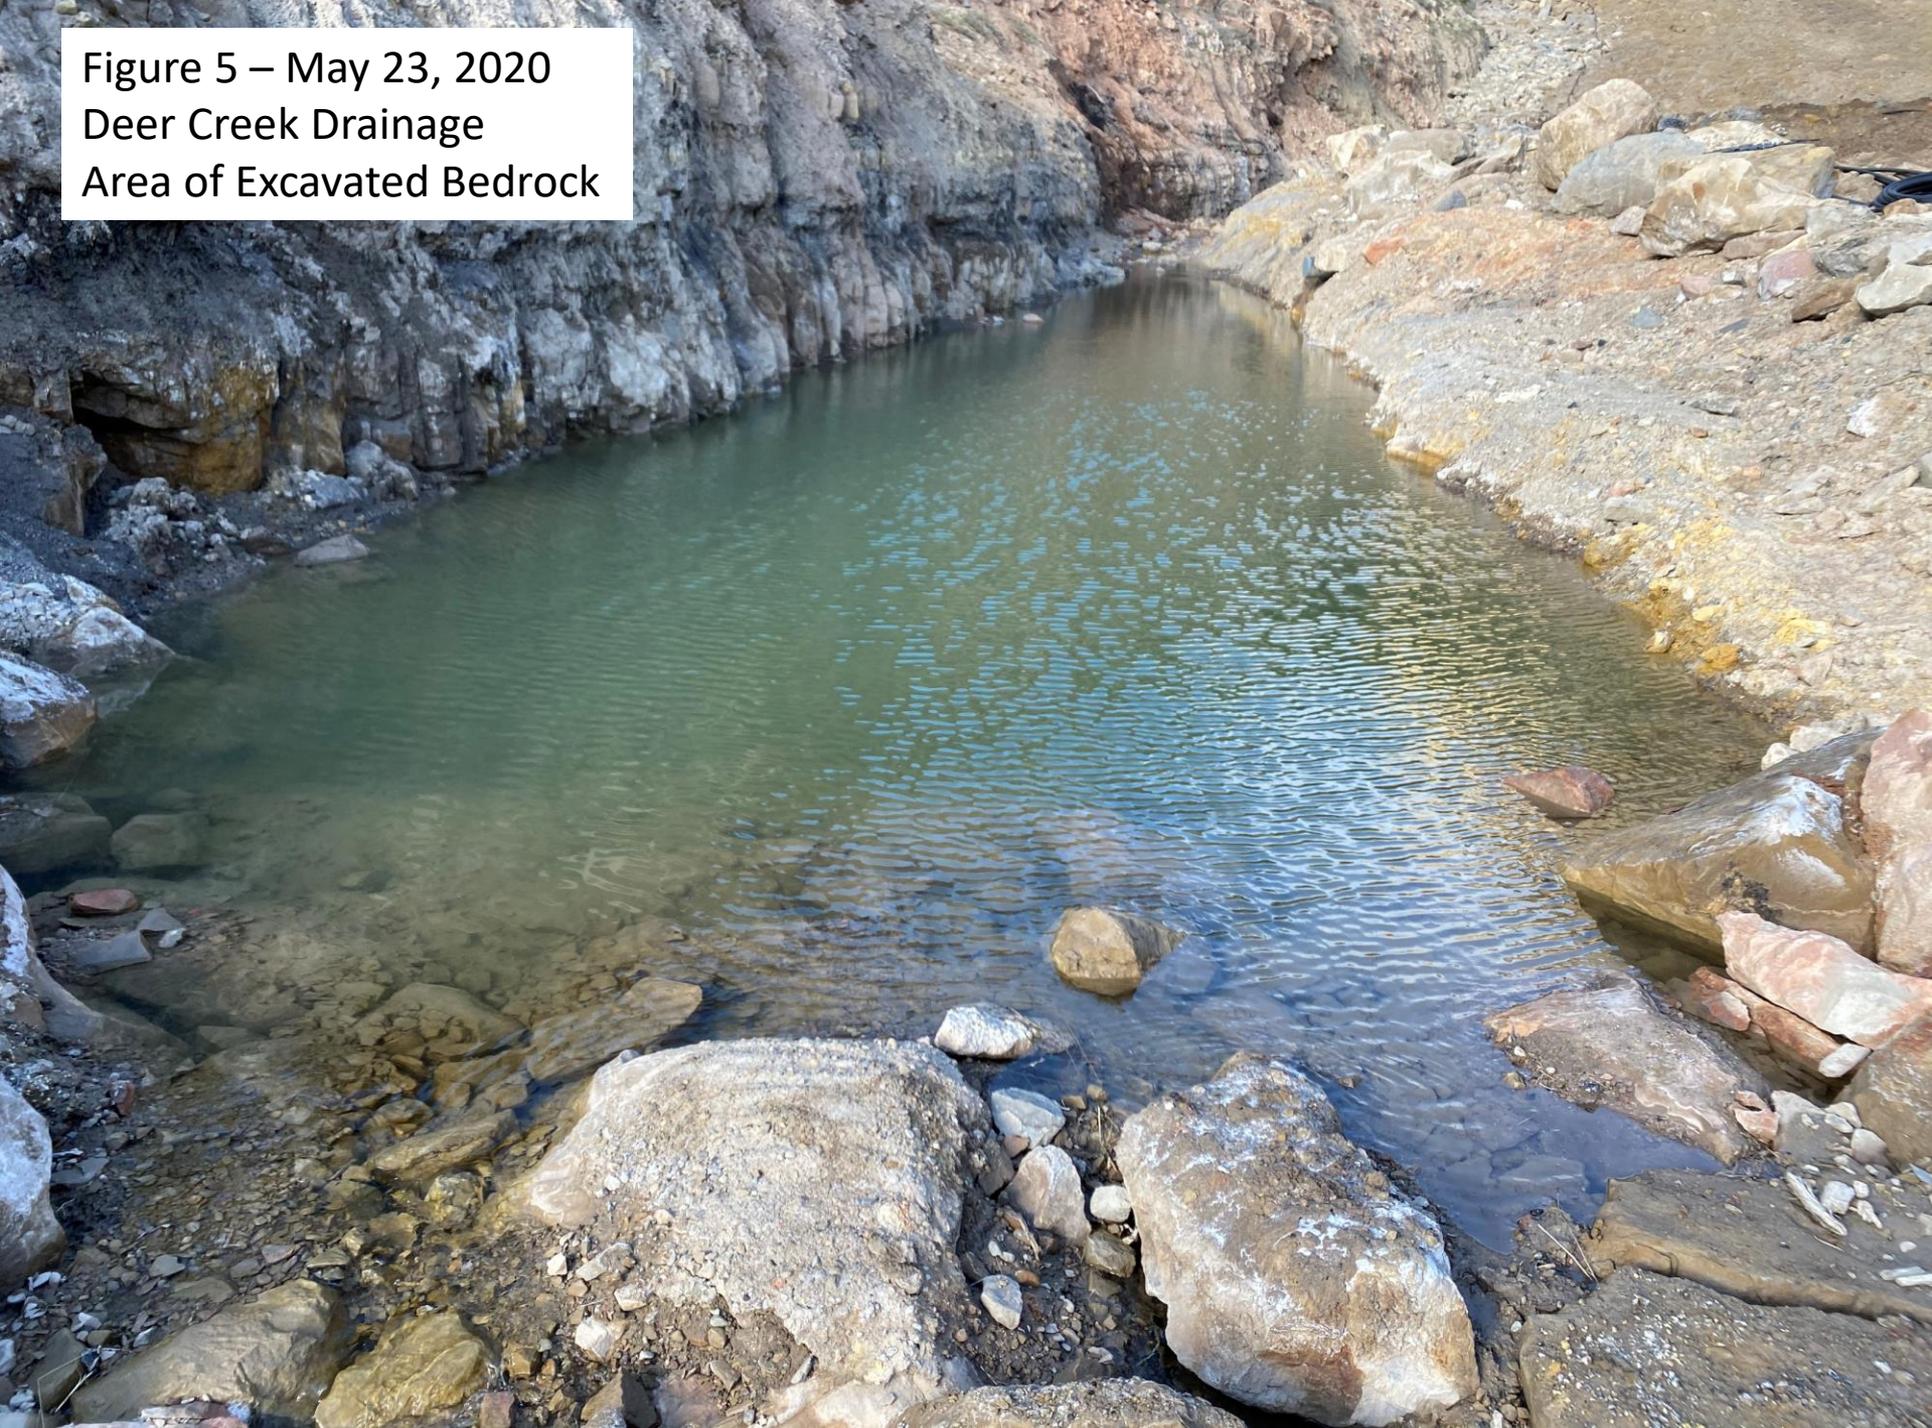
Figure 5 – May 23, 2020  
Deer Creek Drainage  
Area of Excavated Bedrock

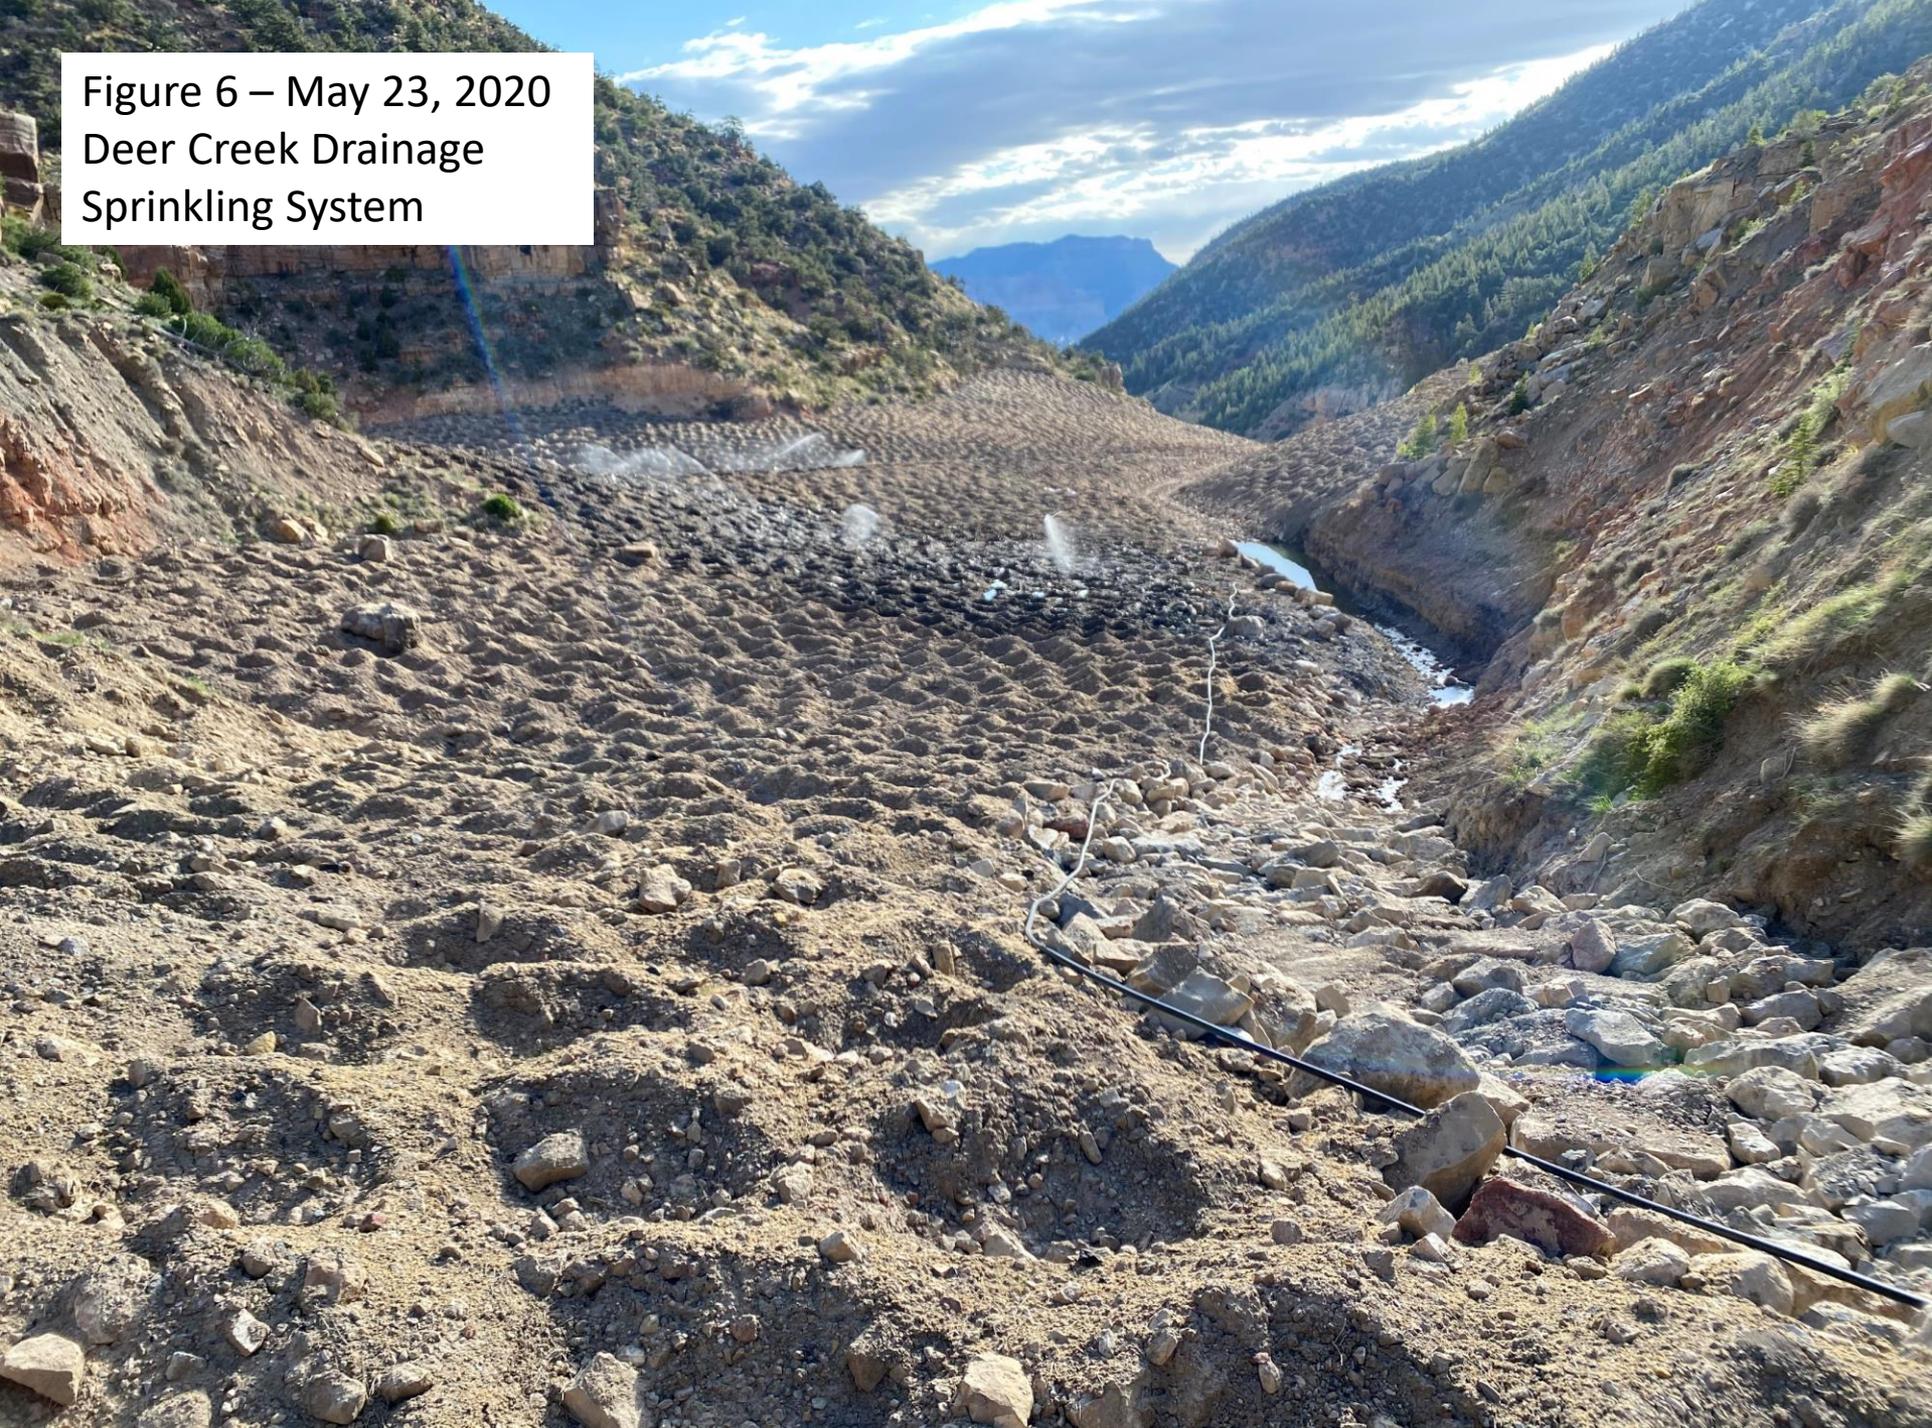
Figure 6 – May 23, 2020  
Deer Creek Drainage  
Sprinkling System

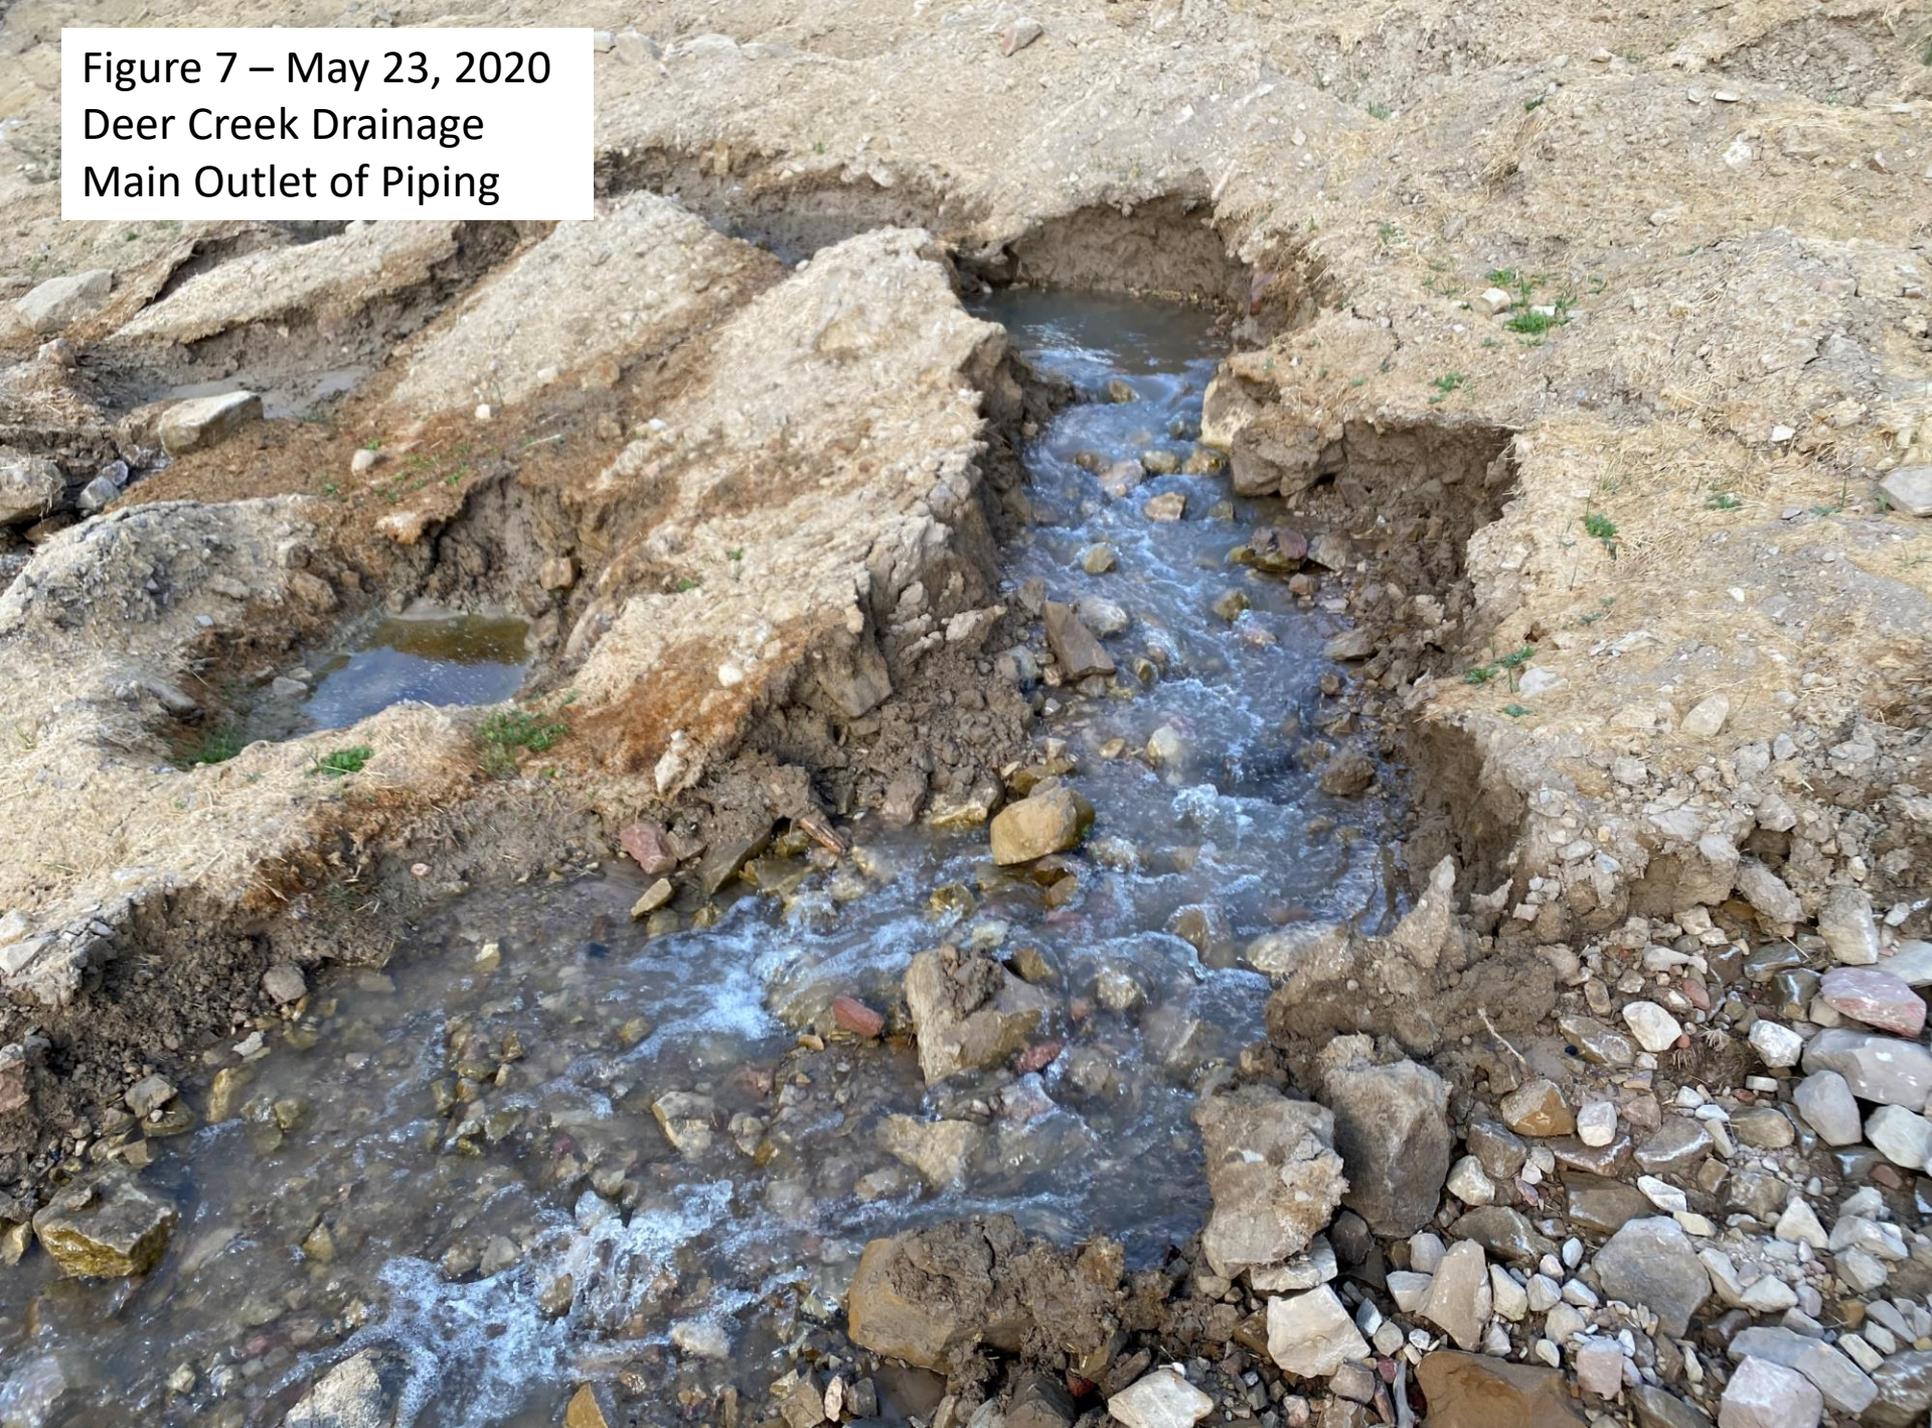
Figure 7 – May 23, 2020  
Deer Creek Drainage  
Main Outlet of Piping

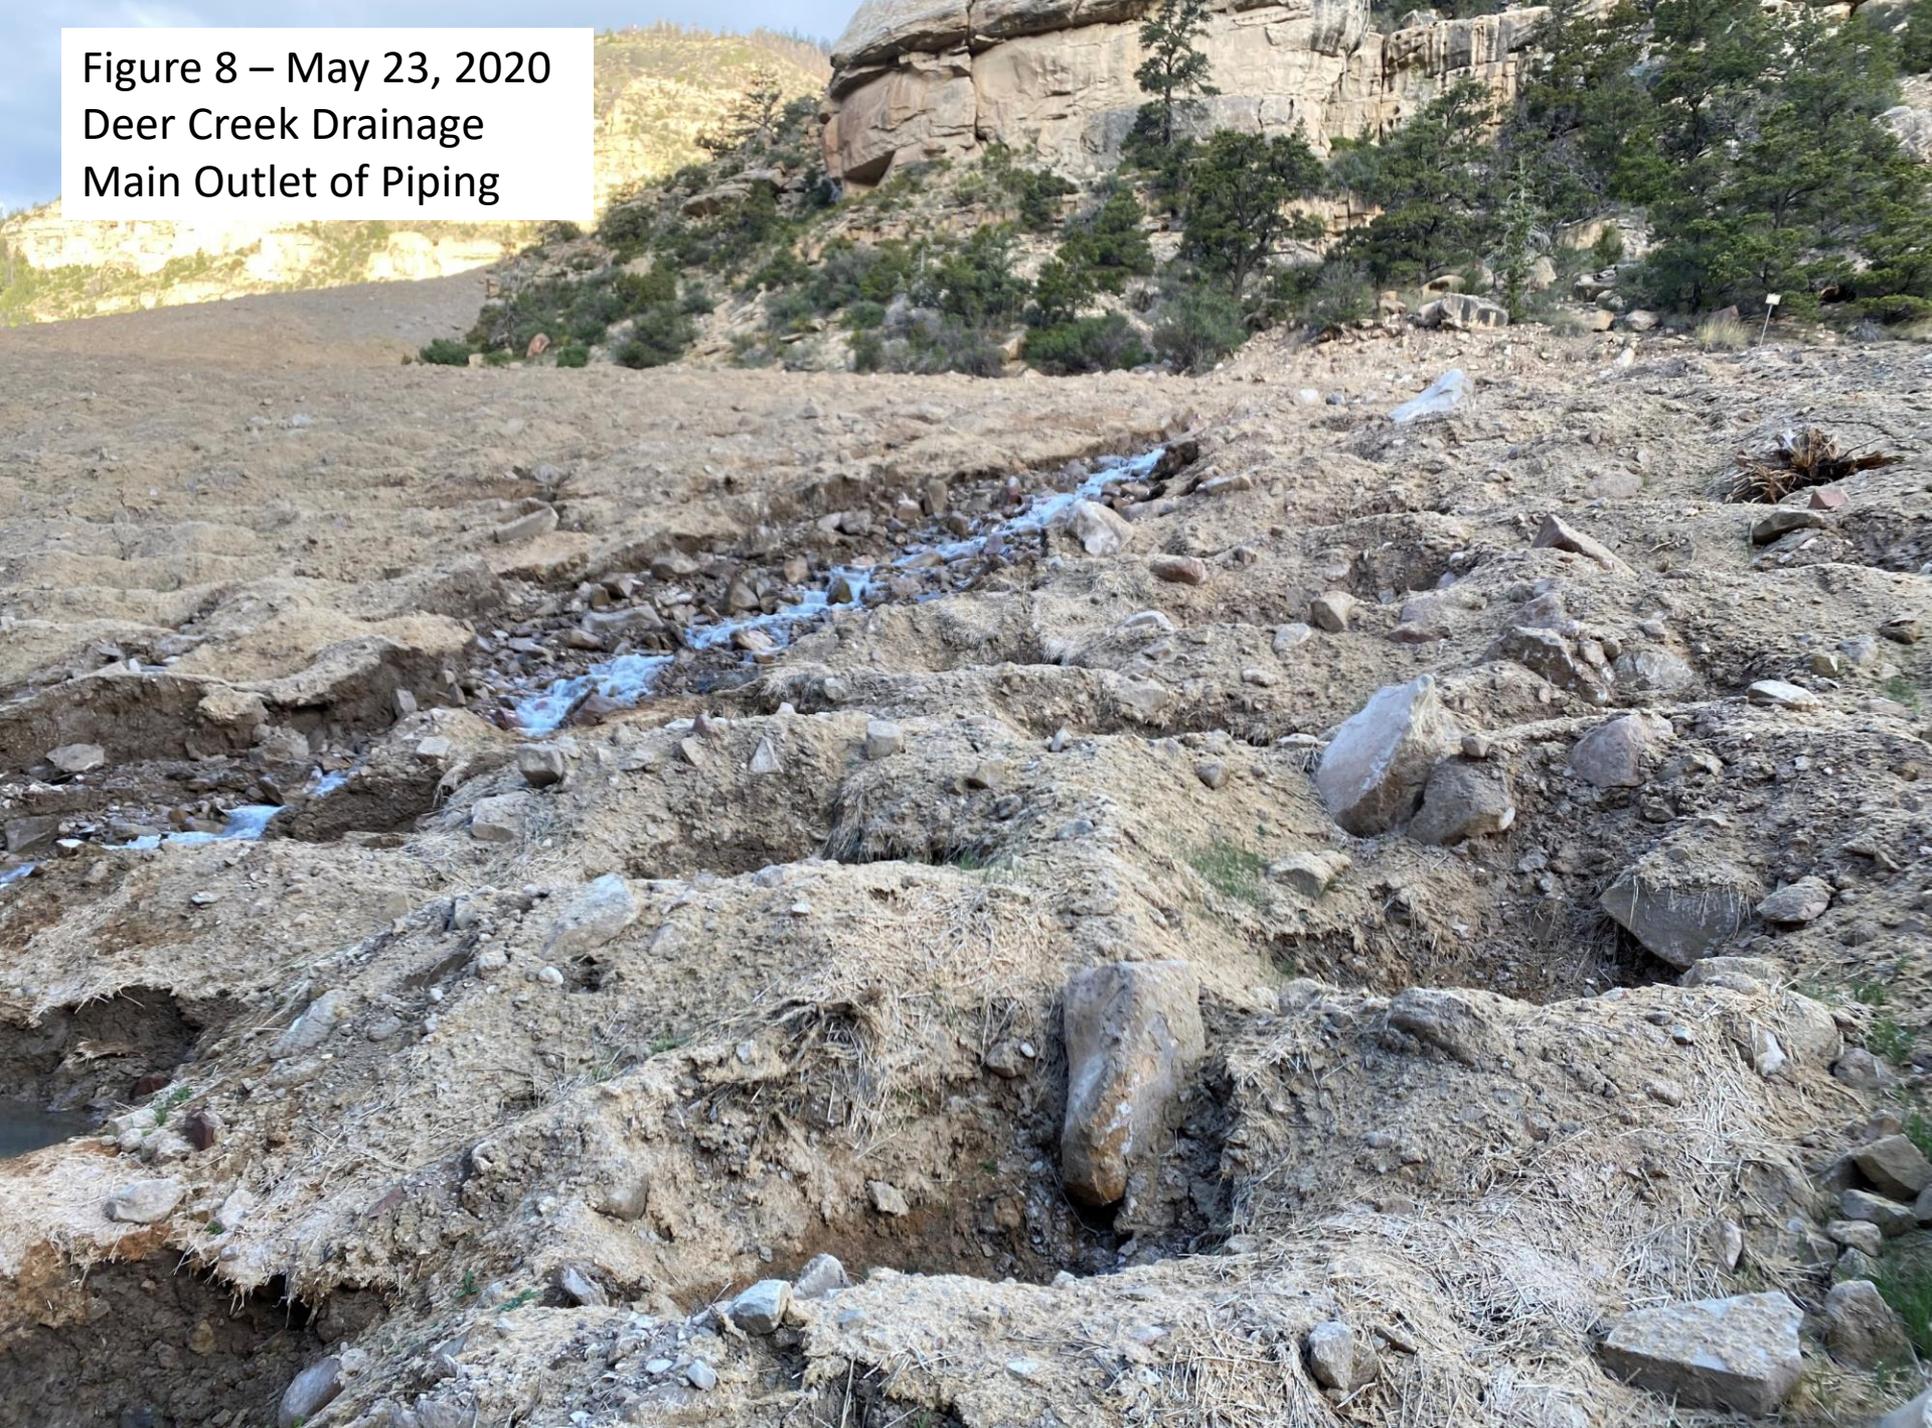
Figure 8 – May 23, 2020  
Deer Creek Drainage  
Main Outlet of Piping

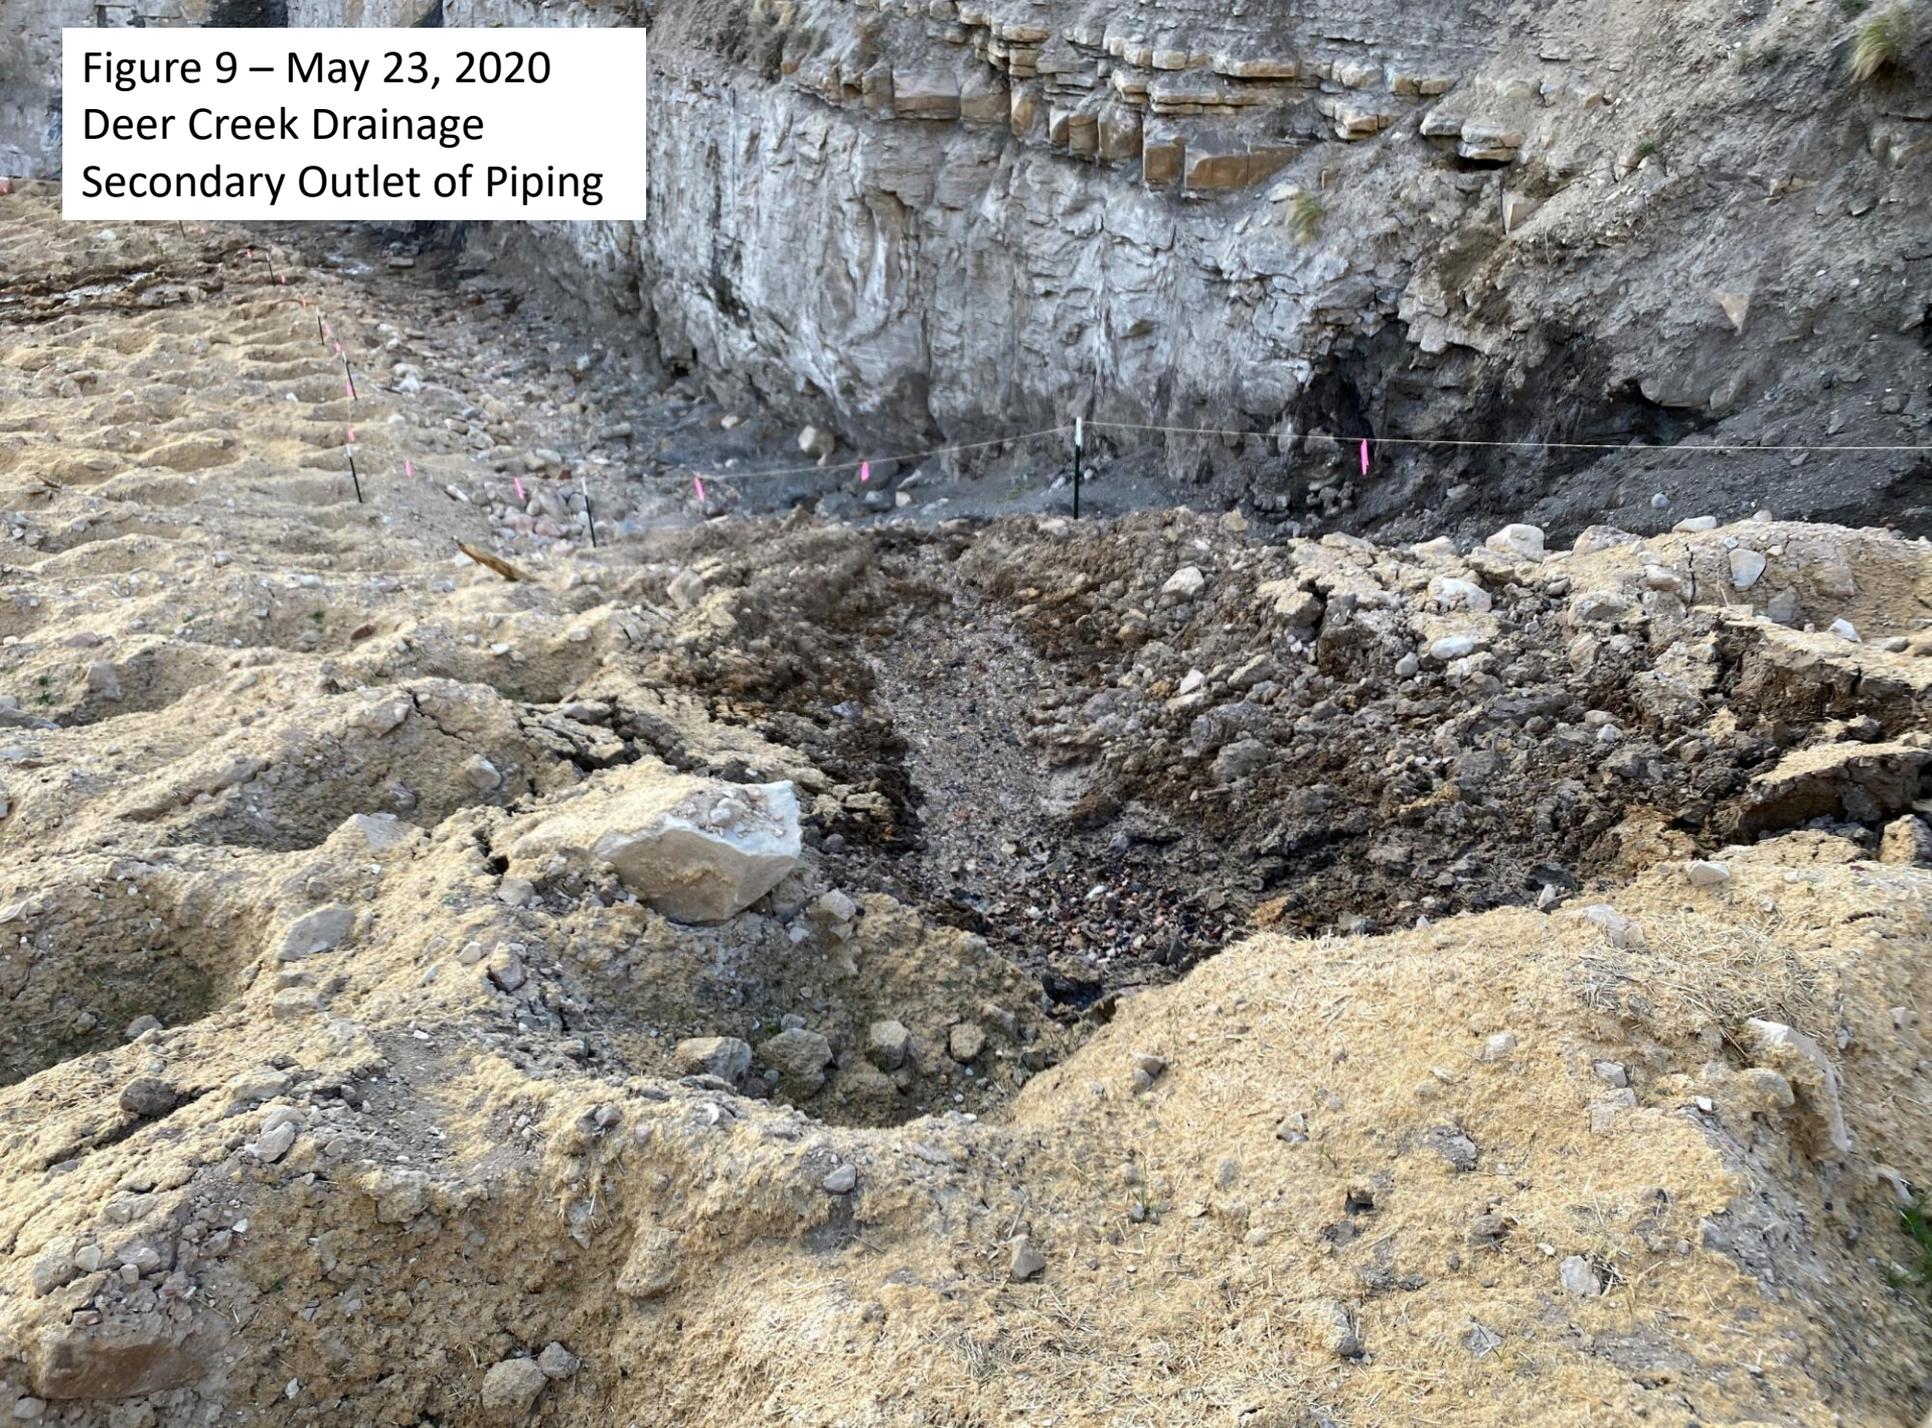
Figure 9 – May 23, 2020  
Deer Creek Drainage  
Secondary Outlet of Piping
