**Fwd: Deer Creek Water Issues - Action Plans**

Subject: Deer Creek Water Issues - Action Plans

**Deer Creek Piping May 23 2020.pdf**

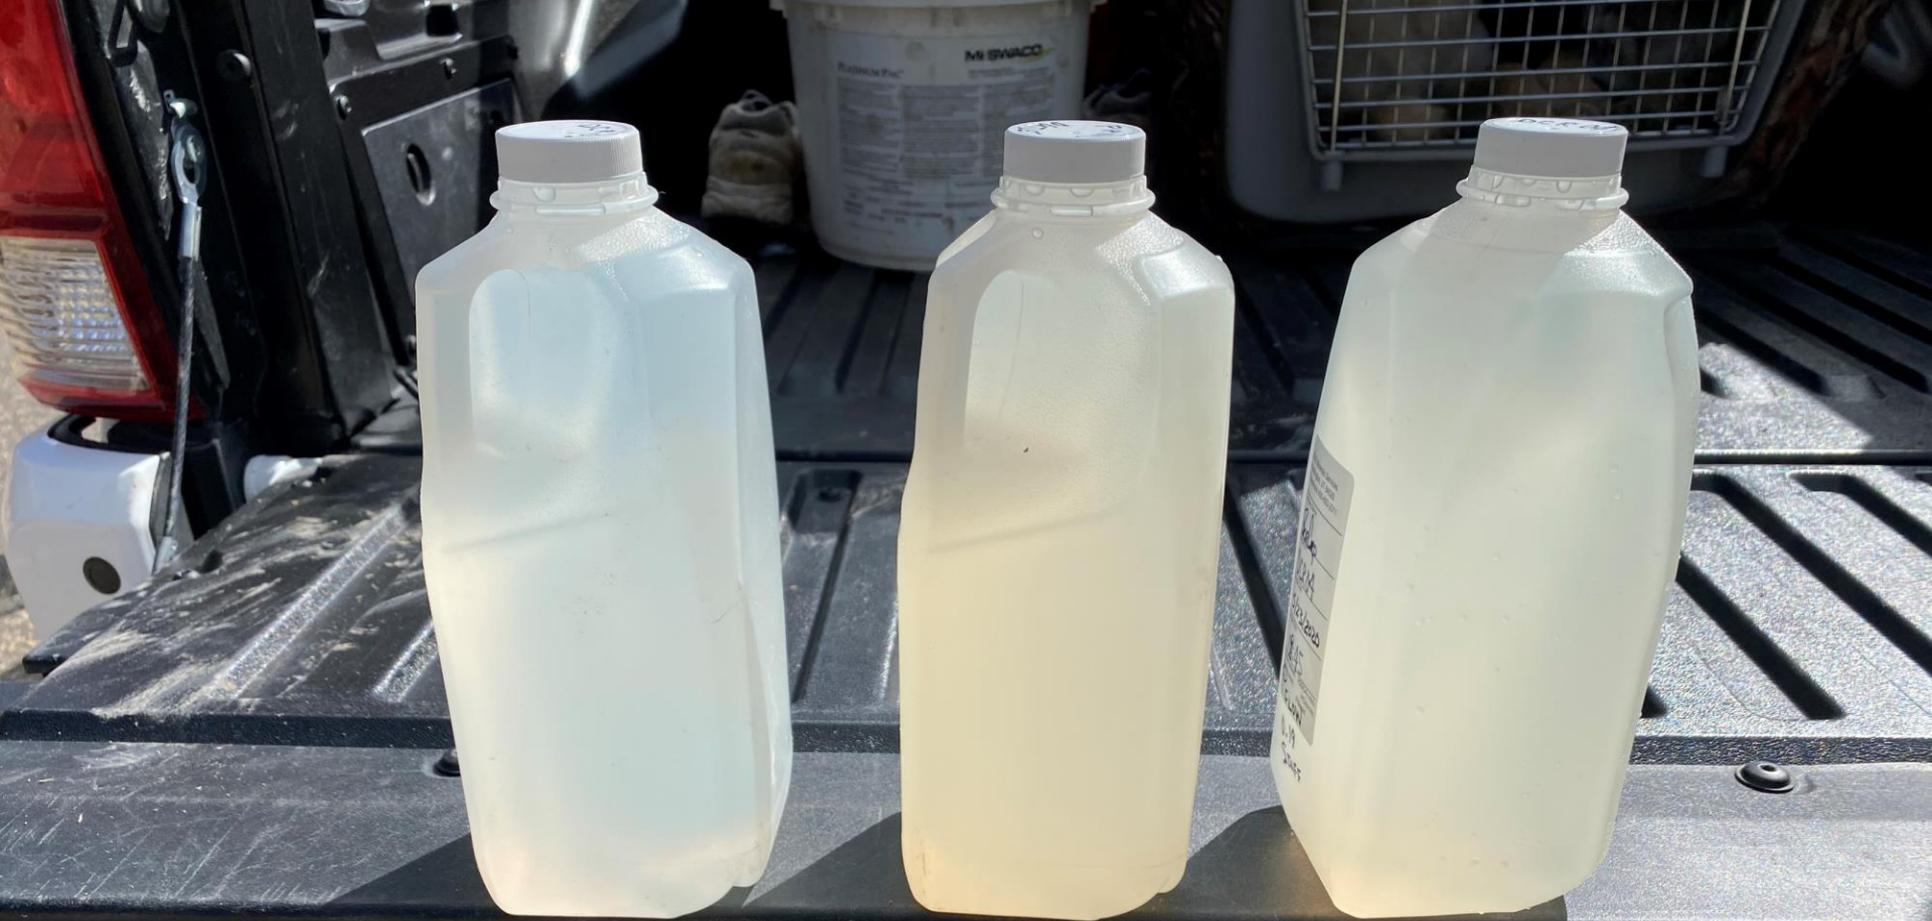
Above Mine

Piping Outlet

Below Mine

Figure 10 – May 23, 2020  
Deer Creek Drainage  
Water Quality Sampling
