Subject: Reconnaissance Inspection for the Reclaimed Deer Creek Mine Site
UPDES Permit No. UT0023604

INSPECTION PROTOCOL

UPDES Permit #: UT0023604 – Deer Creek Mine Reclamation Site
Inspection Type: Reconnaissance Inspection (RI)
Inspection Dates: September 24 and October 1, 2020
Weather Conditions: Sunny and mild, ~70°F (on site)

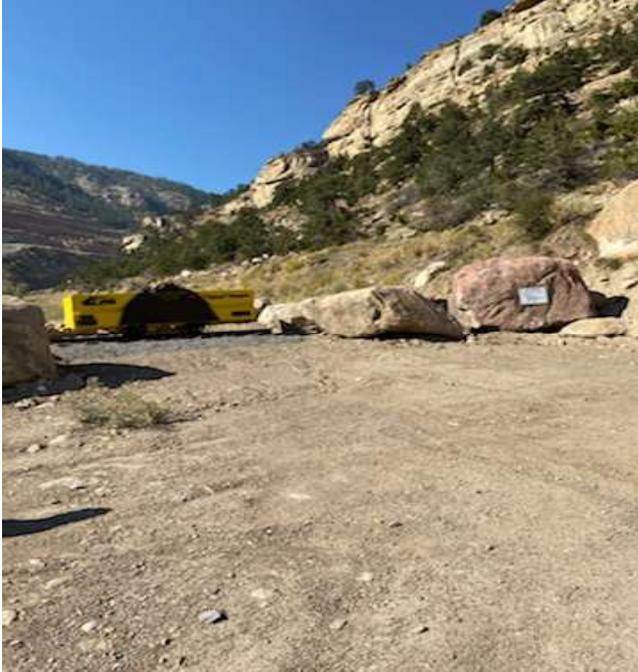
1. Former Deer Creek Mine reclamation site entrance.

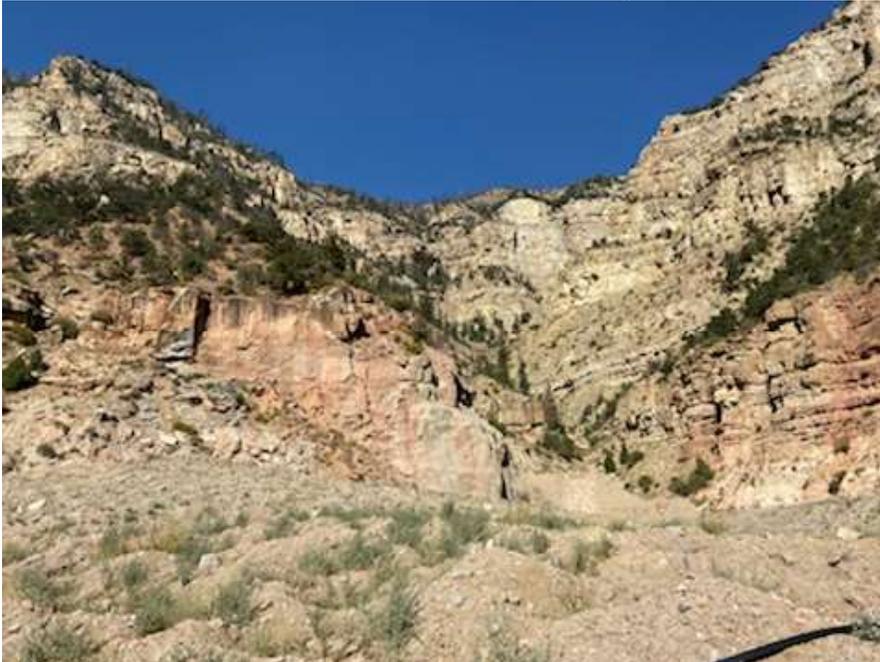
2. Deer Creek Mine reclamation site looking north from Outfall 002 area.

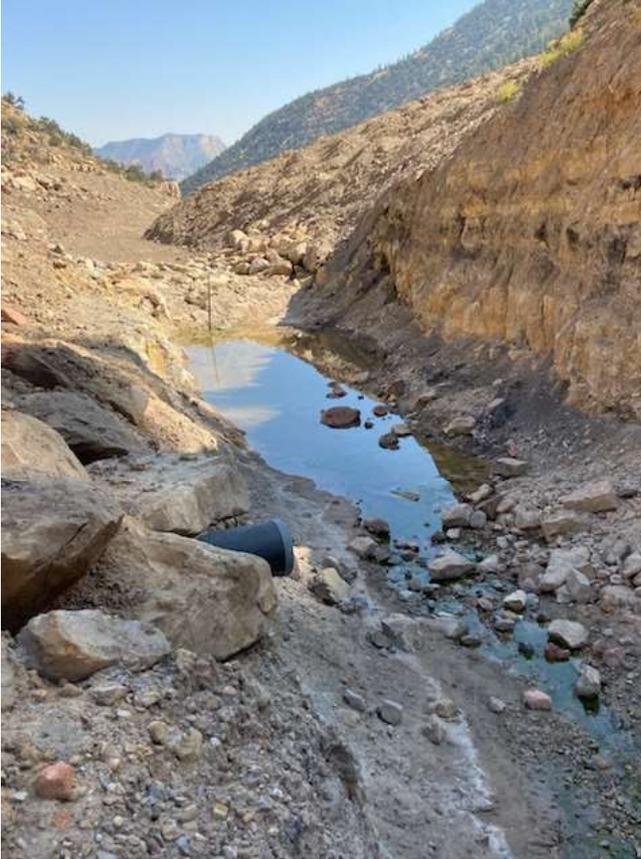
3. Outfall 002 at reclamation site into Deer Creek drainage.
Standing water is from cliffside groundwater seeps.

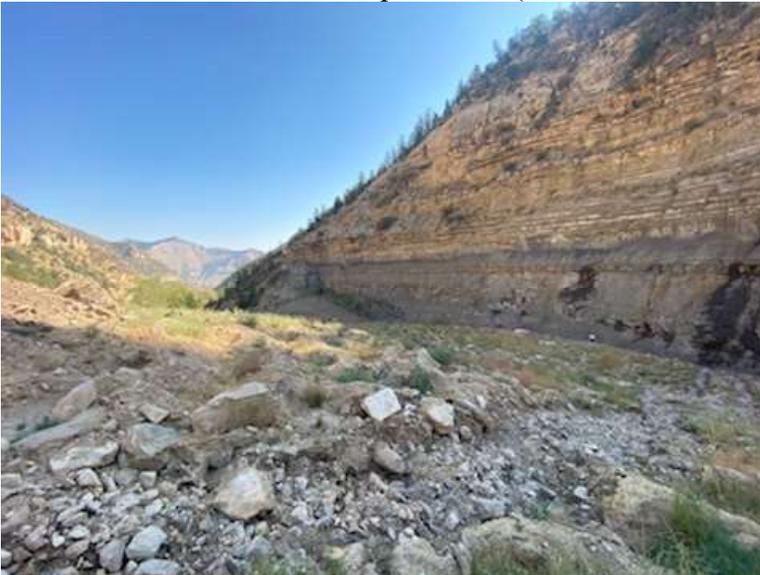
4. Reclaimed sedimentation pond area (former Outfall 001).

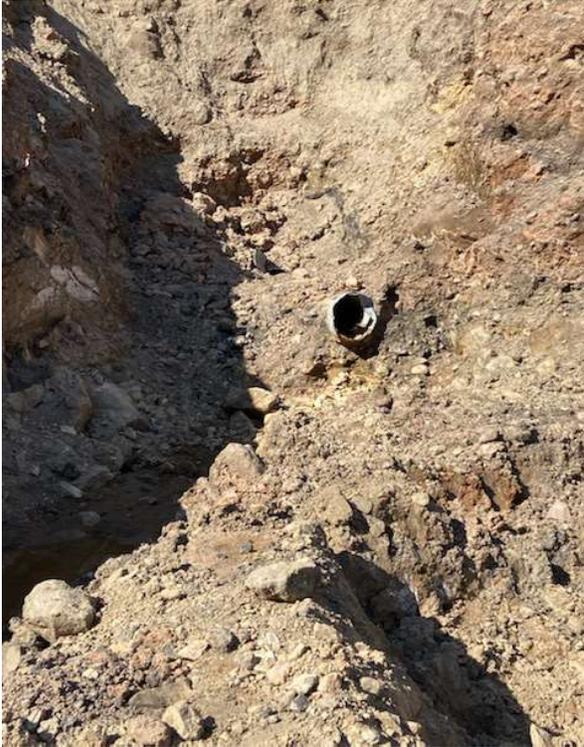
Earlier this year, water was observed flowing on and through the reclaimed DCM site and was investigated further to discover an old unknown plugged culvert was the culprit. The culvert was exposed and will be reconnected so that future groundwater/precipitation runoff flows will not further compromise the reclaimed DCM site. The water was initially monitored by DCM and believed not to be mine related water as detailed in their letter to DWQ dated September 21, 2020.

5. Old culvert exposed, source of onsite nuisance water (flow had recently eased).

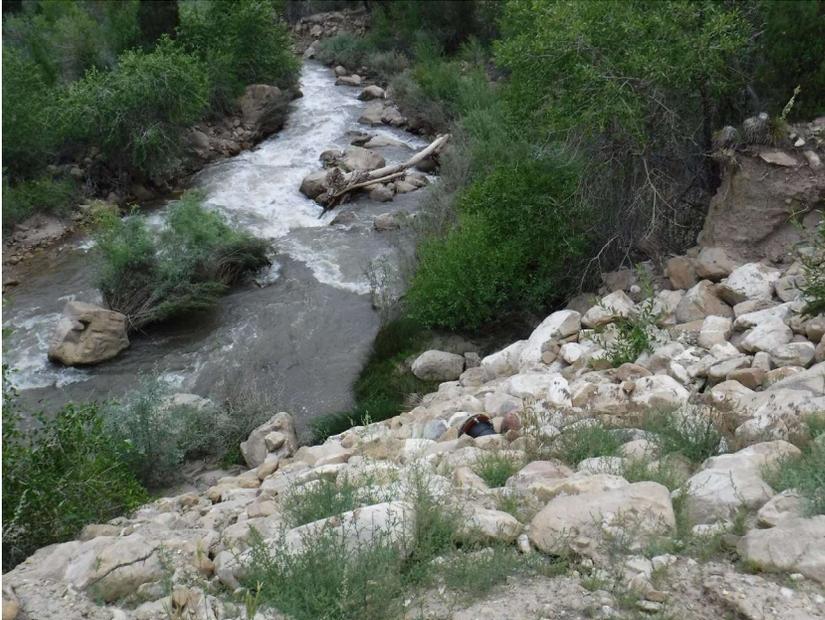
6: Outfall 003 (black pipe sticking out of rocks) and receiving waters of Huntington Creek.
