Division of Oil, Gas and Mining

Inspection Report

Permit Number:	C0150018
Inspection Type:	PARTIAL
Inspection Date:	Wednesday, July 22, 2020
Start Date/Time:	7/22/2020 6:30:00 AM
End Date/Time:	7/22/2020 12:00:00 PM
Last Inspection:	Wednesday, June 24, 2020

Permitee: **PACIFICORP**
 Operator: **INTERWEST MINING CO**
 Site: **DEER CREEK MINE**
 Address: **PO BOX 310, HUNTINGTON UT 84528**
 County: **EMERY**
 Permit Type: **PERMANENT COAL PROGRAM**
 Permit Status: **ACTIVE**

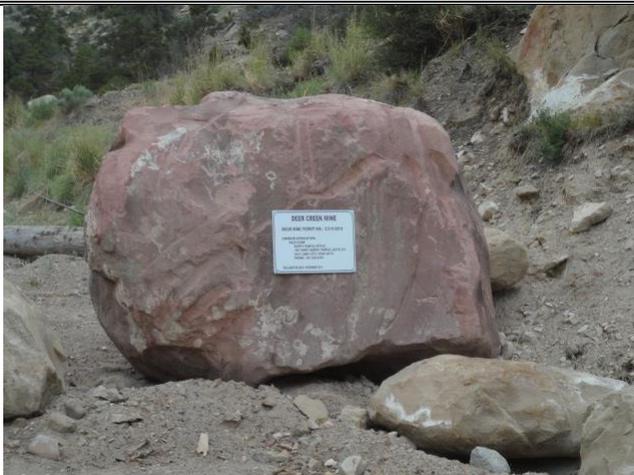
PHOTO 1

The mine identification signs that are required by law were checked during the partial inspection. There are two identification signs. The first sign is posted on a rock at the entrance into the reclaimed area of the Deer Creek mine approximately where the C1 conveyor crossed over the mine access road. The second sign is adjacent to the gate by the cattle guard in Rilda Canyon. Both of these signs are in compliance with the Utah Coal Rules. They display the name, address, phone number and Utah Mining Permit number for Pacificorp.

Deer Creek Identification Sign

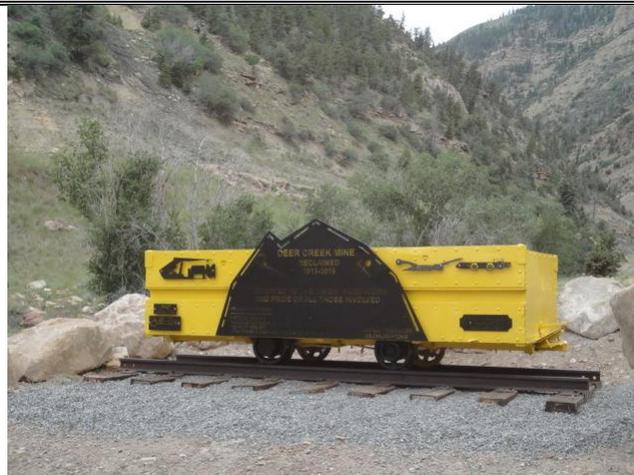
PHOTO 2

Deer Creek Monument

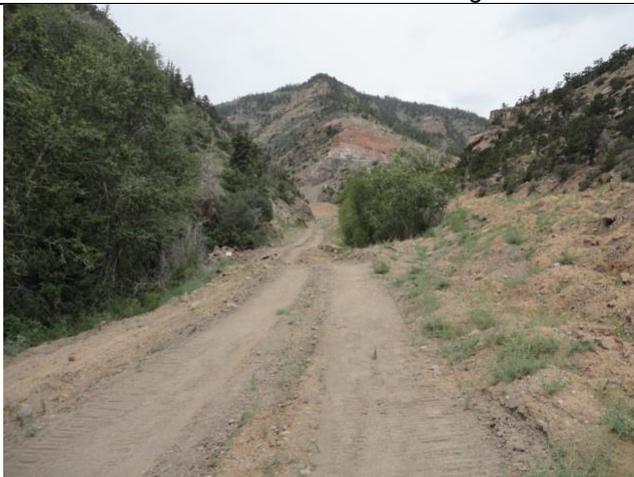
PHOTO 3

Deer Creek Access Road to Make Repairs

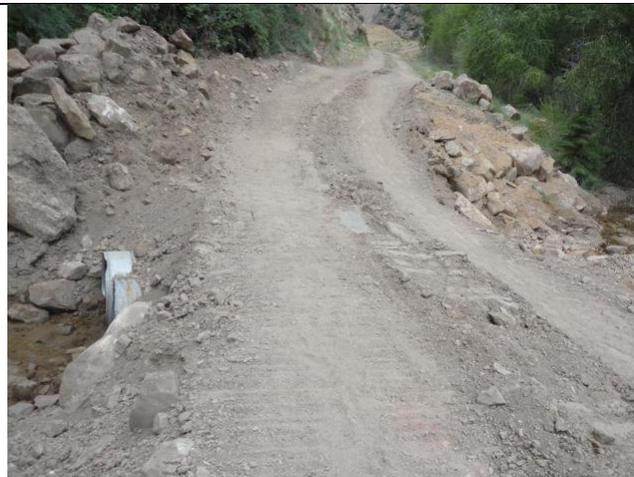
PHOTO 4

Deer Creek Access Road to Make Repairs

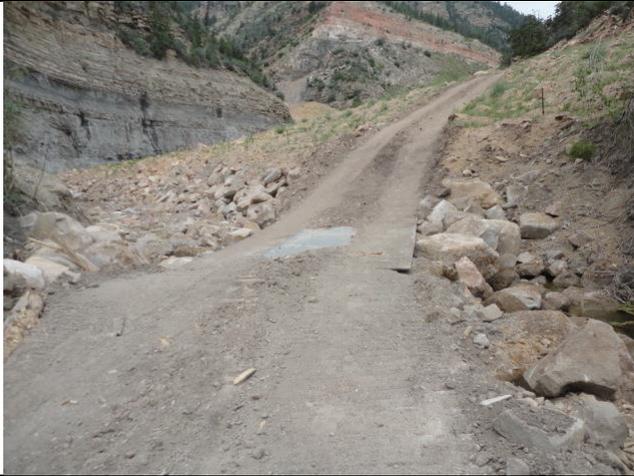
PHOTO 5

Deer Creek Access Road to Make Repairs

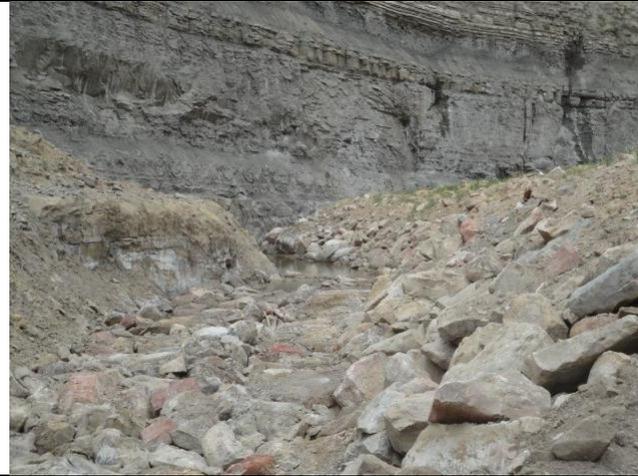
PHOTO 6

The reclamation diversions were inspected during the partial inspection at both the Deer Creek main facility and the Rilda facility. Diversions are functional according to design. In efforts to identify the source of water emanating from the reclaimed slope at the Deer Creek facility two crossing of the reclaimed diversion have been installed by using culverts to bypass the water in the diversion and then heavy steel plates placed on top of the culverts to allow track hoe access over top of the diversion.

Deer Creek Diversion

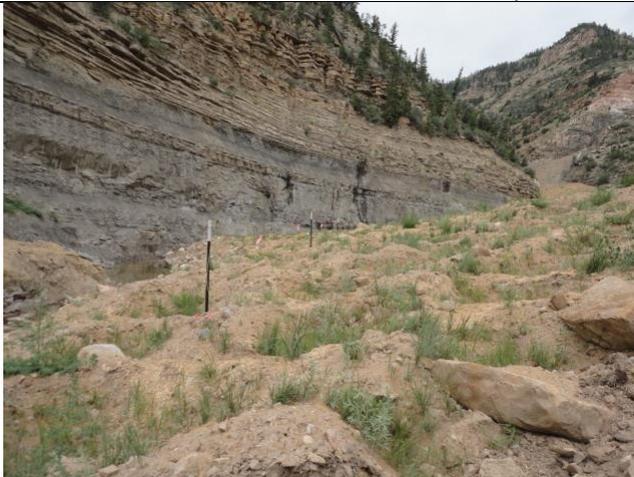
PHOTO 7

Deer Creek Flagged Area (Slope Erosion)

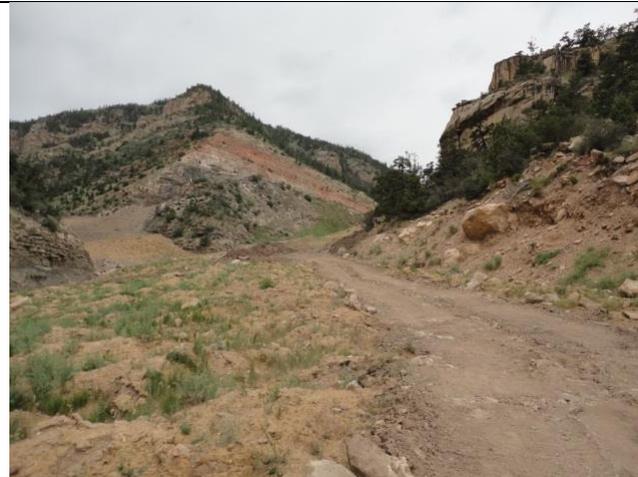
PHOTO 8

Deer Creek Access Road to Make Repairs

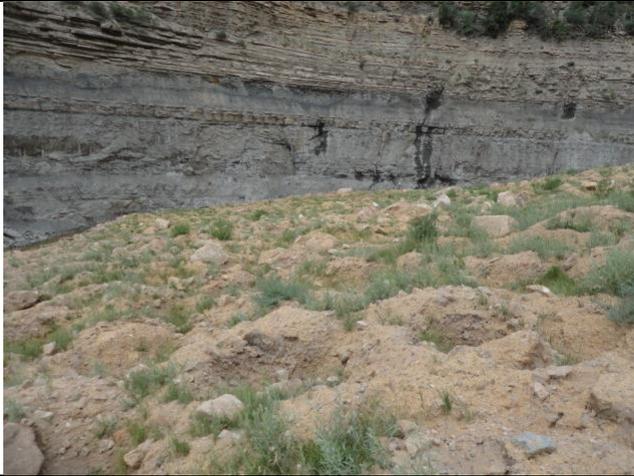
PHOTO 9

Deer Creek Reclamation

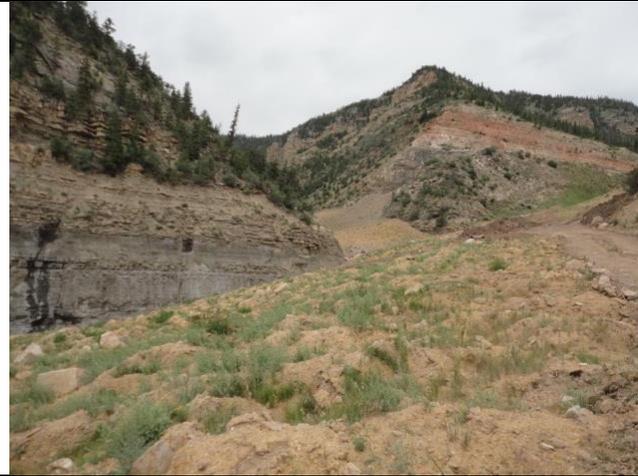
PHOTO 10

Deer Creek Reclamation

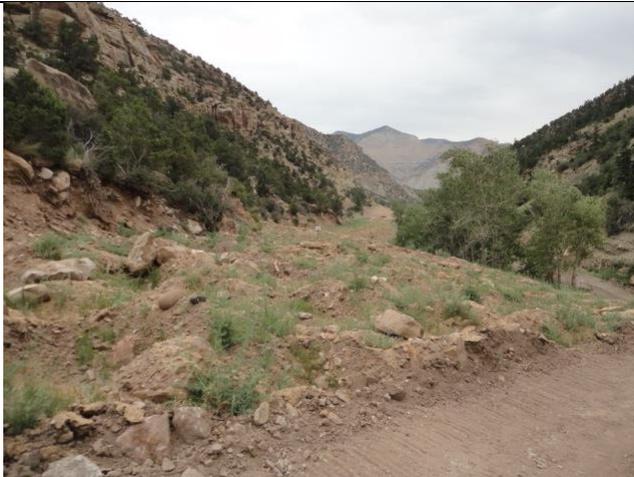
PHOTO 11

Deer Creek Reclamation

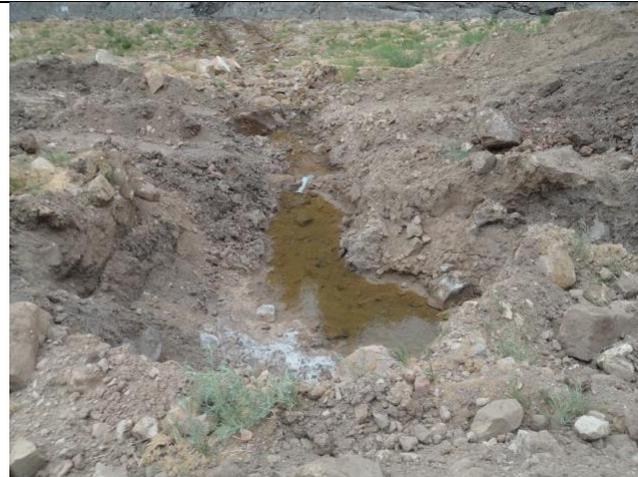
PHOTO 12

Investigation of the source of water emanating from the reclaimed slope and the proposed resolution is still in process. No one was on site during the partial inspection. A two track road used by a track hoe dissects the reclaimed area from the turn around area where the mine identification sign in Deer Creek is located up to the bath house area. At the point where the water is coming out of the slope pits have been excavated revealing an old culvert. There is at least two points where the culvert has been cut into and opened up to determine the extent of the culvert. Water is still actively flowing from the old culvert in this area and running down the reclaimed slope to the reclaimed diversion where the sediment pond was located. See photos attached to the PDF version of this inspection report as Attachment A.

Deer Creek Slope Erosion (Water Coming Out of Slope)

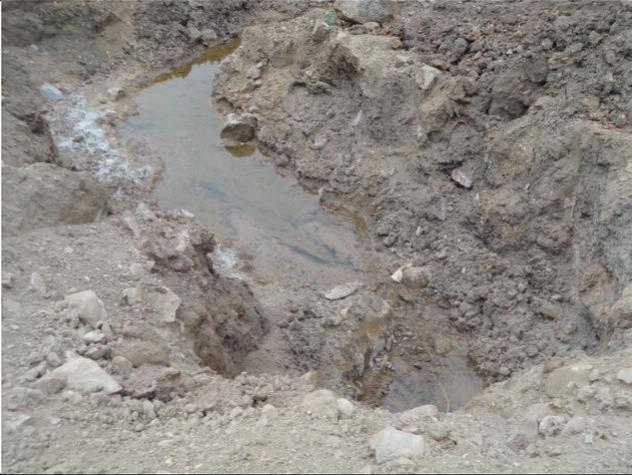
PHOTO 13

Deer Creek Slope Erosion (Water Coming Out of Slope)

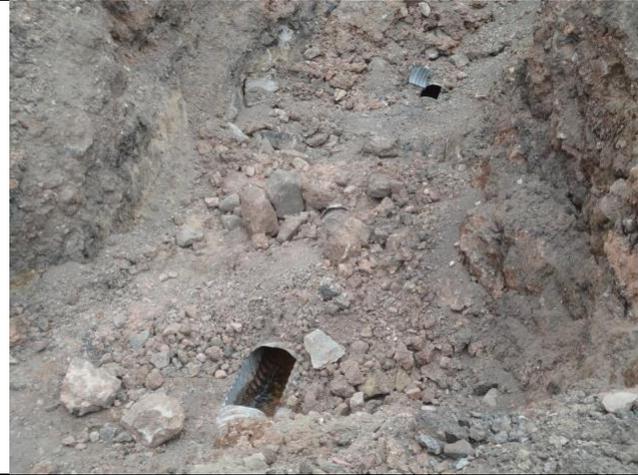
PHOTO 14

Deer Creek Slope Erosion (Water Coming Out of Slope/Old Culvert)

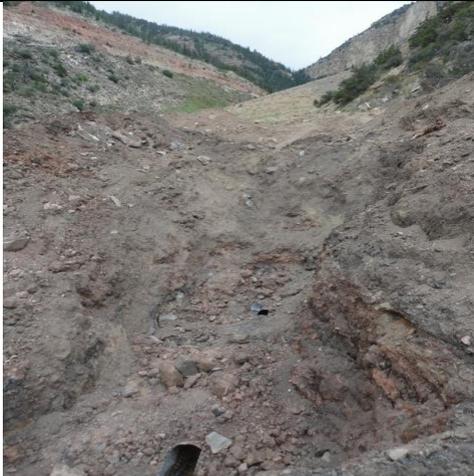
PHOTO 15

Deer Creek Slope Erosion (Water Coming Out of Slope/Old Culvert)

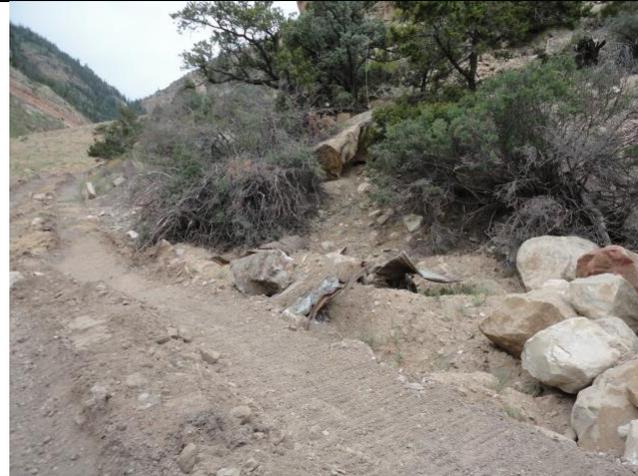
PHOTO 16

Deer Creek Access Road to Make Repairs

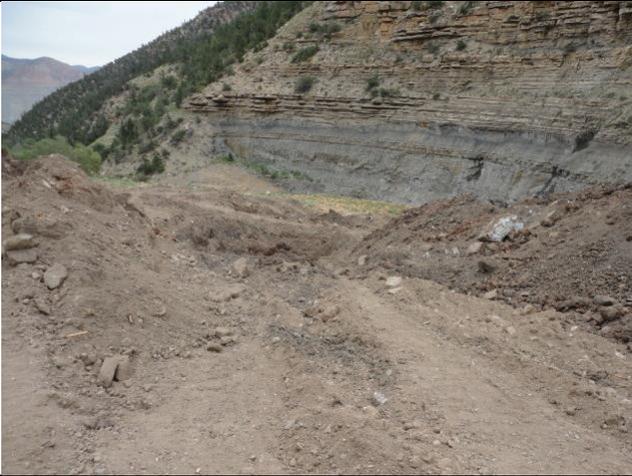
PHOTO 17

Deer Creek Access Road to Make Repairs

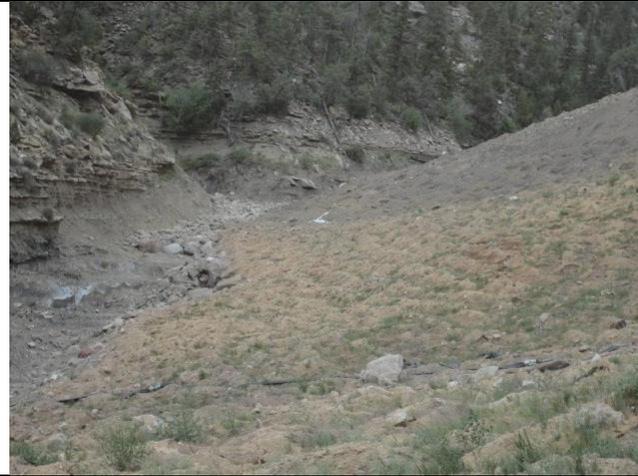
PHOTO 18

Deer Creek Reclamation

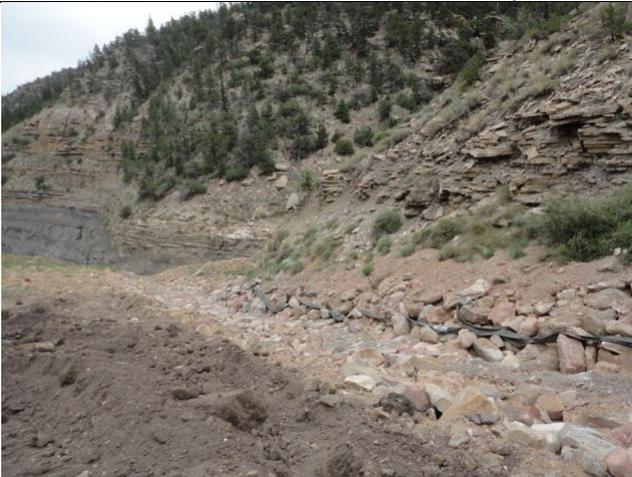
PHOTO 19

Deer Creek Access Road to Make Repairs & Diversion

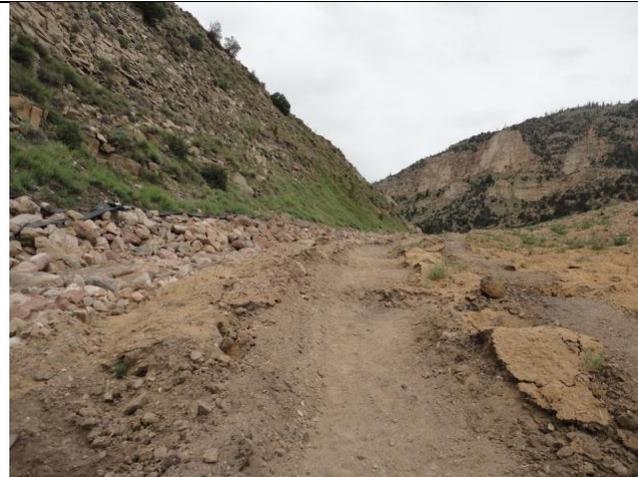
PHOTO 20

Deer Creek Access Road to Make Repairs & Diversion

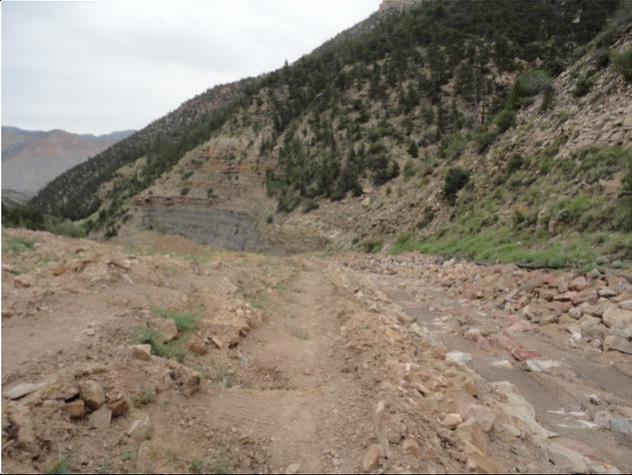
PHOTO 21

Deer Creek Access Road to Make Repairs & Diversion

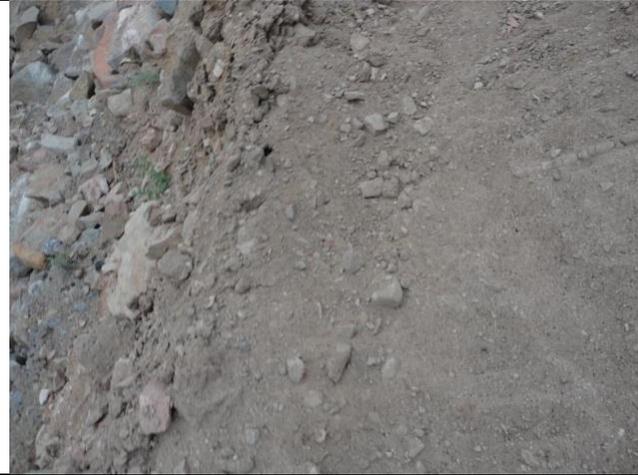
PHOTO 22

Deer Creek Access Road to Make Repairs & Diversion

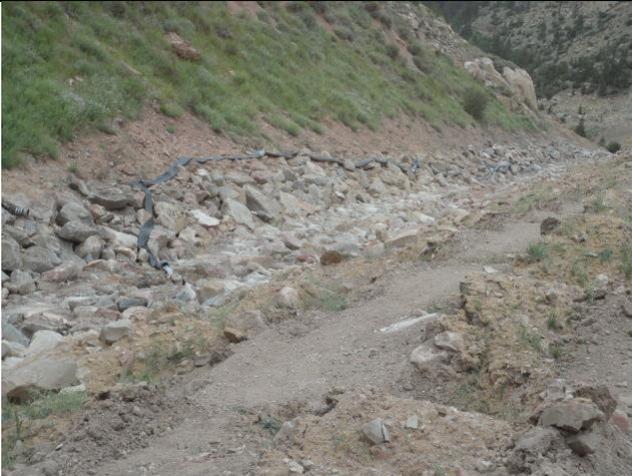
PHOTO 23

Deer Creek Access Road to Make Repairs & Diversion

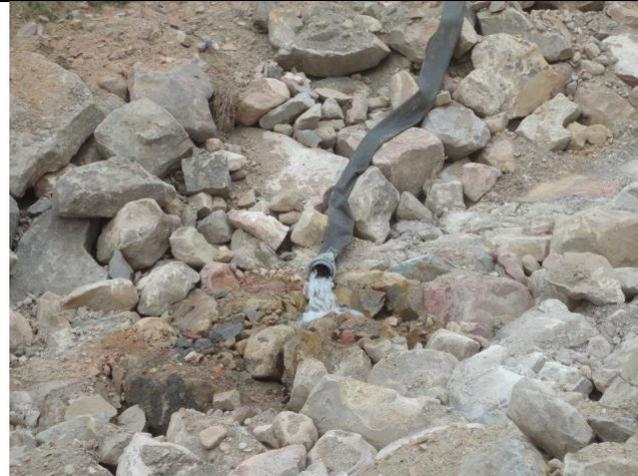
PHOTO 24

Deer Creek Diversion & Water By-Pass

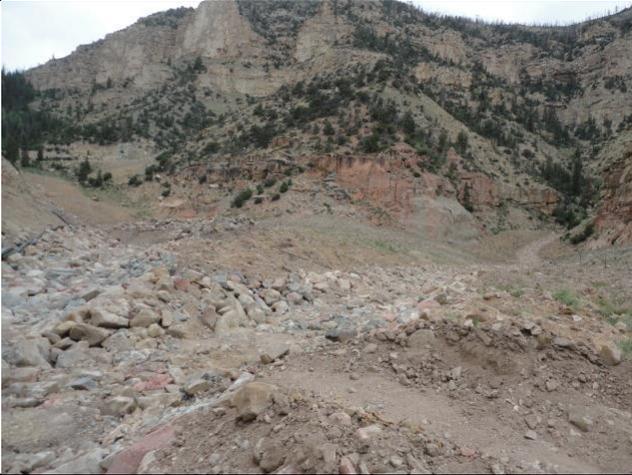
PHOTO 25

Deer Creek Diversion Intersection

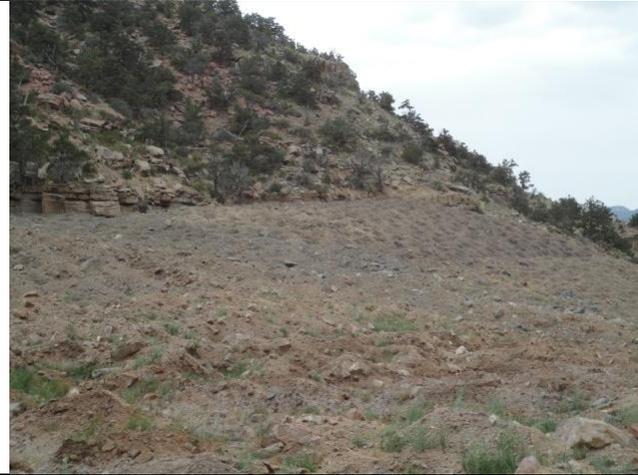
PHOTO 26

Deer Creek Reclamation

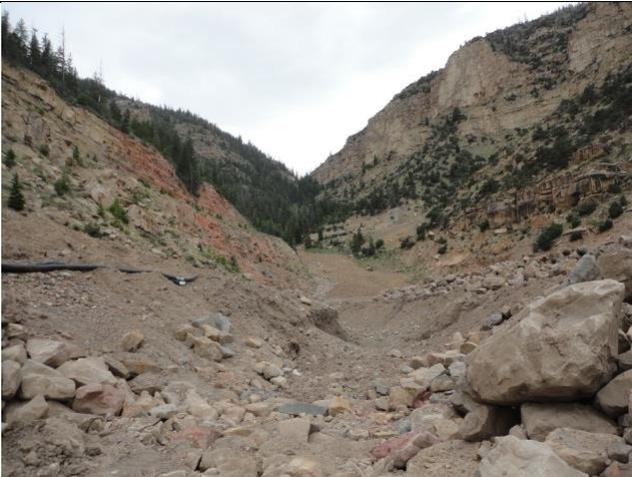
PHOTO 27

Deer Creek Diversion

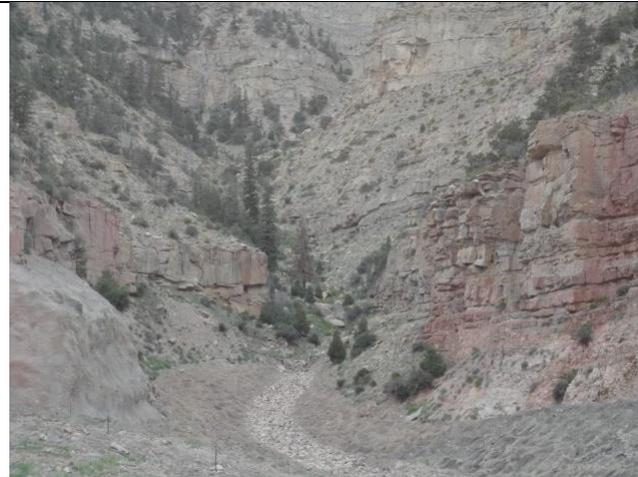
PHOTO 28

Deer Creek Diversion

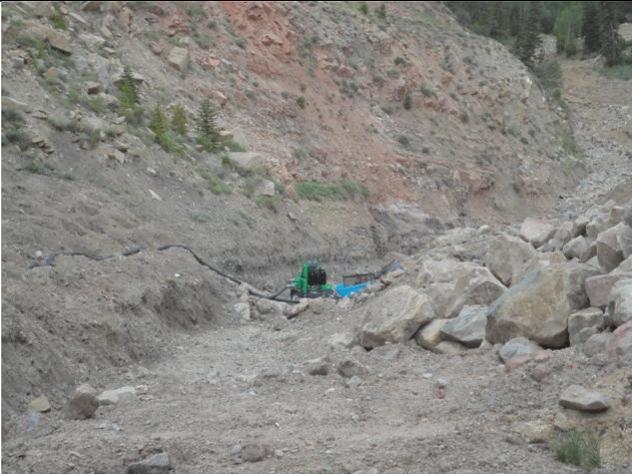
PHOTO 29

Deer Creek Pump for By-Pass

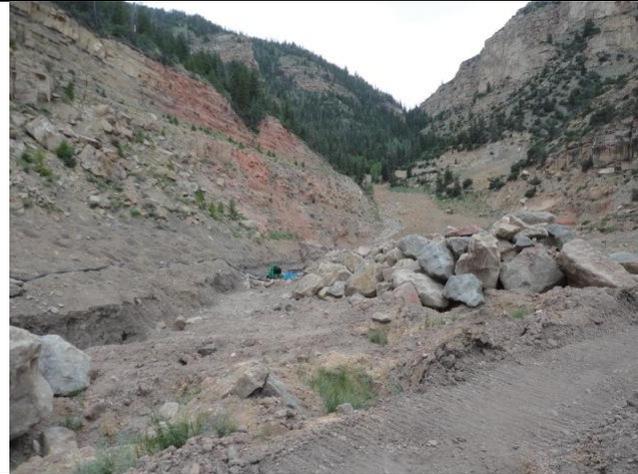
PHOTO 30

Deer Creek Pump for By-Pass

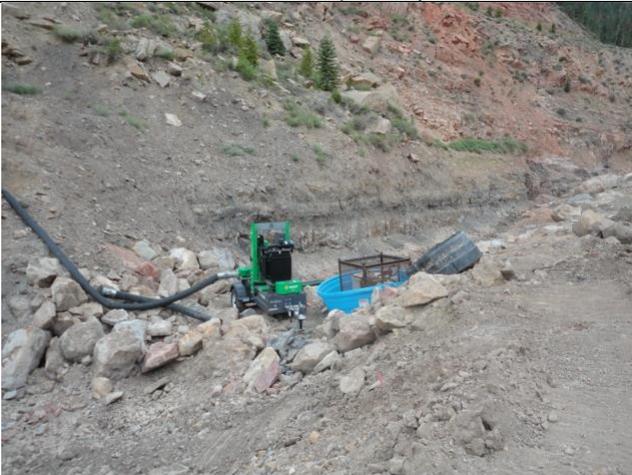
PHOTO 31

Deer Creek Pump for By-Pass

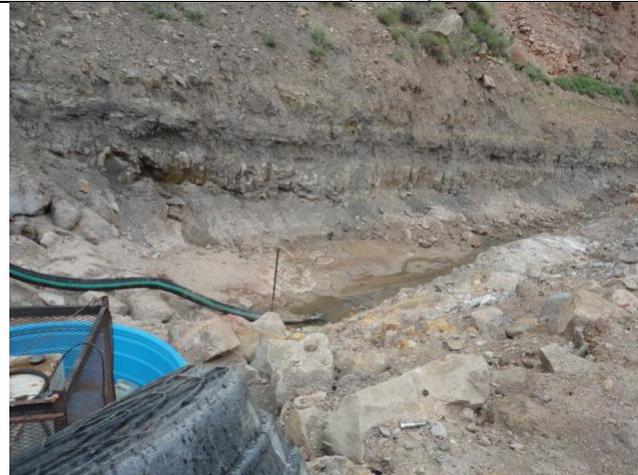
PHOTO 32

Deer Creek Pump for By-Pass

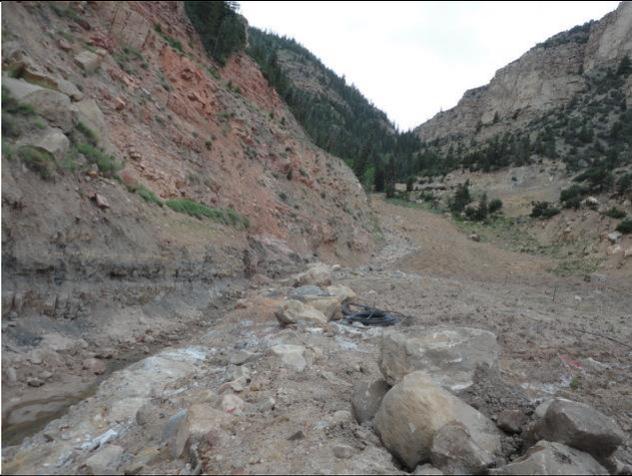
PHOTO 33

Deer Cree Diversion (Prior Bath House Area)

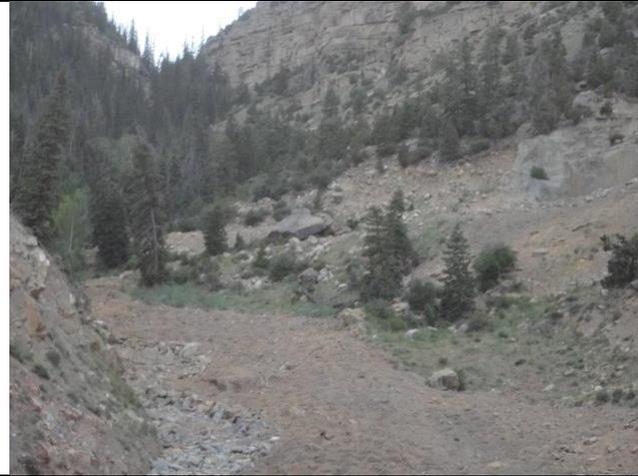
PHOTO 34

Deer Creek Reclamation (Water Tank/Fan Area)

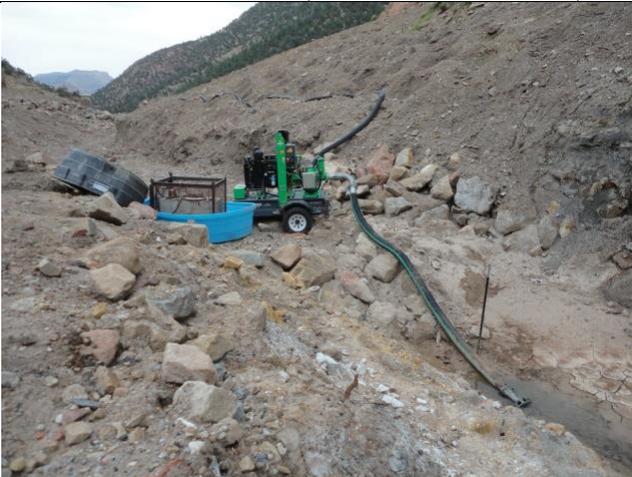
PHOTO 35

Deer Creek Pump for By-Pass

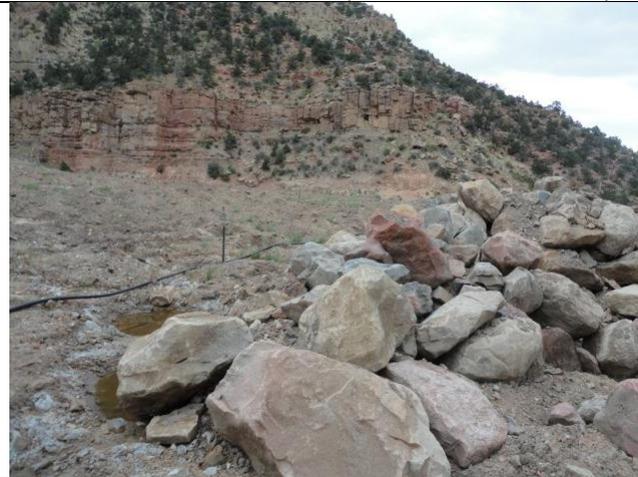
PHOTO 36

Deer Creek Reclamation/Sprinklers

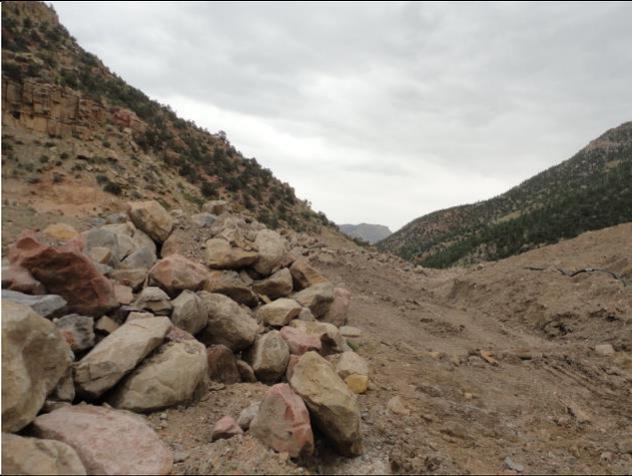
PHOTO 37

Deer Creek Reclamation (Parking Area)

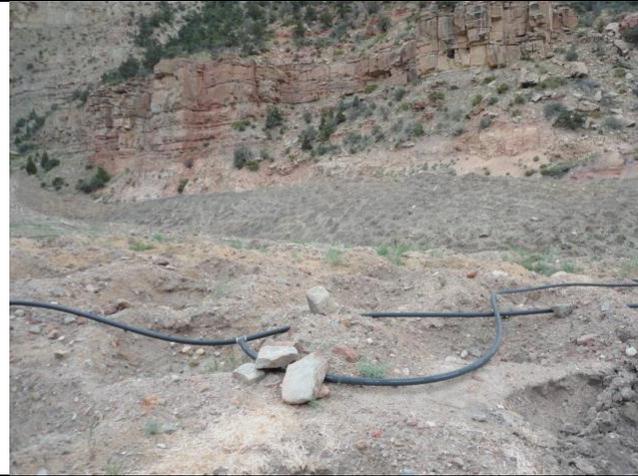
PHOTO 38

Deer Creek Reclamation/Sprinklers

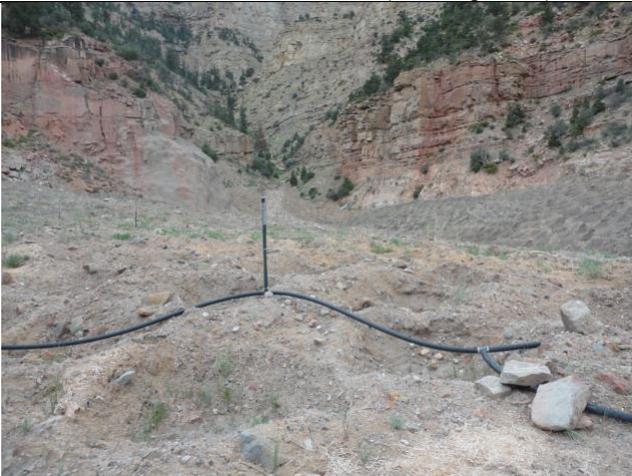
PHOTO 39

Deer Creek Reclamation/Sprinklers

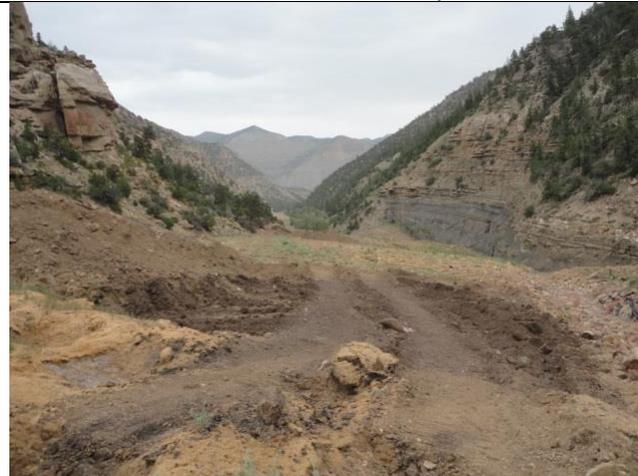
PHOTO 40

Deer Creek Access Road to Make Repairs

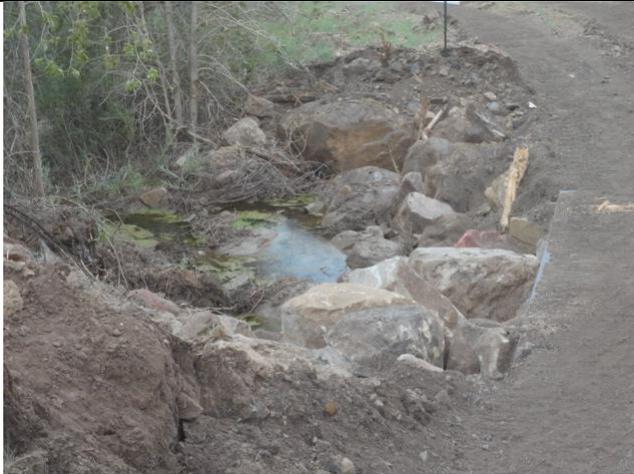
PHOTO 41

Deer Creek Access Road Diversion Crossing

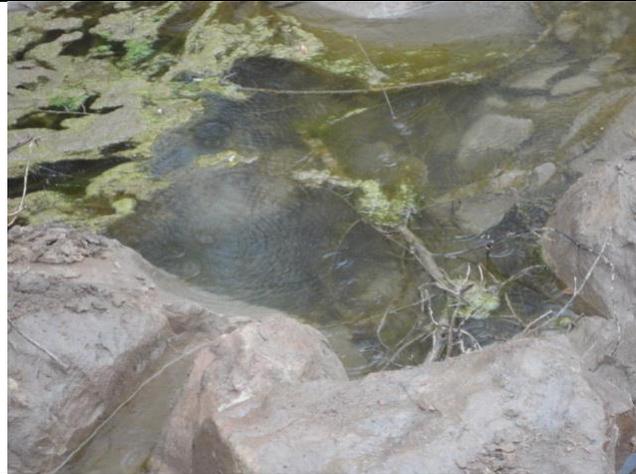
PHOTO 42

Deer Creek Access Road Diversion Crossing

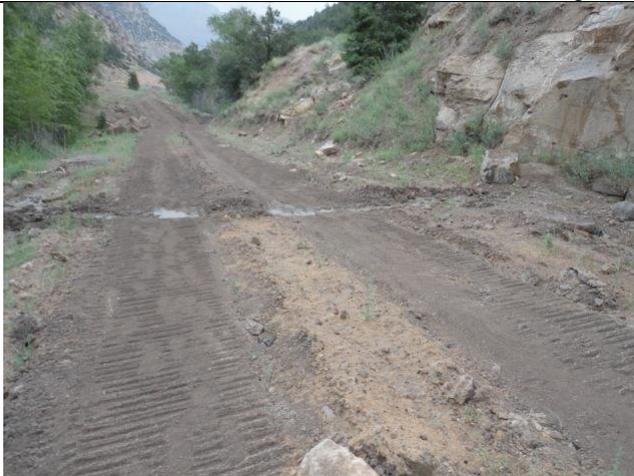
PHOTO 43

Deer Creek Access Road to Make Repairs

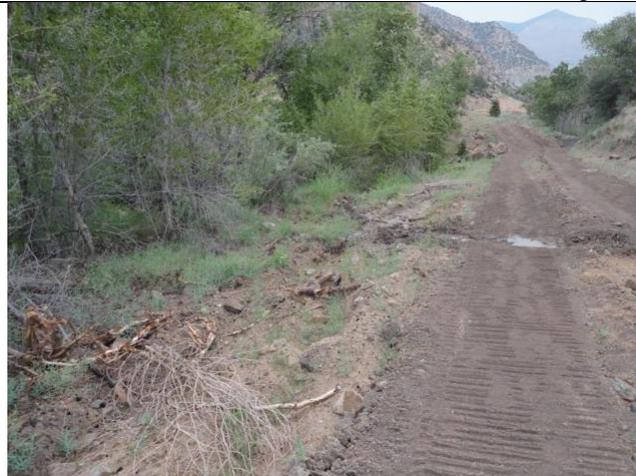
PHOTO 44

Deer Creek Access Road to Make Repairs

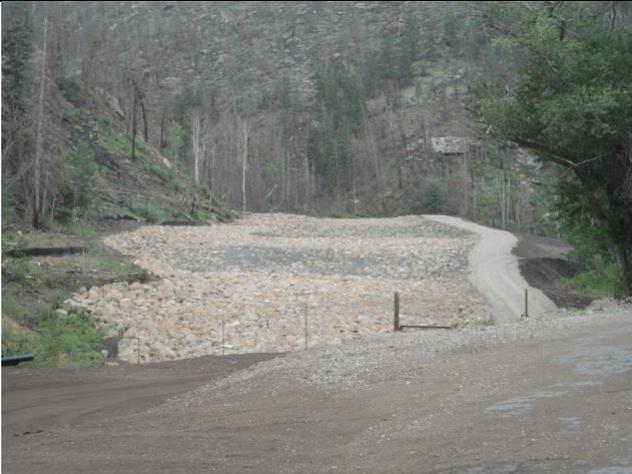
PHOTO 45

Rilda Canyon Emery County Flood Control

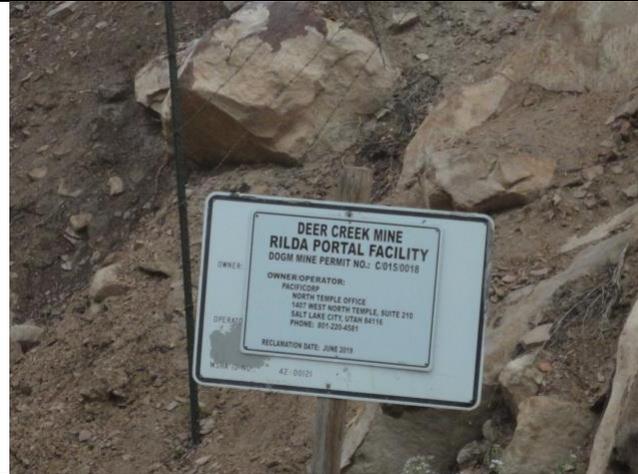
PHOTO 46

Rilda Canyon Identification Sign

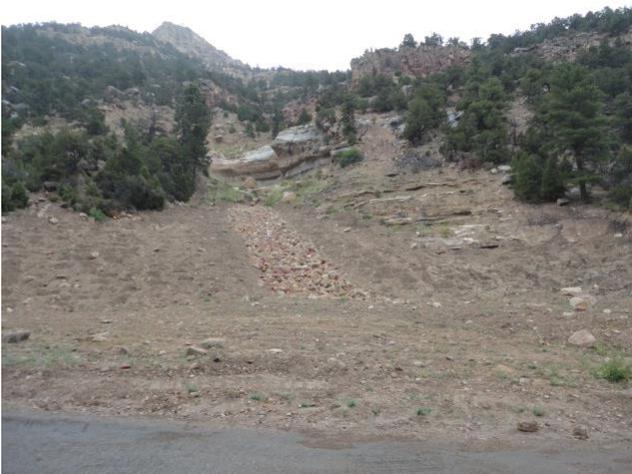
PHOTO 47

Rilda Canyon Reclamation Diversion (Sediment Pond Area)

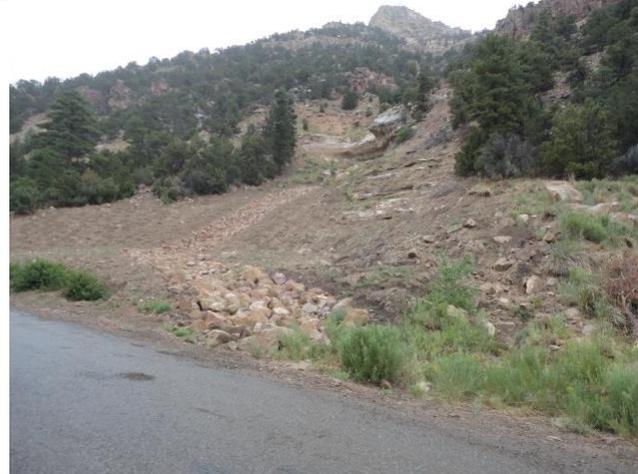
PHOTO 48

Rilda Canyon Reclamation Diversion (Sediment Pond Area)
