0038  
UNITED STATES DEPARTMENT OF AGRICULTURE  
FOREST SERVICE

April 21, 1980

In response to your telephone call of 4/15/80 concerning a possible violation of the Wilberg Mine, we have conducted an on-the-ground review and compiled the attached report. We were able to substantiate your findings, as illustrated by the attached photographs.

U.P. + L. (Wilberg Mine) Trespass Case Illustration

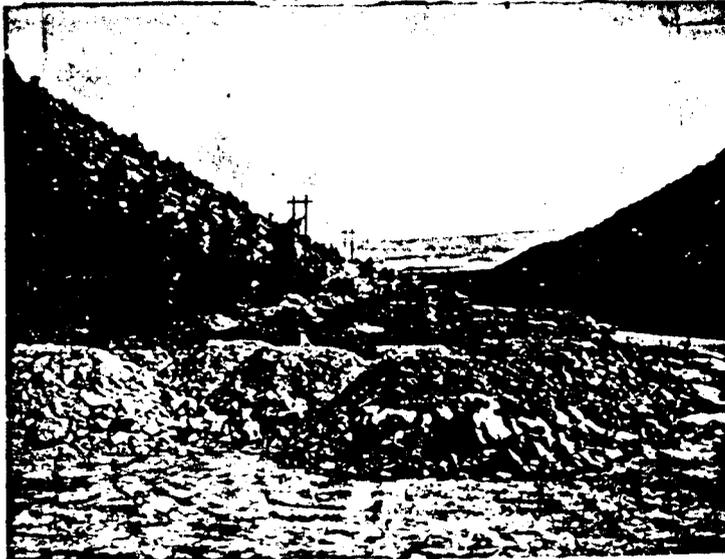
Most of the material in the North Pile (photo 1) was dumped into a small tributary (photos 2-5) which comes in from the (NE) to the live stream

Photo 1. North Pile, looking South

The dimensions of the North Pile are approximately 49' X 221' X 83'. The toe slope dips  $38^{\circ}$ . Height is not easy to judge because of variation of height of pile.

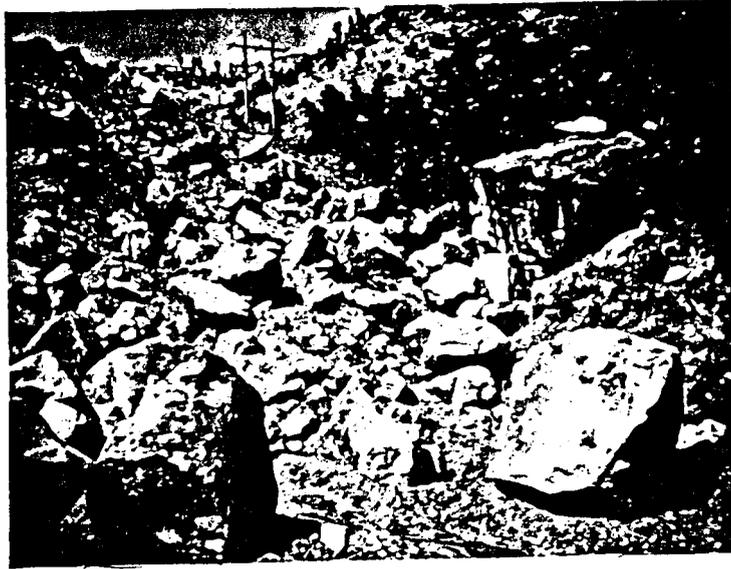
Photo 3. North Pile, looking north along intermittent creek bed.

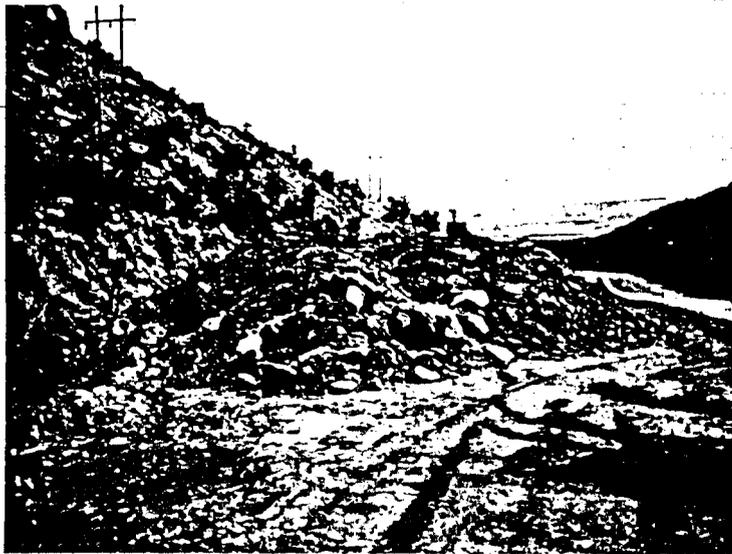
More material is also dumped downstream on the right bank of Grimes Wash below the culvert. This is the South Pile ( photos 6,7) The dimensions of the South Pile are approximately 76' X 178'.

Photo 6. South Pile, looking south. Live stream is to far left in photo.

This pile ranges from about 15' to 7' in height; these figures are a rough measurement since this pile also varies considerably in height. The south pile is located 179' south of the North Pile.

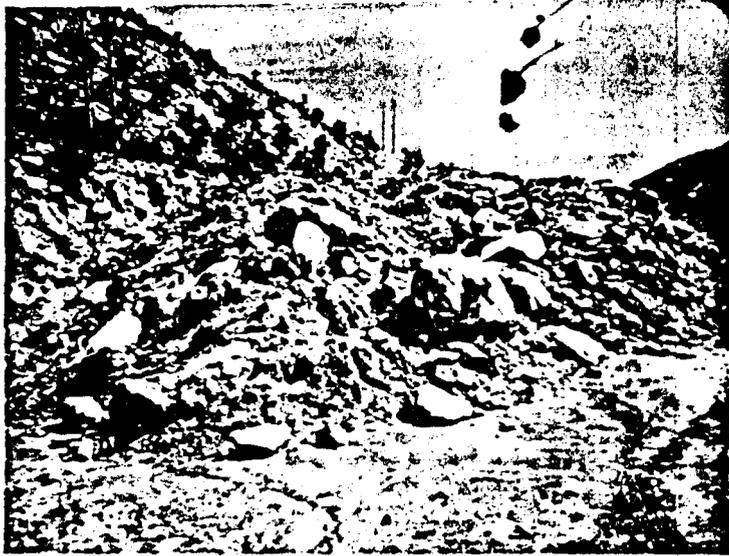
Photo 7. South Pile, looking south. Stream is to extreme left in photo.

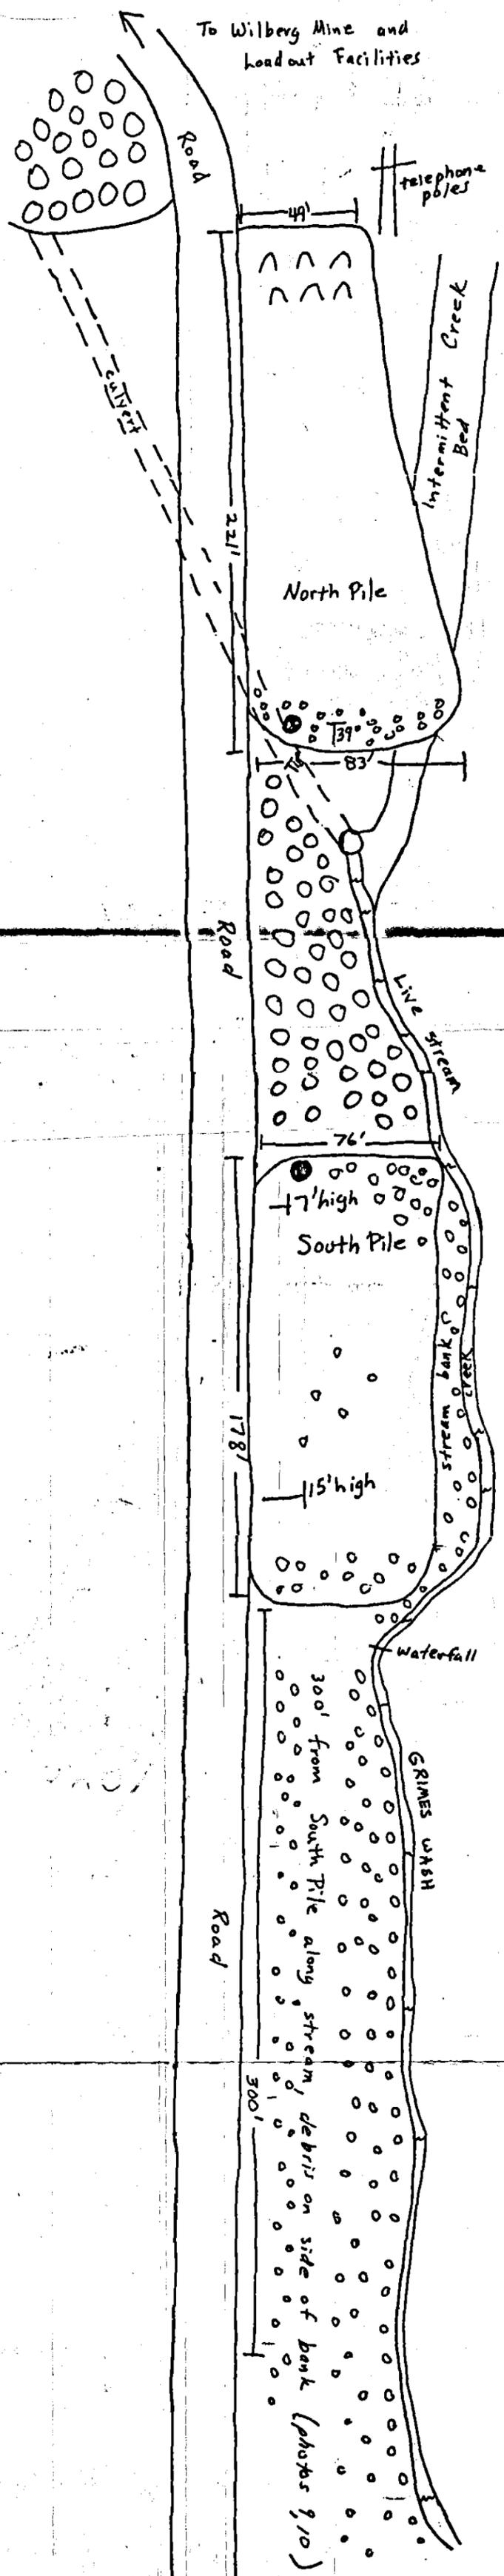
Boulders, debris

●—●: Distance between North and South Piles is 179' as measured from X-X.
