UTAH POWER & LIGHT COMPANY
SUBSIDENCE MONITORING PROGRAM
ANNUAL REPORT FOR 1986

April 1987

Submitted to: United States Department of the Interior
Office of Surface Mining
Minerals Management Service
Utah Division of Oil, Gas and Mining

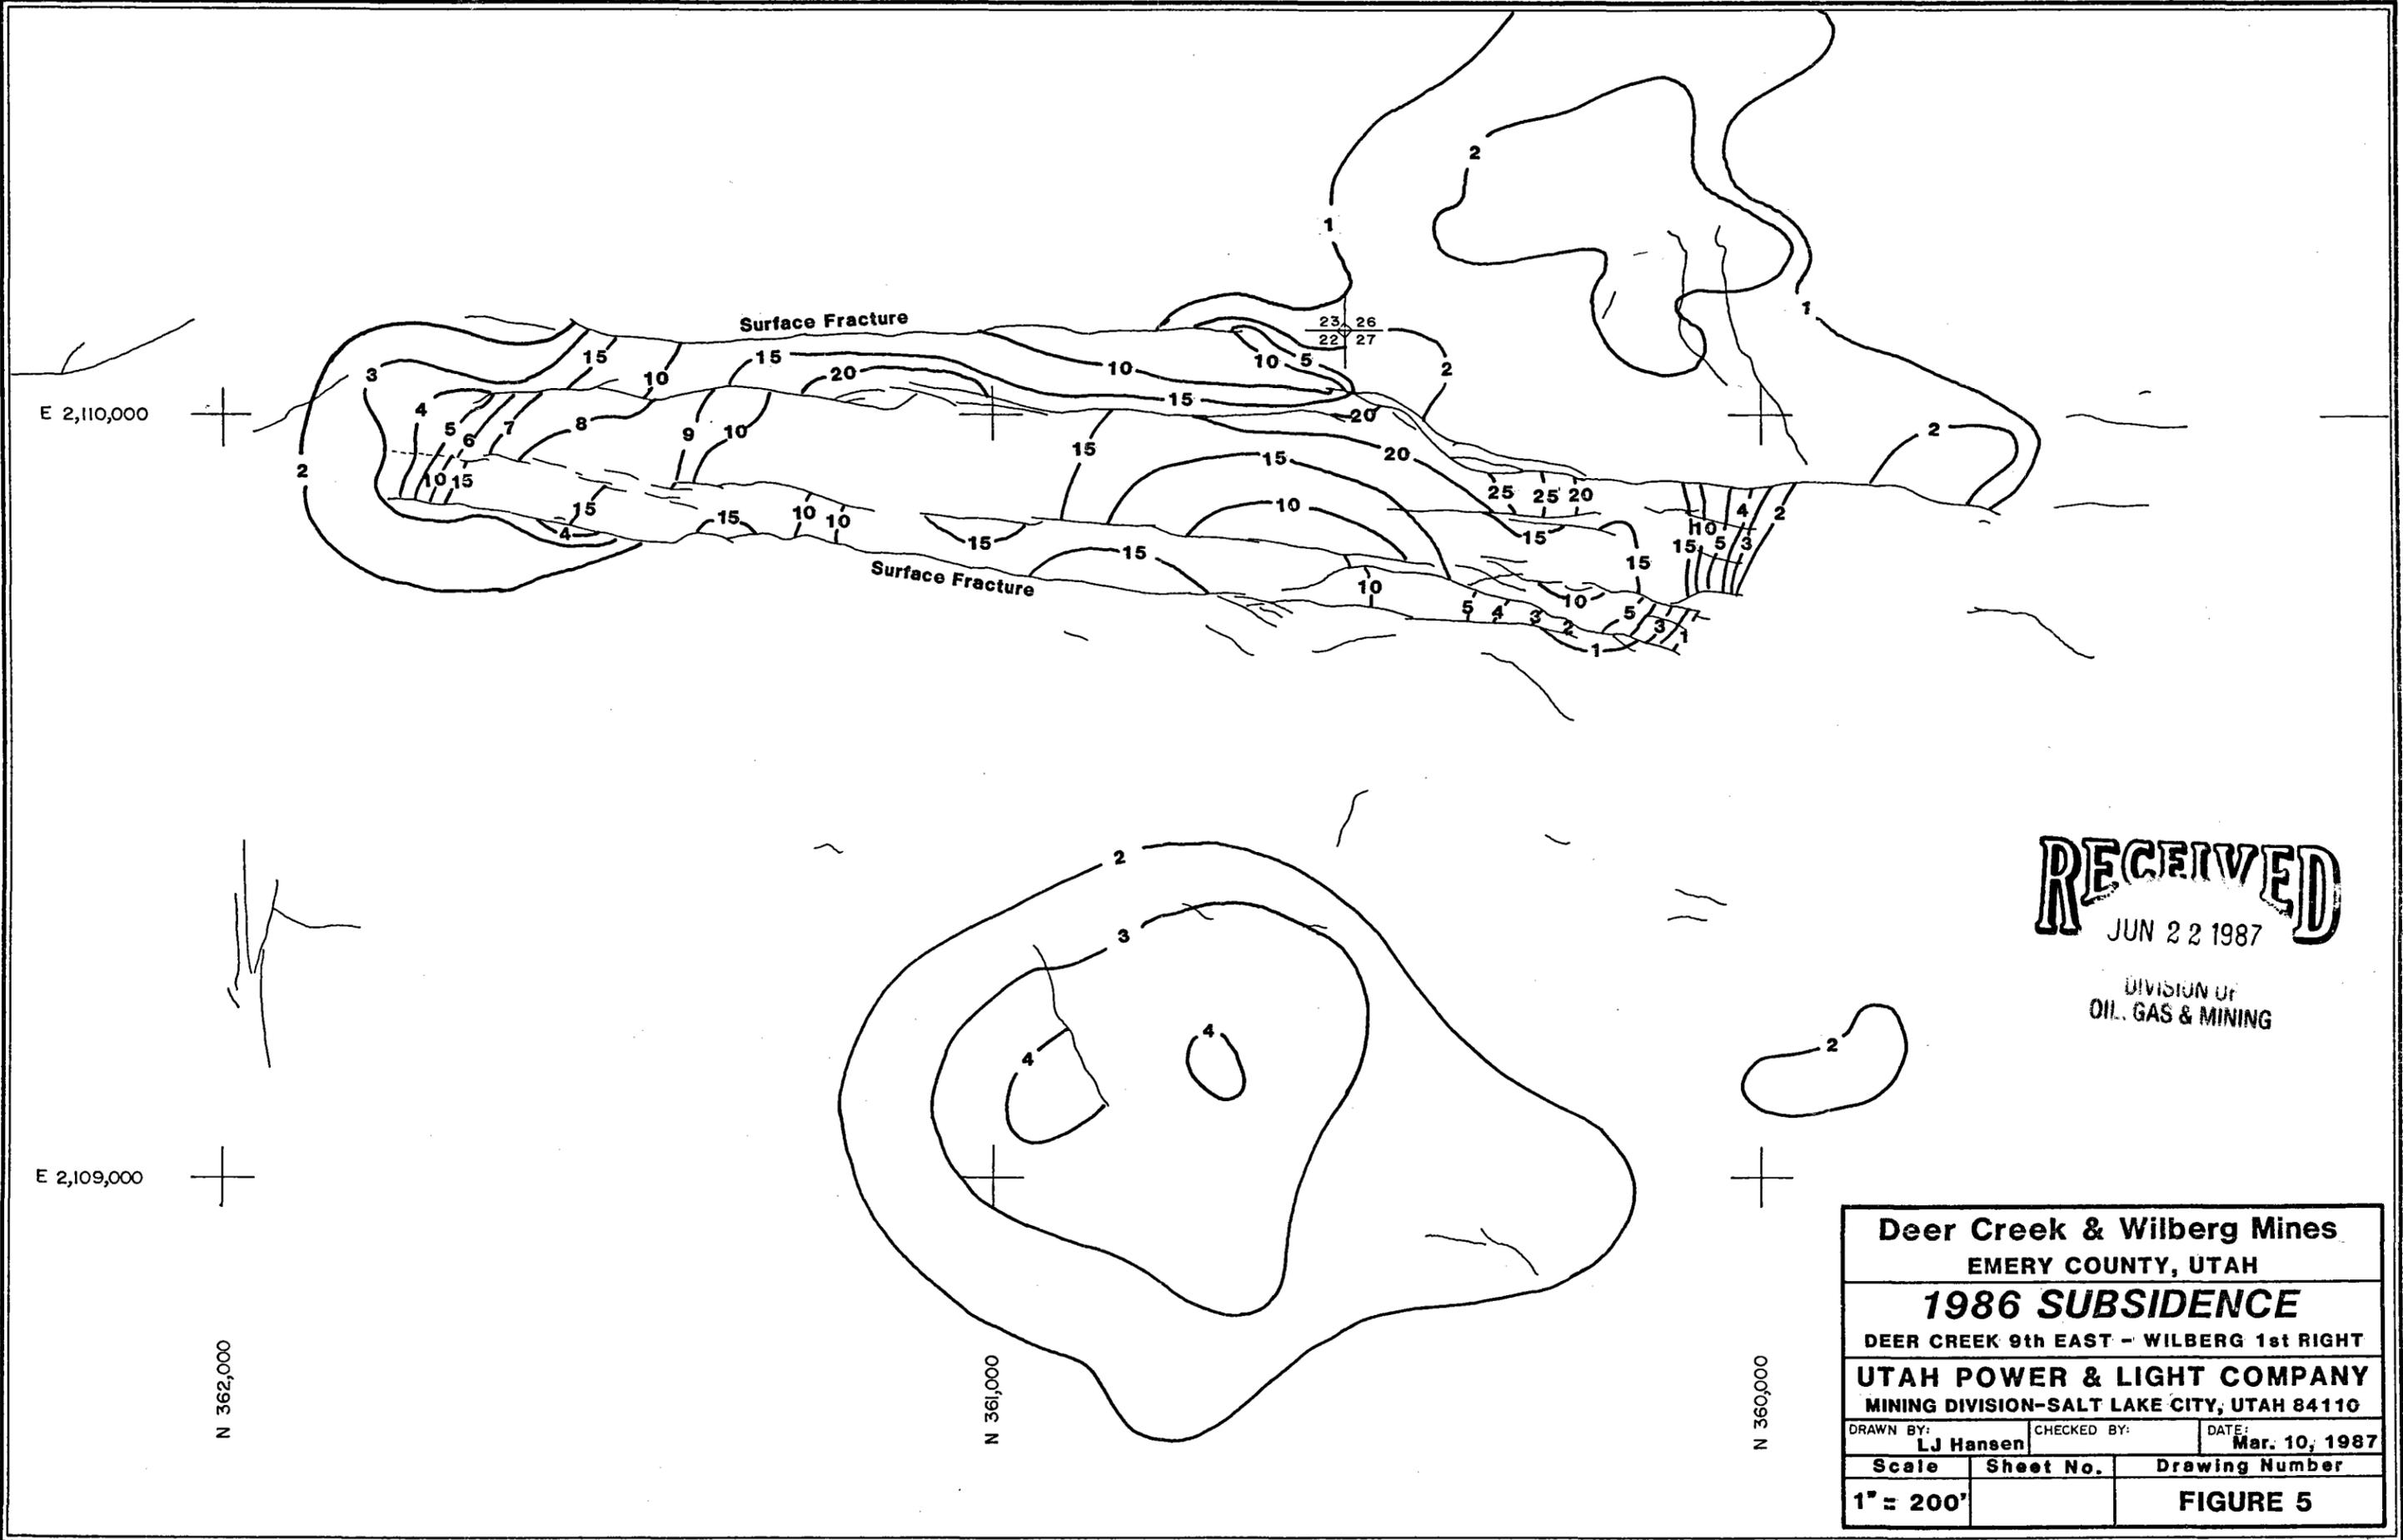
Deer Creek & Wilberg Mines		
EMERY COUNTY, UTAH		
1986 SUBSIDENCE		
DEER CREEK 9th EAST - WILBERG 1st RIGHT		
UTAH POWER & LIGHT COMPANY		
MINING DIVISION-SALT LAKE CITY, UTAH 84110		
DRAWN BY: LJ Hansen	CHECKED BY:	DATE: Mar. 10, 1987
Scale	Sheet No.	Drawing Number
1" = 200'		FIGURE 5

Subsidence monitoring during 1986 showed little or no change in subsidence from 1985. The maximum subsidence observed to date is 25 feet and occurs on a steep slope about 200 feet south of the southernmost mined-out area in 1st Right Wilberg over an area in which both the Hiawatha and Blind Canyon Seams are burned. This supports the theory that the clinker beds have been crushed, allowing subsidence to occur well outside the area of mine workings. An on-the-ground inspection of this area revealed that some of the fractures have begun to heal spontaneously with the soils filling in and smoothing out the fractures.

The angle-of-draw of subsidence in this area appears to be influenced by the Deer Creek Fault plane. On the east side of the mine workings the subsidence abruptly stops about 200 feet east of the mine workings, which coincides with the Deer Creek Fault surface trace. In this area the mine workings are covered with 1200 feet of overburden, indicating a 9.5° angle of draw on subsidence.

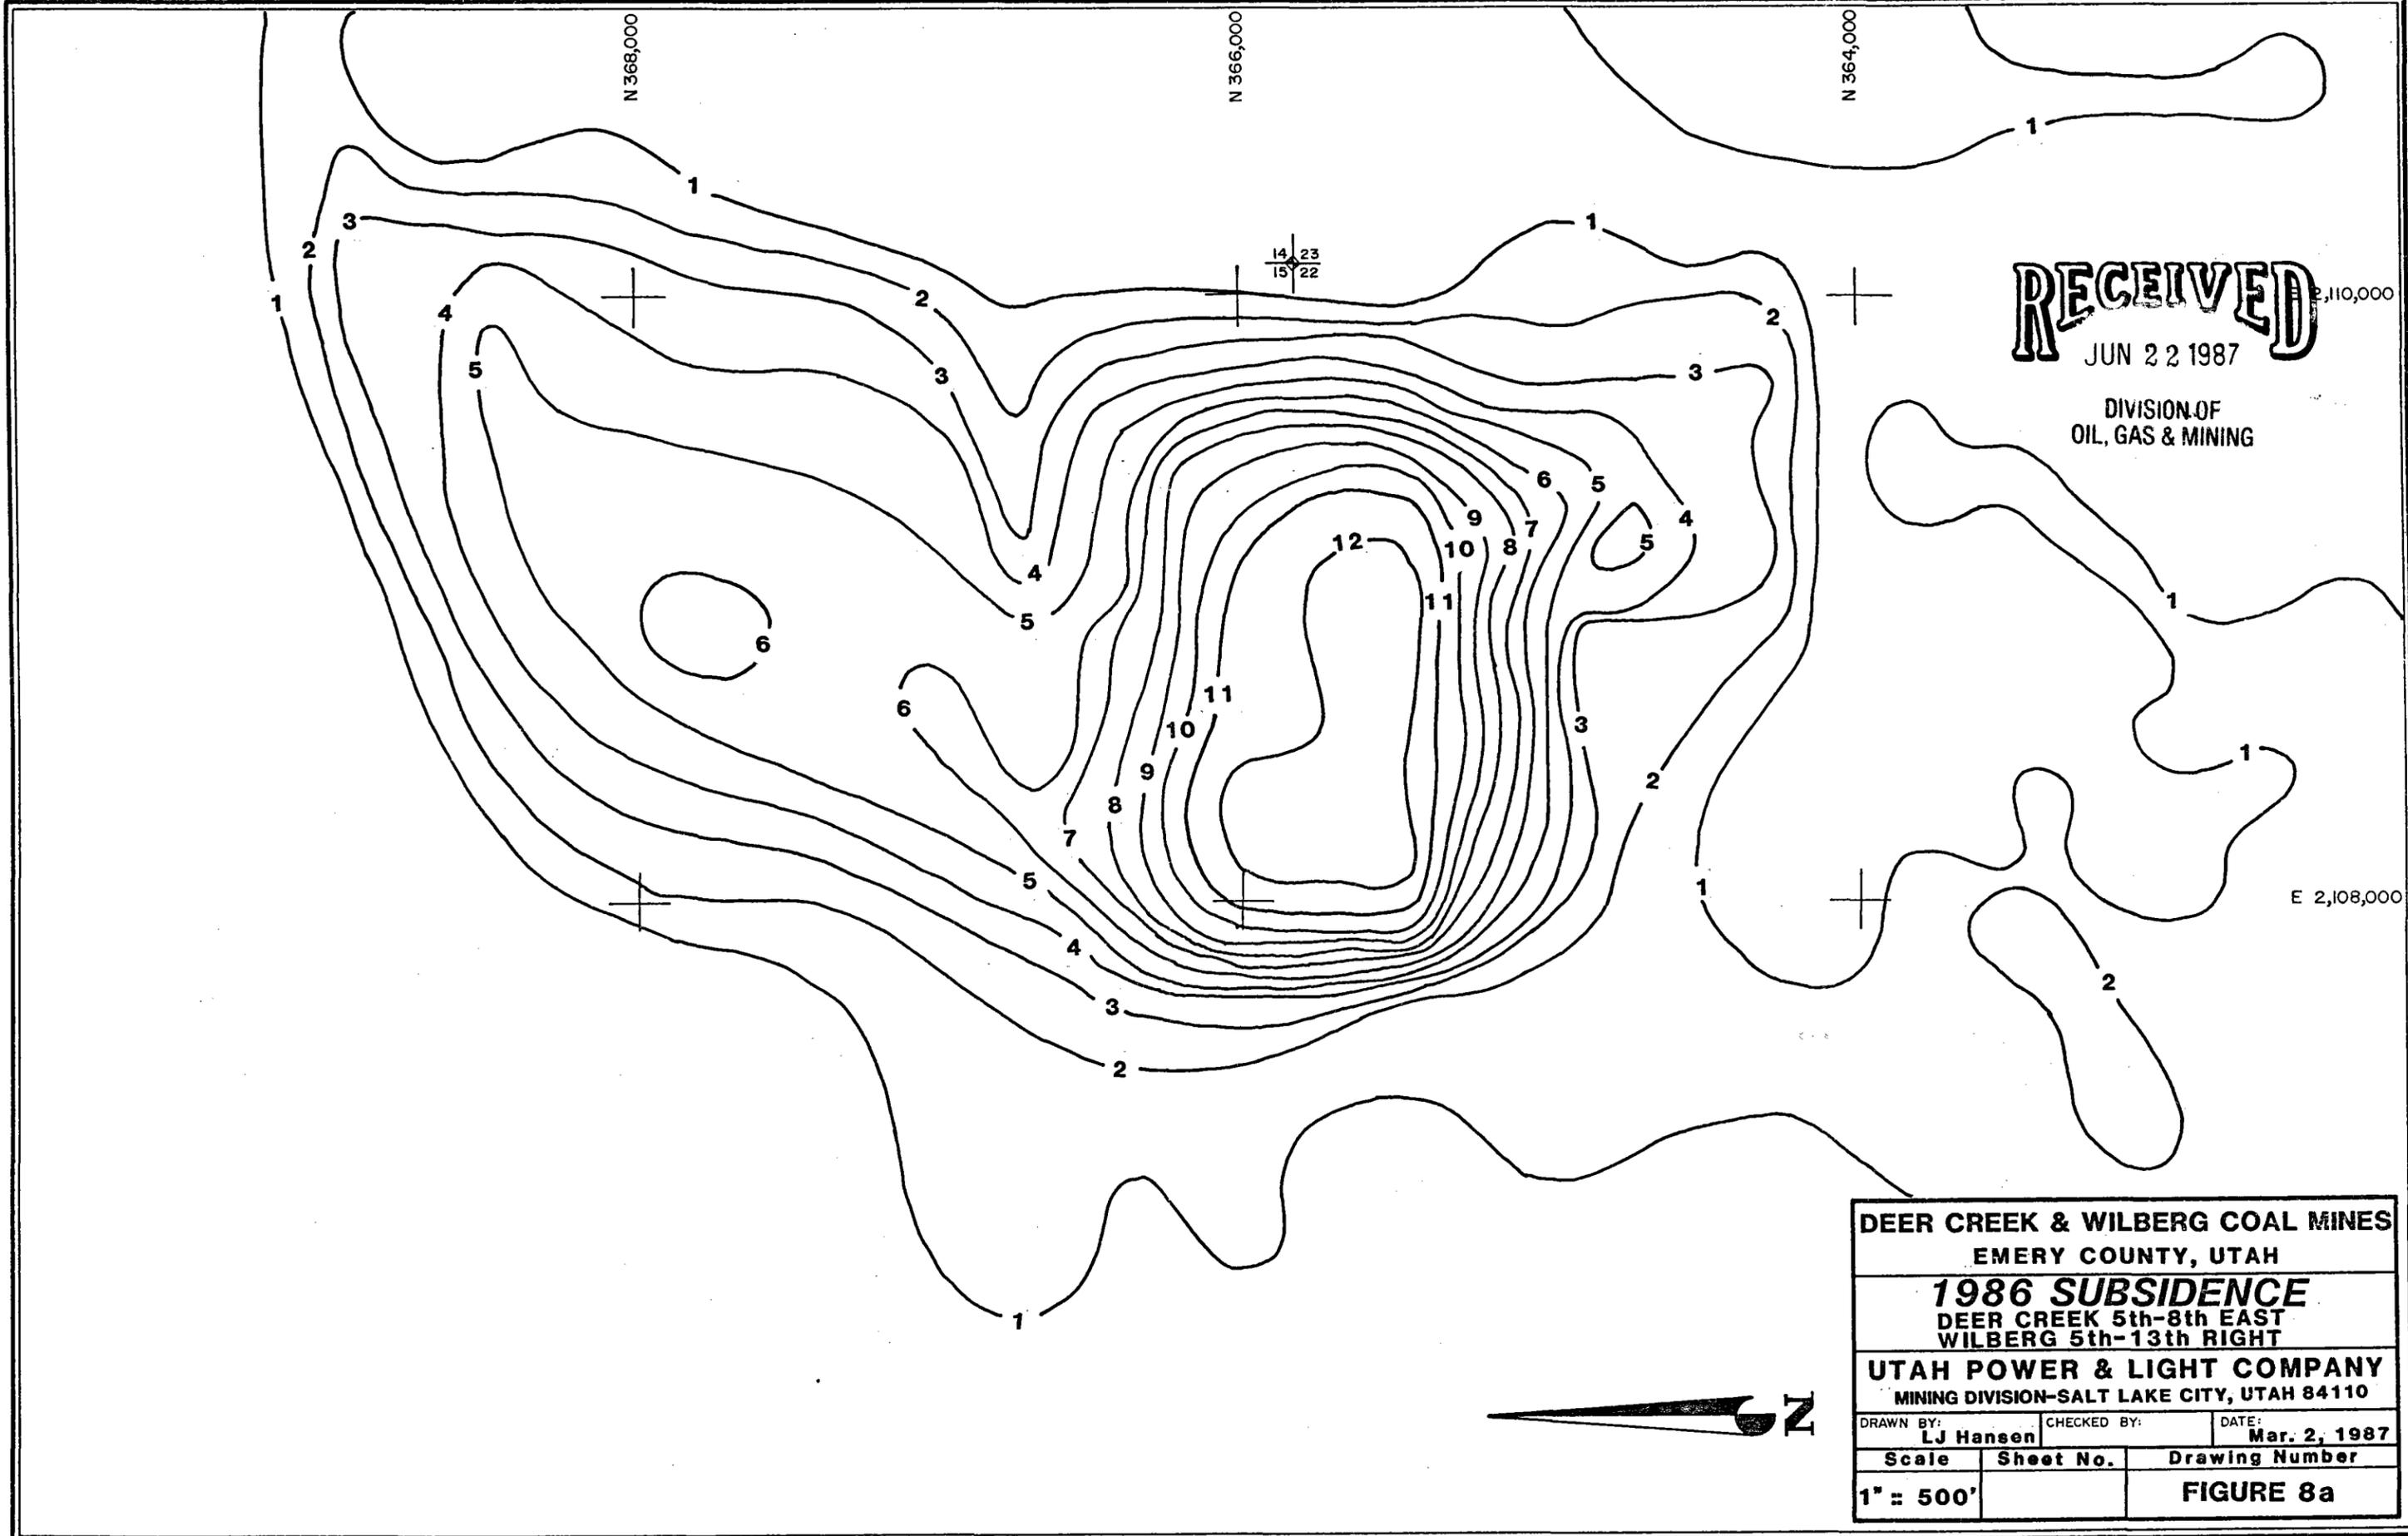
DEER CREEK & WILBERG COAL MINES		
EMERY COUNTY, UTAH		
1986 SUBSIDENCE		
DEER CREEK 5th-8th EAST WILBERG 5th-13th RIGHT		
UTAH POWER & LIGHT COMPANY		
MINING DIVISION-SALT LAKE CITY, UTAH 84110		
DRAWN BY: LJ Hansen	CHECKED BY:	DATE: Mar. 2, 1987
Scale 1" = 500'	Sheet No.	Drawing Number FIGURE 8a

In 1986 this area was surveyed by both photogrammetric methods and conventional on-the-ground methods (Figures 8a and 8b). Once again, the two surveys were in fairly close agreement. The photogrammetric survey showed a maximum of 12 feet of subsidence while on-the-ground methods indicated that nearly 12 feet had occurred. In both surveys maximum subsidence of the Deer Creek 6th East and Wilberg 6th and 7th Right longwall panels occurred. Although the magnitude of the subsidence did not increase, the area continued to elongate to the north and south in 1986. The photogrammetric survey appears to show greater detail since data points are more evenly spaced than with the conventional survey. It is interesting to note that the shape of the subsidence trough seems to be influenced more by the Wilberg Mine workings than the workings in the Deer Creek Mine. Neither UP&L nor contracted survey personnel have detected any surface fissures or any other visible disturbance.

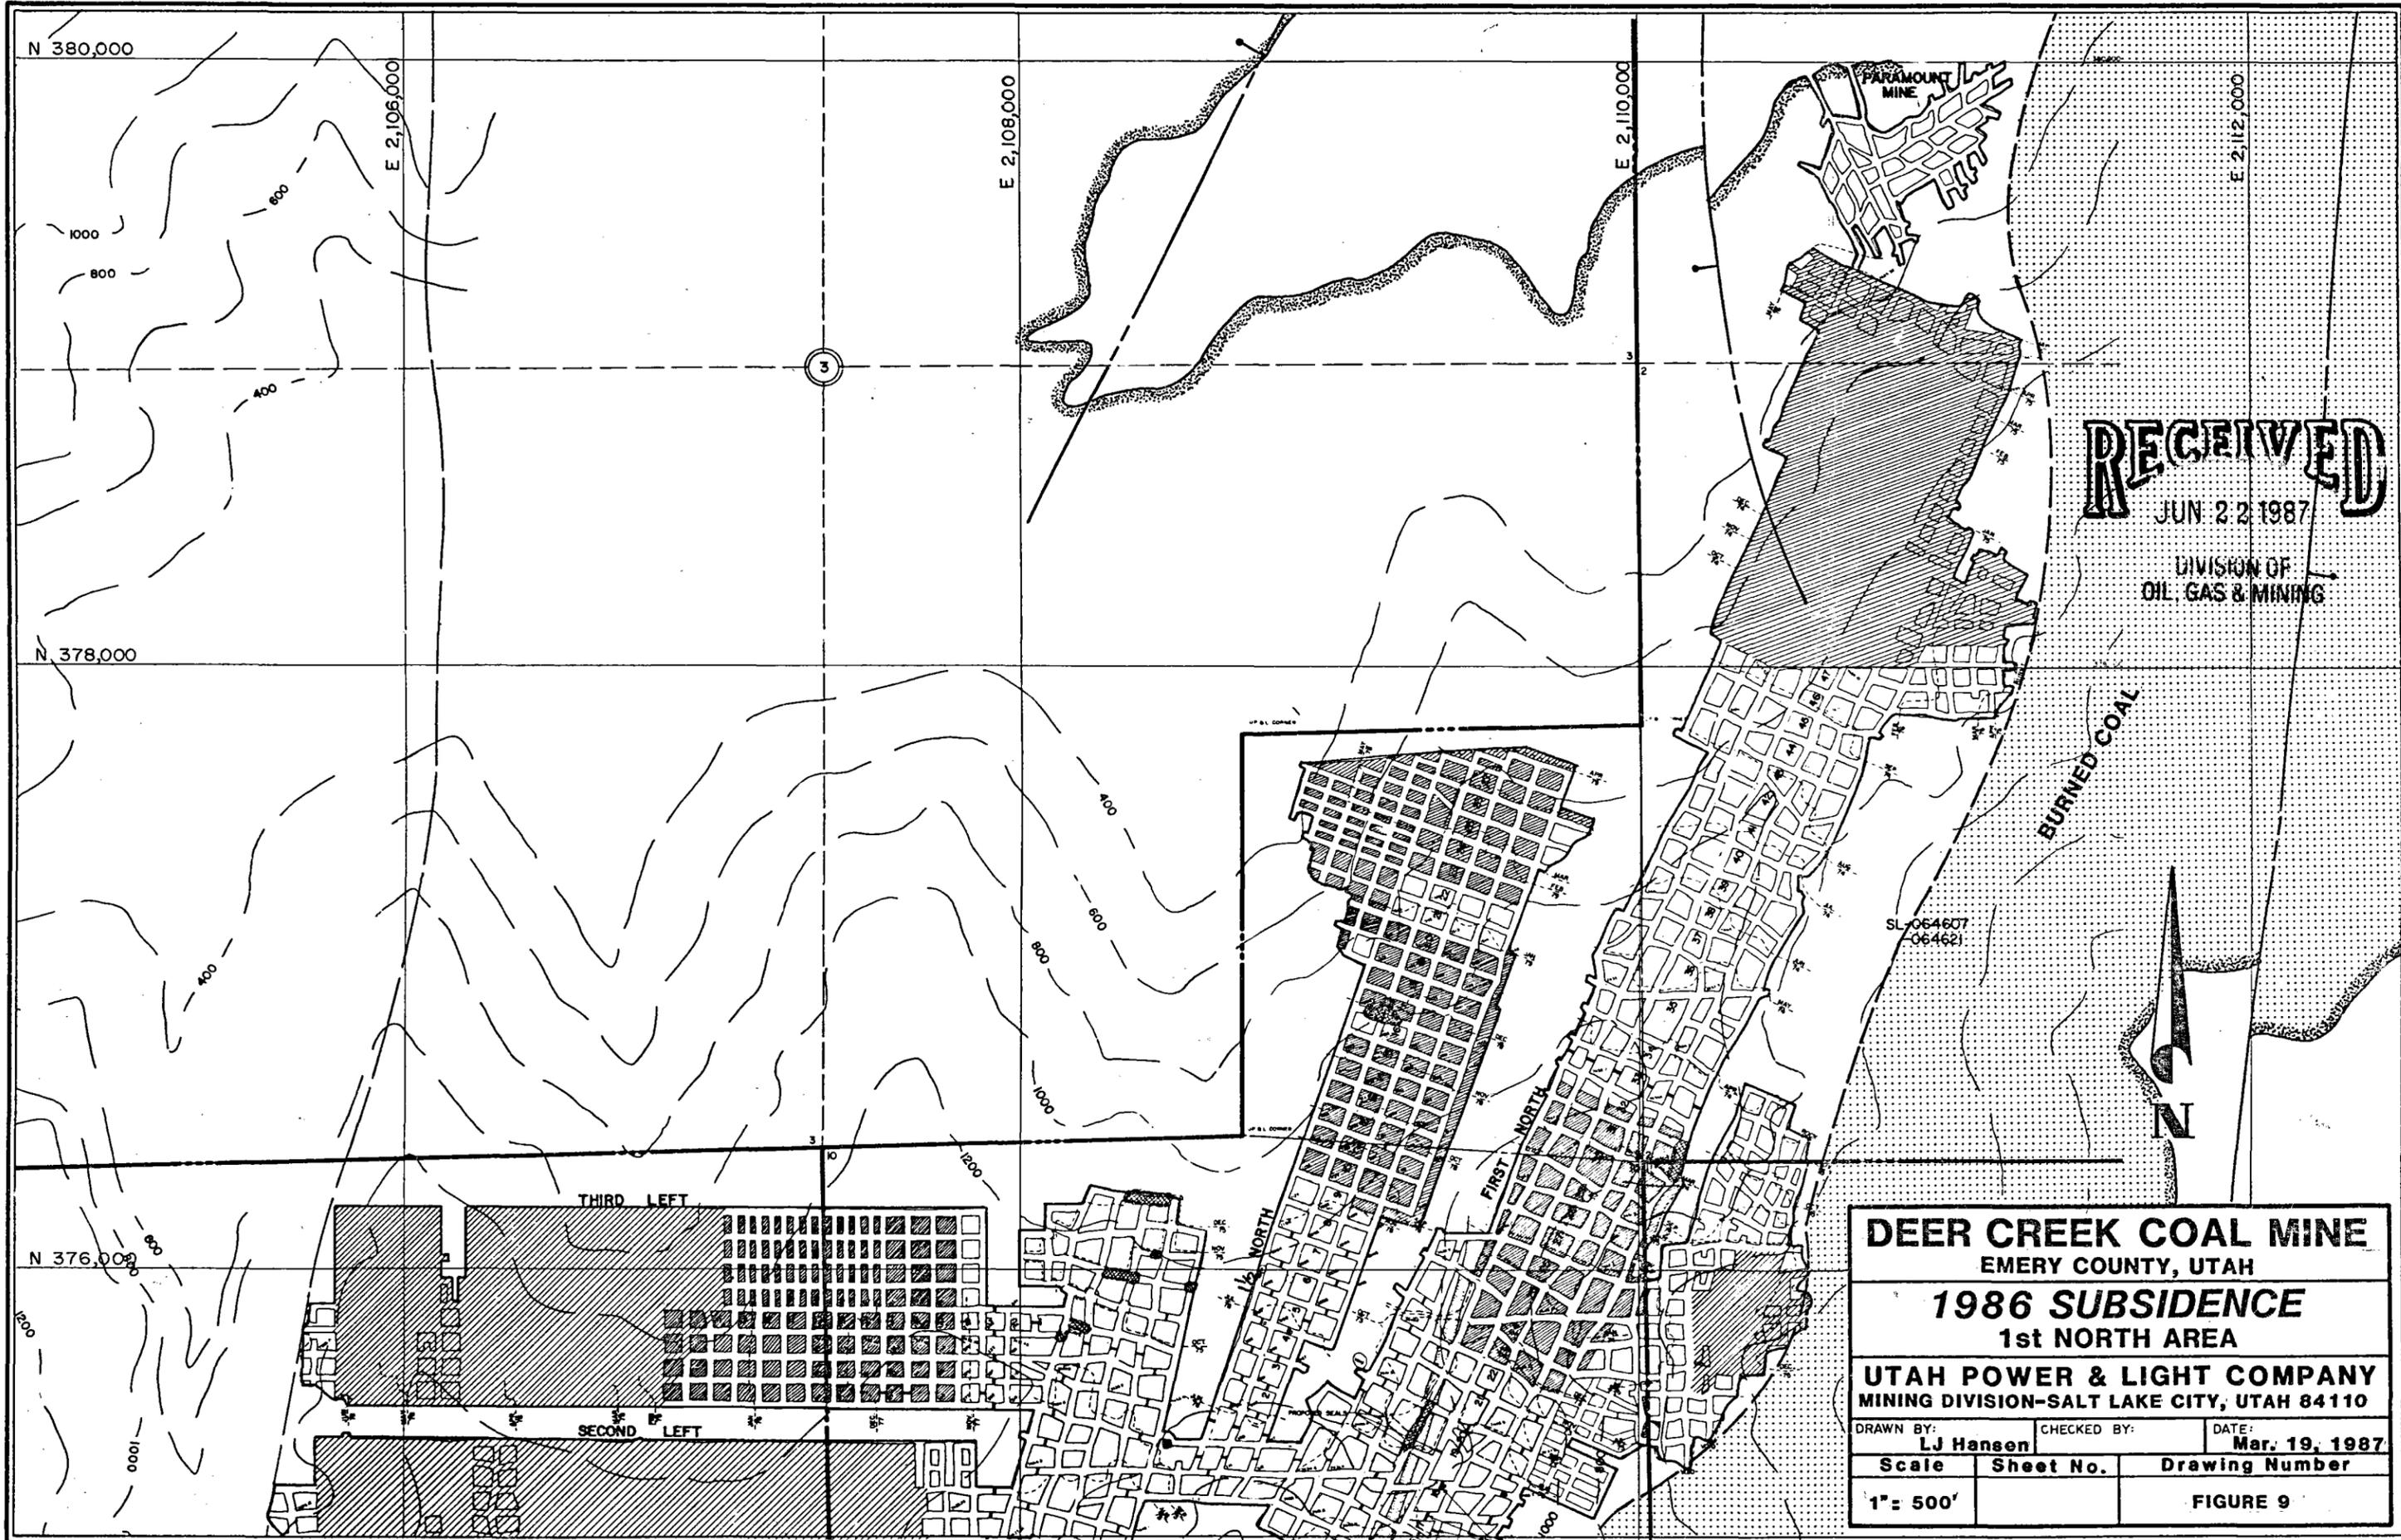
DEER CREEK COAL MINE		
EMERY COUNTY, UTAH		
1986 SUBSIDENCE		
1st NORTH AREA		
UTAH POWER & LIGHT COMPANY		
MINING DIVISION-SALT LAKE CITY, UTAH 84110		
DRAWN BY: LJ Hansen	CHECKED BY:	DATE: Mar. 19, 1987
Scale 1" = 500'	Sheet No.	Drawing Number
		FIGURE 9

Most of the 1st North section of the Deer Creek Mine was abandoned and sealed in 1978 after being mined out. The southern portion is still open and will be used for access to a block of coal which lies to the west. Pillar extraction in the 3rd Left and 1-1/2 North sections was completed early in 1980. The greatest subsidence observed over this area is 3 feet. It occurred over an area of burned coal 600 feet northeast of the 1st North workings (Figures 9 and 10). Other points showing greater elevation changes (up to 15 feet) were noted but these have been attributed to mass wasting, such as movement of a large boulder or escarpment failure. One rock slide occurred since the last monitoring period but it is so far (nearly 2000 feet) from the nearest workings that it is probably not related to mining.

The calculated angle-of-draw for the area ranges from vertical to 40°, but the measurements are influenced by burned coal, steep slopes, and fracturing, which have complicated the subsidence process.

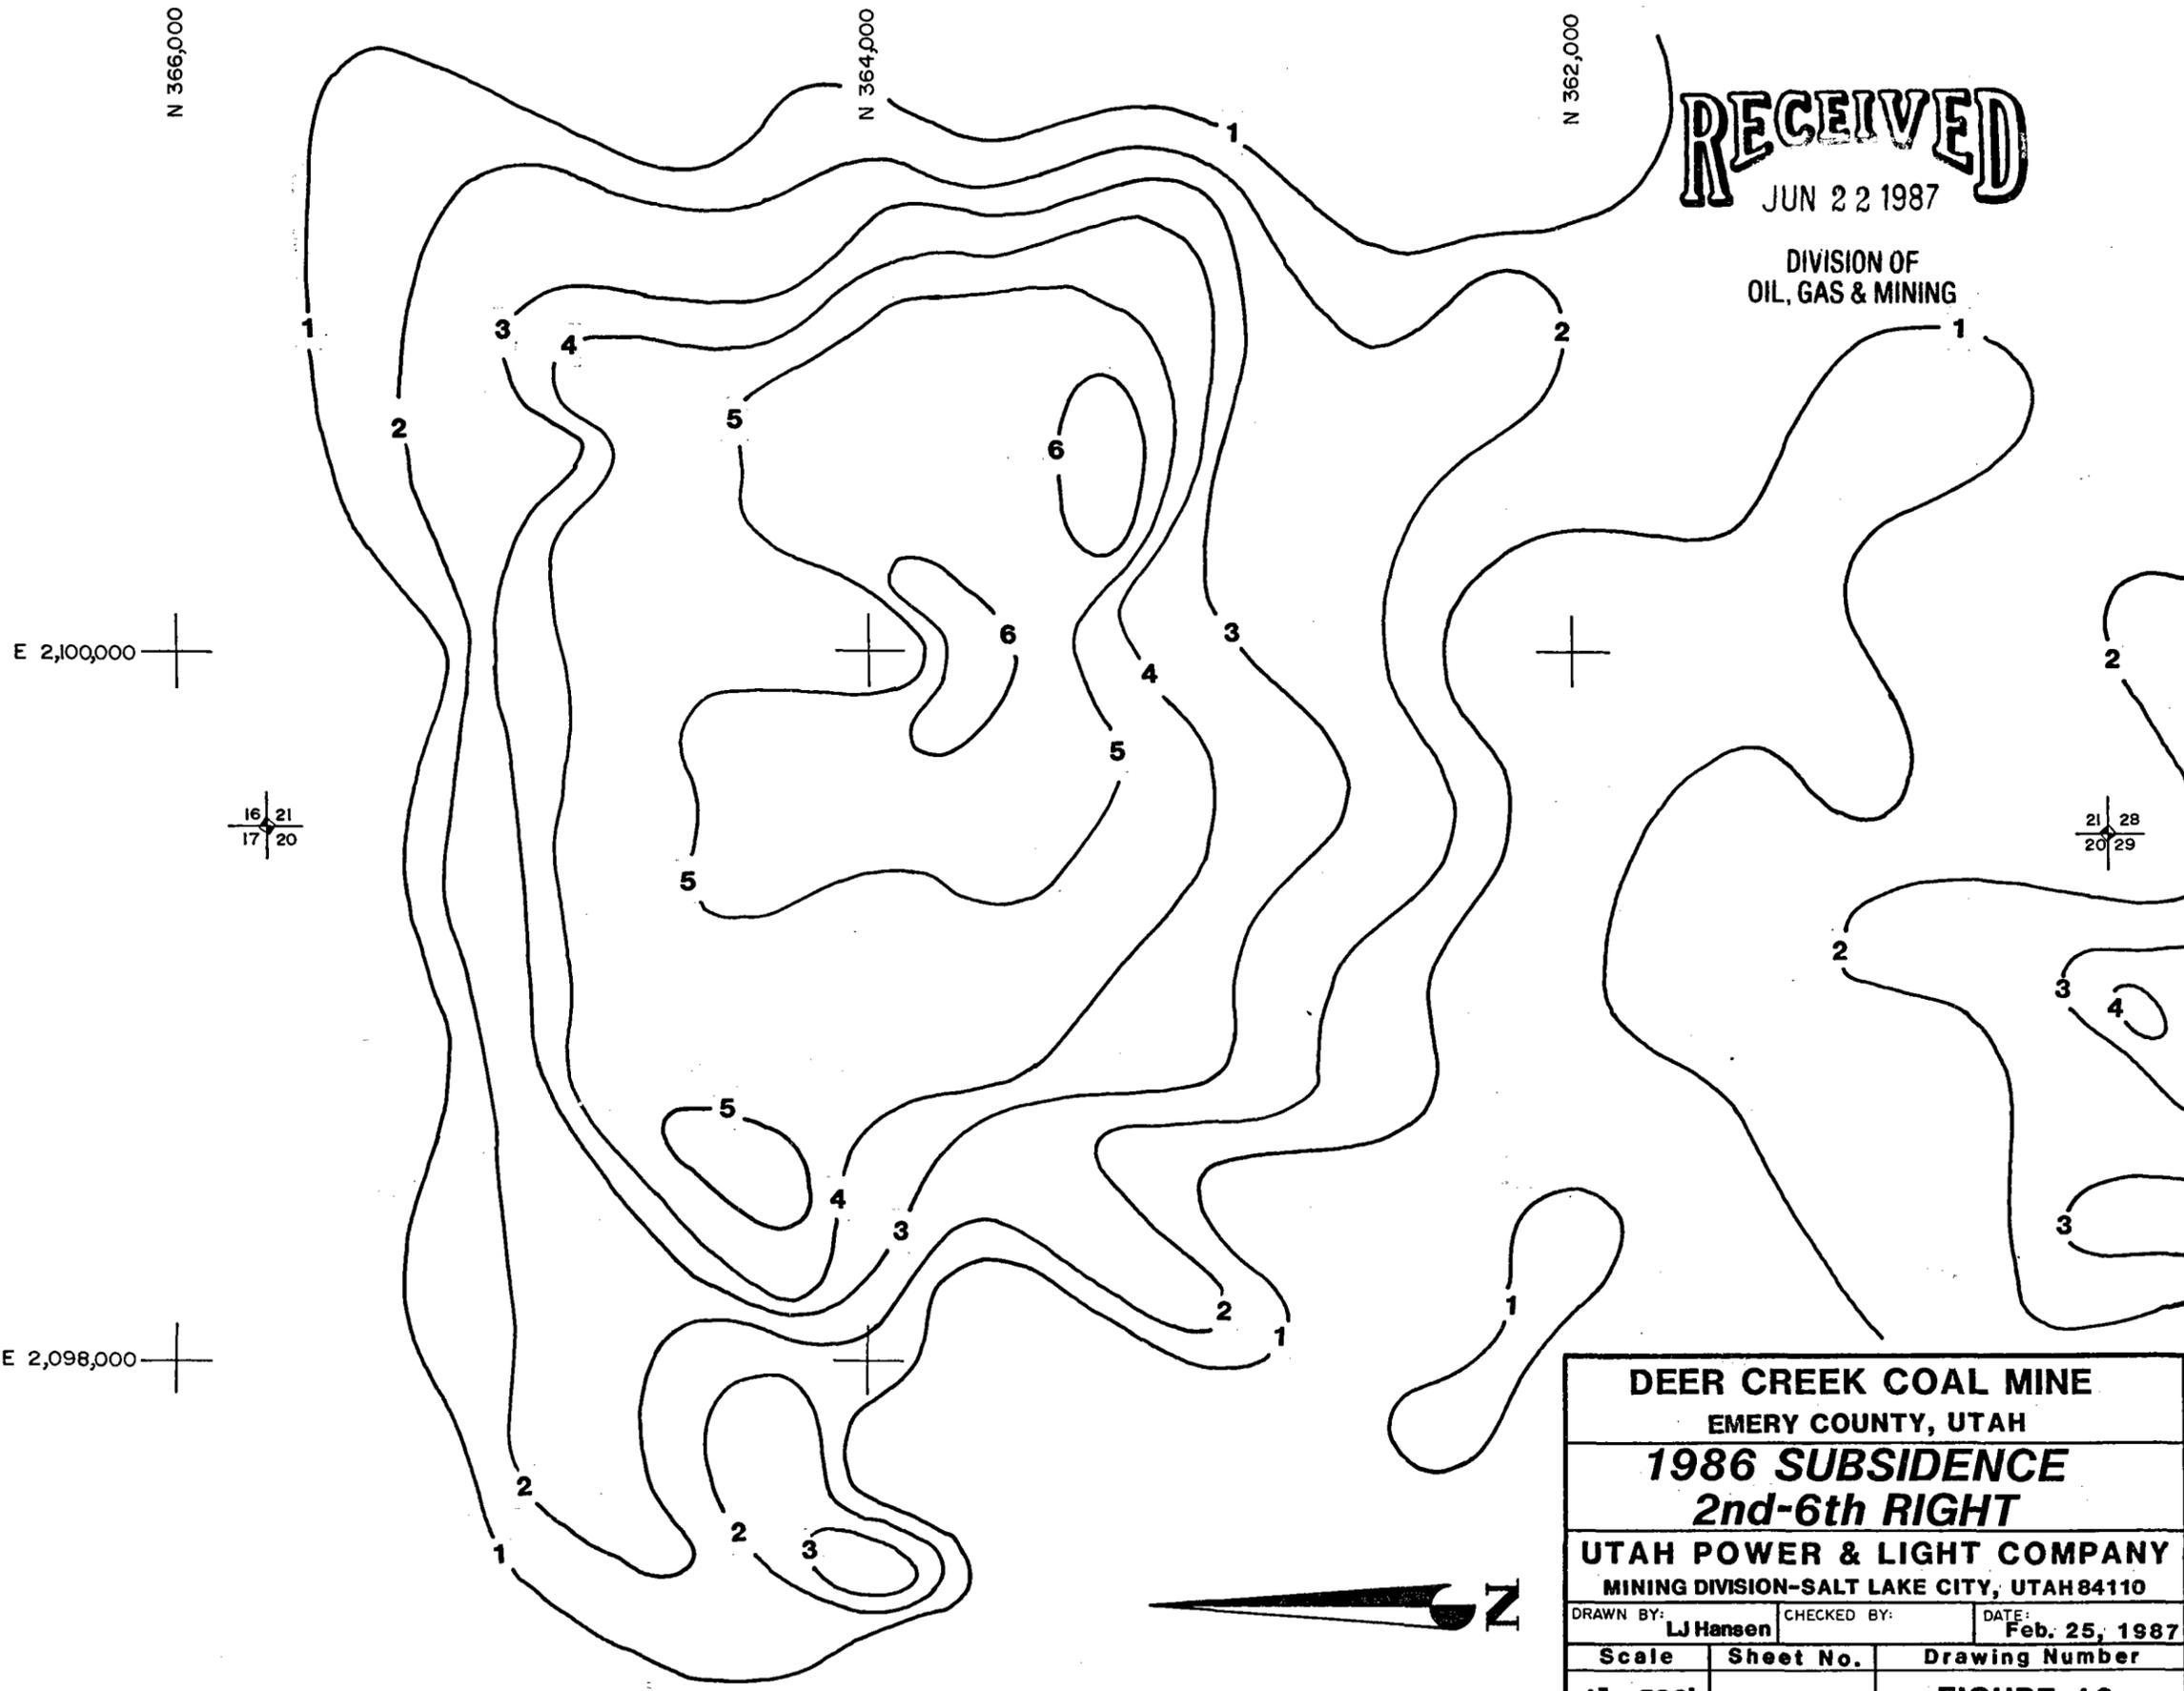
DEER CREEK COAL MINE		
EMERY COUNTY, UTAH		
1986 SUBSIDENCE		
2nd-6th RIGHT		
UTAH POWER & LIGHT COMPANY		
MINING DIVISION-SALT LAKE CITY, UTAH 84110		
DRAWN BY: LJ Hansen	CHECKED BY:	DATE: Feb. 25, 1987
Scale	Sheet No.	Drawing Number
1" = 500'		FIGURE 12

The maximum subsidence yet noted is nearly 7 feet over the 3rd and 4th Right longwall panels (Figure 12). Curiously, where subsidence of up to 5 feet was measured in 1985 over two (2) room-and-pillar sections to the west of these panels, 1986 measurement shows only 3 feet. The surface above these sections forms steep slopes, and it is assumed that some type of ground movement has caused the original depressions to fill slightly. However, no slumping or fractures have been noted in any part of the area, either on the ground or from the air. The calculated angle-of-draw of the subsidence ranges from near vertical to about 22°, but more meaningful estimates may be possible when subsidence has stabilized.

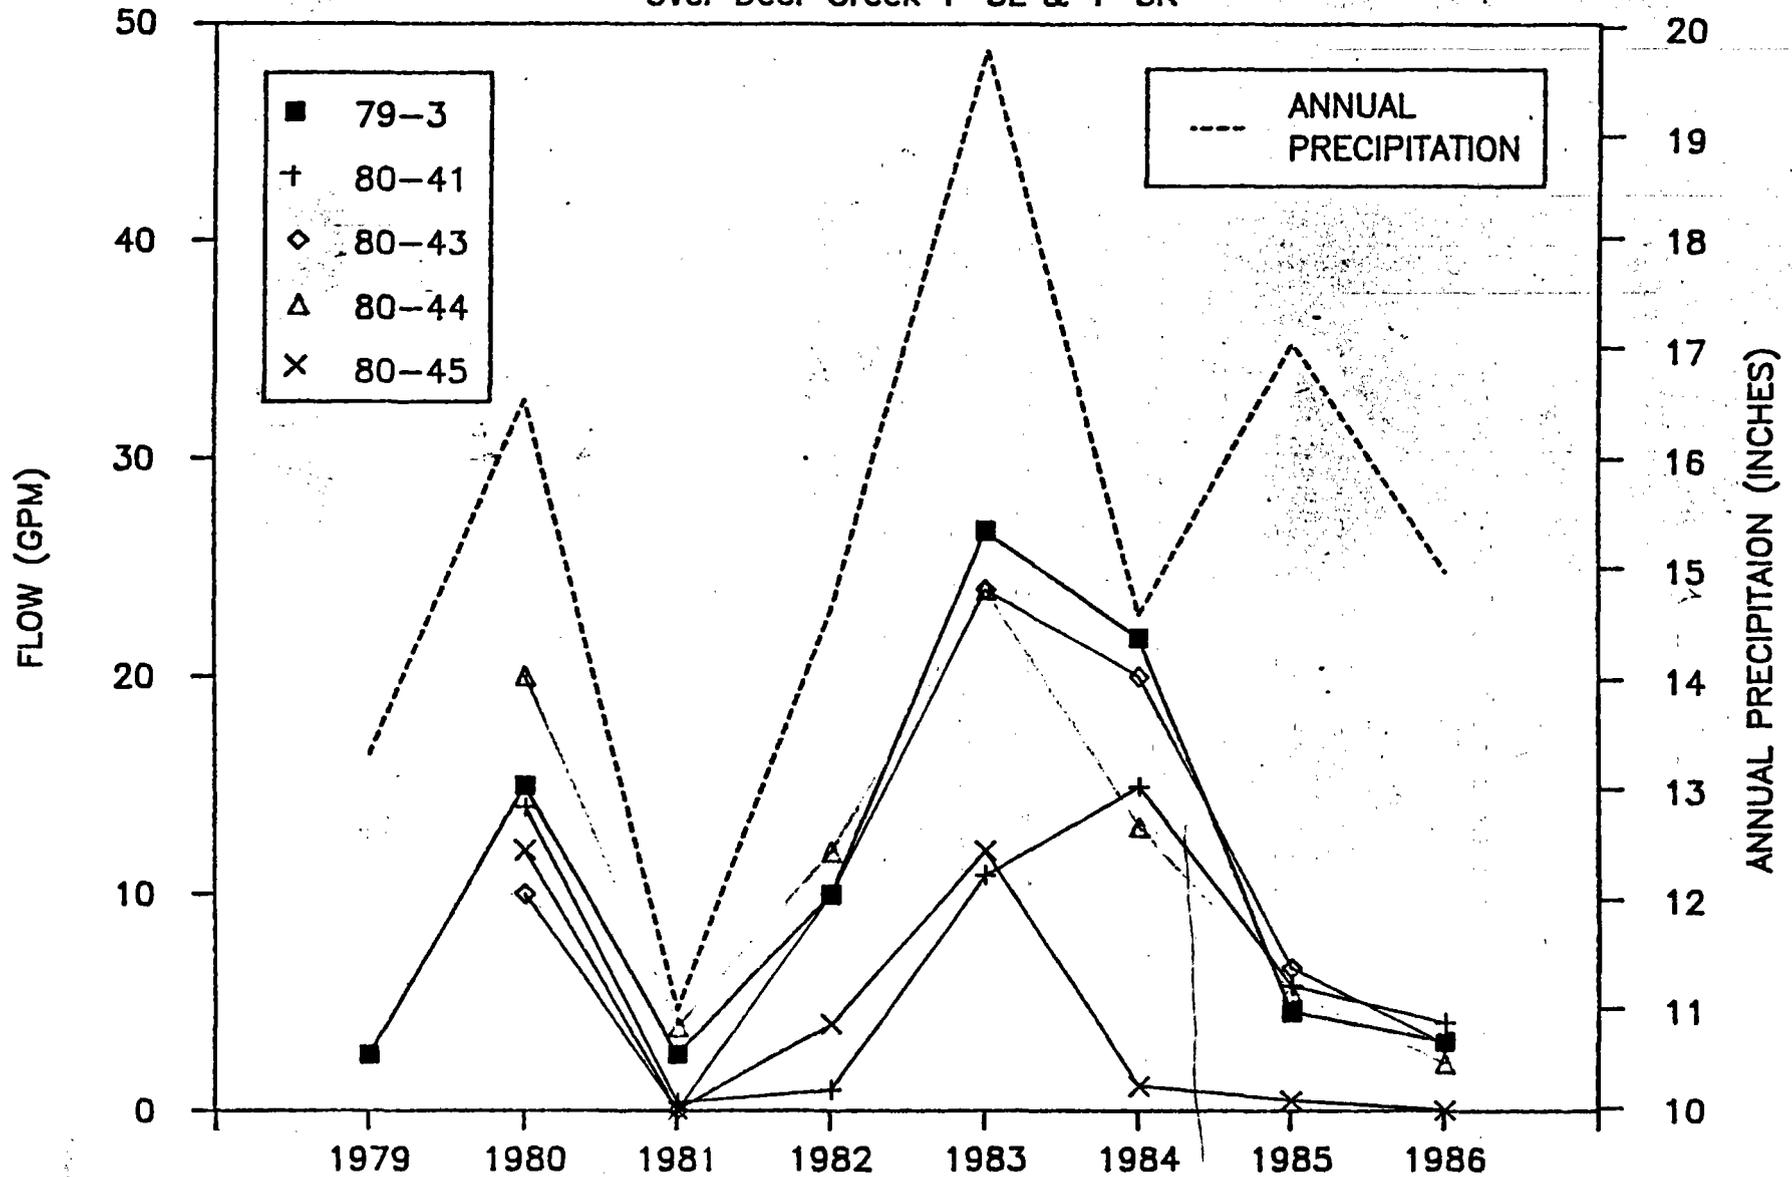
Figure 13
EAST MOUNTAIN SPRINGS
 Over Deer Creek 1-5L & 1-5R

Several springs are located on East Mountain above the Deer Creek 1st through 5th Right and 1st through 5th Left (see Area 5) mine workings. Figure 13 is a graph comparing the discharge from these springs with the annual precipitation on East Mountain. Fluctuations in spring flow appear to be related to variations in precipitation. The relationship appears to hold well for all years except 1985. In examining temperature data obtained from a weather station on East Mountain we found that during the months April and May of 1985

temperatures averaged 7 degrees above normal. The unusually high temperatures caused most of the snow-melt to occur before the springs could be sampled in July, when peak runoff usually occurs, accounting for the lower than expected spring discharges measured in 1985.

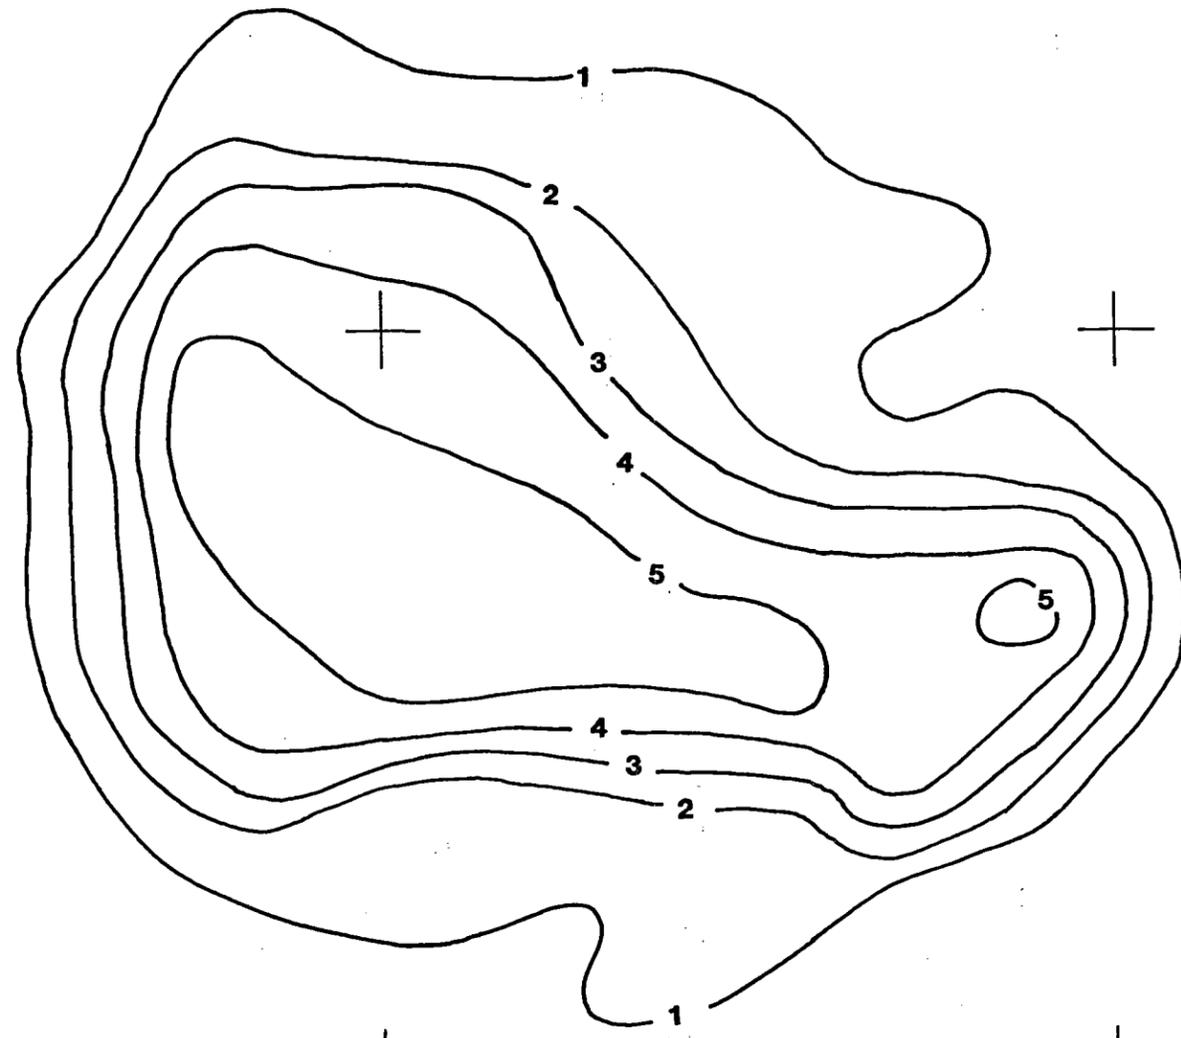
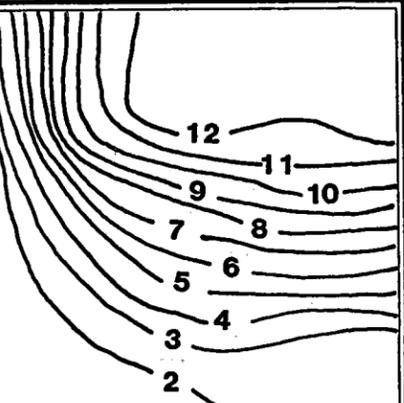
DEER CREEK COAL MINE		
EMERY COUNTY, UTAH		
1986 SUBSIDENCE		
2nd-5th LEFT		
UTAH POWER & LIGHT COMPANY		
MINING DIVISION-SALT LAKE CITY, UTAH 84110		
DRAWN BY: LJ Hansen	CHECKED BY:	DATE: Mar. 3, 1987
Scale	Sheet No.	Drawing Number
1" = 500'		FIGURE 15

Maximum subsidence over the panels continues to be 5 feet and occurs over much of the 3rd Left panel (Figure 15). The maximum angle-of-draw is now approximately 23° but, since the area may continue to subside for a time, this is not considered a reliable figure. No surface disturbance has been seen.
