UTAH POWER & LIGHT COMPANY
SUBSIDENCE MONITORING PROGRAM
ANNUAL REPORT FOR 1986

April 1987

Submitted to: United States Department of the Interior
Office of Surface Mining
Minerals Management Service
Utah Division of Oil, Gas and Mining

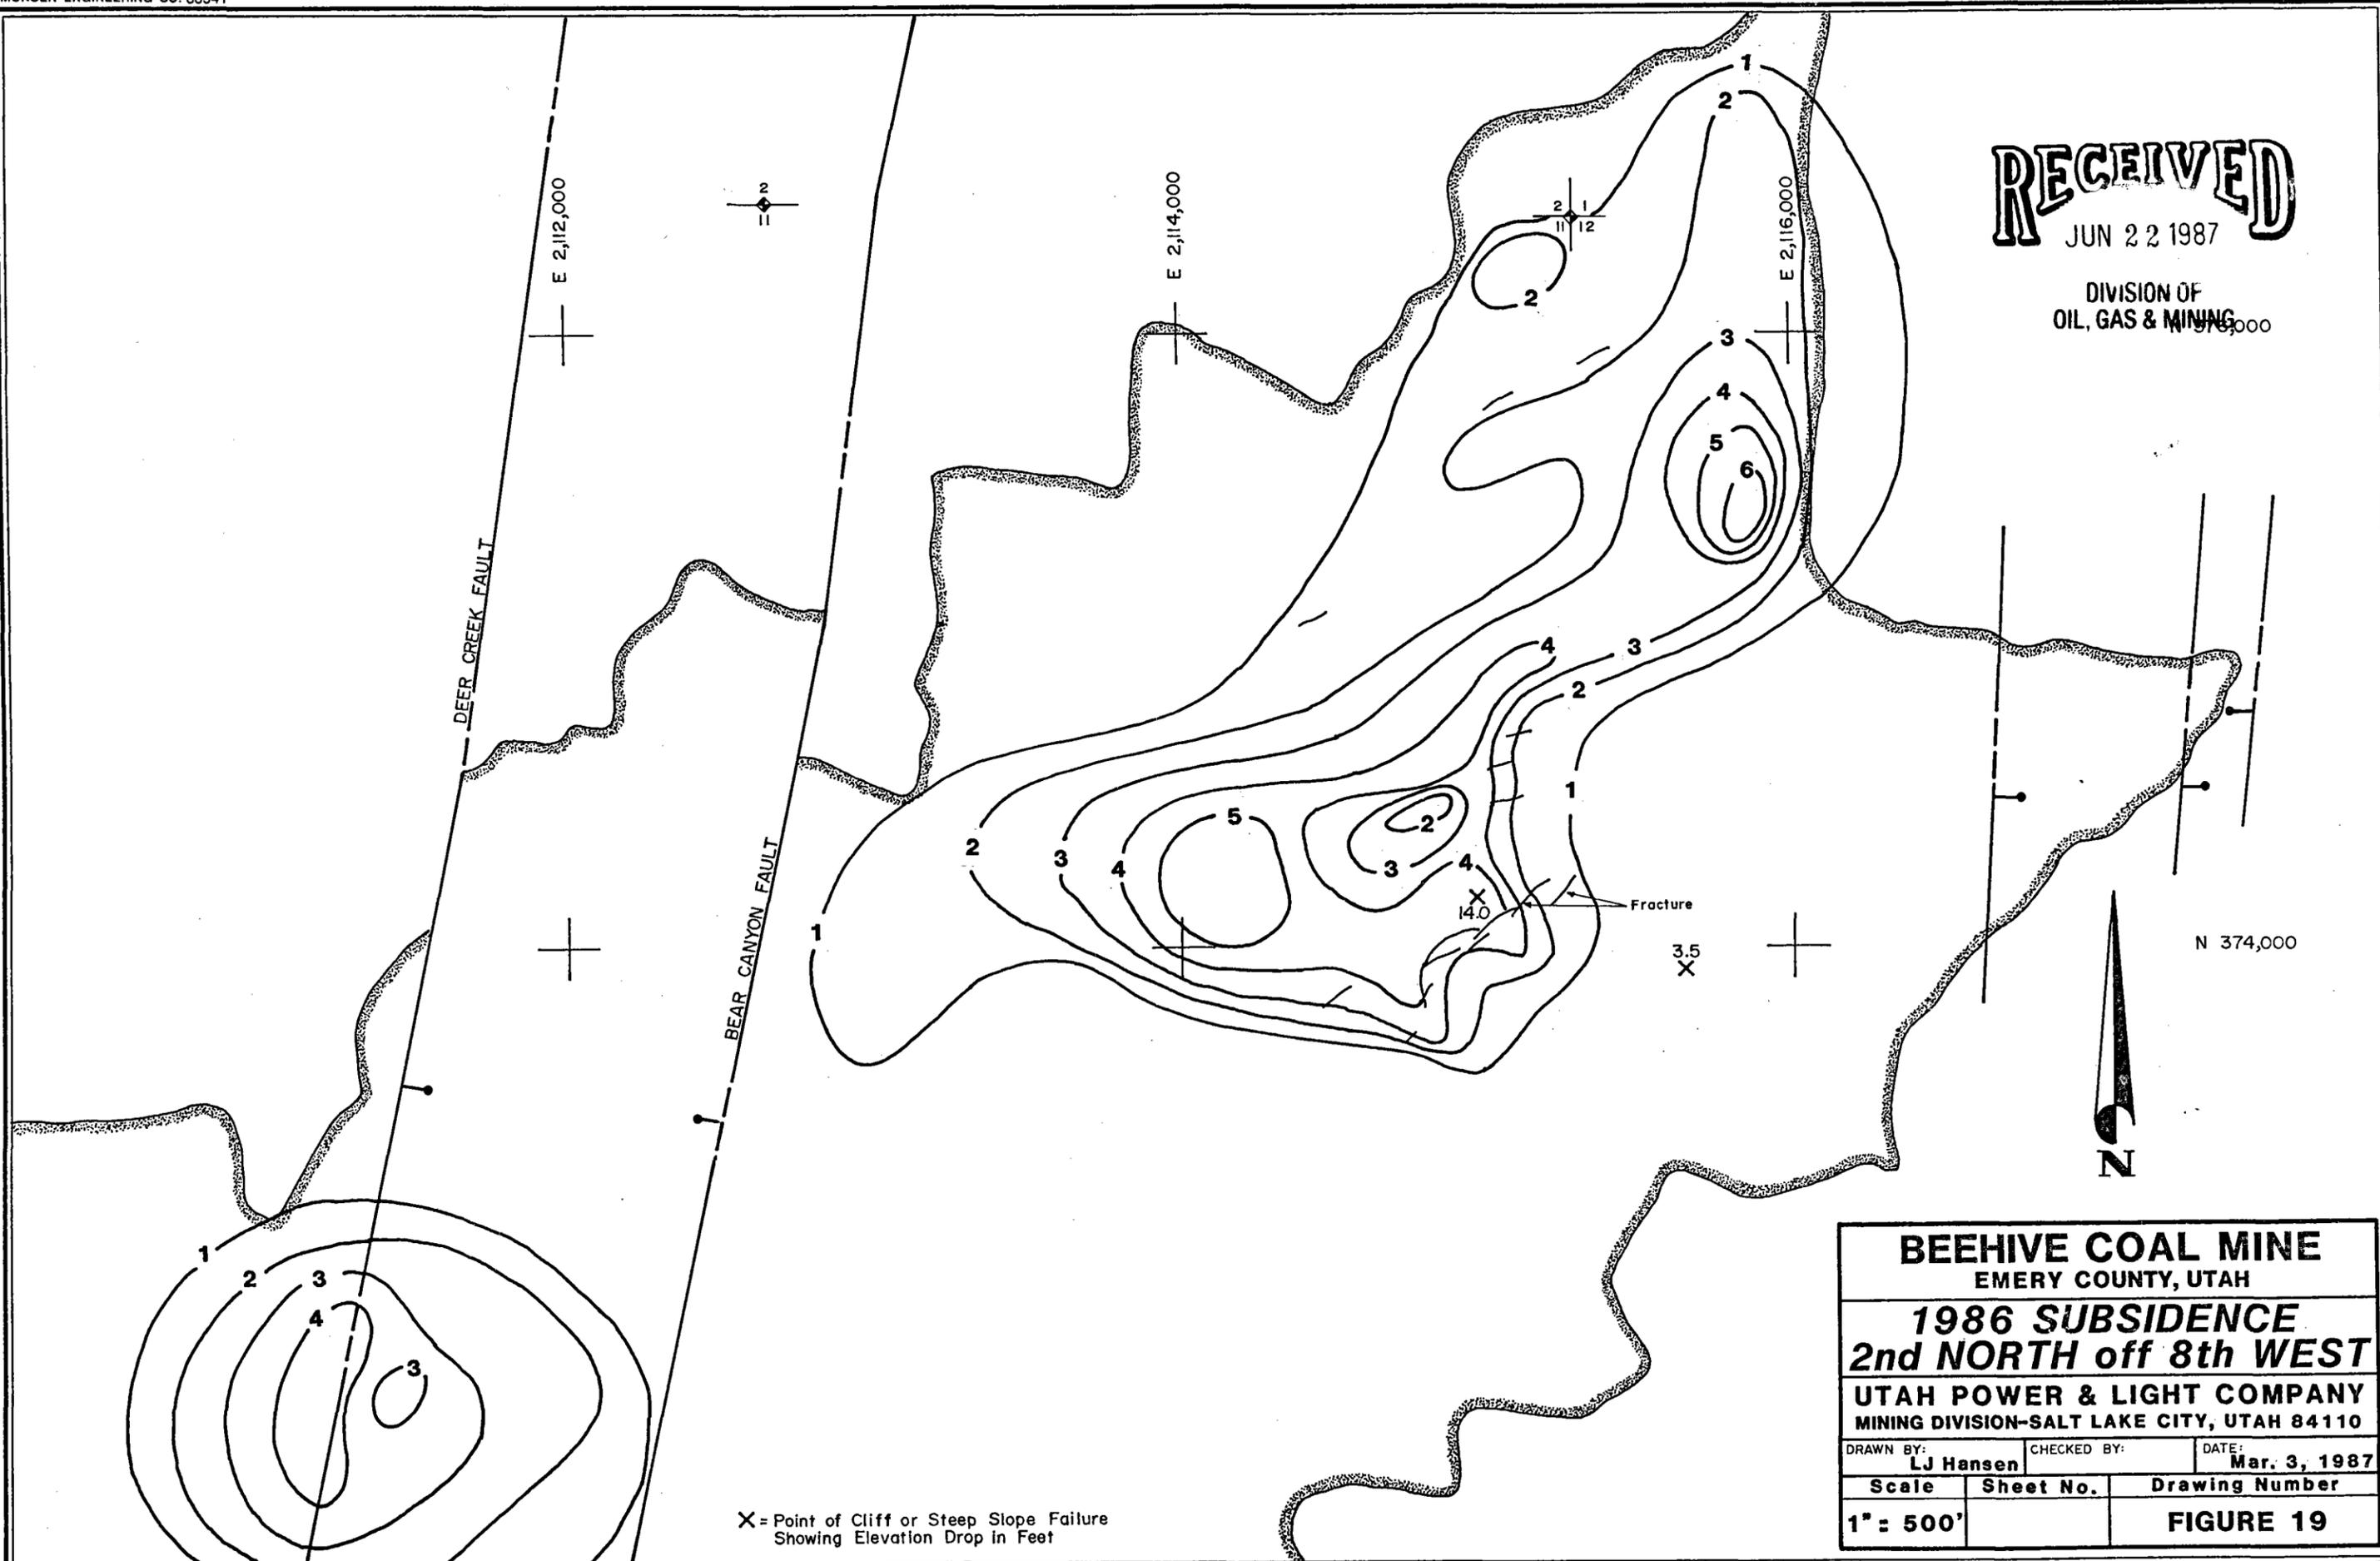
BEEHIVE COAL MINE EMERY COUNTY, UTAH		
1986 SUBSIDENCE 2nd NORTH off 8th WEST		
UTAH POWER & LIGHT COMPANY MINING DIVISION-SALT LAKE CITY, UTAH 84110		
DRAWN BY: LJ Hansen	CHECKED BY:	DATE: Mar. 3, 1987
Scale 1" = 500'	Sheet No.	Drawing Number
FIGURE 19

Since late 1984 little additional subsidence has occurred over the workings. Maximum subsidence reached 6 feet and appears to have stopped. Subsidence in this area will now be monitored every second year instead of annually due to the stabilization. Mass wasting of some type, probably movement of large boulders or blocks of sandstone cliff material (Figure 19), occurred at two locations. The rocks on the ridge overlying the workings were highly fractured prior to mining, and, given the fractured nature of the strata on the surface and the fact that the area overlies burned coal, it is probable that other instances of movement may occur.

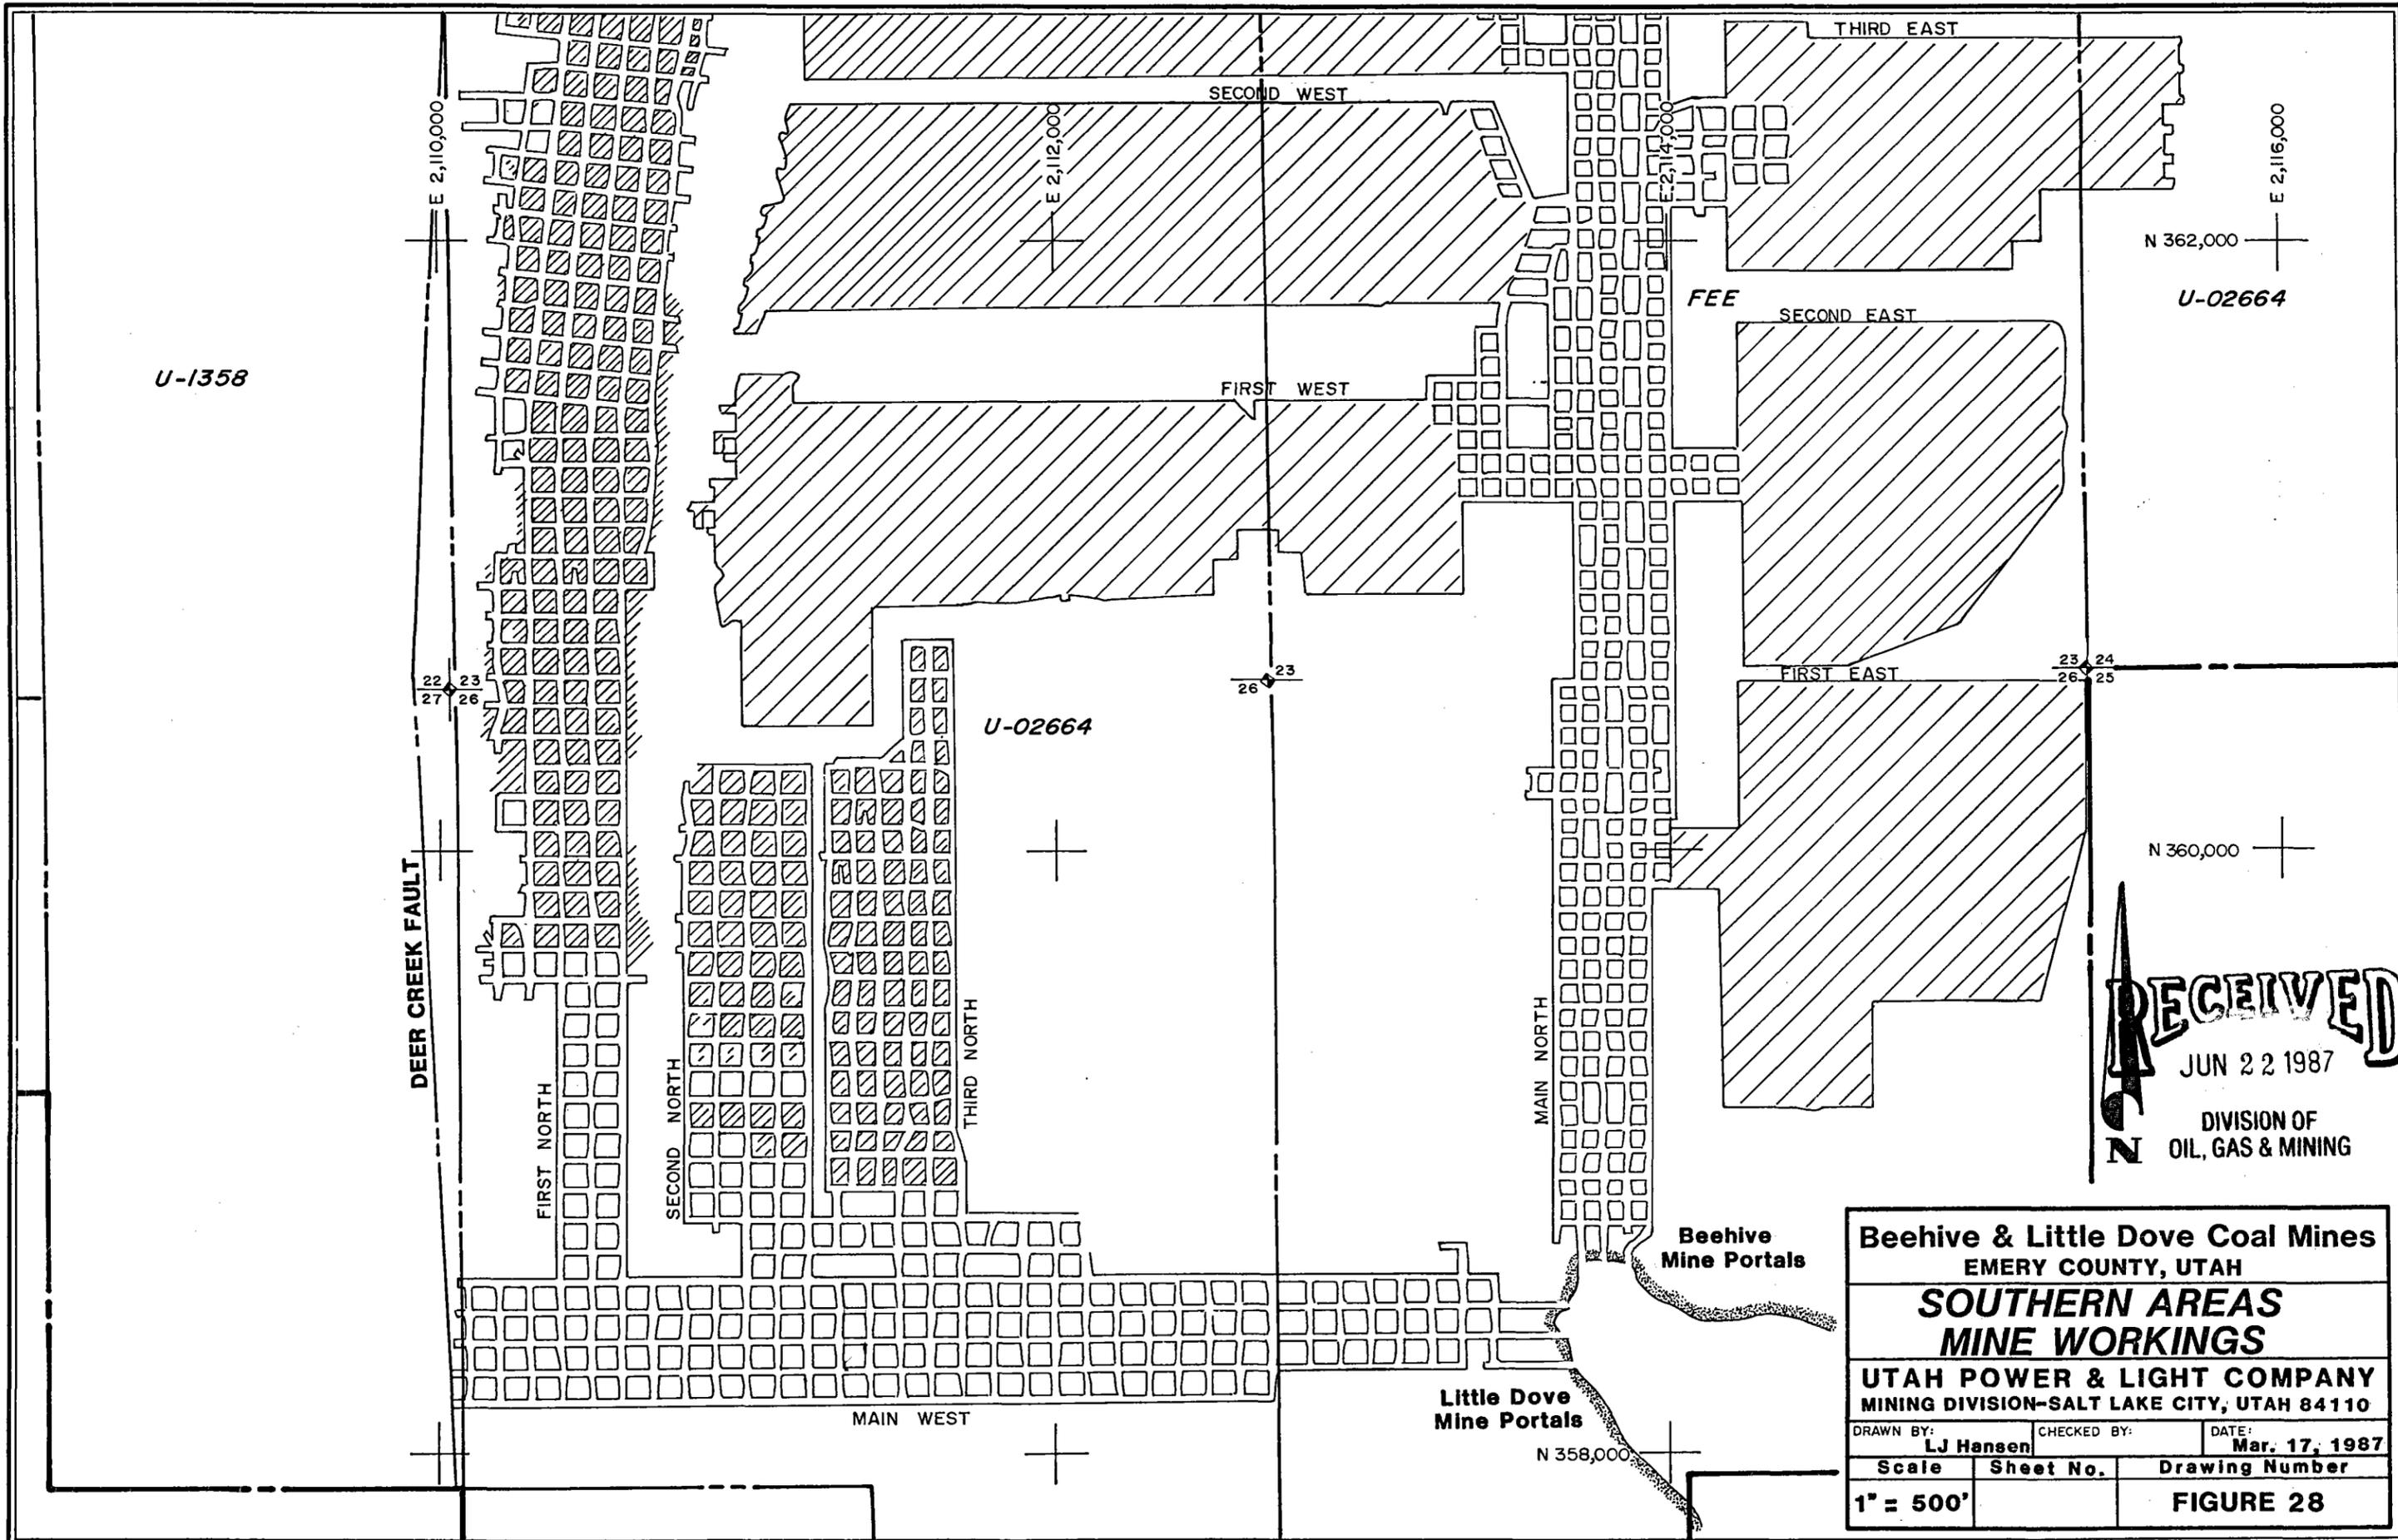
Beehive & Little Dove Coal Mines		
EMERY COUNTY, UTAH		
SOUTHERN AREAS		
MINE WORKINGS		
UTAH POWER & LIGHT COMPANY		
MINING DIVISION-SALT LAKE CITY, UTAH 84110		
DRAWN BY: LJ Hansen	CHECKED BY:	DATE: Mar. 17, 1987
Scale 1" = 500'	Sheet No.	Drawing Number
		FIGURE 28

To date the maximum observed subsidence over 1st North is a little over 3 feet, occurring over some of the most recently extracted pillars (Figures 28 and 30). The remaining portions of the 1st North workings and subsidence can be seen in Figures 21, 22, and 23.

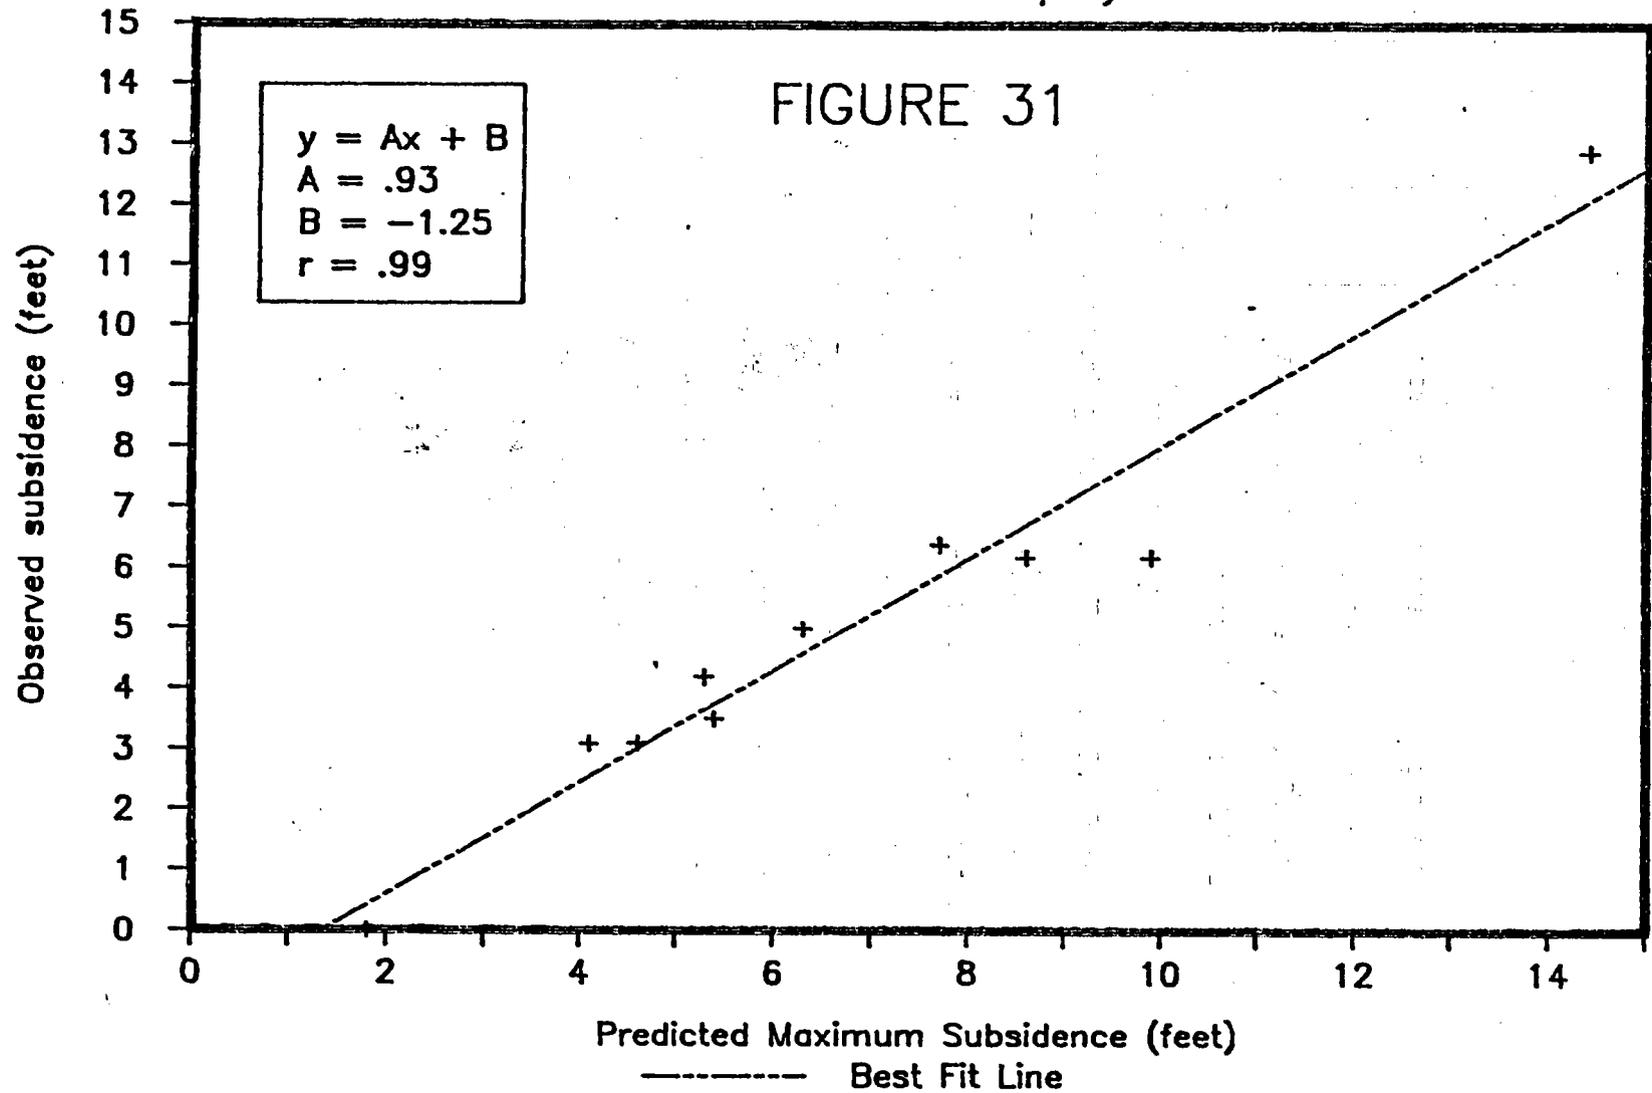
PREDICTED vs OBSERVED SUBSIDENCE

In all areas except one subsidence is less than the maximum predicted by the NCB model. This may be due to the fact that in some areas, such as C North, mining occurred very recently and subsidence has not yet reached its maximum. It could also be that the observed subsidence shown here represents the actual maximum subsidence for these particular geologic conditions. We believe this to be the case since subsidence appears to have ceased in several areas where the NCB predicted maxima were not reached. Figure 31 shows the relationship between predicted and observed subsidence. From the slope of the regression line ($A = .93$) the average observed subsidence is 93% of the NCB predicted maximum.

The one anomalous area is the DC 9th East - Wilberg 1st Right area. This case does not fit the special conditions necessary for prediction by the NCB method. The mine workings there are surrounded by burned coal and bounded on the east by the Deer Creek Fault. As mentioned before, crushing of clinker beds and movement along the fault have added another complication to the subsidence. The maximum subsidence in this area occurs on a steep slope below a cliff, where slumping has occurred. The 25.2 feet measured here is due in part to mass wasting on the steep slope.
