UTAH POWER & LIGHT COMPANY
SUBSIDENCE MONITORING PROGRAM
ANNUAL REPORT FOR 1987

June 1988

UTAH POWER & LIGHT COMPANY
SUBSIDENCE MONITORING PROGRAM
ANNUAL REPORT FOR 1988

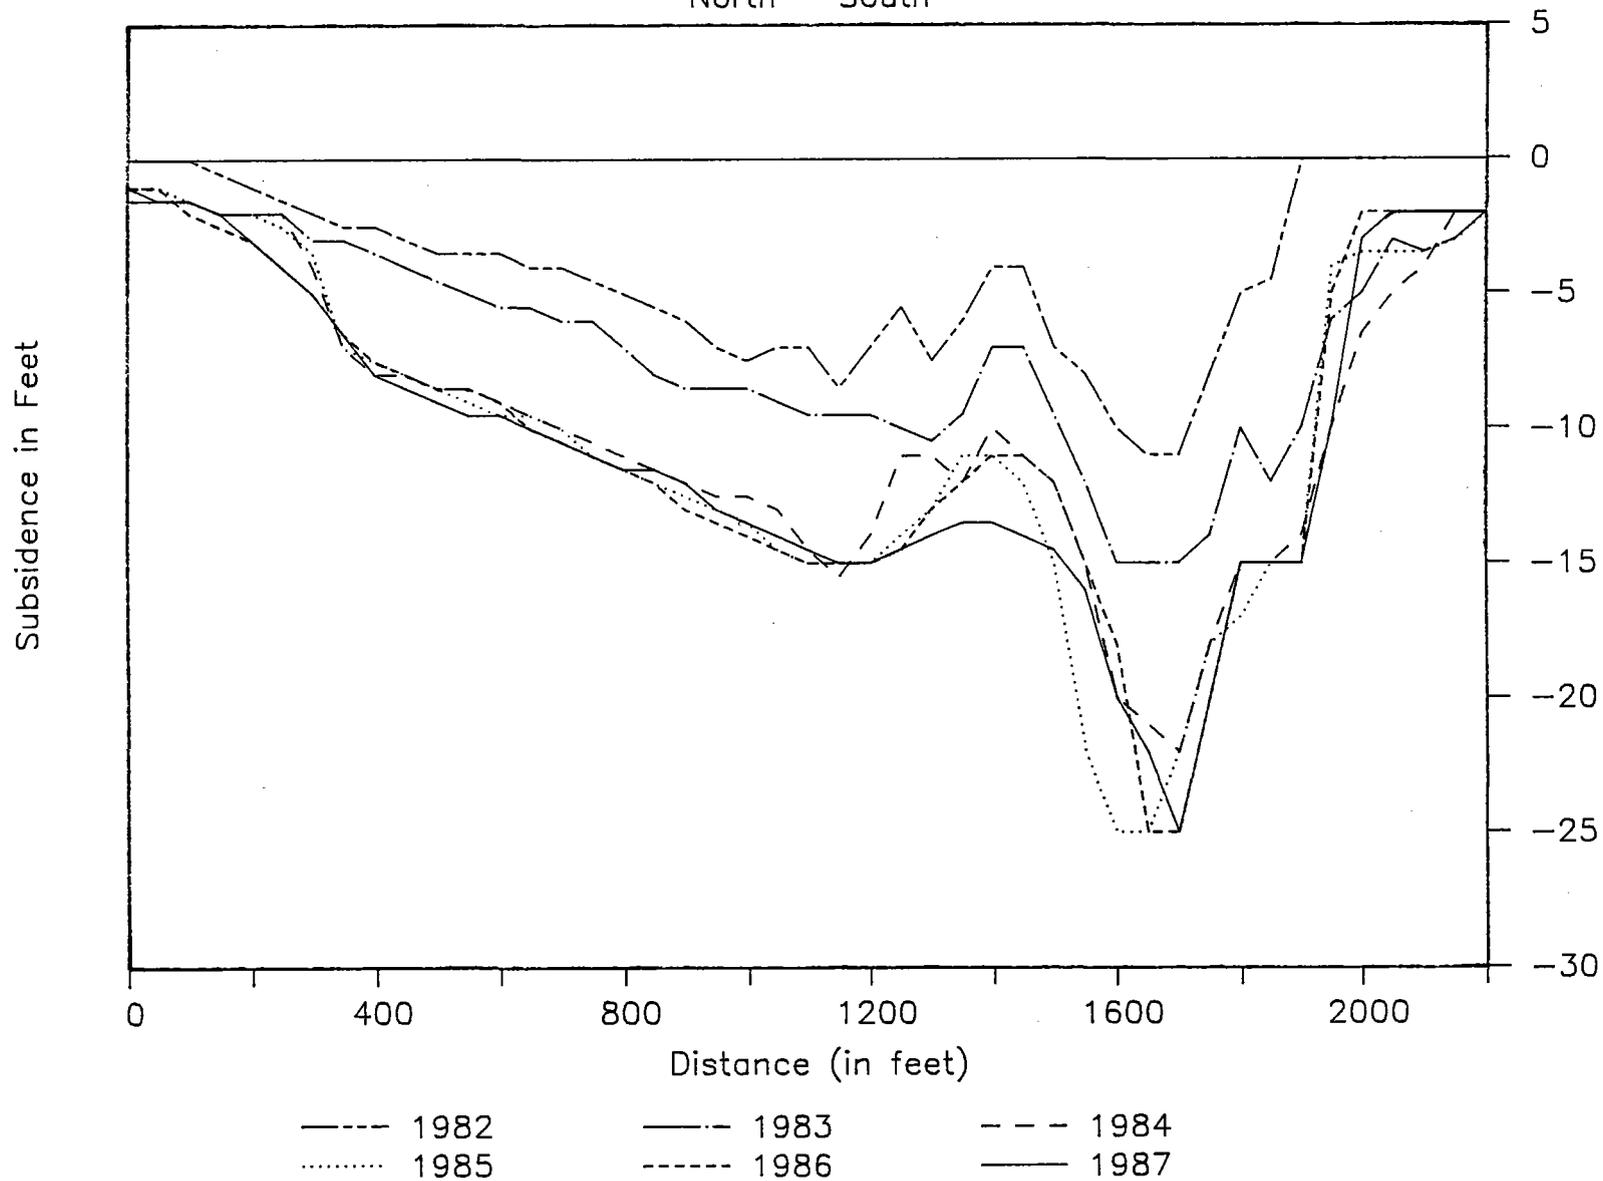
FIGURE 6

Figures 6 and 7 are north to south and west to east profiles showing the amount of subsidence in this area during the past six years. The location of each line is shown on Figure 5. The area has seen little change since 1985. Only in the location where maximum subsidence occurs was there a further drop in the surface, from twenty-five (25) to nearly twenty-eight (28) feet of subsidence; the rest of the area appears to have stabilized. A detailed look from a helicopter revealed that the subsidence maximum is located on a steep slope, about 200 feet south of the southernmost mining, where a good sized rotational slump has occurred. The workings here are also surrounded by burned coal. It is probable that the combination of steep slopes and crushing of clinker beds has allowed subsidence to occur well outside the area of mine workings. An inspection of the area from the ground indicates that many of the open fractures forming the graben-like structure have begun to heal and fill in with soil.

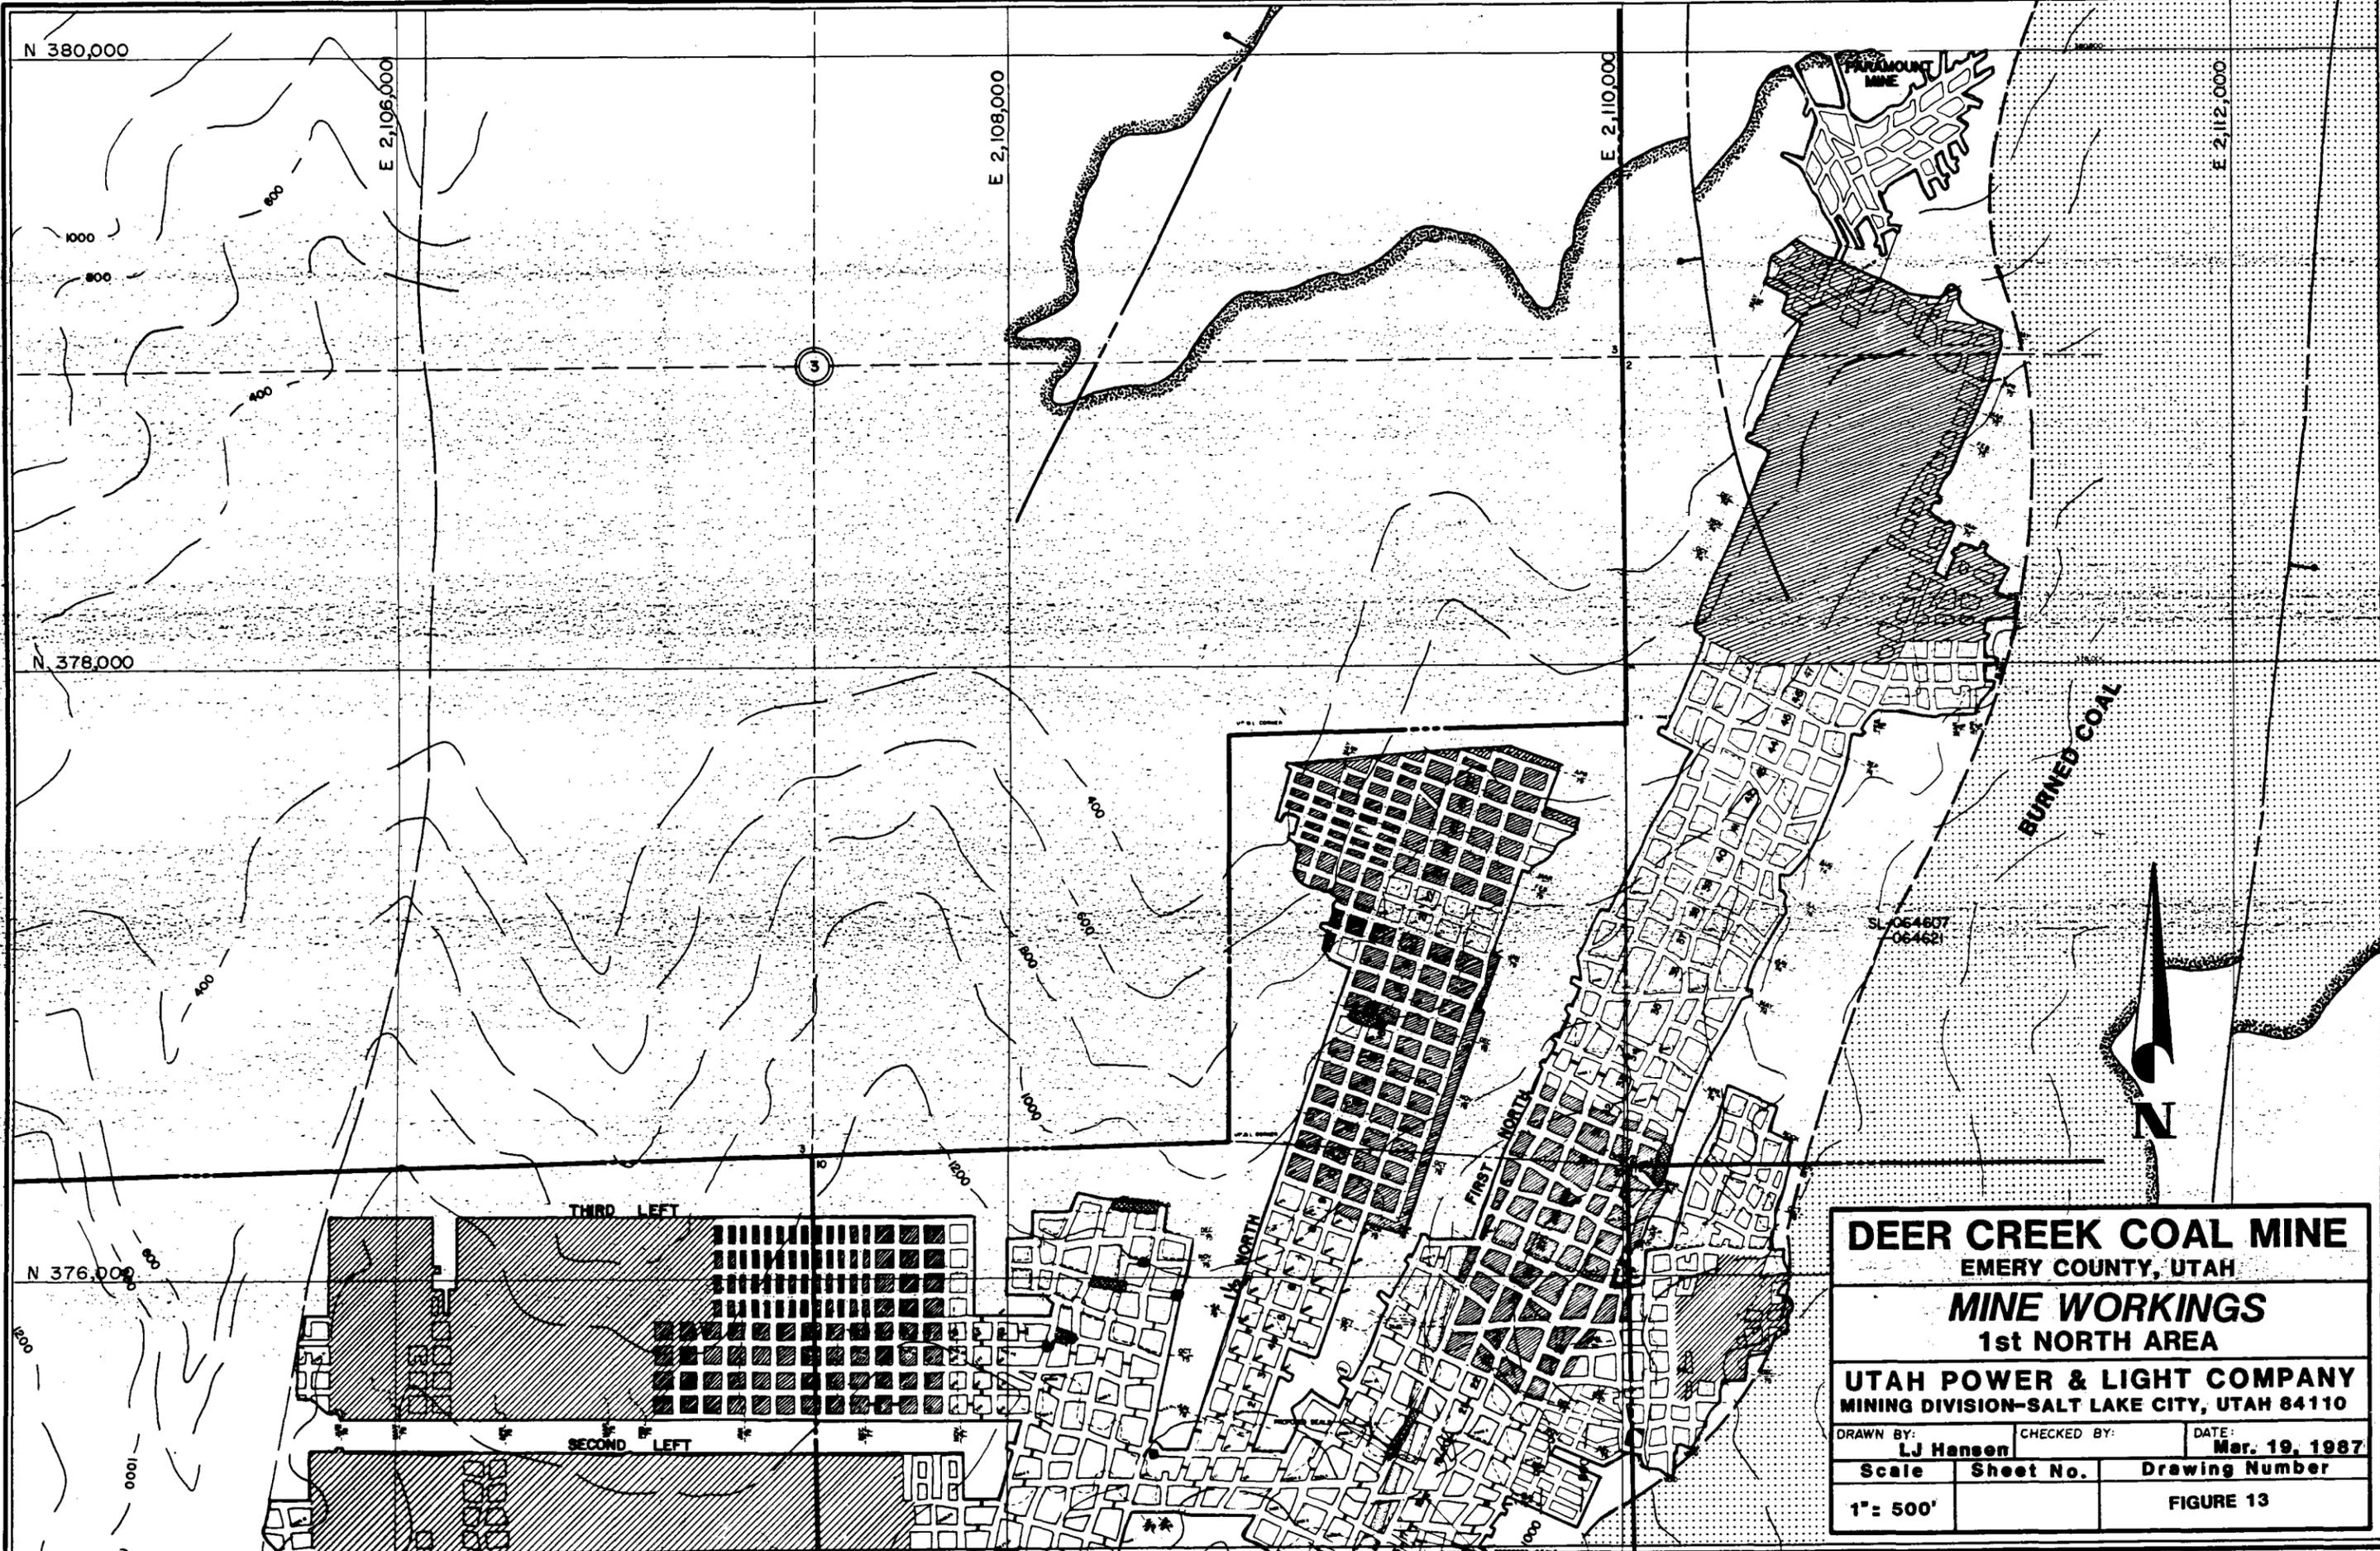
DEER CREEK COAL MINE		
EMERY COUNTY, UTAH		
MINE WORKINGS		
1st NORTH AREA		
UTAH POWER & LIGHT COMPANY		
MINING DIVISION-SALT LAKE CITY, UTAH 84110		
DRAWN BY: LJ Hansen	CHECKED BY:	DATE: Mar. 19, 1987
Scale 1" = 500'	Sheet No.	Drawing Number FIGURE 13

Most of the 1st North section of the Deer Creek Mine was abandoned and sealed in 1978 after being mined out. The southern portion is still open and may be used for access to a block of coal which lies to the west. Pillar extraction in the 3rd Left and 1½ North sections was completed early in 1980. The greatest subsidence observed over the area is 2.6 feet and occurred over a pillared-out section along the eastern side of the workings (Figure 13).

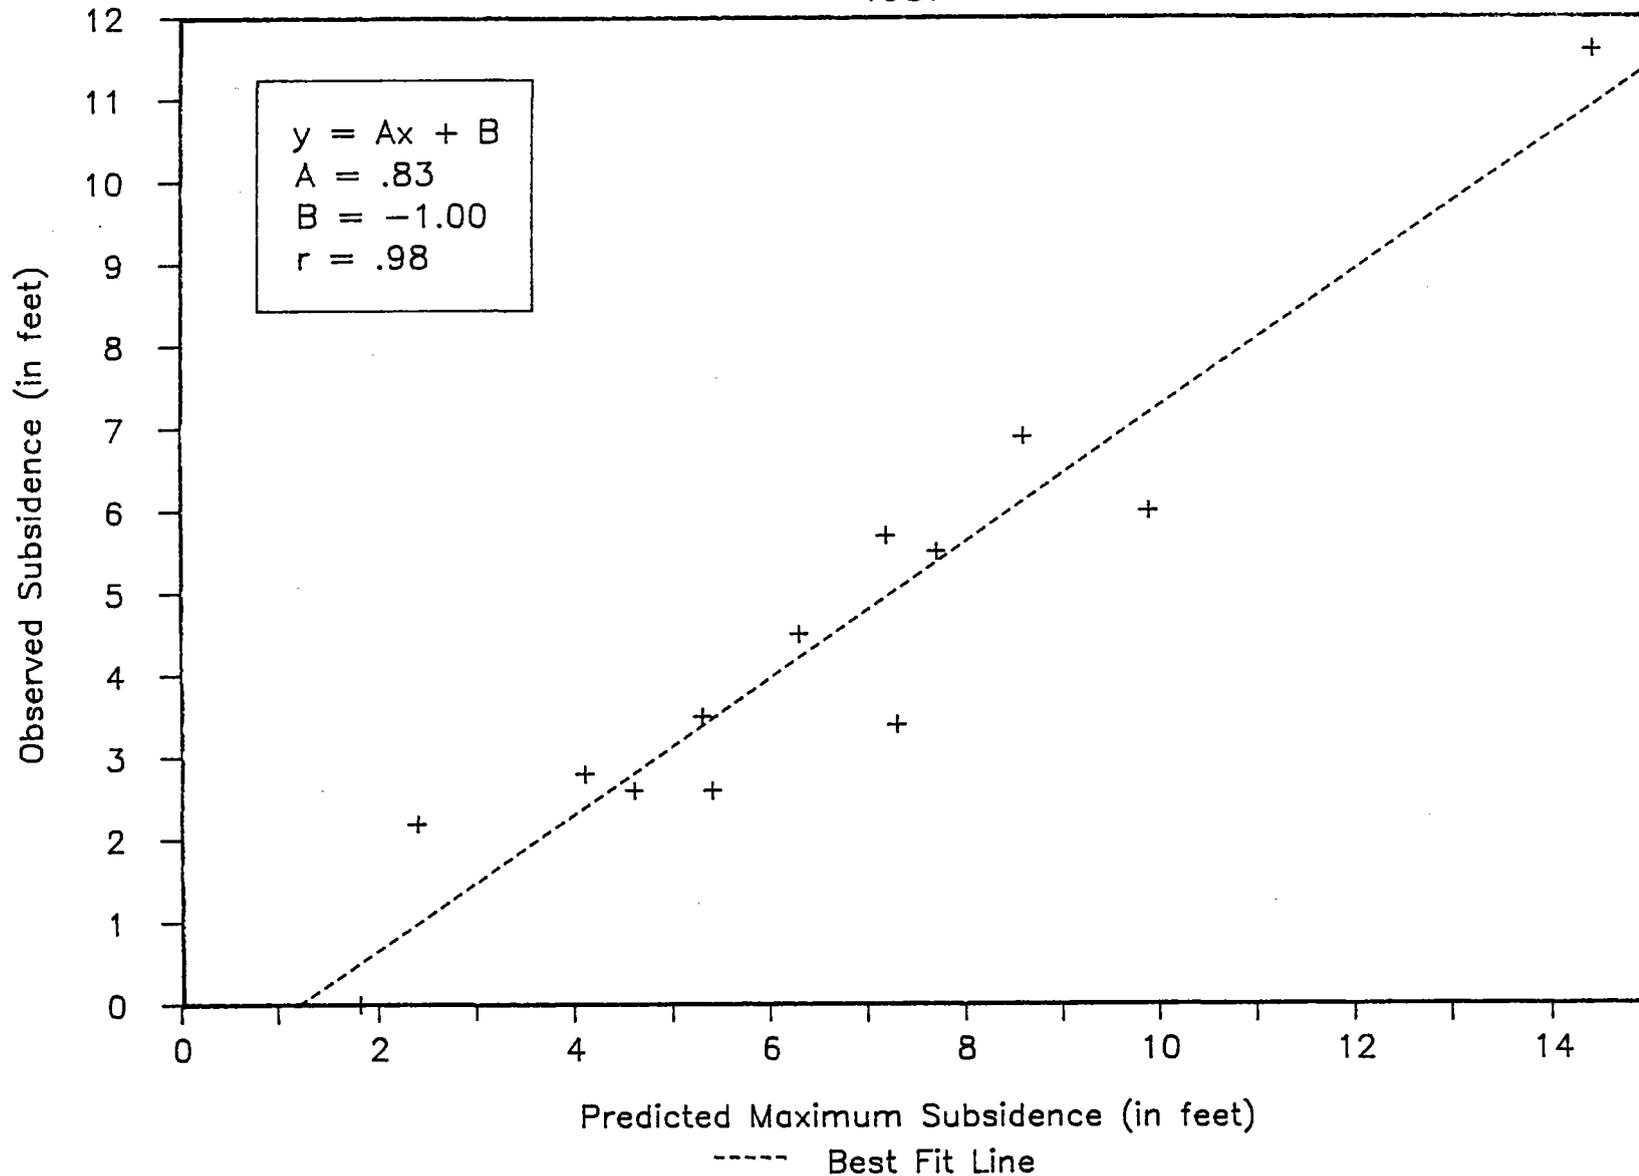
FIGURE 41

In all areas except one subsidence is less than the maximum predicted by the NCB model, possibly due to the fact that in some areas (such as C North) mining occurred very recently and subsidence has not yet reached its maximum. It could also be that the observed

subsidence shown here represents the actual maximum subsidence for the particular geologic conditions -- probably the case in some areas since subsidence appears to have ceased in several areas where the NCB predicted maxima were not reached. Figure 41 shows the relationship between predicted and observed subsidence. From the slope of the regression line ($A = .83$) the average observed subsidence is eighty-three percent (83%) of the NCB predicted maximum. (Area 1 excluded from graph data.)

Area 1 (DC 9th East - Wilberg 1st Right) is the one anomalous area; it does not fit the special conditions necessary for prediction by the NCB method. The mine workings are surrounded by burned coal and bounded on the east by the Deer Creek Fault. As mentioned before, crushing of clinker beds and movement along the fault have added another complication to the subsidence. The maximum subsidence in the area occurs on a steep slope below a cliff, where slumping has occurred. The twenty-eight (28) feet measured here must be due in part to mass wasting on the steep slope.

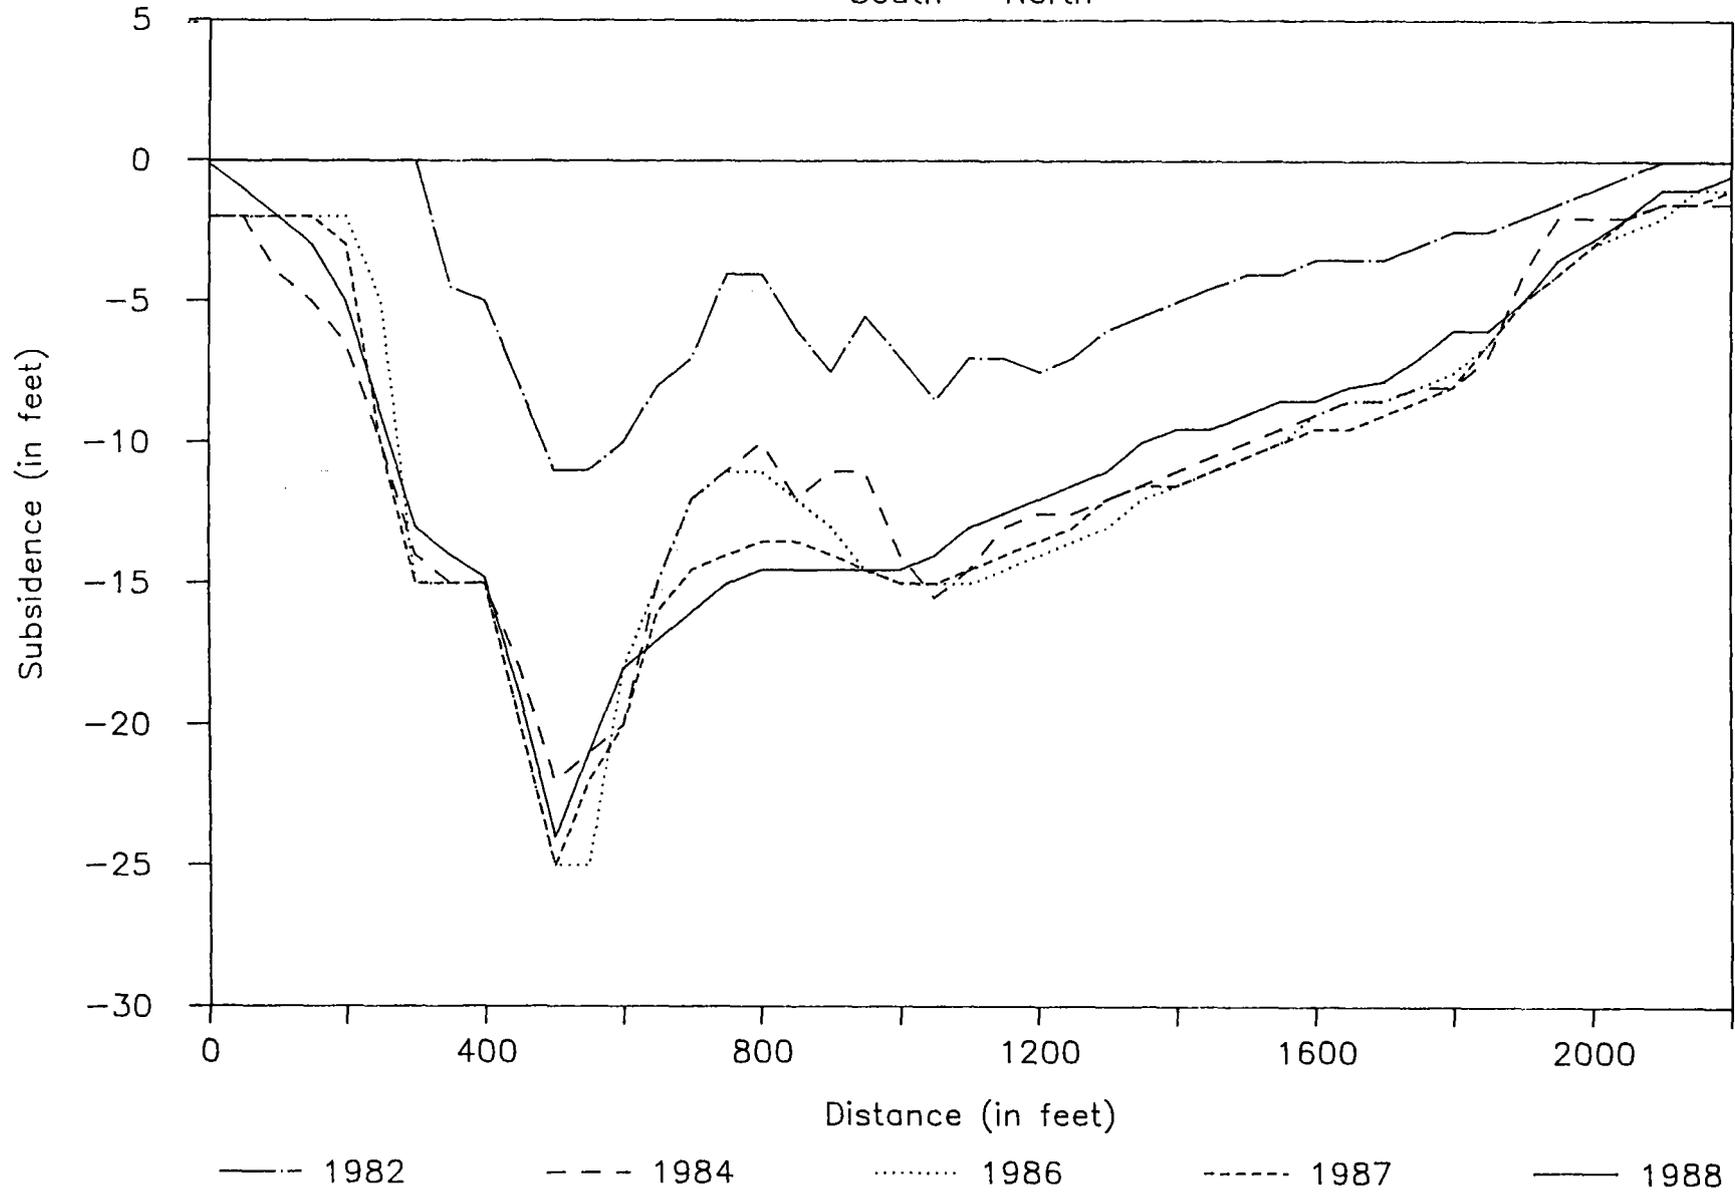
FIGURE 6

Figures 6 and 7 are north to south and west to east profiles showing the amount of subsidence in this area during the past seven years. The location of each line is shown on Figure 5. The area has seen little change since 1985. Maximum subsidence remains at about twenty-five (25) feet. A detailed look from a helicopter revealed that the subsidence maximum is located on a steep slope, about 200 feet south of the southernmost mining, where a good-sized rotational slump has occurred. The workings here are also surrounded by burned coal. It is probable that the combination of steep slopes and crushing of clinker beds has allowed subsidence to occur well outside the area of mine workings. An inspection of the area from the ground indicates that many of the open fractures forming the graben-like structure have begun to heal and fill in with soil.

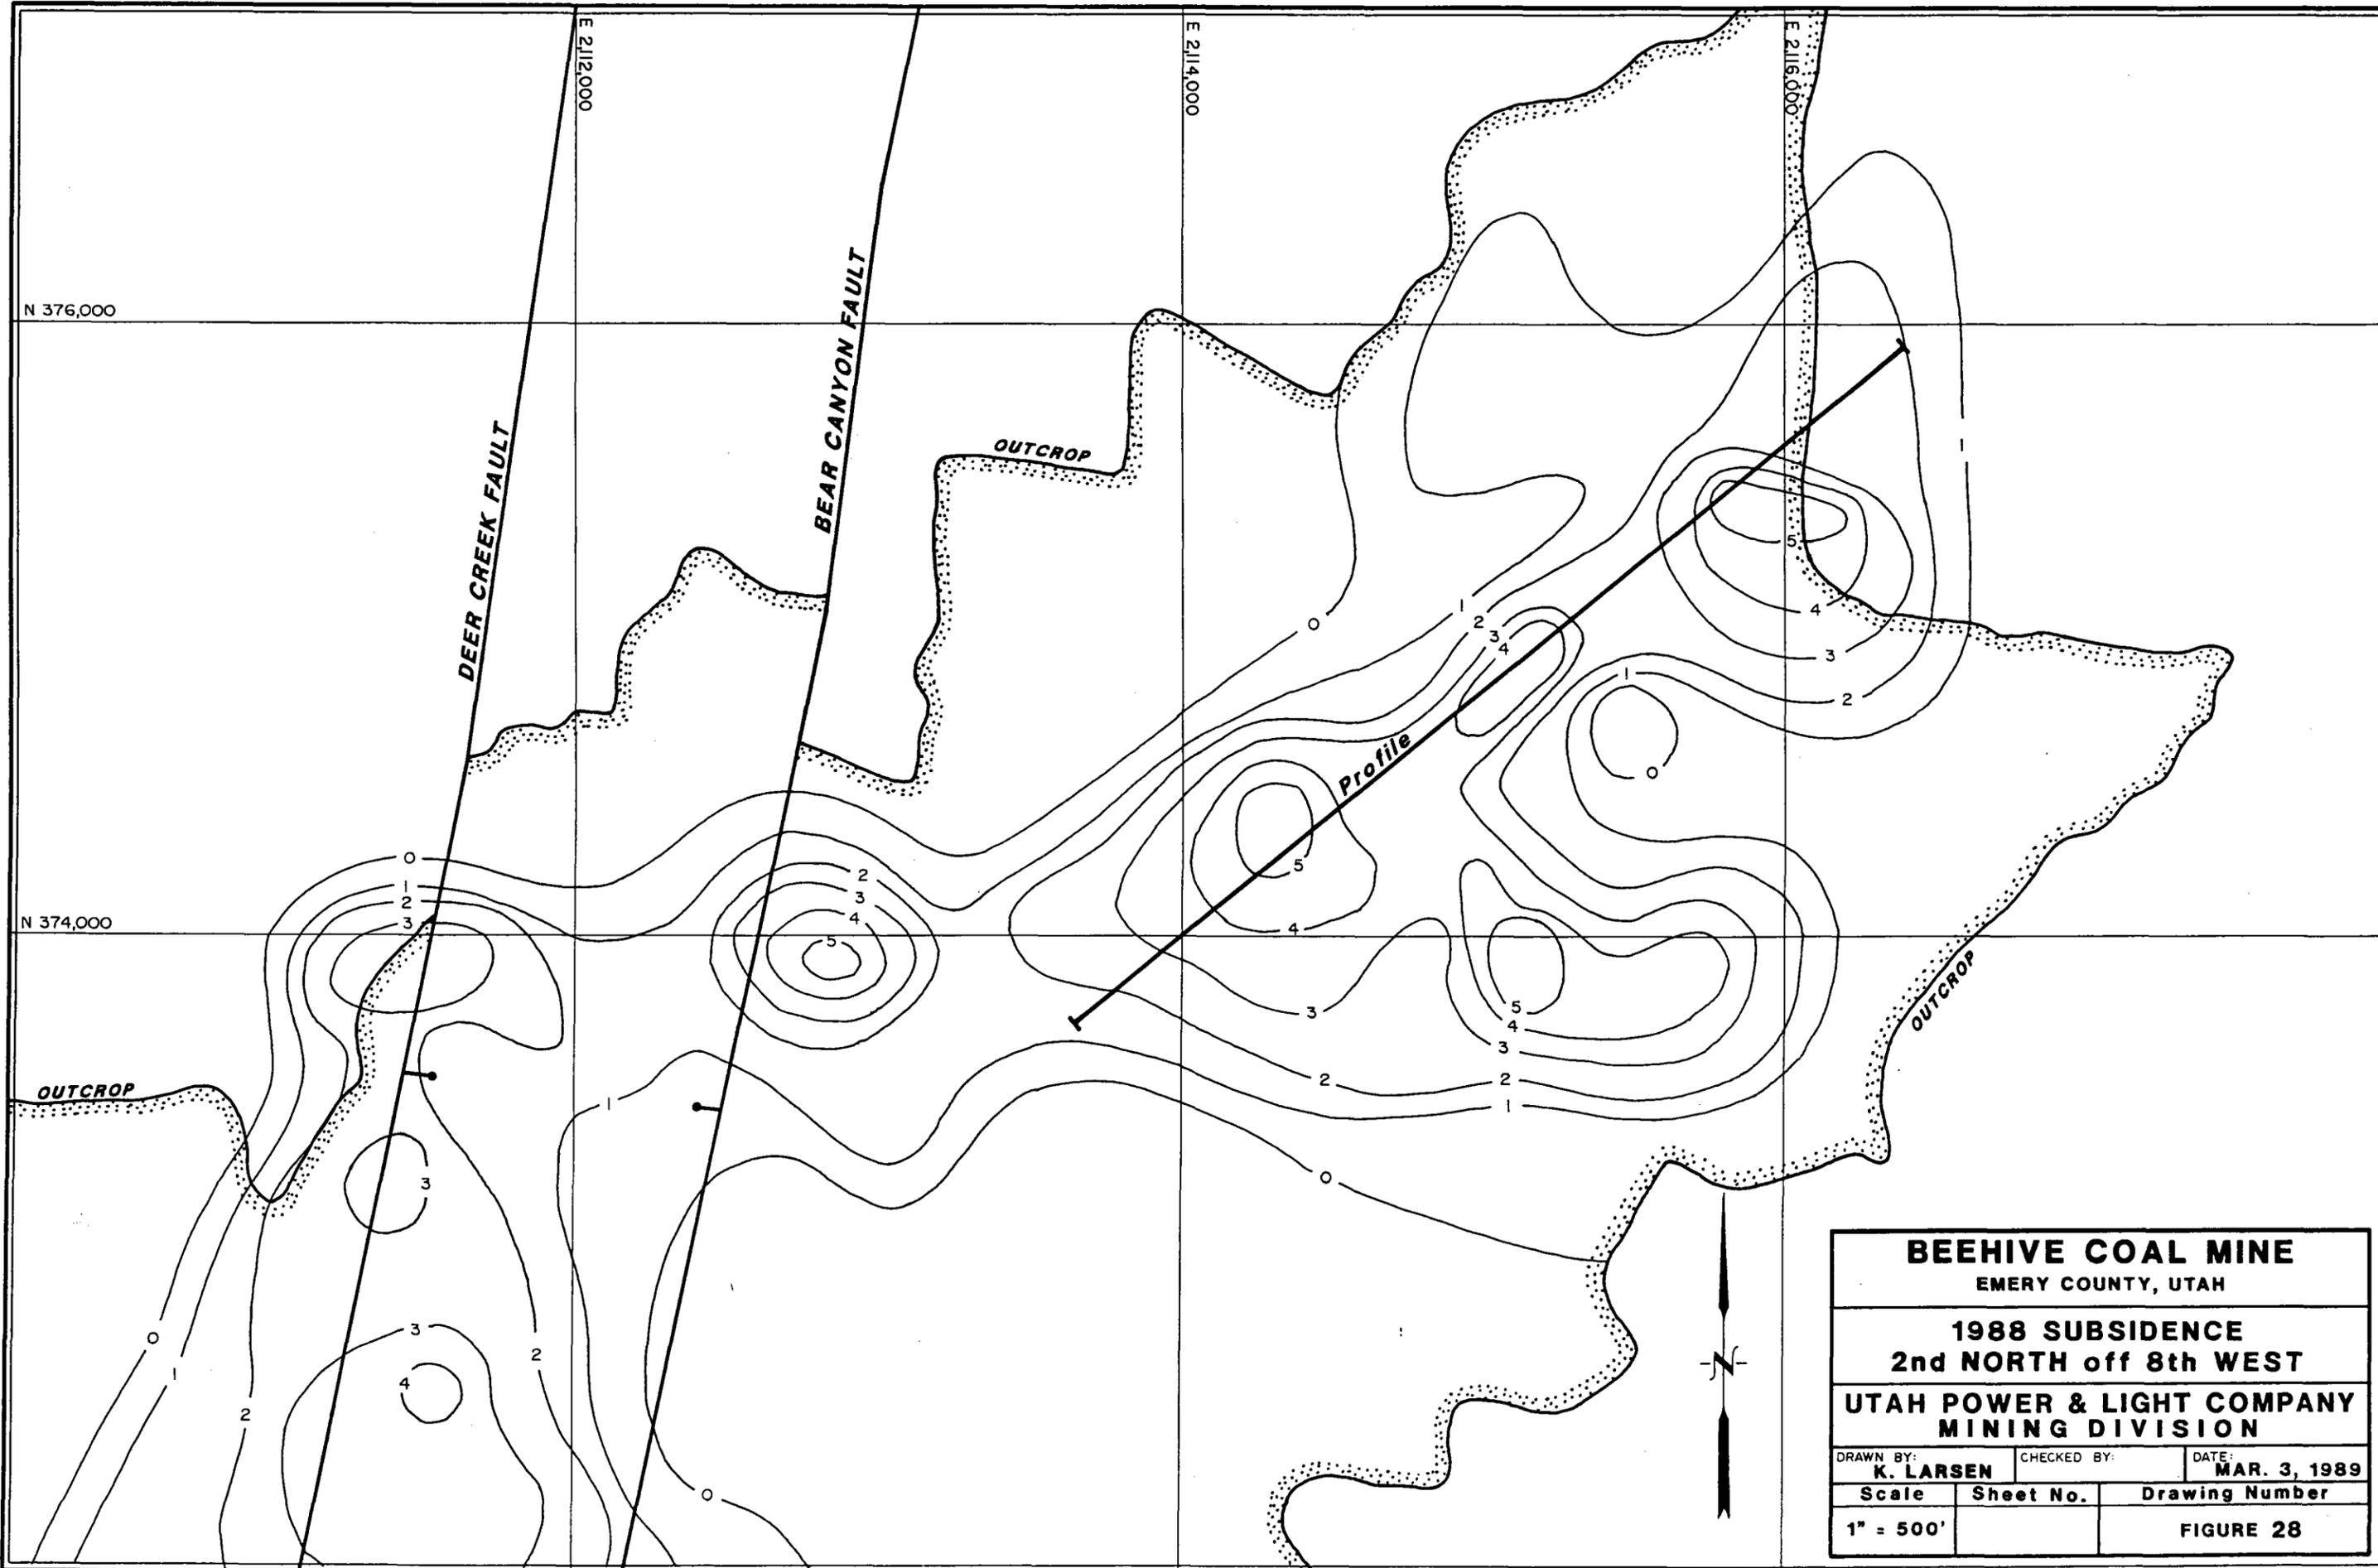
BEEHIVE COAL MINE		
EMERY COUNTY, UTAH		
1988 SUBSIDENCE		
2nd NORTH off 8th WEST		
UTAH POWER & LIGHT COMPANY		
MINING DIVISION		
DRAWN BY: K. LARSEN	CHECKED BY:	DATE: MAR. 3, 1989
Scale	Sheet No.	Drawing Number
1" = 500'		FIGURE 28

Pillar extraction mining in 2nd North was completed in 1983 and, as shown in Figures 28 and 29, little additional subsidence has occurred over the workings since 1984. Subsidence remains at about six (6) feet and, owing to this stability, we also wish to discontinue annual monitoring of this area. For a more complete discussion of subsidence in Area 7, consult the 1986 or a previous report.
