## Area 9

### Little Dove 1st North

### Deer Creek C and D North Longwall Panels and Adjacent Sections

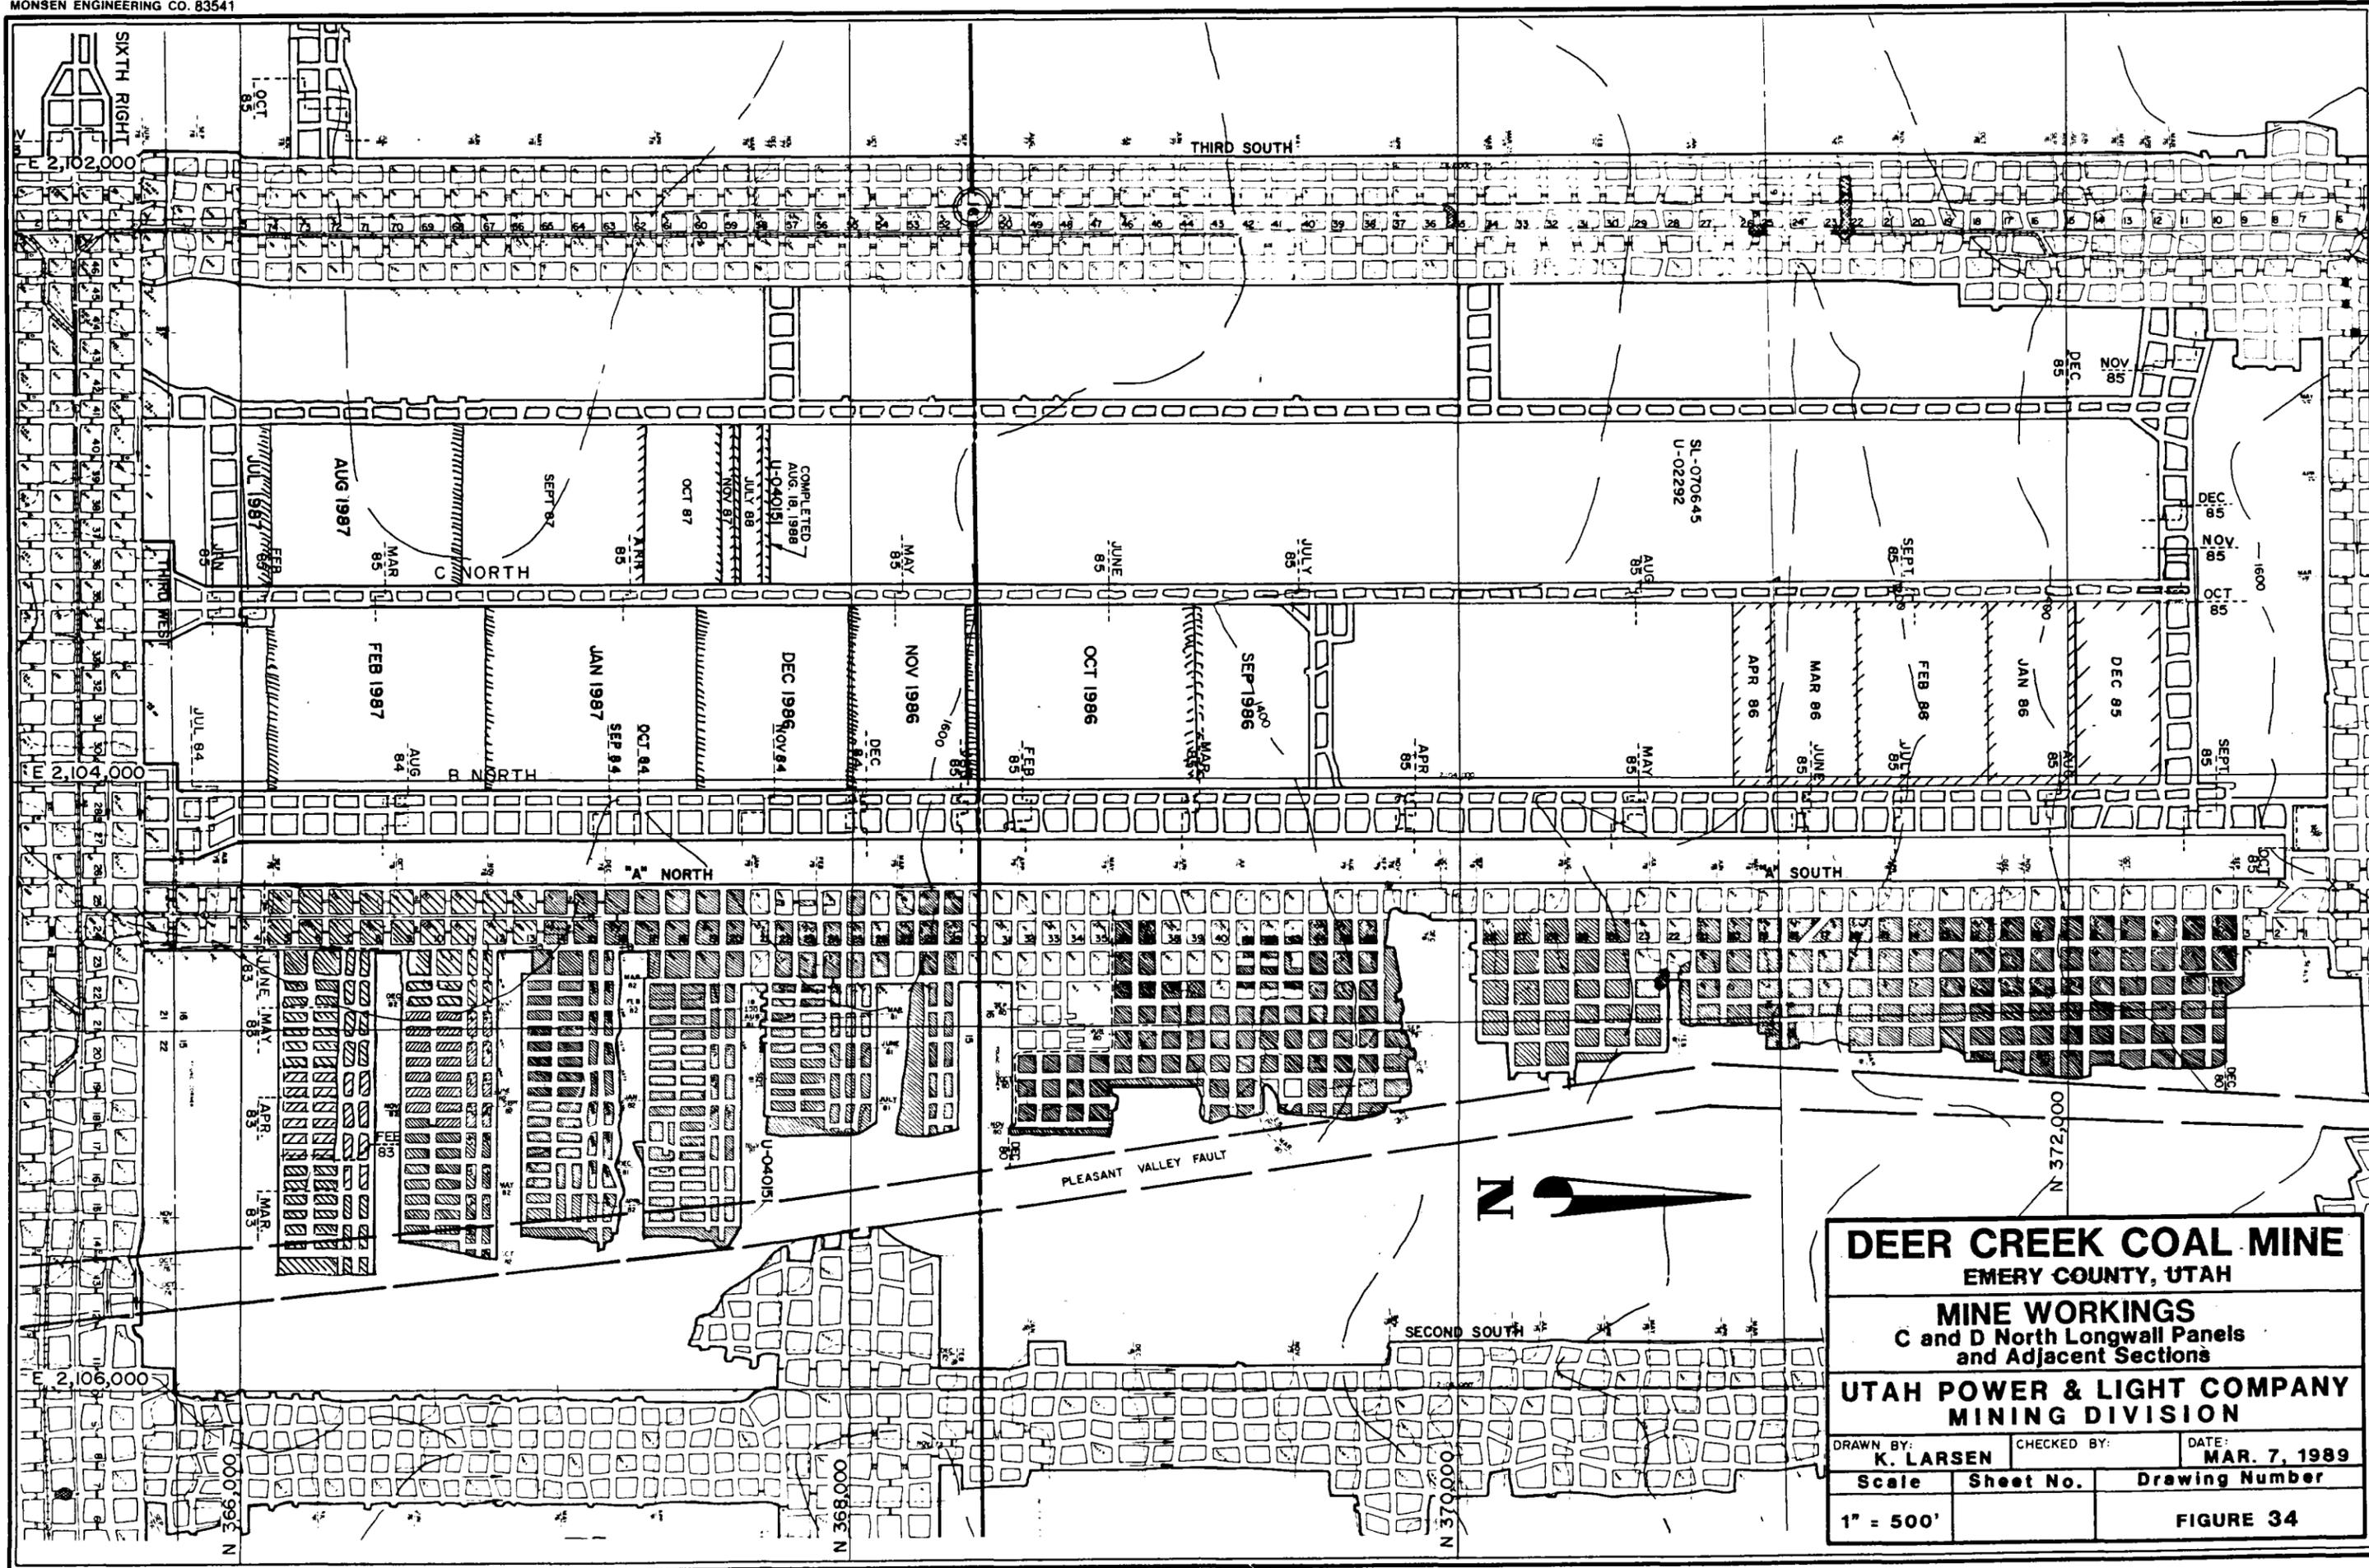
Longwall mining in the C North panel began in December 1984 and was terminated in April 1986 due to geologic complications. New setup entries were driven further south and mining resumed in September 1986; the panel was completed in March 1987. The D North longwall panel began production in July 1987, but after October 1987 production was limited due to poor coal quality. The panel was terminated in August 1988 at a length of 1750 feet. Pillar extraction mining in A North and A South was completed in June 1983 (Figure 34). Measurable subsidence to date has reached six (6) feet over C North and a little more than four (4) feet over the room-and-pillar sections (Figures 35, 36, and 37).

No fractures or disturbance of the surface of the area has been observed. The angle-of-draw measured ranges from less than zero to 28 degrees.

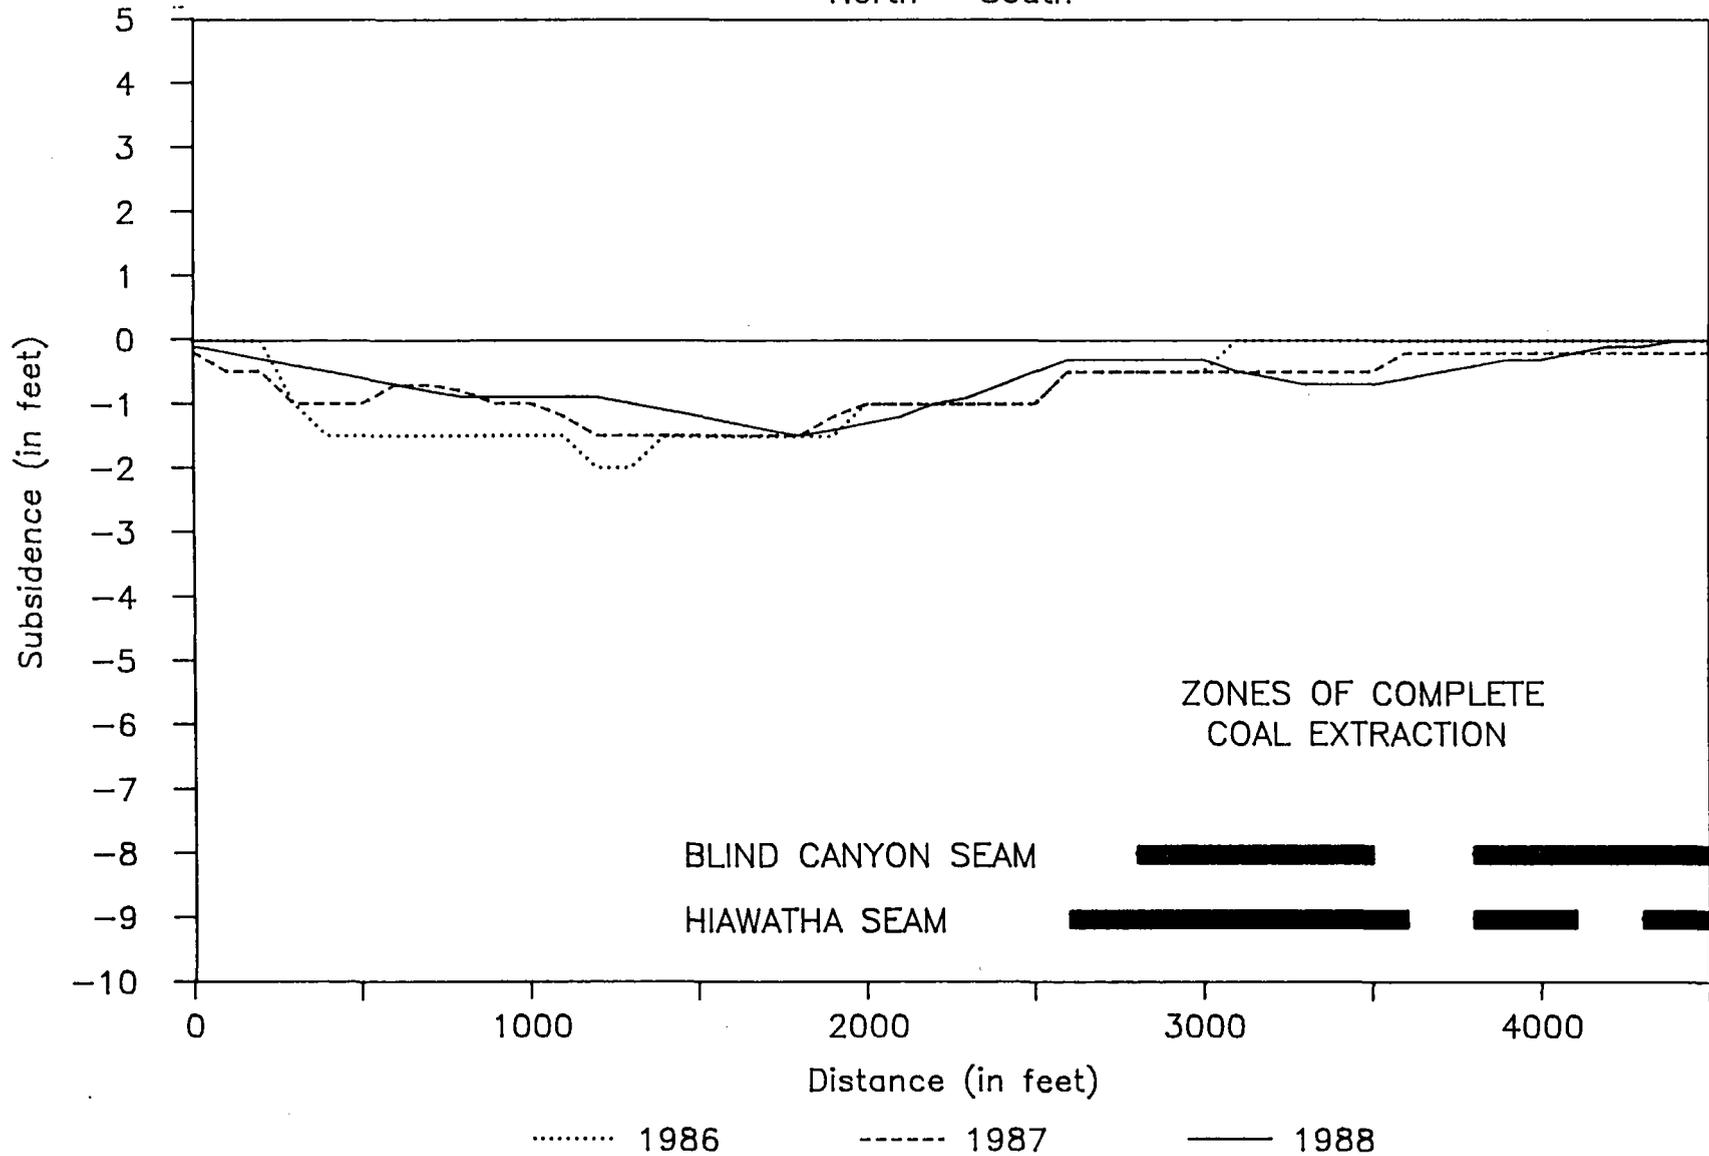
**FIGURE 40**

Maximum subsidence over the area as of August 1988 was about two (2) feet (Figures 40 and 41).

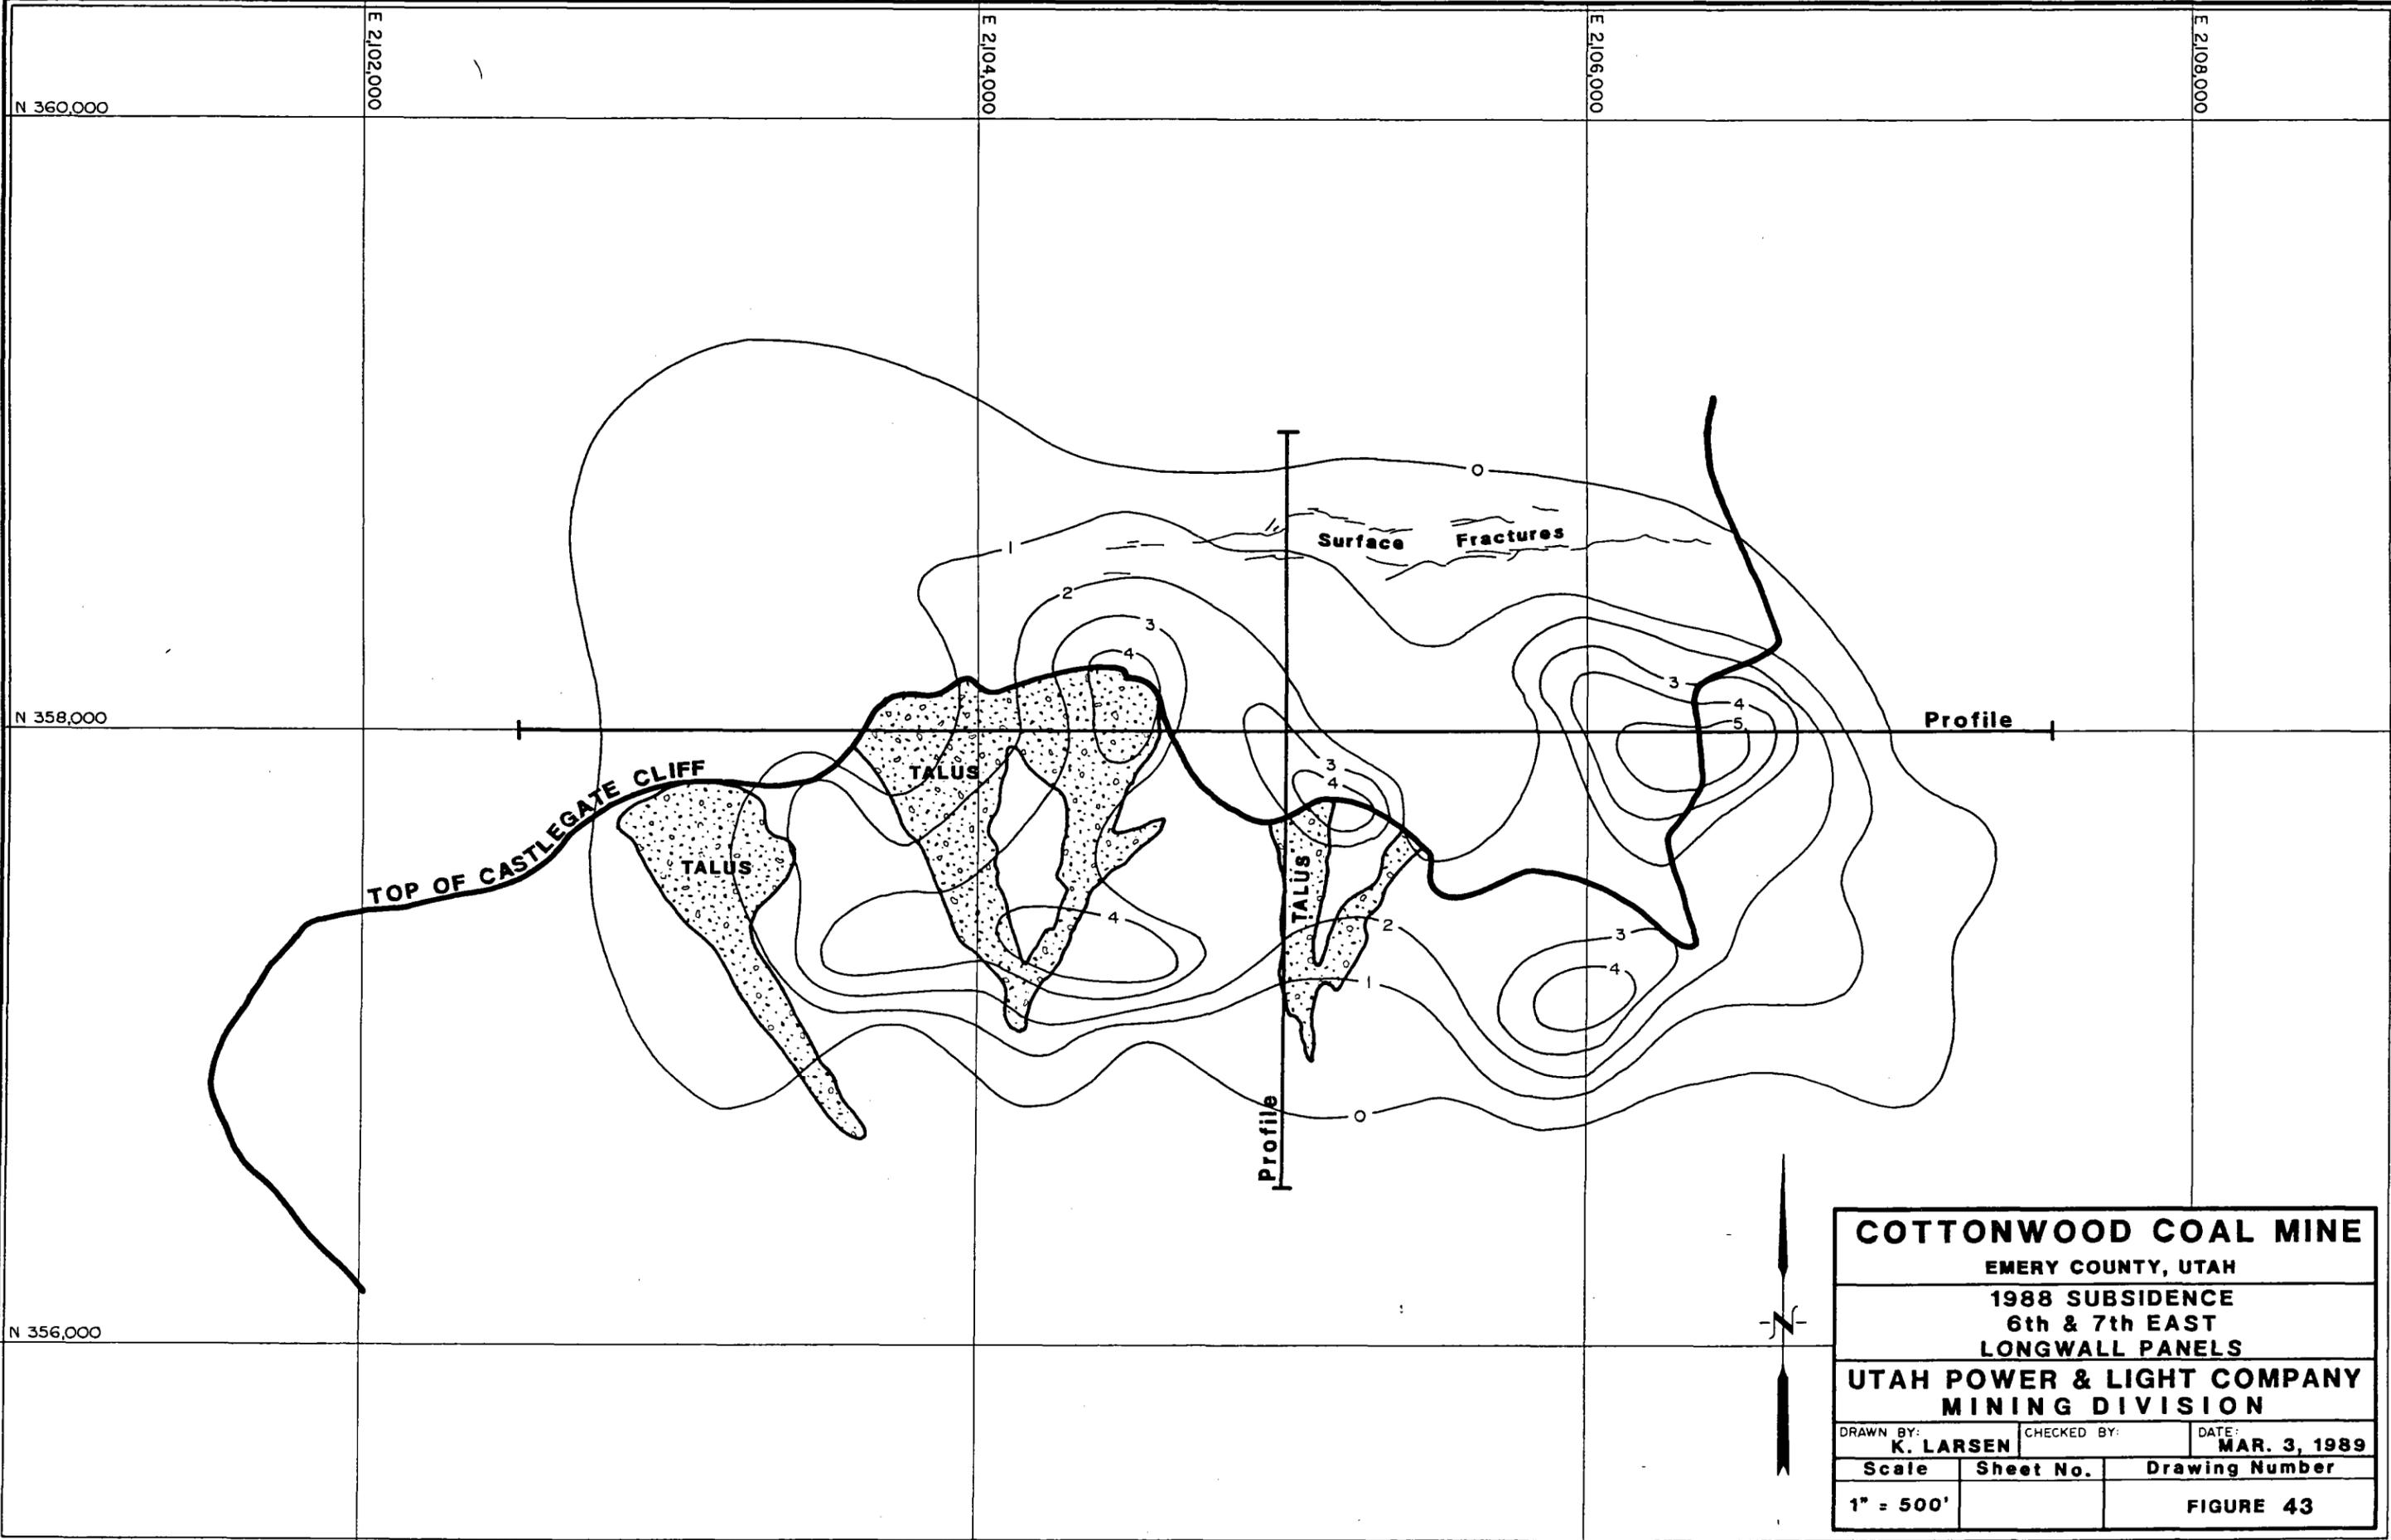
<b>COTTONWOOD COAL MINE</b>		
EMERY COUNTY, UTAH		
1988 SUBSIDENCE		
6th & 7th EAST		
LONGWALL PANELS		
<b>UTAH POWER &amp; LIGHT COMPANY</b>		
<b>MINING DIVISION</b>		
DRAWN BY:	CHECKED BY:	DATE:
K. LARSEN		MAR. 3, 1989
Scale	Sheet No.	Drawing Number
1" = 500'		FIGURE 43

The Castlegate Sandstone forms a 200-foot high escarpment along the north side of Newberry Canyon with numerous naturally occurring joints and fractures. Stress caused by removal of coal was transferred to the fractures resulting in brittle failure of the cliff face (spalling) in some places. Talus from the spalling has accumulated on the steep slopes below the cliffs on older natural talus slopes. The newer debris remains mostly above the coal outcrop level and reaches the canyon floor in only one location. Surface cracks have been observed and mapped along the ridge above the cliff. The cracks are discontinuous and extend for approximately 2000 feet parallel to the northern edge of the 6th East longwall panel. A few cracks are also found directly on top of the Castlegate Sandstone escarpment.

Maximum subsidence to date is over five (5) feet, occurring over the eastern end of the 6th East panel (Figure 43).

Mitigation of effects due to mining may be required in Area 14. A detailed assessment is given in the Newberry Canyon report. Briefly, mitigation may include 1) backfilling, recontouring, and revegetating surface cracks, where accessible; 2) creating artificial eagle nesting sites; and 3) improvement of habitat for existing species or developing habitat for another desirable species.

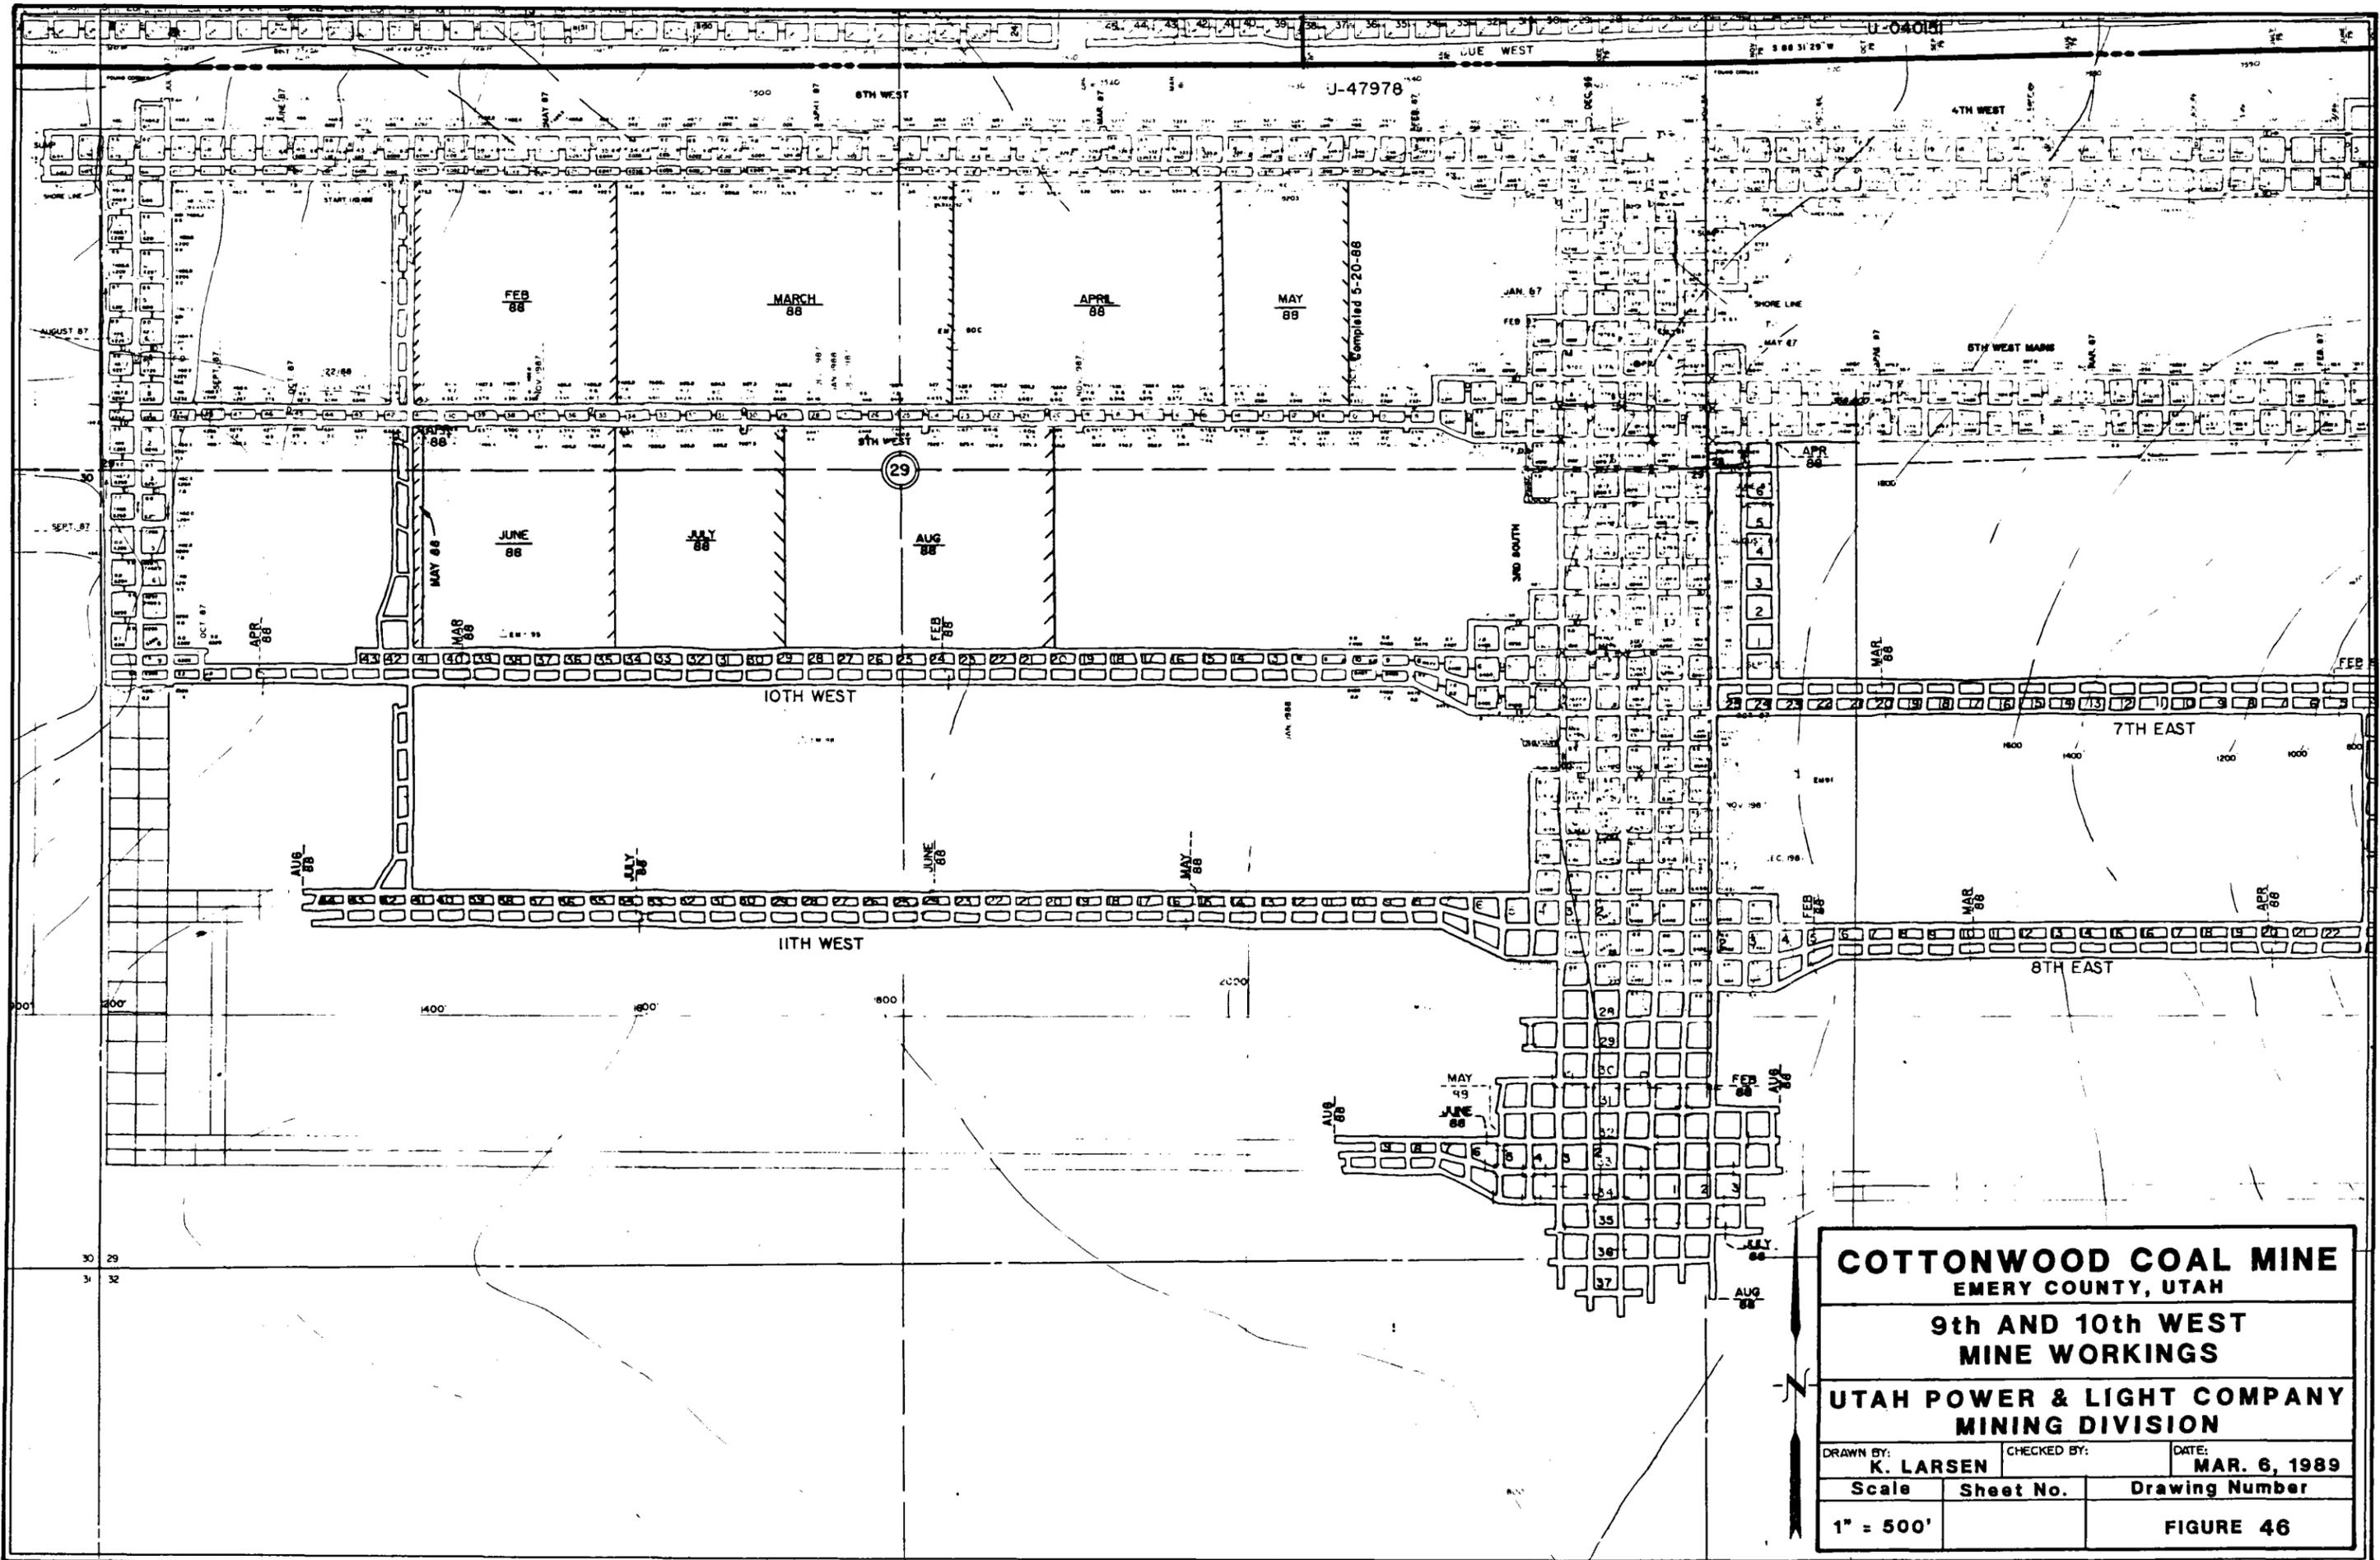
DRAWN BY: <b>K. LARSEN</b>	CHECKED BY:	DATE: <b>MAR. 6, 1989</b>
Scale	Sheet No.	Drawing Number
<b>1" = 500'</b>		<b>FIGURE 46</b>

Subsidence in 9th and 10th West was first monitored and detected in 1988 since longwall extraction there began during this monitoring period. Between February and August 1988 the entire 9th West panel and 2530 feet of the 10th West panel were extracted (Figure 46).

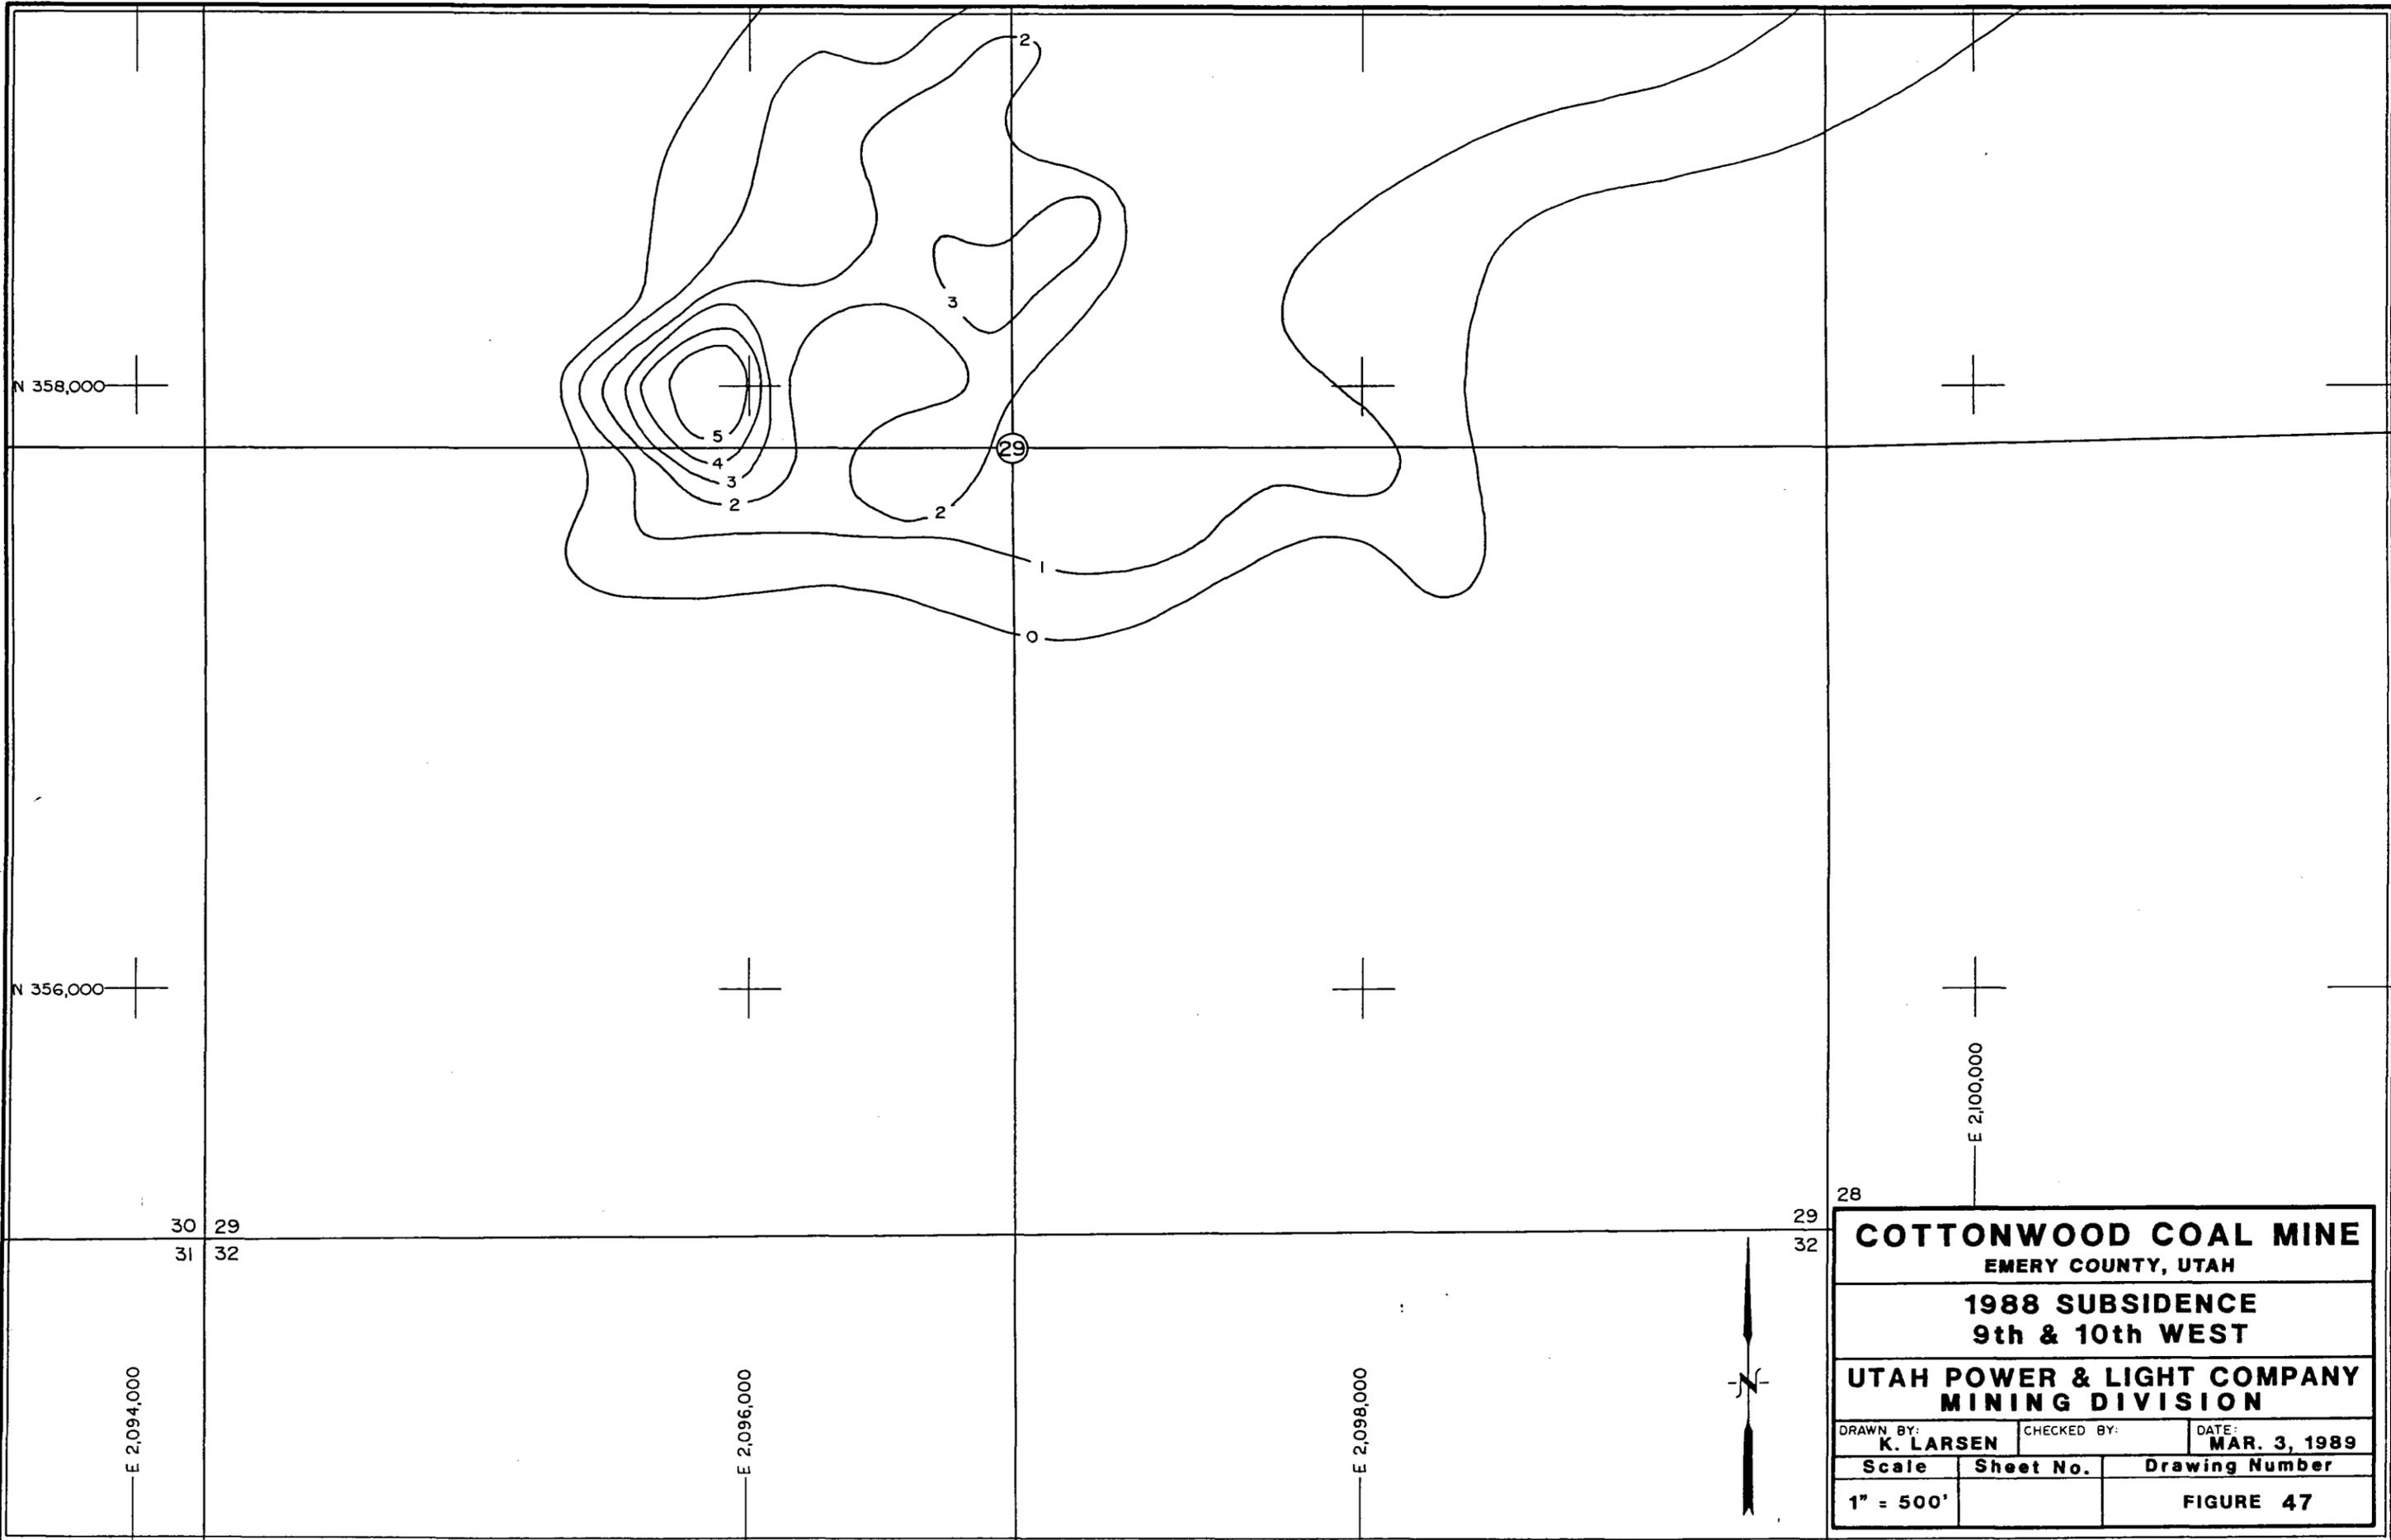
Maximum measured subsidence to date is over five (5) feet above the western ends of the panels (Figure 47).

Calculated angle-of-draw is less than zero on west, south, and east, and reaches 25 degrees on the north where older workings may be causing subsidence to the north of the 9th West panel.

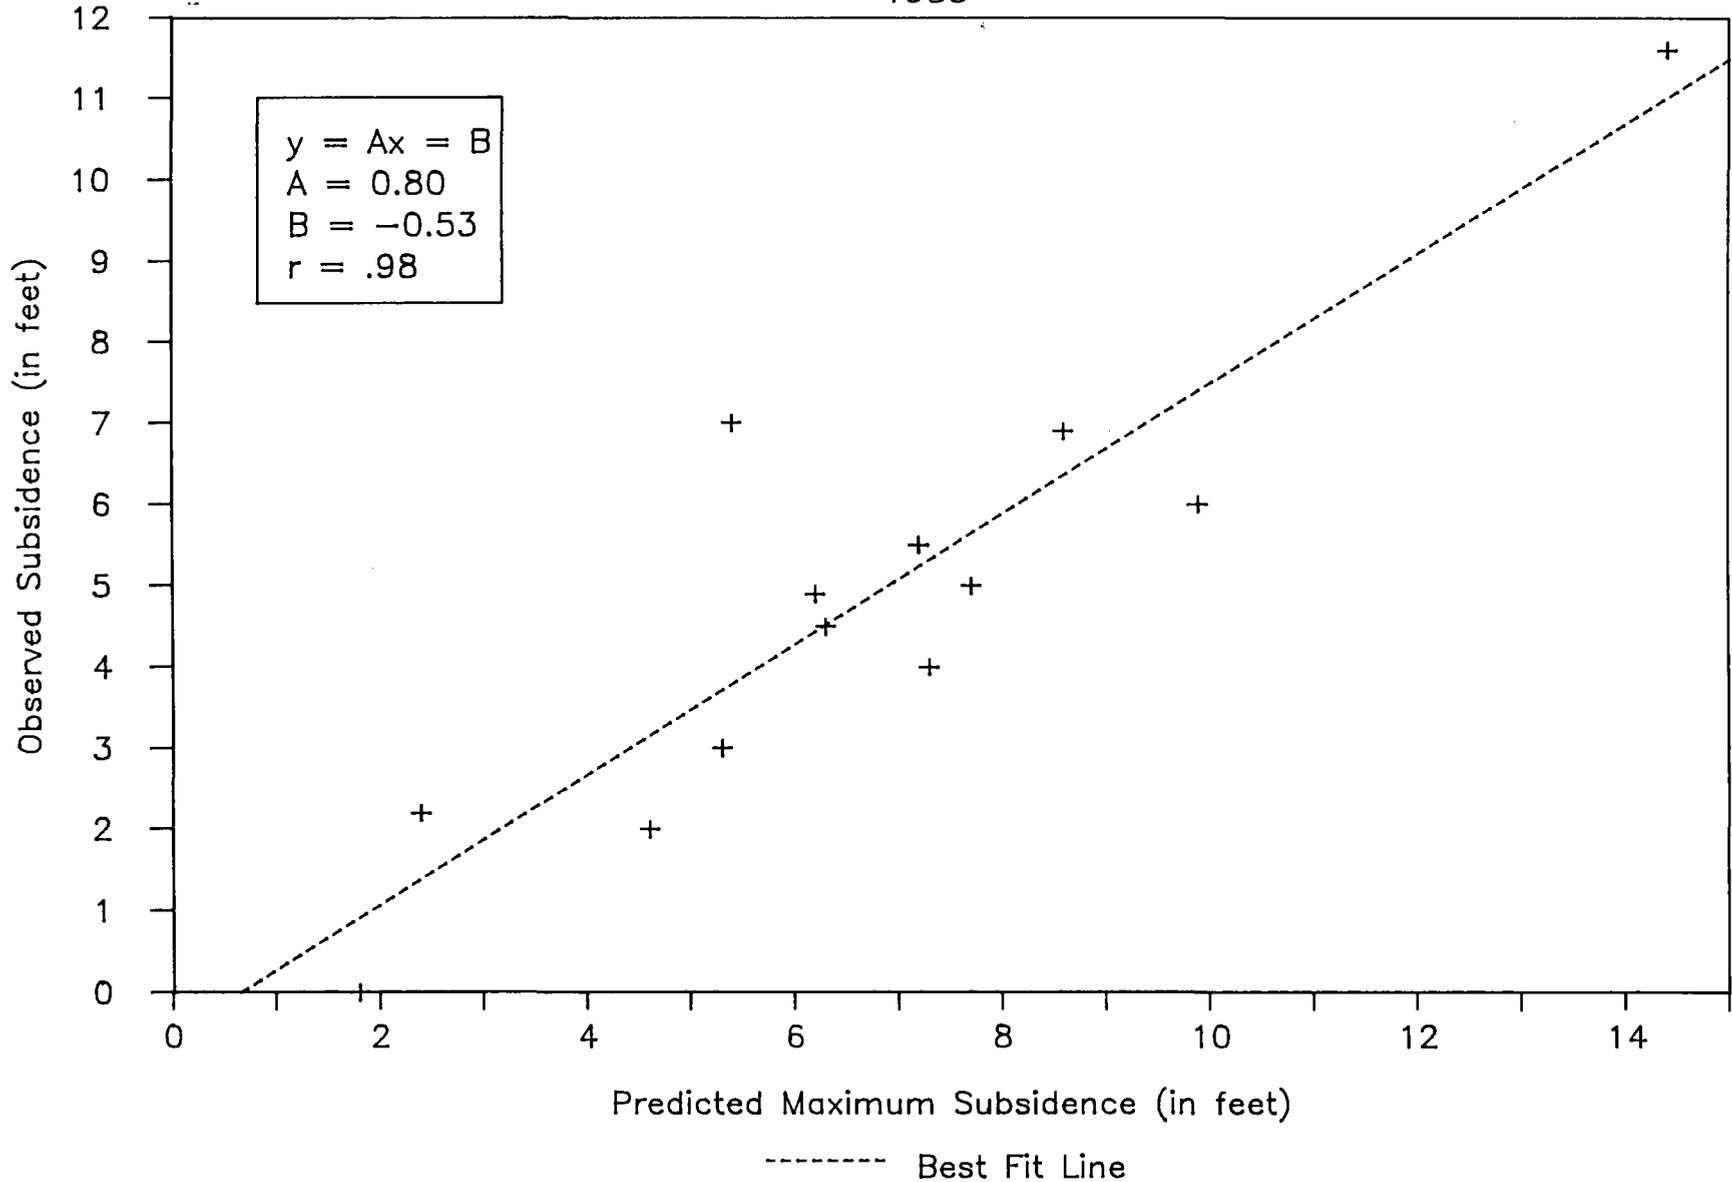
**FIGURE 50**

In all areas except one subsidence is less than the maximum predicted by the NCB model, possibly due to the fact that in some areas mining occurred very recently and subsidence has not yet reached its maximum. It could also be that the observed subsidence shown here represents the actual maximum subsidence for the particular geologic conditions -- probably the case in some areas since subsidence appears to have ceased in several areas where the NCB predicted maxima were not reached. Figure 50 shows the relationship between predicted and observed subsidence. From the slope of the regressions line ( $A = .80$ ) the average observed subsidence is eighty percent (80%) of the NCB predicted maximum. (Area 1 excluded from graph data.)

Area 1 (DC 9th East - Wilberg 1st Right) is the one anomalous area; it does not fit the special conditions necessary for prediction by the NCB method. The mine workings are surrounded by burned coal and bounded on the east by the Deer Creek Fault. As mentioned before, crushing of clinker beds and movement along the fault have added another complication to the subsidence. The maximum subsidence in the area occurs on a steep slope below a cliff, where slumping has occurred. The twenty-five (25) feet measured here must be due in part to mass wasting on the steep slope.
