**UTAH POWER & LIGHT COMPANY
SUBSIDENCE MONITORING PROGRAM
ANNUAL REPORT FOR 1989**

May 1990

**United States Department of the Interior
Office of Surface Mining
Minerals Management Service
Utah Division of Oil, Gas and Mining**

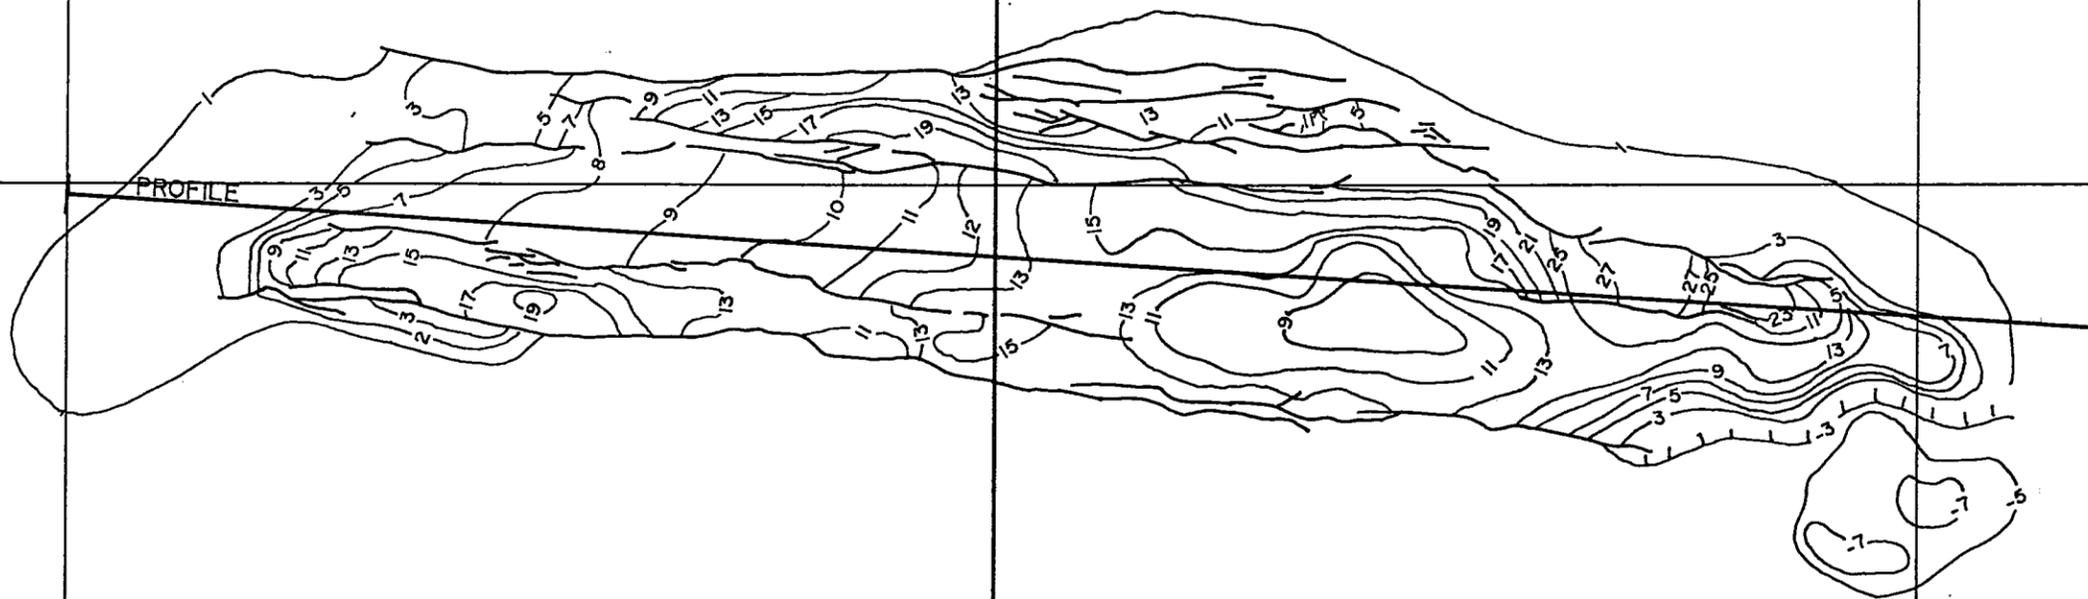
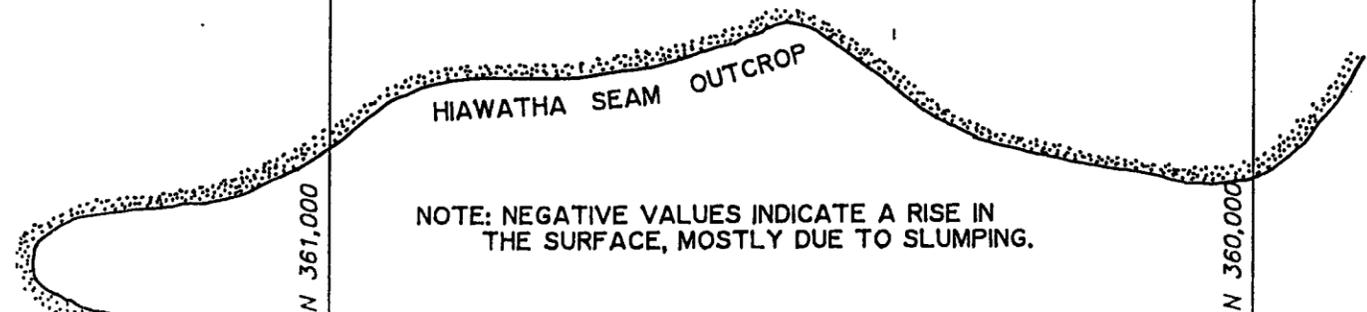
DRAWN BY: J. GARRETT	FIGURE 5	
SCALE: 1" = 200'	DRAWING #:	
DATE: 4-24-90	SHEET 1 OF 1	REV. —

Figures 6 and 7 are north to south and west to east profiles showing the amount of subsidence in this area during the past seven years. The location of each line is shown on Figure 5. The area has seen little change since 1985. Maximum subsidence remains at about twenty-seven (27) feet. A detailed look from a helicopter revealed that the subsidence maximum is located on a steep slope, about 200 feet south of the southernmost mining, where a good-sized rotational slump has occurred. The workings here are also surrounded by burned coal. It is probable that the combination of steep slopes and crushing of clinker beds has allowed subsidence to occur well outside the area of mine workings. An inspection of the area from the ground indicates that many of the open fractures forming the graben-like structure have begun to heal and fill in with soil.

In a few areas, such as Areas 1, 3, 7, 10, and 14, surface fractures have been detected. In order to protect livestock UP&L has erected a fence around Area 1 where fractures are of sufficient magnitude to pose a threat to wandering cattle. In Area 14, where cracks have also been observed, the U.S. Forest Service has determined that no fencing or other measures are needed unless "significant change" occurs in the area. The agency has recommended that no reclamation be undertaken in Areas 1 or 14 at this time; UP&L will reclaim the areas when and if it is deemed necessary.

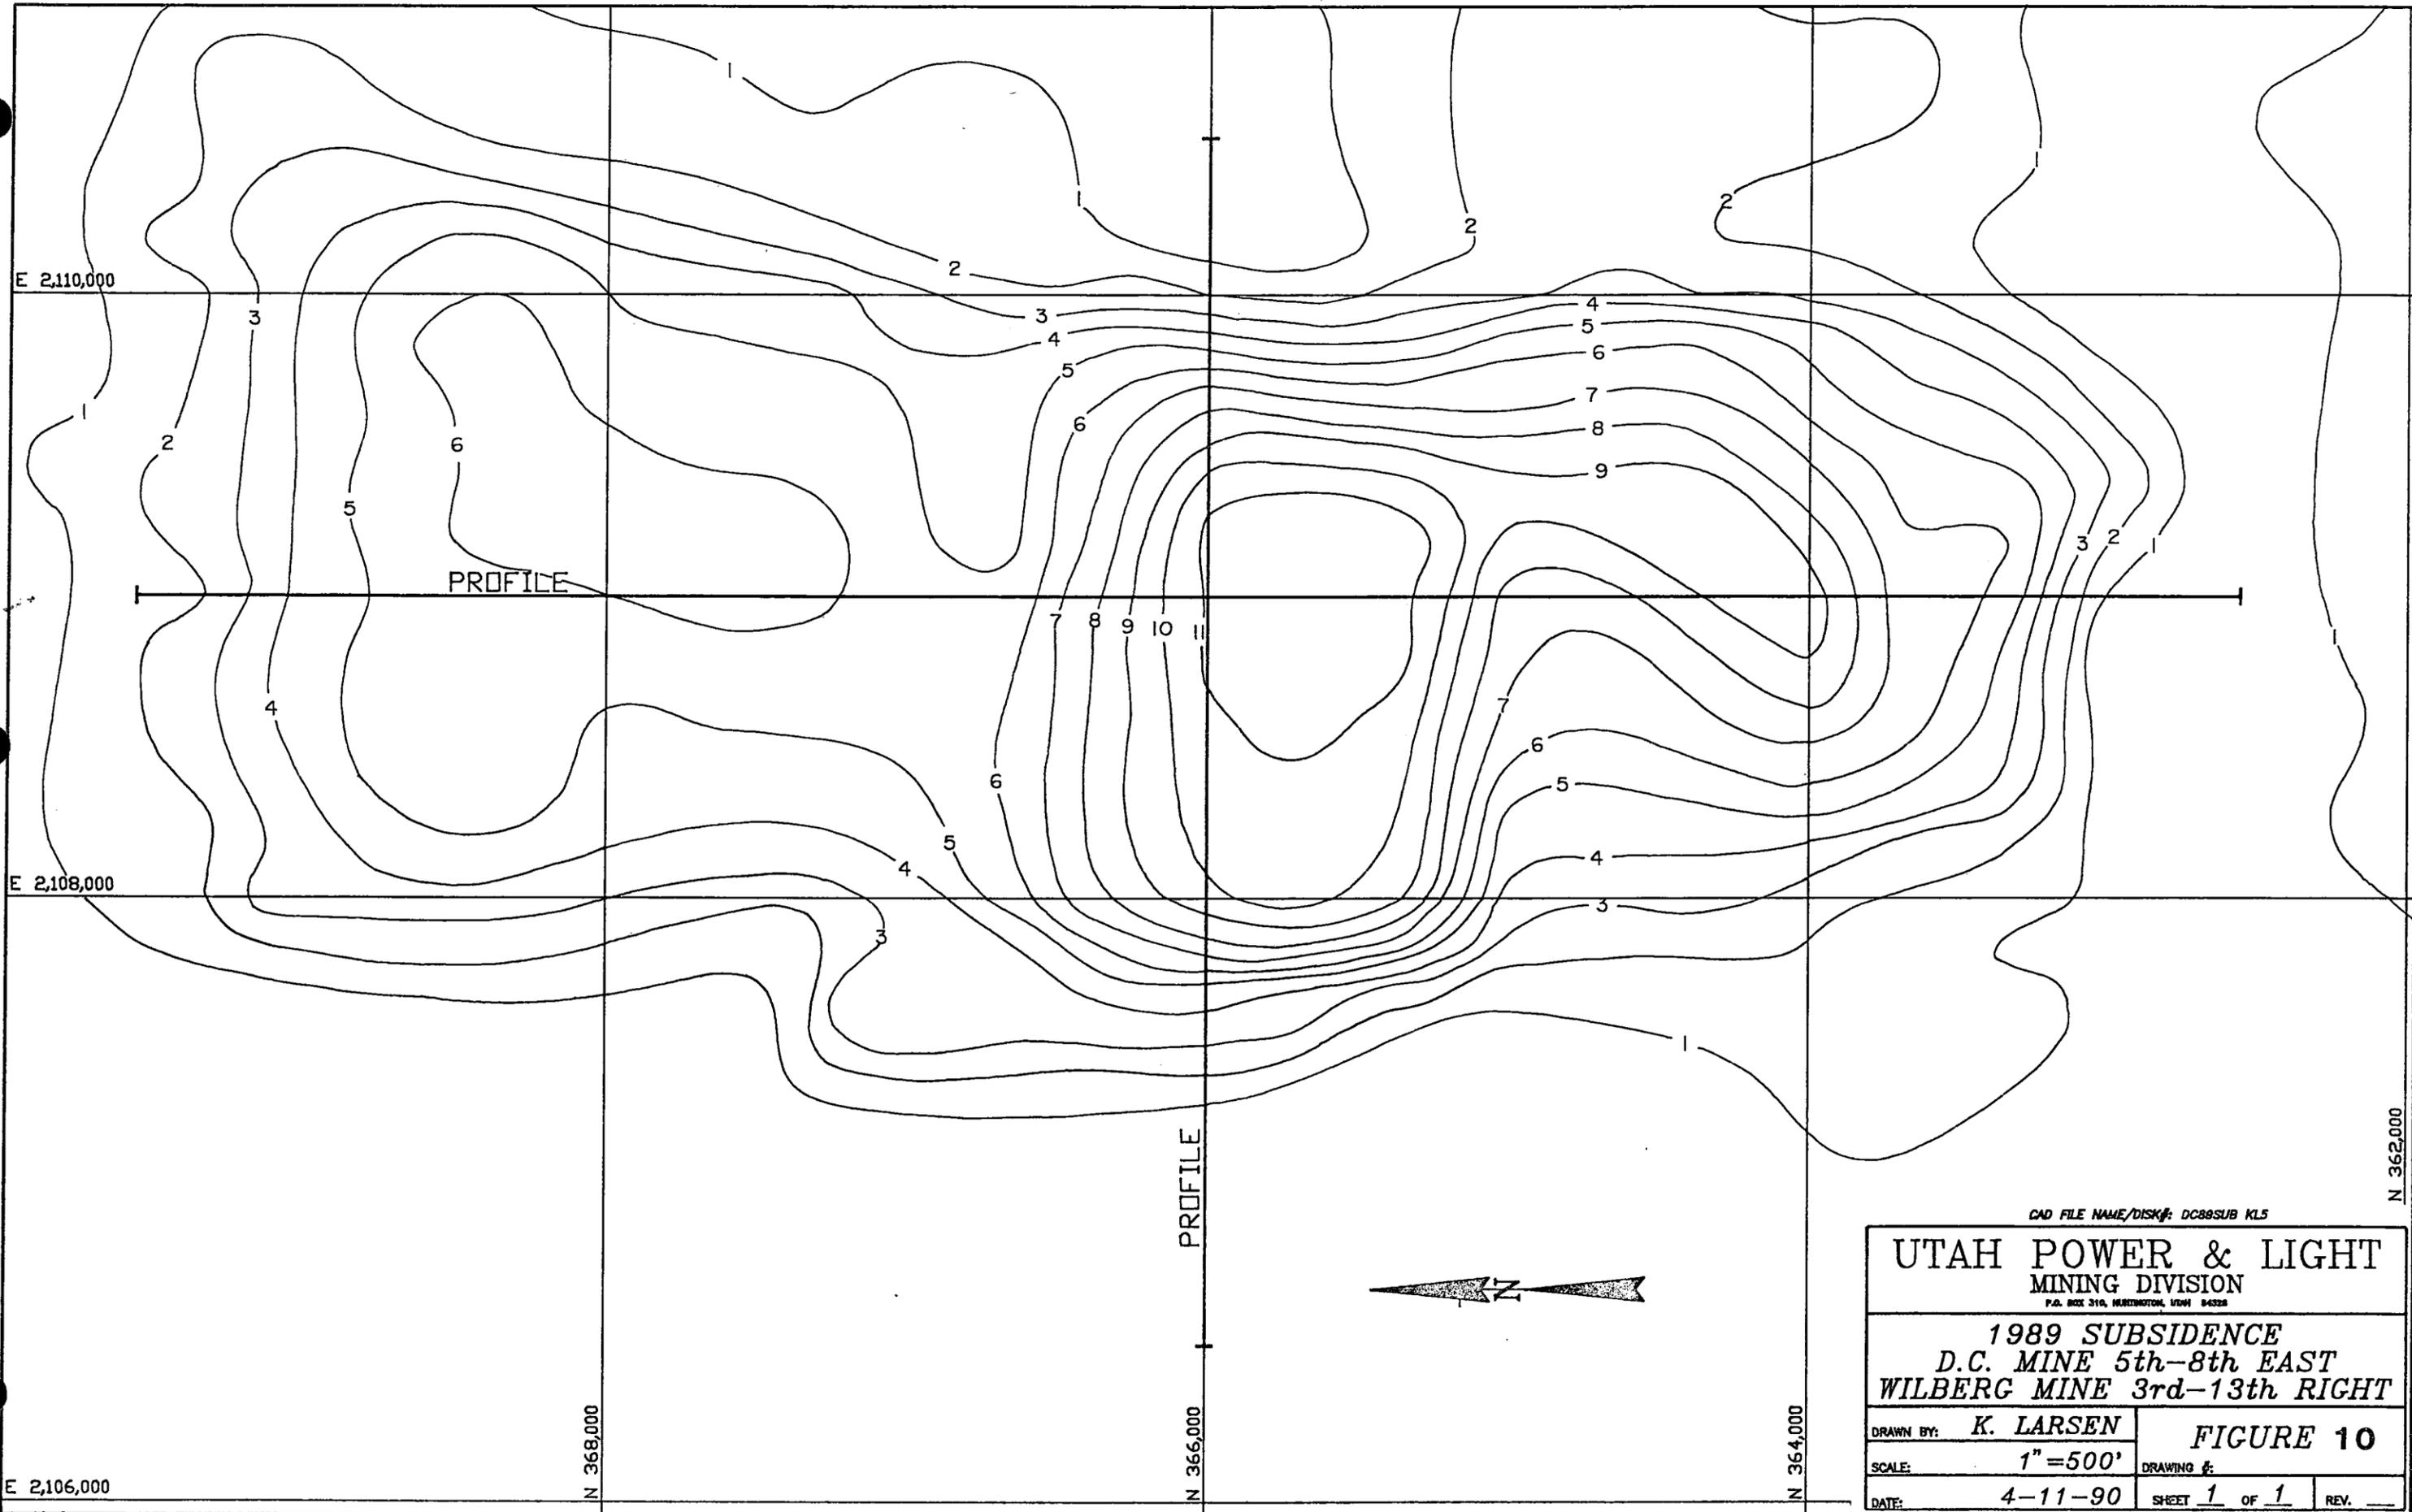
DRAWN BY: K. LARSEN	FIGURE 10
SCALE: 1"=500'	
DATE: 4-11-90	DRAWING #: SHEET 1 of 1 REV. ---

Maximum subsidence in Area 2 remains at just under twelve (12) feet and occurs over the Deer Creek 6th East and the Wilberg 6th and 7th Right longwall panels (Figure 10). The subsidence profiles (Figures 11 and 12) indicate that ground movement over much of the area has stabilized, but the subsidence trough continues to elongate over the most recently mined panels. Neither UP&L nor other contracted personnel have detected any surface fissures or other visible disturbance in the area.

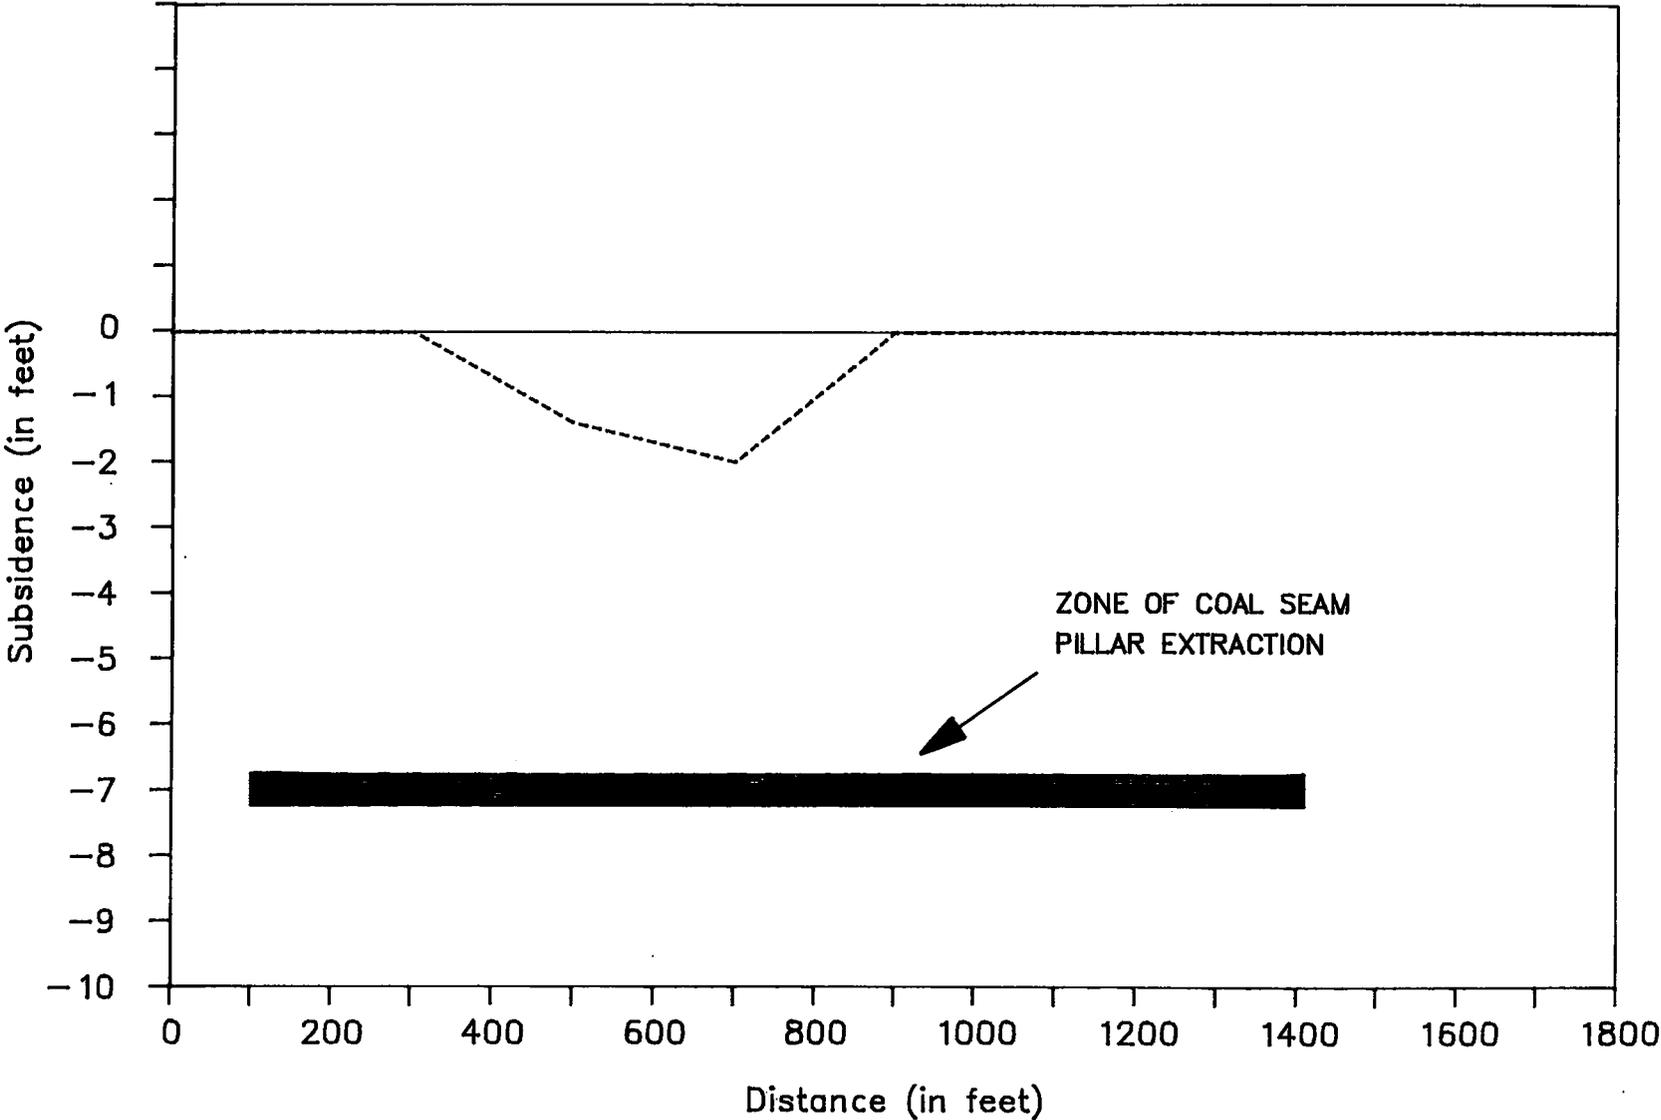
FIGURE 14

The subsidence above 1st North occurs on a narrow ridge capped by a highly fractured sandstone, and a review of the subsidence data indicates that, due to the mode of subsidence, elevation change cannot be depicted accurately with a contour map. Figure 14 is a profile of total subsidence as it occurred along a line of points above the workings.

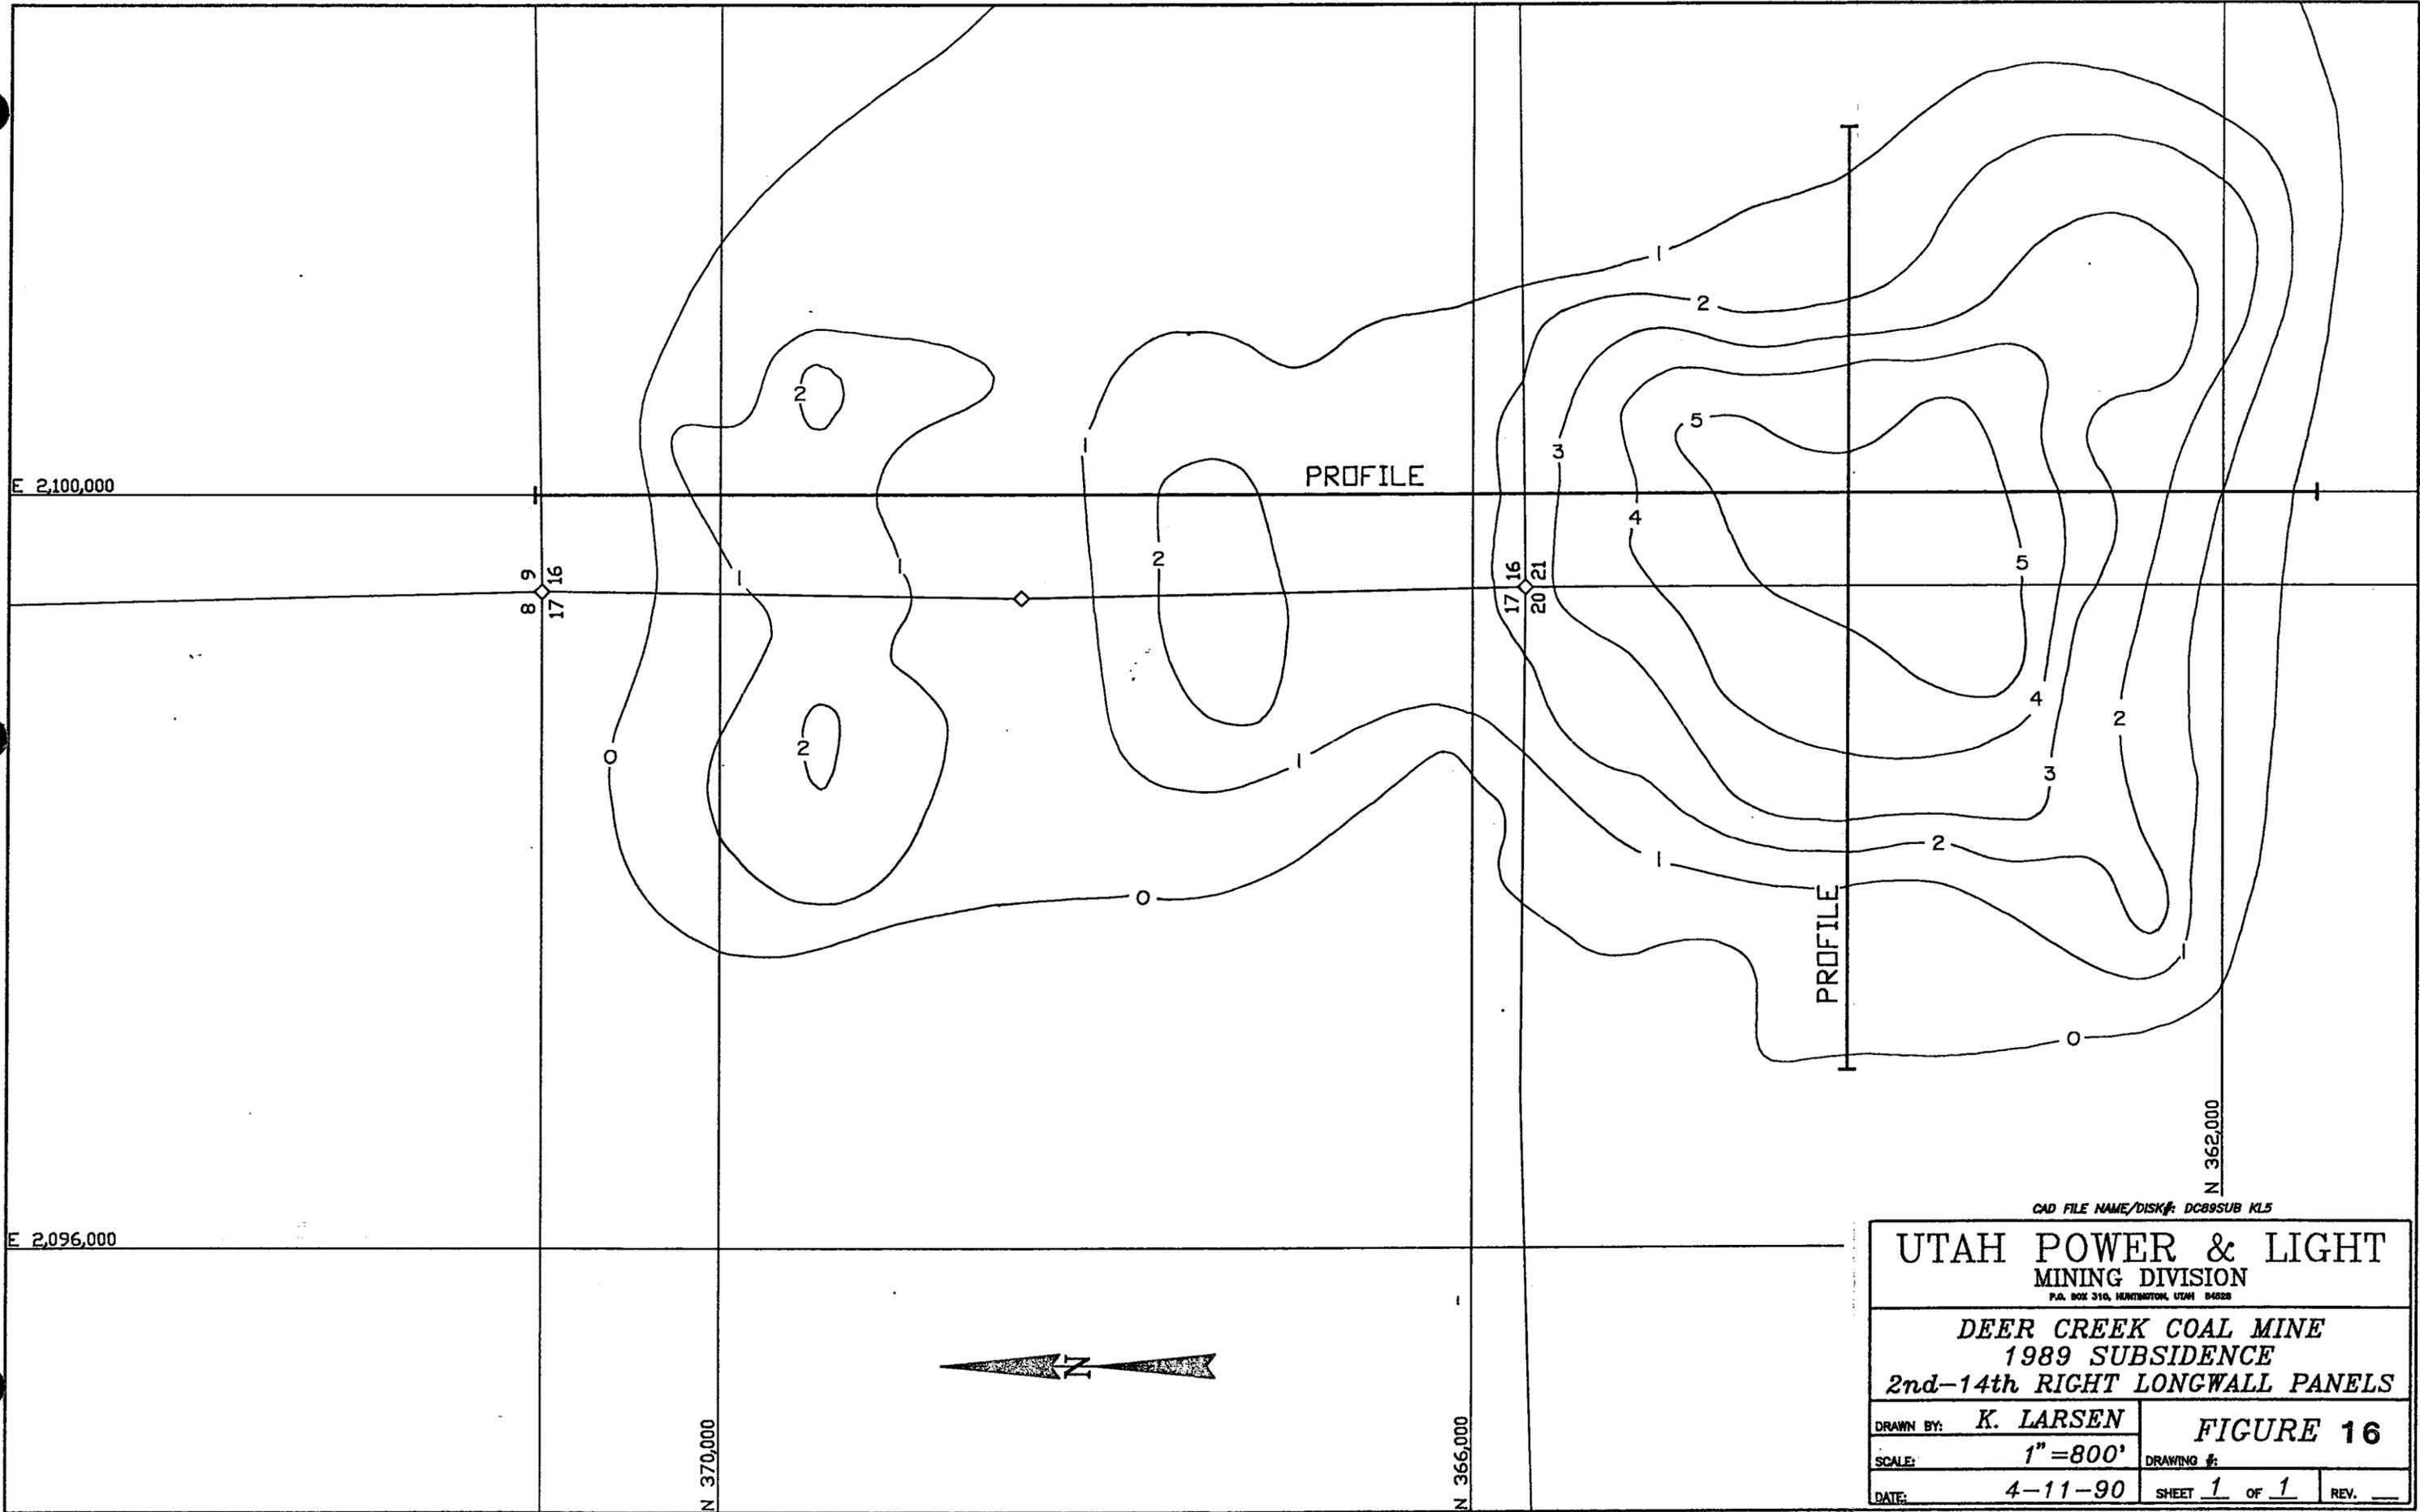
DRAWN BY: K. LARSEN	FIGURE 16
SCALE: 1"=800'	DRAWING #:
DATE: 4-11-90	SHEET 1 OF 1 REV. ___

Maximum subsidence is just under six (6) feet over the 3rd, 4th, and 5th Right longwall panels (Figure 16). The subsidence trough continues to extend northward over the most recently mined longwall panels (see Subsidence Profiles, Figures 17 and 18). The calculated angle-of-draw of the subsidence ranges from less than zero to 11 degrees.

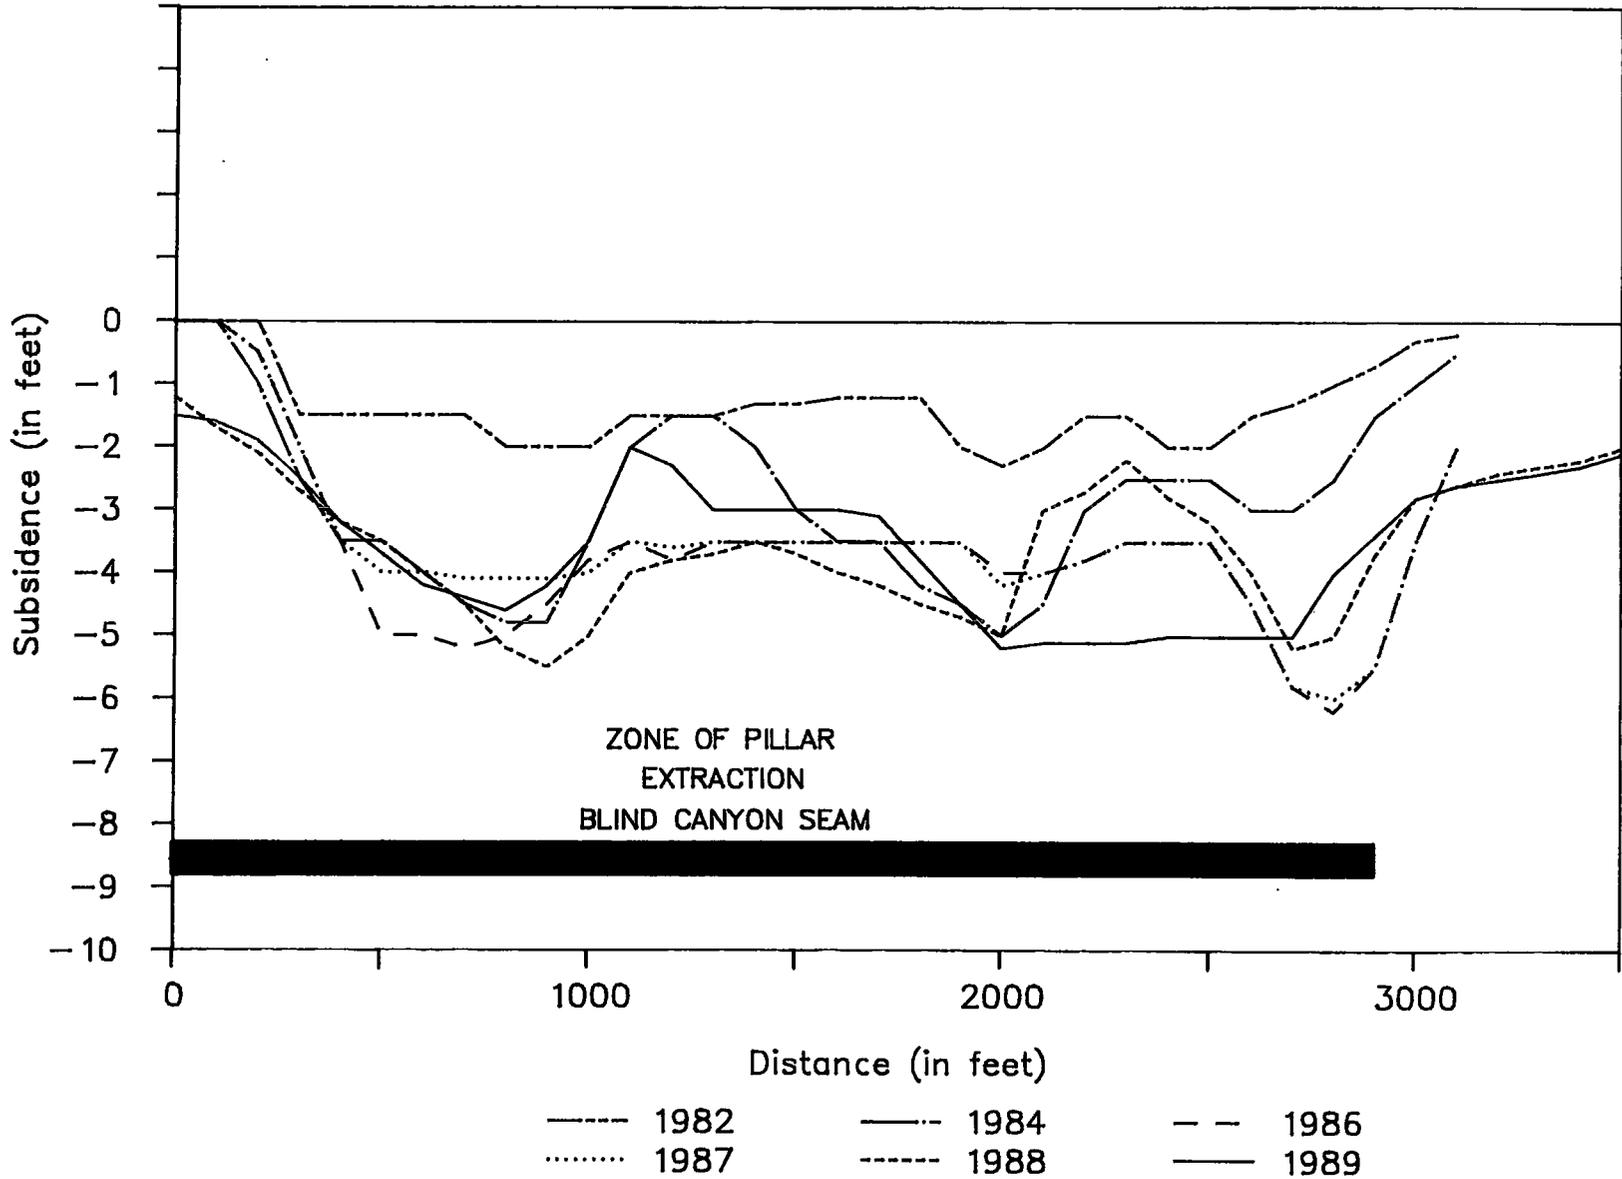
FIGURE 29

Pillar extraction mining in 2nd North was completed in 1983 and, as shown in Figures 27, 28, and 29, little additional subsidence has occurred over the workings since 1984. The workings are surrounded by burned coal.

Maximum subsidence remains at about six (6) feet. In examining the area by helicopter and aerial photography it is apparent that much of the elevation change measured was due to cliff failure and mass wasting on the steep slopes above the workings, where the rocks were highly fractured prior to mining.

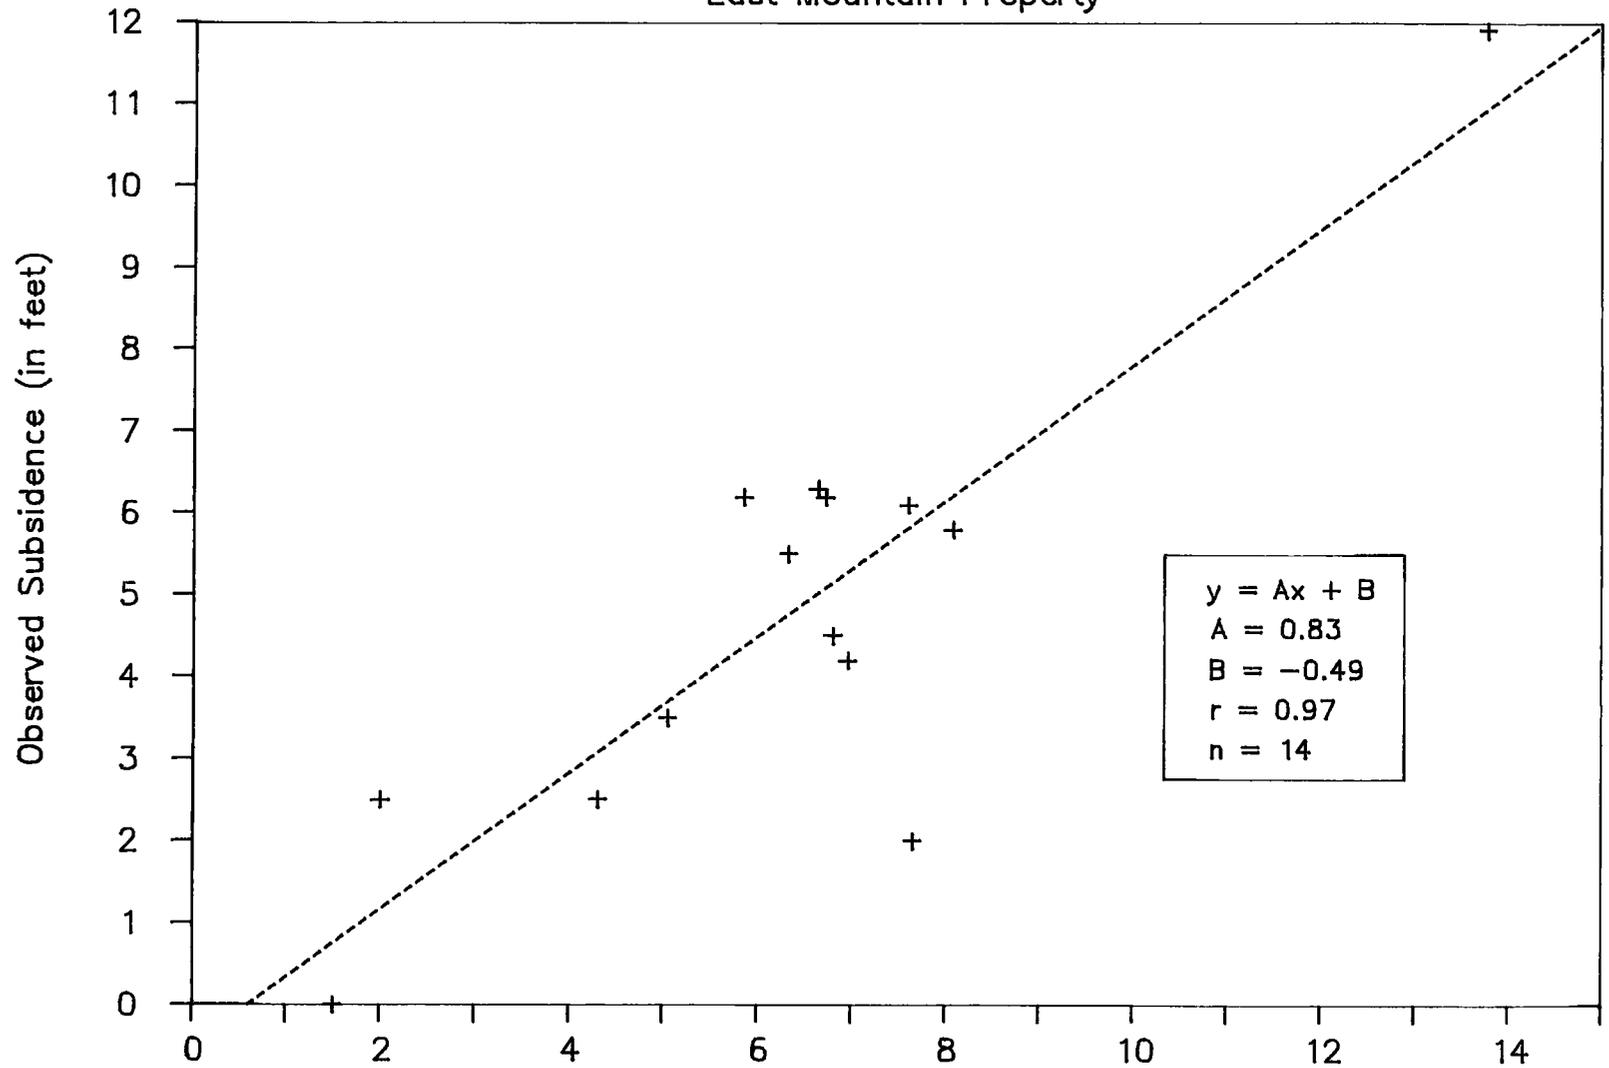
FIGURE 51

In all areas except one subsidence is less than the maximum predicted by the NCB model, possibly due to the fact that in some areas mining occurred very recently and subsidence has not yet reached its maximum. It could also be that the observed subsidence shown here represents the actual maximum subsidence for the particular geologic conditions -- probably the case in some areas since subsidence appears to have ceased in several areas where the NCB predicted maxima were not reached. Figure 51 shows the relationship between predicted and observed subsidence. From the slope of the regression line ($A = .83$) the average observed subsidence is eighty-three percent of the NCB predicted maximum. (Area 1 excluded from graph data.)

Area 1 (DC 9th East - Wilberg 1st Right) is the one anomalous area; it does not fit the special conditions necessary for prediction by the NCB method. The mine workings are surrounded by burned coal and bounded on the east by the Deer Creek Fault. As mentioned before, crushing of clinker beds and movement along the fault have added another complication to the subsidence. The maximum subsidence in the area occurs on a steep slope below a cliff, where slumping has occurred. The twenty-seven (27) feet measured here must be due in part to mass wasting on the steep slope.
