INFORMAL HEARING STATE VIOLATION N92-32-6-1

PACIFICORP, COTTONWOOD MINE, ACT/015/019

EMERY COUNTY, UTAH

JUNE 17, 1992

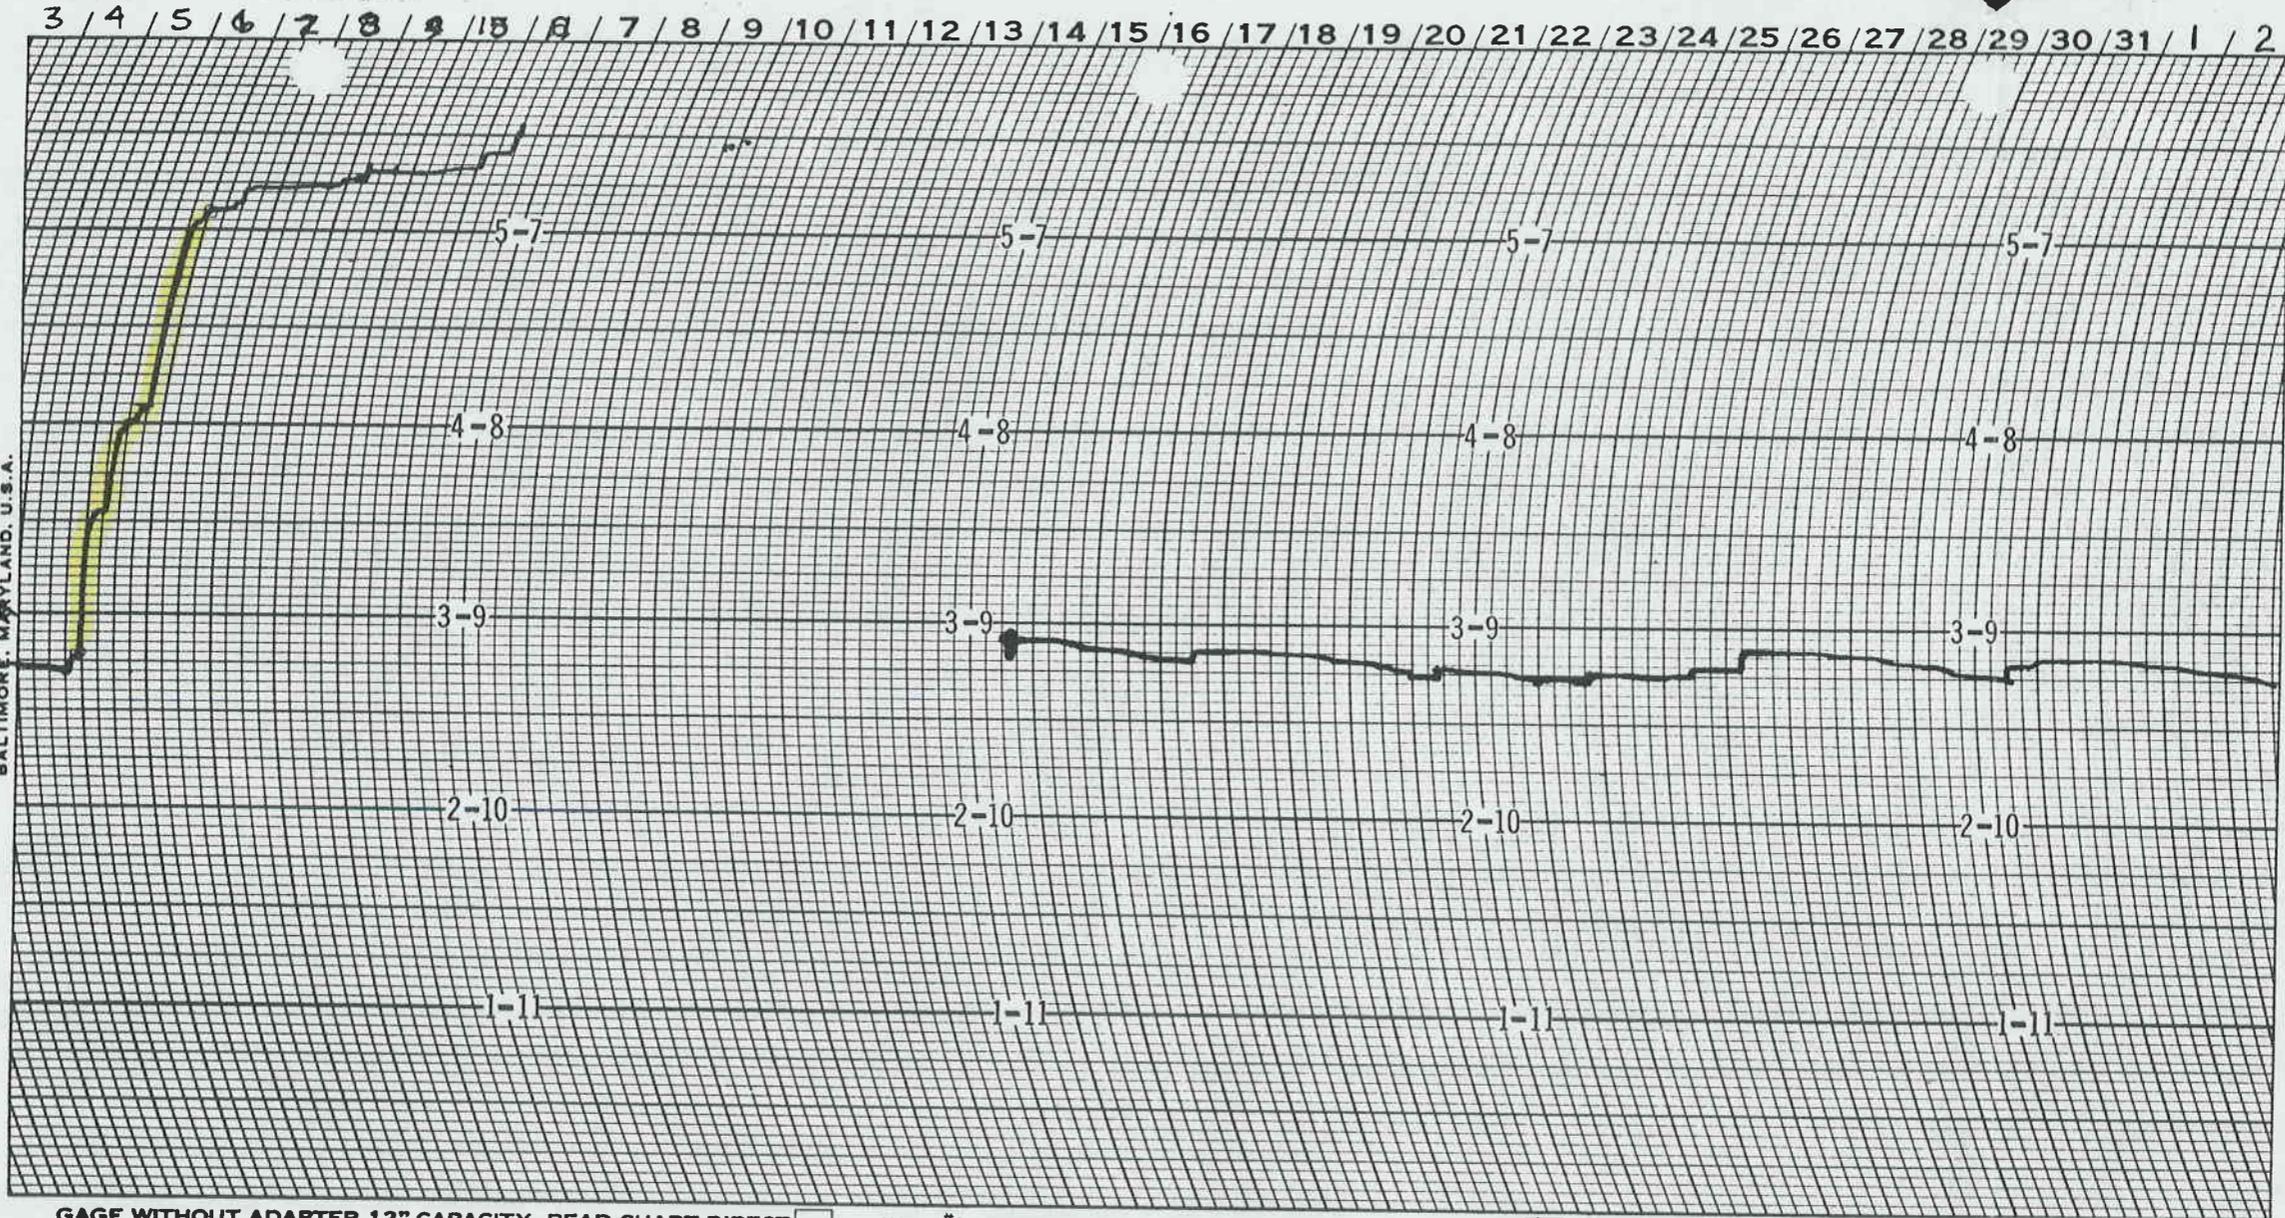
EXHIBIT 3

INCREMENTS ARE IN .05 UNITS OF 1"
 APPROXIMATELY 46 INCREMENTS WERE
 COUNTED FOR THE SEPTEMBER 6, 1991 STORM.
 46 INCREMENTS X .05 UNITS = 2.3" OF PRECIPITATION.

1ST 6 HOUR PERIOD = 0.76" PRECIPITATION.
 2ND 6 HOUR PERIOD = 0.45" PRECIPITATION.
 3RD 6 HOUR PERIOD = 0.09" PRECIPITATION.
 4TH 6 HOUR PERIOD = 1.02" PRECIPITATION.
