State of Utah

DEPARTMENT OF NATURAL RESOURCES DIVISION OF OIL, GAS AND MINING

April 24, 1992

RE: Analysis of Response to Division Order #DO-91B, PacifiCorp Electric Operations, Cottonwood/Wilberg Mine, ACT/O15/O19 #2

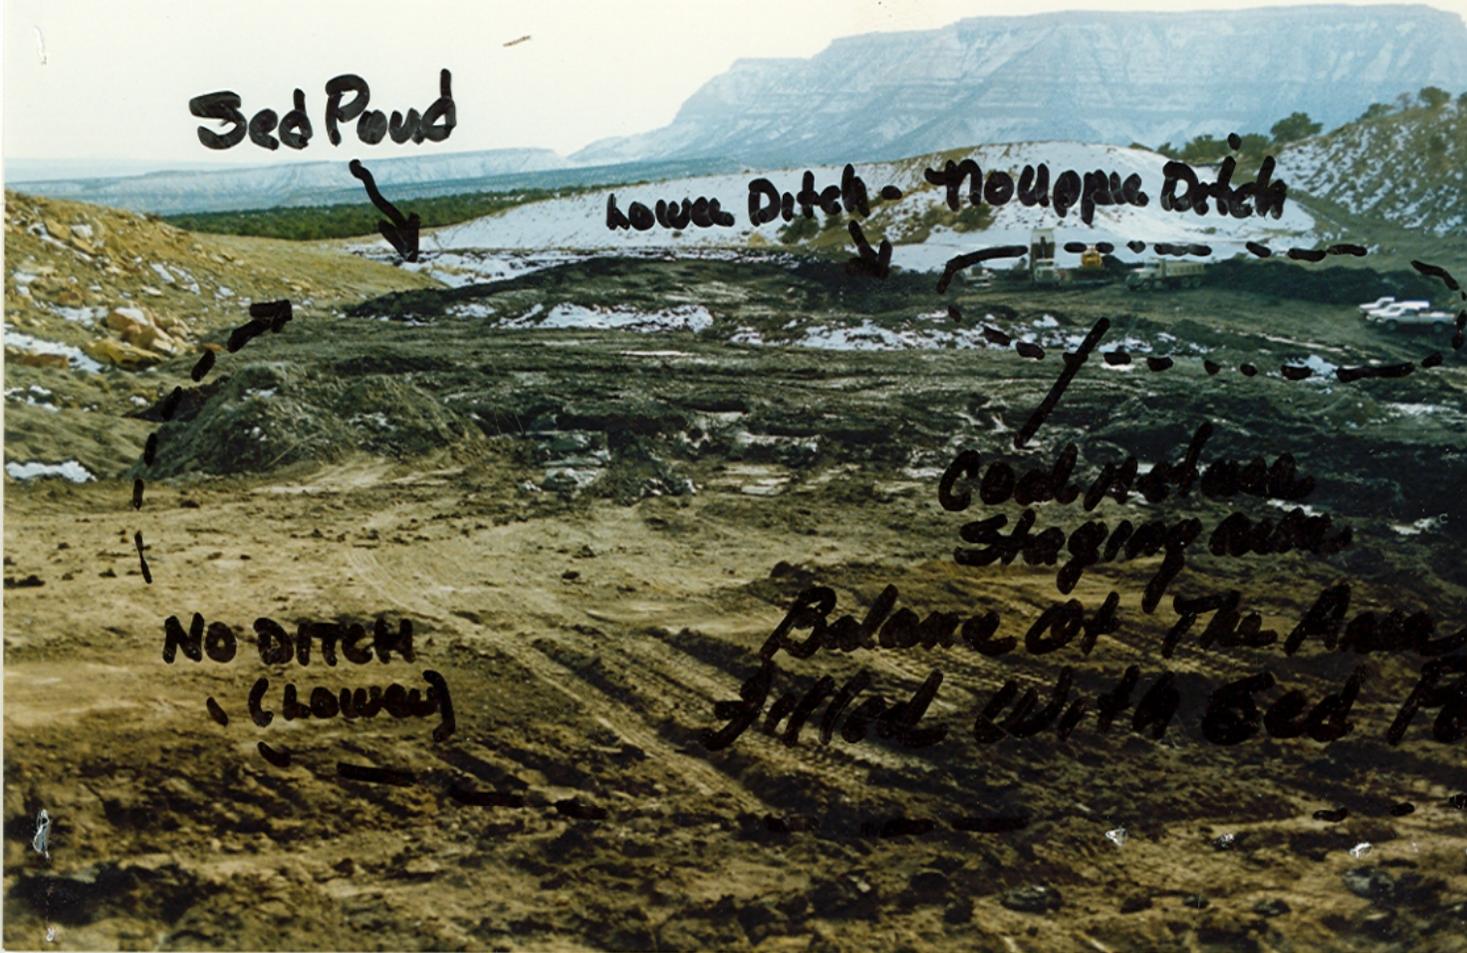
Cottonwood Waste Rock Site
11/9/92 WMM

Furthermore, only one ditch at the toe of the refuse pile was in place at the time of the inspection, ie., the west ditch. No ditch existed on the east portion. While this is in accordance with the PAP, it does not meet performance standards.

East side - no current ditch.

Sed Pond

Lower Ditch - Nollupic Ditch

Coal refuse
Staging area

Balance of the Area
filled with Sed Po

NO DITCH
(Lower)

one ditch ? upper
