State of Utah
DEPARTMENT OF NATURAL RESOURCES
DIVISION OF OIL, GAS AND MINING

September 5, 2000

Re: Technical Field Visit - Cottonwood Fan Portal Phase-1 Reclamation Bond Release, Energy West, Cottonwood/Wilberg Mine, ACT/015/019

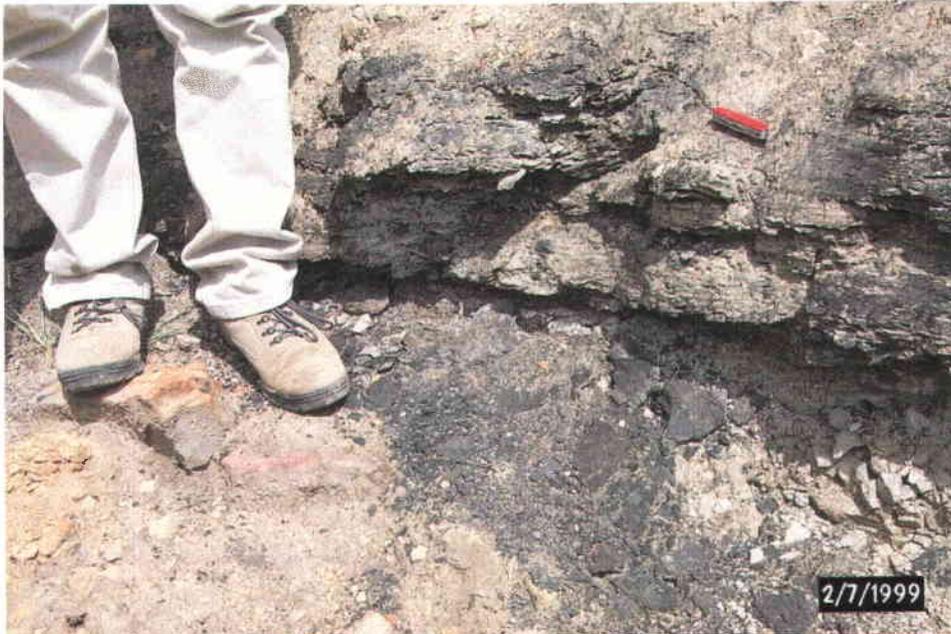
- Coal or carbonaceous shale has been left exposed under massive sandstone ledges in several locations on the reclaimed site (Photo 1);
- Several active seeps issue from rock exposed by the cut. The installed French drains are not evident, not actively draining the fill, but the weather has been dry; and

Photo 1 - carbonaceous shale and coal exposed at terrace number 1 (date should read 8/24/2000).

- Energy West needs to either cover the exposed carbonaceous material with 4 feet of soil or demonstrate that the material is non-combustible.
- The cross-sections and text describing the fill and remaining cut-slopes along the old road to the Johnson Mine need to be clarified.
- The permittee needs to address the unreclaimed section of the access road by the Johnson Mine portals.

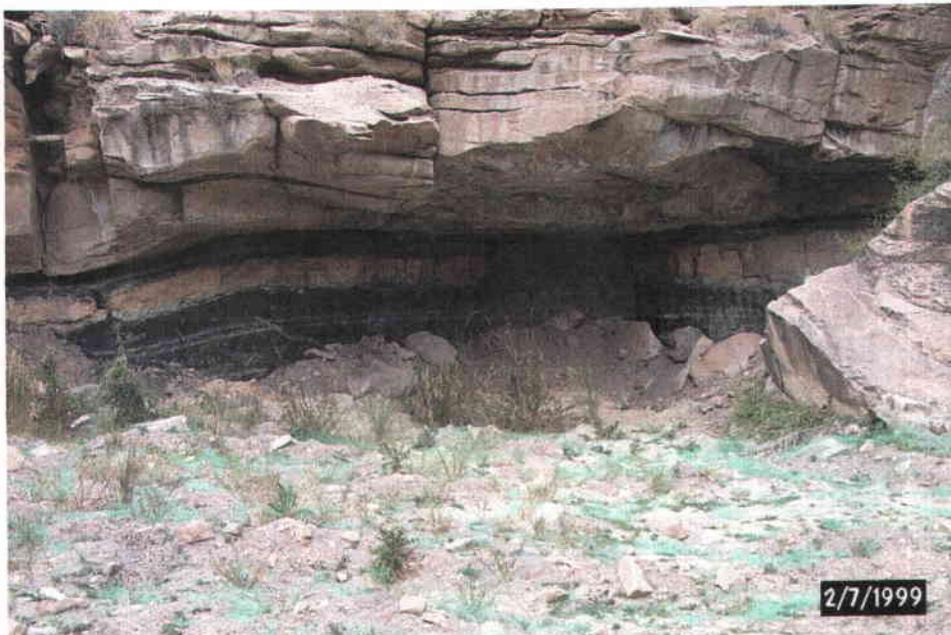
- The portals of the old Johnson Mine are sealed , but the coal seam is exposed adjacent to the portals and across most of the Johnson Mine site (Photos 2 and 3);

Photo 2 - coal seam exposed adjacent to the northern portal at the Johnson Mine (date should read 8/24/2000).

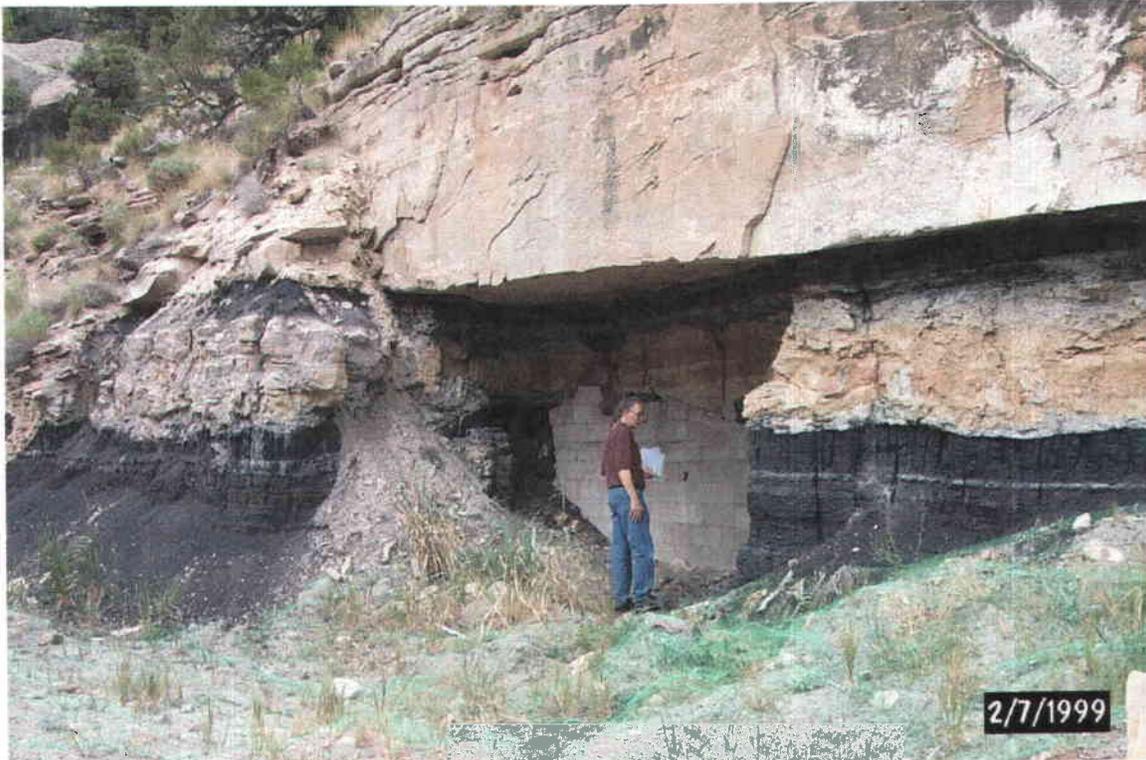
Photo 3 - north portal of the Johnson Mine with exposed coal seam (date should read 8/24/2000).
