**State of Utah**  
 DEPARTMENT OF NATURAL RESOURCES  
 DIVISION OF OIL, GAS AND MINING

To: ~~Internal File~~  
 Thru: Daron R. Haddock, Permit Supervisor *DRH*  
 From: *P* Priscilla W. Burton, Soils Reclamation Specialist  
 Re: Technical Field Visit, PacifiCorp, Cottonwood/ Wilberg Mine, C ~~...~~

To observe reclamation of the access road, fan portal terraces and condition of remaining subsoil stockpile.

TECHNICAL FIELD VISIT MEMO  
COTTONWOOD WILBERG FAN PORTAL  
January 4, 2001  
ATTACHMENT A

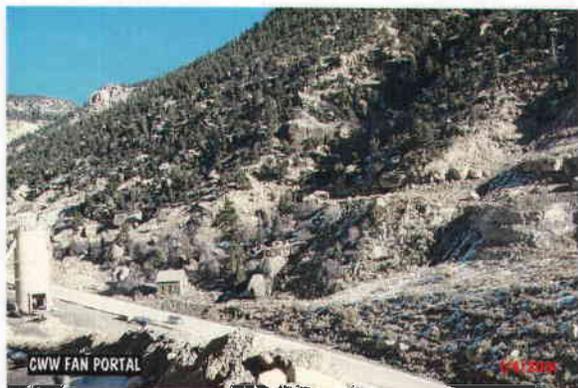
- From a distance the regrading of the access road and terraces blends with the landscape (See figures 1, 2, 3 of Attachment A). The permittee utilized existing boulders and rock outcrops to their advantage, requiring less fill than anticipated. As the terraces become covered with pines, the disturbance will be less noticeable.
- The surface material has remained rough from pocking (See figure 4 of Attachment A). Large plants of Salina Wildrye were seen, as were a couple of young Pinyon pine.
- Many rocks and boulders scattered the surface.
- Water seeps from the rock at several locations (5 or more) and freezes on its way down slope. (See figures 2 and 3 of Attachment A)

**Figure 1** Old Johnson Mine Access Road

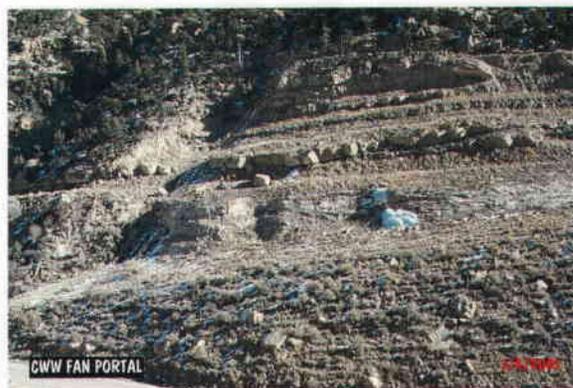
**Figure 2** Central portion of Reclamation

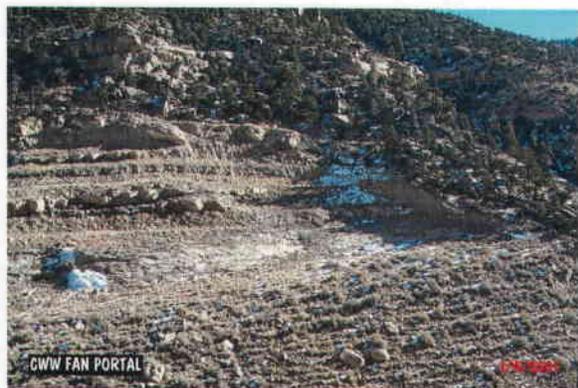
- There is a cut slope (approximately 15 feet high) at the south end of the first terrace that could not be treated with topsoil or subsoil due to the NW sloping sandstone shelf beneath the cut which would undermine the stability of any added material. Apparently this area has been the topic of much discussion between staff and Energy West and the conclusion has been drawn that the slope is best left to reclaim itself. (See Figure 3 of Attachment A)

**Figure 3** South portion of Reclamation

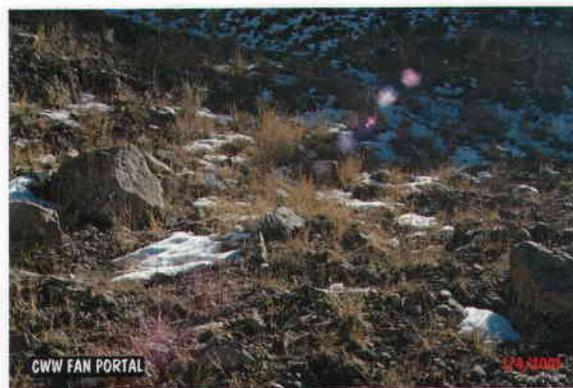
**Figure 4** Roughness

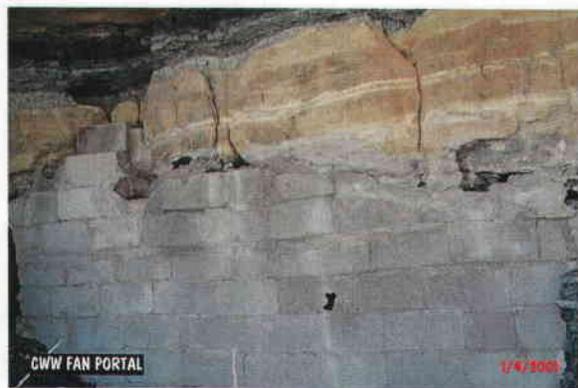
- The Johnson portals were left exposed as per the owners request. The south portal is being vandalized. The stone closure is being chipped away. (See figure 5 of Attachment A)

**Figure 5** Old Johnson Mine Portal
