# TECHNICAL MEMORANDUM

## Utah Coal Regulatory Program

RE: Phase II & III Bond Release Miller Canyon Portals, PacifiCorp,  
Cottonwood/Wilberg Mine, Permit # C/015/0019, Task ID # 3594

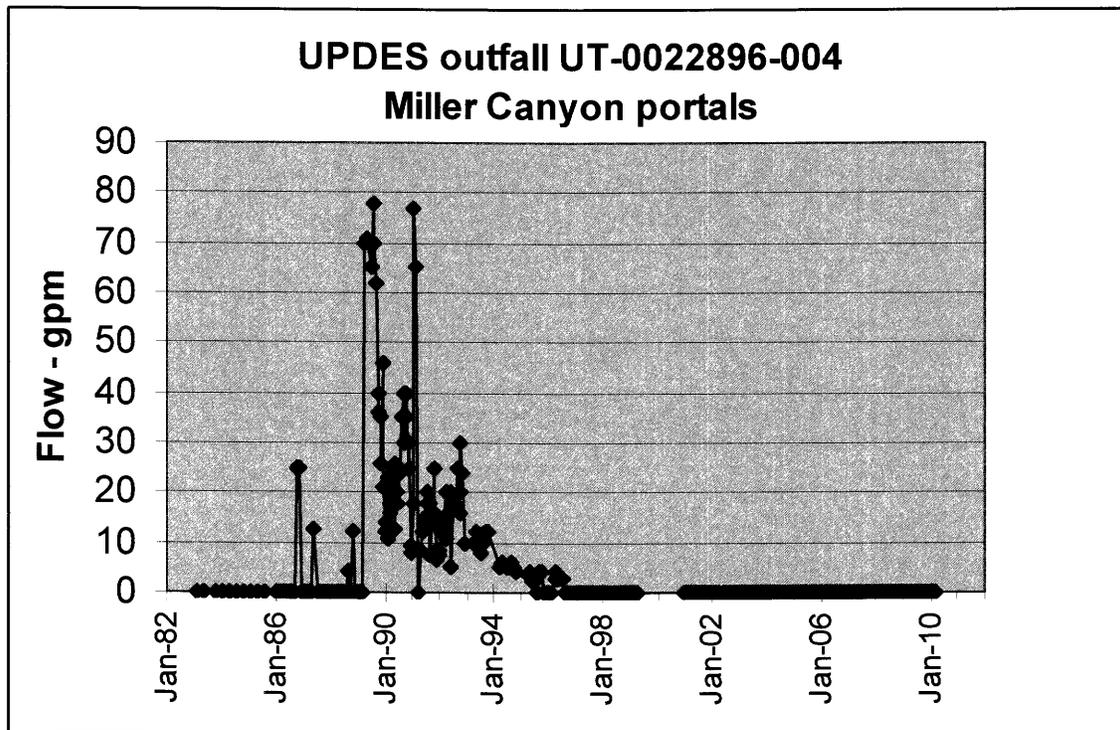
August 1996. A field investigation in May 1999 revealed that caving of Portal #1 had pinched off the pipe, allowing the portal discharge to flow freely over the rock ledge to the canyon floor.

During the June 1999 reclamation, the Permittee utilized six-inch rock material to create French drains to facilitate drainage from the breakout portals. The Permittee also removed the 2-inch water monitoring pipe during the 1999 reclamation. The monitoring point for outfall UT-0022896-004 remains near the mouth of Miller Canyon. Discharge from the breakout portal area, along with other seepage from the canyon, does not reach this monitoring point because of infiltration and evapotranspiration along the canyon floor. No flow attributable to portal discharge has been reported since July 1966. This bond release application does not amend the monitoring plan and monitoring of outfall -004 will continue.
