Division of Oil, Gas and Mining

Inspection Report

Permit Number:	C0150019
Inspection Type:	COMPLETE
Inspection Date:	Tuesday, November 18, 2014
Start Date/Time:	11/18/2014 9:00:00 AM
End Date/Time:	11/18/2014 2:00:00 PM
Last Inspection:	Tuesday, October 21, 2014

Permitee: **PACIFICORP**
 Operator: **ENERGY WEST MINING CO**
 Site: **COTTONWOOD/ WILBERG**
 Address: **PO BOX 310, HUNTINGTON UT 84528**
 County: **EMERY**
 Permit Type: **PERMANENT COAL PROGRAM**
 Permit Status: **ACTIVE**

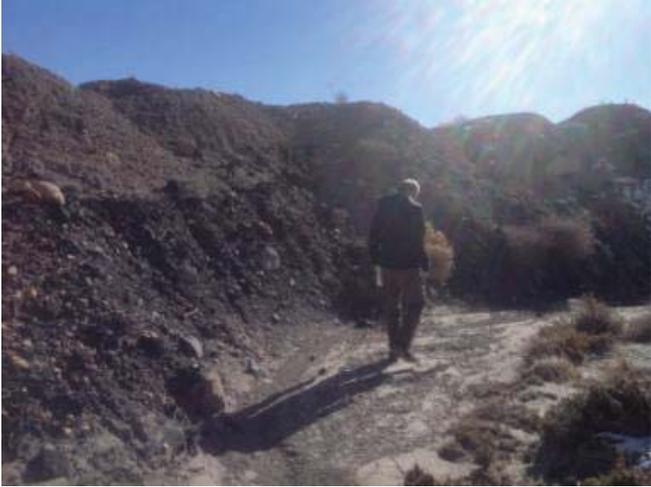
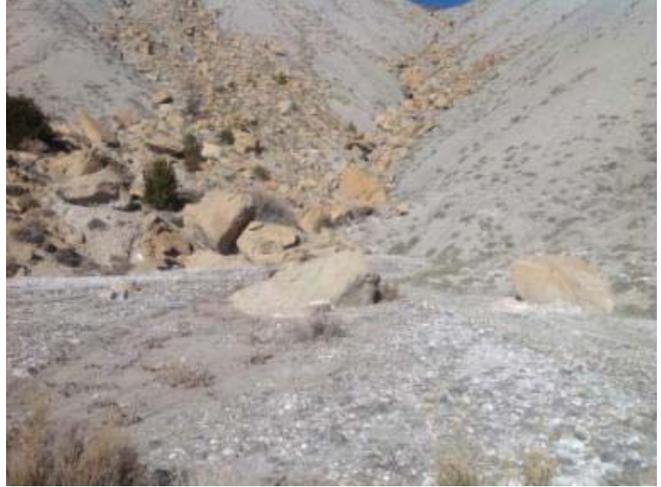
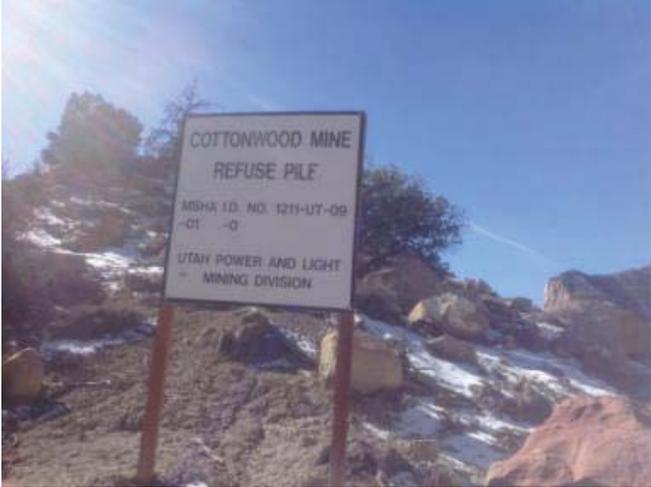
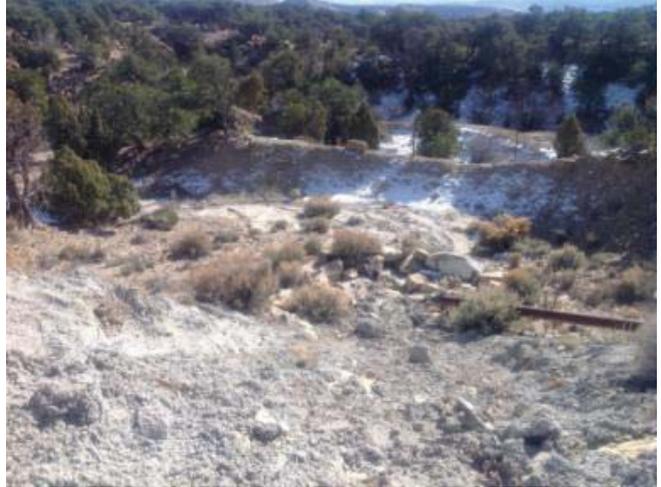
The sediment pond at the waste rock site has exceeded the planned sediment level due to recent extremely heavy rainstorms. As documented in letter dated 10/7/14 to OGM, the remote weather station of top of East Mountain was not functioning normally but other recording stations and instruments noted 1.23" rain at The Huntington Power Plant and the rain gauge at Rilda Canyon collected 3.45" of rain. This rainstorm resulted in exceeding the 10 year 24 hour event threshold. As noted and requested in inspection dated 10/21/14 the operator has pumped the sediment pond and is waiting for it to dry enough to support equipment for removal of the sediment. Because the soil is too saturated for equipment access at this time, operator is requested to submit documentation of the situation.

Waste rock site, refuse pile, sediment pond, ditch DA

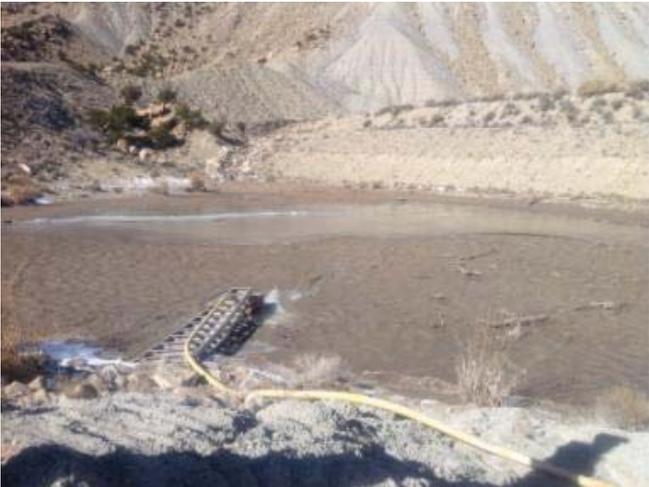
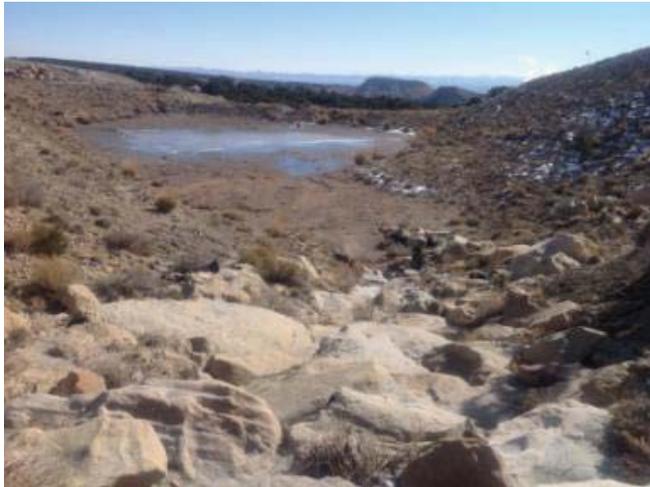
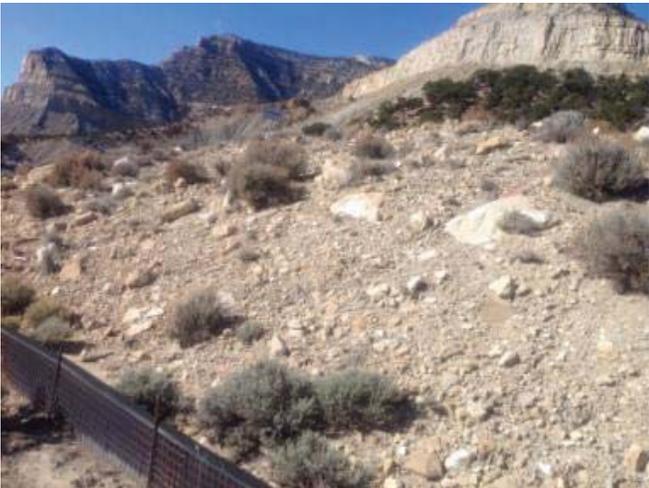
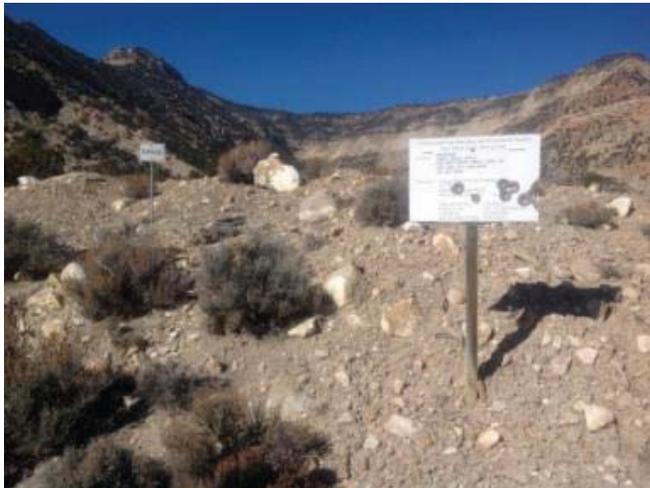
Silt fence at the south section of the subsoil pile at the waste rock storage site has overtopped and needs repair. Sediment from this area still reports to the sediment pond.

Waste rock site, refuse pile, sediment pond, sediment control fabric

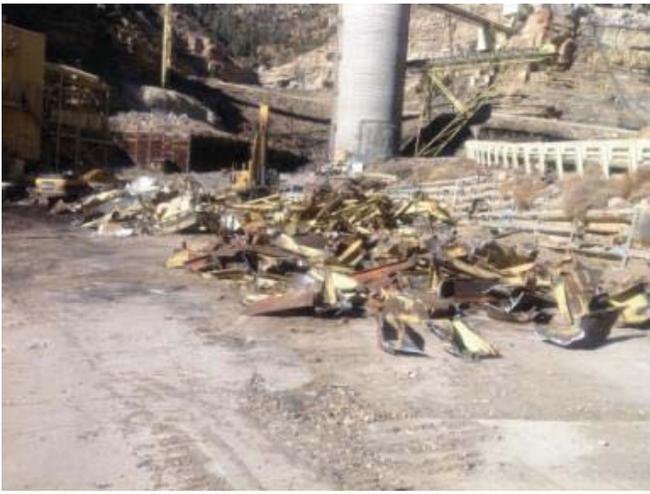
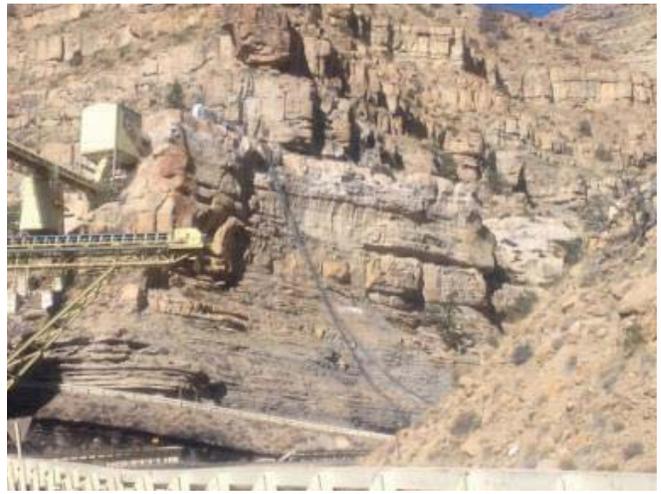
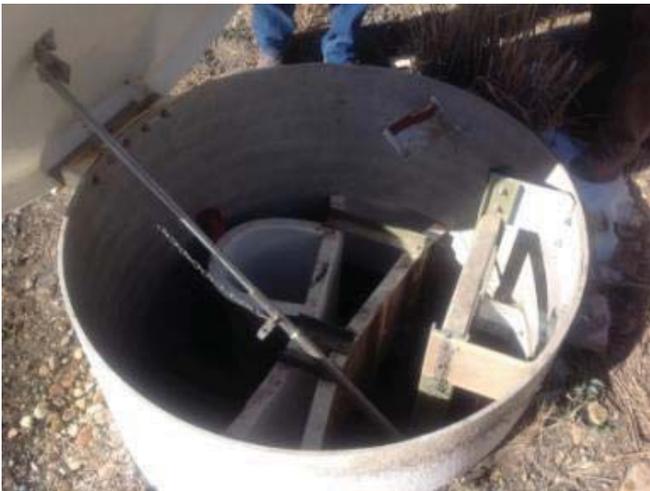
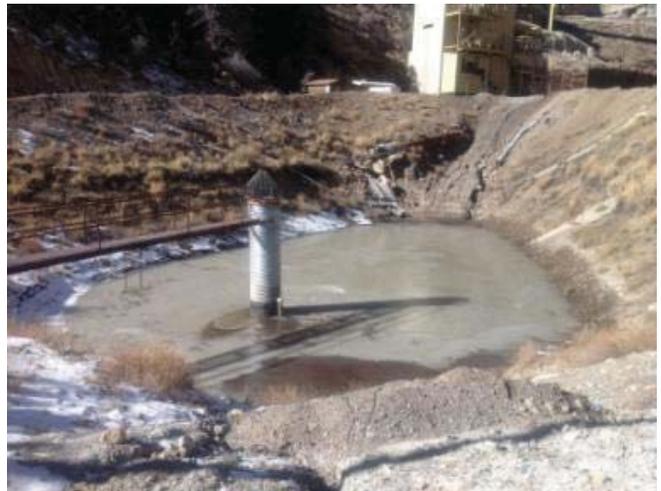
Obtained copy of Cottonwood Prep Plant MSHA Impoundment Inspection, Inspected by Guy Davis on 10/10/2014. The north sediment pond contains minimal water and the dam and slopes appear stable. Dam out slope rip-rap is intact. The south sediment pond is dry and a new culvert has been installed as it was noted as damaged in MSHA Inspection Report.

Water monitoring was reviewed at the office. Water reports were filed as required. Site 001A-routinely discharges and was observed as functioning properly

The steel structures at the loadout area are demolished and crushed and are being recycled. The substation was being demolished at the time of inspection. Operator stated the cement silo is anticipated to come down in the next few weeks.

Load out structure demo, substation removal, Discharge 001, No. Sed Pond
