# Inspection Report

Permit Number:	<b>C0150019</b>
Inspection Type:	COMPLETE
Inspection Date:	Thursday, May 21, 2015
Start Date/Time:	5/21/2015 10:40:00 AM
End Date/Time:	5/21/2015 2:45:00 PM
Last Inspection:	Friday, April 24, 2015

Permitee: **PACIFICORP**  
 Operator: **ENERGY WEST MINING CO**  
 Site: **COTTONWOOD/ WILBERG**  
 Address: **PO BOX 310, HUNTINGTON UT 84528**  
 County: **EMERY**  
 Permit Type: **PERMANENT COAL PROGRAM**  
 Permit Status: **ACTIVE**

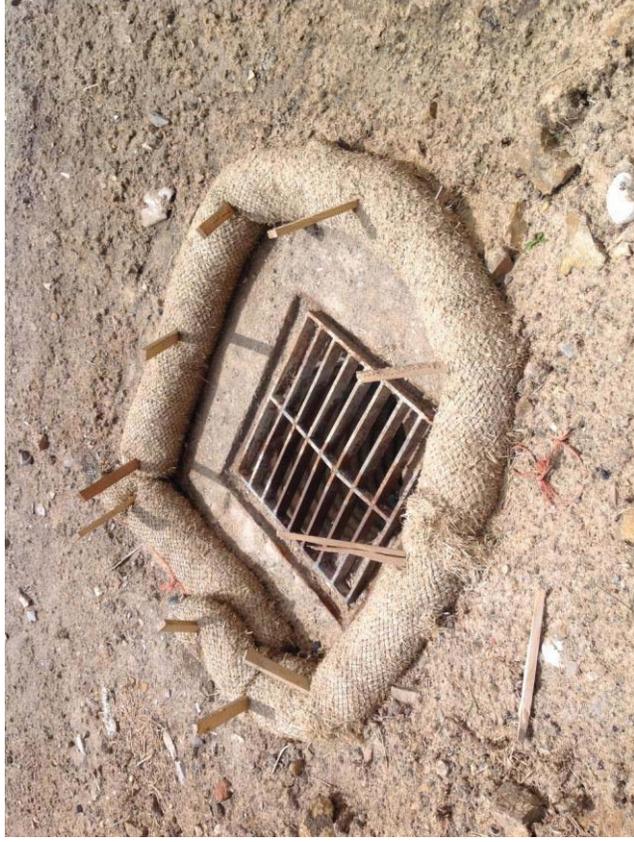
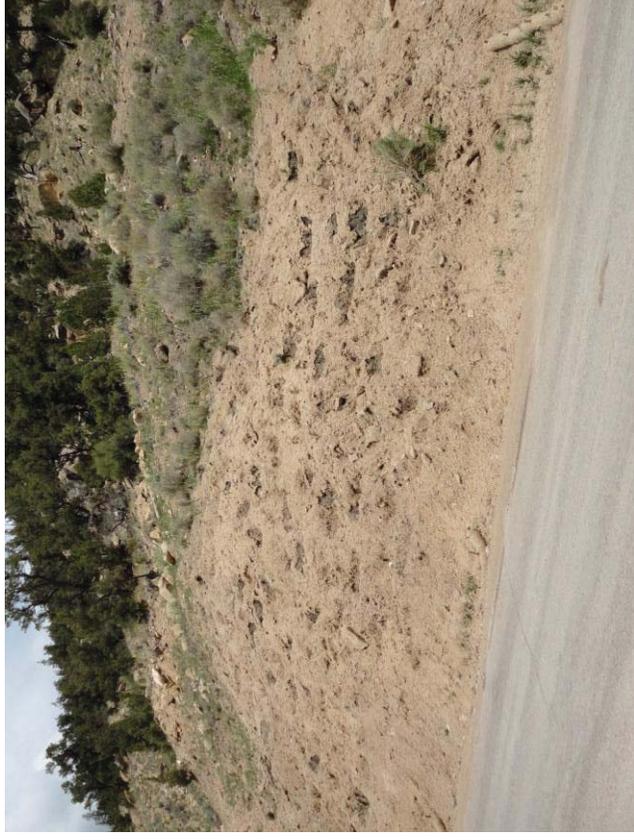
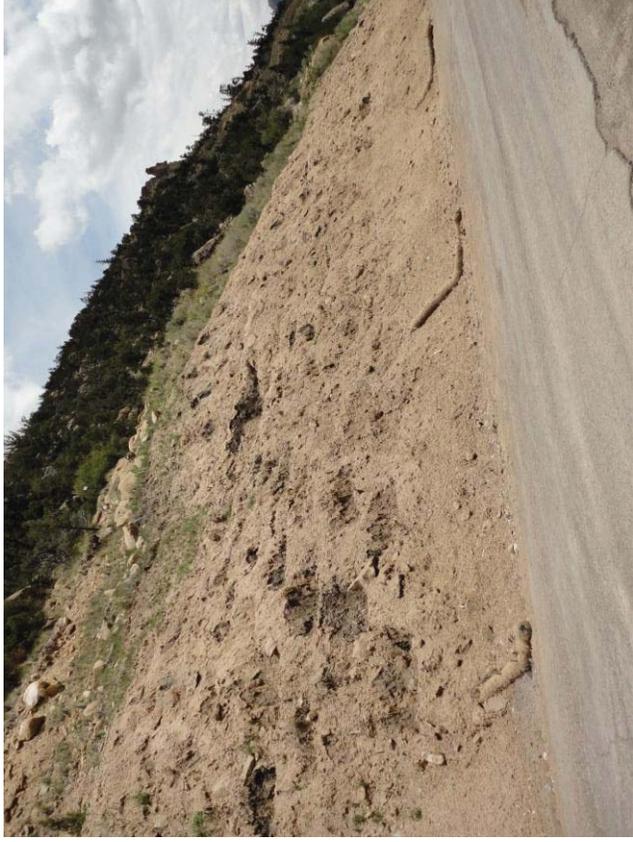
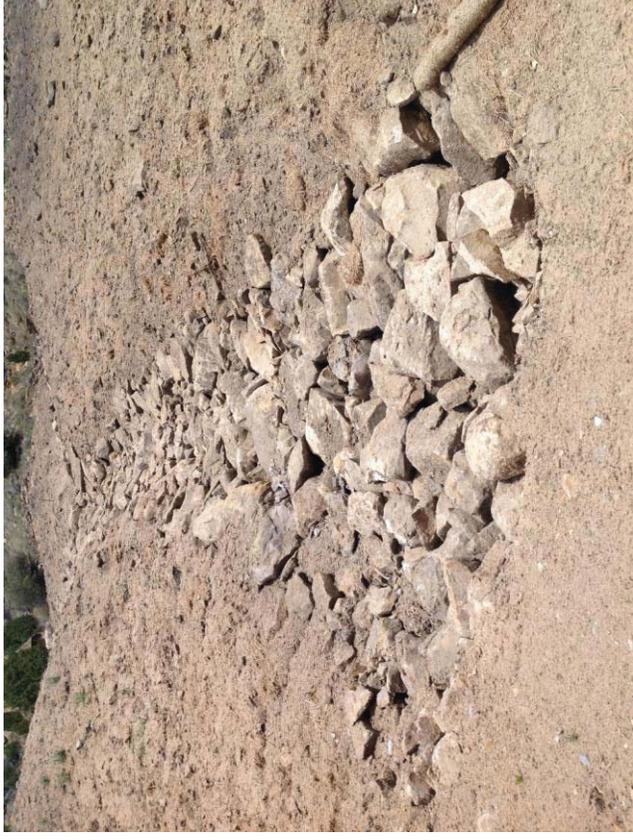
# Cottonwood Inspection 05/21/15 Cottonwood Fan Portal (Trail Mountain Access)

The permittee states that earth work is anticipated for late fall 2015 into winter and spring. Backfilling and grading of the Trail Mountain Access /Cottonwood fan portal is being has been conducted and appears to meet approximate original contour. Appropriate sediment controls are in place.

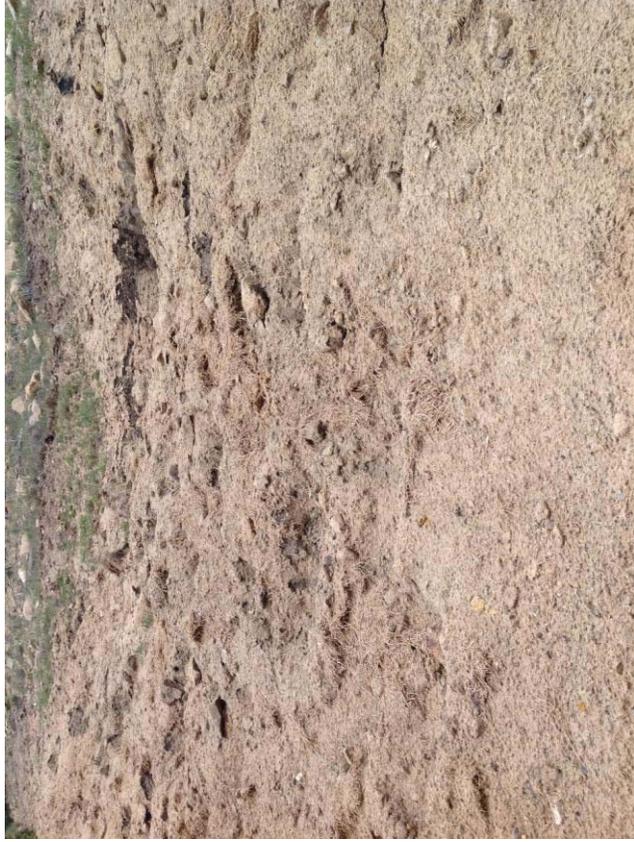
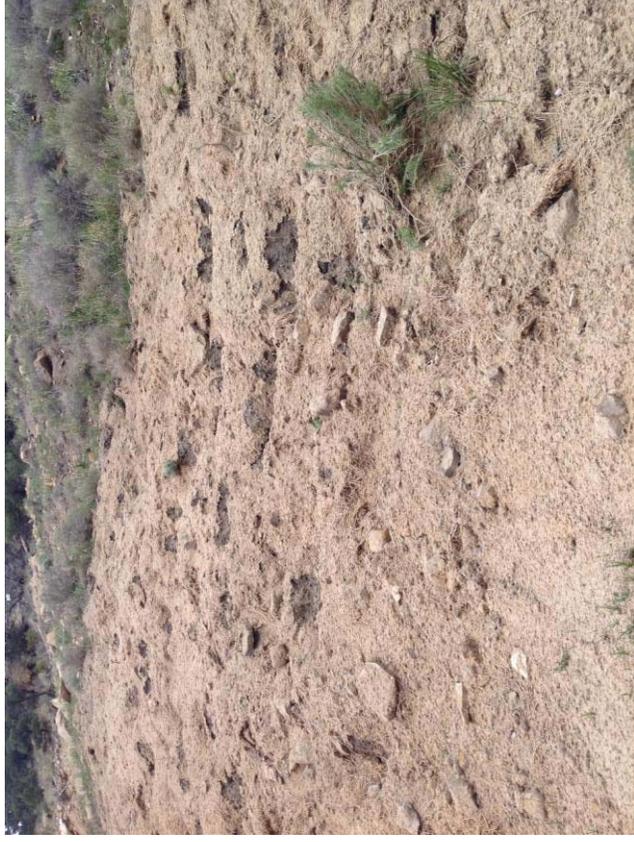
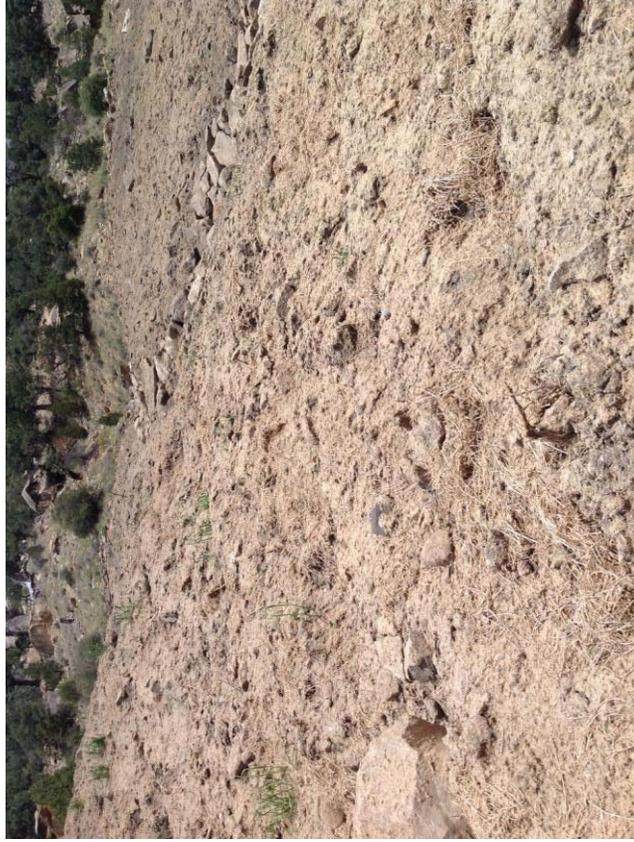
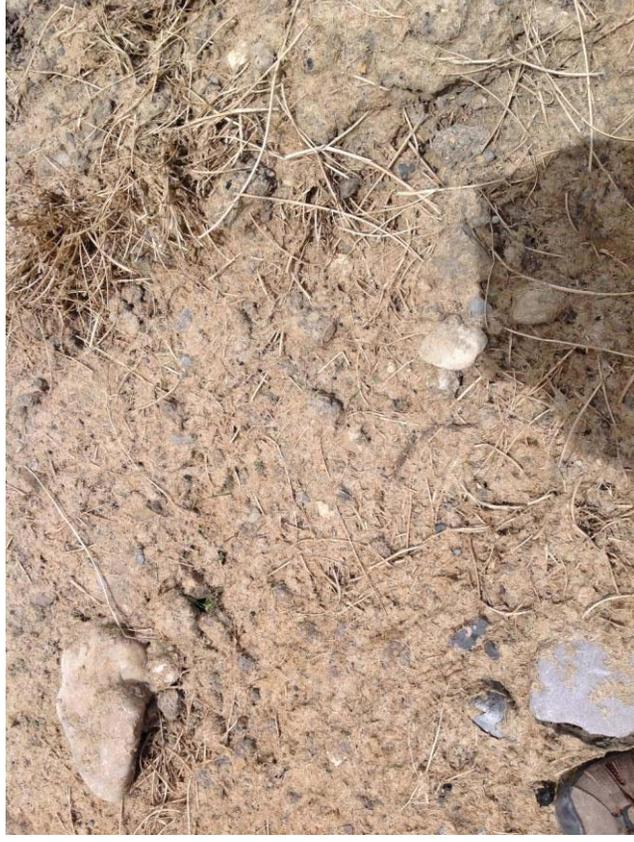
## Cottonwood Fan Portal (Trail Mountain Access) Veg Growth

Seed tags for the Cottonwood fan portal and grimes wash leach field have been submitted to the Division.

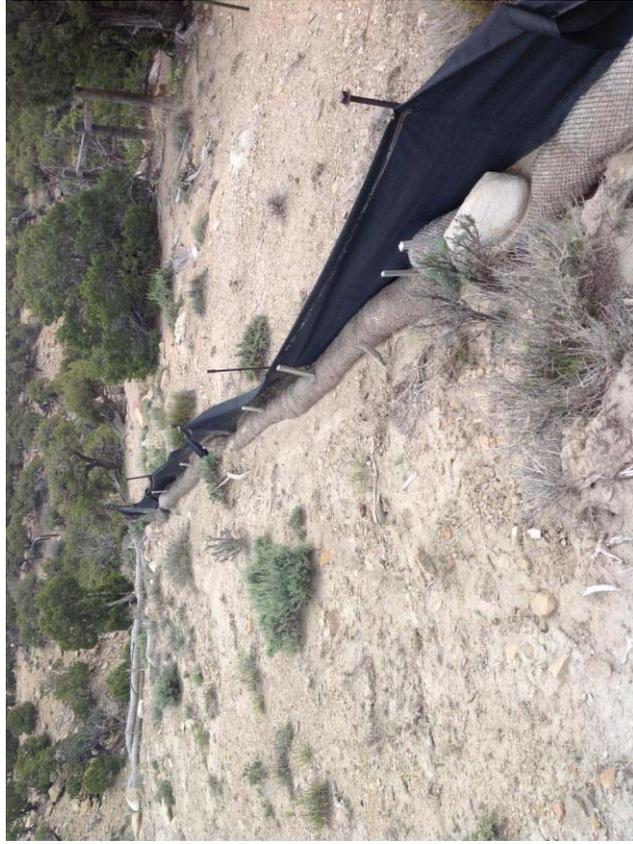
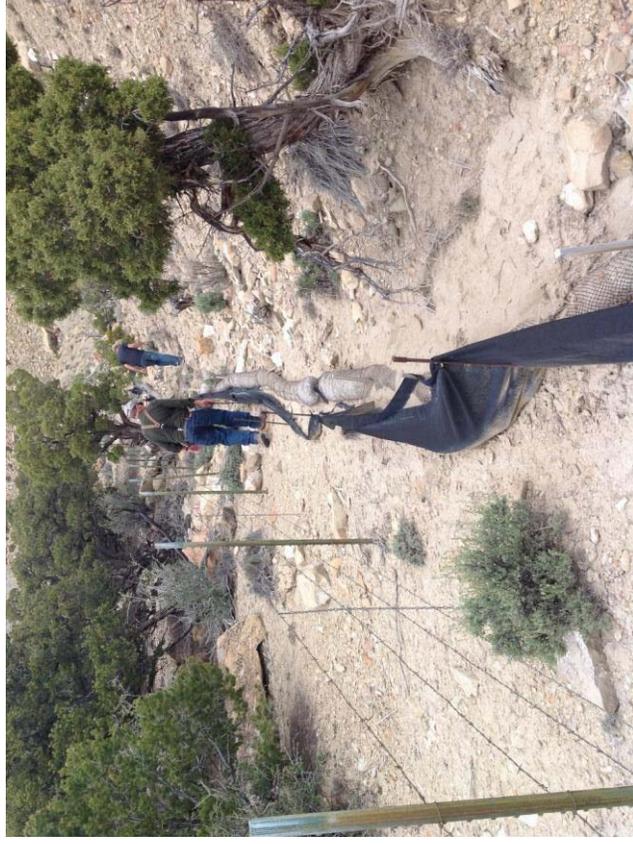
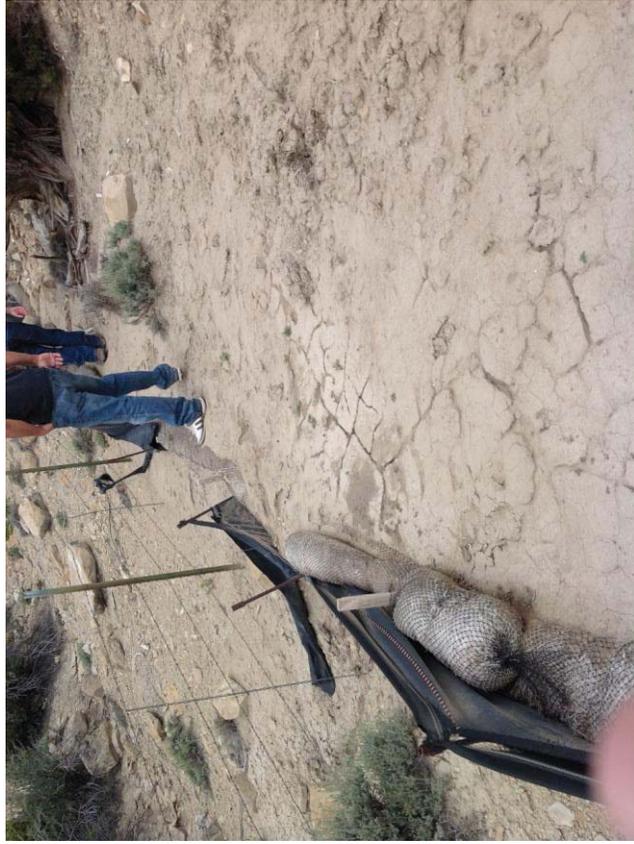
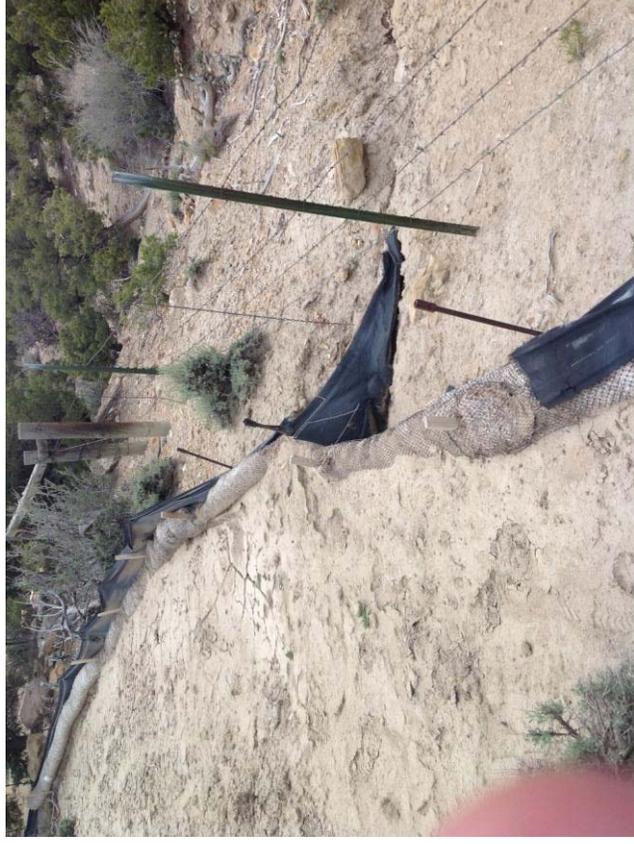
# Cottonwood Inspection 05/21/15 Waste Rock Site Top Soil Pile # 1

Waste Rock Site: All sediment controls and impoundments were inspected. For the most part, sediment control structures are in good repair. Waddles and silt fences at the base of topsoil #1 and 2 should be reinforced as they are at capacity in several areas. Due to recent cleaning of the sediment pond during muddy conditions, the access road is a little rough in spots and could impede designed water flow. The road should be regraded to ensure drainage from the road flows into the sediment pond as designed. Although it is not in the MRP, a silt fence or sediment control on the east side of the subsoil pile could be installed to prevent subsoil from migrating into the sediment pond.. NOTE: This is the last time the Waste Rock Site will be inspected as part of the Cottonwood/Wilberg Mine permit. From this point forward, the Waste Rock Site will be inspected as part of the Trail Mountain Mine permit. Almost all of the scrap and concrete are gone from the Silo yard. Concrete has been broken up and placed in the lower storage yard and also backfilled into portals along Rhino Run. All the buildings in the upper storage yard are gone and at the time of inspection there were 2 workers continuing removal of concrete and scrap. Drains and culverts are clear and ditches are maintained. We did not travel beyond the loading/unloading area due to the stage of reclamation and demolition. However, we walked Rhino Run and inspected all the portals and the conveyer and fan pads from a distance. The Cottonwood Fan Portal site has been completely reclaimed with the last augmented seeding taking place in the Spring of 2015. The site looks exceptionally well. Although it's early in the season, it was apparent that seeds have germinated and grass/forb seedlings are sprouting on the newly regraded site. Minor slumping is obvious above the

All top soil piles are located at the Waste Rock Site. Topsoil piles are signed and stable with adequate vegetative cover for the location. Waddles and sediment control structures should be maintained/repared in areas near capacity.

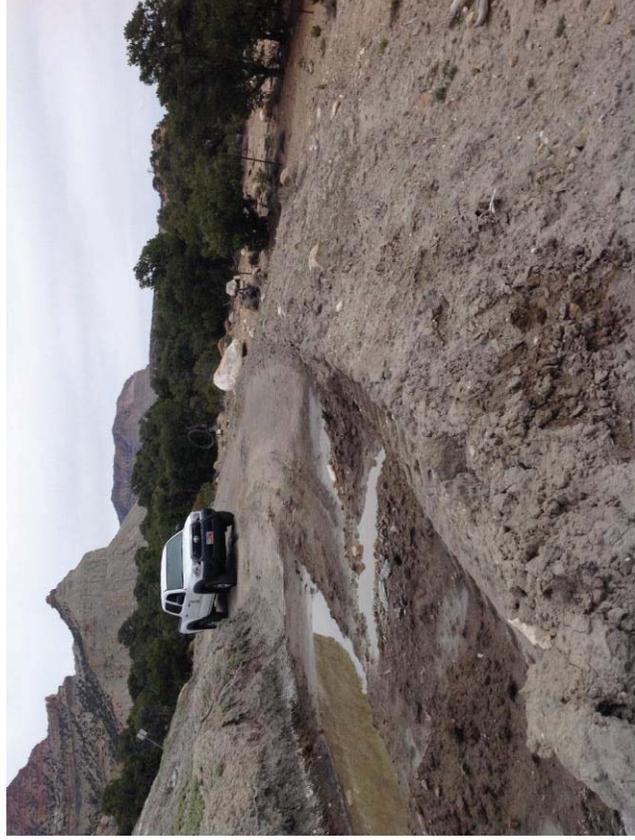
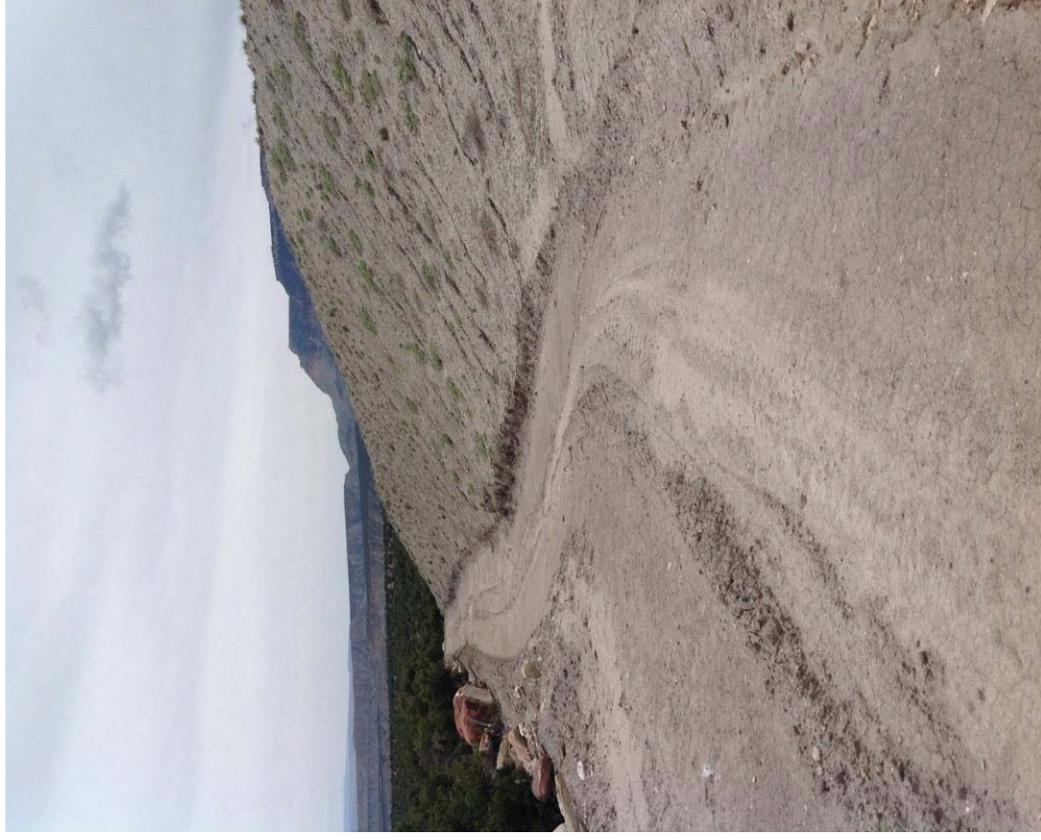
## Waste Rock Site Access Road

The access road around the subsoil pile at the Waste Rock Facility could be graded to facilitate drainage.
