Inspection Report

Permit Number:	C0150019
Inspection Type:	COMPLETE
Inspection Date:	Friday, November 20, 2015
Start Date/Time:	11/20/2015 11:00:00 AM
End Date/Time:	11/20/2015 1:30:00 PM
Last Inspection:	Tuesday, October 27, 2015

Permitee: **PACIFICORP**
 Operator: **INTERWEST MINING CO**
 Site: **COTTONWOOD/ WILBERG**
 Address: **PO BOX 310, HUNTINGTON UT 84528**
 County: **EMERY**
 Permit Type: **PERMANENT COAL PROGRAM**
 Permit Status: **ACTIVE**

Cottonwood/Wilberg Mine
Complete Inspection 11/20/2015

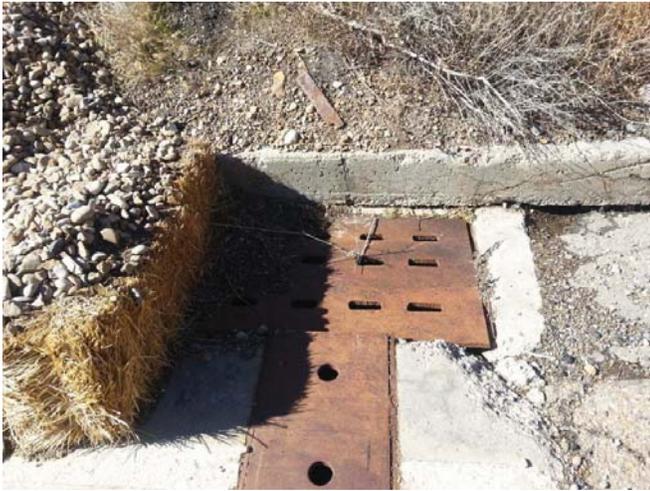
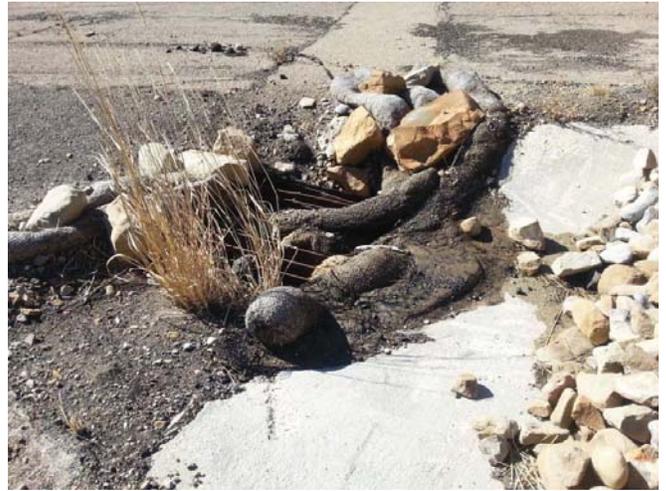
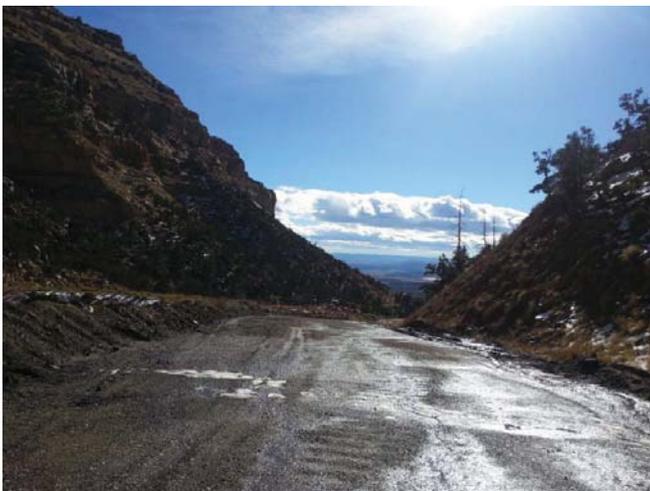
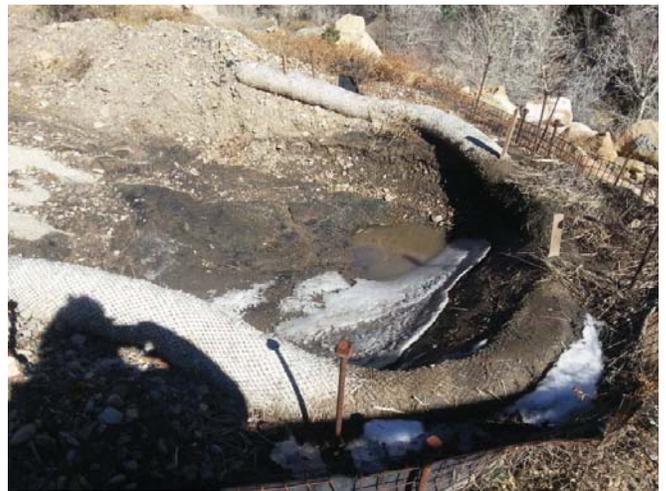
Cottonwood/Wilberg Mine
Complete Inspection 11/20/2015 : Hydrologic Balance

Ditches, diversions and culverts are constructed and functioning as designed. Due to the removal of all structures and road base, temporary gravel berms have been installed to divert water in lieu of curbing. At final reclamation, these berms will no longer be necessary. No abnormal erosion was observed in the diversions, outlets or downstream.

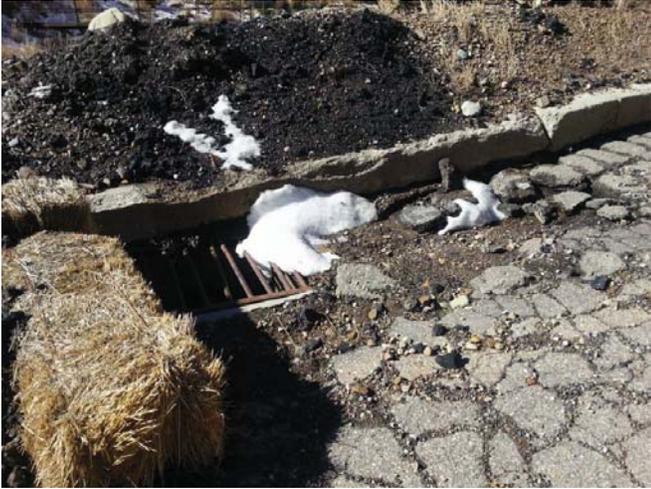
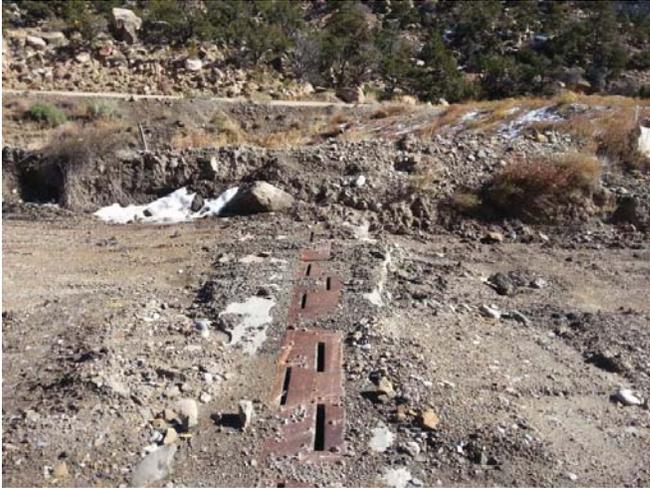
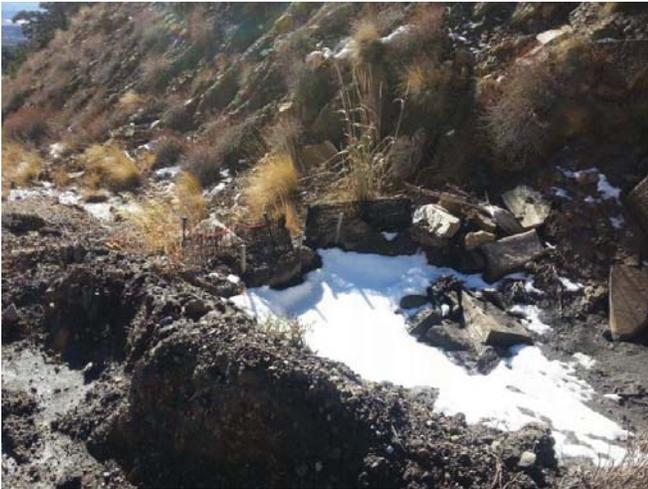
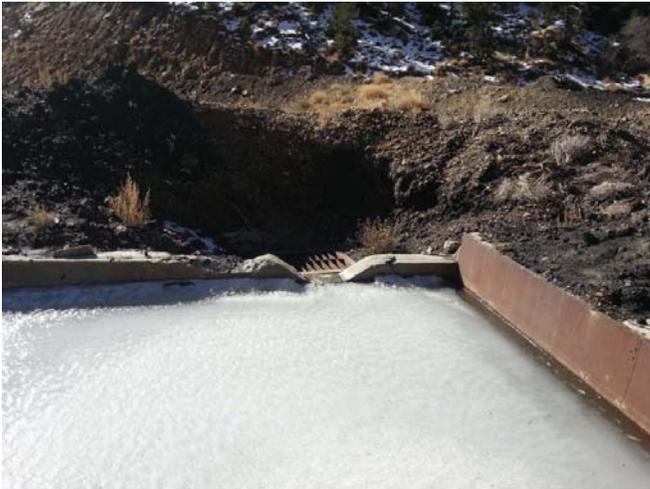
Cottonwood/Wilberg Mine
Complete Inspection 11/20/2015 : Hydrologic Balance

North sediment pond: Standing water was measured at 8.05' at the primary outlet. According to the inspection report, remaining sediment capacity is 0.24 AF. 60% Sediment storage capacity is at 7351.0 ft. Current sediment volume is 7348.0 ft. Water impounded is 0.029 AF.

South sediment pond: The southern sediment pond was dry and sediment level was 2.82'. 60% sediment storage capacity is .19 AF at 7322.3 ft. Current sediment volume is 0.00 with remaining storage capacity at 0.19 AF. Water impounded is 0.04 AF.

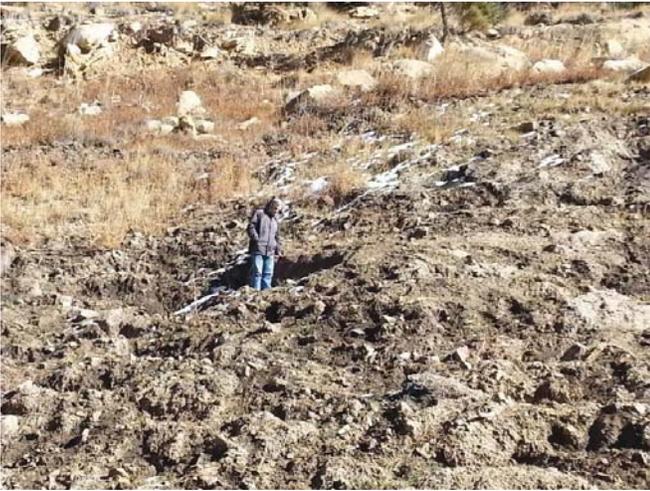
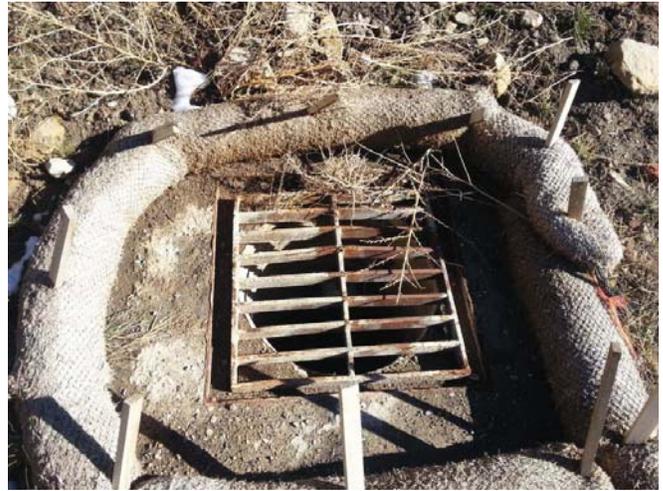
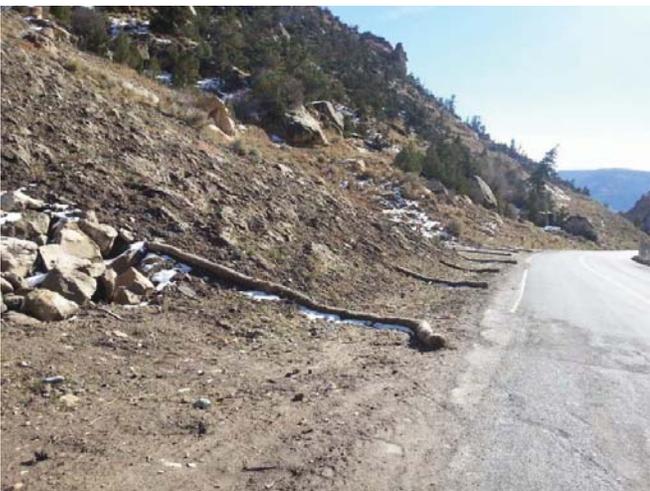
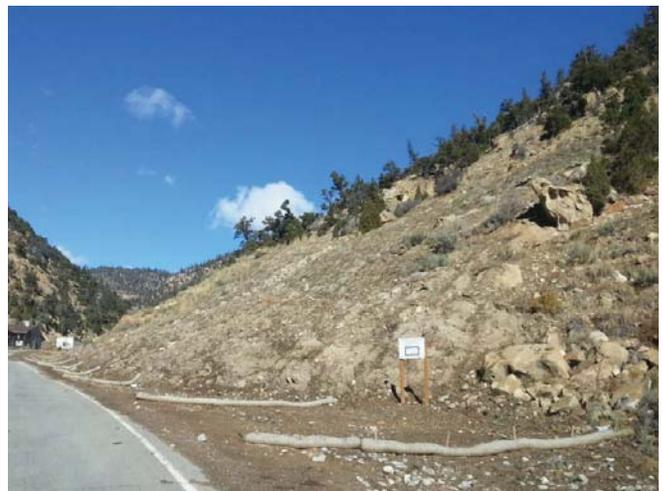
Cottonwood/Wilberg Mine
Complete Inspection 11/20/2015 : Cottonwood Fan Portal

Verified all required documents have been submitted to Division. Inspected the mine site and reclaimed cottonwood portal. No activities are occurring at present time. All demolition (with exception to facilities needed for earthwork) is complete and Interwest is redesigning reclamation plan prior to starting construction.
