Inspection Report

Permit Number:	C0150019
Inspection Type:	PARTIAL
Inspection Date:	Tuesday, March 20, 2018
Start Date/Time:	3/20/2018 10:00:00 AM
End Date/Time:	3/20/2018 2:00:00 PM
Last Inspection:	Wednesday, February 7, 2018

Permitee: **PACIFICORP**
 Operator: **INTERWEST MINING CO**
 Site: **COTTONWOOD/ WILBERG**
 Address: **PO BOX 310, HUNTINGTON UT 84528**
 County: **EMERY**
 Permit Type: **PERMANENT COAL PROGRAM**
 Permit Status: **ACTIVE**

ATTACHMENT A – Cottonwood Inspection March 20, 2018

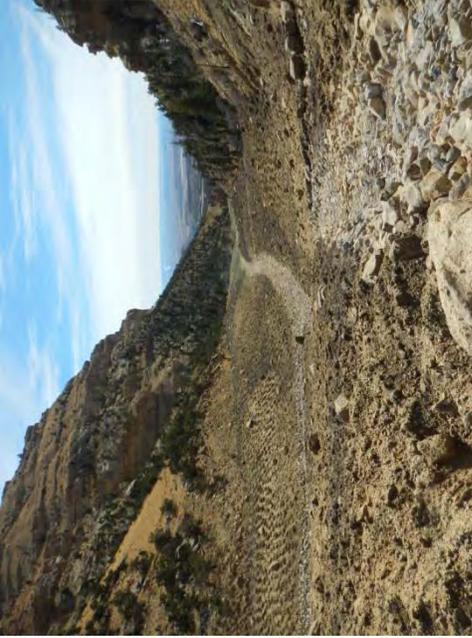
PHOTO 1 Looking down the reclaimed Main Drainage

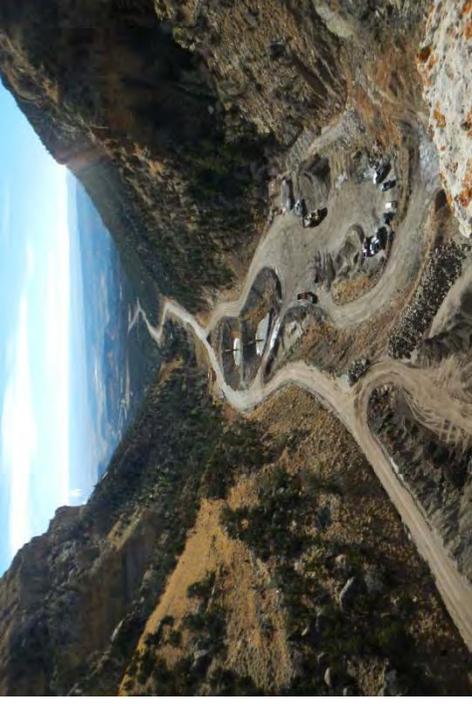
PHOTO 2 Main drainage before reclamation (Nov 2017)

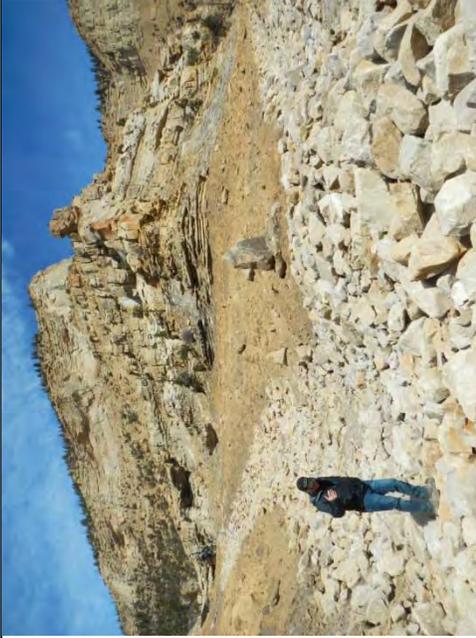
PHOTO 3 Confluence Left and Right Forks

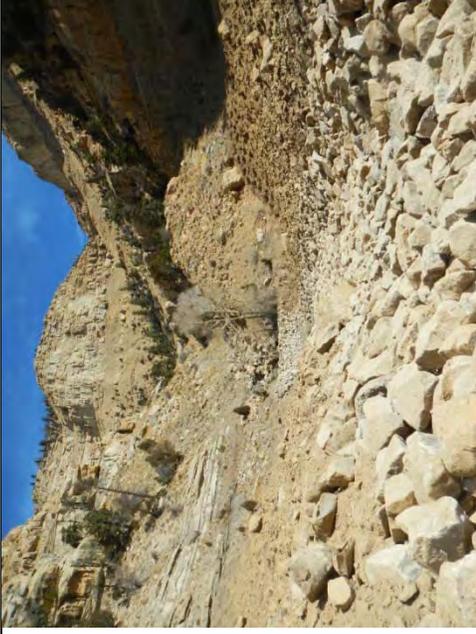
PHOTO 4 Upper Reach of Right Fork

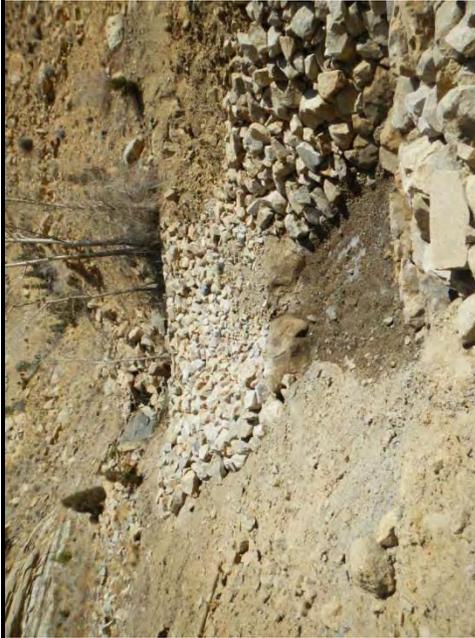
PHOTO 5 Looking upstream at pool formed at sandstone contact in Right Fork near the undisturbed boundary.

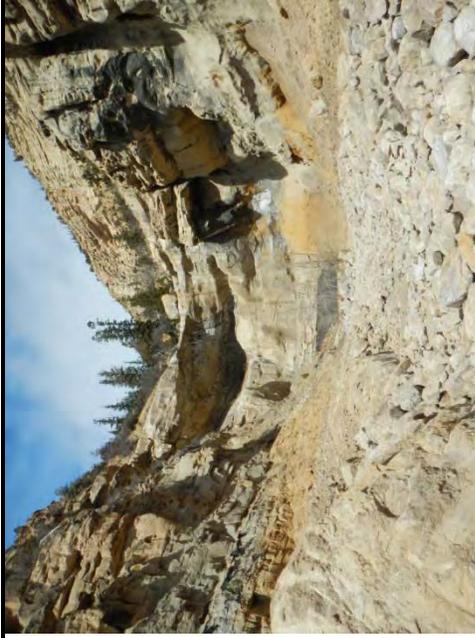
PHOTO 6 Looking upstream at Left Fork reclamation near undisturbed boundary.

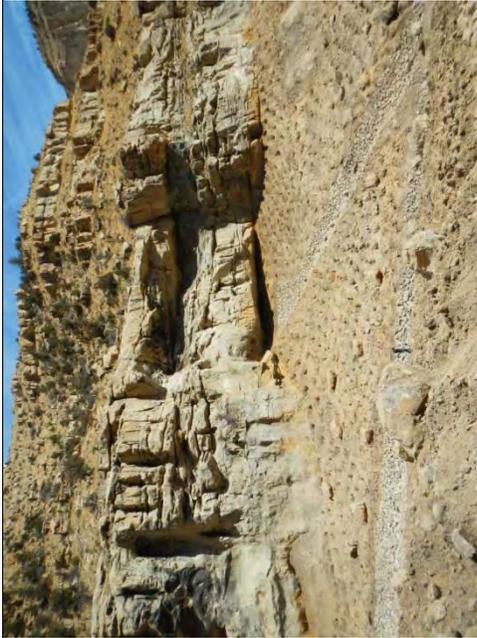
PHOTO 7
Left fork, Subdrainage and portal bench reclamation

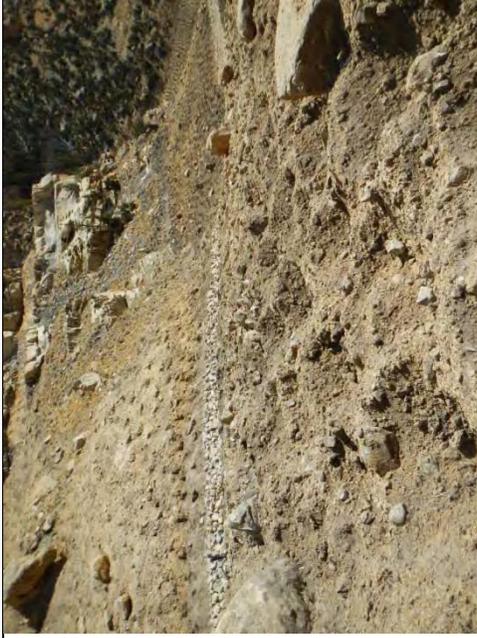
PHOTO 8
Hydromulch and gouging Left Fork

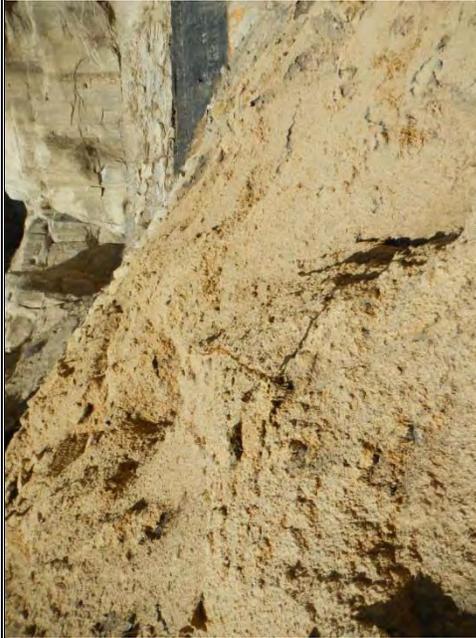
PHOTO 5 hydromulch coverage upper Left Fork

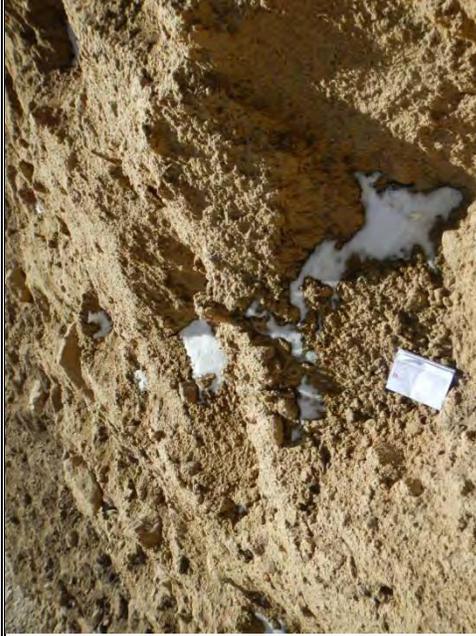
Large, 3 ft deep diameter pocks line the perimeter of the graded site. Smaller 18 inch pocks were created over the slopes. During the inspection an 18 inch bucket was being used to create the pocks. To demonstrate sediment control by pocking, Mr. Oakley will establish a rain gauge, three Manning remote water samplers, two sediment transects and 4 sediment monitoring points as shown on Plate 4E.

PHOTO 6 Pocking at base of cliffs West side upper Left Fork map is 6 x 8 inches

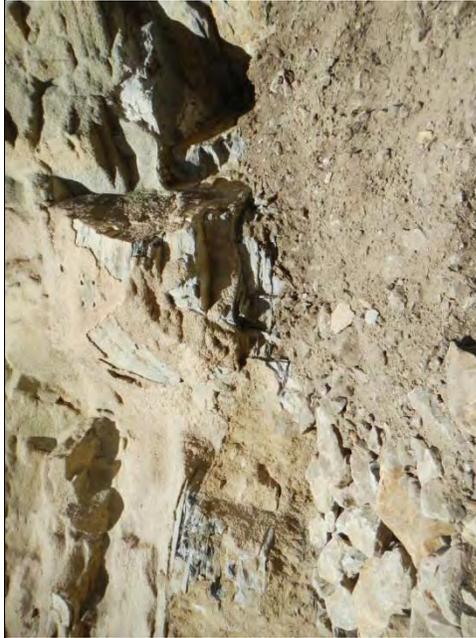
PHOTO 7

Wood fiber hydromulch was applied at a rate of 2,000 lbs/acre over the fertilizer and seed. A small area in the upper reach of the first sub-drainage below the Left Fork had little hydromulch coverage. But the remainder of the site had good coverage.

Noted an area with little to no hydromulch at the outcrop, West side subdrainage Left Fork

Seeding and fertilizer/hydromulching of the last 300 ft² of reclaimed area and the topsoil storage area will be completed this week. After which, the hydro-truck access will be ripped, covered with soil, seeded, and fertilizer/hydromulched.
