Subject: Reconnaissance Inspections for UPDES Permit Nos. **UT0022896 - Cottonwood/Wilberg Mine & UT0023604 – Deer Creek Mine**

INSPECTION PROTOCOL

UPDES Permit #: UT0022896
Inspection Type: Reconnaissance Inspection
Inspection Date: July 31, 2019
Weather Conditions: Cloudy, mild with light rain, ~70°F

UPDES Permit #: UT0023604
Inspection Type: Reconnaissance Inspection (RI)
Inspection Date: July 31, 2019
Weather Conditions: Cloudy and mild with light rain, ~70°F

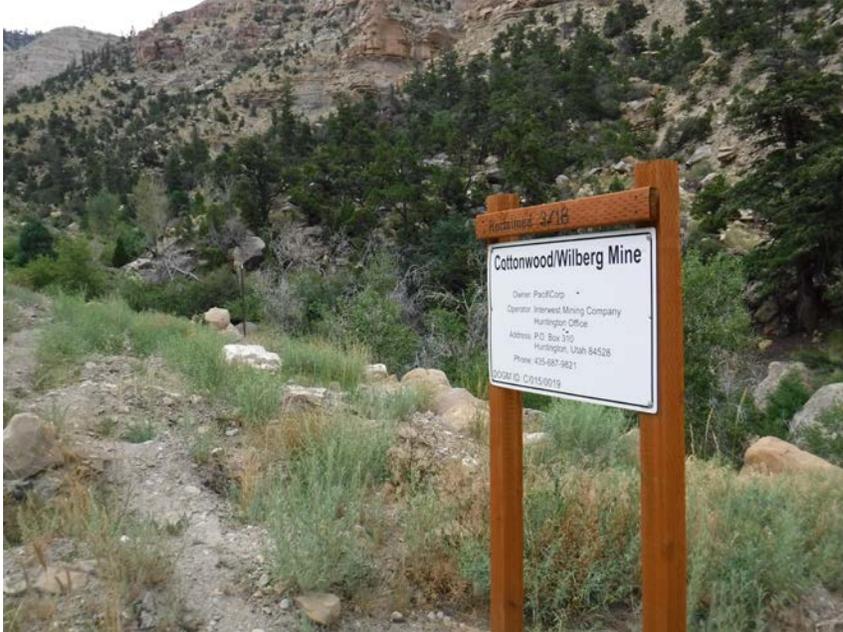
1. Former gated entrance location to mine site, now reclaimed.

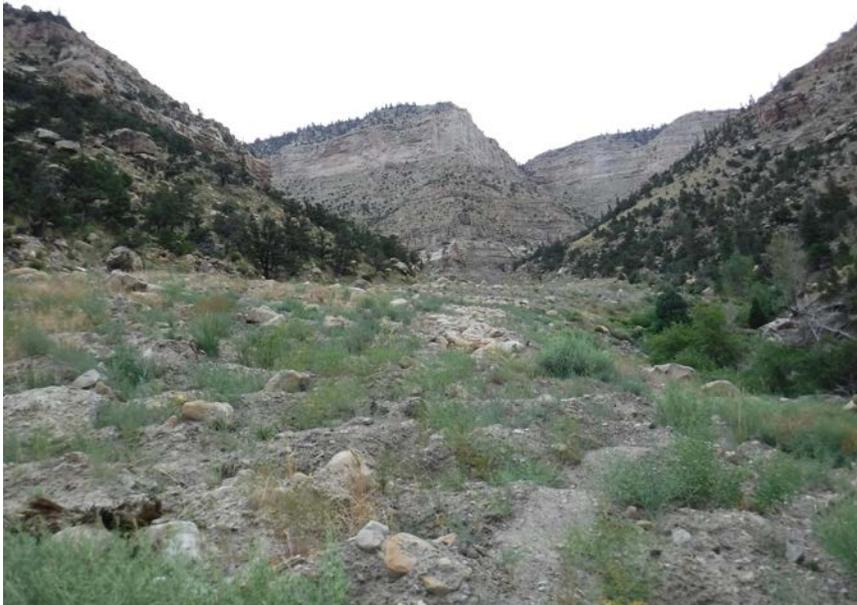
2. View of reclaimed mine site, former sed ponds and outfall 003.

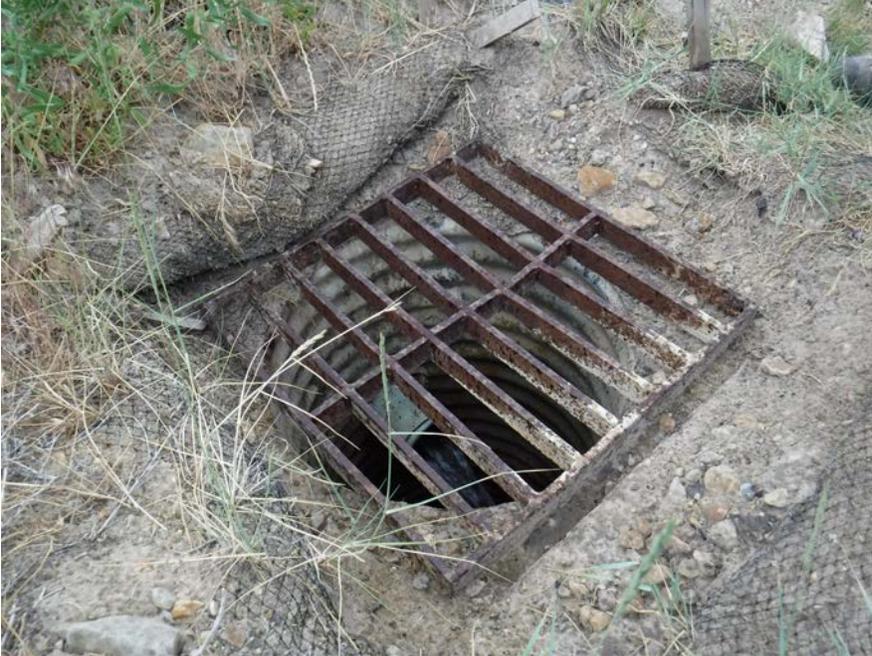
Permit requirements and reclamation activities were reviewed at the Huntington office, which was followed by a facility tour. The outfall locations, both current (001) and former (003), were observed as well as the receiving waters of Cottonwood Canyon Creek. Outfall 001 was flowing clear and steady with no issues observed. Site photos were collected and included herein. The Storm Water Pollution Prevention Plan was reviewed on site and determined to be adequate to meet the permit requirements, even though there are no remaining undisturbed areas on site that would discharge anything but storm water. DWQ was on site from approximately 10:20-11:30 am.

3. Roadside location of discharging Outfall 001 in Cottonwood Canyon.

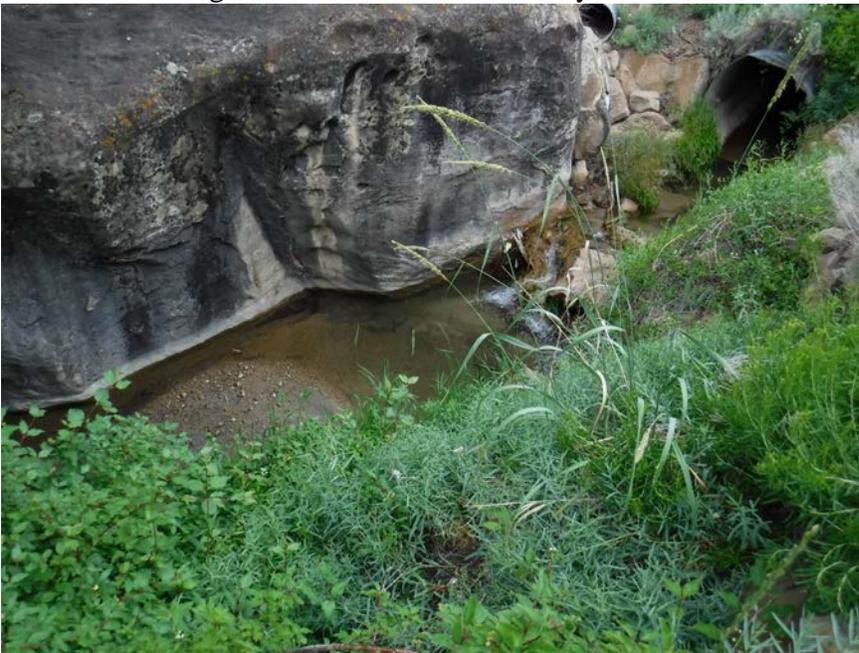
4. Receiving waters of Cottonwood Canyon Creek.

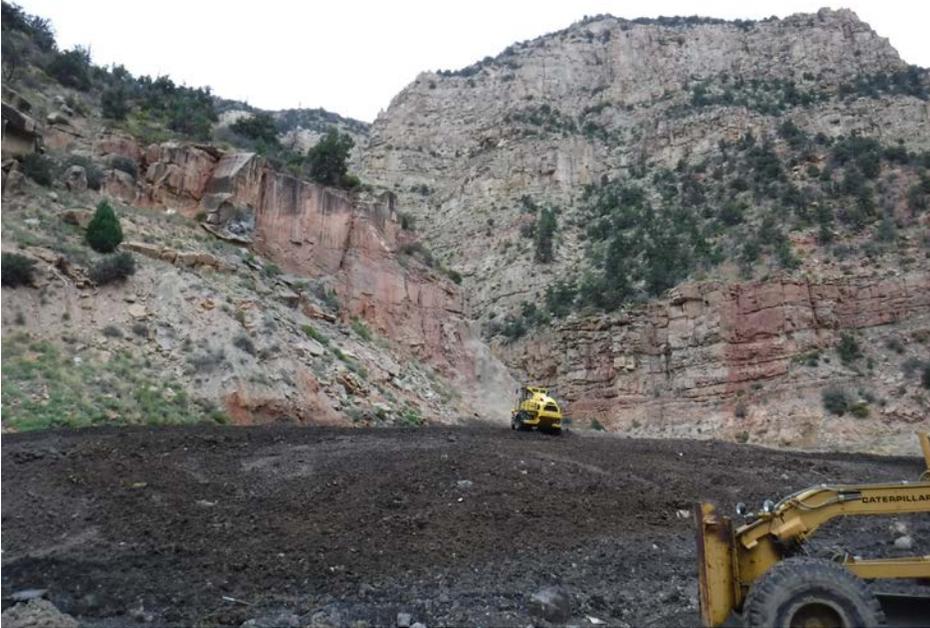
1. Reclamation activities underway at former Deer Creek Mine site.

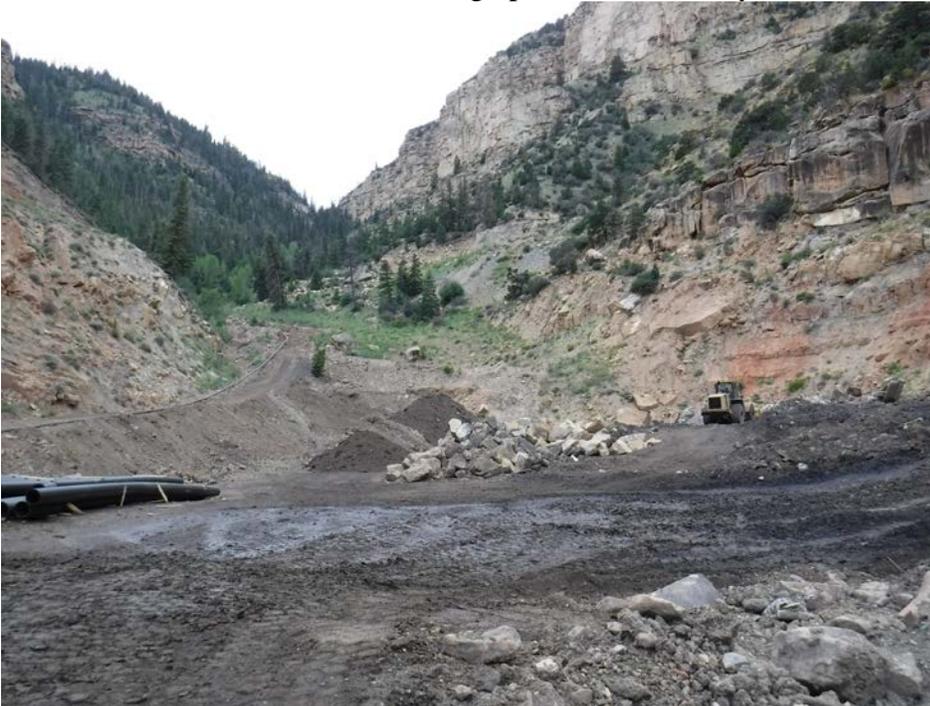
2. Reclamation activities looking up Deer Creek Canyon from Outfall 002 area.

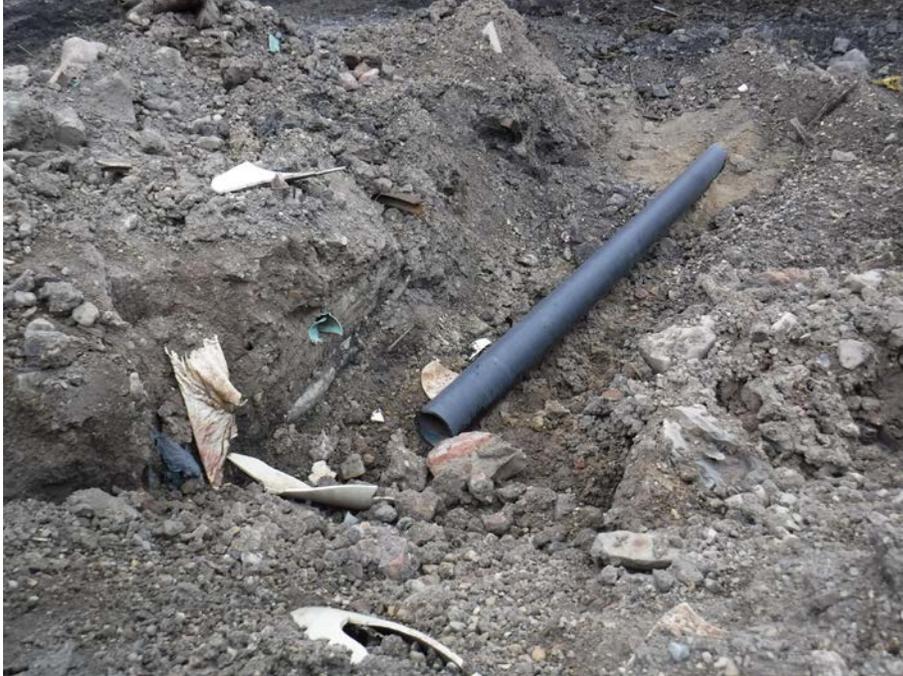
3. Outfall 002 currently in place at reclamation site.

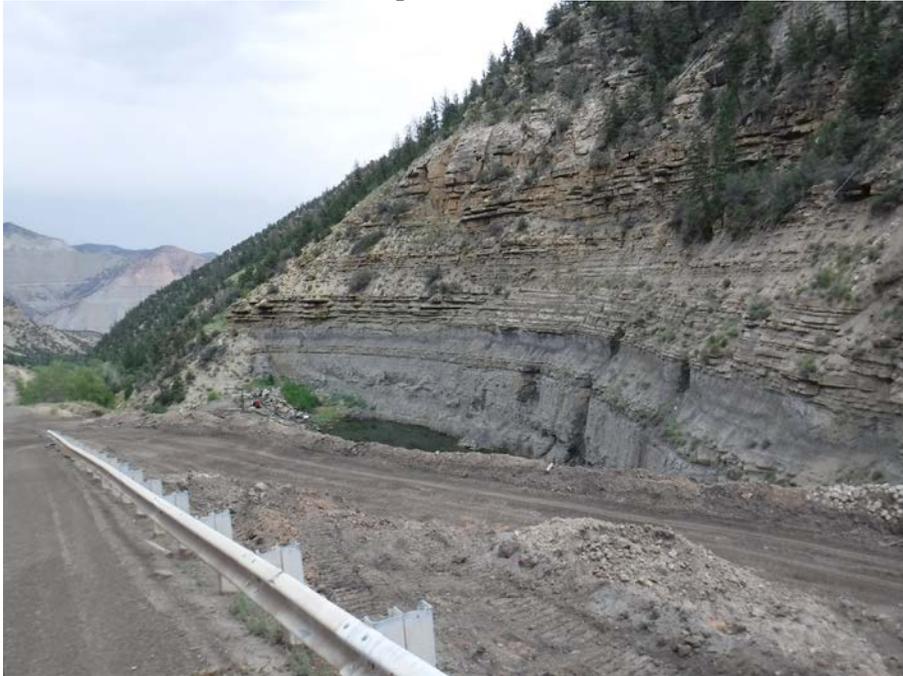
4. View of sedimentation pond (Outfall 001).

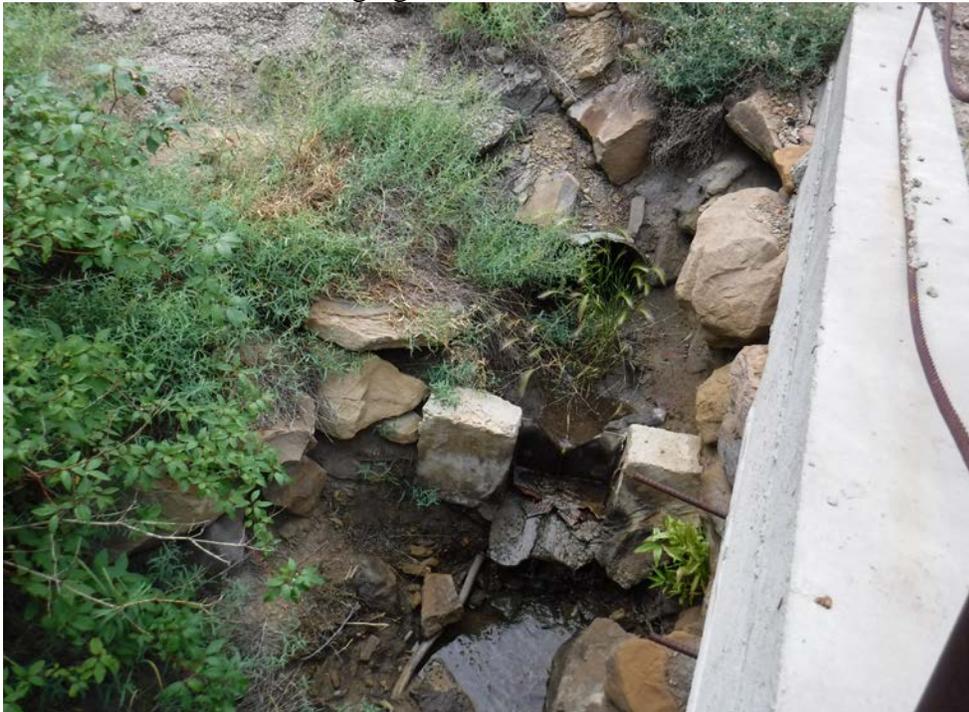
locations (001, 002, and 003) were observed as well as the receiving waters of Deer Creek and Huntington Creek. Outfall 001 from the existing sedimentation pond was slowly discharging <10 gpm and flowing clear with no issues observed. Outfalls 002 & 003 were not discharging and no evidence of any prior discharges. Site photos were collected and included herein. DWQ was on site from approximately 11:50 am to 1:35 pm.

5. Outfall 001 discharging. Note the low flows from the v-notch weir.

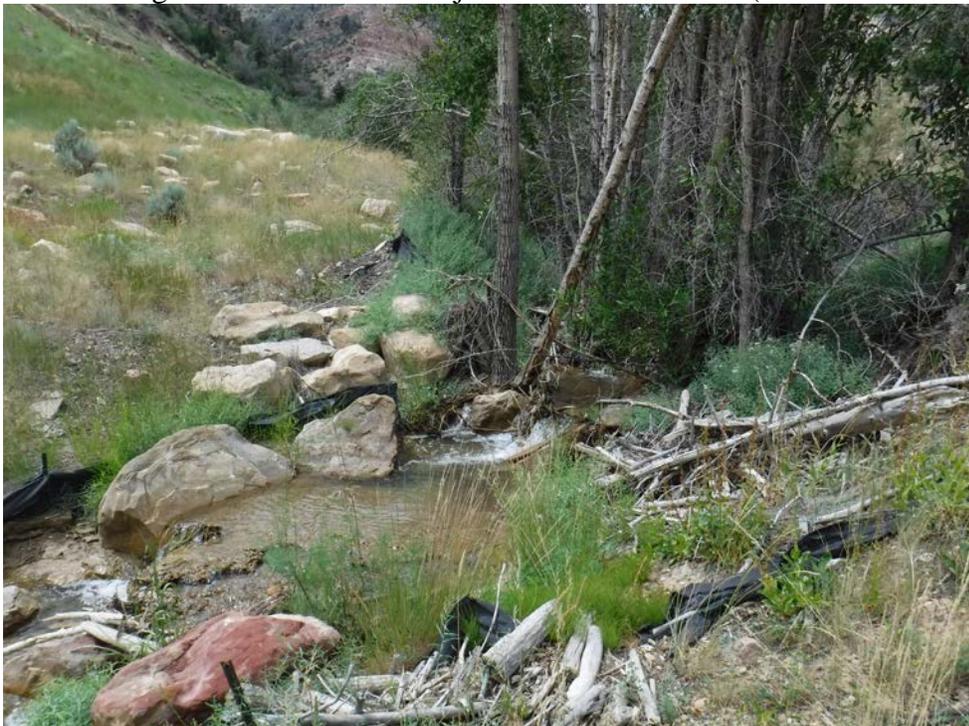
6. Receiving waters of Deer Creek just below Outfall 001 (also SUM-A sample location).

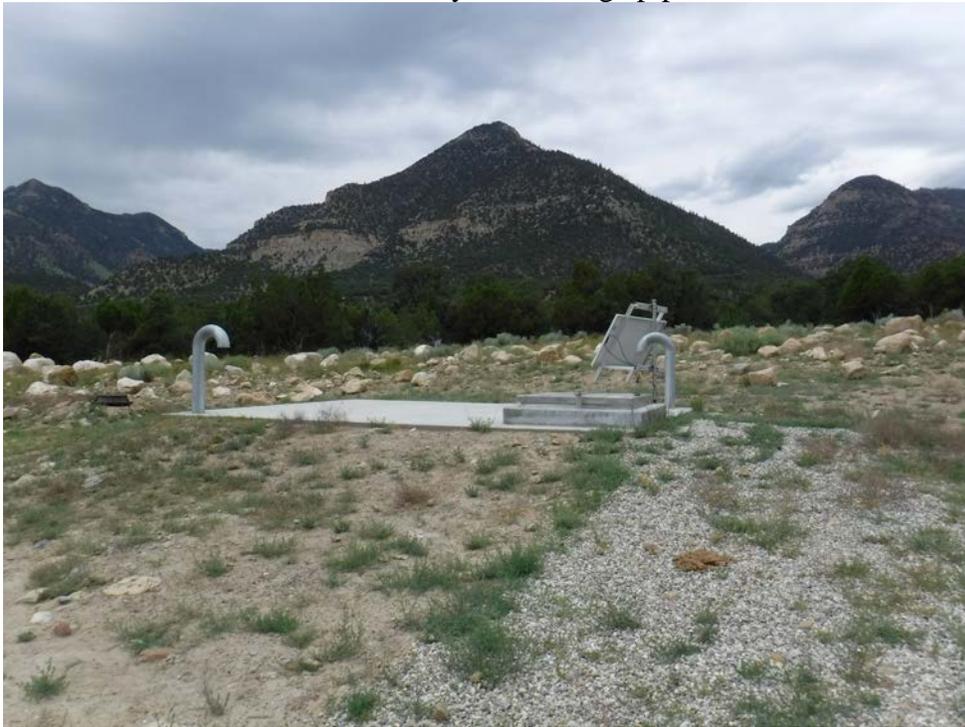
7. Flow control vault for Rilda Canyon discharge pipeline.

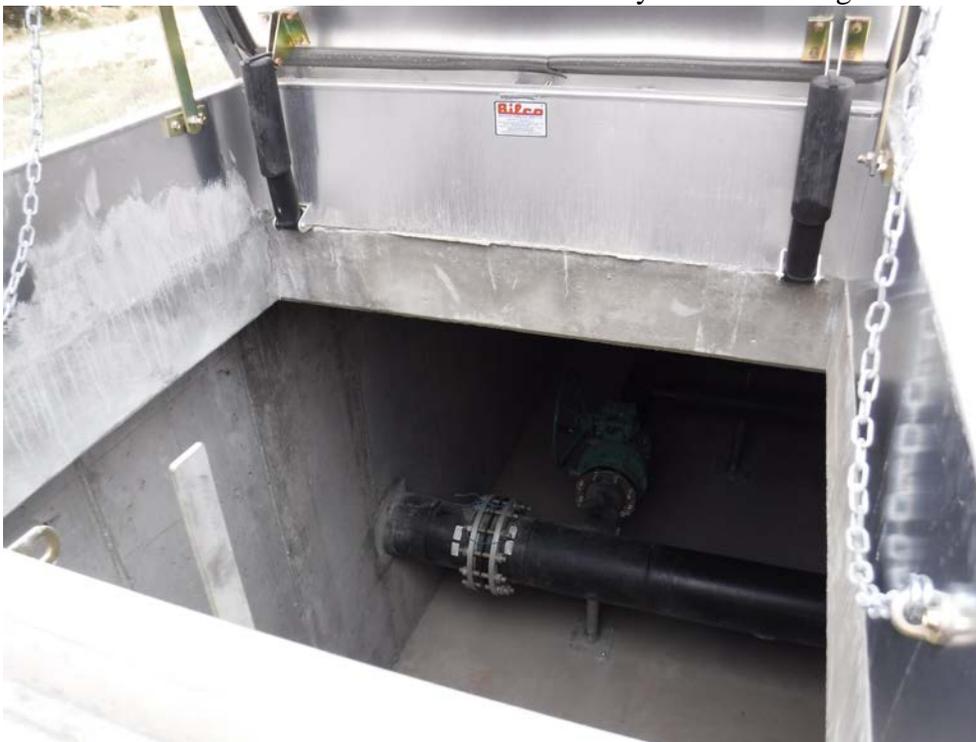
8. Inside view of vault. Note manual valve for any future discharges via Outfall 003.

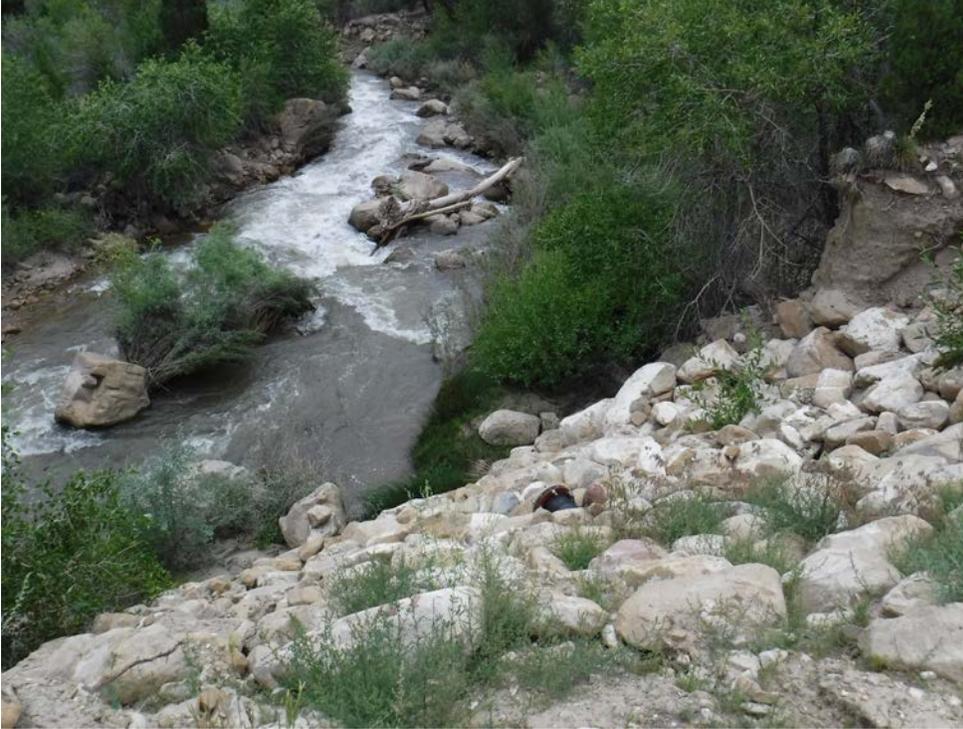
9. Outfall 003 (black pipe sticking out of rocks) and receiving waters of Huntington Creek.

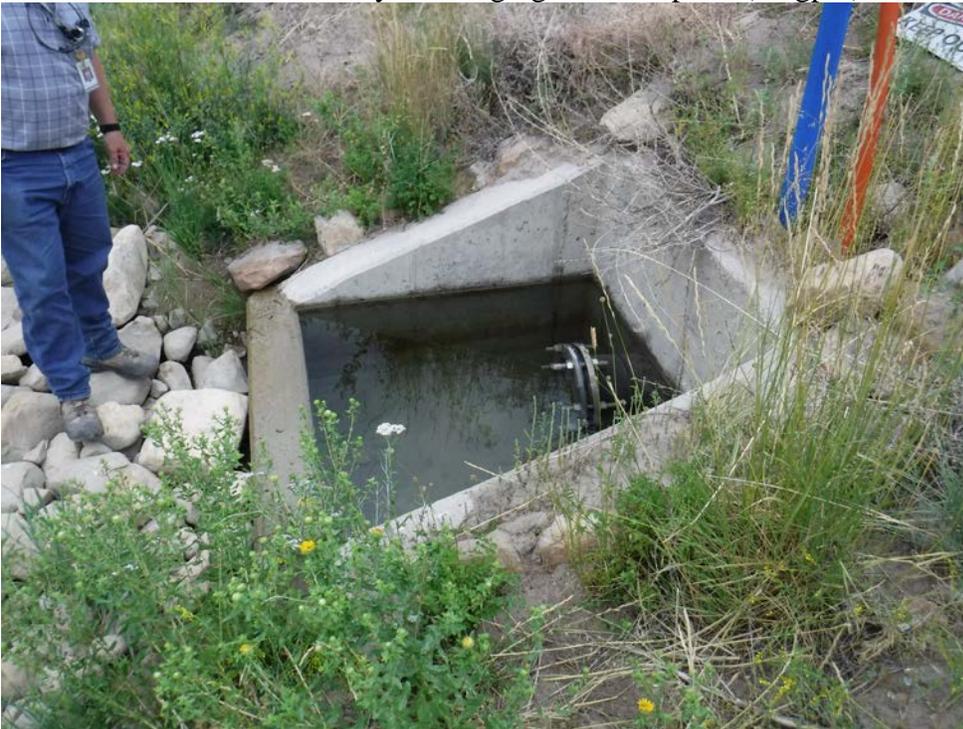
10. Rilda mine water currently discharging to onsite pond (~ 3gpm).

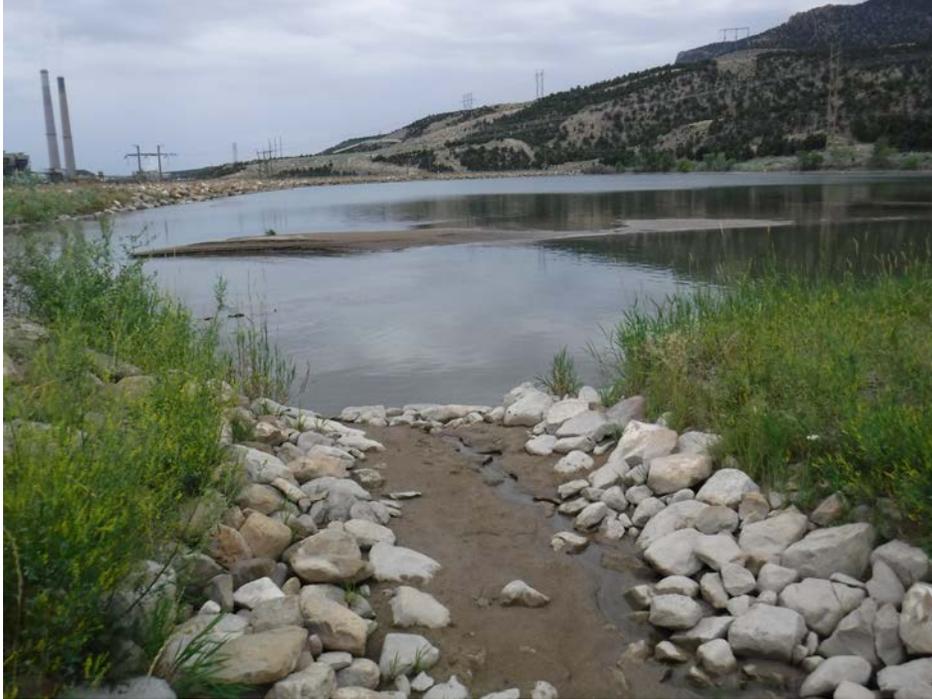
11. Discharge into Raw Water Pond onsite for consumptive use by power plant operations.
