# Inspection Report

Permit Number:	<b>C0150019</b>
Inspection Type:	BOND RELEASE
Inspection Date:	Tuesday, March 24, 2020
Start Date/Time:	3/24/2020 10:00:00 AM
End Date/Time:	3/24/2020 2:00:00 PM
Last Inspection:	Tuesday, February 11, 2020

Permitee: **PACIFICORP**  
 Operator: **INTERWEST MINING CO**  
 Site: **COTTONWOOD/ WILBERG**  
 Address: **PO BOX 310, HUNTINGTON UT 84528**  
 County: **EMERY**  
 Permit Type: **PERMANENT COAL PROGRAM**  
 Permit Status: **ACTIVE**

This is an inspection for a Phase II and III Bond Release of 0.08 acres. The 0.08 acres will be used as an Emery County truck turn around. This area will be used mostly in the winter time for snow plows to turn and go back down the road. This area did receive Phase 1 Bond Release on May 7, 2019. However, this area's contours have been changed from it's Phase 1 constructed hillside into a level area for a truck turnaround. The Division approved construction of the truck turn-around on October 24, 2019. Emery County Road Department did the construction of the turn-around. All designs and calculations were done by Johansen and Tuttle Engineering.

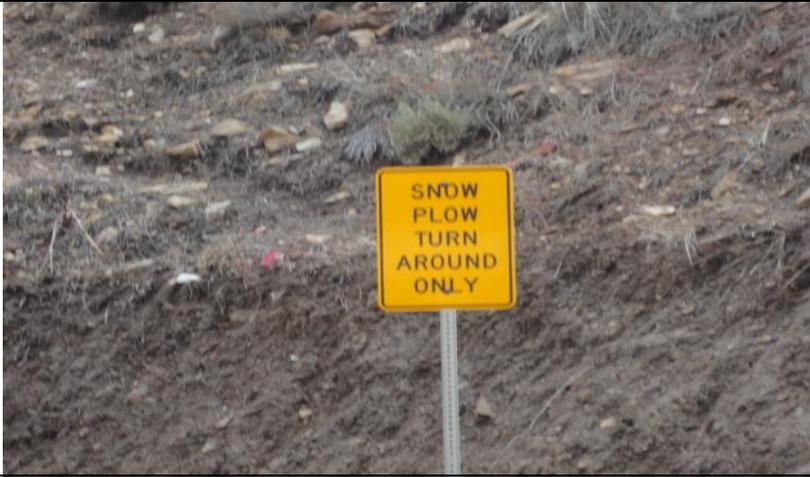
**PHOTO 5**

The road department has installed a sign stating "Snow Plow Turn around". See Photo

Sign Stating Turn-A-Round

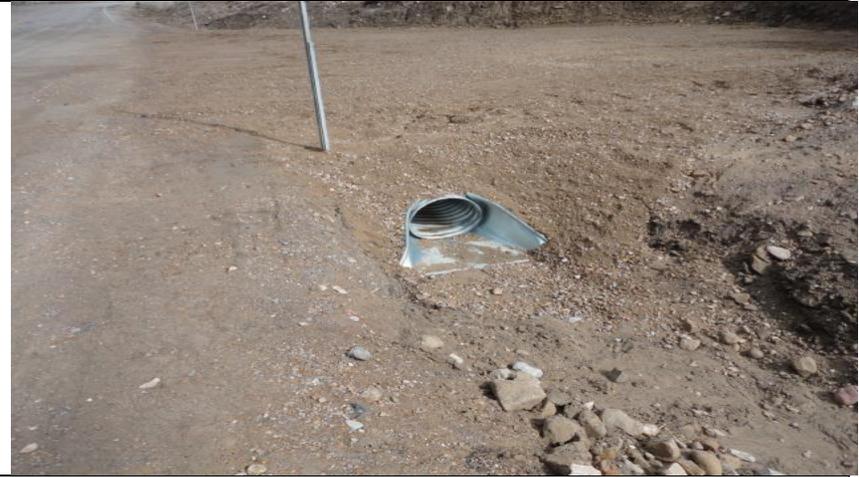
**PHOTO 6**

An 18 inch culvert has been installed along the road for the length of the road turn around.

New culvert (outlet) for Road Drainage.

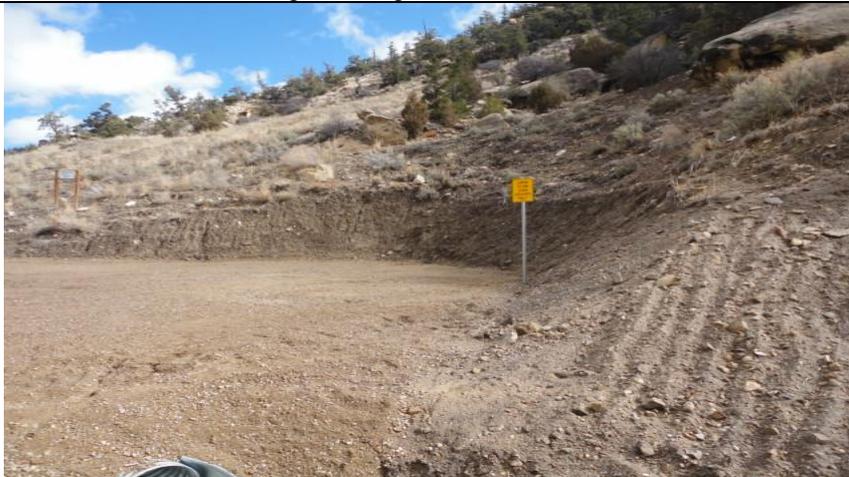
**PHOTO 7**

Overview of Turn-A-Around
