Subject: Phase II and III Bond Release of Truck Turnaround Area, PacifiCorp,  
Cottonwood/Wilberg Mine, C/015/0019, Task #6084

**PID:** C0150019  
**TaskID:** 6084  
**Mine Name:** COTTONWOOD/ WILBERG  
**Title:** PHASE II & III BOND RELEASE TRUCK TURNAROUND

## Inspection Report

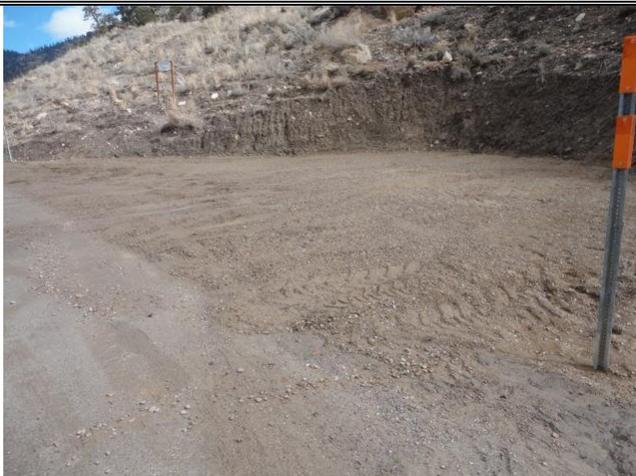
The turnaround was developed by removing the material from the hillside. A greater than 2:1 slope was formed with no stabilization measures in place. It is likely that erosion will occur on and above this cutslope after a rainstorm. The area above the cutslope is currently in year 6 of the liability period. Rills will likely form in the Phase I bond released area above the cutslope. If rills are formed in the Phase I area; it is unlikely the permittee will receive Phase II and III bond release. It is recommended that additional action be taken to prevent erosion of the Phase I area above the turnaround or reduce the cutslope angle to 2:1.

**PHOTO 1**  
Cutslopes Turn around

R645-301-553.130: Permittee must propose a method for stabilizing the cutslopes within the vicinity of the constructed truck turnaround.

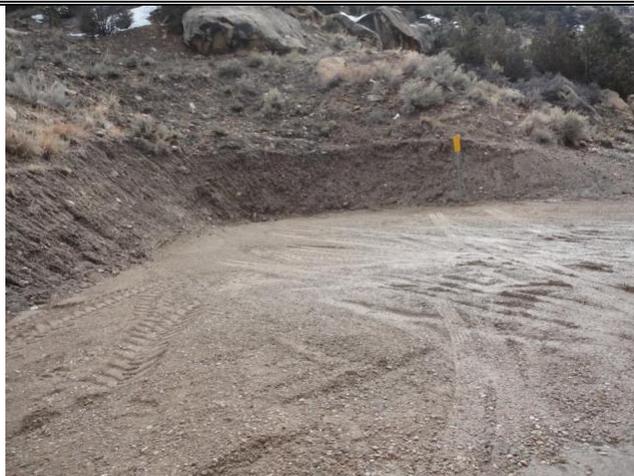
**PHOTO 2**  
Wide Angle of Turn around

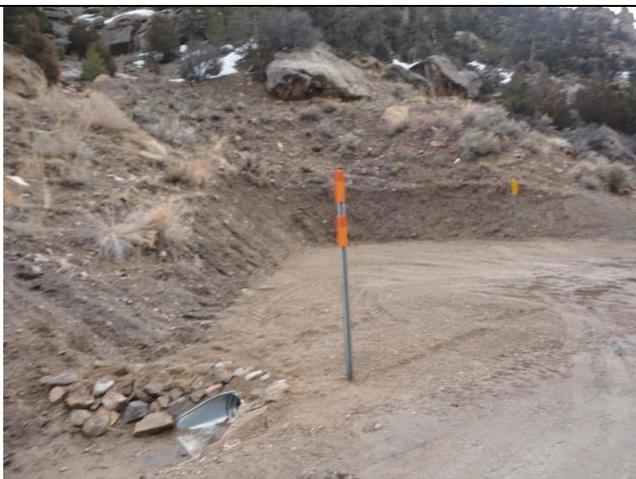
**PHOTO 3**  
Turn around

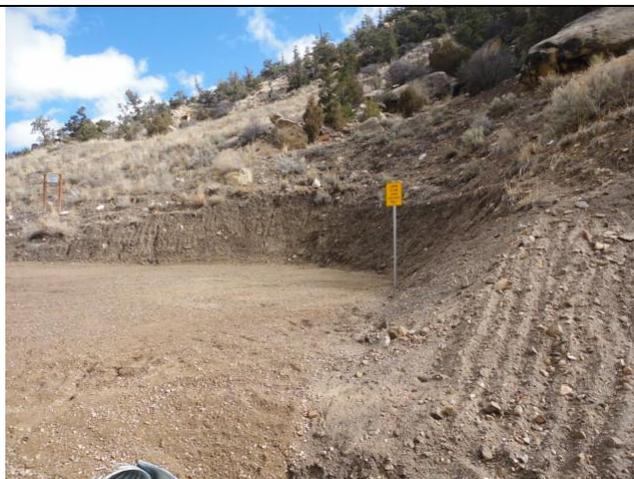
**PHOTO 4**  
Back of Leach Field

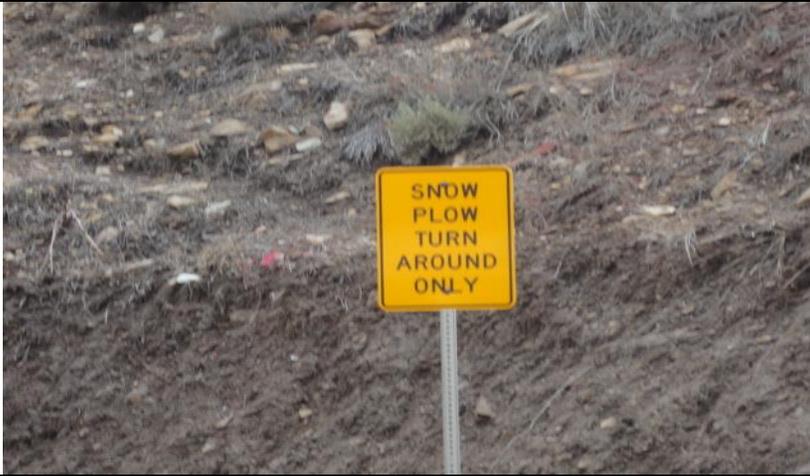
**PHOTO 5**

The road department has installed a sign stating "Snow Plow Turn around". See Photo

Sign Stating Turn-A-Round

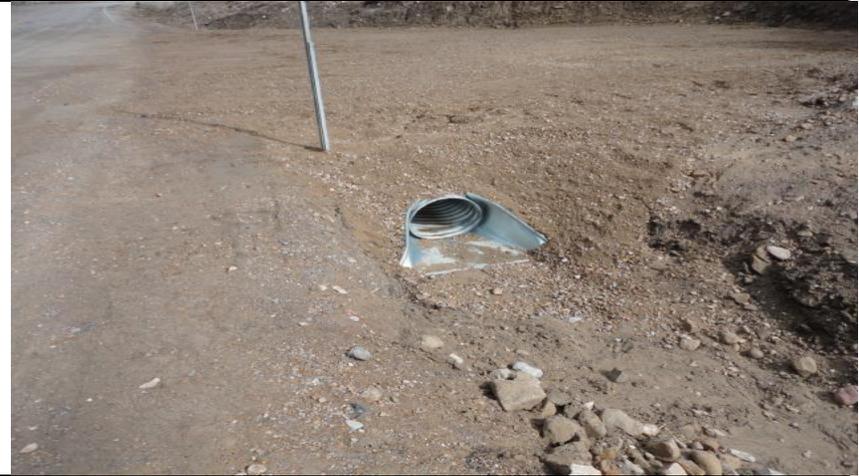
**PHOTO 6**

New culvert (outlet) for Road Drainage.

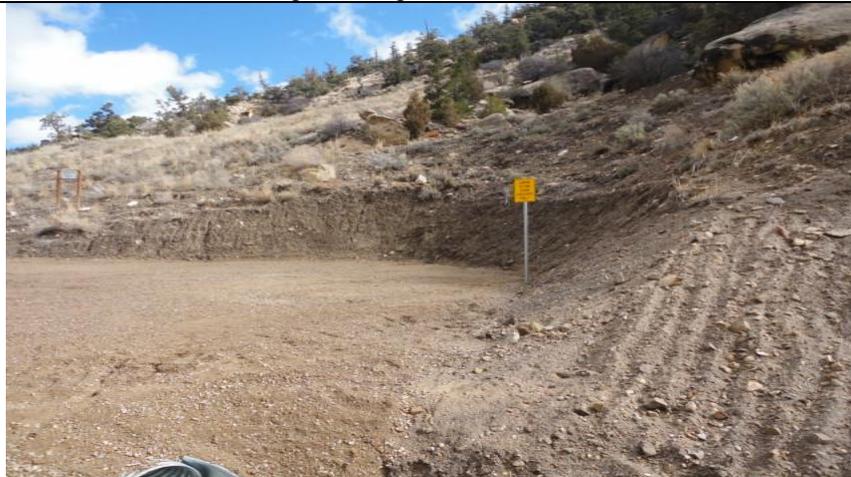
**PHOTO 7**

Overview of Turn-A-Around

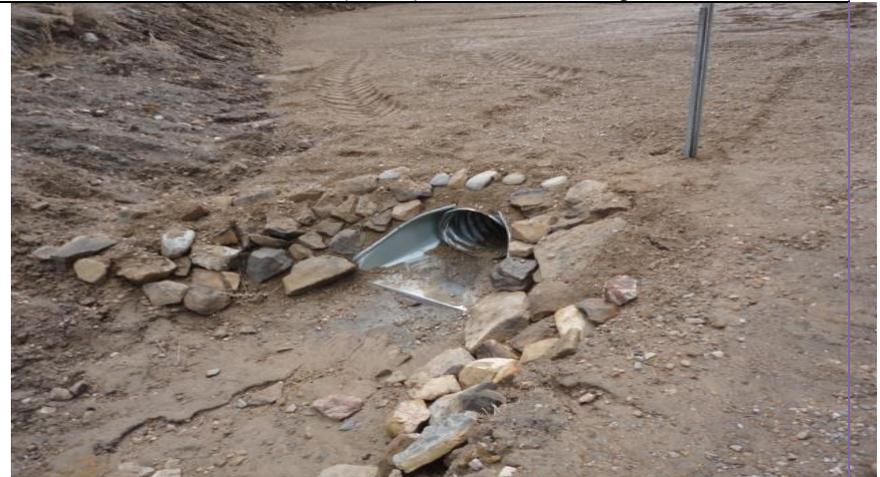
**PHOTO 8**

The permittee installed an 18 inch culvert between the turnaround and the main road. The culvert will transport water from the hillside and the main road. The culvert replaced the road diversion in this area. It enables trucks to turn around easily without going in to a ditch. The inlet side of the culvert is protected by rocks. See Photos

Culvert Inlet Rocked
