State of Utah  
DEPARTMENT OF NATURAL RESOURCES  
DIVISION OF OIL, GAS AND MINING

Re: Response Adequacy from Cyprus Plateau Mining Corporation and Co-Op Mining Corporation  
Regarding the Birch Spring Monitoring Issues per: Tech Directive 005.

RE: Response Adequacy from Cyprus Plateau Mining Corporation and Co-Op Mining Corporation  
Regarding the Birch Spring Monitoring Issues per: Tech Directive 005.

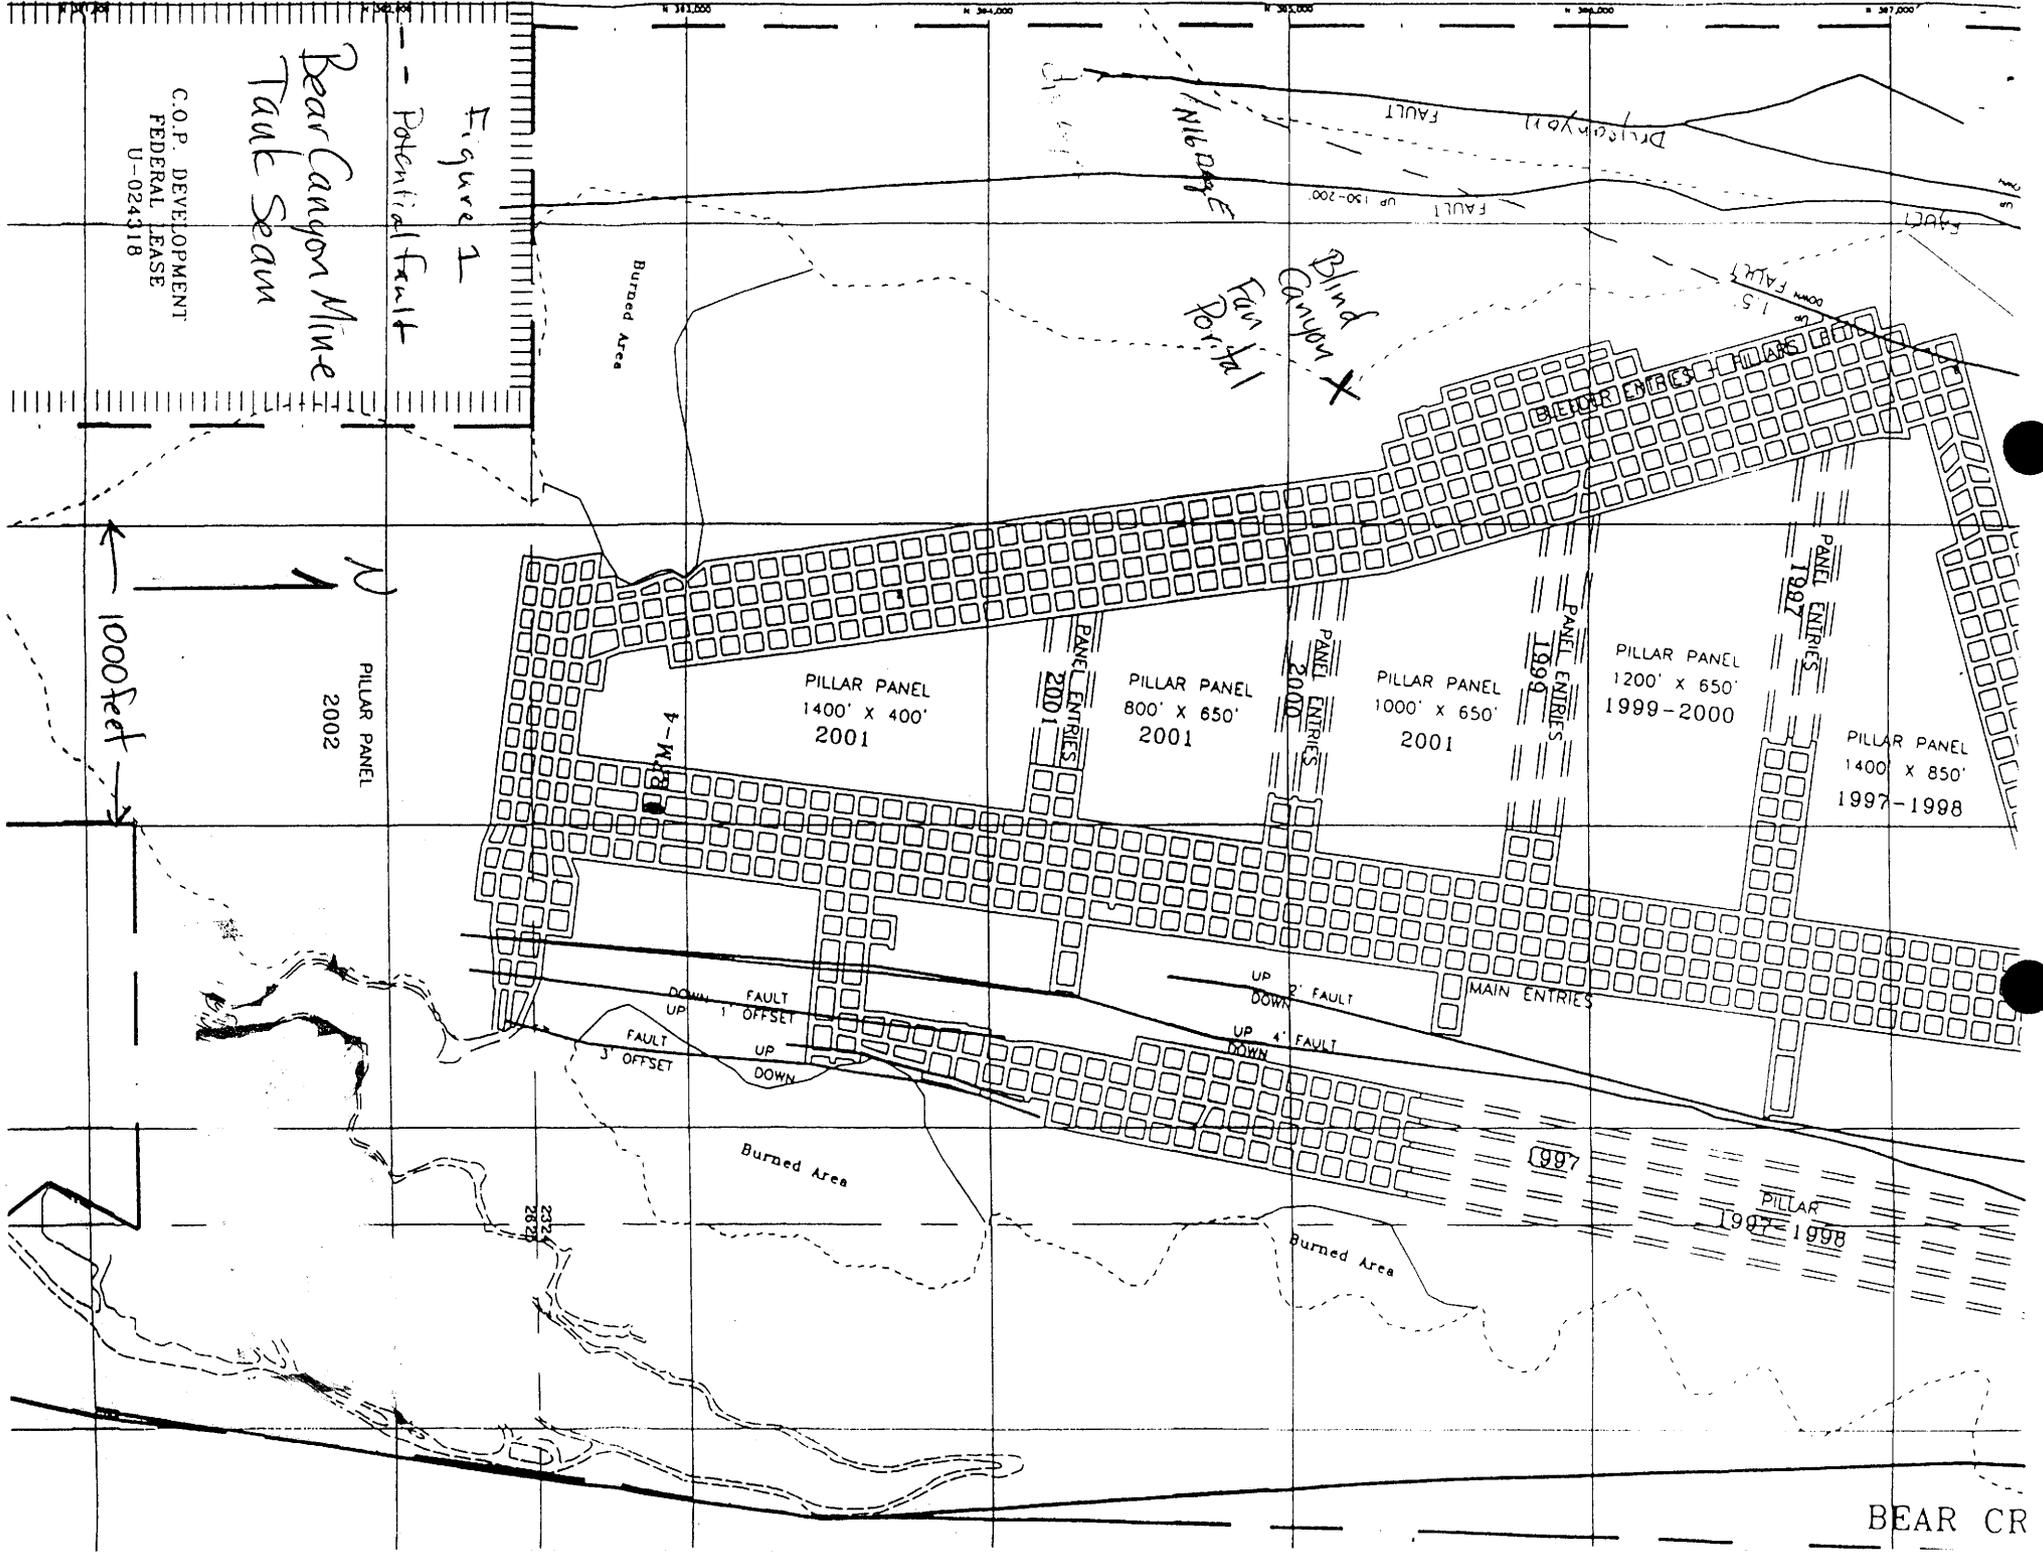
**Appendix C: Bear Canyon Mine Faults**

There are two fault zones mapped in the region that might provide such a path between the Bear Canyon Mine and Birch Spring. One of these faults is located south of Birch Spring, and if projected along strike it would extend through Birch Spring, cross the Blind Canyon Fault, and intersect the Bear Canyon Mine north of the Blind Canyon Fan Portal (Figure 2 in Appendix C). This fault, where it is mapped, is down-dropped to the west and strikes N17°E. Mining in the Tank Seam has exposed a fault north of the Blind Canyon Fan Portal that strikes N17°E (Figure 1 of Appendix C), is offset 1.5 feet, and is down-dropped to the west. A second projected fault, shown on Figure 3 of Appendix E, lies northwest of the large sandstone channel ("low coal area") that has been exposed by mining of the Blind Canyon Seam in the Bear Canyon Mine.

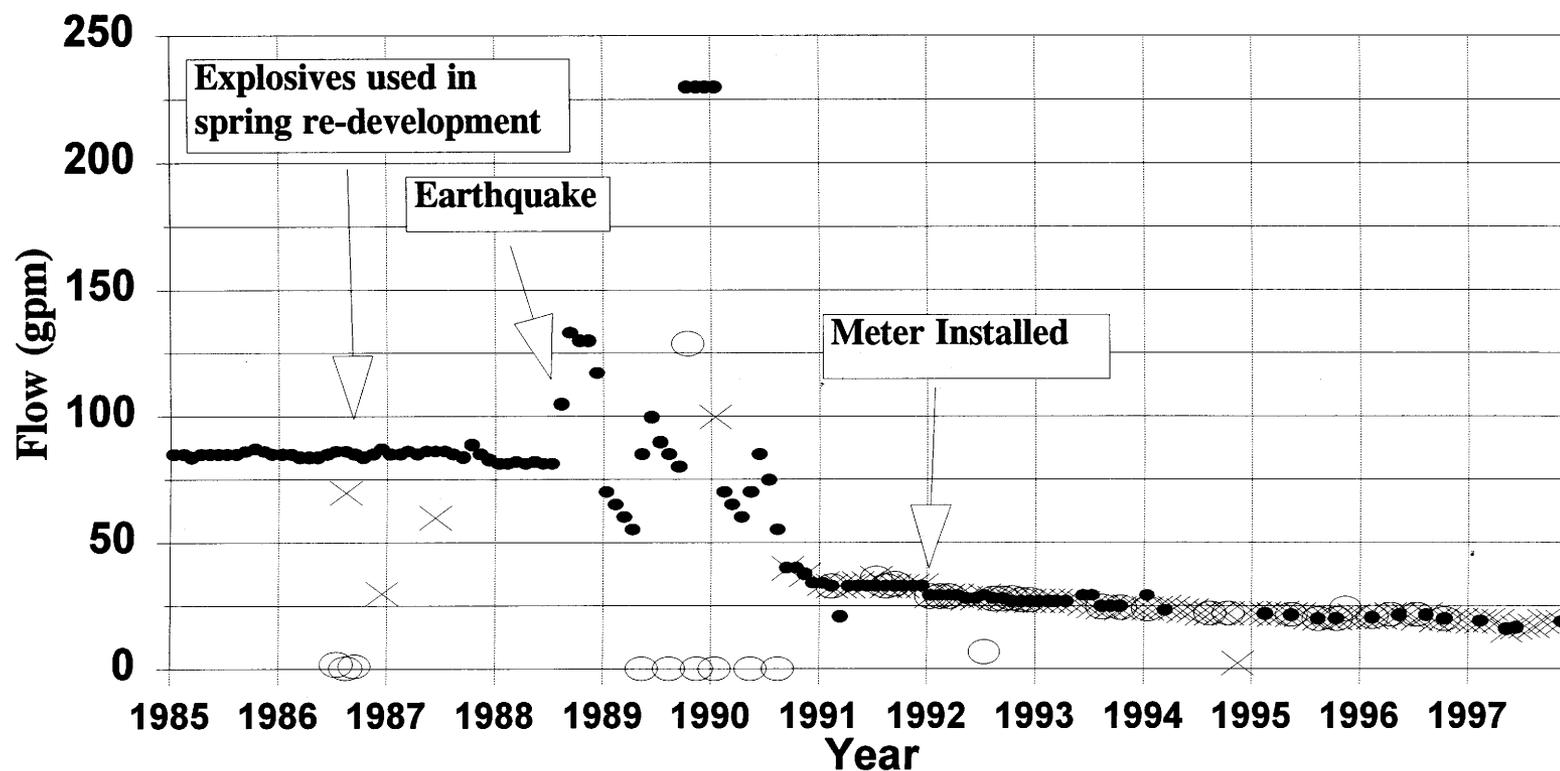
Recorded water flow data are summarized in Figure 1 in Appendix D. The data show two significant concerns. The first and main issue is the trend of decreasing flow since 1991, and perhaps earlier. Second is the increased flows or "peak flows" observed in August through December 1988, June 1989, and October 1989 through January 1990. The "peak flows" are discussed because of the possibility that they are related to the trend of reduced flow that followed them, although the cause or source for the "peak flows" appears to be separate from the normal flow from Birch Spring.

Based on the information provided by Cyprus in the Star Point Mine MRP, prior to the first "peak flow" the Birch Spring average discharge was 80 gpm. The recorded "peak flow" discharges reached 133, 100 and 230 gpm during August through December 1988; June 1989; and October 1989 through January 1990, respectively. Following the three periods of increased flows, the spring flow declined to 33 gpm in February 1990. Since that time the flow has diminished to about 19 gpm, with a low flow observed in May 1997 at around 16 gpm.

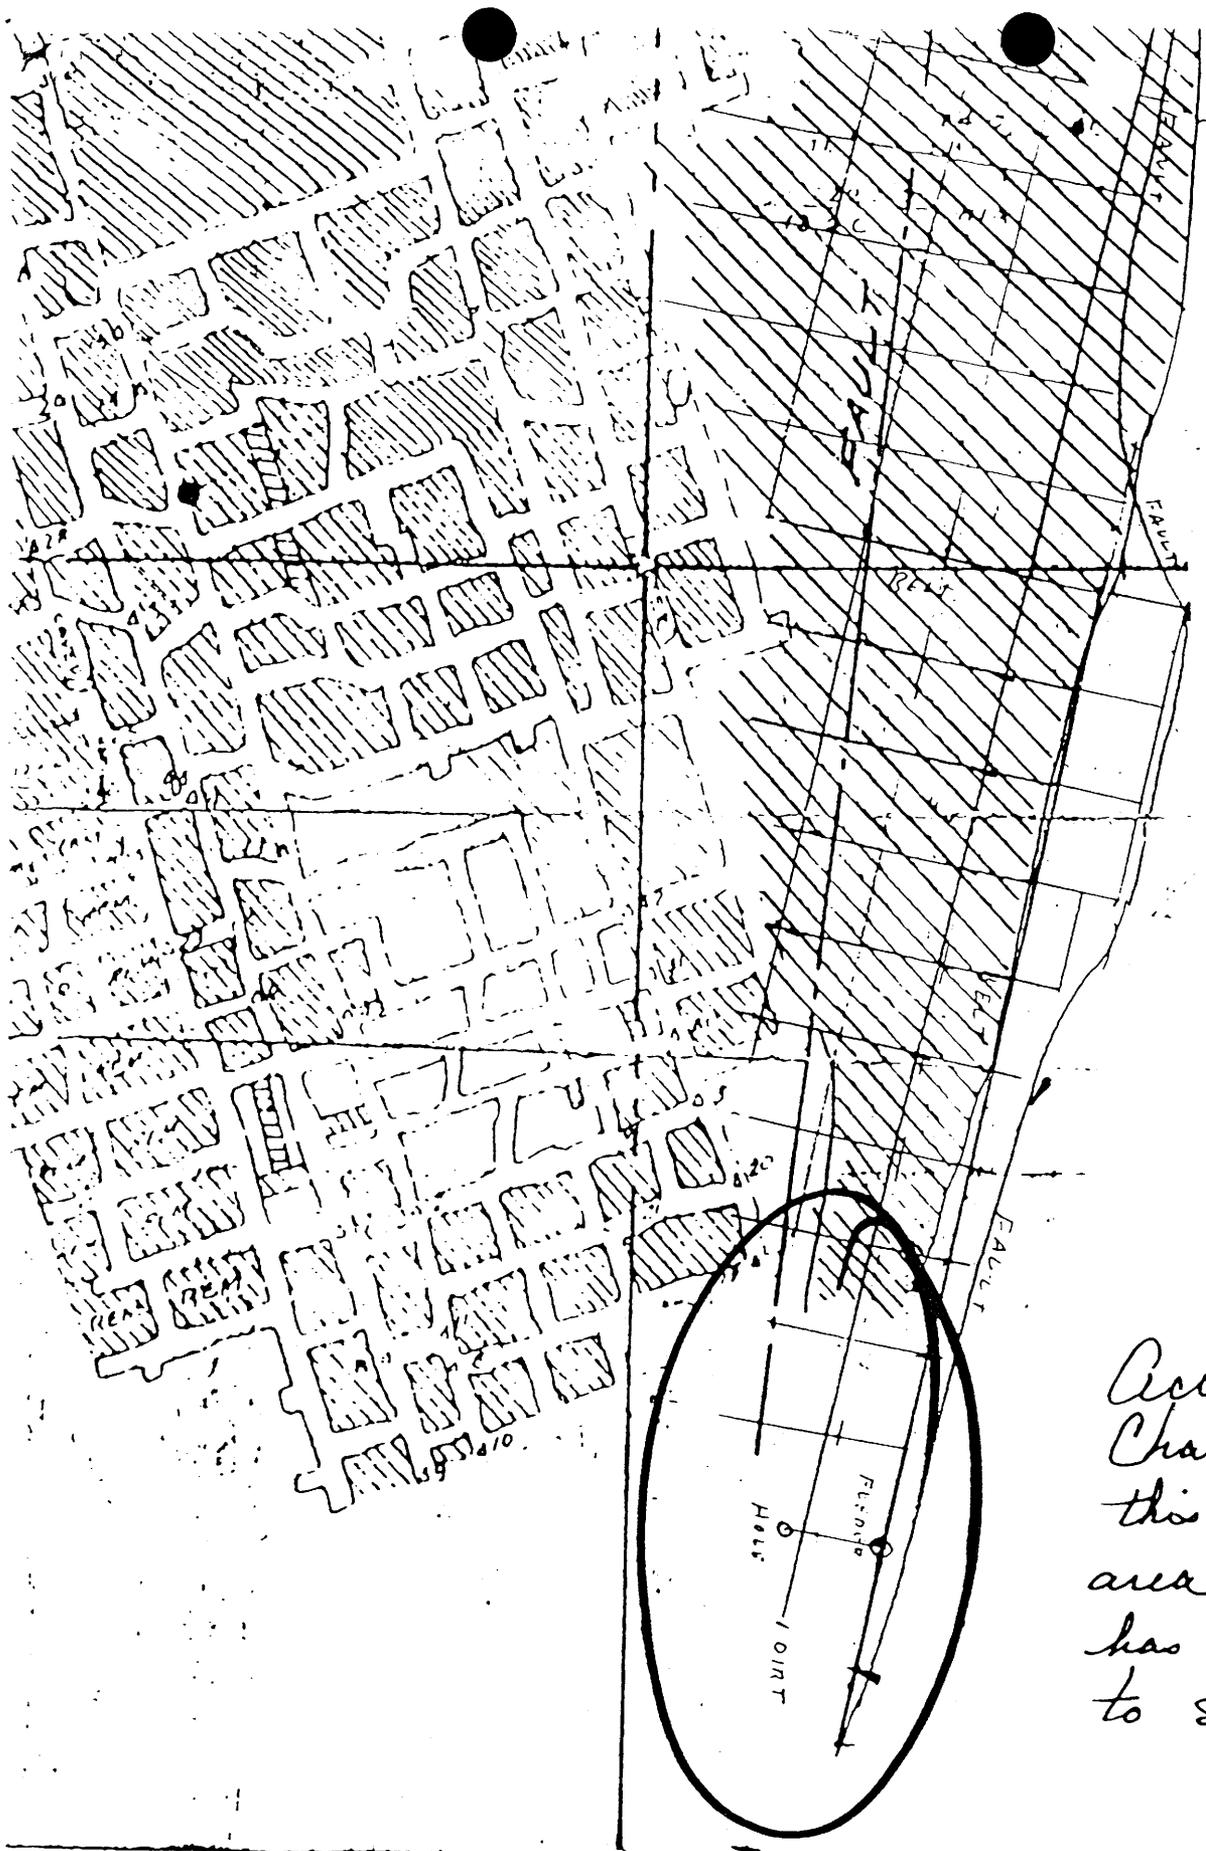
According to Charles Reynolds, this is the mined area where subsidence has broken through to surface.  
PH
