State of Utah
DEPARTMENT OF NATURAL RESOURCES
DIVISION OF OIL, GAS AND MINING

INSPECTION REPORT

Mine Name: Bear Canyon Mine County: Emery Permit Number: ACT/015/025
Permittee and/or Operator's Name: Co-Op Mining Company
Business Address: P.O. Box 1245, Huntington, Utah 84528
Type of Mining Activity: Underground XXX Surface Prep. Plant Other
Company Official(s): Charles Reynolds and Aldon Gustafson
State Officials(s): Robert Davidson and Wayne Western
Federal Official(s):
Weather Conditions: Snowing, cold, and low cloud deck
Existing Acreage: Permitted- 1377.75 Disturbed- 24 Regraded- 0 Seeded- 0 Bonded- 24
Increased/Decreased: Permitted- Disturbed- Regraded- Seeded- Bonded-
Status: Exploration/ XXX Active/ Inactive/ Temporary Cessation/ Bond Forfeiture
Reclamation ( Phase I/ Phase II/ Final Bond Release/ Liability Year)

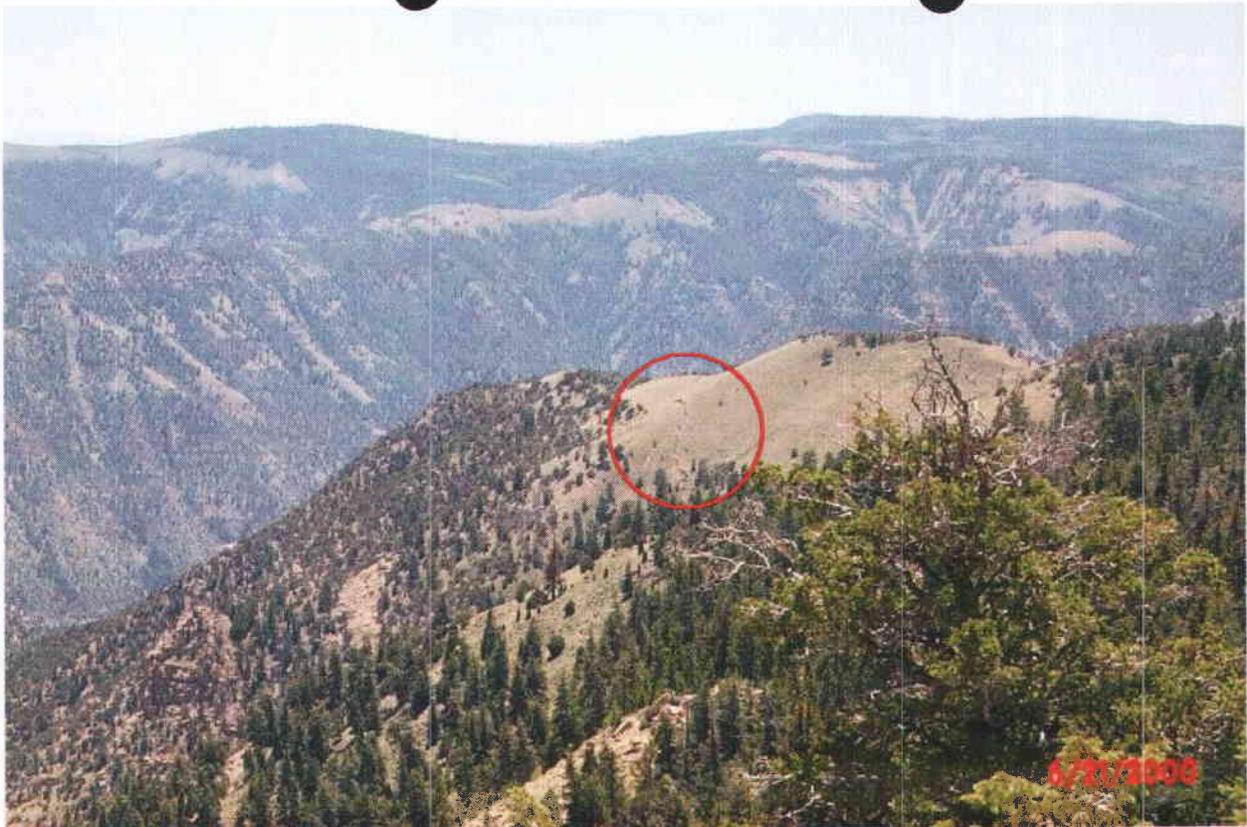
Subsidence has recently resulted from retreat mining from both the 1<sup>st</sup> north Tank Seam panel and the 2<sup>nd</sup> east Barrier Seam panel. One panel directly overlays the other panel, thus resulting in the 5 feet or more surface subsidence. The Barrier area lies directly west and has had no mining and will remain unmined. As a result, this surface area above the Barrier will not subside. The surface subsidence results are striking and can clearly be seen from the canyon bottom. The retreat panel area runs 70° east from true north; however, the surface subsidence crack runs about 30° east from true north. Since subsidence had to penetrate the Castle Gate Sandstone, it is hypothesized that the subsidence crack and escarpment is the result of subsidence acting on an old fault (See Appendix 1 photos 1 through 9 for documentation of the subsidence).

**Figure 1.** Subsidence crack seen in lower left grassy area on the middle ridge.

Co-Op plans on mitigating the resulting subsidence to eliminate any physical hazard threat to wildlife or livestock. Since no further subsidence will take place on the upside of the subsidence escarpment, Co-Op will repair and reclaim the affected surface area. An amendment to the MRP will be submitted for DOGM approval to allow Co-Op to proceed on reclamation of the subsidence area. Efforts will possible include hand shovel work, including blasting of the escarpment face to help fill in the deeper cracks and fissure openings. There should be enough native seed source to naturally vegetate the exposed soil surfaces with native grasses, shrubs and forbes.

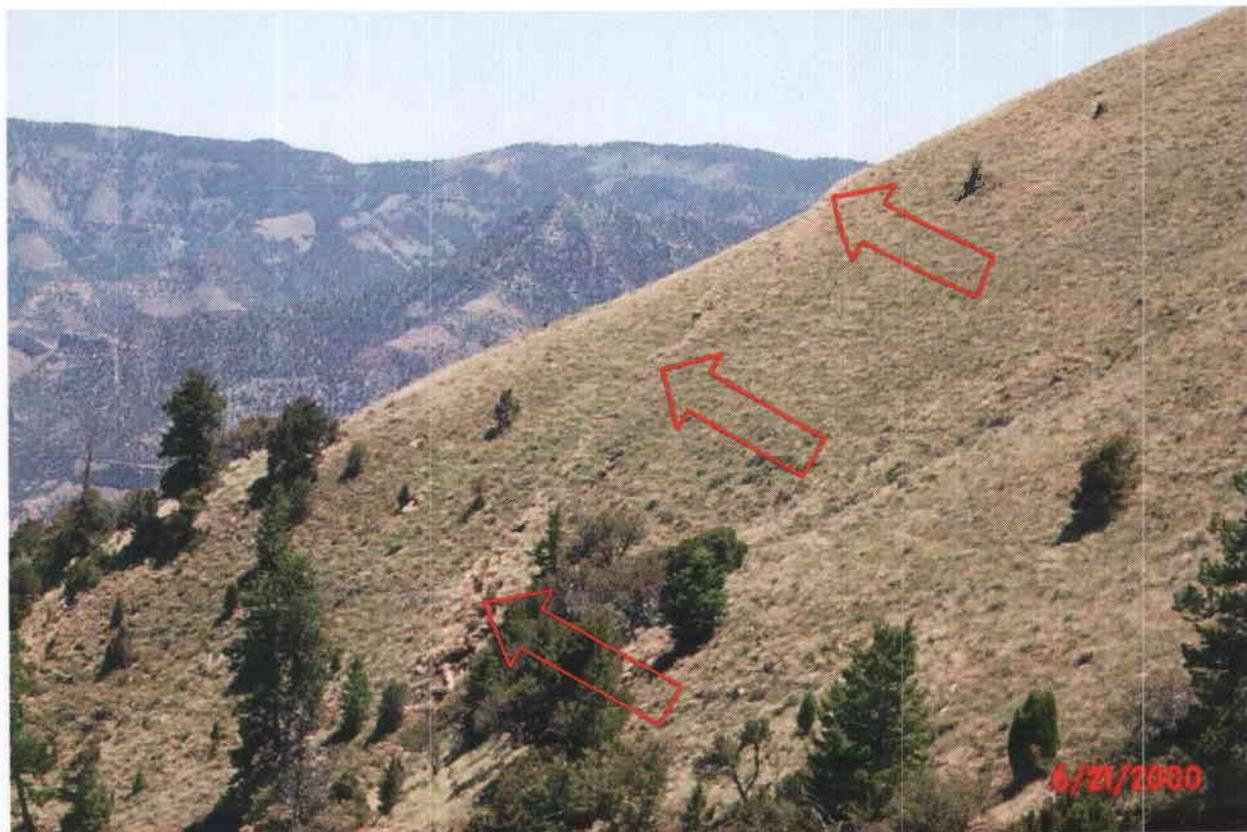
**Figure 2.** Subsidence crack seen running up grassy hillside from trees to ridge crest. Note the displacement on ridge line.

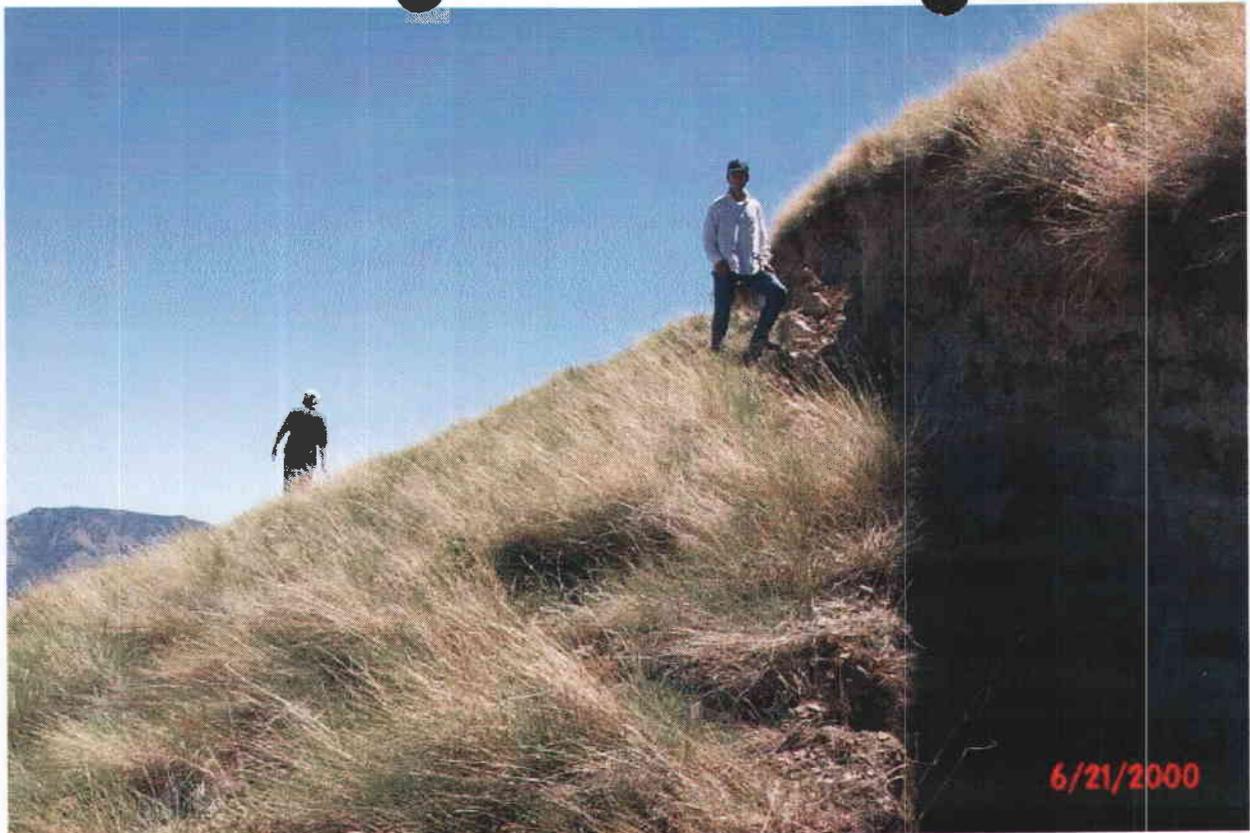
**Figure 3.** Subsidence on ridge crest. Approximately 5 feet has displaced with no fissure or chasm present in deeper soil areas.

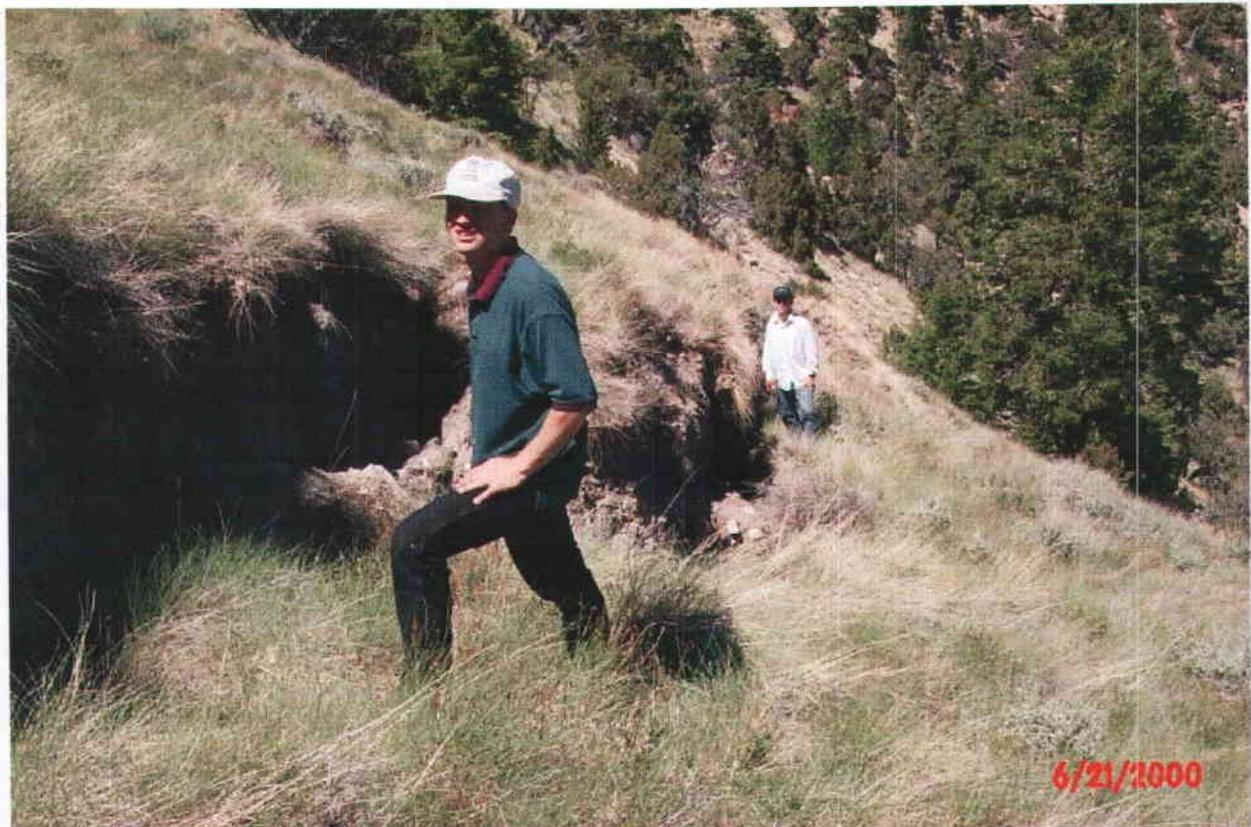
**Figure 4.** Subsidence crack runs 30° east from true north. Crack and deeper fissures form along crack toward the north.

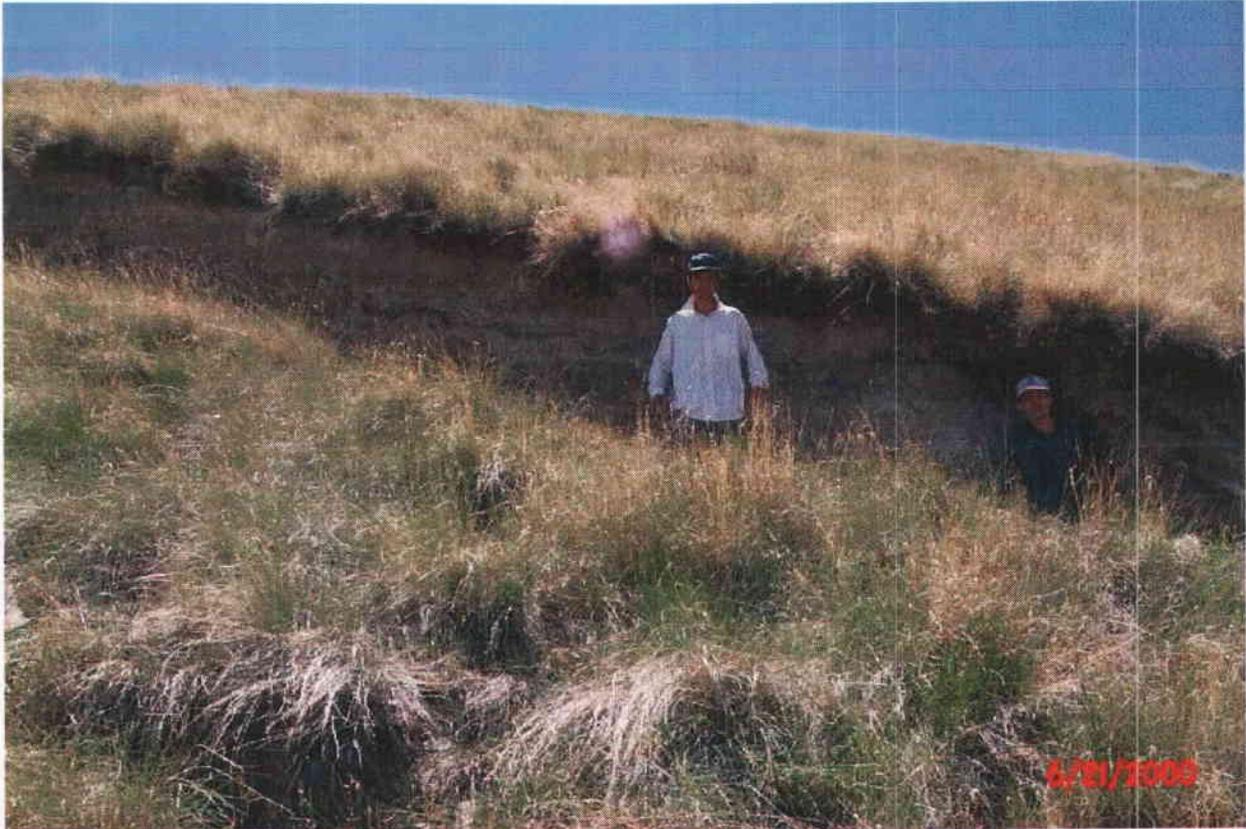
**Figure 5.** Subsidence near ridge crest. Approximately 6 feet of displacement.

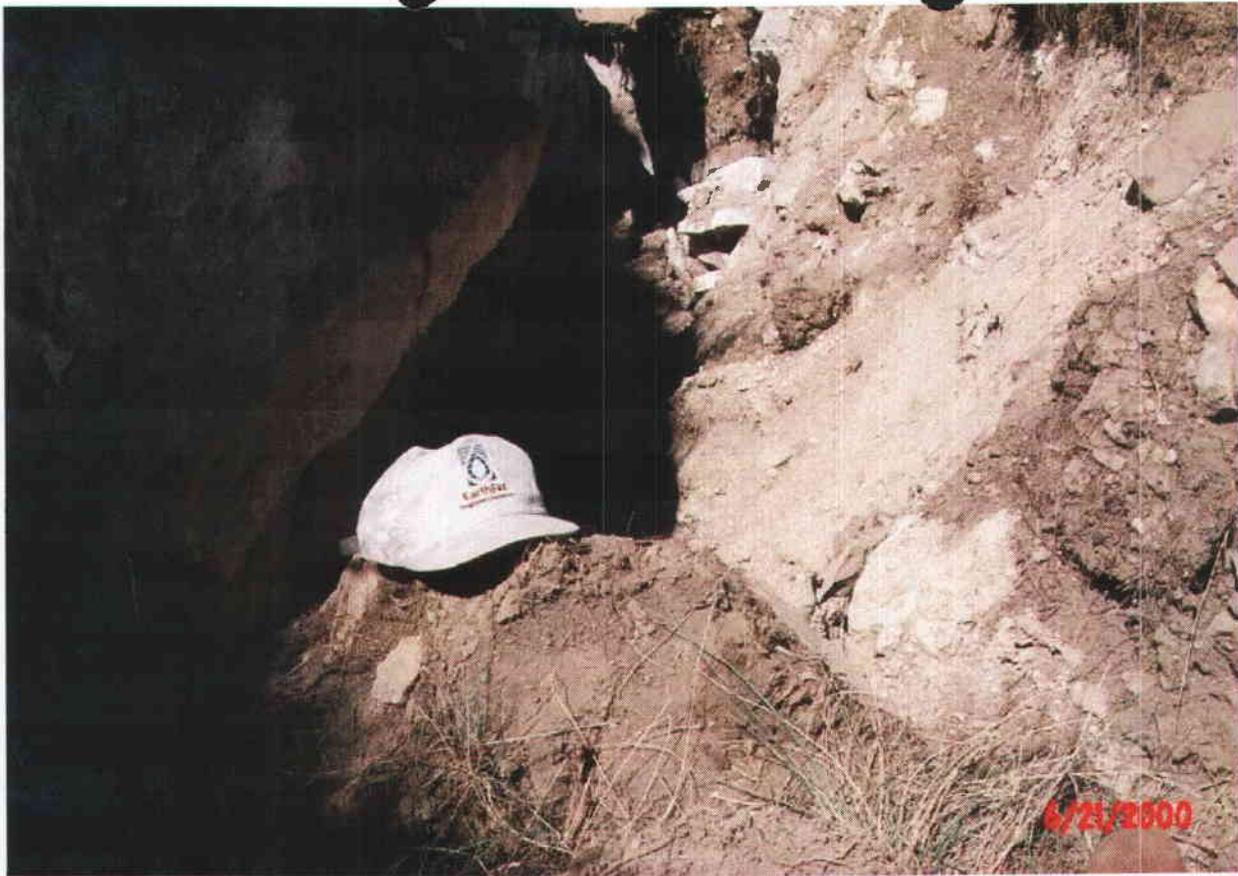
**Figure 7.** Crack opens and deepens into fissures as the subsidence moves down the slope toward the north.

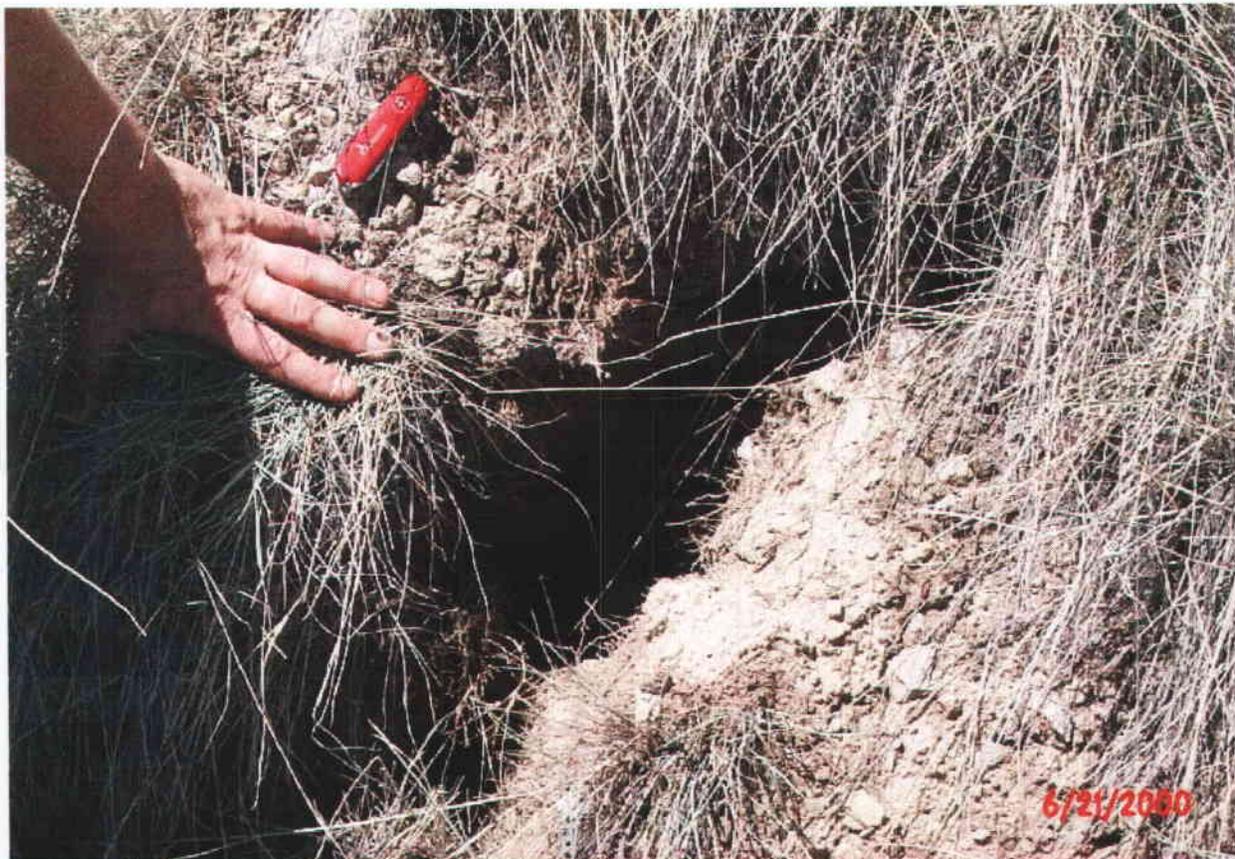
**Figure 8.** Smaller tension cracks are located up the slope above the subsidence crack.

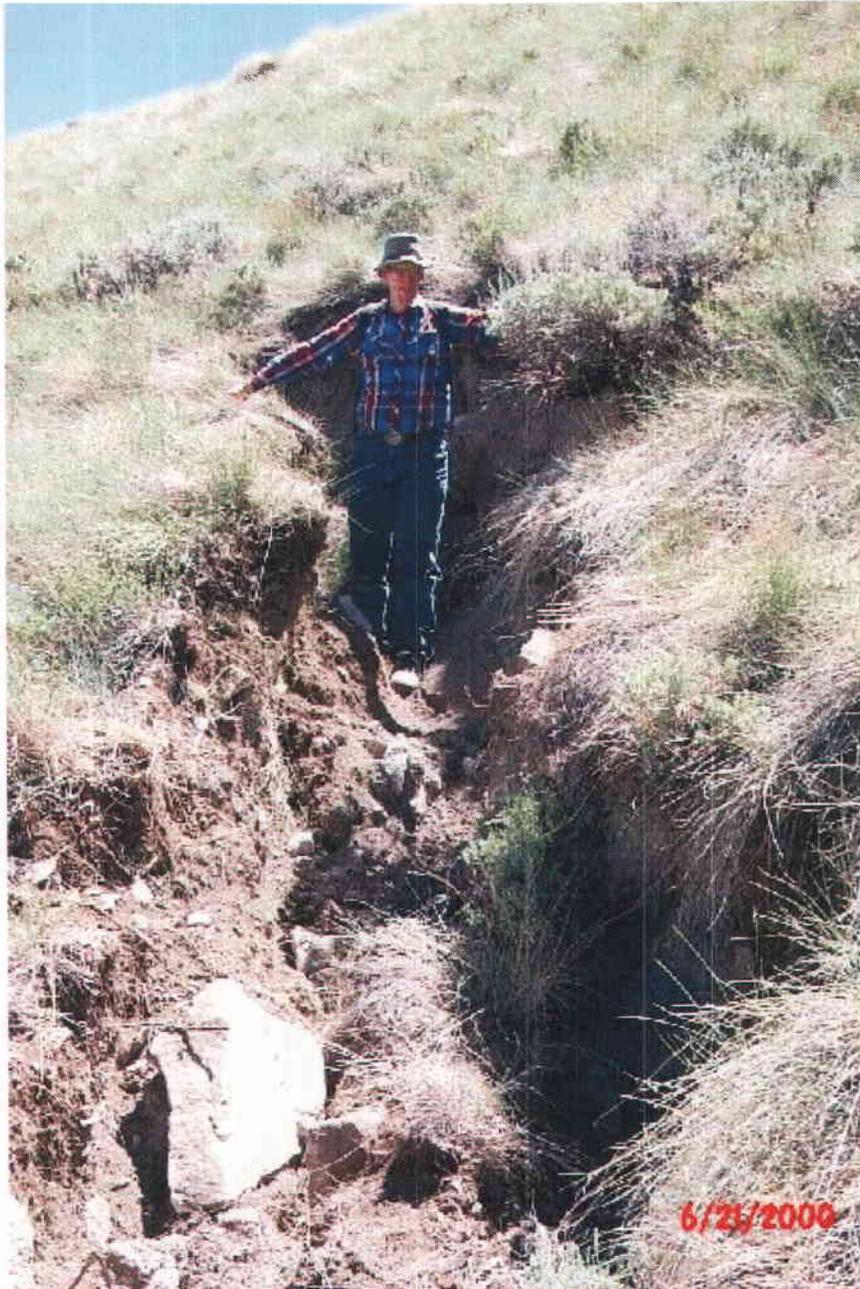
**Figure 9.** This larger tension crack is located immediately adjacent and up the slope from the subsidence crack. Wayne Western is 6 ft 6 inches tall with an equal arm span.
