Inspection Report

| Permit Number: | C0150025 |
| Inspection Date: | Tuesday, July 31, 2012 |

Site: **BEAR CANYON MINE**

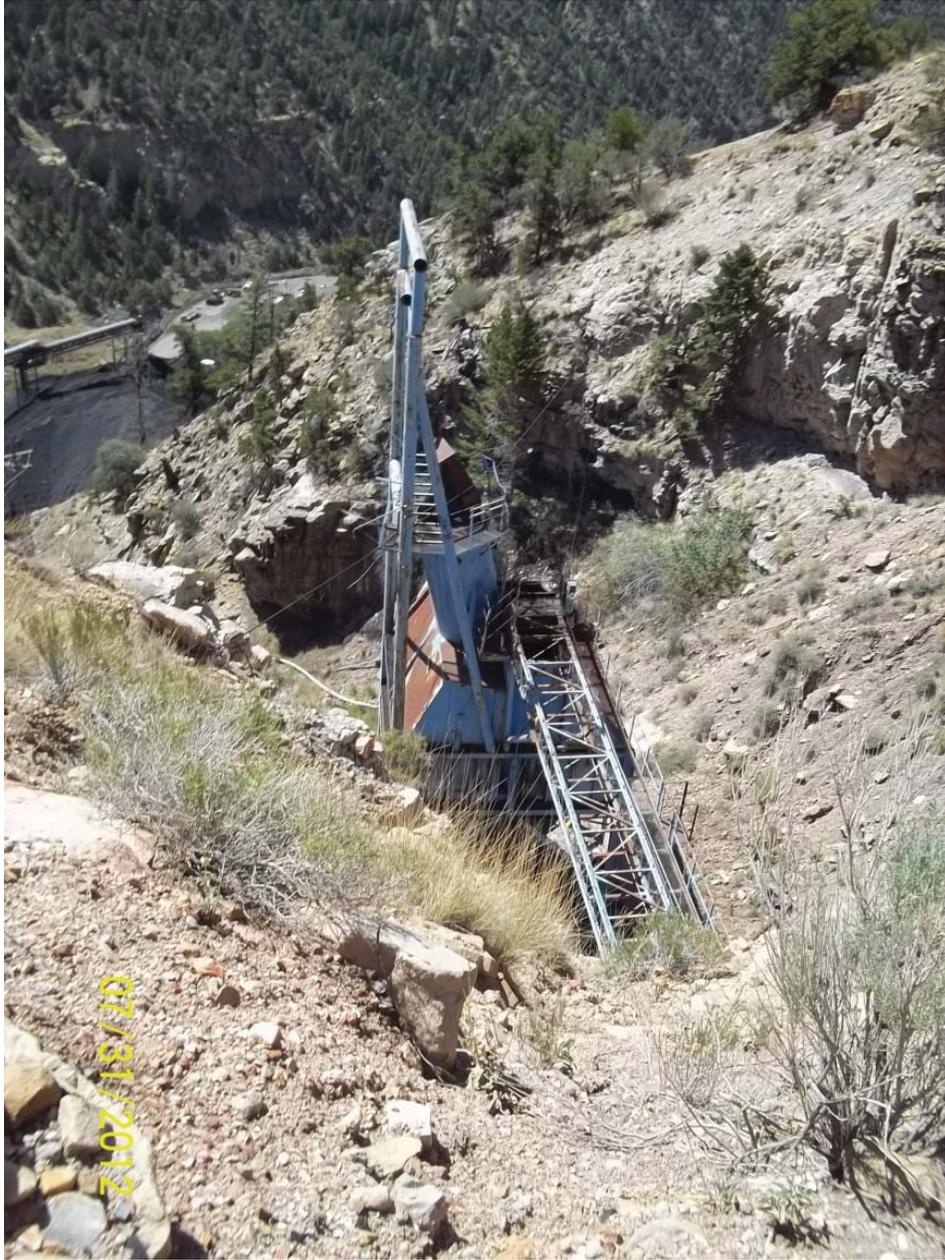
Figure 1. Old C.O.P. Conveyor. Castle Valley is currently looking into scrapping this equipment and conducting reclamation work in this area.

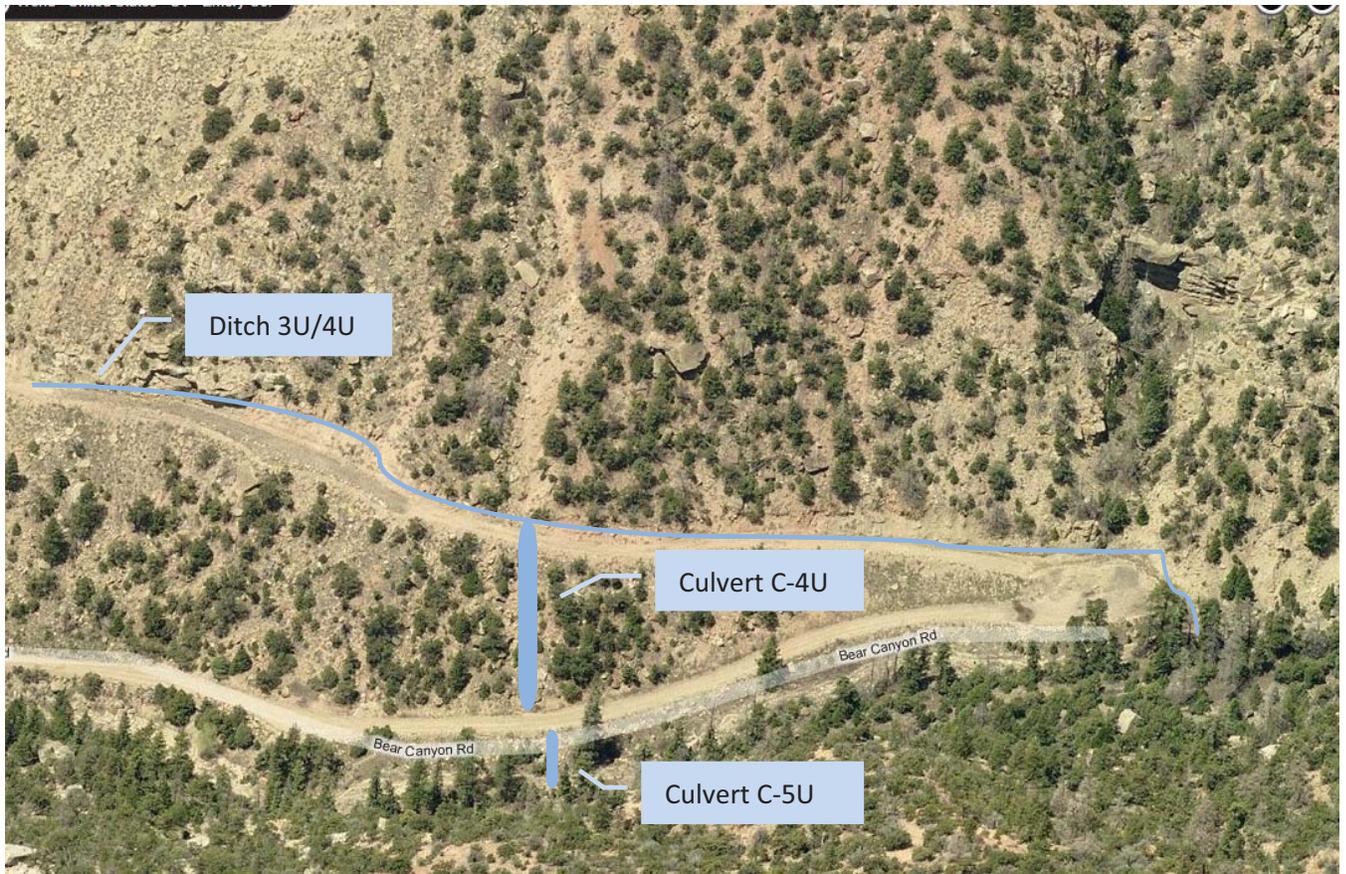
Met with the operator to discuss how the mine plan is intended to manage drainage in the area of the Primary Portal Access Road. Explained that several subwatershed areas located on the slope adjacent to the road are broken out and depicted on Map 7-1D. Runoff from these subwatersheds (AU-8, AU-9, and AU-10 on Map 7-1D) drains water from the undisturbed areas. The Mine Plan as it is currently written, directs this water to Ditch D-3U/4U and conveys it to culverts C-3U, C-4U, C-5U, and ultimately discharges to Bear Creek. It was discovered during the inspection that the road is pitched toward Ditch D-3U/4U and is receiving road runoff (disturbed area drainage) that is ultimately making its way to Bear Creek. Culverts 3U and C-4U were reported as blocked from recent storm activities. Operator had cleaned out C-4U prior to inspection. Culverts C-3U and C-4U were also observed to be receiving road runoff. Discussed with operator isolating culverts from the road with either berms or other forms of sediment control such as haybales, siltfence. Discussed resolving the problem with the operator and gave two options: 1. Either come into compliance with the plan as written and repitch the road so that it is not draining toward the ditch and using the ditch as it was intended as a means to convey undisturbed runoff. Or 2). Modify the mine plan so that the culverts alone can handle the undisturbed runoff and use the ditch to route disturbed drainage from the road. Based on this scenario, the engineering design of culverts will need to be reevaluated to determine if their sizing is appropriate to handle the amount of runoff from watersheds AU-8, AU-9, AU-10. All references to Ditch D-3U/4U will have to be modified in the plan to be a disturbed area runoff ditch. In the interim, the operator agreed to isolate the drainage from the road so that it is not directed toward Bear Creek. Operator will be given 30 days from the date of this inspection report to submit these changes to the drainage plan. Also looked at drainage at intersection of main road and Primary Haul Road. Berms were stable. Area on south side of road had a break in the berm but had haybales and siltfence installed for sediment control.

Figure 2. Primary Portal Access Road. Ditch D-3U/4U is intended to route disturbed drainage from the base of the hill slope to Bear Creek. However, the road is pitched toward this ditch and it is accepting road runoff. The road runoff is flowing into Bear Ck.

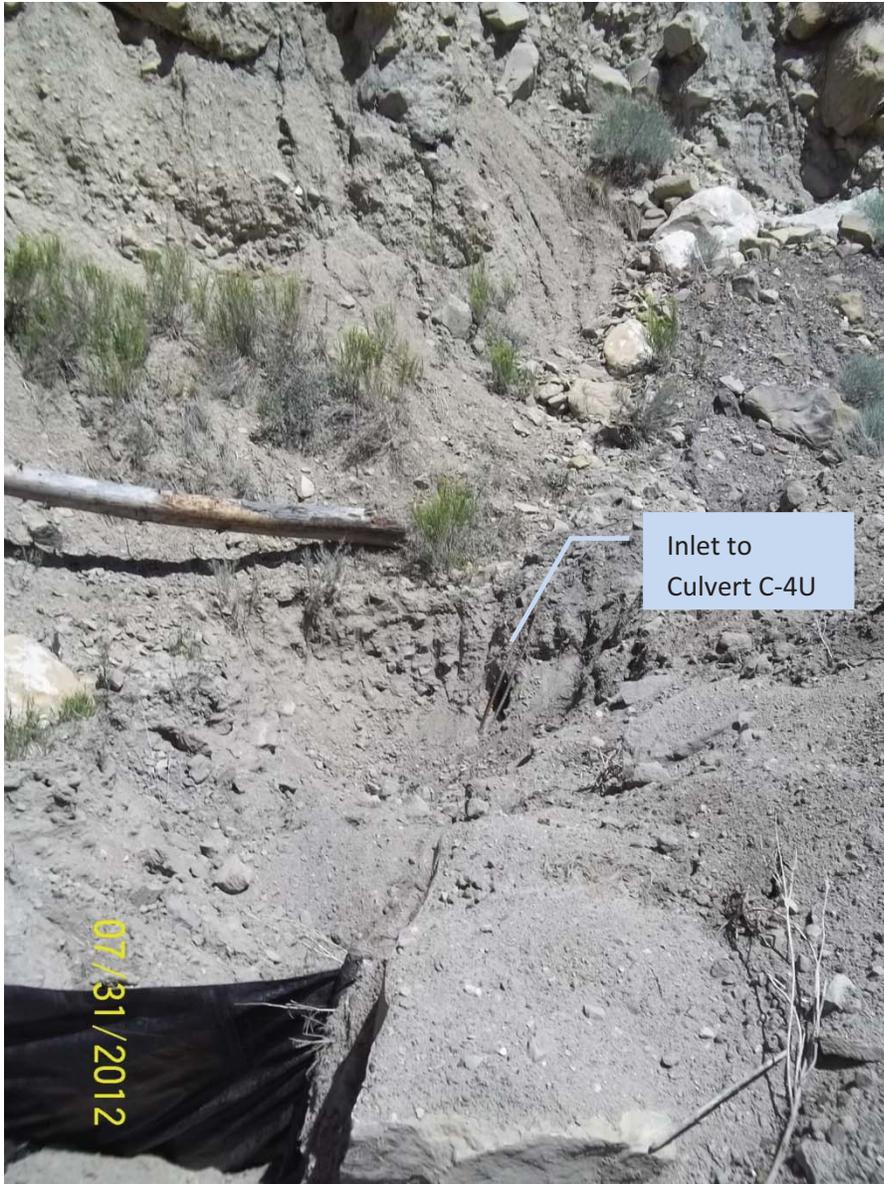
Figure 3. View from road of C-4U. Recent storm activity had caused this culvert to be blocked with debris. Operator had cleaned out culvert prior to inspection.

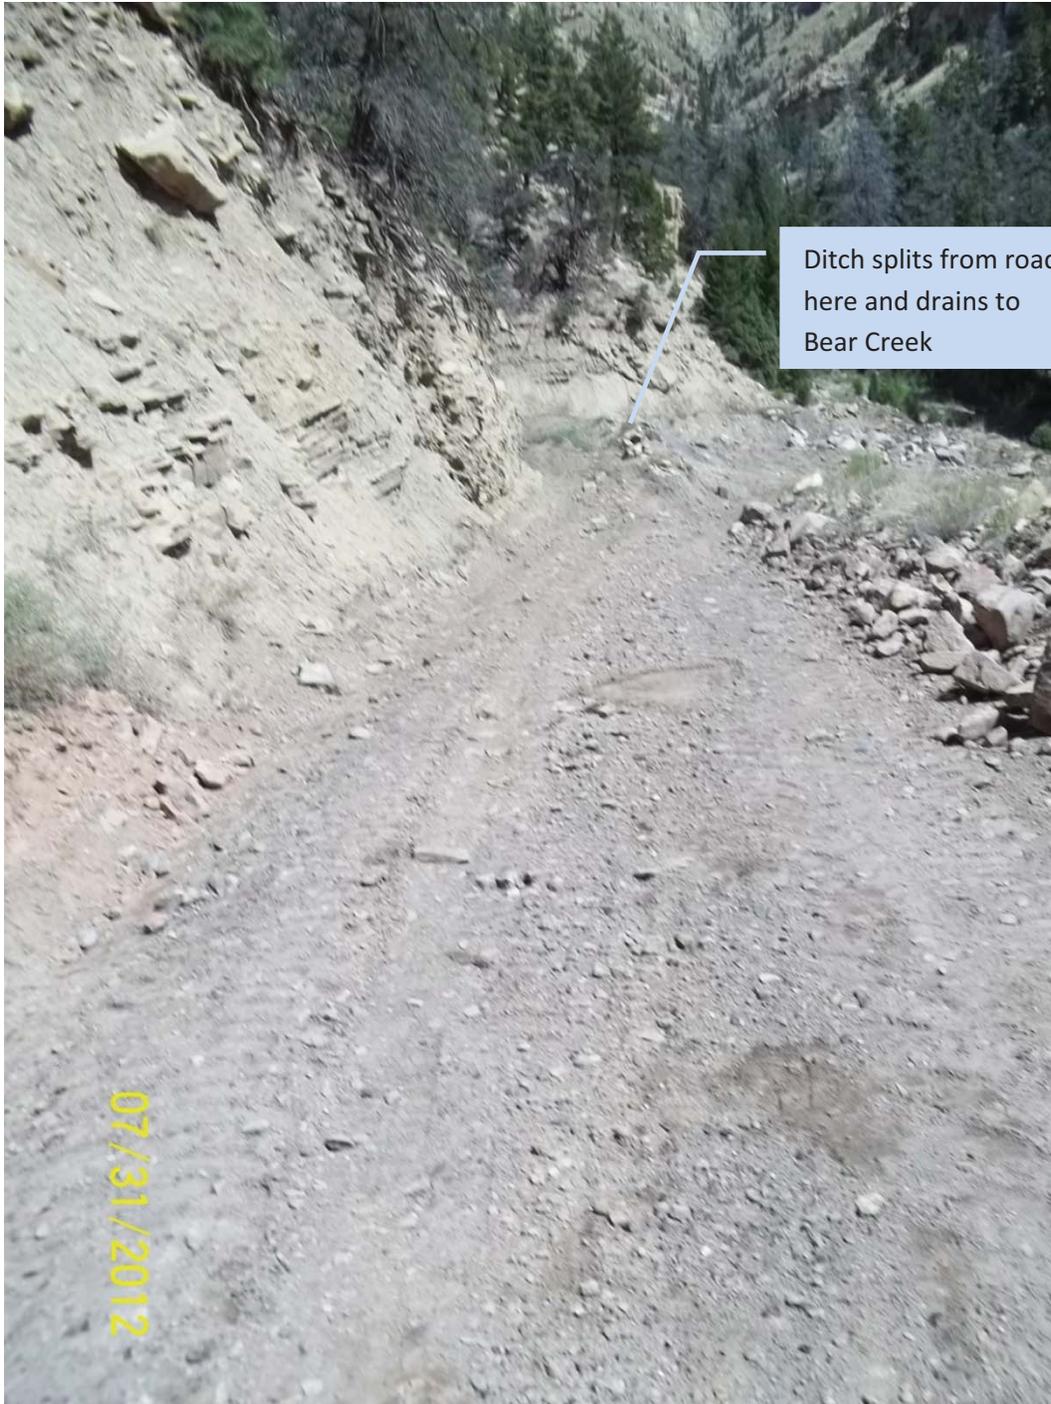
Figure 4. View downhill of Primary Portal Access Road. Ditch 3U/4U is on left side of road.

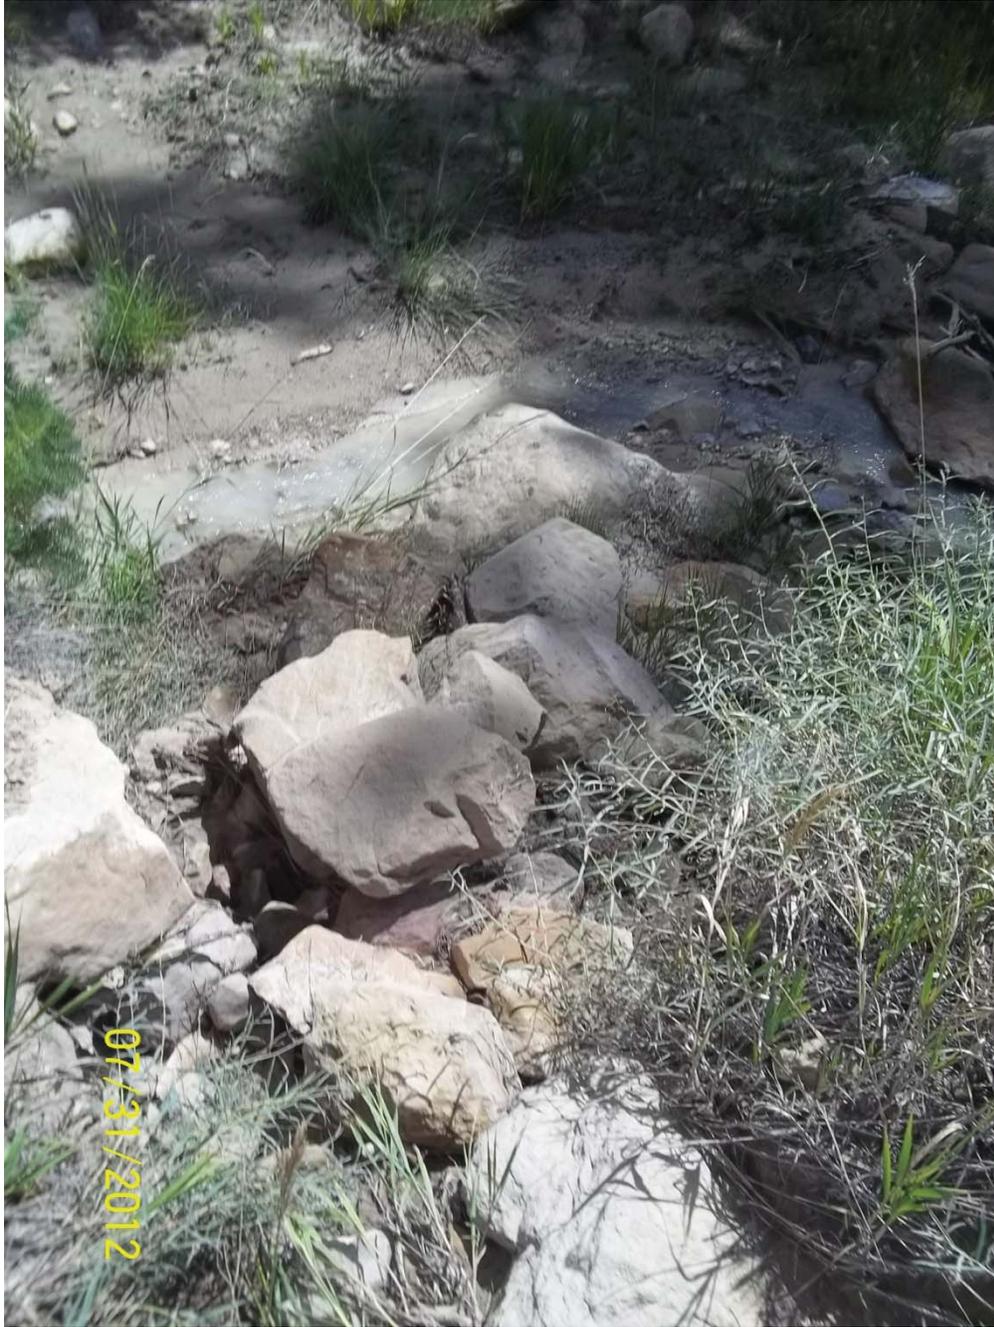
Figure 5. Outlet from Ditch 3U/4U into Bear Creek.

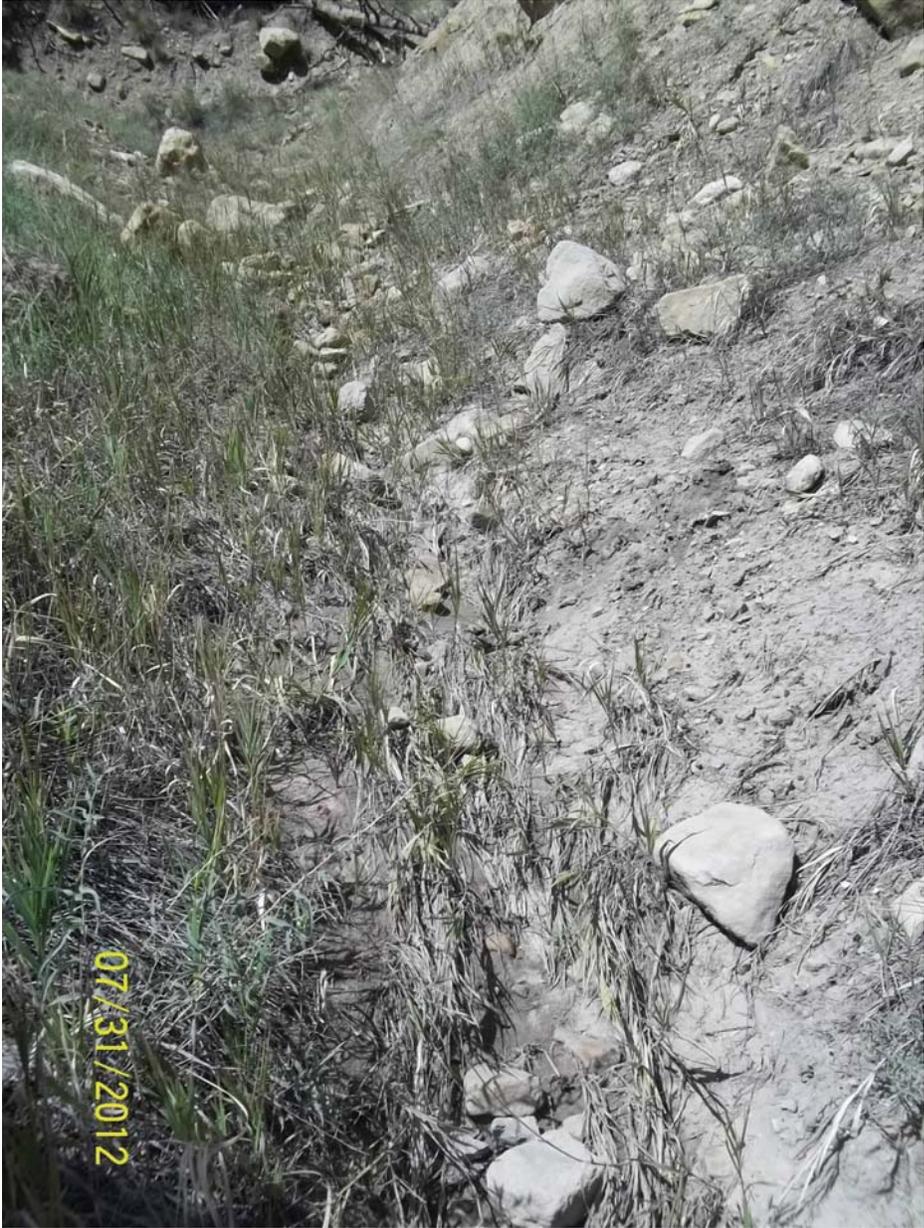
Figure 6. View of Ditch looking upstream from outlet.
