Subject: 2014 Annual Report Submittal for Castle Valley Mining LLC Bear Canyon Mine, C/015/0025

Annual Report

Company Name	Rhino Energy	Mine Name	Bear Canyon Mine
Permit Number	C/015/0025	Permit expiration Date	12-16-2015
Operator Name	CASTLE VALLEY MINING LLC	Phone Number	+1 (435) 687-5454
Mailing Address	P.O. BOX 475	Email	jjorgensen@rhinolp.com
City	HUNTINGTON		
State	UTAH	Zip Code	84528

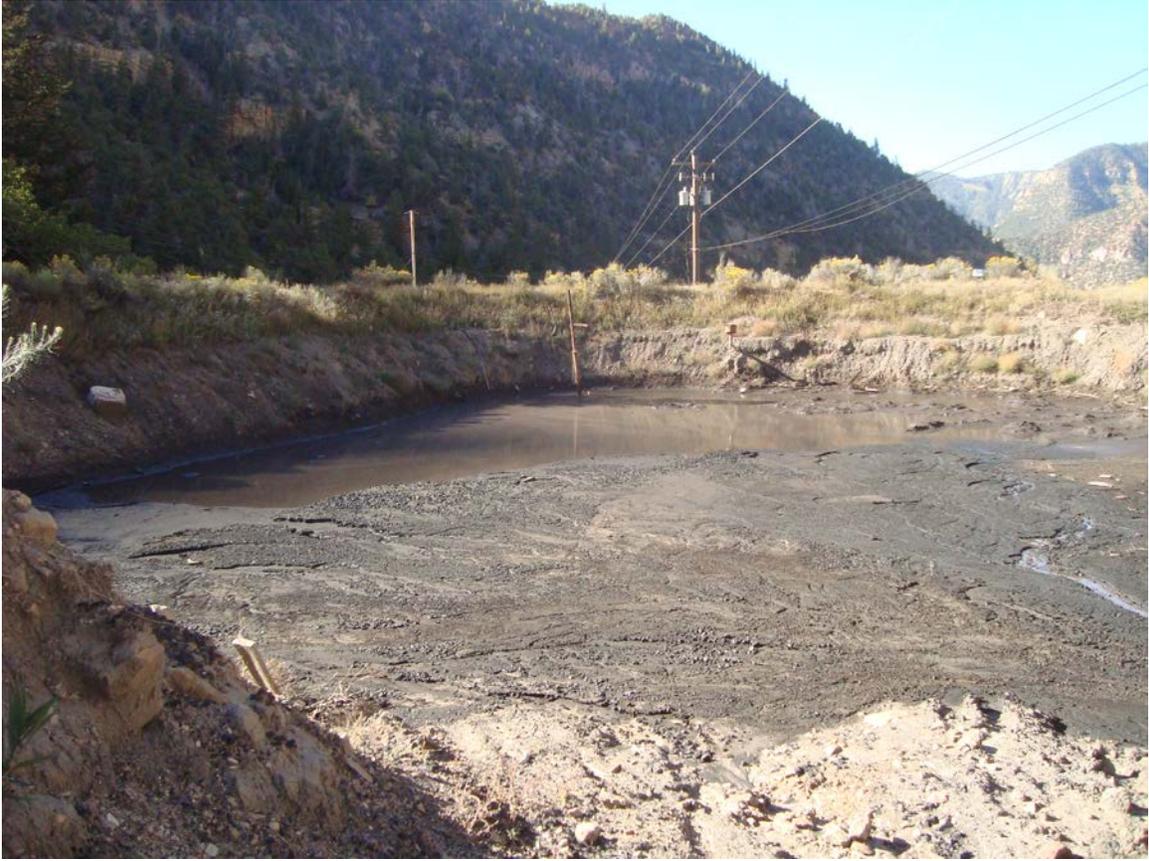
SEDIMENT POND A

1. Describe any appearances of any instability, structural weakness, or any other hazardous condition.			
The pond's dam shows no signs of structural instability or other hazardous conditions.			
Required for an impoundment which functions as a SEDIMENTATION POND	2. Sediment storage capacity, including elevation of 60% and 100% sediment storage volumes and estimated average elevation of existing sediment.		
	Sediment storage capacity is 29,835 cu ft. Sediment has been removed.		
	60% Cleanout Elevation: 7,086		
	100% Sediment storage elevation: 7,087.9		
	Existing sediment elevation: Average sediment elevation 7,083

3. Principle and emergency spillway elevations		
	Principle spillway elevation: 7,088		
	Emergency spillway elevation: 7,094.5		
4. Field Information: Provide current water elevation, whether pond is discharging, type and number of samples taken, monitoring/instrumentation information, inlet/outlet conditions or other related activities associated with the pond including but not limited to sediment cleanout, pond decanting, embankment erosion/repairs, monitoring information, vegetation on out slopes of embankment erosion/repairs, monitoring information, vegetation on out slopes of embankments, etc.			
Pond has some water near dam. Vegetative cover looked good with no signs of erosion.

5. Field Evaluation: Describe any changes in the geometry of the impounding structure, average and maximum depths and elevations of impounded water, estimated sediment or slurry volume and remaining storage capacity, estimated volume of water impounded and any other aspect of the impounding structure affecting its stability or function which has occurred during the reporting period.			
Principal spillway appears to have been bent during the removal of sediment in May 2010. This structure is still working properly. Bent pipe should be straightened to preserve water discharge elevations. Average sediment is 3' below 60% cleanout level.			
Qualified State	I hereby certify that I am experienced in the construction of impoundments; I am qualified and authorized under the direction of a Registered Professional Engineer to inspect the condition and appearance of impoundments in accordance with the certified and approved designs for this structure, that the impoundment has been maintained in accordance with approved design and meet or exceed the minimum design requirements under all applicable federal, state and local regulations; and, that inspections and inspection reports are made by myself and include any appearances of instability, structural weakness or other hazardous conditions of the structure affecting stability.

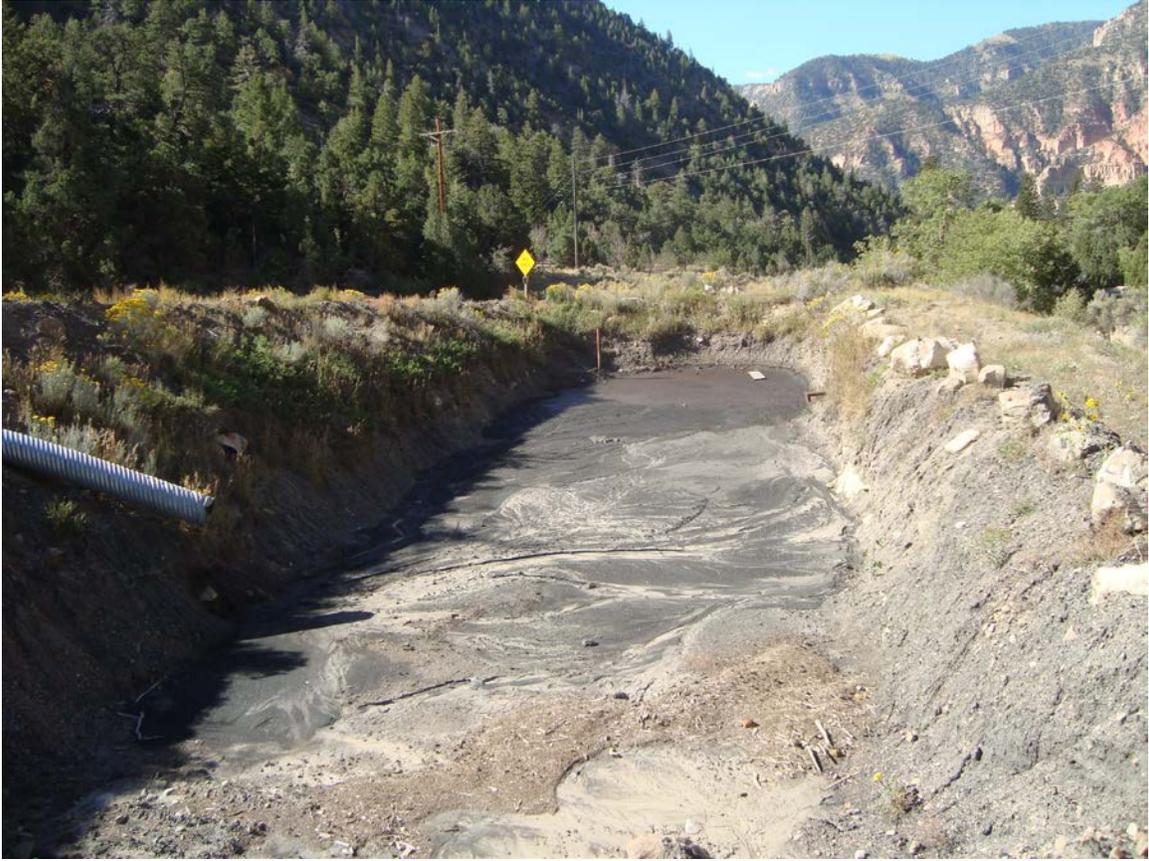
SEDIMENT POND B

1. Describe any appearances of any instability, structural weakness, or any other hazardous condition.			
The pond's dam shows no signs of structural instability or other hazardous conditions.			
Required for an impoundment which functions as a SEDIMENTATION POND	2. Sediment storage capacity, including elevation of 60% and 100% sediment storage volumes and estimated average elevation of existing sediment.		
	Sediment storage capacity is approximately 16,963 cu ft. Sediment has been removed.		
	60% Cleanout Elevation: 7,062.9		
	100% Sediment storage elevation: 7,063.4		
	Existing sediment elevation: Average sediment elevation 7,059.1

3. Principle and emergency spillway elevations		
	Principle spillway elevation: 7,064.9		
	Emergency spilway elevation: 7066.9		
4. Field Information: Provide current water elevation, whether pond is discharging, type and number of samples taken, monitoring/instrumentation information, inlet/outlet conditions or other related activities associated with the pond including but not limited to sediment cleanout, pond decanting, embankment erosion/repairs, monitoring information, vegetation on out slopes of embankment erosion/repairs, monitoring information, vegetation on out slopes of embankments, etc.			
Pond is dry. Vegetative cover looked good with no signs of erosion. Vegetation could be removed from emergency spillway.

5. Field Evaluation: Describe any changes in the geometry of the impounding structure, average and maximum depths and elevations of impounded water, estimated sediment or slurry volume and remaining storage capacity, estimated volume of water impounded and any other aspect of the impounding structure affecting its stability or function which has occurred during the reporting period.			
Sediment has been removed. Average sediment is 3.8' below the 60% cleanout level.			
Qualified Statement	I hereby certify that I am experienced in the construction of impoundments; I am qualified and authorized under the direction of a Registered Professional Engineer to inspect the condition and appearance of impoundments in accordance with the certified and approved designs for this structure, that the impoundment has been maintained in accordance with approved design and meet or exceed the minimum design requirements under all applicable federal, state and local regulations; and, that inspections and inspection reports are made by myself and include any appearances of instability, structural weakness or other hazardous conditions of the structure affecting stability.

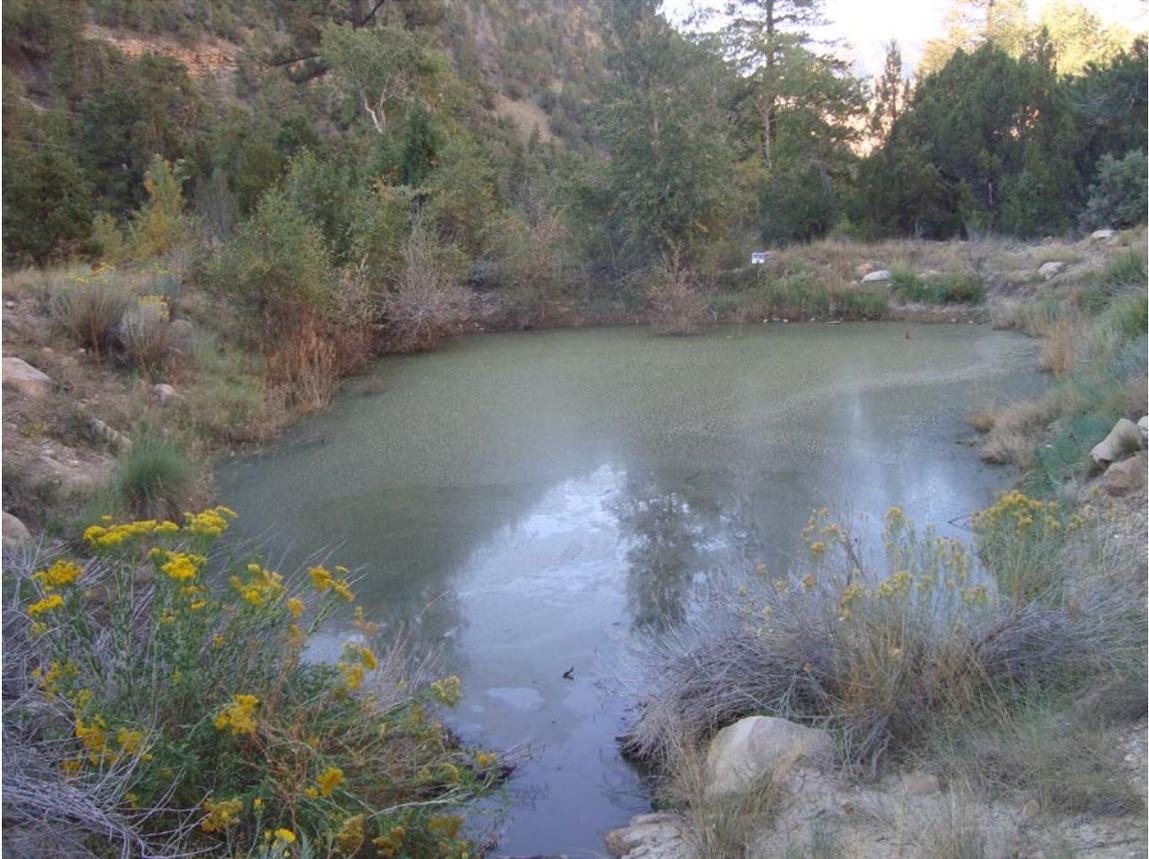
SEDIMENT POND C

The pond's dam shows no signs of structural instability or other hazardous conditions.

Pond is full of water and cannot see sediment level. It appears that sediment level is the same as 12/10/2012. Vegetative cover looked good with no signs of erosion.

Average sediment level is 2.3' below the 60% cleanout level (Taken from 12/10/12). This structure is still working properly.

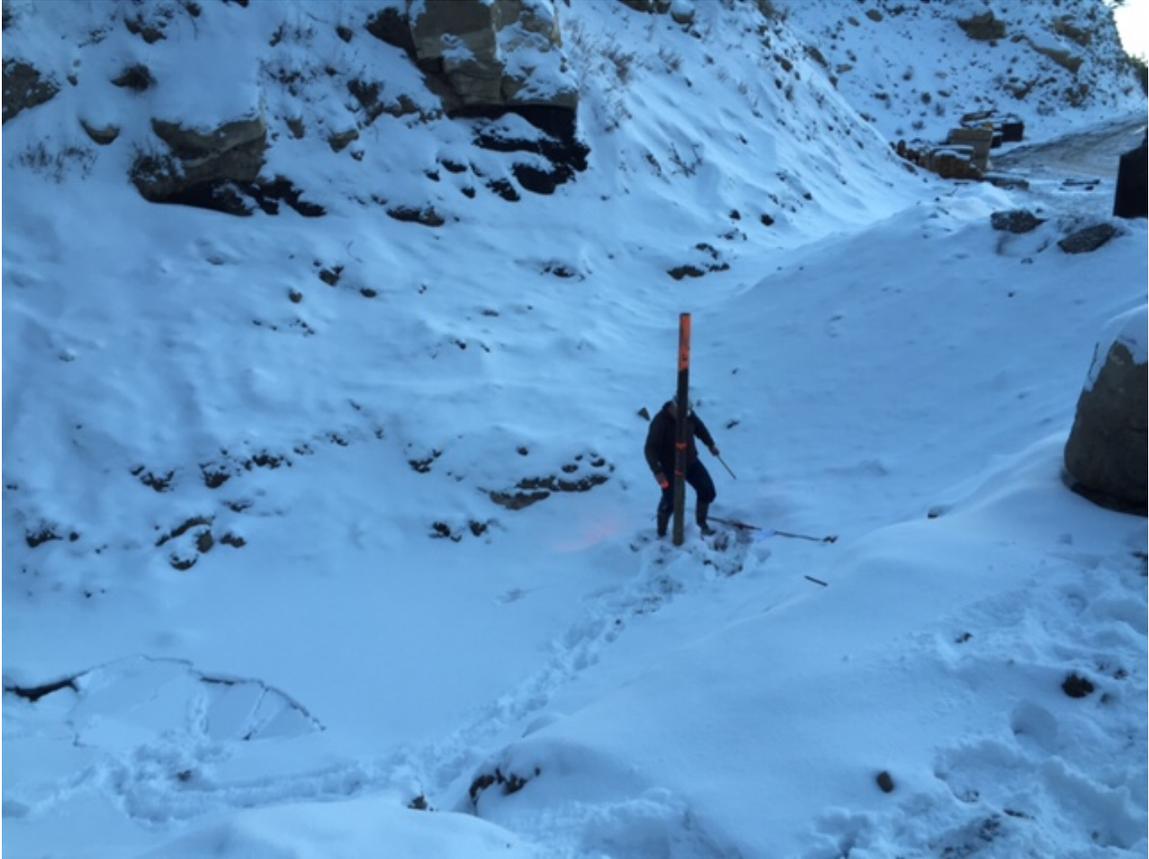
SEDIMENT POND D

1. Describe any appearances of any instability, structural weakness, or any other hazardous condition.			
The pond's dam shows no signs of structural instability or other hazardous conditions. Pond elevations have been corrected.			
Required for an impoundment which functions as a SEDIMENTATION POND	2. Sediment storage capacity, including elevation of 60% and 100% sediment storage volumes and estimated average elevation of existing sediment.		
	Sediment storage capacity: Estimated 1603 cu ft		
	60% Cleanout Elevation: 7,641.8		
	100% Sediment storage elevation: 7,643.1		
	Existing sediment elevation: Average sediment elevation 7,640.1

3. Principle and emergency spillway elevations		
	Principle spillway elevation: 7,644.1		
	Emergency spillway elevation: 7,646.6		
4. Field Information: Provide current water elevation, whether pond is discharging, type and number of samples taken, monitoring/instrumentation information, inlet/outlet conditions or other related activities associated with the pond including but not limited to sediment cleanout, pond decanting, embankment erosion/repairs, monitoring information, vegetation on out slopes of embankment erosion/repairs, monitoring information, vegetation on out slopes of embankments, etc.			
Pond is dry. Incised pond has minimal vegetation with no signs of erosion.

5. Field Evaluation: Describe any changes in the geometry of the impounding structure, average and maximum depths and elevations of impounded water, estimated sediment or slurry volume and remaining storage capacity, estimated volume of water impounded and any other aspect of the impounding structure affecting its stability or function which has occurred during the reporting period.			
Pond elevations have been modified. Error on surface elevations were corrected. Average sediment level is 7640.1 and is 1.7' below the 60% cleanout level. Oil removal elbow still needs to be installed on principal spillway.			
Qualified Statement	I hereby certify that I am experienced in the construction of impoundments; I am qualified and authorized under the direction of a Registered Professional Engineer to inspect the condition and appearance of impoundments in accordance with the certified and approved designs for this structure, that the impoundment has been maintained in accordance with approved design and meet or exceed the minimum design requirements under all applicable federal, state and local regulations; and, that inspections and inspection reports are made by myself and include any appearances of instability, structural weakness or other hazardous conditions of the structure affecting stability.
