I have enclosed copies of OSMRE's inspection report for the Bear Canyon Mine (Partial Independent) that was conducted the week of May 11, 2015.

**U.S. DEPT. OF THE INTERIOR
OFFICE OF SURFACE MINING
Mine Site Evaluation
State Program**

Bear Canyon Mine Partial Independent Oversight Inspection Report
Utah Division of Oil, Gas and Mining (DOGGM) Permit ID # C/015/0025

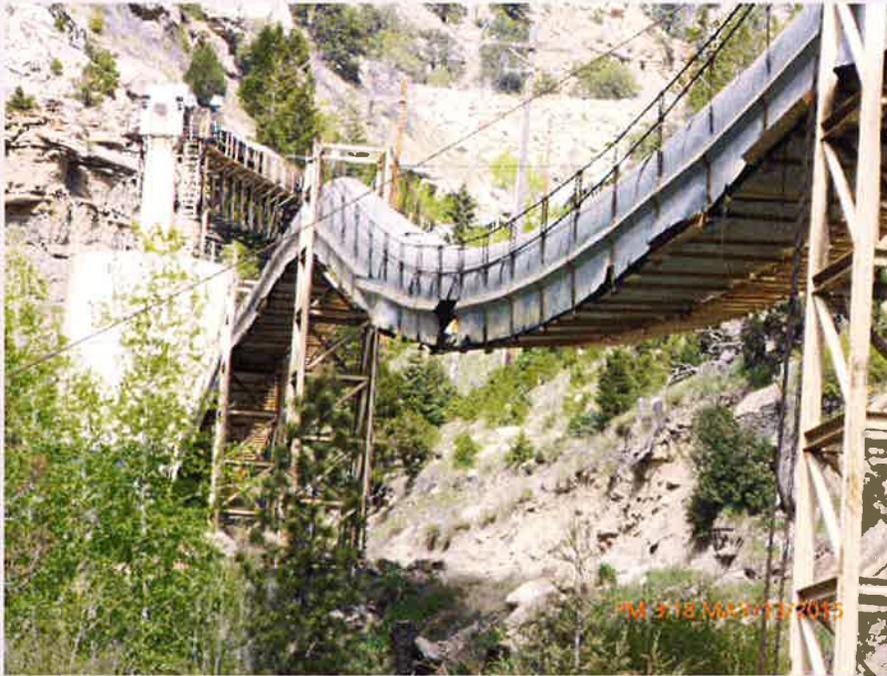
Subject: Figure 1

Inspection of the overland conveyer (Portal #3 Area) was missing a side panel. As a result, a significant amount of coal has dumped into the undisturbed drainage flowing to Bear Creek. Appendix 7K and Figure 7K-1 of the approved permit provides specification for construction and maintenance regarding the overland conveyer. See Figure 1, attached.

Missing side panel in area over undisturbed drainage. Significant coal has spilled out as a result.

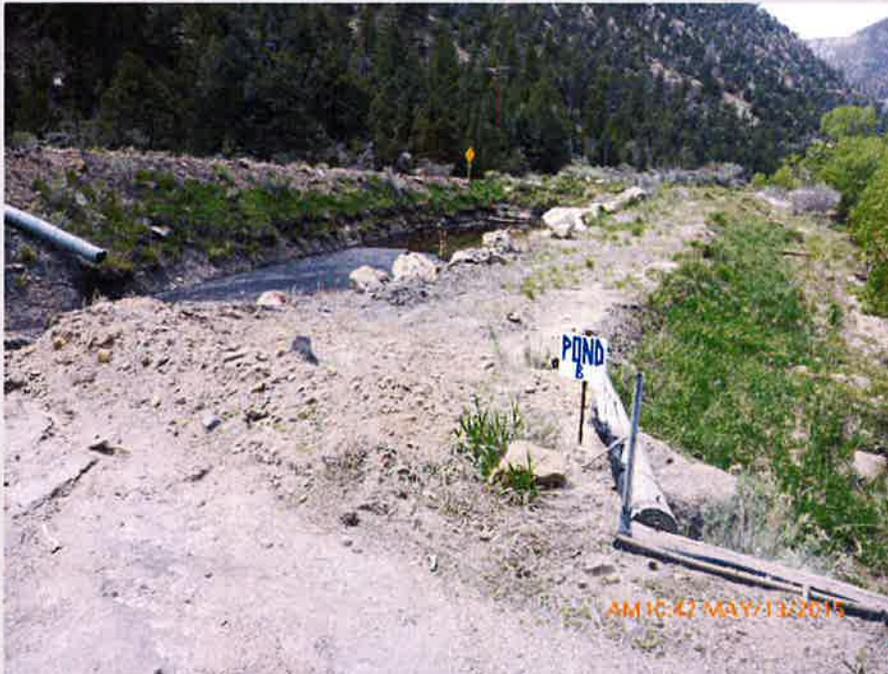
Subject: Figure 2

Inspected the pond for stability and functionality. This included the inlet structure, principle spillway, and emergency spillway. Significant erosion to the ponds inlet was observed. Further review of the permit (Appendix 7-F) indicates that Pond B is designed with TWO inlets, one of which shows that grouted riprap will be used. Additionally, the design information found at Appendix 7-F does not account for the corrugated pipe used as the other inlet. Furthermore, there is concern of potential “short-circuiting” as it relates to the close proximity of the principle spillway. See Figure 2 and 3, attached.

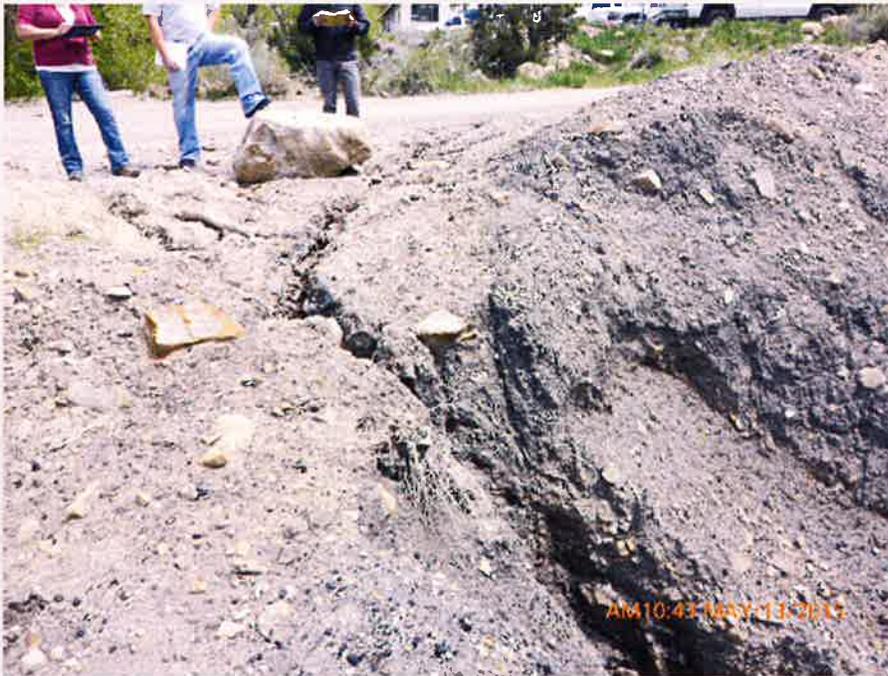
Subject: Figure 3

New inlet formed at Pond B from erosion.

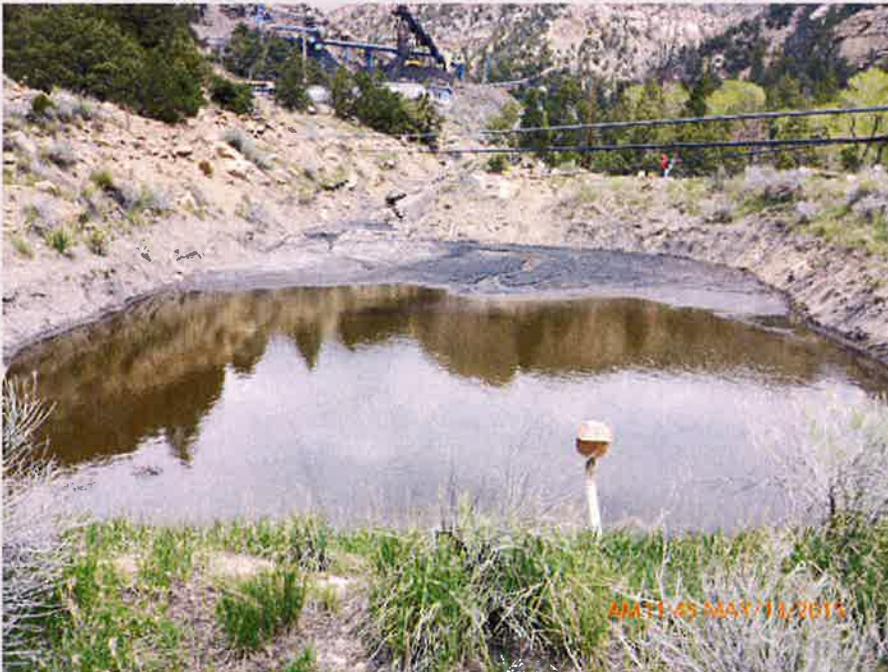
Subject: Figure 5

Inspected the pond for stability and functionality. This included the inlet structure, principle spillway, and emergency spillway. Significant erosion to the ponds inlet was observed. Further review of the permit (Appendix 7-F) indicates that the pond inlet and cleanout access ramp are “one in the same” and if erosional features develop, they will be maintained. Additionally, it is evident material that has been excavated during pond clean out is being stored on the ponds embankment rather than hauled to the approved sediment pond waste area (*Chapter 7, R645-301-700 Hydrology, and Page 7-104*). See Figure 5 and 6, attached.

Eroded Inlet

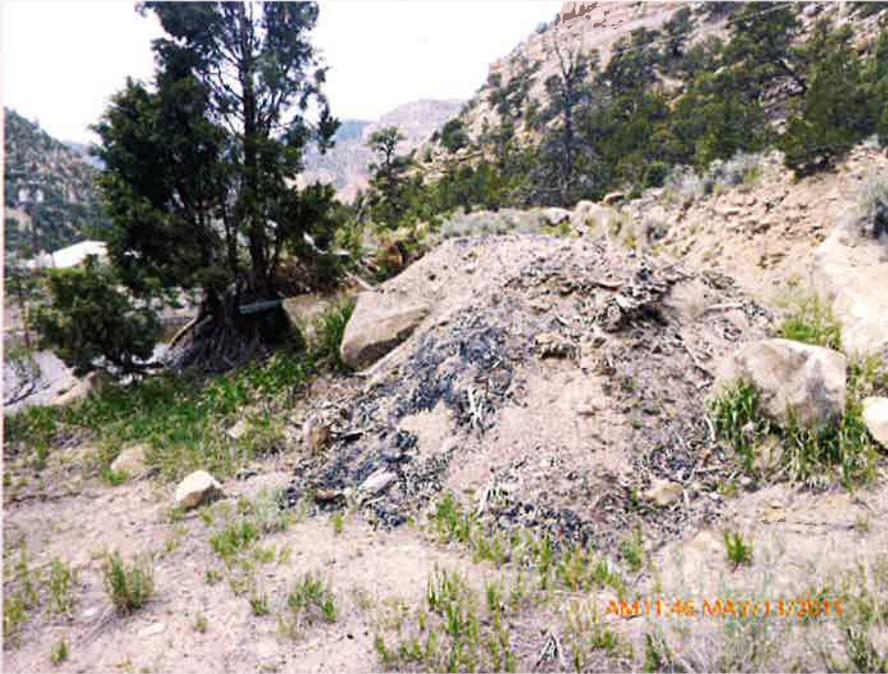
Subject: **FIGURE 6**

Pond A cleanout material being stockpiled on pond embankment.

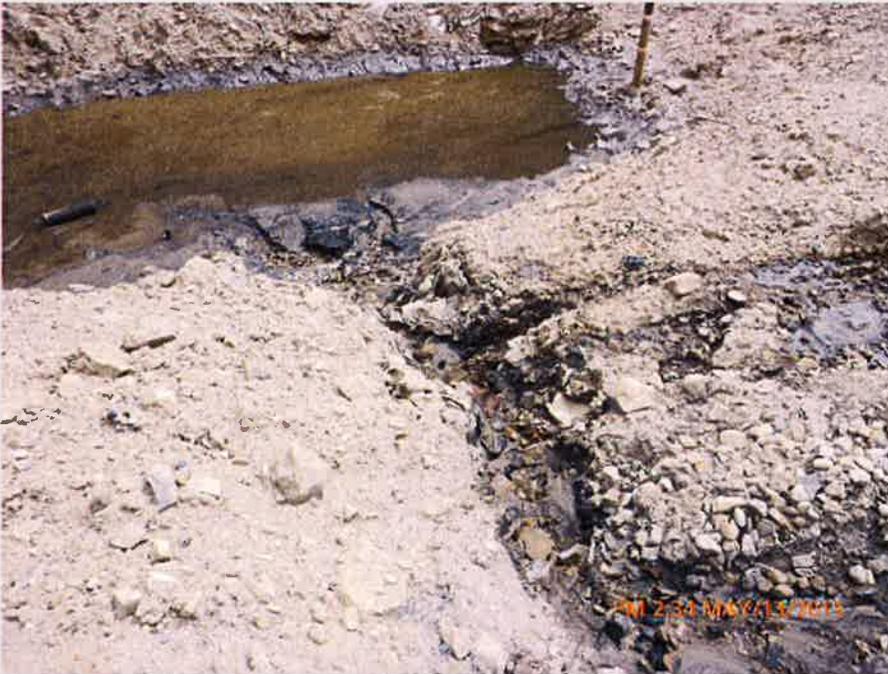
Subject: **FIGURE 7**

Inspected the pond for stability and functionality. This included the inlet structure, principle spillway, and emergency spillway. Significant erosion has created an additional inlet. Appendix 7-F states, in part, that the pond inlet will be protected using grouted riprap. OSMRE notes the pond is not functioning as designed, at the time of inspection. See Figure 7, attached.

New inlet forming at Pond D due to erosion.

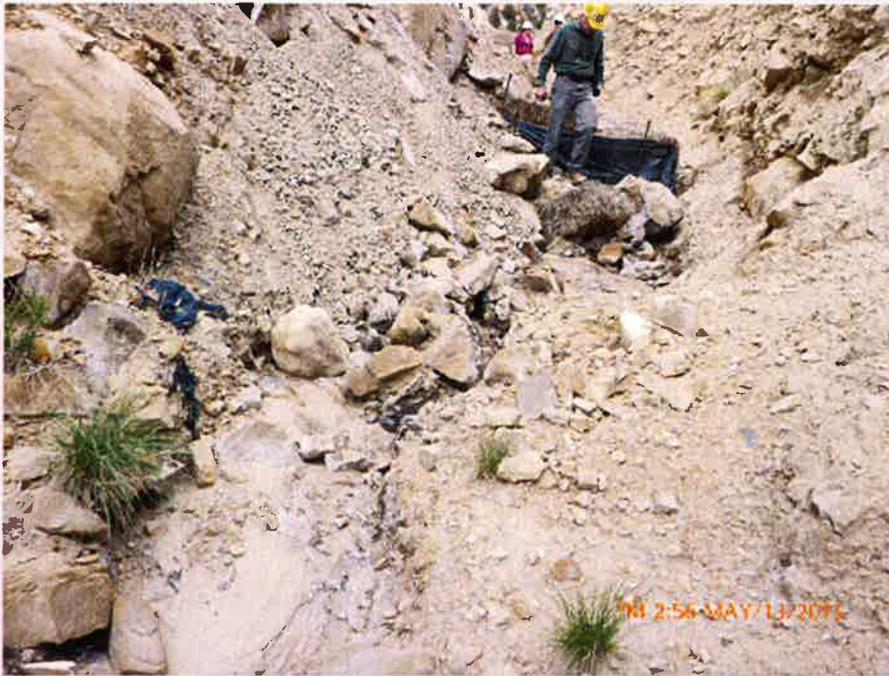
Subject: FIGURE 8

The Drainage pipe that crosses under the main haul road (down gradient from Portal #3) has not been maintained nor constructed as designed. Appendix 7-K provides that erosion control matting will be maintained to prevent further erosion. No erosional matting was observed at the time of inspection. As a result, there is significant erosion in this area. See Figure 8 through 16, attached.

ASCA not maintained.

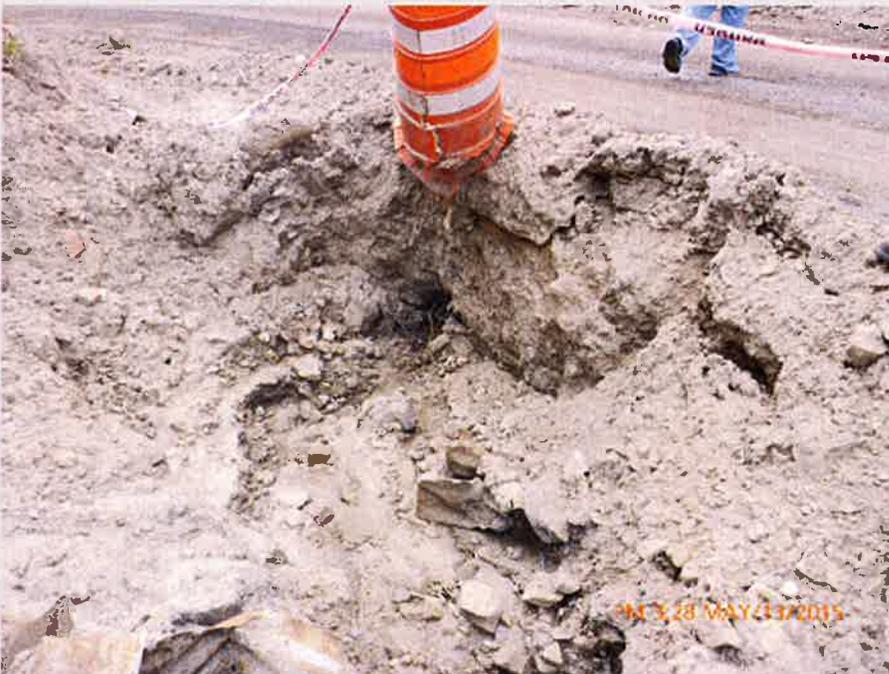
Subject: FIGURE 9

ASCA not maintained.

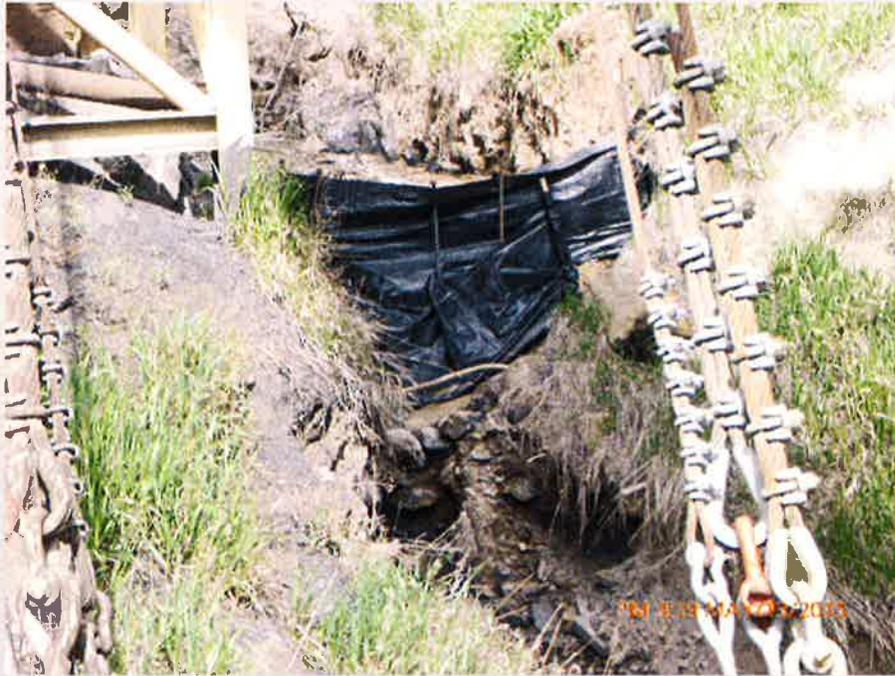
Subject: FIGURE 10

ASCA not maintained.

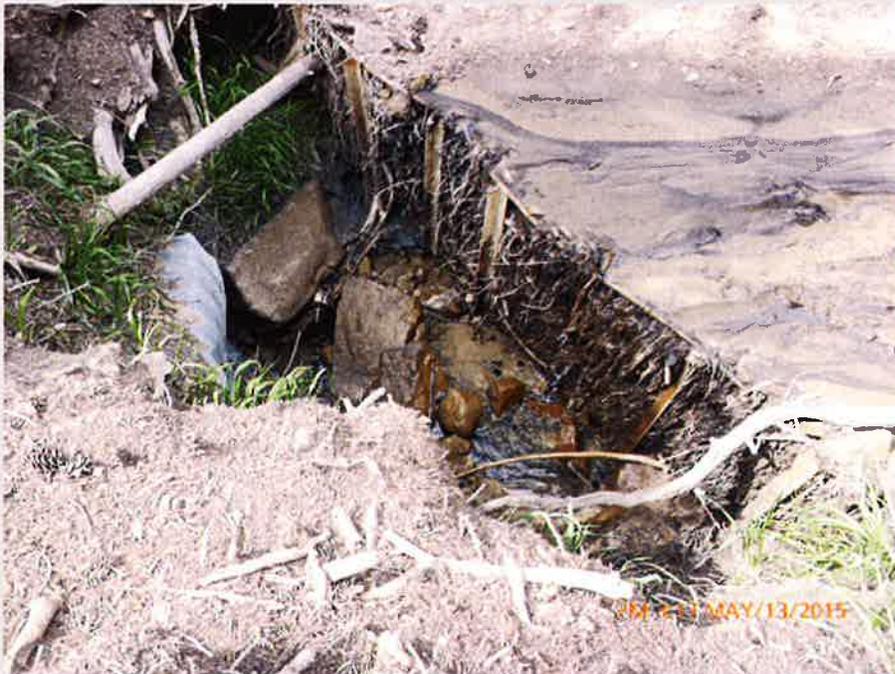
Subject: FIGURE 11

ASCA not maintained.

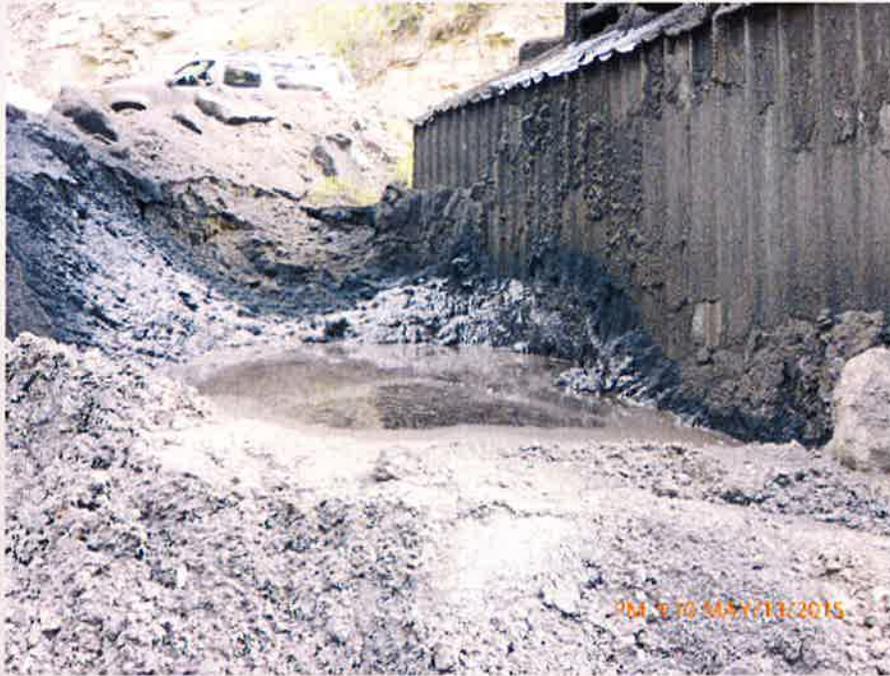
Subject: FIGURE 12

ASCA not built as designed or maintained.

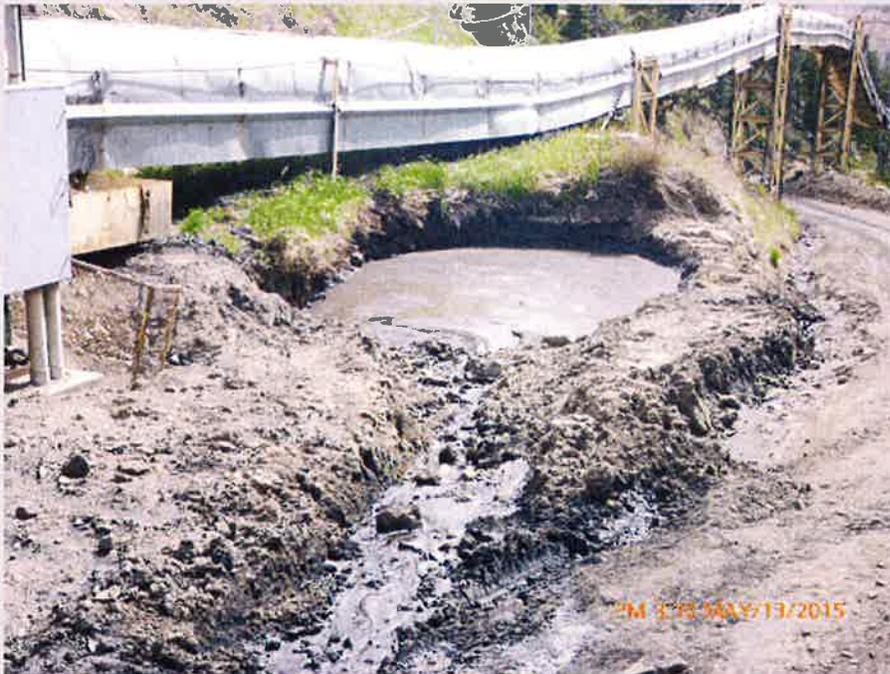
Subject: FIGURE 13

ASCA not maintained.

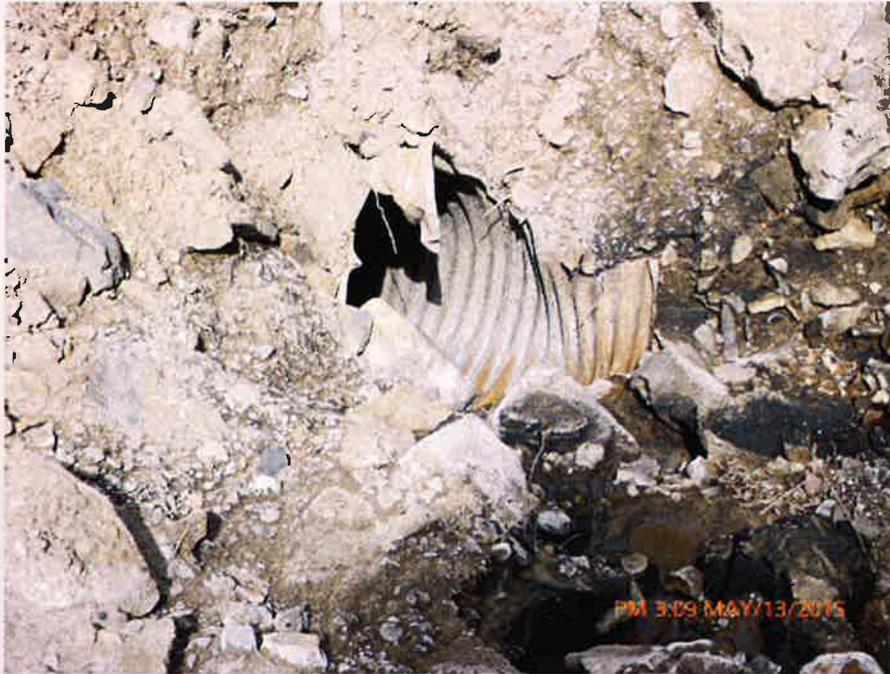
Subject: FIGURE 14

ASCA drainage culvert in disrepair.

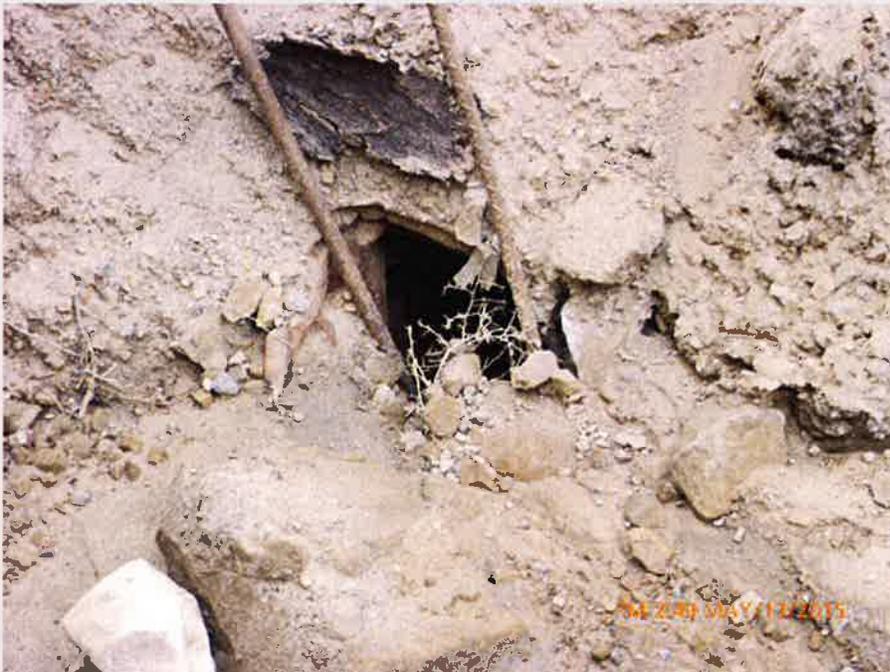
Subject: FIGURE 15

ASCA drainage culvert in disrepair.

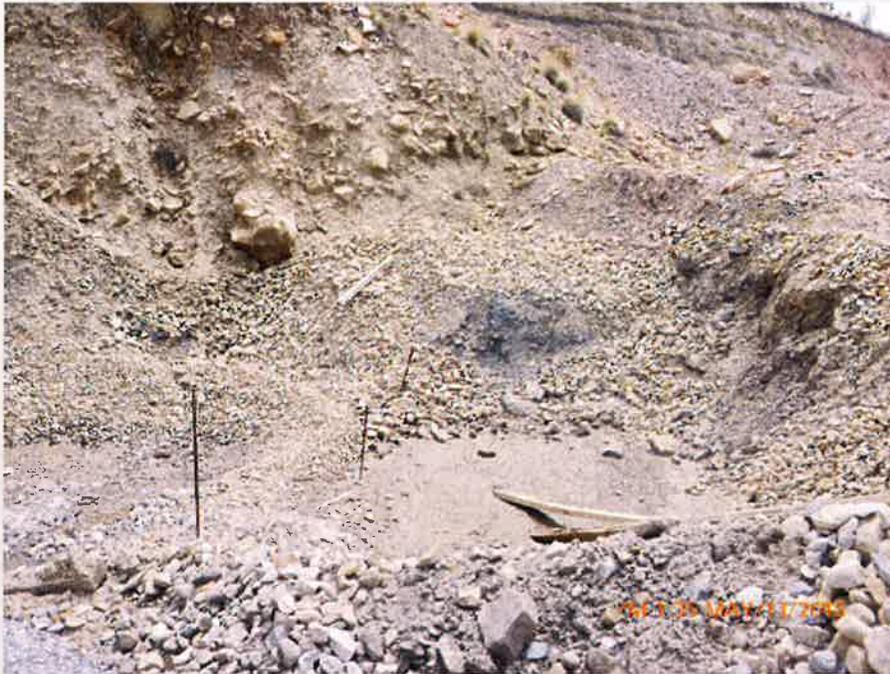
Subject: FIGURE 16

ASCA at Portal #4 not designed or maintained. Surface drainage is unable to report to the ASCA due to storage of gravel.

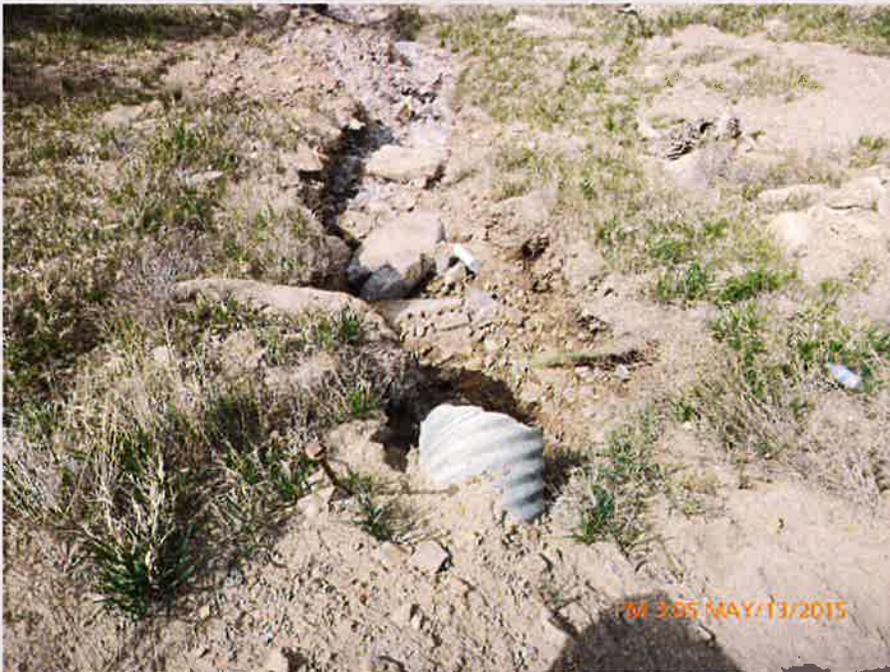
Subject: FIGURE 17

Two additional areas of concern were noted along the access road to the East portals. At these locations, it is evident that the ASCA structures have not been maintained in quite some time. As a result, down cutting beneath the ASCA and around the sides were observed. See Figure 17, attached.

Eroded roadside drainage near Portal # 3.

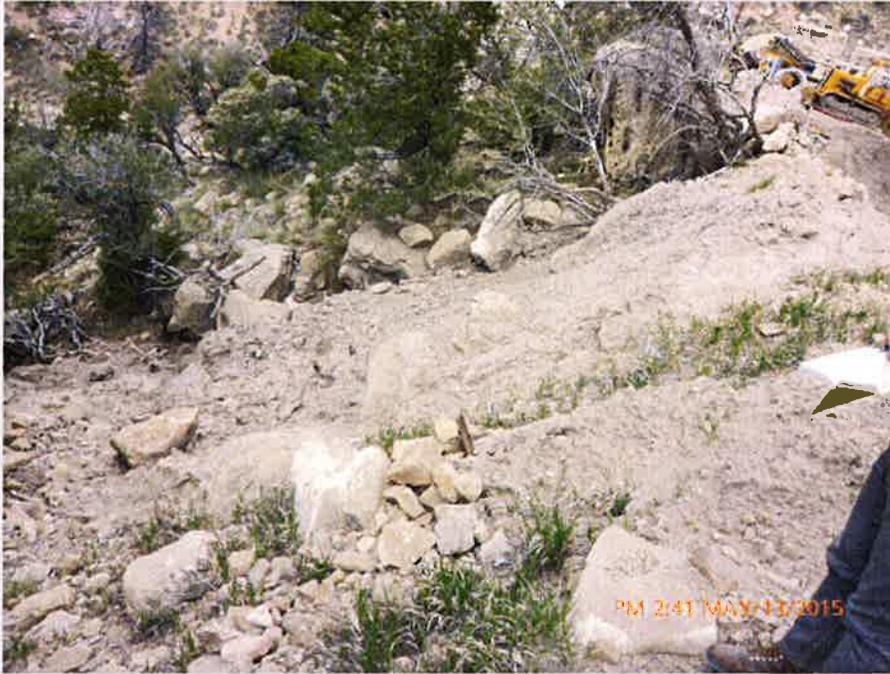
Subject: FIGURE 18

While walking down the main haul road from Portal #3 area (just before dumpster location), observation of dried, sludgy mud was identified on the out slope of the road. This material appears to be material that was dumped over the roadside berm while snowplowing the road as part of regular maintenance. Further review of the approved permit (Appendix 7K-12A) provides reference to approved snow storage areas, none of which is where the material was observed. See Figure 18, attached.

Erosion along haulroad near Portal #3.

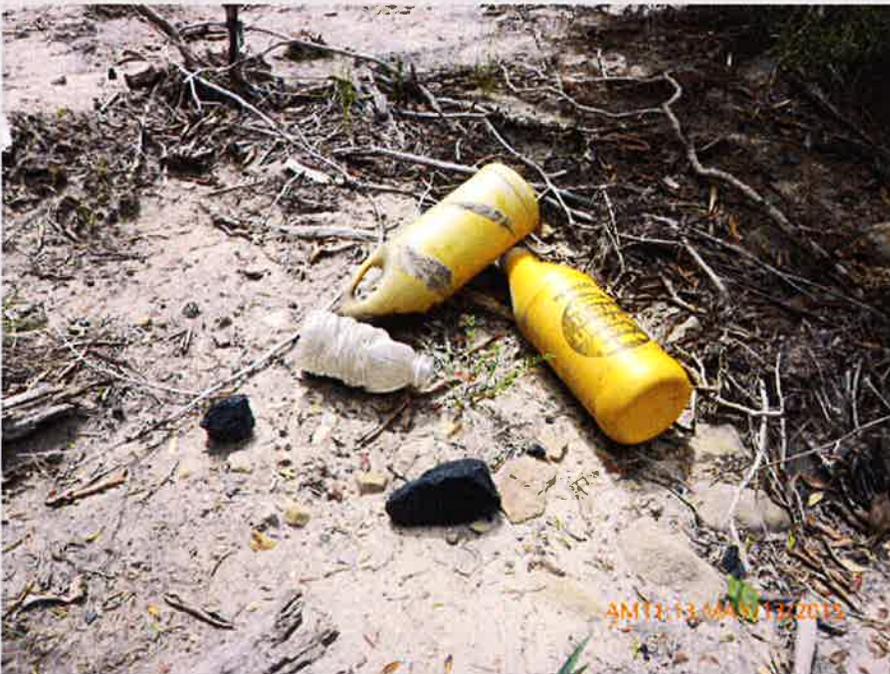
Subject: FIGURE 19

OSMRE notes several areas that were marked “Stream Buffer Zone-Do Not Disturb” throughout the permit area. Conversely, the markers were well within the 100ft of mine disturbance that is allowed by R645-301-731.600. Specifically, the disturbance identified within the Stream Buffer Zones included:

1. A wooden structure that appeared to be some sort of “fort” or “hideout”;
2. A mine employee cutting limbs along a footpath with a sawzall;
3. Various non-coal waste items ranging from gear lubricant, coal, pump hoses, metals and a bag of Calcium-Chloride.

Noncoal waste in SBZ.

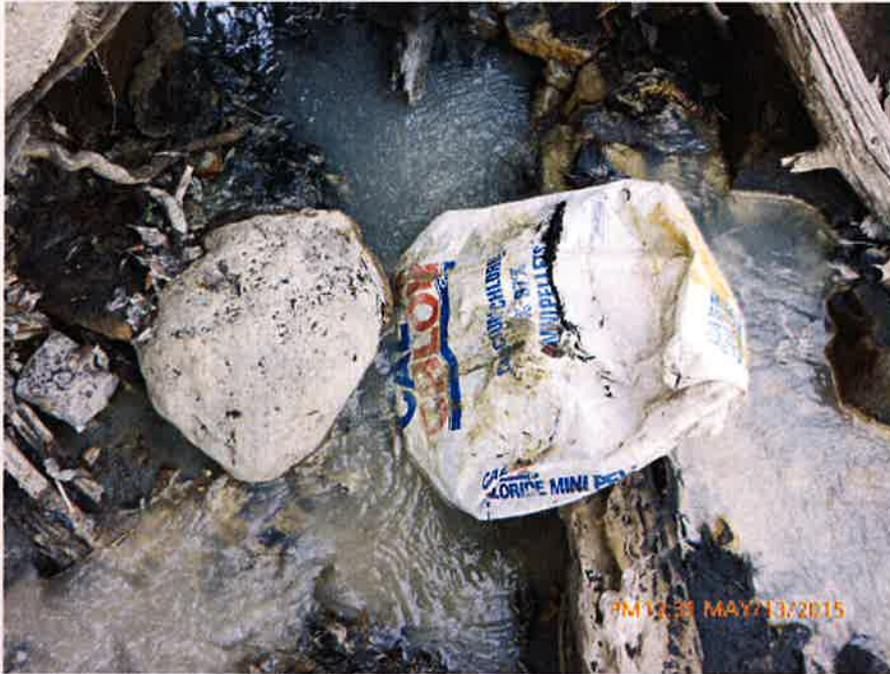
Subject: FIGURE 20

Noncoal waste in SBZ. NOTE: Discoloration of undisturbed drainage has not been identified yet.

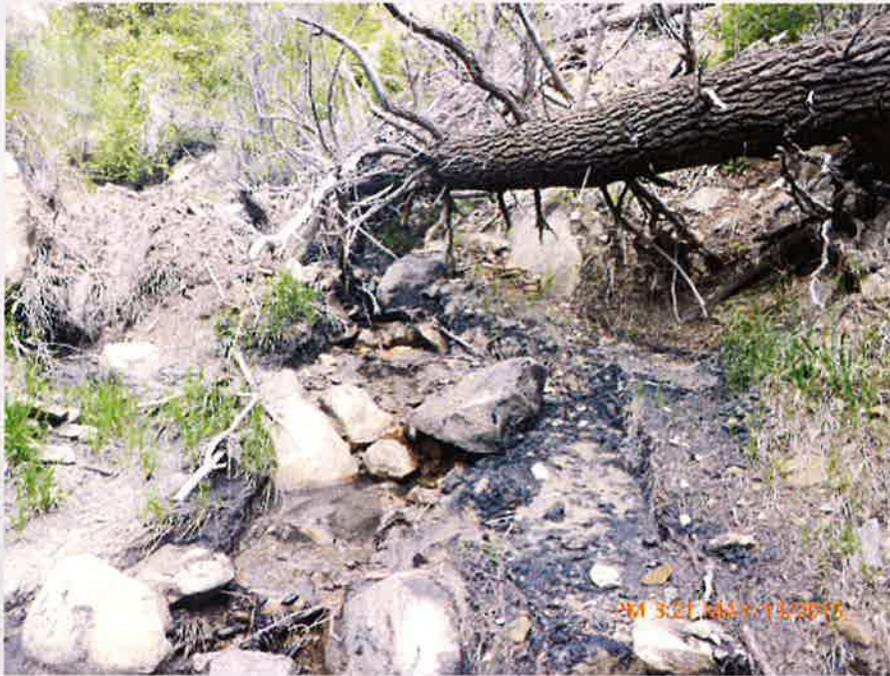
Subject: FIGURE 22

Coal mine waste in undisturbed SBZ.

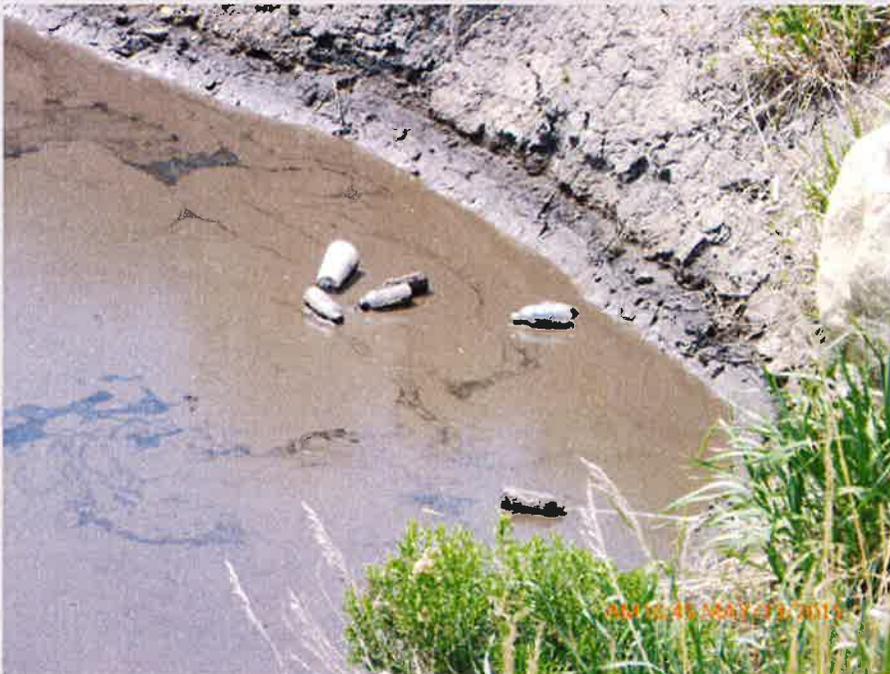
Subject: FIGURE 23

Noncoal waste was observed consistently throughout the inspection of the mine permit area. To be clear, no particular area was considered to be "excessive". Nevertheless, trash items were noted throughout the entire inspection at various areas of the Bear Canyon Mine. Trash was also observed in the Stream Buffer Zones, Sediment ponds A, B, C, and D. See Figures 23- through 26, attached.

Trash in Sediment Pond B.

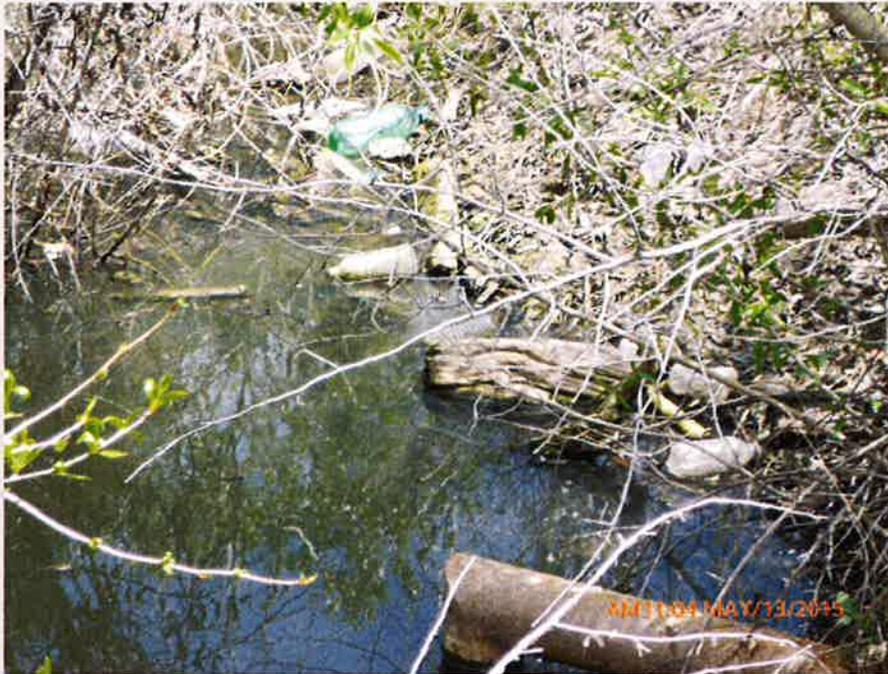
Subject: FIGURE 24

Trash in Sediment Pond C.

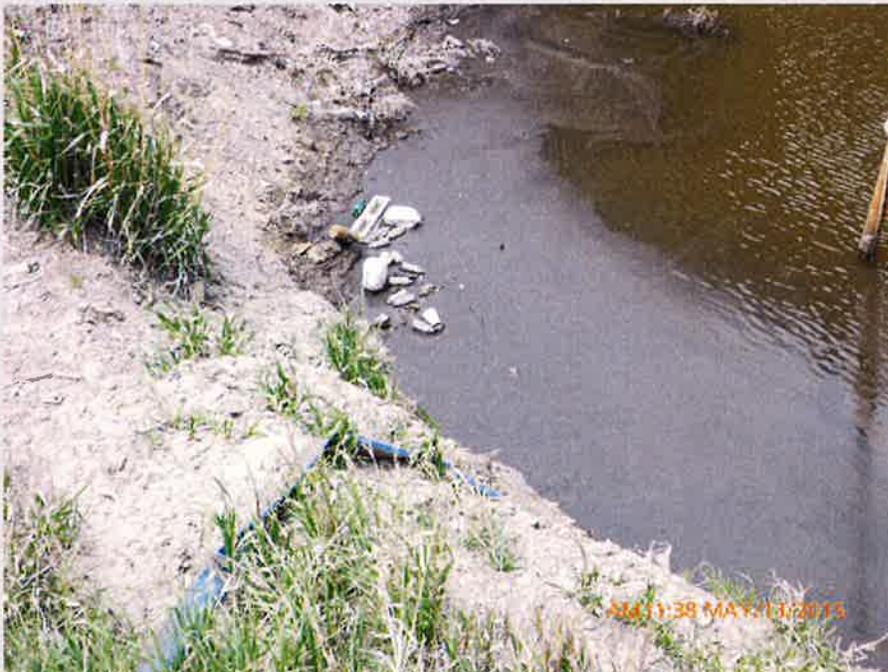
Subject: FIGURE 25

Trash in Sediment Pond A

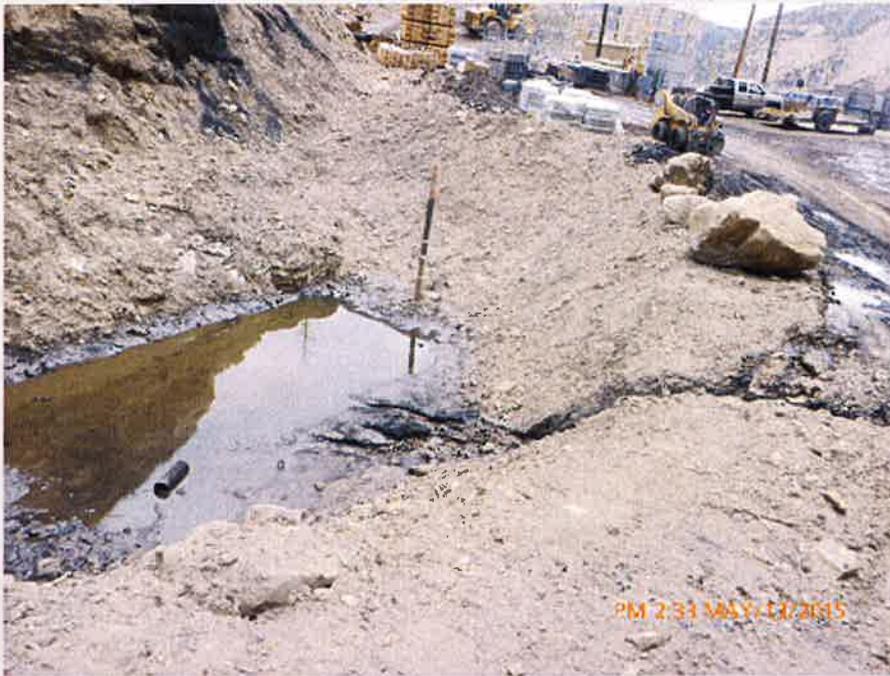
Subject: FIGURE 26

Oil Filter floating in Pond D.
