## United States Department of the Interior

I have enclosed copies of the OSMRE's Ten Day Notice (TDN) issued to the Utah Division of Oil, Gas and Mining on March 16, 2016. TDN X16-140-545-004 has been issued as a result of noncompliance OSMRE and DOGM identified during the course of the 2015 and 2016 Independent Partial Oversight inspections.

**U.S. DEPT. OF THE INTERIOR  
OFFICE OF SURFACE MINING  
Mine Site Evaluation  
State Program**

Permit:	C0150025	Inspection Date:	3/3/2016
Permittee:	CASTLE VALLEY MINING LLC

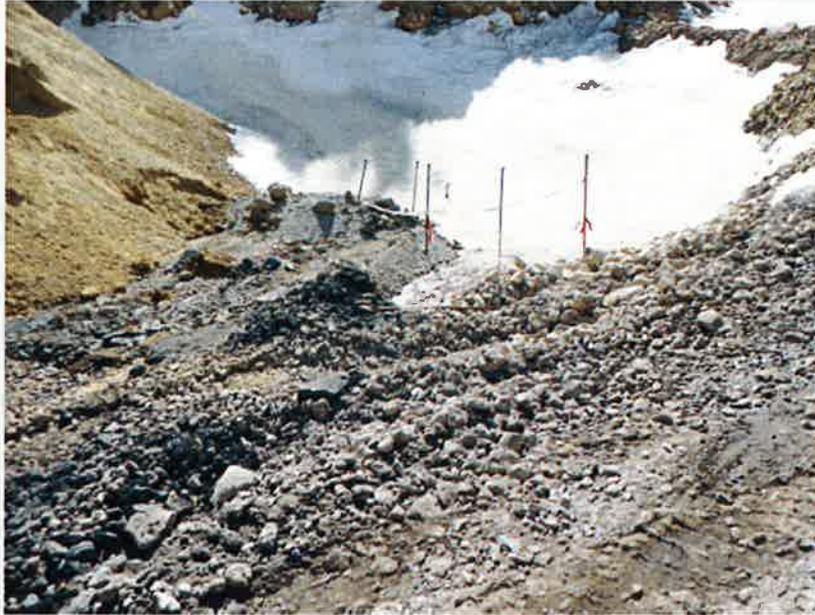
Portal 4 area ASCA not maintained. Stockpile material prevents positive flow. This issue was noted in 2015 as well.

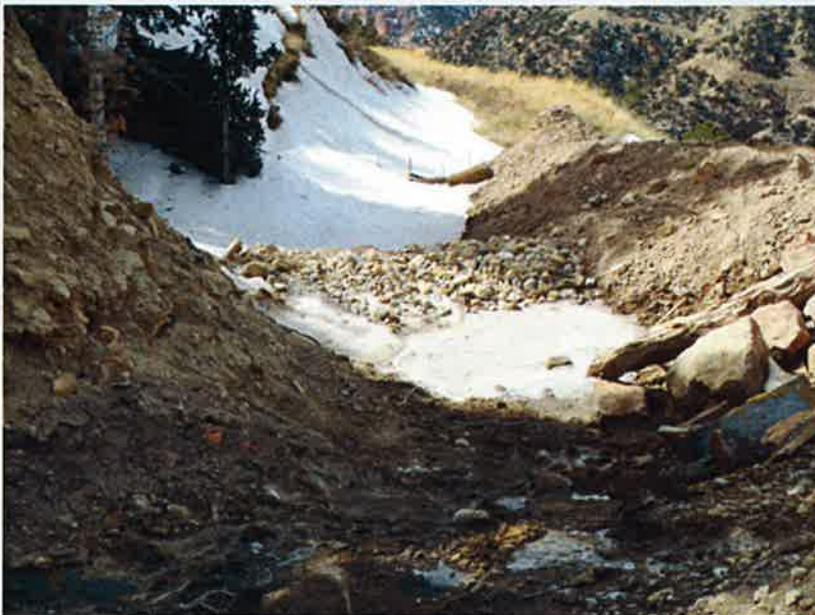
Newly reconstructed ASCA

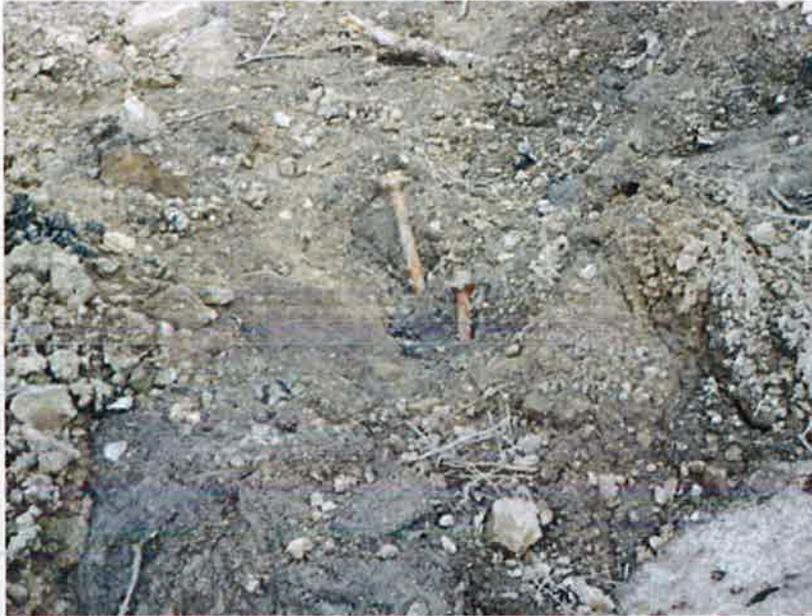
Inlet side of culvert at roadside ASCA is 100 percent buried.

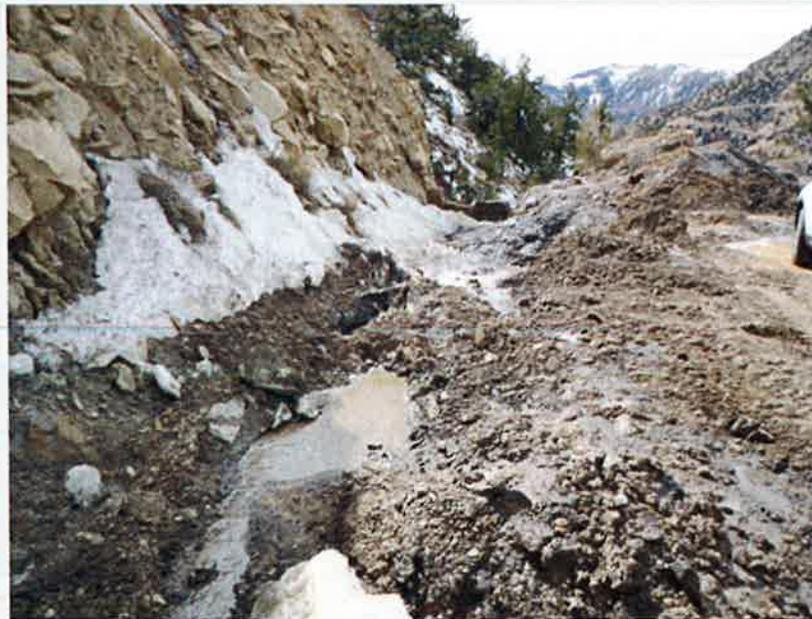
Newly reconstructed ASCA.  
 NOTE: Drainage has not been graded to ensure positive flow.

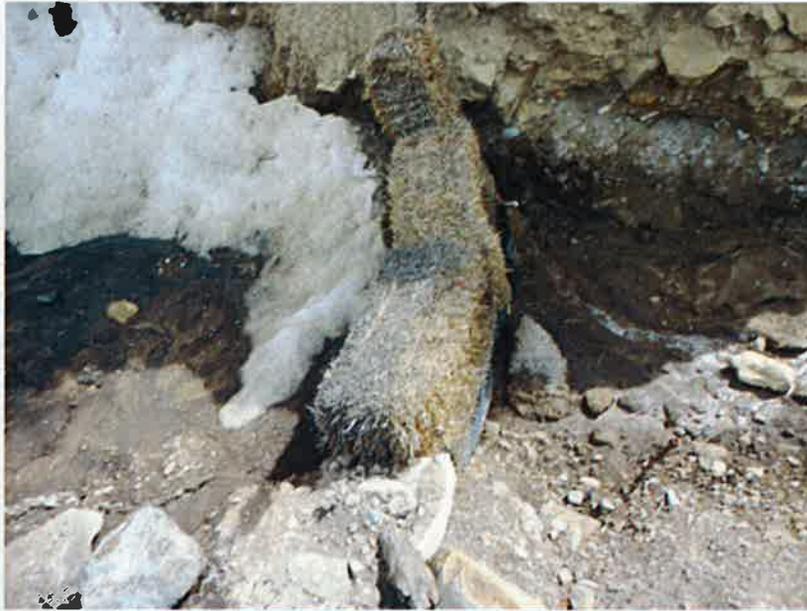
Improper installation of BMP.  
NOTE: Hay-bales should be installed where banding is not making contact with the surface to ensure intended function and design are achieved.

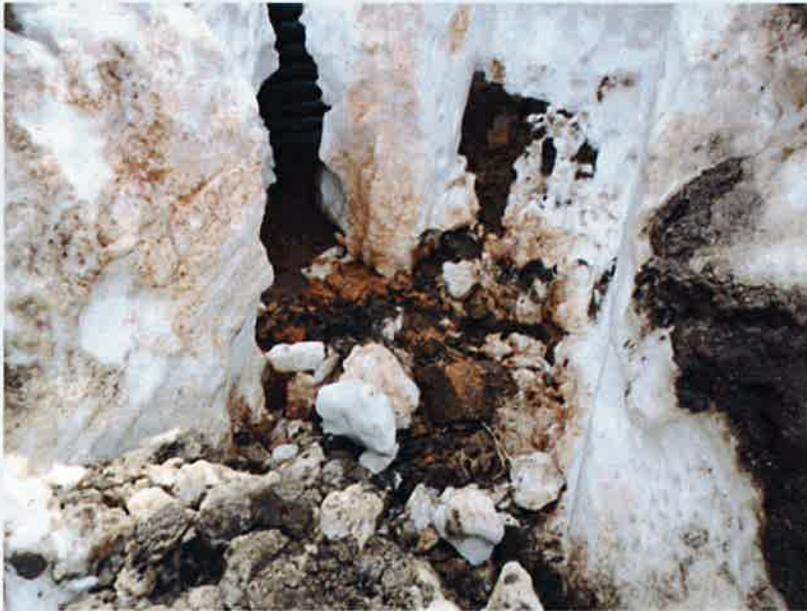
Culvert inlet at roadside ASCA is 100 percent buried.

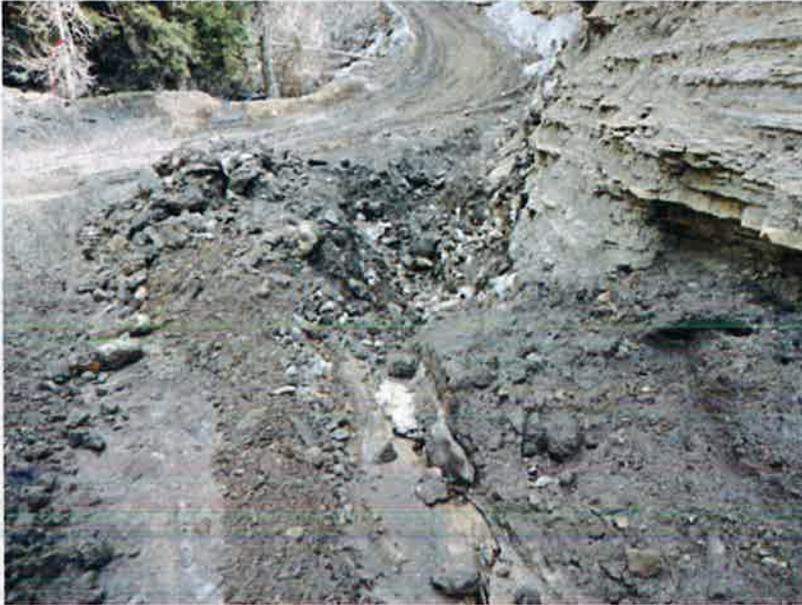
Culvert inlet at roadside ASCA is 100 percent buried.

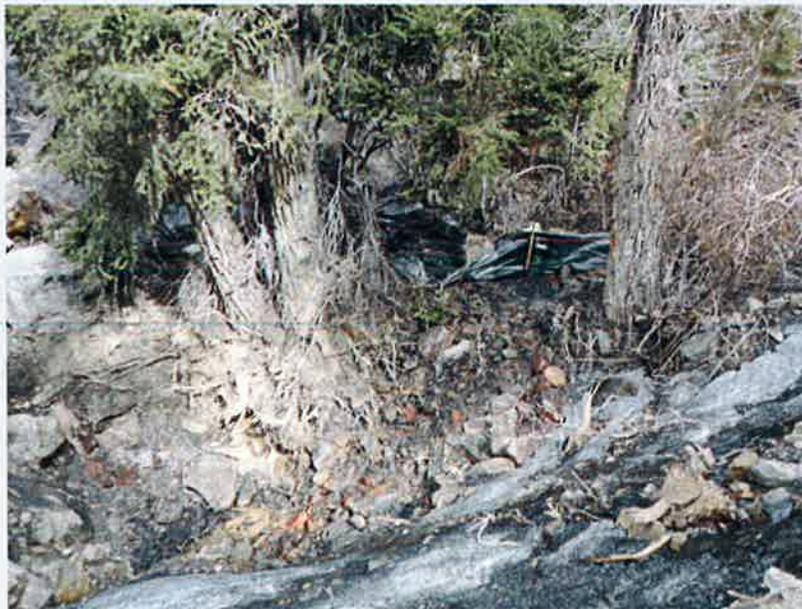
Dilapidated SM fence within stream buffer zone along portal access road.

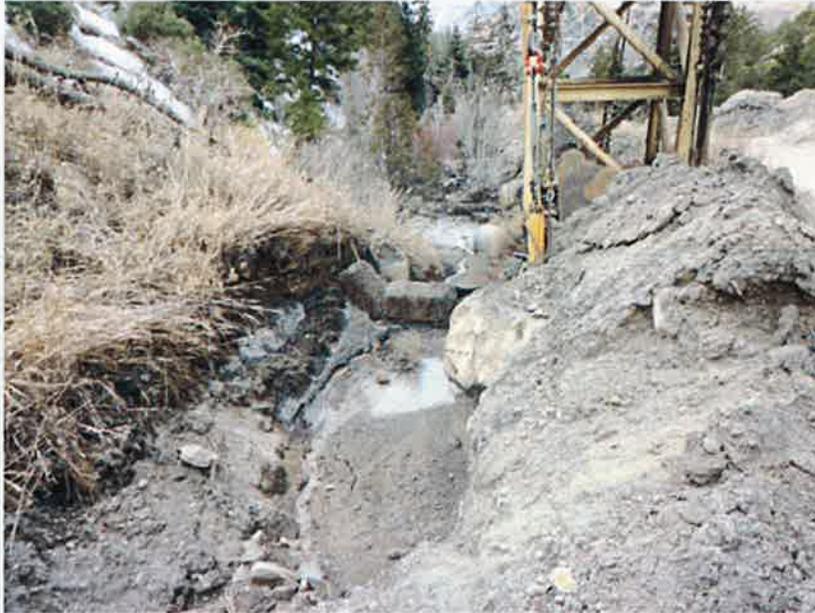
Improper installation and failure to maintain siltation structure.  
 NOTE: This BMP is within the stream buffer zone.

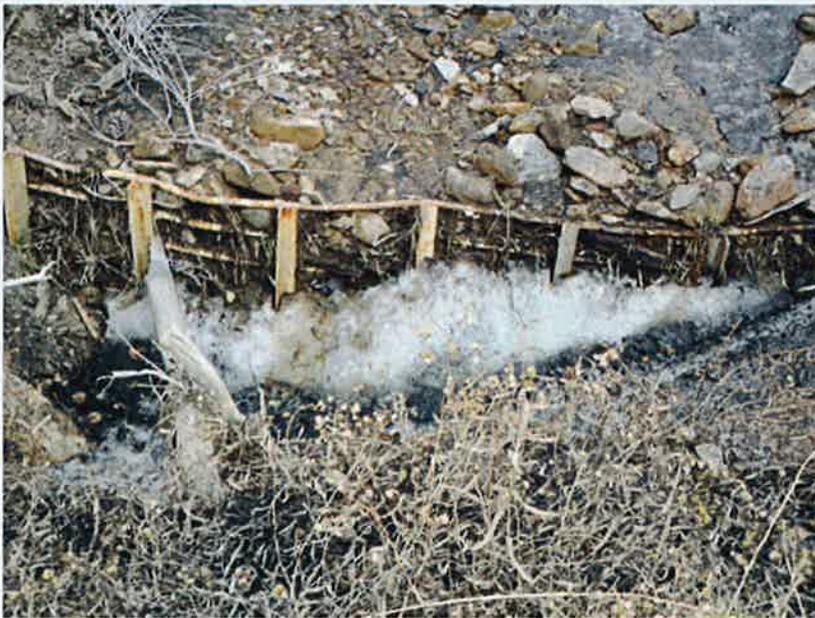
Failure to maintain BMP.  
 NOTE This BMP is within the stream buffer zone.

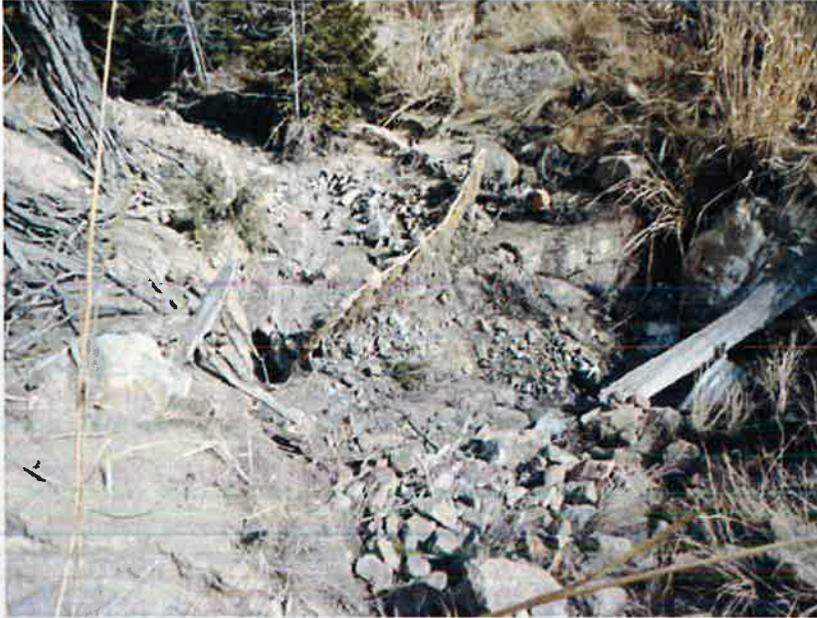
Failure to maintain BMP-Culvert is becoming blocked by woody debris.

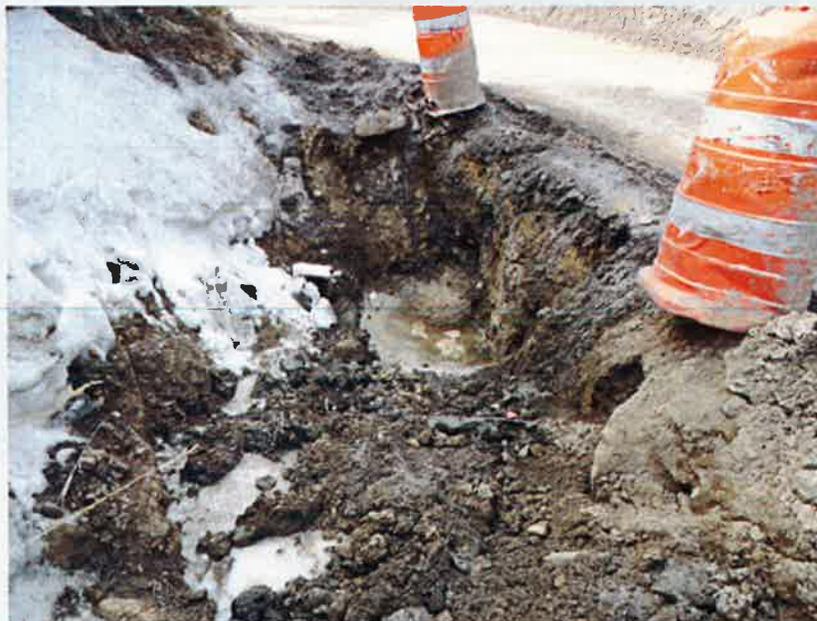
Culvert inlet at roadside ASCA is 100 percent buried.

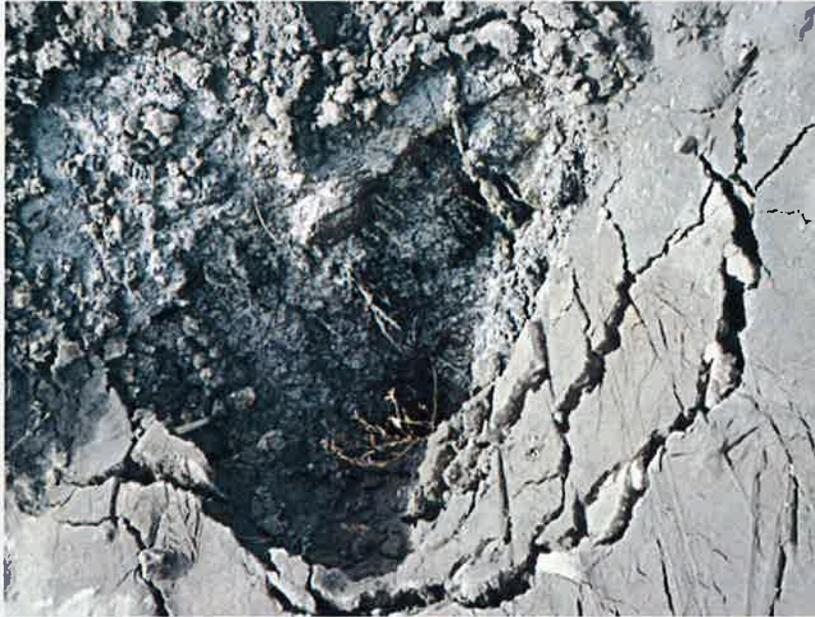
Inlet culvert adjacent to grease trap at welding shop pad has clogged and created sump.

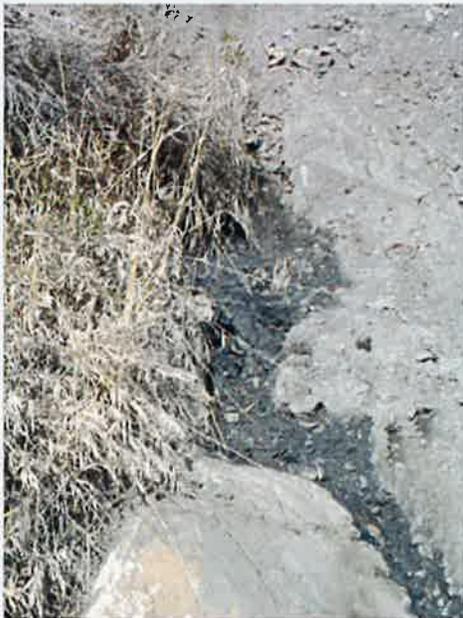
Culvert outlet down gradient of grease trap clogged.

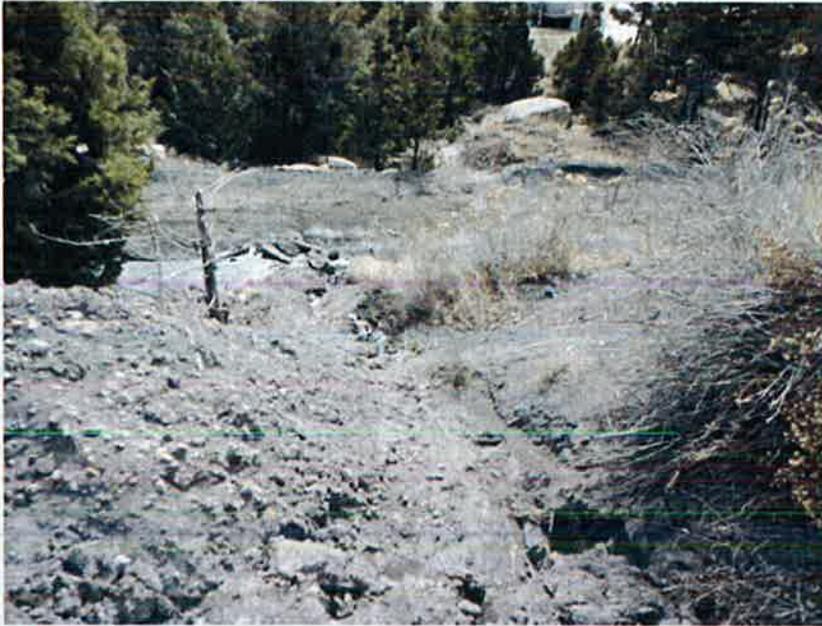
Berm has eroded due to a failure to maintain clogged culverts and grease trap holding capacity at welding shop pad area.

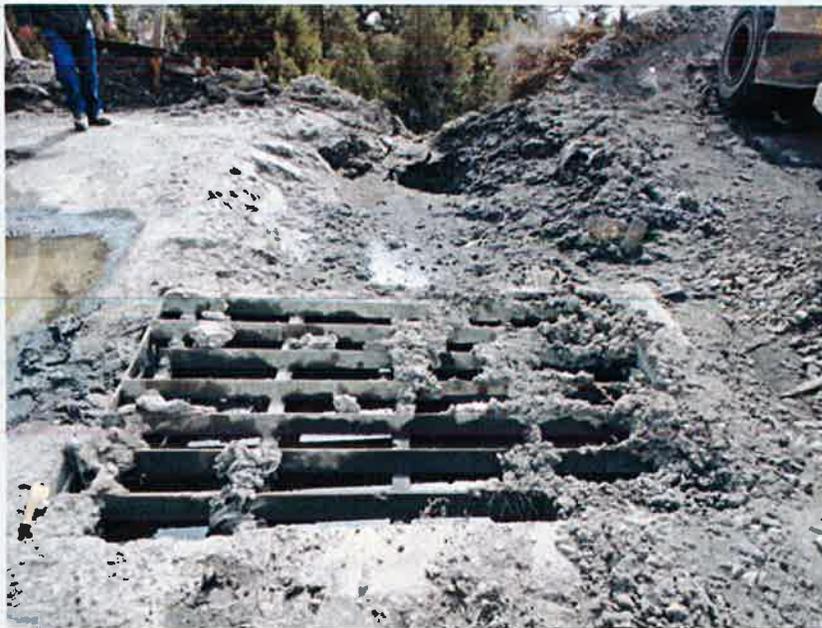
As noted in the 2015 inspection, the grated "grease trap" (4'x4') needs cleaning. The grease trap located on the pad of the welding shop area is full of grease and petroleum like substance. During the 2016 inspection, it was apparent that this grease trap over flowed at some point in time and completely blew out the berm directly adjacent to it. OSMRE notes that the undisturbed Bear Creek drainage is no more than twenty feet down gradient of where the erosion is occurring. This is important to note because there are not adequate BMP's in place to provide protection to the undisturbed area. Although there is a poorly maintained drainage on the west side of the road (same side the blow out occurred) the drainage is obstructed with miscellaneous noncoal waste, thus adding potential for untreated drainage to enter Bear Creek. Inspection of the stream buffer zone at this location is indicative of coal fine deposition.

Grease trap with picture of erosion.

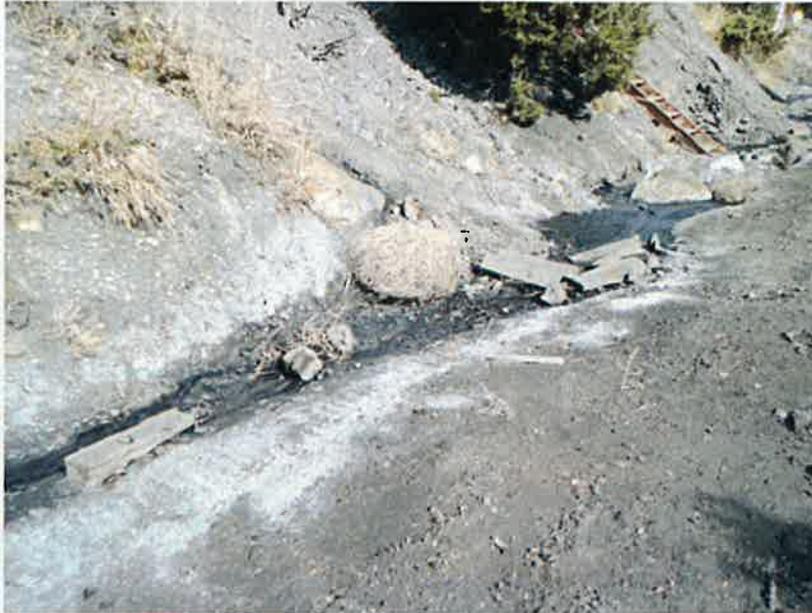
Noncoal waste and debris in drainage just below erosional feature at welding shop pad area.

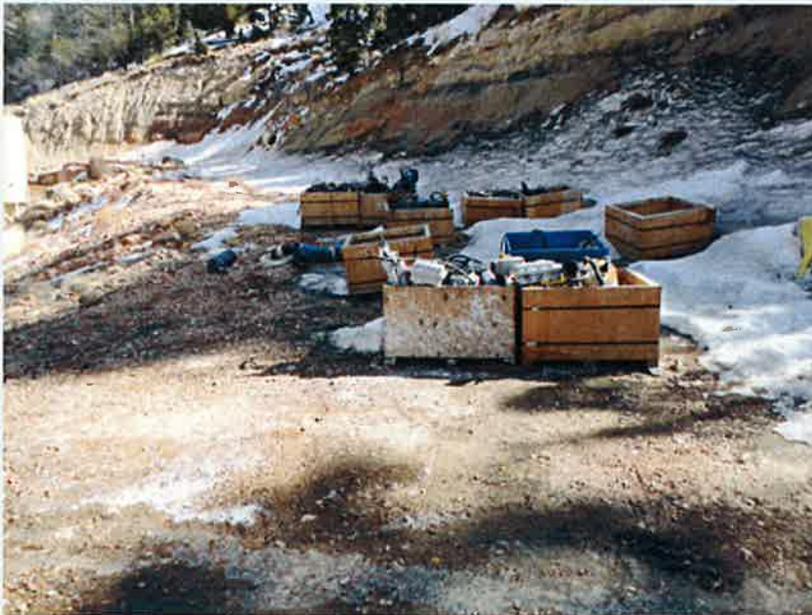
Containers near portal 4

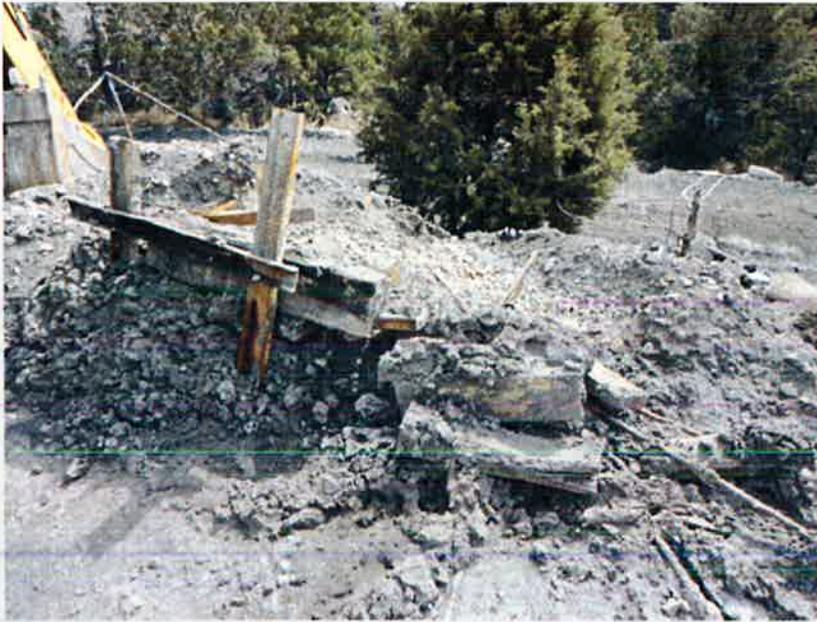
Noncoal waste piled up at welding shop pad area.

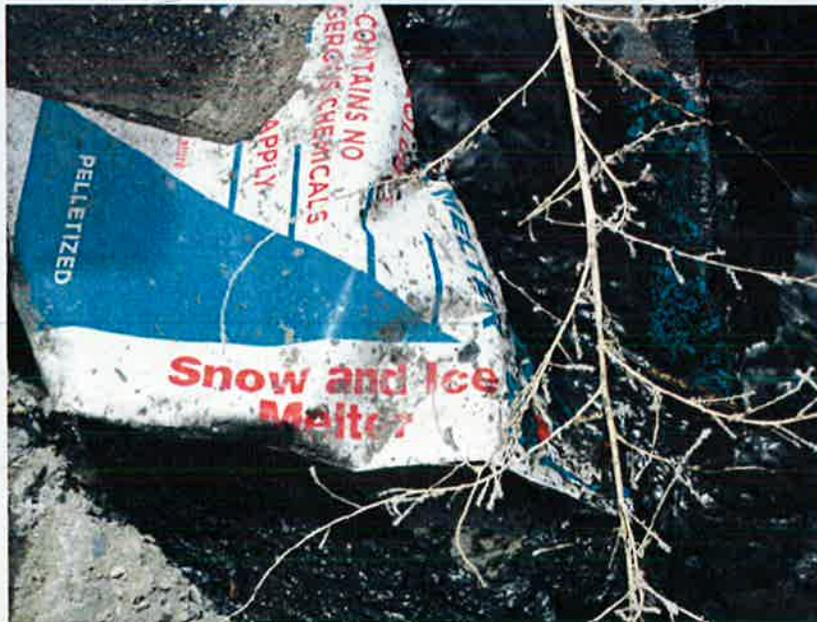
Litter in roadside drainage.

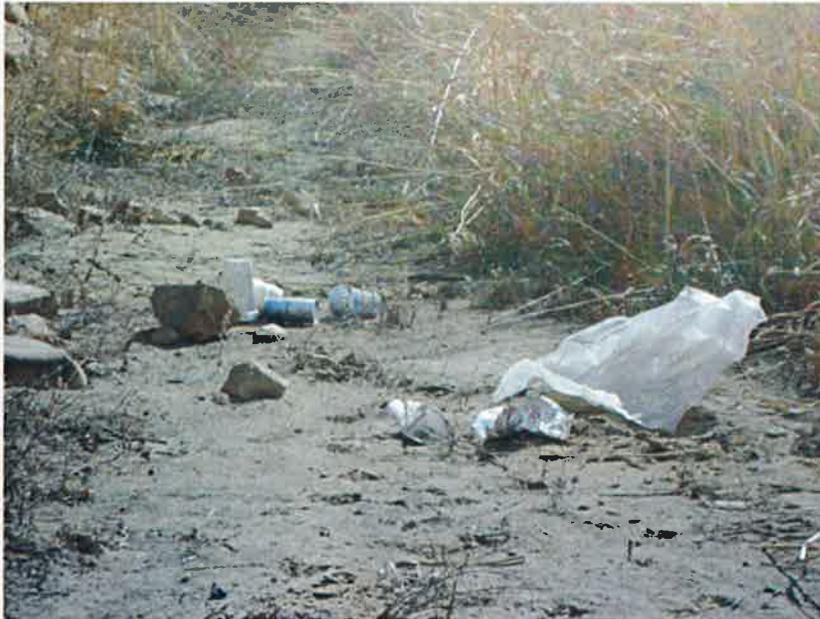
Litter in drainage below pond A spillway. Note: This is approximately 100 feet from where drainage enters undisturbed Bear Creek drainage.

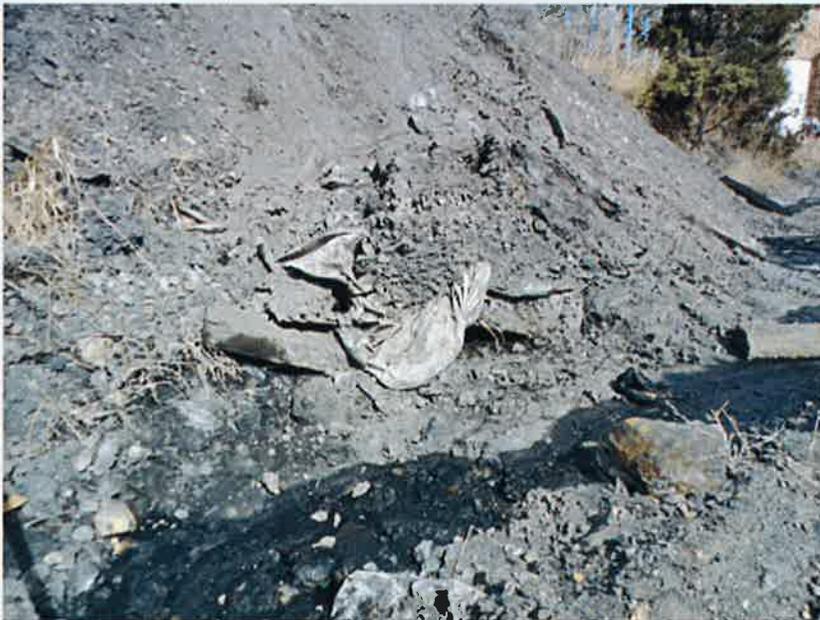
Brick and other trash items in drainage along pond A access road.

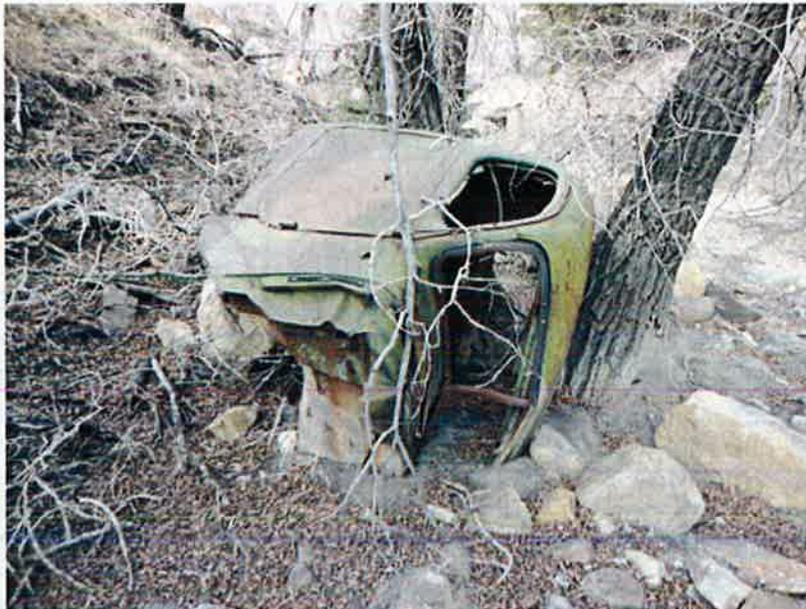
Old car parts within stream buffer zone

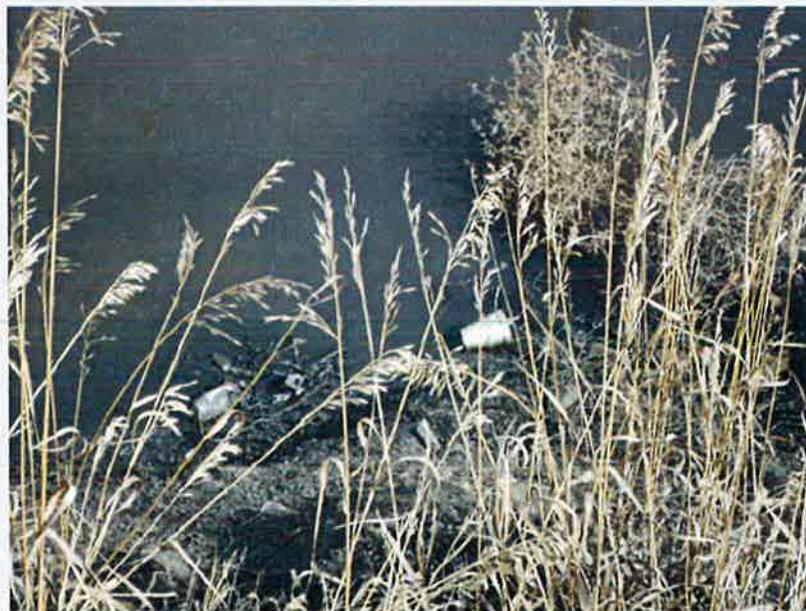
Trash items in pond A

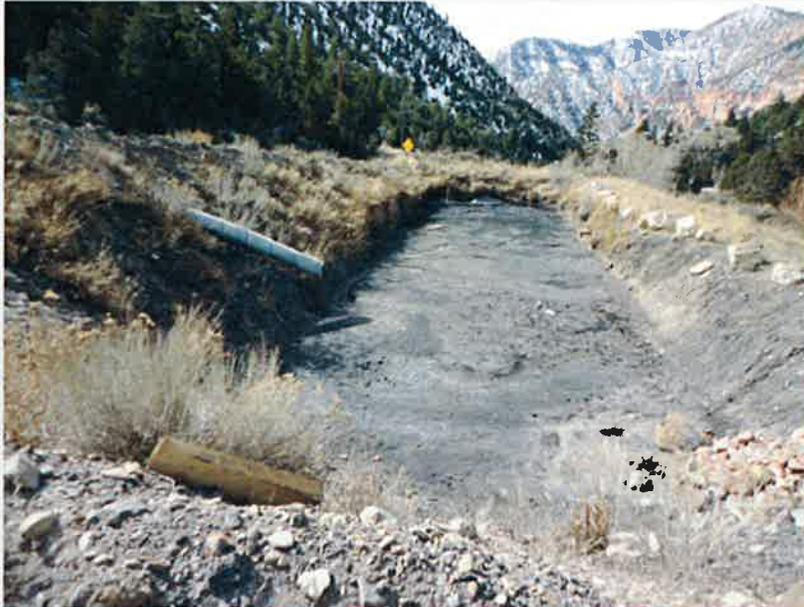
Subject: **SEDIMENT POND B**

It is apparent that repair work for the eroded inlet has been performed since OSMRE’s 2015 inspection; however, the maintenance is still not in accordance with the approved permit, as it has not been grouted.

Inlet to pond has not been maintained/designed in accordance with approved permit.

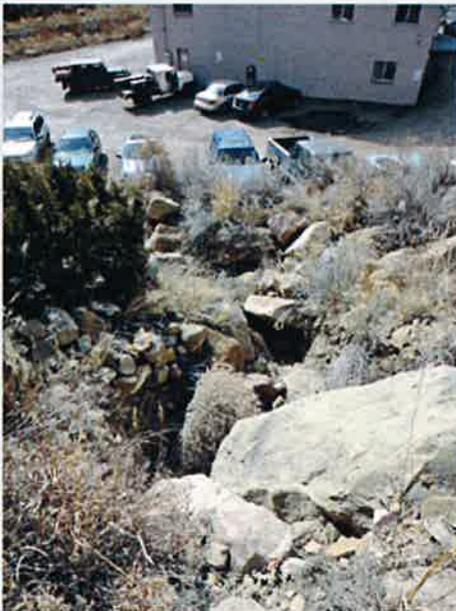
Erosion at spillway of pond A.

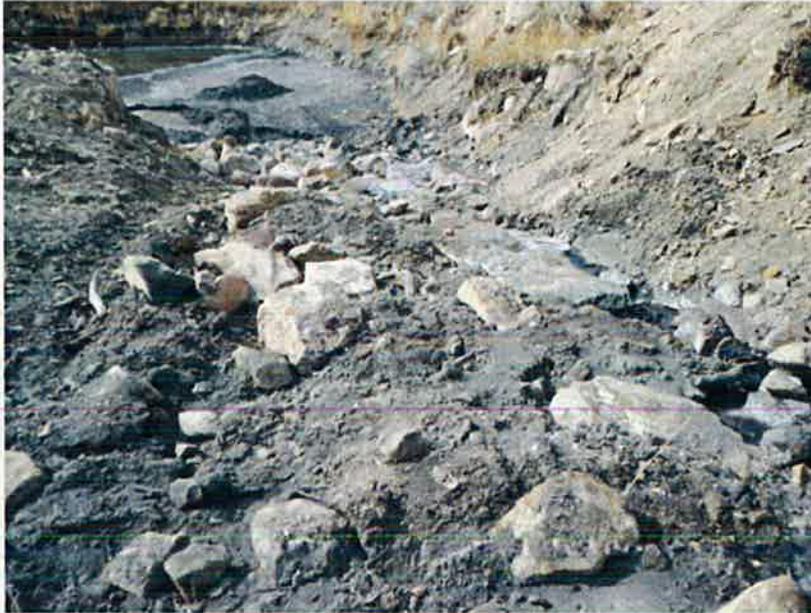
Subject: POND A INLET

OSMRE notes that the pond inlet appears to be in much better shape than what was observed during the 2015 inspection. As to the excavated material being stored at pond A, it does appear that some work has been done but it is clear the job has not been completed since it was noted in September 2015.

Excessive sediment creating a paving effect at pond A inlet. This was noted in the 2015 inspection report.

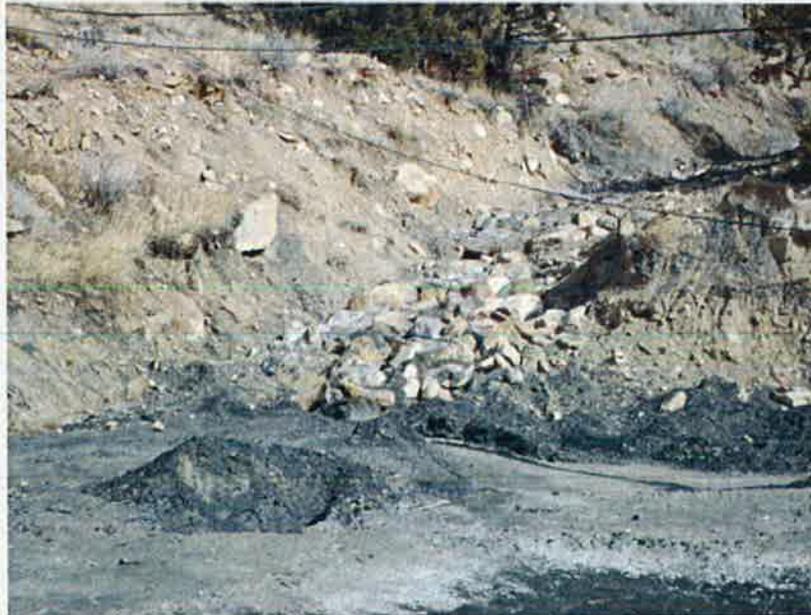
Excessive sediment deposition at pond inlet and erosion of embankment.

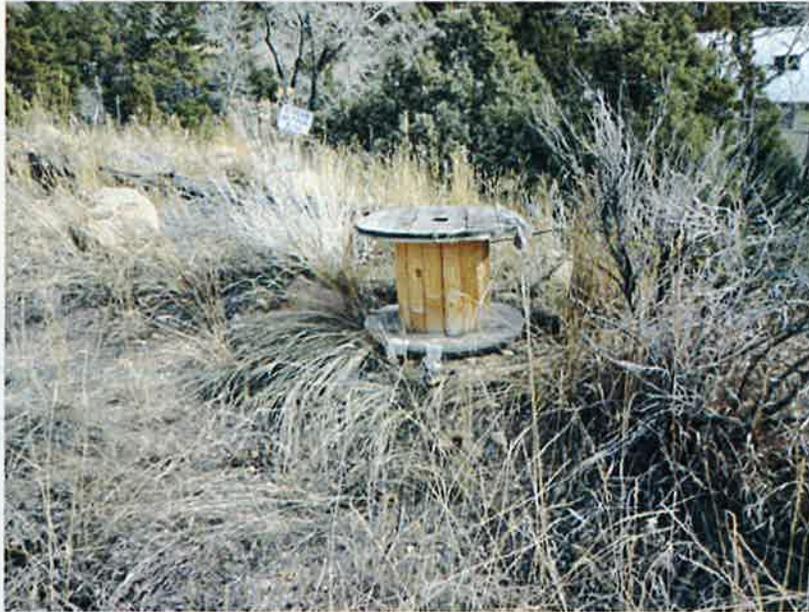
Cable spool on pond A embankment.

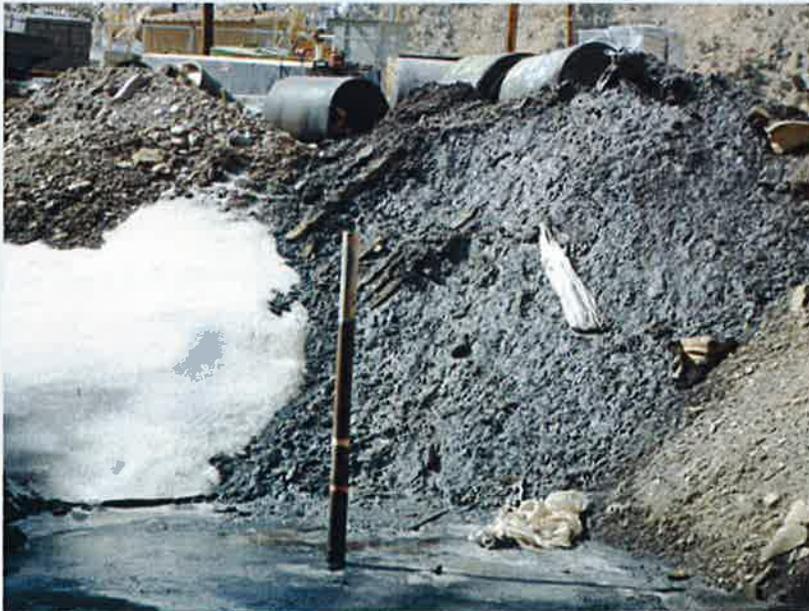
Noncoal waste being stored on pond D embankment. Pond embankment not maintained properly.

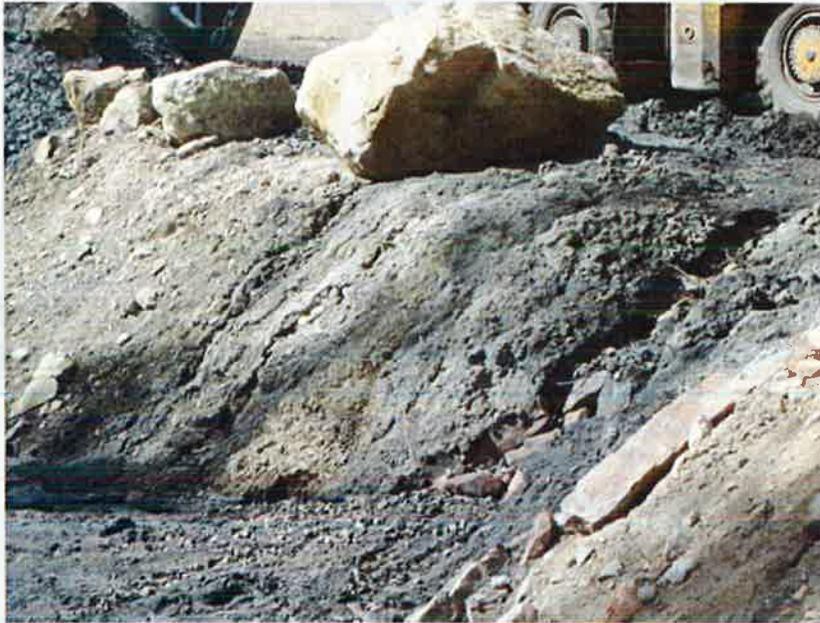
Subject: POND D

This pond was inspected for overall stability and functionality. This included the inlet structure, principle spillway, and emergency spillway. As was noted in the 2015 inspection report, erosion has created an additional inlet at pond D. Appendix 7-F states, in part, that the pond inlet will be protected using grouted riprap. Snow/slurry sludge/ and other noncoal waste was observed on the pond embankment. Further review of the approved permit (Appendix 7K-12A) provides reference to approved snow storage areas, none of which is where the material was observed. OSMRE notes the pond is not functioning as designed, at the time of inspection.

Inlet to the pond has not been designed/maintained as required. NOTE: This was identified in 2015 inspection report.

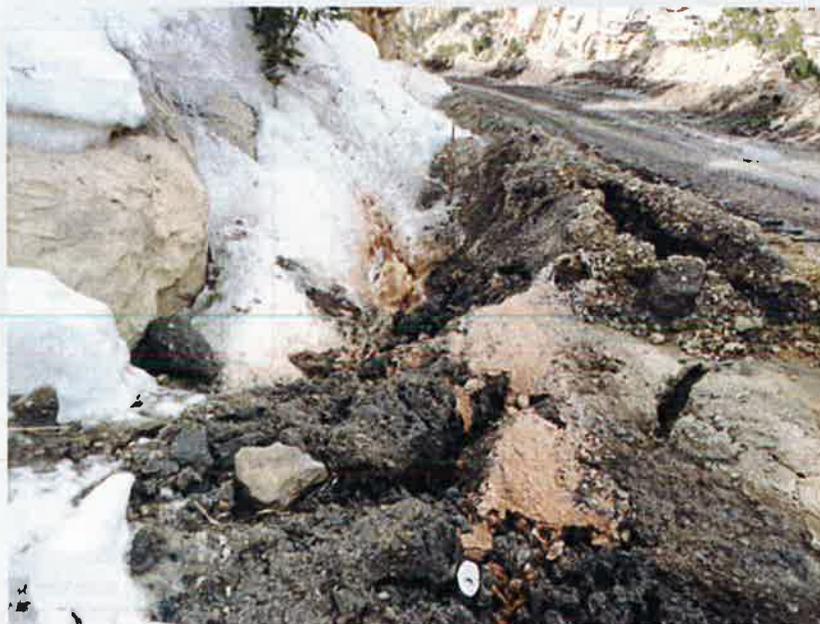
Bear Creek by-pass drainage at pond D is clogged and has not been maintained.

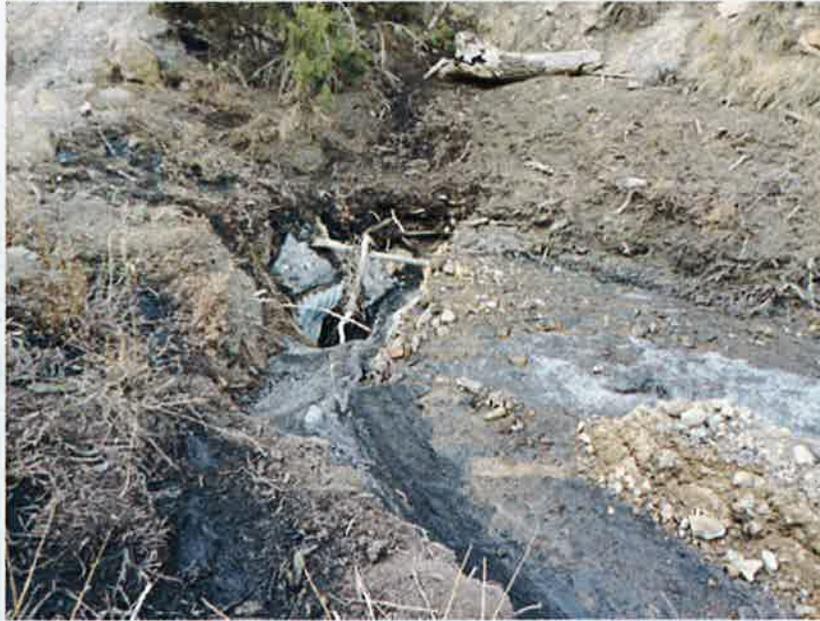
Drainage culvert has not been maintained.

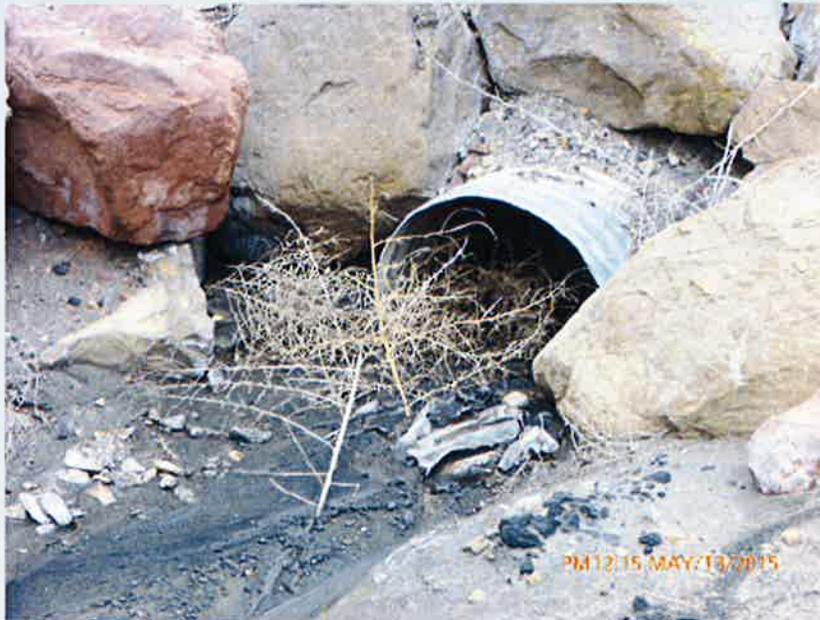
This picture depicts a clogged culvert that was identified during the 2015 inspection along the access road to pond A and load out facility.

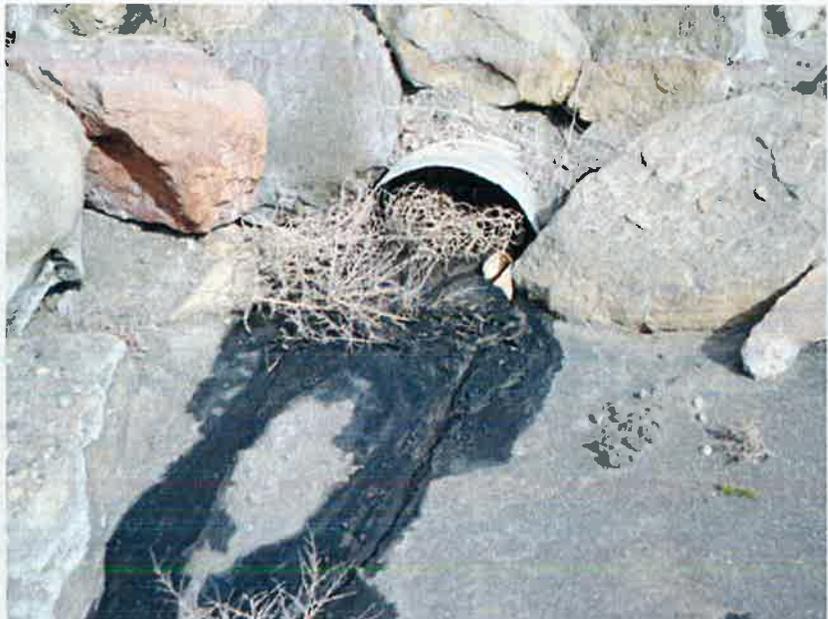
As noted in OSMRE's 2015 inspection, a lack of maintenance regarding clogged culverts appears to be a systemic issue throughout the mine site. Numerous culvert inlets along the portal access road contained snow and mud mixtures. This was observed to be the case during the 2016 inspection. Notwithstanding, culvert C-4D was identified as clogged with sediment in 2015 and the comparative picture that was taken during the 2016 inspection depicts that there has been zero maintenance conducted.

Notes:  
This picture depicts the same clogged culvert during the 2016 inspection along the access road to pond A and load out facility.

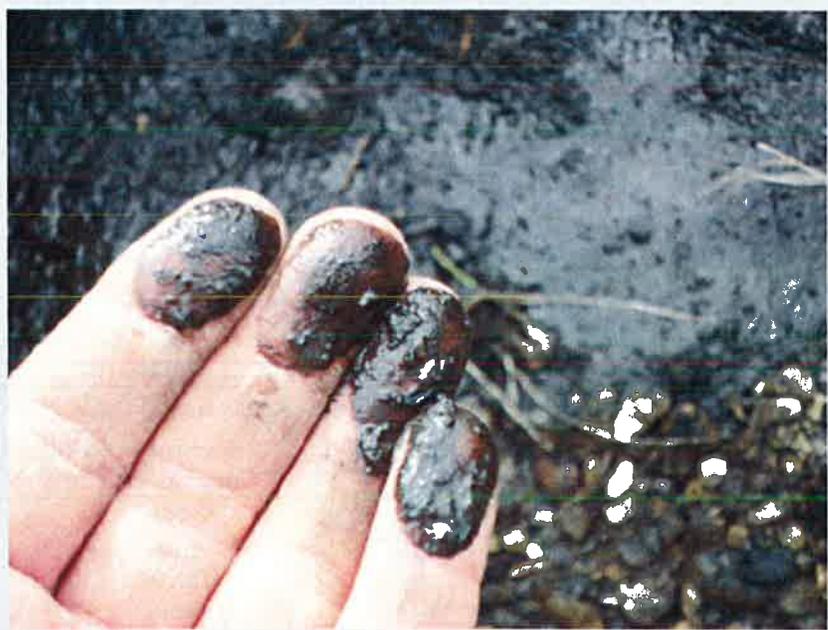
Notes:  
Coal fine deposition in undisturbed drainage.

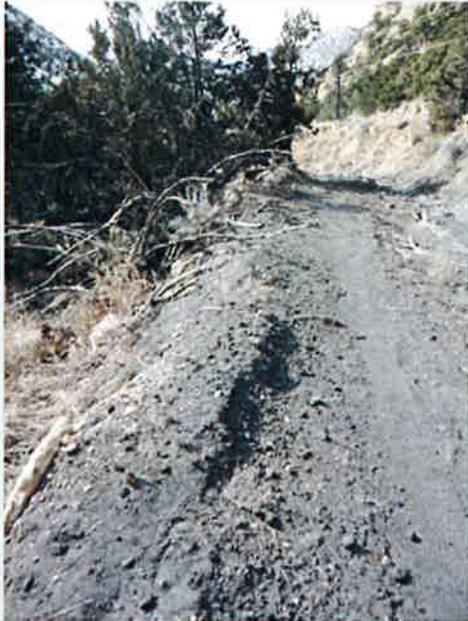
Encroachment of stream buffer zone along access road to Pond A. NOTE: This is directly below the welding shop pad area where berm has eroded.

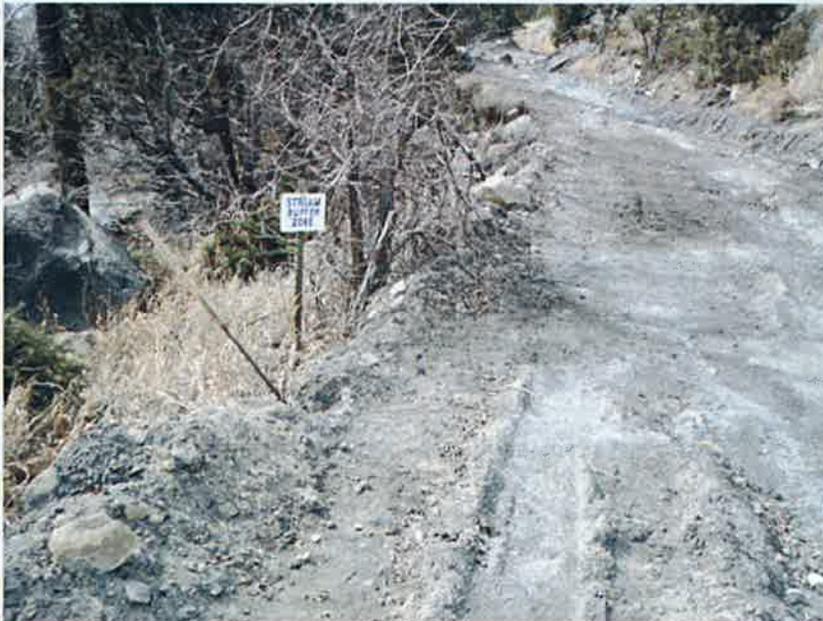
Failure to implement/maintain adequate BMP along access road and stream buffer zone.

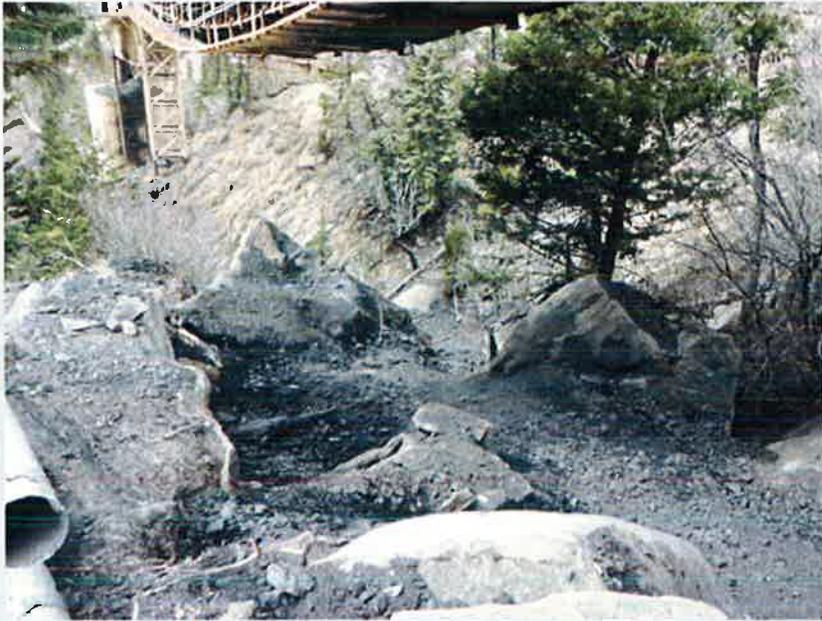
Notes:  
Coal in undisturbed area of stream buffer zone.

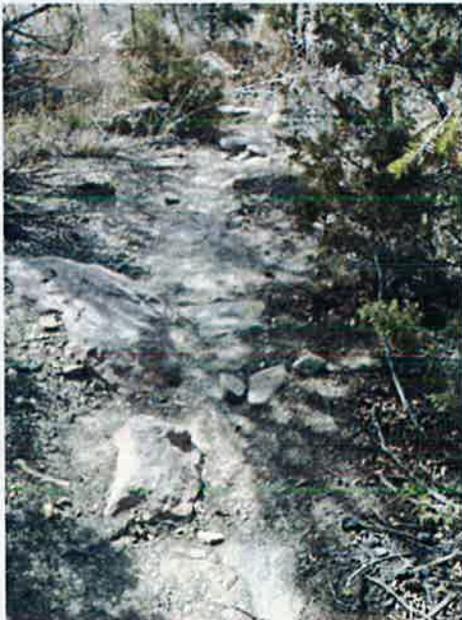
Notes:  
Foot path constructed through the stream buffer zone between welding shop area and electrical shop.

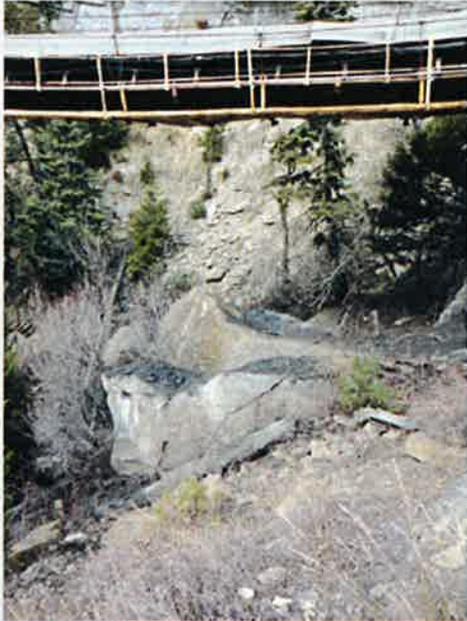
Coal deposition in stream buffer zone area beneath overland conveyor.

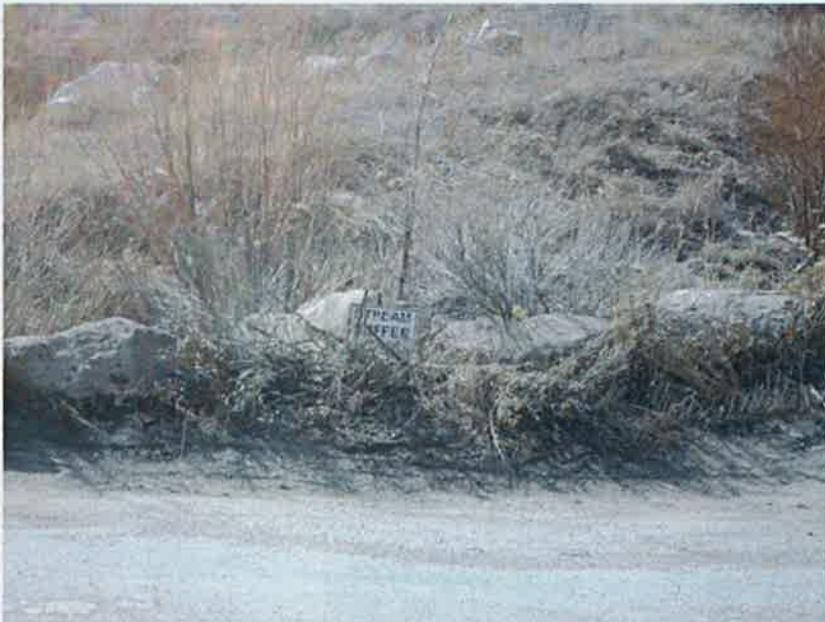
Stream buffer zone sign not easily noticed.

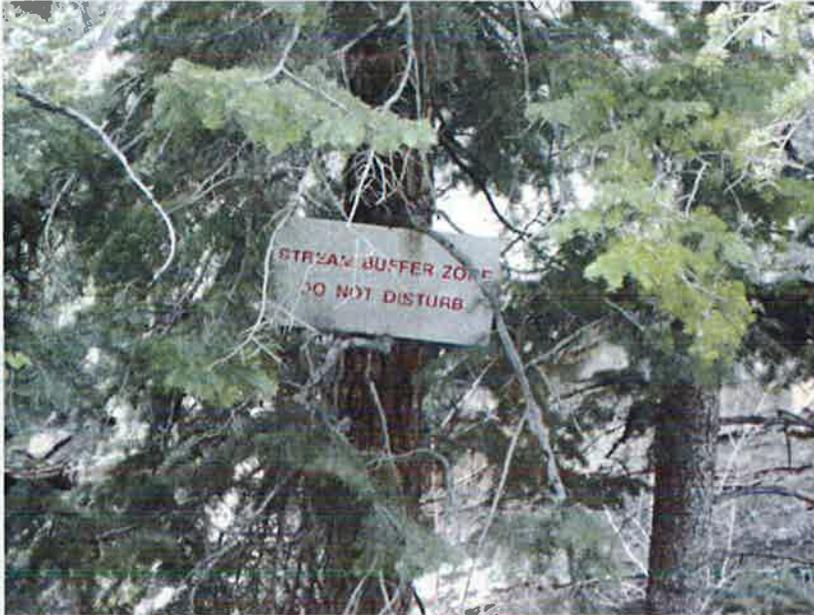
Stream buffer zone sign positioned in a location that is easily observed.

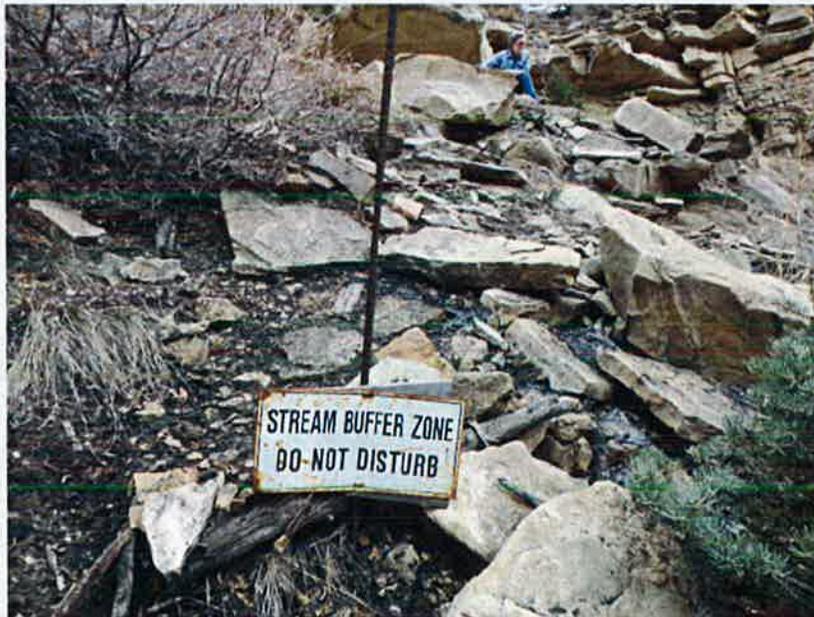
Stream Buffer Zone is facing the wrong direction.
