## United States Department of the Interior

I have enclosed copies of the OSMRE's Ten Day Notice (TDN) issued to the Utah Division of Oil, Gas and Mining on March 16, 2016. TDN X16-140-545-004 has been issued as a result of noncompliance OSMRE and DOGM identified during the course of the 2015 and 2016 Independent Partial Oversight inspections.

**U.S. DEPT. OF THE INTERIOR  
OFFICE OF SURFACE MINING  
Mine Site Evaluation  
State Program**

Permit:	C0150025	Inspection Date:	3/3/2016
Permittee:	CASTLE VALLEY MINING LLC

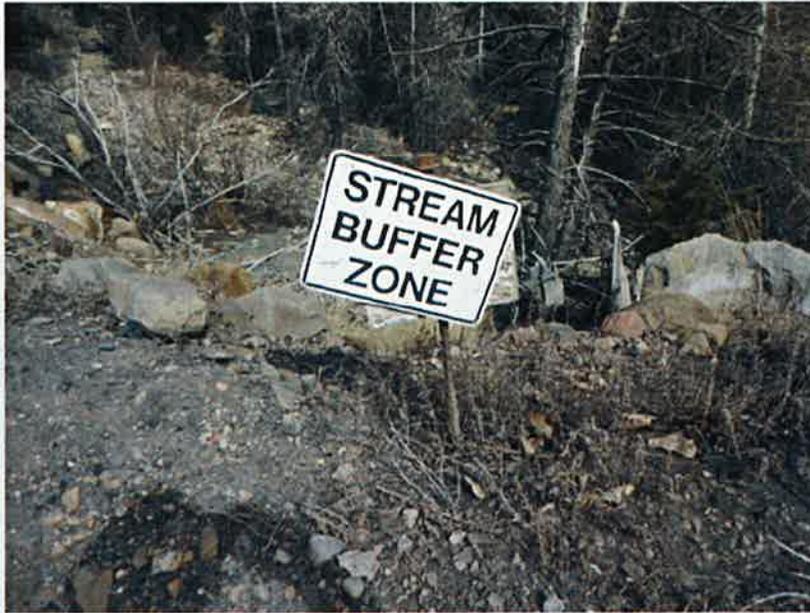
Failure to maintain/implement adequate BMP's to ensure disturbed area drainage doesn't co-mingle with undisturbed drainage.

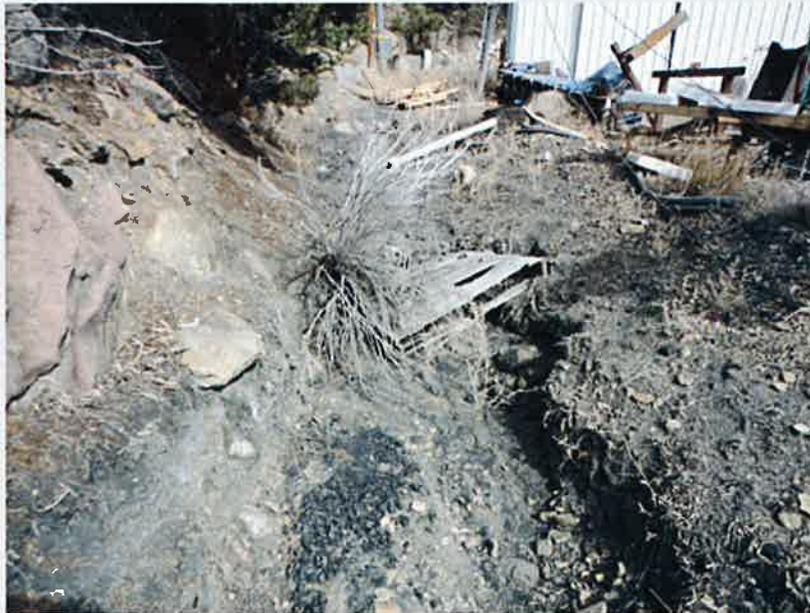
Noncoal waste in diversion near welding shop area  
Failure to maintain diversions.

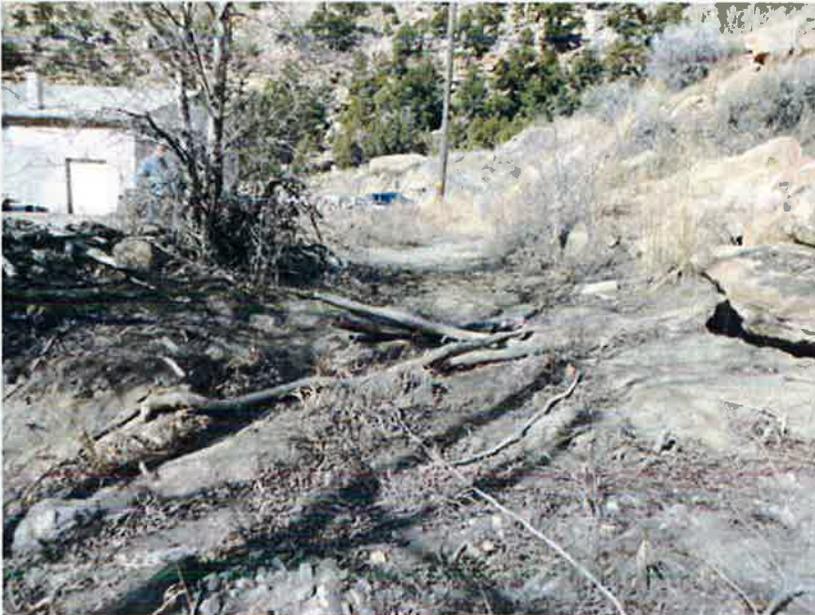
<p>Notes:</p> <div style="border: 1px solid black; padding: 5px; min-height: 150px;"> <p>Failure to maintain diversions</p> </div>	
<p>Photo ID: 25867</p> <p>Photographer: SMJSHUMATE</p> <p>Date Taken: 3/3/2016</p> <p>State: UT</p> <p>County: EMERY</p> <p>Latitude: 0.00000000</p> <p>Longitude: 0.00000000</p>		
Subject: DIVERSION		
Mine Name: BEAR CANYON

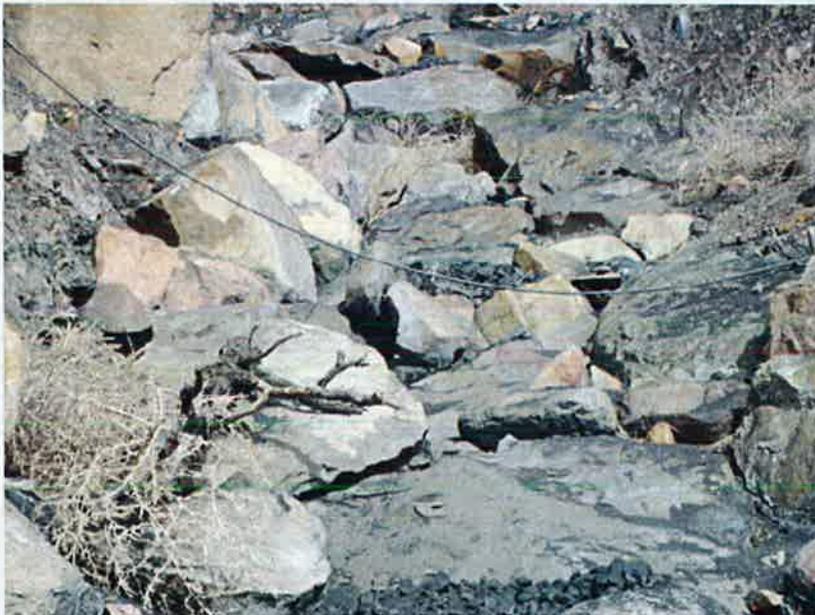
<p>Notes:</p> <div style="border: 1px solid black; padding: 5px; min-height: 150px;"> <p>Electrical wire/cable hanging down in the diversion ditch behind welding shop area.</p> </div>	
<p>Photo ID: 25868</p> <p>Photographer: SMJSHUMATE</p> <p>Date Taken: 3/3/2016</p> <p>State: UT</p> <p>County: EMERY</p> <p>Latitude: 0.00000000</p> <p>Longitude: 0.00000000</p>		
Subject: DIVERSION		
Mine Name: BEAR CANYON

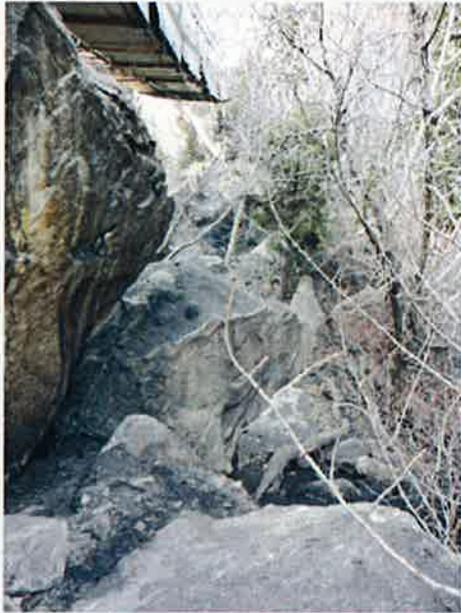
Inspection of the overland conveyer revealed that there was still a missing side panel that was identified during the May 13, 2015 inspection. In addition to the missing side panel, several sections of the conveyer are in disrepair, thus allowing more coal and coal fines to fall out into the designated stream buffer zone. Significant amounts of coal fines were observed. It also appears that much of the overland conveyer has not been constructed as required by the approved designs. Appendix 7K and Figure 7K-1 of the approved permit provides specification for construction and maintenance regarding the overland conveyer.

Loose side panels on overland conveyor contributing to coal deposition in undisturbed drainage.

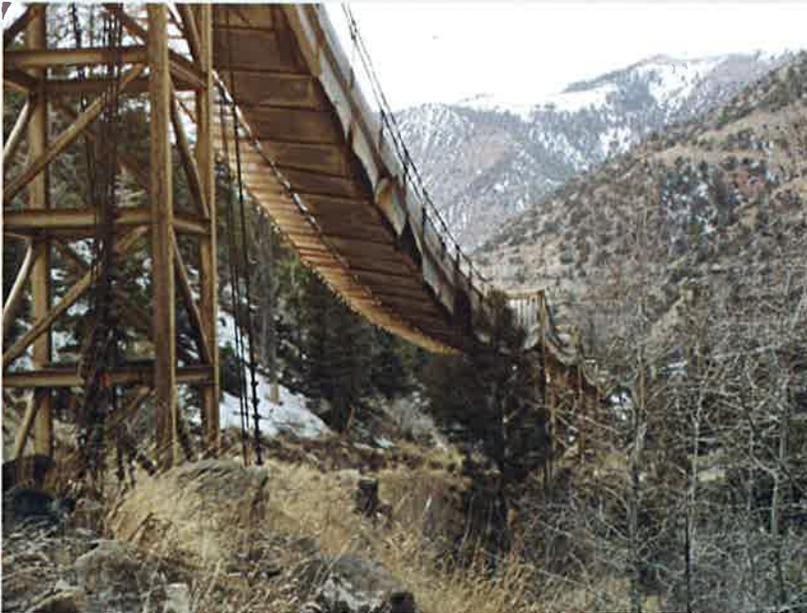
Loose and missing side panel.

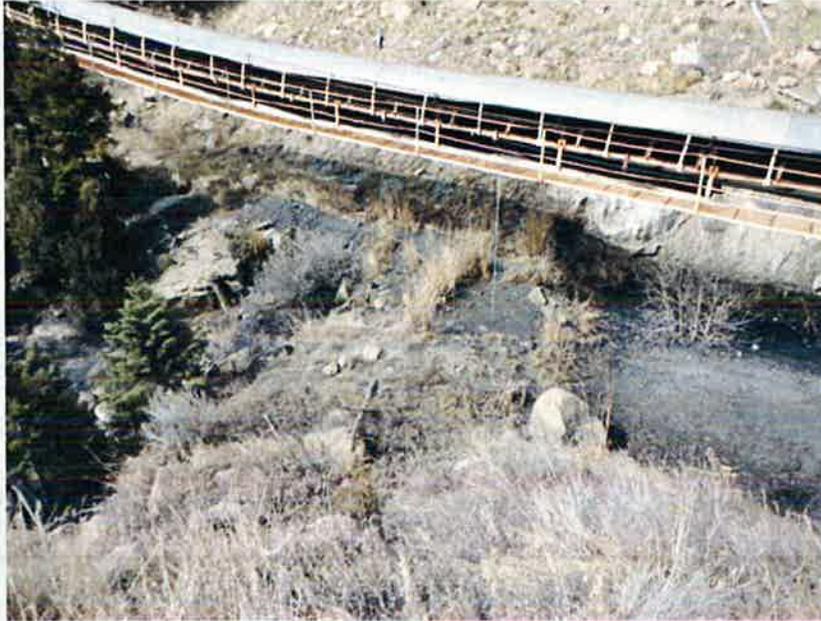
Coal in undisturbed area via overland conveyor.
