Subject: 2015 Annual Report Submittal for Castle Valley Mining LLC Bear Canyon Mine, C/015/0025

# Annual Report

<b>1. IMPOUNDMENT INSPECTION AND CERTIFIED REPORT</b>		<b>007A</b>	<b>Page 1 of 2</b>
<b>Permit Number:</b>	ACT/015/025	Report Date: 10/27/2015	
<b>Mine Name:</b>	Castle Valley Mine		
<b>Company Name</b>	Rhino Energy LLC		
<b>Impoundment Identification:</b>		Sediment Pond "A"	
	<b>Impoundment Number:</b>	002A	
	<b>UPDES Permit Number:</b>	UTG040006	
	<b>MSHA ID Number:</b>	42-02263, 42-02335	
<b>IMPOUNDMENT INSPECTION</b>			
<b>Inspection Date:</b>	10/20/2015		
<b>Inspected By:</b>	J.T. Paluso		
<b>Reason for Inspection:</b>	Annual Inspection		
(Annual, Quarterly or other Periodic Inspection, Critical Installation or Completion of Construction)			
<b>1. Describe any appearances of any instability, structural weakness, or any other hazardous condition.</b>			
The pond's dam shows no signs of structural instability or other hazardous conditions.			
Required for an impoundment which functions as a SEDIMENTATION POND	<b>2. Sediment storage capacity, including elevation of 60% and 100% sediment storage volumes and estimated average elevation of existing sediment.</b>

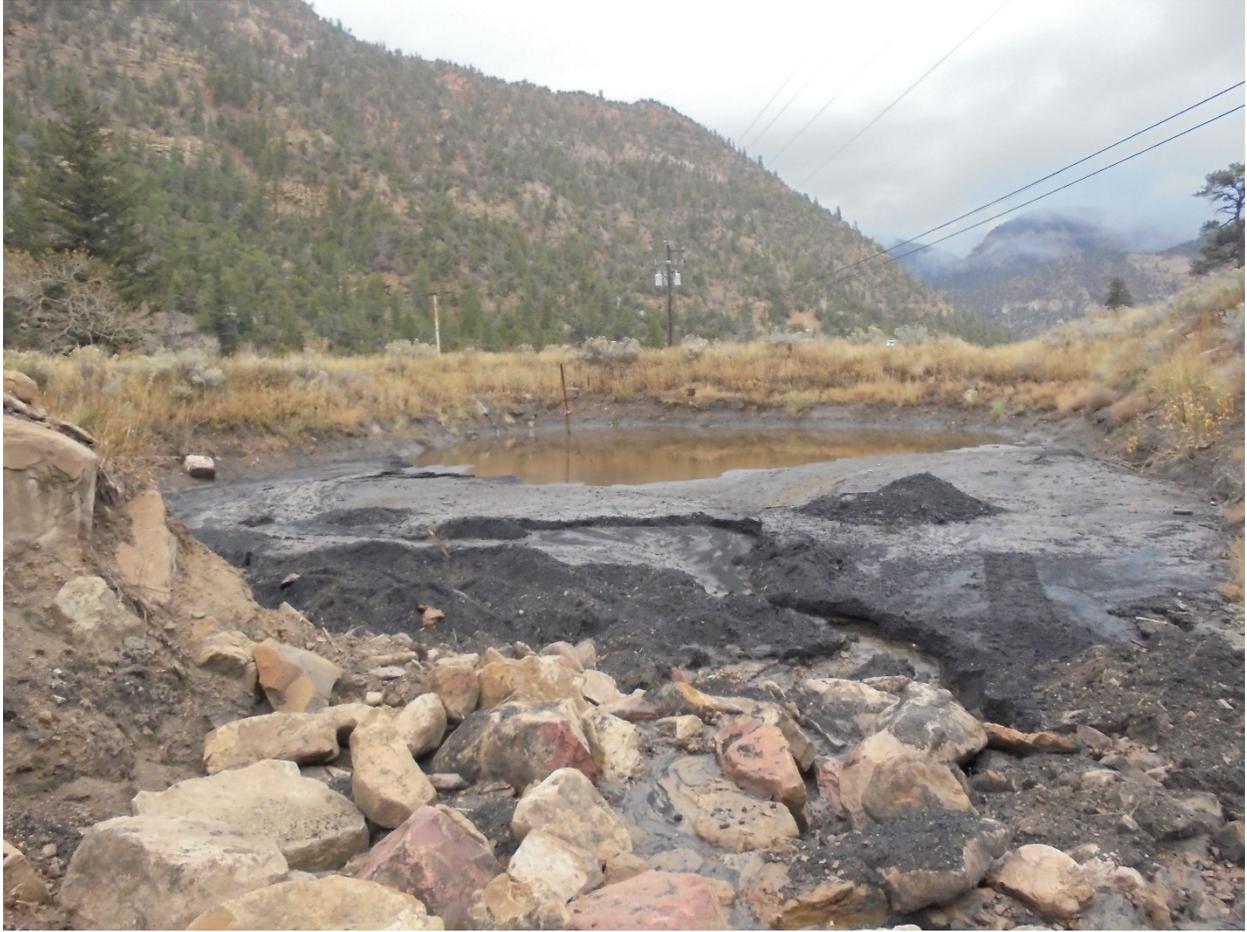
POND A

Sediment storage capacity is 15,912 cu ft.		
	60% Cleanout Elevation: 7,086'		
	100% Sediment storage elevation: 7,087.9'		
	Existing sediment elevation: Average sediment elevation 7,084.4'		
	<b>3. Principle and emergency spillway elevations</b>		
	Principle spillway elevation: 7,088'		
	Emergency spillway elevation: 7,094.5'		
<b>4. Field Information:</b> Provide current water elevation, whether pond is discharging, type and number of samples taken, monitoring/instrumentation information, inlet/outlet conditions or other related activities associated with the pond including but not limited to sediment cleanout, pond decanting, embankment erosion/repairs, monitoring information, vegetation on outslopes of embankment erosion/repairs, monitoring information, vegetation on outslopes of embankments, etc.			
Pond has some water near dam. Water elevation is 7084.4'. Vegetative cover looked good with no signs of erosion.

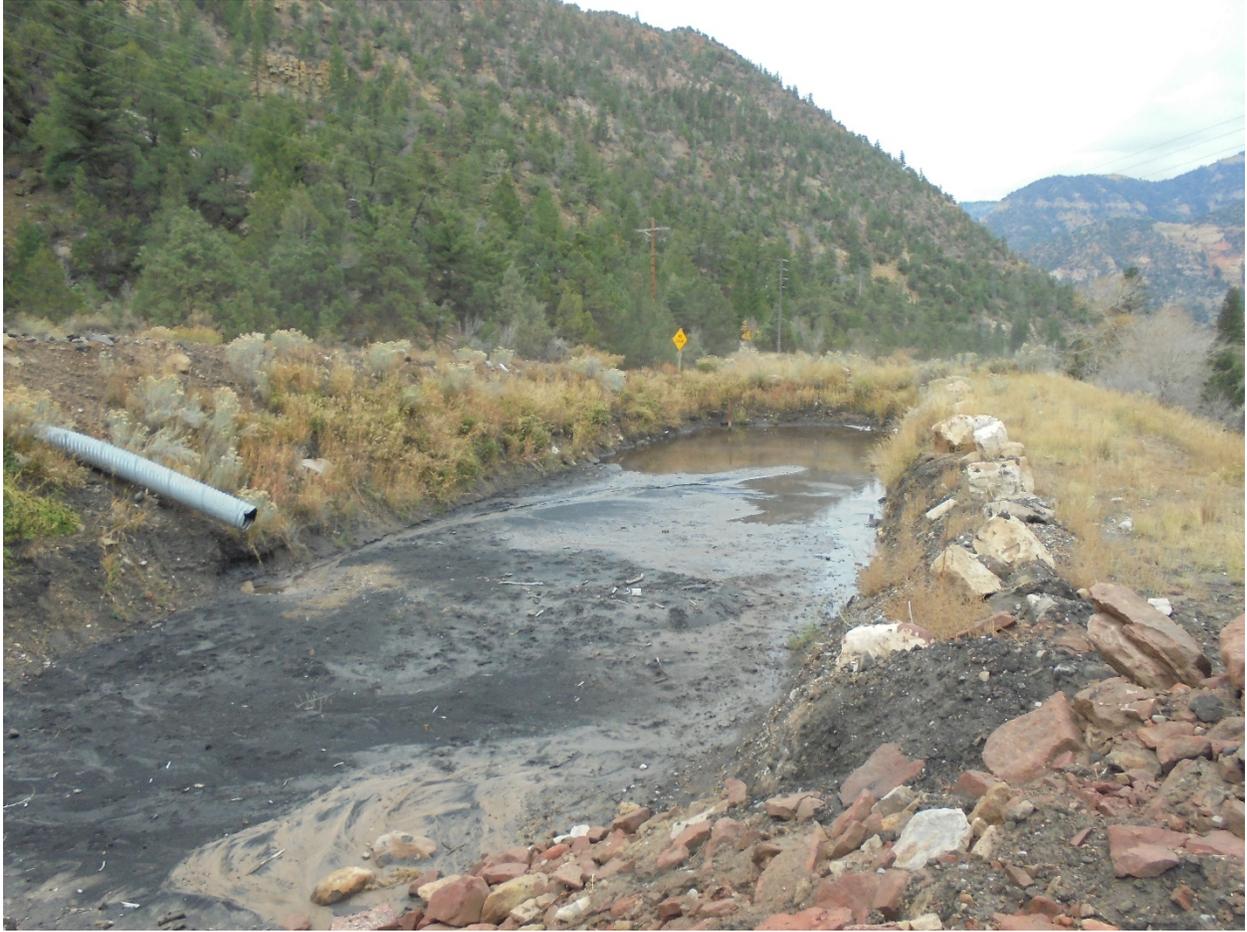
POND B

Sediment storage capacity is approximately 5,803 cu ft. Sediment has been removed.		
	60% Cleanout Elevation: 7,062.9'		
	100% Sediment storage elevation: 7,063.4'		
	Existing sediment elevation: Average sediment elevation 7,061.6'		
	<b>3. Principle and emergency spillway elevations</b>		
	Principle spillway elevation: 7,064.9'		
	Emergency spillway elevation: 7066.9'		
<b>4. Field Information:</b> Provide current water elevation, whether pond is discharging, type and number of samples taken, monitoring/instrumentation information, inlet/outlet conditions or other related activities associated with the pond including but not limited to sediment cleanout, pond decanting, embankment erosion/repairs, monitoring information, vegetation on out slopes of embankment erosion/repairs, monitoring information, vegetation on out slopes of embankments, etc.			
Pond has water. Vegetative cover looked good with no signs of erosion.

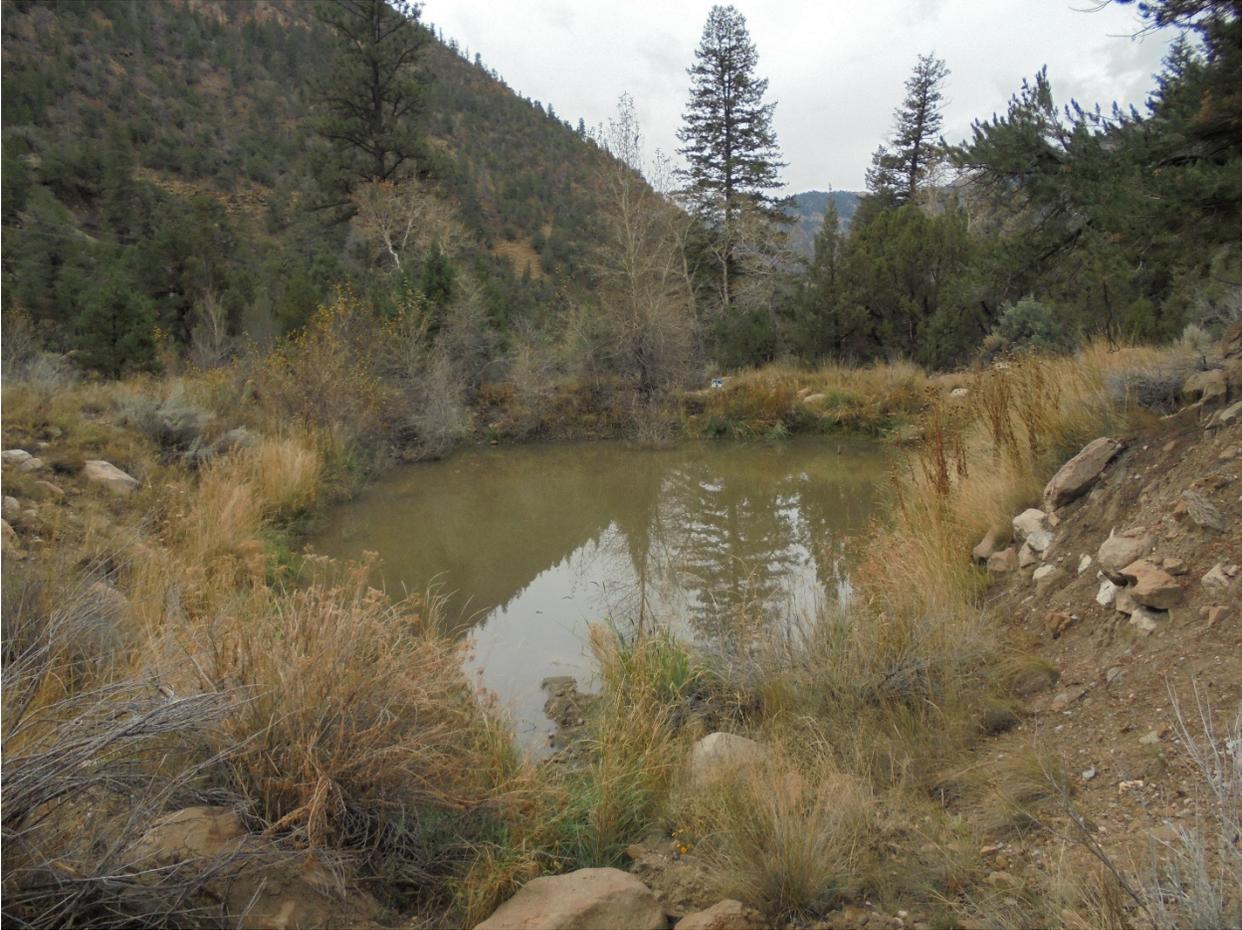
POND C

Sediment storage capacity: 3,802 cu ft		
	60% Cleanout Elevation: 7,030.3'		
	100% Sediment storage elevation: 7,031.4'		
	Existing sediment elevation: Average sediment elevation 7,028' (Water covering sediment level)		
	<b>3. Principle and emergency spillway elevations</b>		
	Principle spillway elevation: 7,032.3'		
	Emergency spillway elevation: 7035.3'		
<b>4. Field Information:</b> Provide current water elevation, whether pond is discharging, type and number of samples taken, monitoring/instrumentation information, inlet/outlet conditions or other related activities associated with the pond including but not limited to sediment cleanout, pond decanting, embankment erosion/repairs, monitoring information, vegetation on out slopes of embankment erosion/repairs, monitoring information, vegetation on out slopes of embankments, etc.			
Pond is full of water and cannot see sediment level. It appears that sediment level is the same as 12/10/2012. Vegetative cover looked good with no signs of erosion. Water level is at 7032.3'.

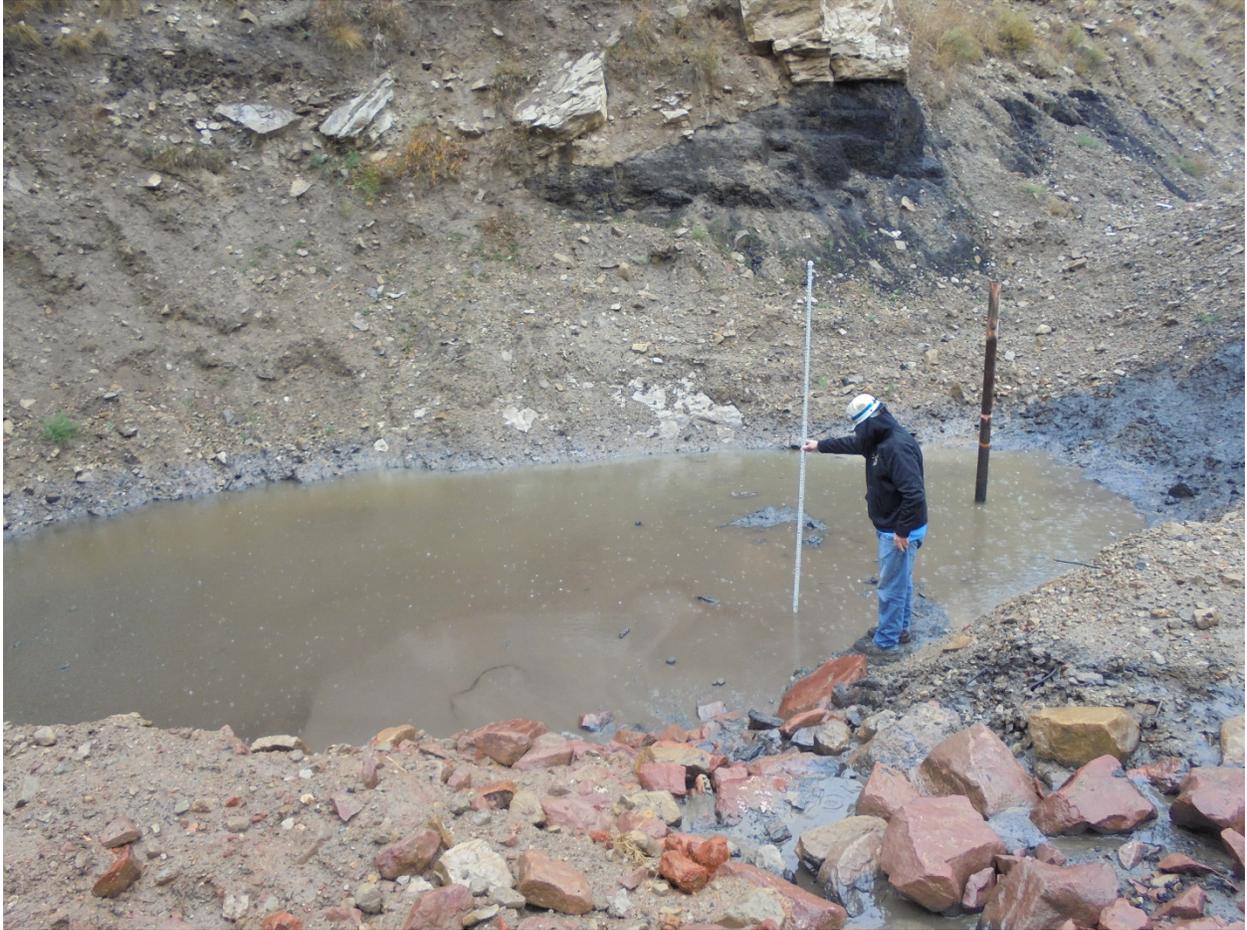
POND D

Incised pond has minimal vegetation with no signs of erosion. Water elevation is at 7641.4'.			
<b>5. Field Evaluation:</b> Describe any changes in the geometry of the impounding structure, average and maximum depths and elevations of impounded water, estimated sediment or slurry volume and remaining storage capacity, estimated volume of water impounded and any other aspect of the impounding structure affecting its stability or function which has occurred during the reporting period.			
Pond elevation has been modified. Error on surface elevations were corrected. As of 9/17/2014, average sediment level was 7640.1 and was 1.7' below the 60% cleanout level. Oil removal elbow still needs to be installed on principal spillway.			
<b>Qualified Statement</b>	I hereby certify that I am experienced in the construction of impoundments; I am qualified and authorized under the direction of a Registered Professional Engineer to inspect the condition and appearance of impoundments in accordance with the certified and approved designs for this structure, that the impoundment has been maintained in accordance with approved design and meet or exceed the minimum design requirements under all applicable federal, state and local regulations; and, that inspections and inspection reports are made by myself and include any appearances of instability, structural weakness or other hazardous conditions of the structure affecting stability.
