Inspection Report

Permit Number:	C0150025
Inspection Type:	PARTIAL
Inspection Date:	Tuesday, April 19, 2016
Start Date/Time:	4/19/2016 10:30:00 AM
End Date/Time:	4/19/2016 1:00:00 PM
Last Inspection:	Tuesday, March 29, 2016

Permitee: **CASTLE VALLEY MINING LLC**
 Operator: **CASTLE VALLEY MINING LLC**
 Site: **BEAR CANYON MINE**
 Address: **2352 NORTH 7TH STREET, UNIT B, GRAND JUNCTION CO 81501**
 County: **EMERY**
 Permit Type: **PERMANENT COAL PROGRAM**
 Permit Status: **ACTIVE**

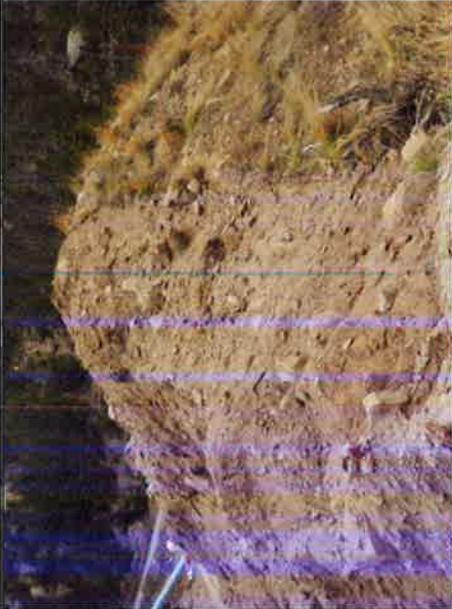
The toe at the base of the WHR Topsoil Stockpile has been cut and moved to build the Access Road to Catch Basin 1 (Panorama 1). Much of the topsoil has been relocated to the top of the stockpile (Photos 1 and 2). However, in two locations it appears topsoil has been relocated off either side of the Primary Conveyor Road Access No. 1 (Photos 3 and 4).

<p>PHOTO 1 Relocation of topsoil to the top of the Stockpile. April 19, 2016</p>	<p>PHOTO 2 Relocation of topsoil to the top of the Stockpile. April 19, 2016</p>

There is no berm at the base of the WHR Topsoil Stockpile (Panorama 1). There are no sediment control measures for the other piles of topsoil on either side of the Primary Conveyor Road Access No. 1. This is in non-compliance with the MRP that states, "topsoil will be relocated on the same stockpile (as shown on Dwg 2-2B) and the berm will be re-established". A berm must be re-established around the Topsoil Stockpile and the separate piles on either side of the road must be maintained according to the MRP.

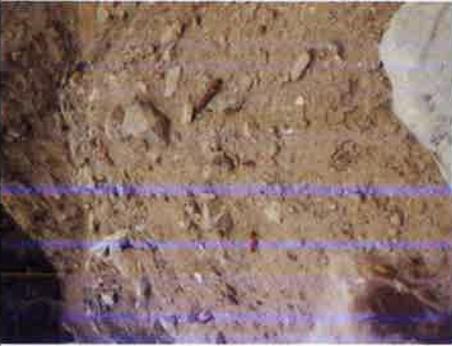
<p>PHOTO 3 Topsoil located on the wrong side of Access road and Primary Conveyor Road Access No. 1. April 19, 2016</p>	<p>PHOTO 4 Topsoil relocated to the wrong side of Primary Conveyor Road Access No. 1 April 19, 2016</p>

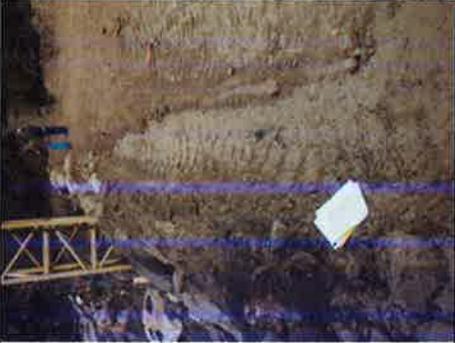
Diversion ditch D-15D was removed by the construction of the Access Road to Catch Basin 1 (Panorama 1). The runoff from watershed AD-16 is now captured and routed by the Access Road down to Catch Basin 1. The new Access road must be graded to direct water to the borrow ditch. The berm running along the borrow ditch must be regraded and strengthened along its length in order to properly route water to Catch Basin 1 (Photo 5).

<p>PHOTO 5 Berm constructed of loose fill. April 19, 2016</p>		<p>PHOTO 6 Spillway into Catch Basin 1 made up of loose fill. April 19, 2016</p>

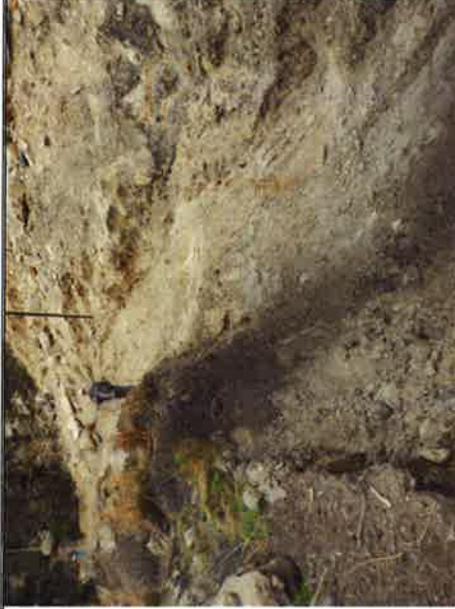
There was no spillway inlet into Catch Basin 1 (Photo 6). This basin will likely need a hardened inlet in order to prevent the spillway from scouring and eroding.

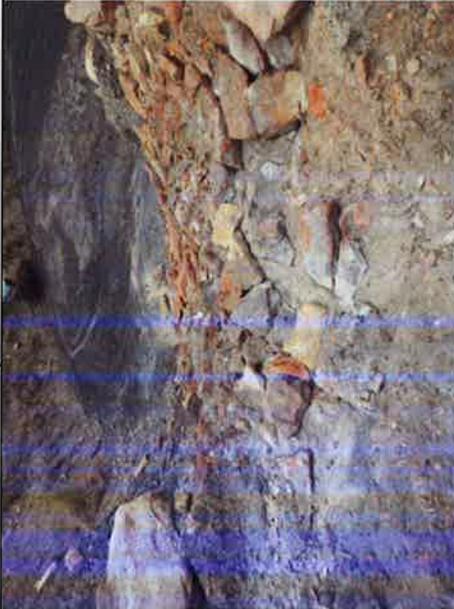
The inlet to Pond B appeared to be stable and properly functioning (Photo 7 and 8). Pond D inlet appeared to be stable (Photo 9). The Permittee has until May 13th, 2016 to abate NOV 19151 requiring the inlets to these two ponds be grouted or to provide calculations showing grout is not needed.

<p>PHOTO 7 Pond B inlet appears stable and is properly functioning. April 19, 2016</p>		<p>PHOTO 8 Pond B inlet appears stable and is properly functioning. April 19, 2016</p>

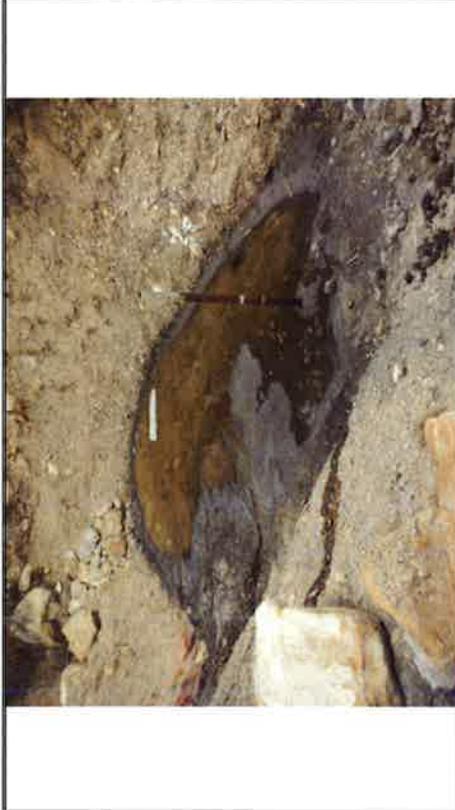
<p>PHOTO 9 Pond D inlet appears to be stable. April 19, 2016</p>

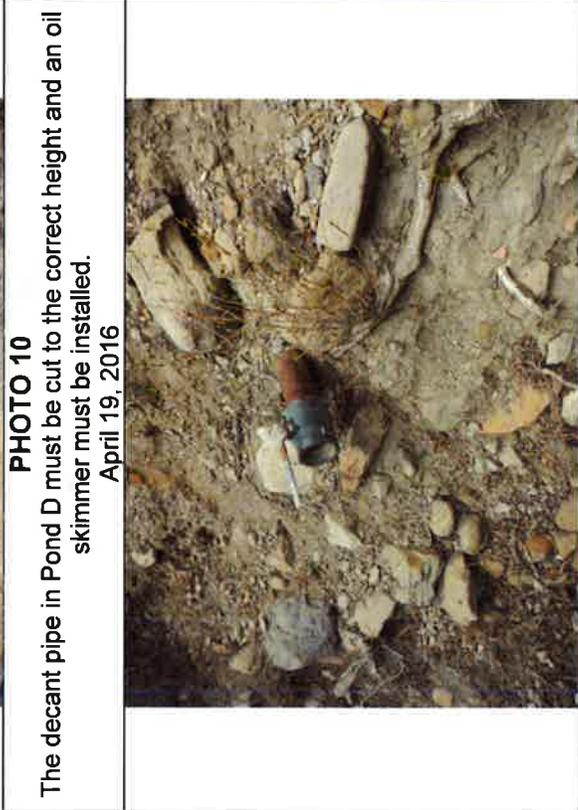
<p>PHOTO 10 The decant pipe in Pond D must be cut to the correct height and an oil skimmer must be installed. April 19, 2016</p>

The decant pipe in Pond D needs to be reduced to the correct height (Photo 10). When the height of the pipe is reduced, it must have a grease skimmer installed. The top of the decant pipe must be lower in elevation than the emergency spillway in the northeast corner of the pond. Dogm is requesting the permittee to complete this construction by no later than May 30th.

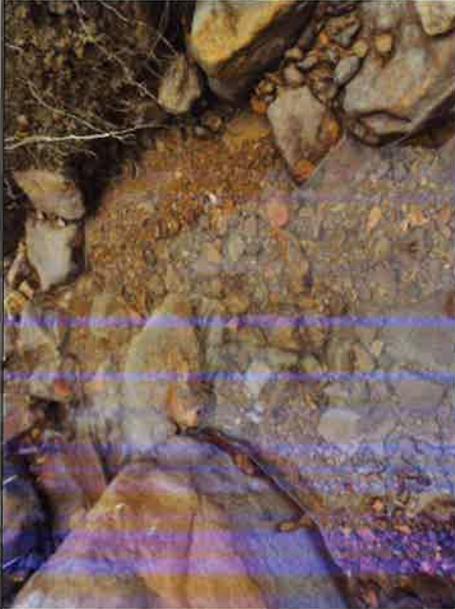
Two sections of Bear Creek were walked and inspected for coal and coal fines. Bear Creek was walked for roughly 200 yards directly downstream of the disturbed permit area. The Division inspected the stream bed and banks as well as the high water marks along the stream. In the area directly downstream of the disturbed boundary there was no coal or coal fines found (Photo 13 – 16). Riffles and pools showed no signs of coal fines settling out. The sediment was dug into and no coal or coal fines were found.

<p>PHOTO 13 No coal fines seen directly downstream of disturbed permit boundary. April 19, 2016</p>

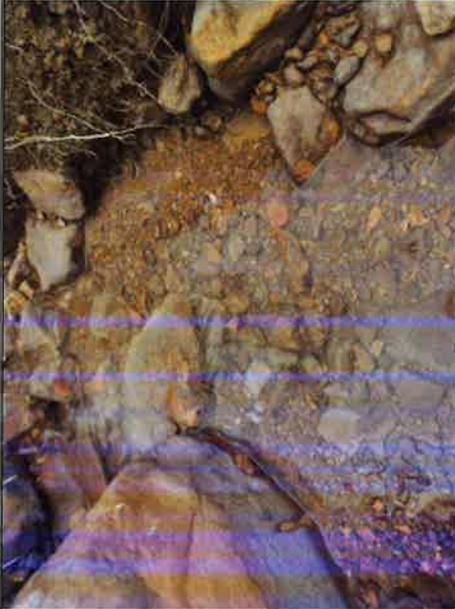
<p>PHOTO 14 No coal fines seen directly downstream of disturbed permit boundary. April 19, 2016</p>

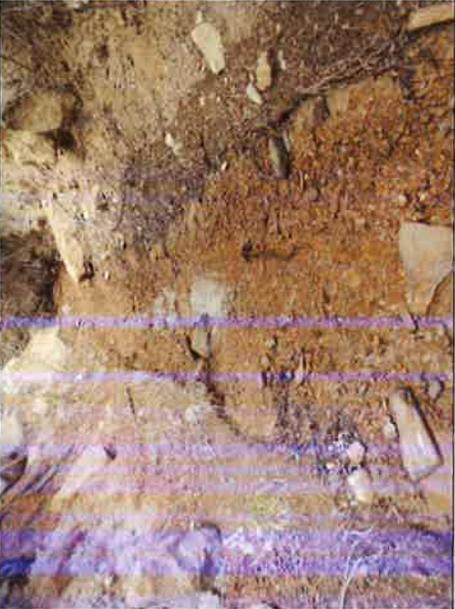
<p>PHOTO 15 No coal fines seen directly downstream of disturbed permit boundary. April 19, 2016</p>

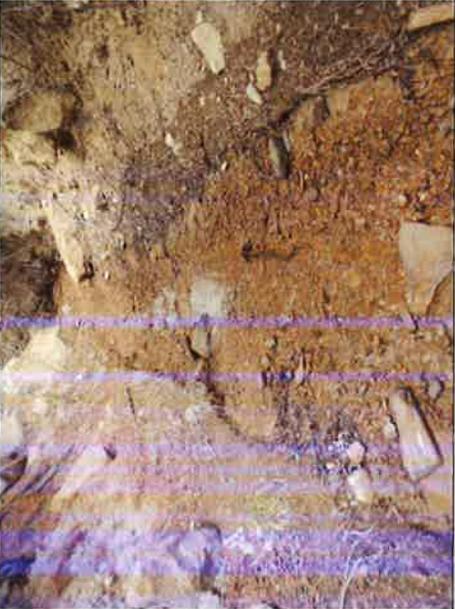
<p>PHOTO 16 No coal fines seen directly downstream of disturbed permit boundary. April 19, 2016</p>

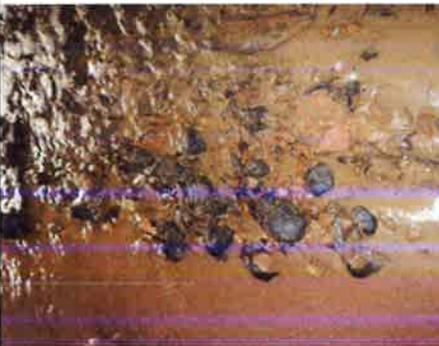
Bear Creek was inspected at a second section where it flows underneath the highway and joins with Huntington Creek. There were chunks of coal in the stream bed as it flows underneath the highway (Photo 17) and chunks in the stream bed of Bear Creek after passing under the highway (Photo 18). It is unclear where these coal chunks originated from. Since there was no coal chunks directly below the mine it is more likely these coal chunks were introduced to the stream by falling off coal trucks. There were no coal fines in the stream and at the junction with Huntington Creek (Photo 19 - 20).

<p>PHOTO 17 Coal chunks in Bear Creek in culvert under highway. April 19, 2016</p>	<p>PHOTO 18 Coal chunks in Bear Creek downstream of highway crossing. April 19, 2016</p>

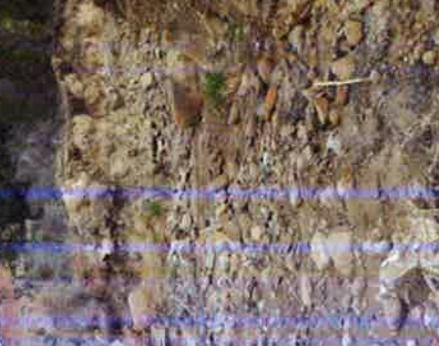
<p>PHOTO 19 No fines or major coal chunks at junction with Huntington Creek. April 19, 2016</p>	<p>PHOTO 20 No fines or major coal chunks at junction with Huntington Creek. April 19, 2016</p>

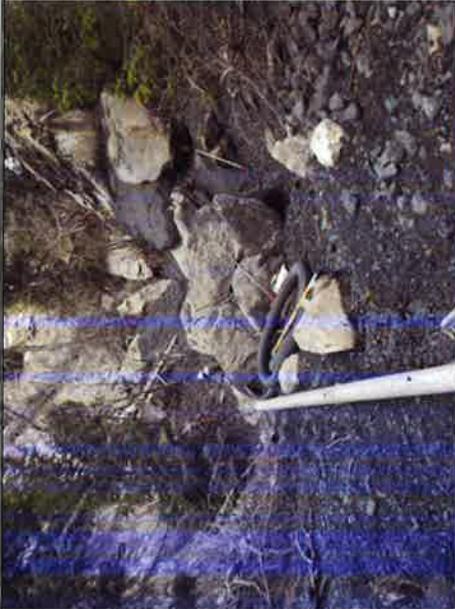
The pans underneath the WHR conveyor need immediate maintenance. NOV 21171 was issued to fix the conveyor and clean up the coal underneath the conveyor. The Permittee was given 60 days to abate the violation with the abatement date being June 13th. There is still a significant amount of coal underneath the conveyor along its entire length as it travels from the portal down Wild Horse Ridge (Photo 21 – 24). The pans underneath the conveyor have failed in multiple locations along the conveyor as it travels down Wild Horse Ridge (Photo 25 – 28). Refer to the attached page in this report from the MRP that outlines the construction and maintenance of the pans under the belt. The pans must be cleaned and water must be able to be flushed down the pans where it will discharge into one of the two catch basins. The pans need to be cleaned out (Photo 29 – 30). The added weight held in these pans is likely contributing to the failures of the belt line. There are also several areas along the conveyor that will require the dust side covers to be replaced.

<p>PHOTO 21 Coal under belt on WHR uphill from the Coal Storage Bin. April 19, 2016</p>	<p>PHOTO 22 Coal under belt on WHR uphill from the Coal Storage Bin. April 19, 2016</p>

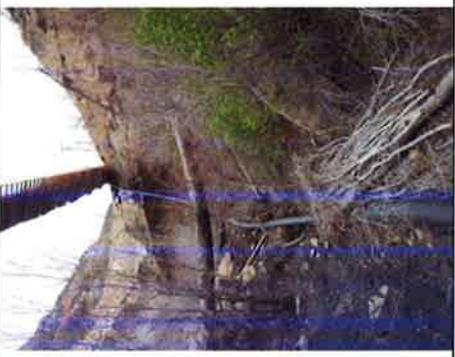
<p>PHOTO 23 Coal under belt on WHR uphill from the Coal Storage Bin. April 19, 2016</p>	<p>PHOTO 24 Coal under belt on WHR just above Catch Basin 1. April 19, 2016</p>

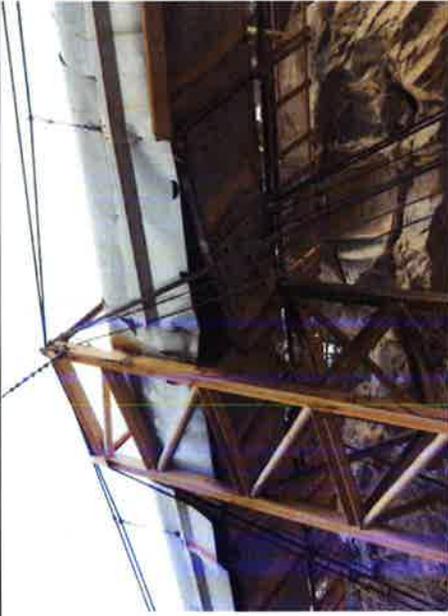
<p>PHOTO 25 Pans in need of maintenance. April 19, 2016</p>	<p>PHOTO 26 Missing pan underneath the conveyor. April 19, 2016</p>

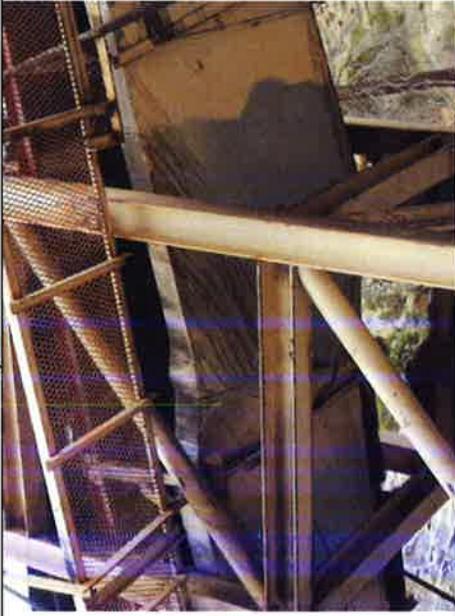
<p>PHOTO 27 Pan in need of maintenance. April 19, 2016</p>	<p>PHOTO 28 Pans missing under the conveyor. April 19, 2016</p>

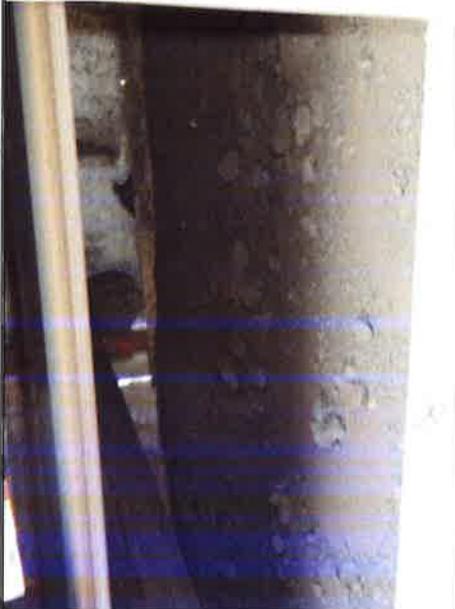
<p>PHOTO 29 Pans need to be cleaned out. April 19, 2016</p>	<p>PHOTO 30 Pans need to be cleaned out. April 19, 2016</p>

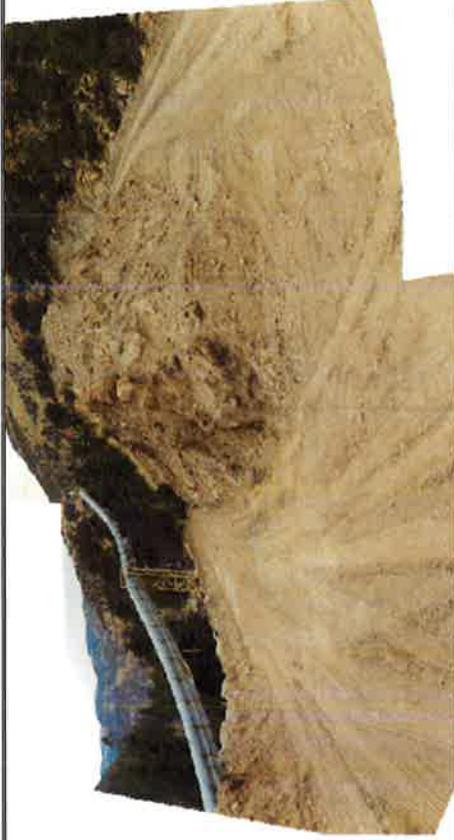
PANORAMA 1

The Access Road to Catch Basin 1 was constructed prior to Division approval (Panorama 1). NOV # 21177 was issued for the Permittee not following the approved MRP. The Access Road is currently under review by the Division under Task #5109. Additional information regarding the violation and associated amendment are provided under item #1.

Access Road to Catch Basin 1 has been constructed. The toe of WHR topsoil pile has been cut on the left and a significant amount was relocated to the top of the pile on the right. There is no berm at the base of the topsoil pile.
April 19, 2016
