Subject: 2016 Annual Report Submittal for Castle Valley Mining LLC Bear Canyon Mine, C/015/0025

Annual Report

1. IMPOUNDMENT INSPECTION AND CERTIFIED REPORT		007A	Page 1 of 2
Permit Number:	ACT/015/025	Report Date: 10/13/2016	
Mine Name:	Castle Valley Mine		
Company Name	Rhino Energy LLC		
Impoundment Identification:		Sediment Pond "A"	
	Impoundment Number:	002A	
	UPDES Permit Number:	UTG040006	
	MSHA ID Number:	42-02263, 42-02335	
IMPOUNDMENT INSPECTION			
Inspection Date:	9/28/2016		
Inspected By:	J.T. Paluso		
Reason for Inspection:	Annual Inspection		
(Annual, Quarterly or other Periodic Inspection, Critical Installation or Completion of Construction)

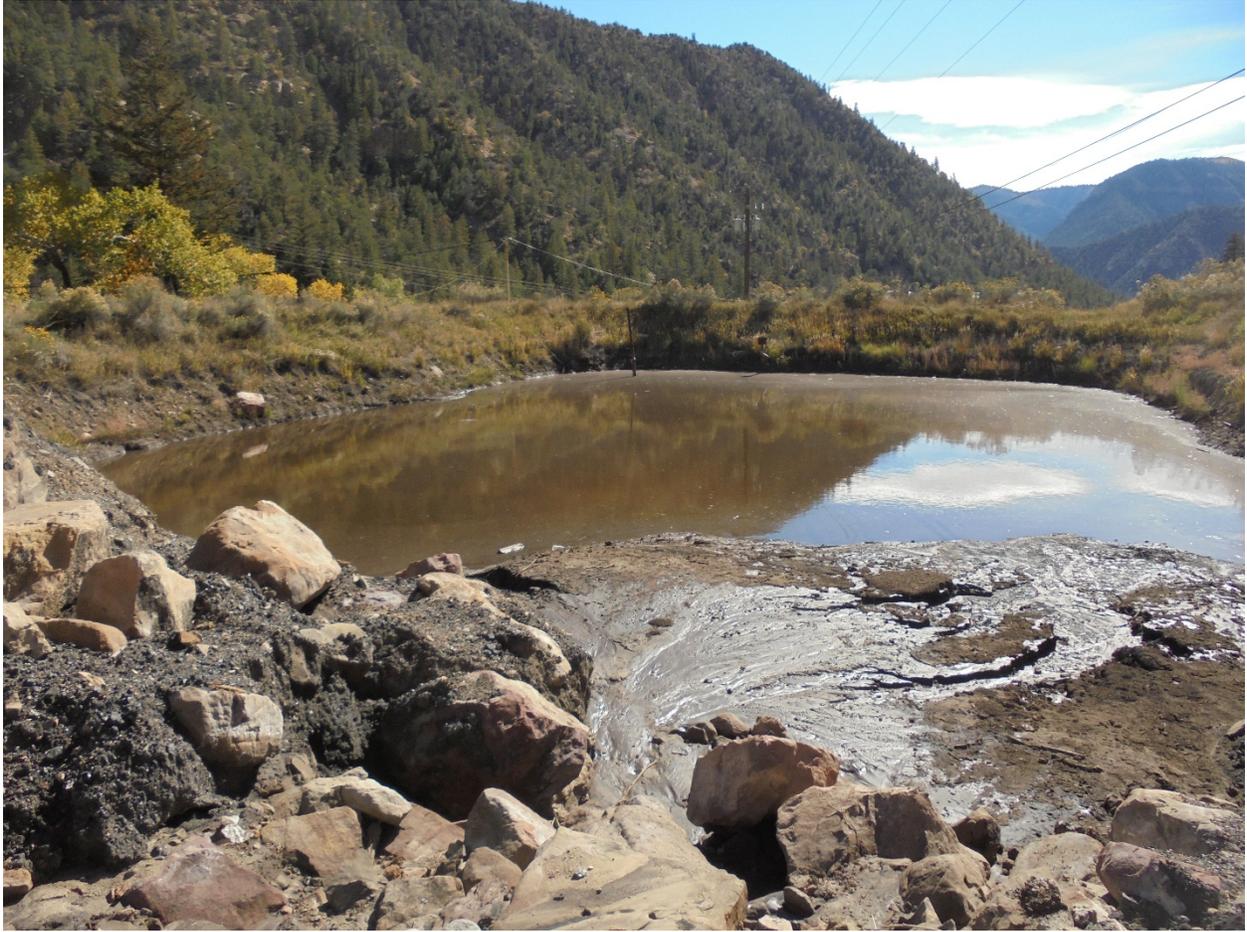
SEDIMENT POND A

1. Describe any appearances of any instability, structural weakness, or any other hazardous condition.			
The pond's dam shows no signs of structural instability or other hazardous conditions.			
Required for an impoundment which functions as a SEDIMENTATION POND	2. Sediment storage capacity, including elevation of 60% and 100% sediment storage volumes and estimated average elevation of existing sediment.		
	Sediment storage capacity is 16,000 cu ft.		
	60% Cleanout Elevation: 7,086'		
	100% Sediment storage elevation: 7,087.9'		
	Existing sediment elevation: Approx. average sediment elevation 7,084.3'

3. Principle and emergency spillway elevations		
	Principle spillway elevation: 7,088'		
	Emergency spillway elevation: 7,094.5'		
4. Field Information: Provide current water elevation, whether pond is discharging, type and number of samples taken, monitoring/instrumentation information, inlet/outlet conditions or other related activities associated with the pond including but not limited to sediment cleanout, pond decanting, embankment erosion/repairs, monitoring information, vegetation on out slopes of embankment erosion/repairs, monitoring information, vegetation on out slopes of embankments, etc.			
Pond Water elevation is 7087.0'. Vegetative cover looked good with no signs of erosion. Recent heavy precipitation occurred.

5. Field Evaluation: Describe any changes in the geometry of the impounding structure, average and maximum depths and elevations of impounded water, estimated sediment or slurry volume and remaining storage capacity, estimated volume of water impounded and any other aspect of the impounding structure affecting its stability or function which has occurred during the reporting period.			
Principal spillway appears to have been bent during the removal of sediment in May 2010. This structure is still working properly. Bent pipe should be straightened to preserve water discharge elevations. Due to high water elevation, the exact sediment level can not be determined. Sediment has recently been removed.			
Qualified Statement	I hereby certify that I am experienced in the construction of impoundments; I am qualified and authorized under the direction of a Registered Professional Engineer to inspect the condition and appearance of impoundments in accordance with the certified and approved designs for this structure, that the impoundment has been maintained in accordance with approved design and meet or exceed the minimum design requirements under all applicable federal, state and local regulations; and, that inspections and inspection reports are made by myself and include any appearances of instability, structural weakness or other hazardous conditions of the structure affecting stability.

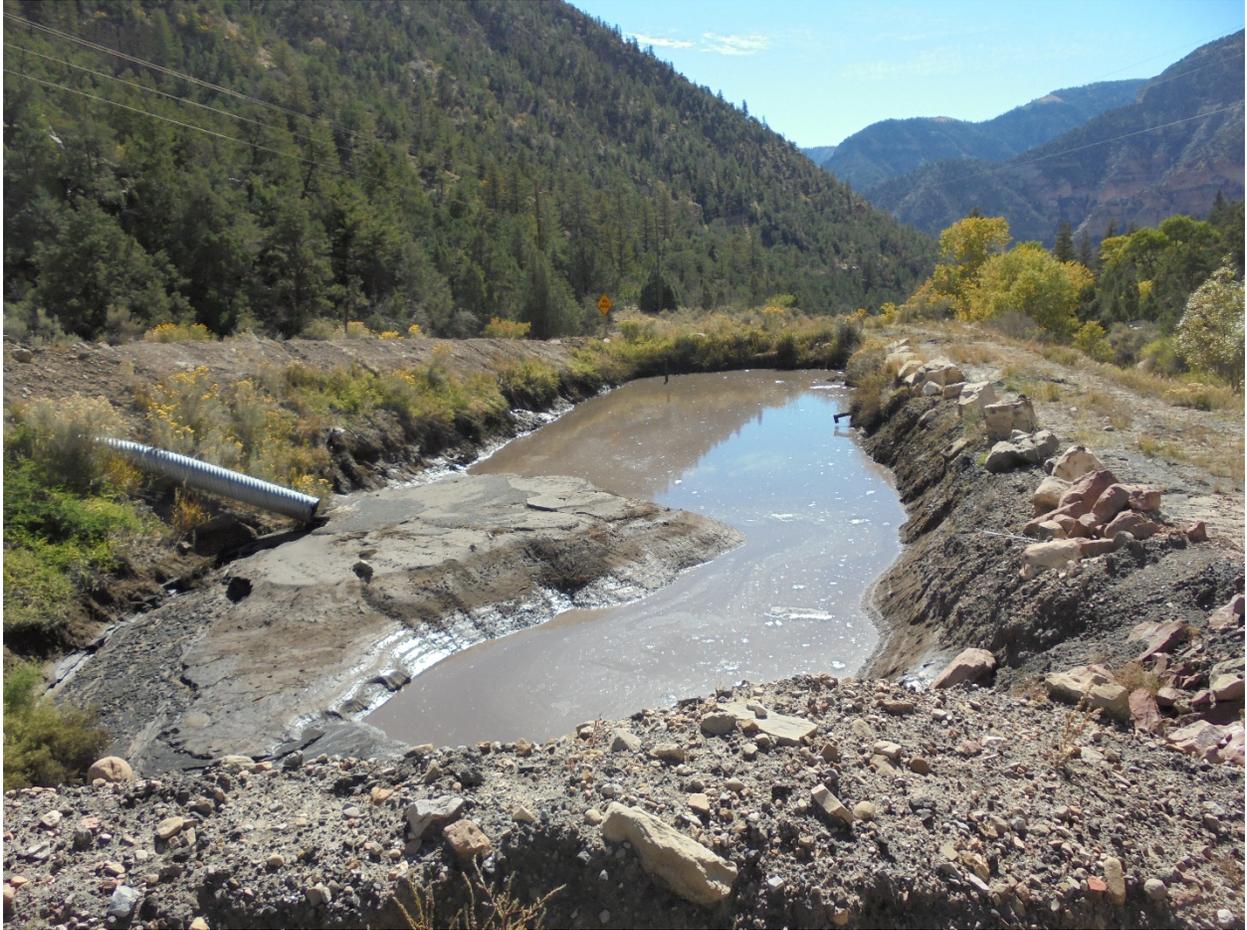
SEDIMENT POND B

1. Describe any appearances of any instability, structural weakness, or any other hazardous condition.			
The pond's dam shows no signs of structural instability or other hazardous conditions.			
Required for an impoundment which functions as a SEDIMENTATION POND	2. Sediment storage capacity, including elevation of 60% and 100% sediment storage volumes and estimated average elevation of existing sediment.		
	Sediment storage capacity is approximately 5,000 cu ft. Sediment has been removed.		
	60% Cleanout Elevation: 7,062.9'		
	100% Sediment storage elevation: 7,063.4'		
	Existing sediment elevation: Approx. average sediment elevation 7,061.7'

3. Principle and emergency spillway elevations		
	Principle spillway elevation: 7,064.9'		
	Emergency spillway elevation: 7066.9'		
4. Field Information: Provide current water elevation, whether pond is discharging, type and number of samples taken, monitoring/instrumentation information, inlet/outlet conditions or other related activities associated with the pond including but not limited to sediment cleanout, pond decanting, embankment erosion/repairs, monitoring information, vegetation on out slopes of embankment erosion/repairs, monitoring information, vegetation on out slopes of embankments, etc.			
Pond has water. Vegetative cover looked good with no signs of erosion. Recent heavy precipitation occurred.

5. Field Evaluation: Describe any changes in the geometry of the impounding structure, average and maximum depths and elevations of impounded water, estimated sediment or slurry volume and remaining storage capacity, estimated volume of water impounded and any other aspect of the impounding structure affecting its stability or function which has occurred during the reporting period.			
Due to high water elevation, the exact sediment level can not be determined. Sediment has recently been removed. Water elevation is 7064.2'.			
Qualified Statement	I hereby certify that I am experienced in the construction of impoundments; I am qualified and authorized under the direction of a Registered Professional Engineer to inspect the condition and appearance of impoundments in accordance with the certified and approved designs for this structure, that the impoundment has been maintained in accordance with approved design and meet or exceed the minimum design requirements under all applicable federal, state and local regulations; and, that inspections and inspection reports are made by myself and include any appearances of instability, structural weakness or other hazardous conditions of the structure affecting stability.

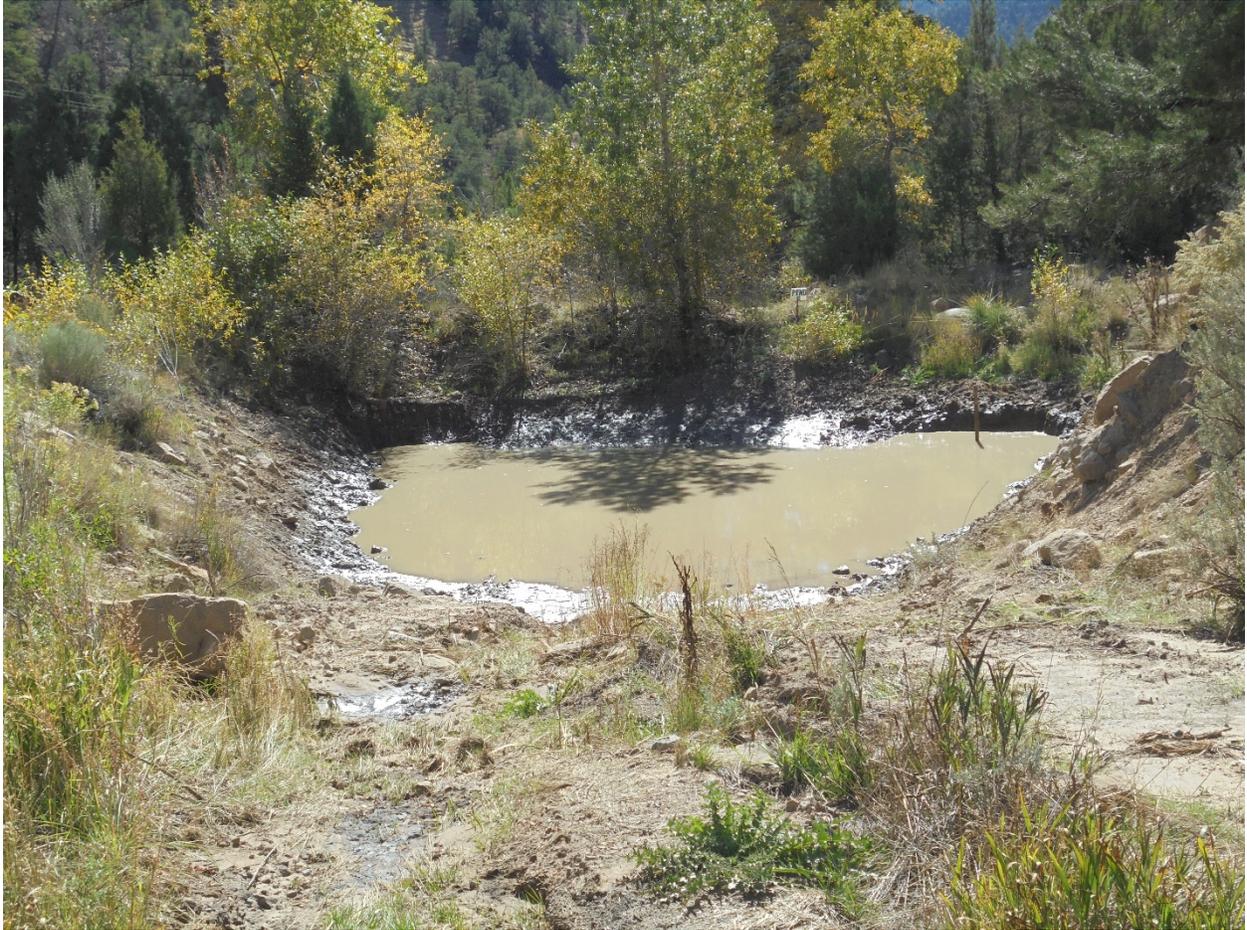
SEDIMENT POND C

1. Describe any appearances of any instability, structural weakness, or any other hazardous condition.			
The pond's dam shows no signs of structural instability or other hazardous conditions.			
Required for an impoundment which functions as a SEDIMENTATION POND	2. Sediment storage capacity, including elevation of 60% and 100% sediment storage volumes and estimated average elevation of existing sediment.		
	Sediment storage capacity is 4,500 cu ft.		
	60% Cleanout Elevation: 7,030.3'		
	100% Sediment storage elevation: 7,031.4'		
	Existing sediment elevation: Approx. average sediment elevation 7,028'

3. Principle and emergency spillway elevations		
	Principle spillway elevation: 7,032.3'		
	Emergency spillway elevation: 7,035.3'		
4. Field Information: Provide current water elevation, whether pond is discharging, type and number of samples taken, monitoring/instrumentation information, inlet/outlet conditions or other related activities associated with the pond including but not limited to sediment cleanout, pond decanting, embankment erosion/repairs, monitoring information, vegetation on outslopes of embankment erosion/repairs, monitoring information, vegetation on outslopes of embankments, etc.			
Water level in pond is high. Vegetative cover looked good with no signs of erosion. Water level is at 7030.3'.

5. Field Evaluation: Describe any changes in the geometry of the impounding structure, average and maximum depths and elevations of impounded water, estimated sediment or slurry volume and remaining storage capacity, estimated volume of water impounded and any other aspect of the impounding structure affecting its stability or function which has occurred during the reporting period.			
Due to high water elevation, the exact sediment level can not be determined. Sediment has recently been removed. This structure is still working properly.			
Qualified Statement	I hereby certify that I am experienced in the construction of impoundments; I am qualified and authorized under the direction of a Registered Professional Engineer to inspect the condition and appearance of impoundments in accordance with the certified and approved designs for this structure, that the impoundment has been maintained in accordance with approved design and meet or exceed the minimum design requirements under all applicable federal, state and local regulations; and, that inspections and inspection reports are made by myself and include any appearances of instability, structural weakness or other hazardous conditions of the structure affecting stability.

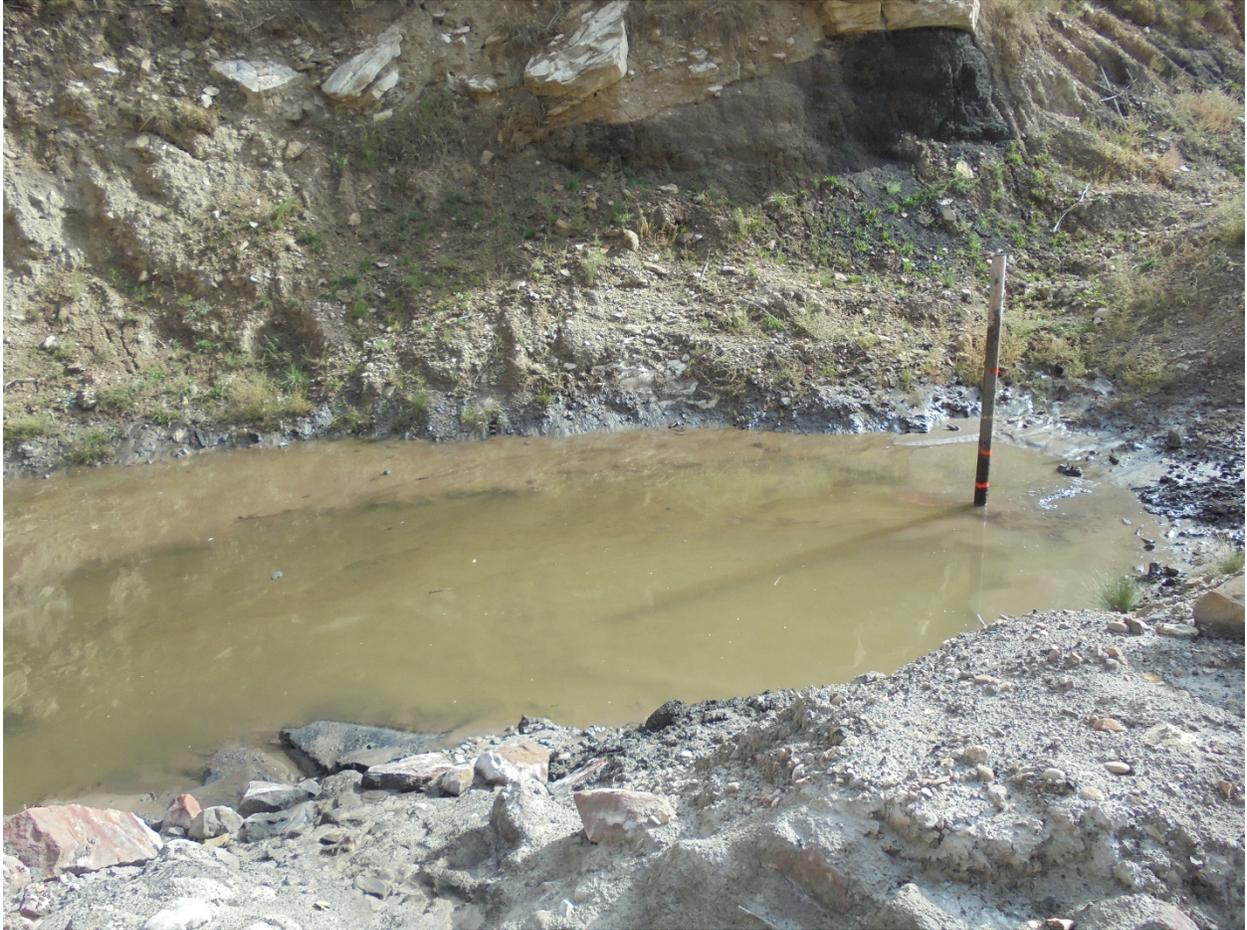
SEDIMENT POND D

1. Describe any appearances of any instability, structural weakness, or any other hazardous condition.			
The pond's dam shows no signs of structural instability or other hazardous conditions. Pond elevations have been corrected.			
Required for an impoundment which functions as a SEDIMENTATION POND	2. Sediment storage capacity, including elevation of 60% and 100% sediment storage volumes and estimated average elevation of existing sediment.		
	Sediment storage capacity: Estimated 1600 cu ft		
	60% Cleanout Elevation: 7,641.8'		
	100% Sediment storage elevation: 7,643.1'		
	Existing sediment elevation: Approx. average sediment elevation 7,640', water covering sediment level.

3. Principle and emergency spillway elevations		
	Principle spillway elevation: 7,644.1'		
	Emergency spillway elevation: 7,646.6'		
4. Field Information: Provide current water elevation, whether pond is discharging, type and number of samples taken, monitoring/instrumentation information, inlet/outlet conditions or other related activities associated with the pond including but not limited to sediment cleanout, pond decanting, embankment erosion/repairs, monitoring information, vegetation on out slopes of embankment erosion/repairs, monitoring information, vegetation on out slopes of embankments, etc.			
Incised pond has minimal vegetation with no signs of erosion. Water elevation is at 7642.9'. Recent heavy precipitation occurred.

5. Field Evaluation: Describe any changes in the geometry of the impounding structure, average and maximum depths and elevations of impounded water, estimated sediment or slurry volume and remaining storage capacity, estimated volume of water impounded and any other aspect of the impounding structure affecting its stability or function which has occurred during the reporting period.			
Pond elevation has been modified in the past. Oil removal elbow still needs to be installed on principal spillway. High water makes it impossible to determine sediment level.			
Qualified Statement	I hereby certify that I am experienced in the construction of impoundments; I am qualified and authorized under the direction of a Registered Professional Engineer to inspect the condition and appearance of impoundments in accordance with the certified and approved designs for this structure, that the impoundment has been maintained in accordance with approved design and meet or exceed the minimum design requirements under all applicable federal, state and local regulations; and, that inspections and inspection reports are made by myself and include any appearances of instability, structural weakness or other hazardous conditions of the structure affecting stability.
