Subject: 2017 Annual Report Submittal for Castle Valley Mining LLC Bear Canyon Mine, C/015/0025

ANNUAL REPORT

RHINO - CASTLE VALLEY MINING, LLC
November 2017 - Annual Subsidence Survey

| 1. IMPOUNDMENT INSPECTION AND CERTIFIED REPORT | | 007A | Page 1 of 2 |

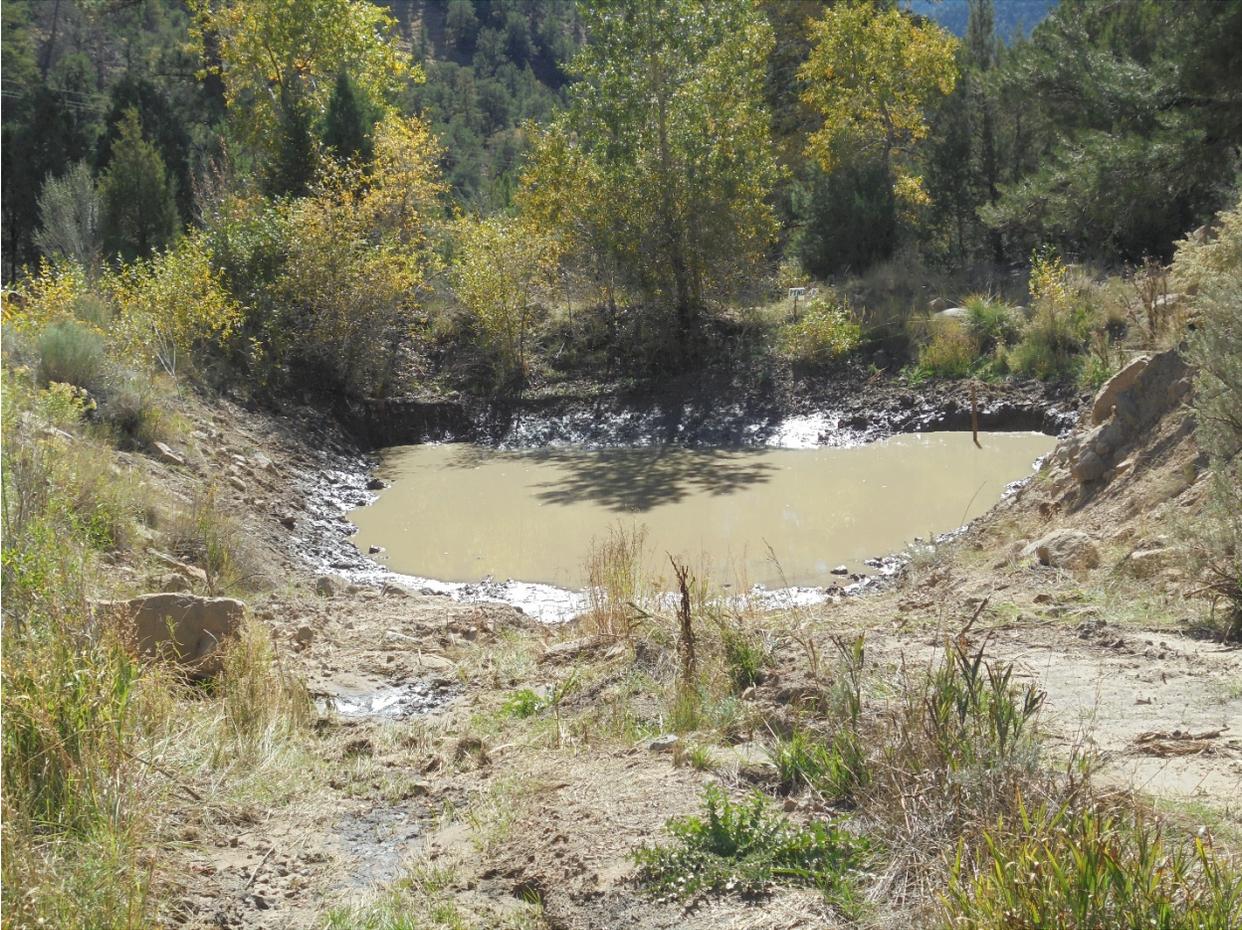
SEDIMENT POND C

| The pond's dam shows no signs of structural instability or other hazardous conditions. | | | |
