State of Utah
 DEPARTMENT OF NATURAL RESOURCES
 MICHAEL R. STYLER
Executive Director
Division of Oil, Gas and Mining
 JOHN R. BAZA
Division Director

Inspection Report

Permit Number:	C0150025
Inspection Type:	TECHNICAL
Inspection Date:	Wednesday, March 14, 2018
Start Date/Time:	3/14/2018 12:00:00 PM
End Date/Time:	3/14/2018 2:30:00 PM
Last Inspection:	Tuesday, February 6, 2018

Permittee: **CASTLE VALLEY MINING LLC**
 Operator: **CASTLE VALLEY MINING LLC**
 Site: **BEAR CANYON MINE**
 Address: **2352 NORTH 7TH STREET, UNIT B, GRAND JUNCTION CO 81501**
 County: **EMERY**
 Permit Type: **PERMANENT COAL PROGRAM**
 Permit Status: **ACTIVE**

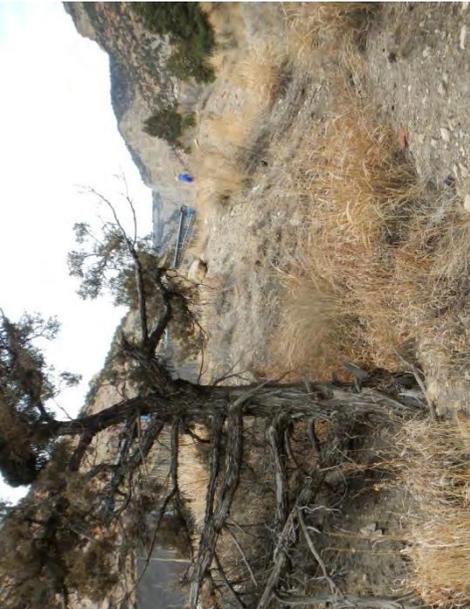
The Main topsoil stockpile is shown on the East side of the Primary Haul Road on Plate 5-2C. This stockpile has established vegetation with the most vigorous growth on the North facing side. There is some evidence of coal fine accumulation on the stockpile on the West side near the road. The Main Topsoil Stockpile was estimated to be 4 feet deep placed against a steep slope and was GPS'd as 0.21 acres. Given these dimensions, the topsoil stockpile would hold 1,355 CY. Table 2-5 reports a volume of 1,480 CY which is consistent with these rough field measurements.

<p>PHOTO 1 Main Topsoil Pile West side</p>

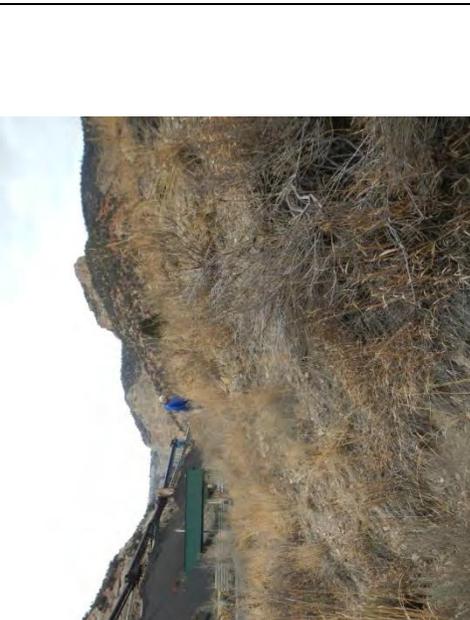
<p>PHOTO 2 Main Topsoil Piles East side</p>

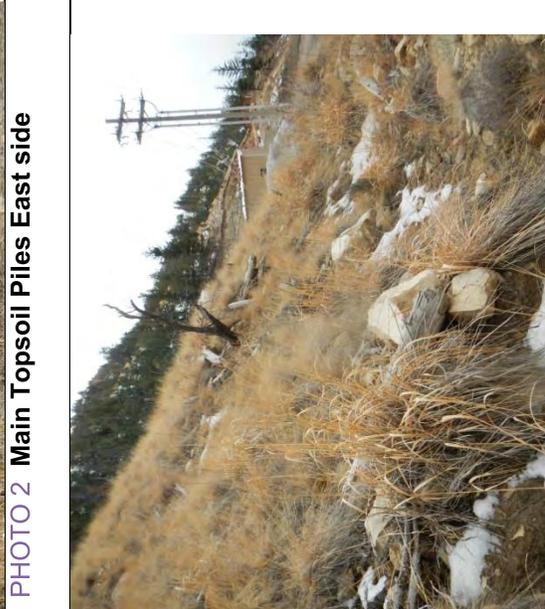
Wildhorse Ridge Tank Seam topsoil stockpile is shown on the East side of the Primary No. 4 Mine Access Road on Plate 5-2G. This stockpile has established, vigorous vegetation, including elderberry shrubs. This stockpile was estimated to be 7 feet deep placed against a steep slope and was GPS'd as 0.12 acres. Given these dimensions, the topsoil stockpile would hold 1,355 CY. Table 2-5 reports a volume of 1,400 CY which is consistent with these rough field measurements.

<p>PHOTO 3 WHR Tank Seam Topsoil pile South side</p>

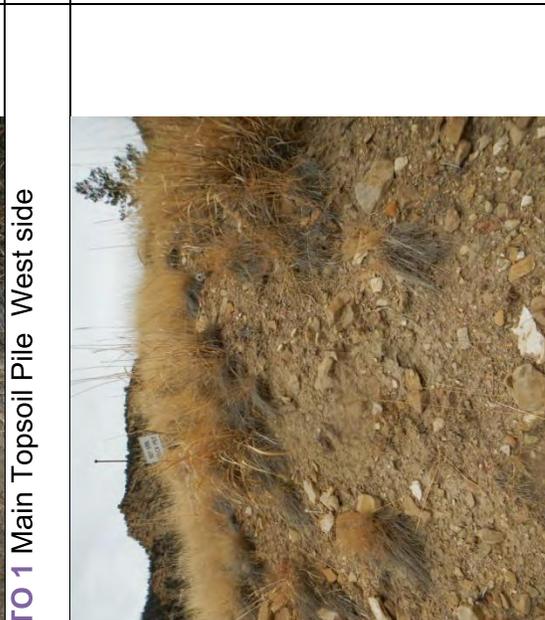
<p>PHOTO 4 WHR Tank Seam topsoil pile West face</p>

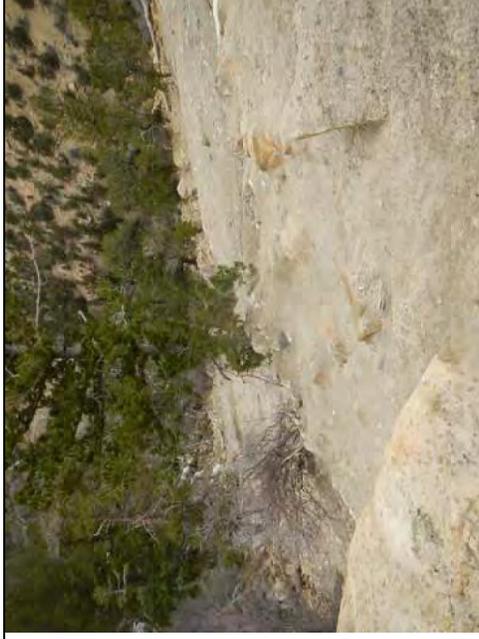
Road maintenance is creating a sediment control issue at the hairpin turns of the Mine #4 and Mine #3 Primary Access Roads. Mud pushed from the roadway onto the soil berms at these turns is sliding down the steep outslope. Re-seeding of the outslopes at the hairpin turns was suggested. In the future, removing the mud to another location should be considered as well as sediment logs along the disturbed area boundary.

PHOTO 12 TS 12 and TS16 outlopes of hairpin turns where sediment control is needed
