1. IMPOUNDMENT INSPECTION AND CERTIFIED REPORT		007A	Page 1 of 2
Permit Number:	ACT/015/025	Report Date: 11/07/2019	
Mine Name:	Castle Valley Mine		
Company Name	Rhino Energy LLC		
Impoundment Identification:		Sediment Pond "A"	
	Impoundment Number:	002A	
	UPDES Permit Number:	UTG040006	
	MSHA ID Number:	42-02263, 42-02335	
IMPOUNDMENT INSPECTION			
Inspection Date:	10/3/2019		
Inspected By:	J.T. Paluso		
Reason for Inspection:	Annual Inspection		
(Annual, Quarterly or other Periodic Inspection, Critical Installation or Completion of Construction)

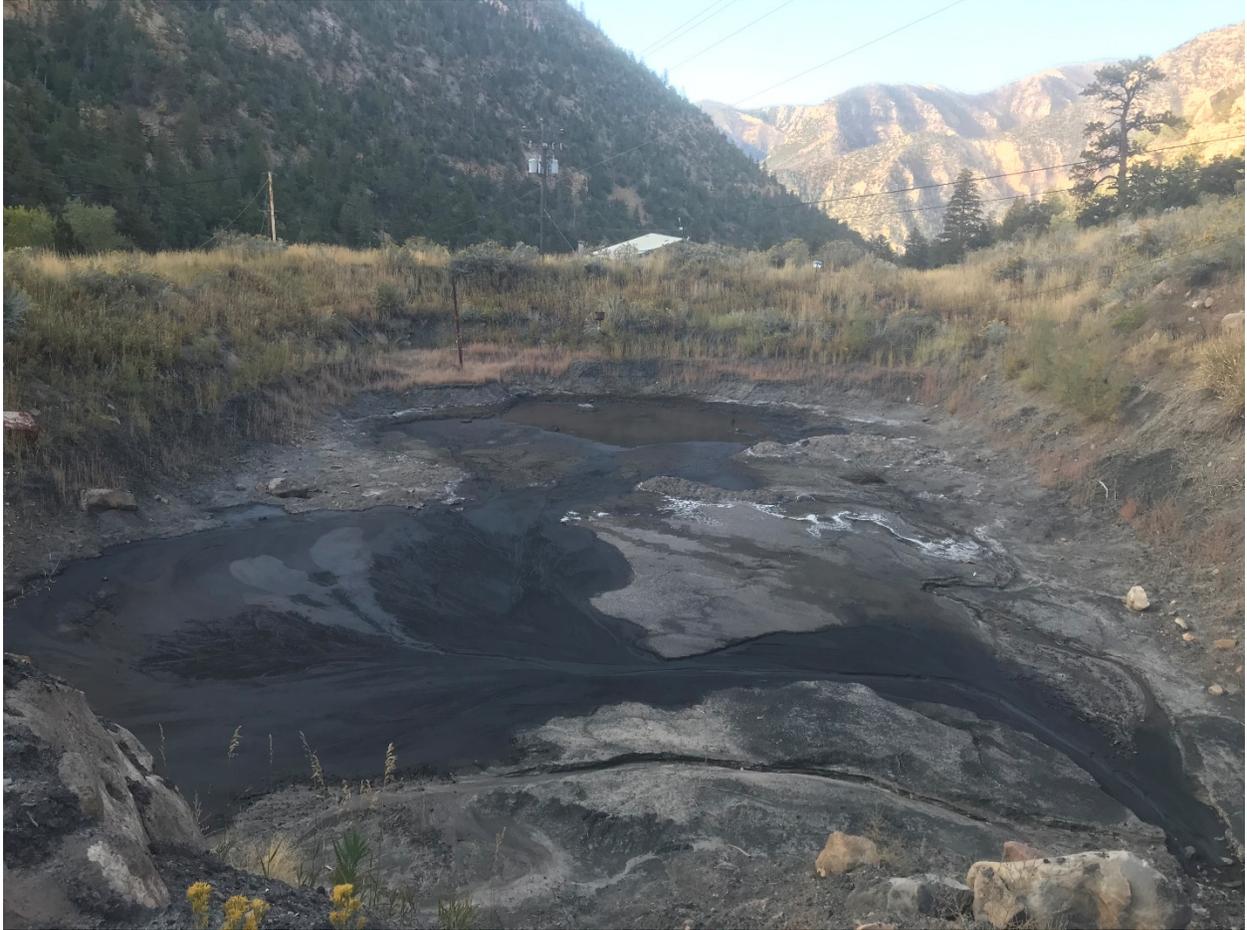
POND A

1. Describe any appearances of any instability, structural weakness, or any other hazardous condition.			
The pond's dam shows no signs of structural instability or other hazardous conditions.			
Required for an impoundment which functions as a SEDIMENTATION POND	2. Sediment storage capacity, including elevation of 60% and 100% sediment storage volumes and estimated average elevation of existing sediment.		
	Sediment storage capacity is 32,620 cu ft.		
	60% Cleanout Elevation: 7,086'		
	100% Sediment storage elevation: 7,087.1'		
	Existing sediment elevation: Approx. average sediment elevation 7,080'

3. Principle and emergency spillway elevations		
	Principle spillway elevation: 7,088'		
	Emergency spillway elevation: 7,094.5'		
4. Field Information: Provide current water elevation, whether pond is discharging, type and number of samples taken, monitoring/instrumentation information, inlet/outlet conditions or other related activities associated with the pond including but not limited to sediment cleanout, pond decanting, embankment erosion/repairs, monitoring information, vegetation on out slopes of embankment erosion/repairs, monitoring information, vegetation on out slopes of embankments, etc.			
Pond ice elevation is 7081'. Vegetative cover looked good with no signs of erosion.

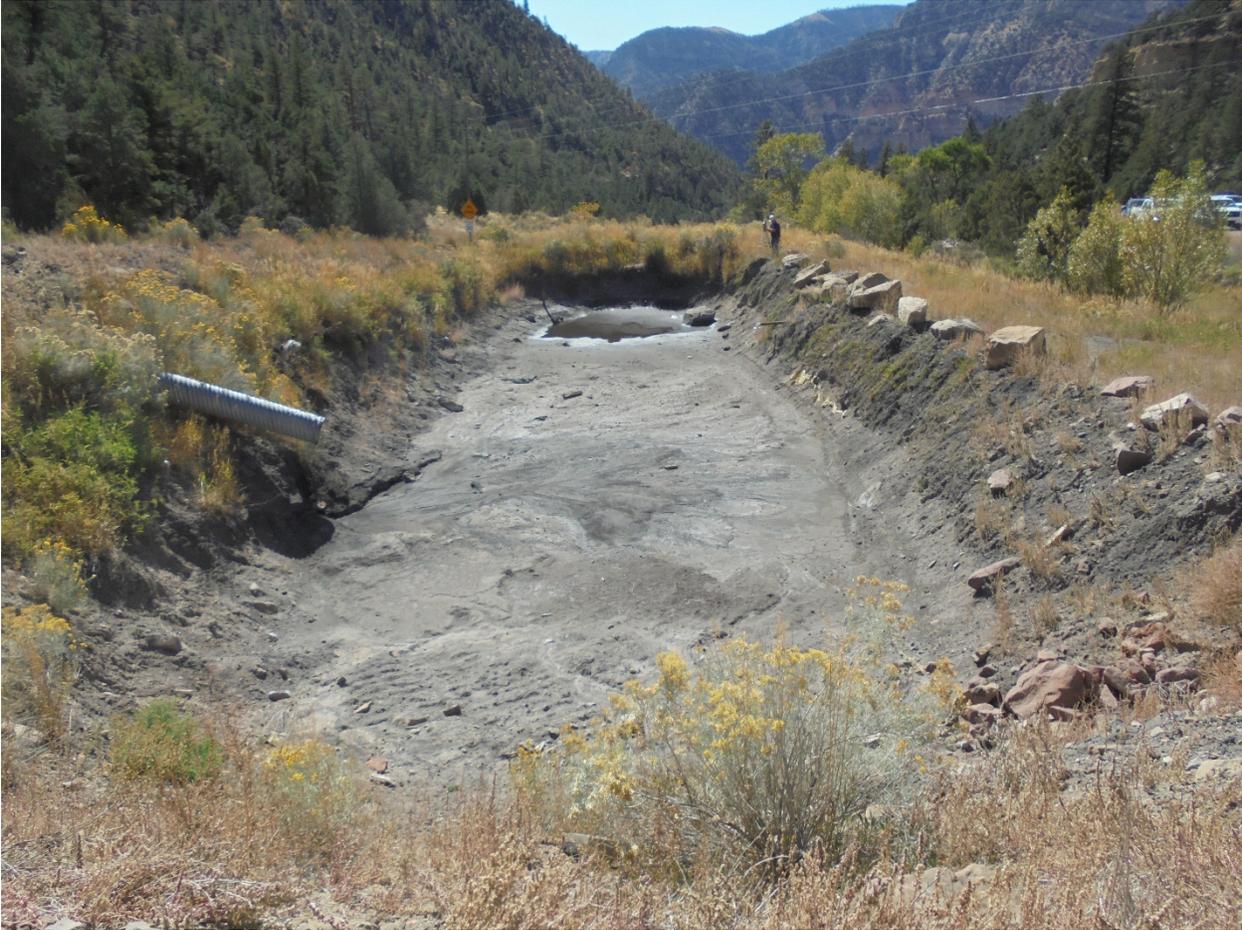
POND B

1. Describe any appearances of any instability, structural weakness, or any other hazardous condition.			
The pond's dam shows no signs of structural instability or other hazardous conditions.			
Required for an impoundment which functions as a SEDIMENTATION POND	2. Sediment storage capacity, including elevation of 60% and 100% sediment storage volumes and estimated average elevation of existing sediment.		
	Sediment storage capacity is approximately 8,482 cu ft.		
	60% Cleanout Elevation: 7,062.9'		
	100% Sediment storage elevation: 7,063.4'		
	Existing sediment elevation: Approx. average sediment elevation 7,061'

3. Principle and emergency spillway elevations		
	Principle spillway elevation: 7,064.9'		
	Emergency spillway elevation: 7066.9'		
4. Field Information: Provide current water elevation, whether pond is discharging, type and number of samples taken, monitoring/instrumentation information, inlet/outlet conditions or other related activities associated with the pond including but not limited to sediment cleanout, pond decanting, embankment erosion/repairs, monitoring information, vegetation on out slopes of embankment erosion/repairs, monitoring information, vegetation on out slopes of embankments, etc.			
Pond has water. Vegetative cover looked good with no signs of erosion.

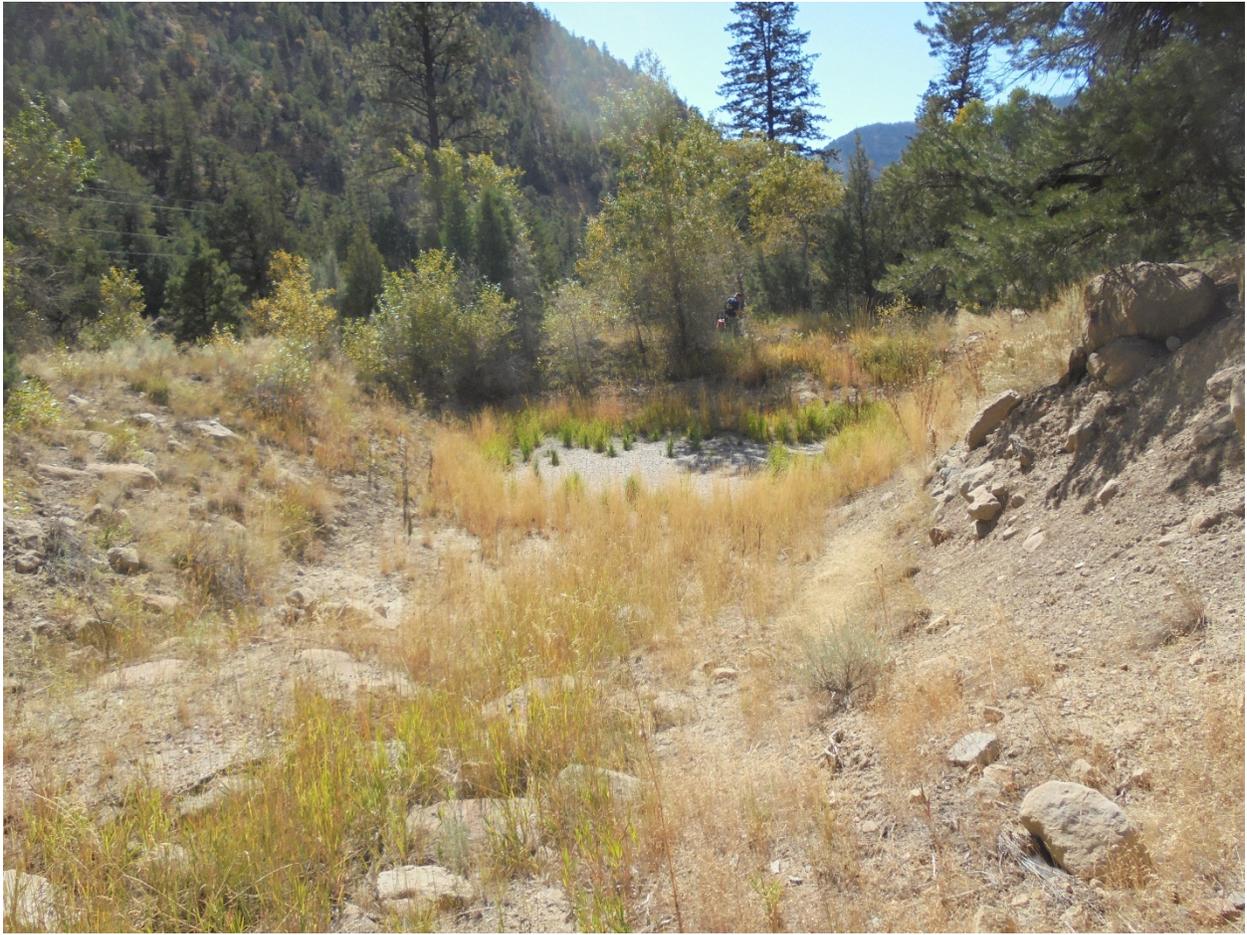
POND C

1. Describe any appearances of any instability, structural weakness, or any other hazardous condition.			
The pond's dam shows no signs of structural instability or other hazardous conditions.			
Required for an impoundment which functions as a SEDIMENTATION POND	2. Sediment storage capacity, including elevation of 60% and 100% sediment storage volumes and estimated average elevation of existing sediment.		
	Sediment storage capacity is 959 cu ft.		
	60% Cleanout Elevation: 7,030.3'		
	100% Sediment storage elevation: 7,031.4'		
	Existing sediment elevation: Average sediment elevation 7,029.72'

3. Principle and emergency spillway elevations		
	Principle spillway elevation: 7,032.3'		
	Emergency spillway elevation: 7,035.3'		
4. Field Information: Provide current water elevation, whether pond is discharging, type and number of samples taken, monitoring/instrumentation information, inlet/outlet conditions or other related activities associated with the pond including but not limited to sediment cleanout, pond decanting, embankment erosion/repairs, monitoring information, vegetation on outslopes of embankment erosion/repairs, monitoring information, vegetation on outslopes of embankments, etc.			
Pond is dry and the vegetative cover looked good with no signs of erosion.

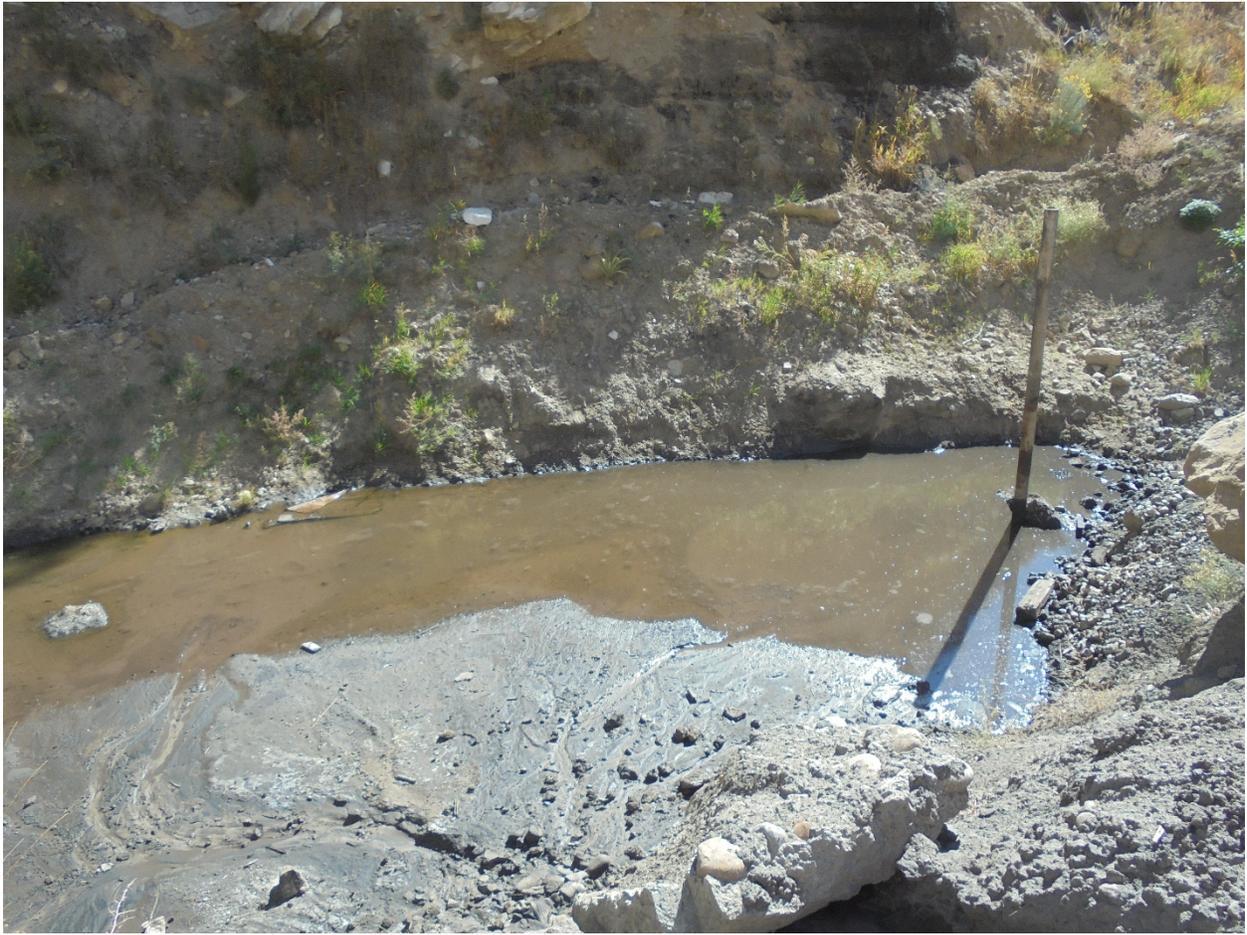
POND D

1. Describe any appearances of any instability, structural weakness, or any other hazardous condition.			
The pond's dam shows no signs of structural instability or other hazardous conditions. Pond elevations have been corrected.			
Required for an impoundment which functions as a SEDIMENTATION POND	2. Sediment storage capacity, including elevation of 60% and 100% sediment storage volumes and estimated average elevation of existing sediment.		
	Sediment storage capacity: Estimated 1091 cu ft		
	60% Cleanout Elevation: 7,640.9'		
	100% Sediment storage elevation: 7,642.2'		
	Existing sediment elevation: Approximately 7638'.

3. Principle and emergency spillway elevations		
	Principle spillway elevation: 7,643.2'		
	Emergency spillway elevation: 7,645.7'		
4. Field Information: Provide current water elevation, whether pond is discharging, type and number of samples taken, monitoring/instrumentation information, inlet/outlet conditions or other related activities associated with the pond including but not limited to sediment cleanout, pond decanting, embankment erosion/repairs, monitoring information, vegetation on out slopes of embankment erosion/repairs, monitoring information, vegetation on out slopes of embankments, etc.			
Incised pond has minimal vegetation with no signs of erosion. Pond had approximately 1' of water. See the attached photograph.
