SLOPE STABILITY INVESTIGATION
PORTAL PADS AND PORTAL ACCESS ROADS
GENWAL COAL MINE
HUNTINGTON, UTAH

Subject: Cut Slopes and Safety Factors for
Portal Pads and Access Roads to
Genwal Coal Mine

Delta Job No. 1169

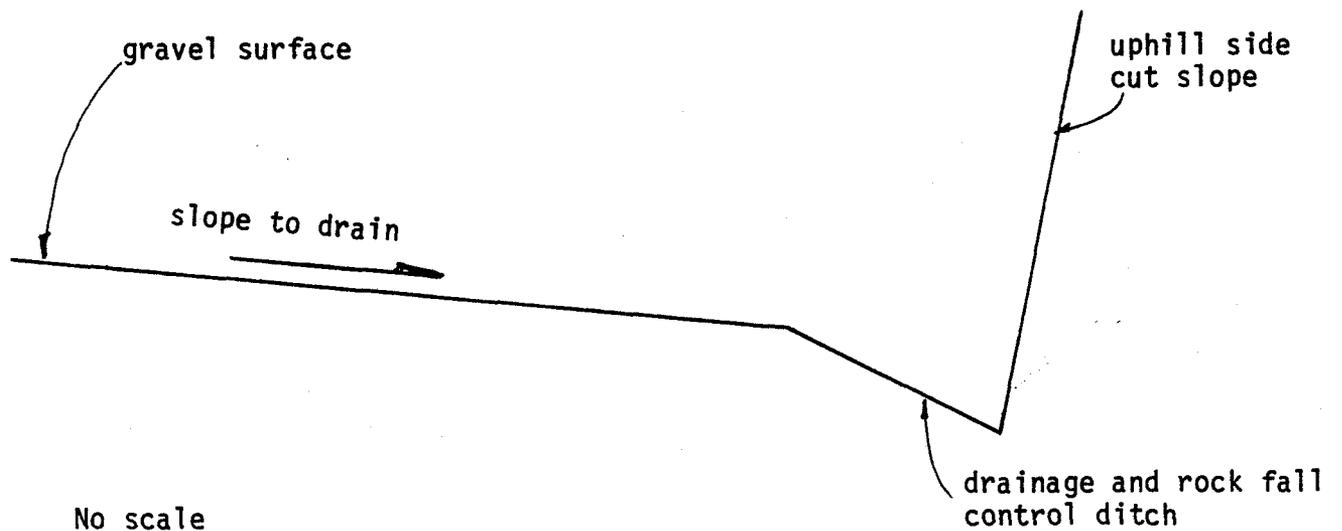
TYPICAL ROADWAY CROSS SECTION

Control of surface runoff and rock falls from higher elevations, in our opinion, are the two most critical factors to be incorporated in the design and construction of the proposed facilities. Uncontrolled surface runoff will saturate surficial deposits, particularly in the areas of shallow bedrock, and will cause major slides (or mud flows) in these areas. These slides not only would delay the mine operations, but could cause major damage to men and equipment. The results of our "sliding block" slope stability analyses, which confirms our opinion, are presented on Figure 7. Rock falls, on the other hand, are unpredictable. Rock fall

could occur any time of the year due to weathering of the overhanging cliffs, and erosive forces causing the stranded rocks to loosen and roll downward. Both problems, in our opinion, can be minimized by providing a drainage (or rock fall ditch) as illustrated below. Details of the ditch construction are presented on Figure 6.

The following design and construction details should also be observed:

- (1) The construction activities will unavoidably alter and block the natural drainage paths along the proposed alignments. We recommend that culverts or other drainage means be provided for these areas.
- (2) The roadway should be graded toward the drainage (or rock fall) ditch to prevent ponding of water in the roadway.

- (3) The drainage ditch should be paved or properly lined with a suitable material to prevent penetration of water into the subsoils or surficial deposits. Where the roadway is underlain by claystone or impervious sandstone, ditch lining will not be required.
- (4) The excavated material should not be dumped over the downhill side of the cuts as this will lower the stability of the hillside.
- (5) The drainage ditch should be cleaned and maintained periodically to insure that the system remains functional at all times.
- (6) The natural soil cover and vegetation should be protected as much as possible to prevent erosion.

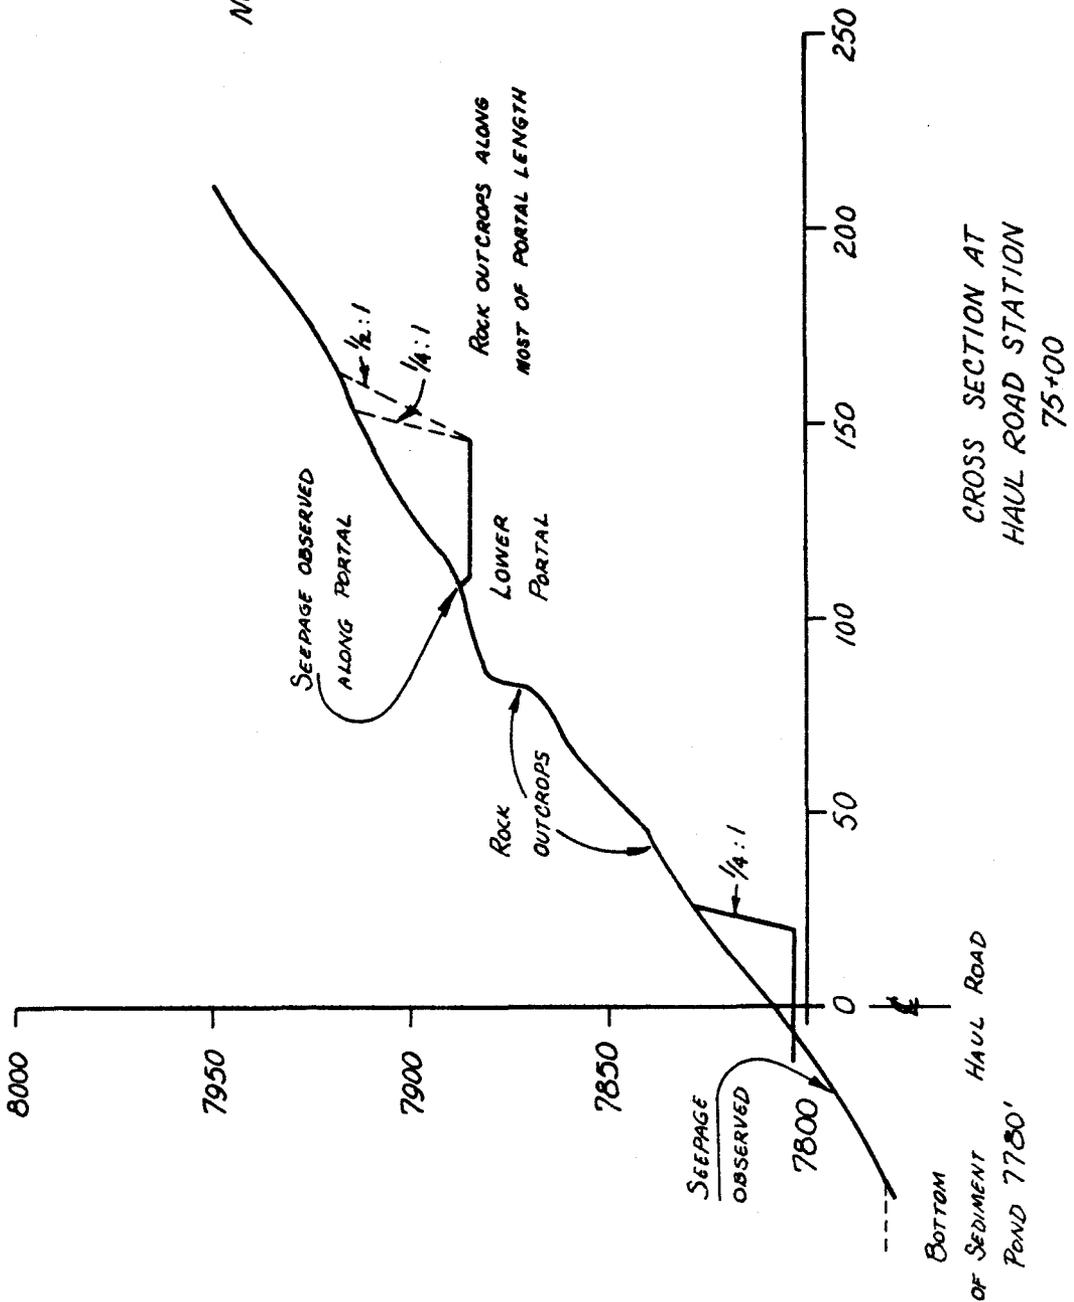
CROSS SECTION AT HAUL ROAD STATION 75+00

Cut slope profiles for four different locations are shown on Figures 2 through 5. These profiles indicate typical surface and subsurface conditions that may be expected along the proposed alignments. The profiles also show some of the problems associated with flatter excavations such as 1:1 cut slopes. As shown on Figures 4 and 5, a 1:1 cut slope could undercut the upper access road. The flatter slopes will also unnecessarily scar the hillside, and create large erosion paths. Flatter slopes will also increase the cost of construction. We, therefore, do not recommend cut slopes flatter than ½:1, except under the conditions outlined in our recommendations above.

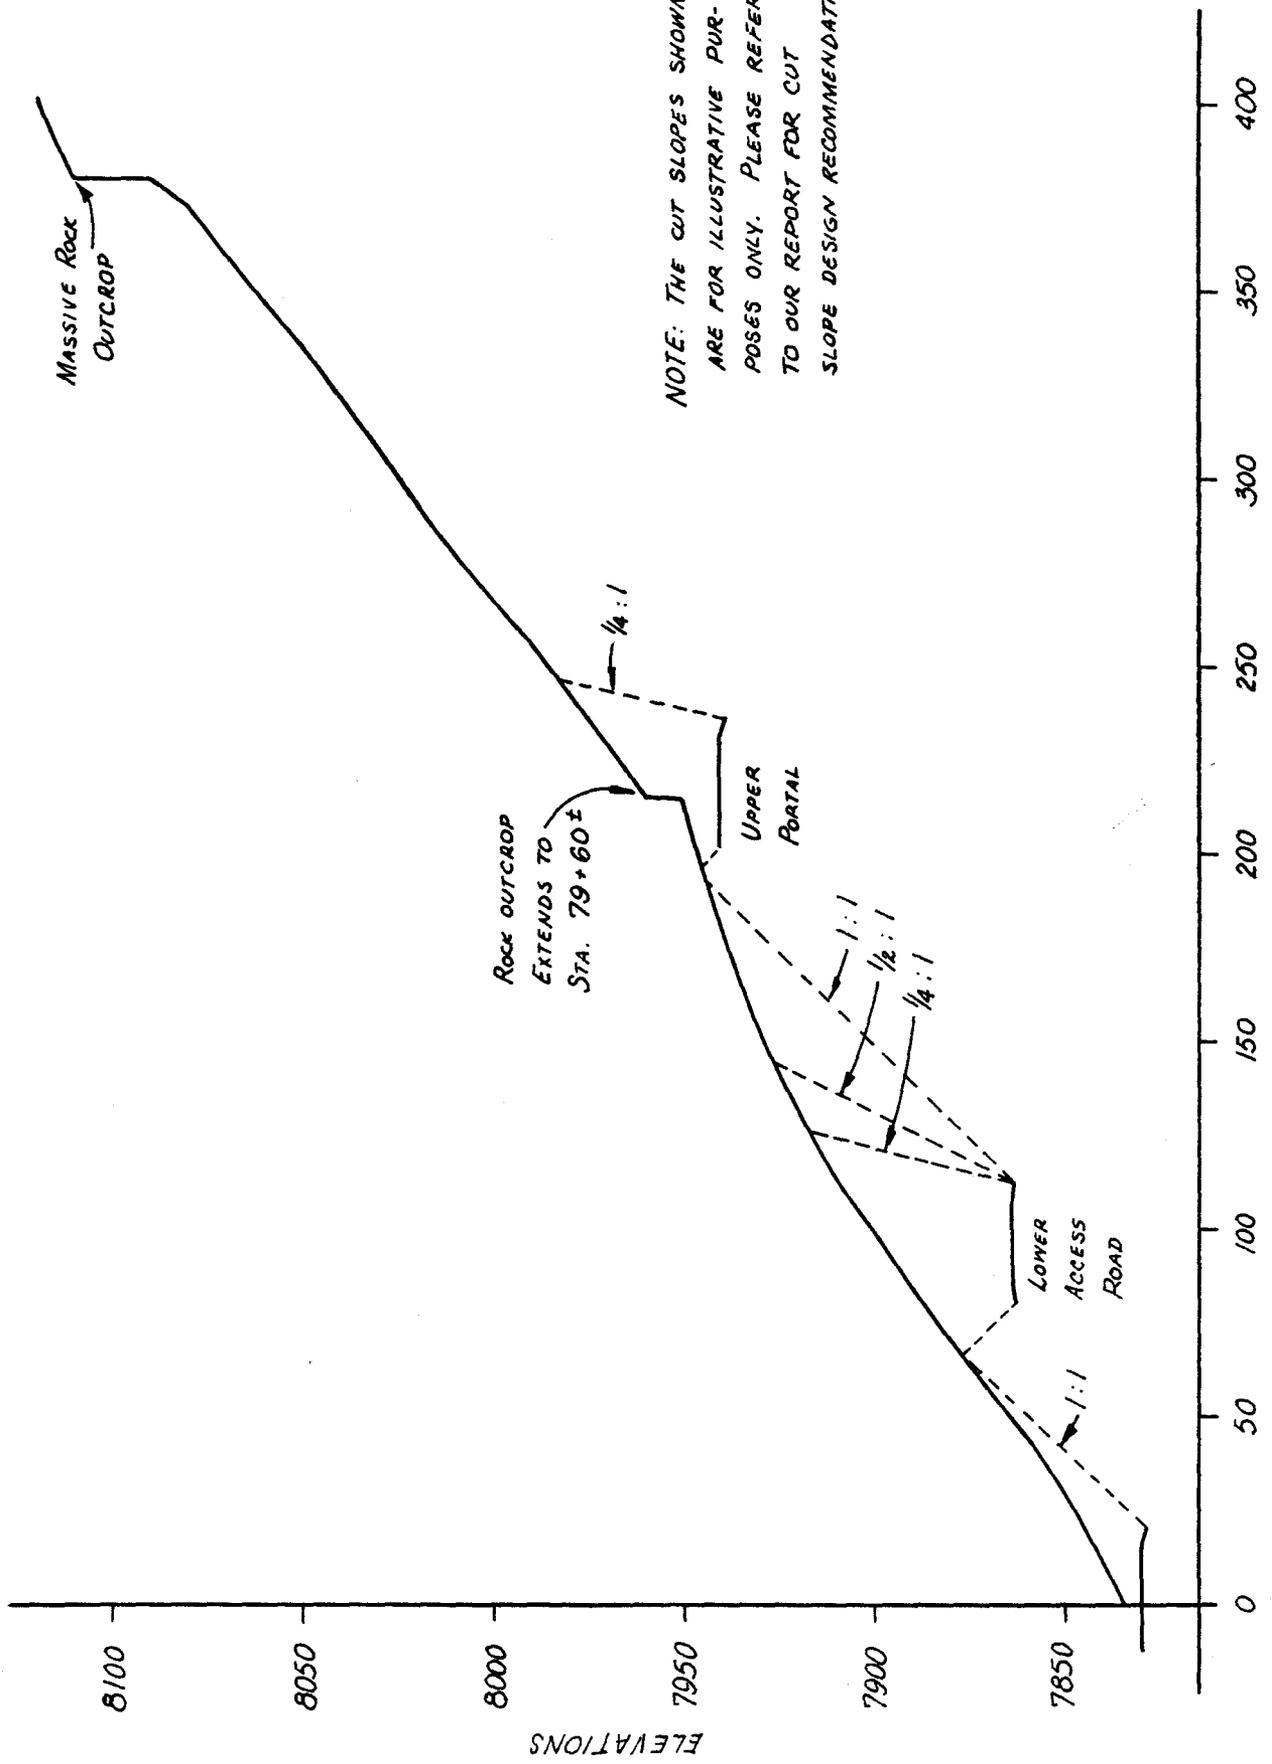
CROSS SECTION AT
HAUL ROAD STATION
79+00

MASSIVE ROCK
OUTCROP

Rock outcrop
EXTENDS TO
STA. 79+60 ±

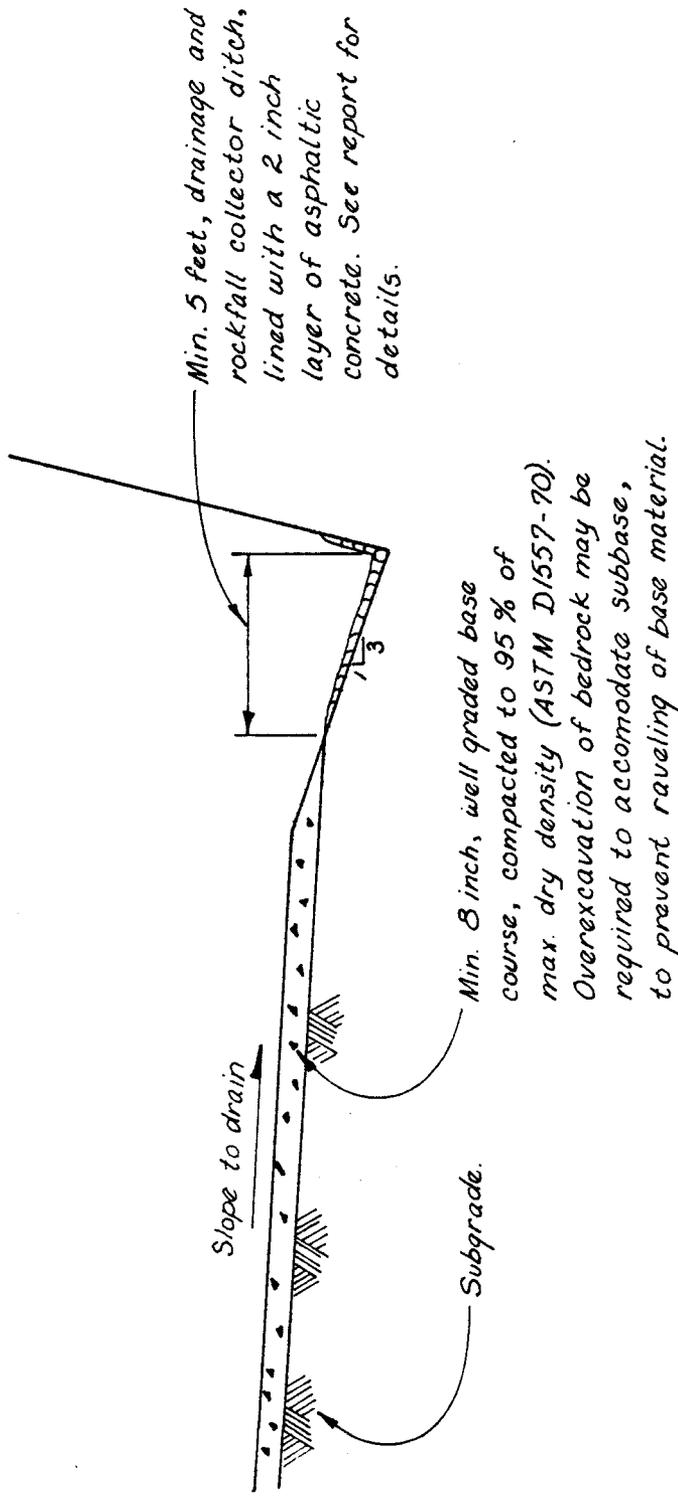
PROPOSED DRAINAGE AND
ROCKFALL
COLLECTOR DITCH

NOTE: Edge of roadway not to be located in the surficial deposits.

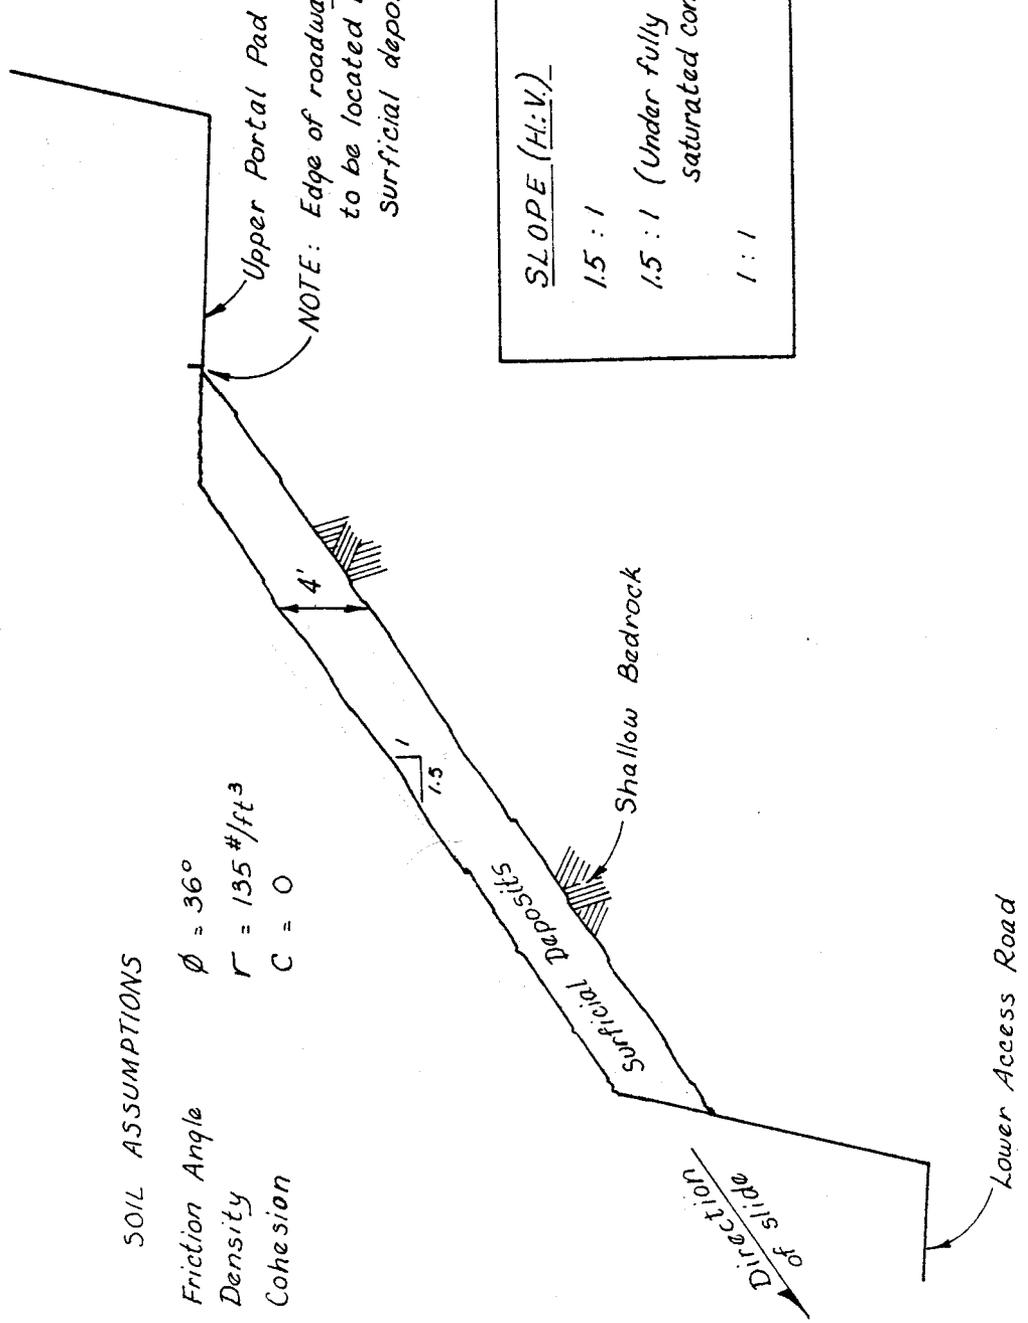
SLIDING BLOCK OR "MUDFLOW" STABILITY ANALYSIS

SLOPE (H:V)	SAFETY FACTOR
1.5 : 1	1.10
1.5 : 1 (Under fully saturated conditions)	0.64
1 : 1	0.72
