**Inspection Report**

Permit Number:	C0150032
Inspection Type:	PARTIAL
Inspection Date:	Wednesday, July 30, 2008
Start Date/Time:	7/30/2008 9:00:00 AM
End Date/Time:	7/30/2008 1:00:00 PM
Last Inspection:	Wednesday, July 23, 2008

Permittee: **GENWAL RESOURCES INC**  
 Operator: **GENWAL RESOURCES INC**  
 Site: **CRANDALL CANYON MINE**  
 Address: **PO BOX 1077, PRICE UT 84501**  
 County: **EMERY**  
 Permit Type: **PERMANENT COAL PROGRAM**  
 Permit Status: **ACTIVE**

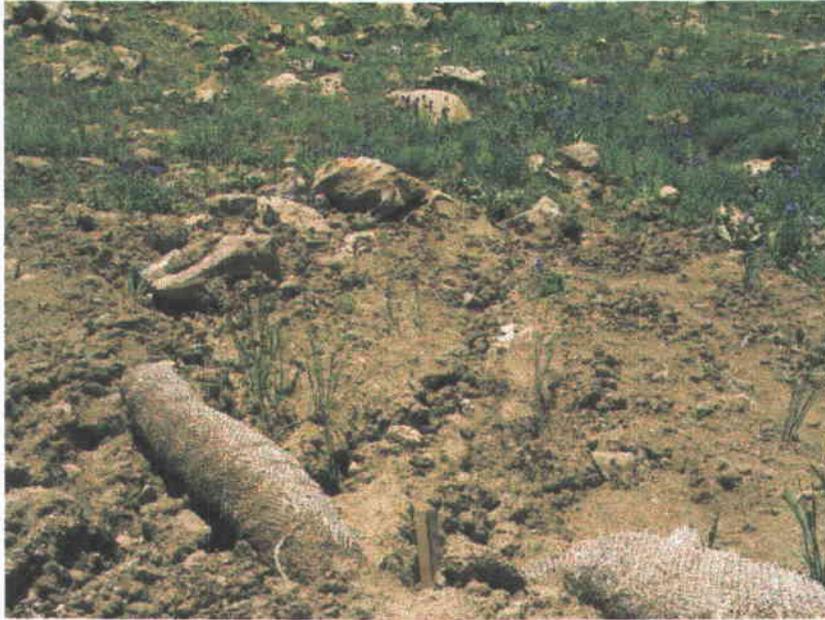
Justin Cooper and a crew of three were on site. Jerry Cripps (foreman) was not there. Justin indicated that last Friday, July 25, 2008, they had made the first pass on the outslopes of the SITLA road with a roller compaction attachment to the track hoe. I walked the length of the site from the SITLA road to pad #3 and did not see any evidence of compaction (no crushed plants; rills and gullies still evident on the outslopes). By the time I left the site at 1:00 pm, approximately 1/2 mile of the SITLA road had wood straw and seed applied to the outslope. After straw/seed application, the slopes were rolled with the hoe arm. This method does not appear to be very effective in achieving a firm surface, as the slope is still very loose and subject to sloughing. Photographs and a seed tag are attached to this inspection report.

no crushed plants on compacted road

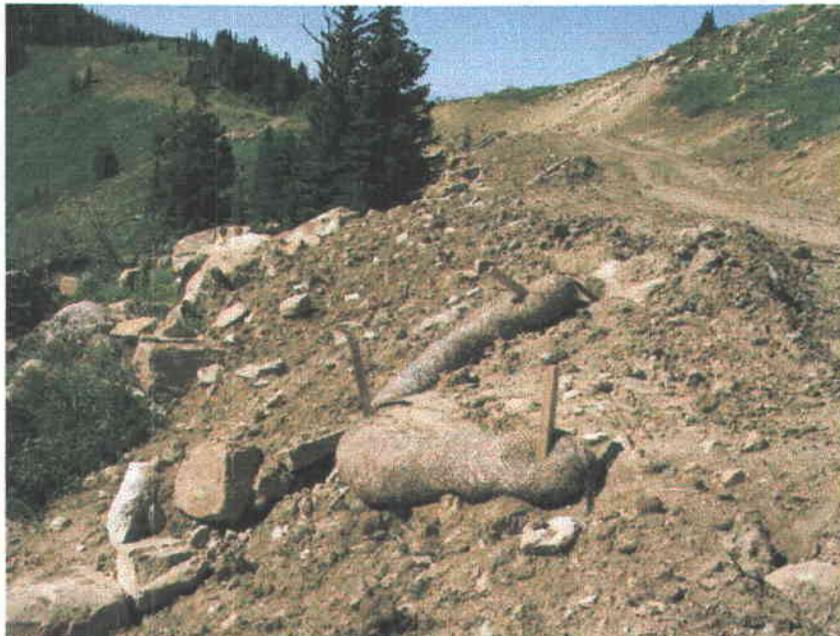
SITLA road outslope does not appear compacted

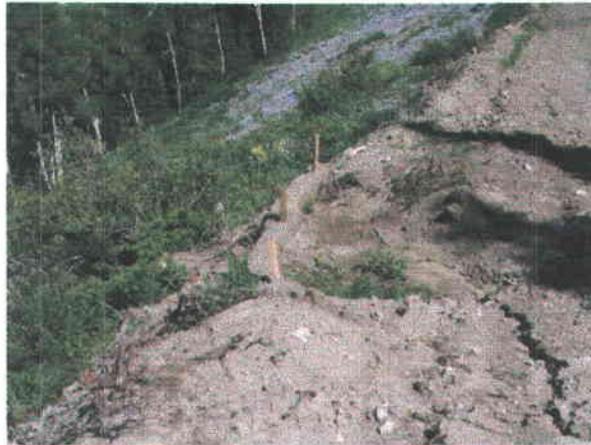
No work has yet been done on improving soil contact with the existing excelsior logs at water bar locations on the SITLA road or along the pad access roads. (Ditto for the USFS road section north of the red gate.) The plan calls for doubling and/or tripling the excelsior log placement at each swale in the road. This had not yet been accomplished. Photographs attached.

excelsior logs require work

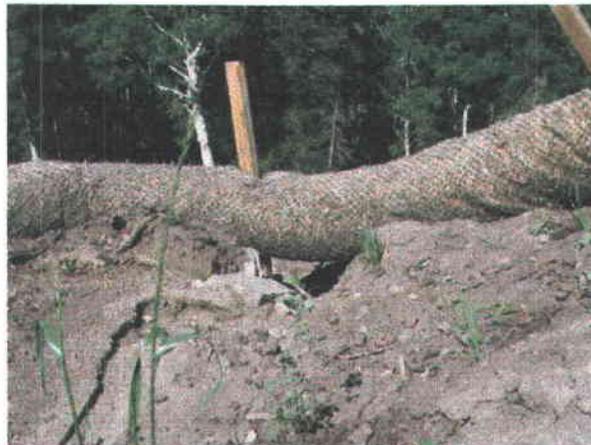
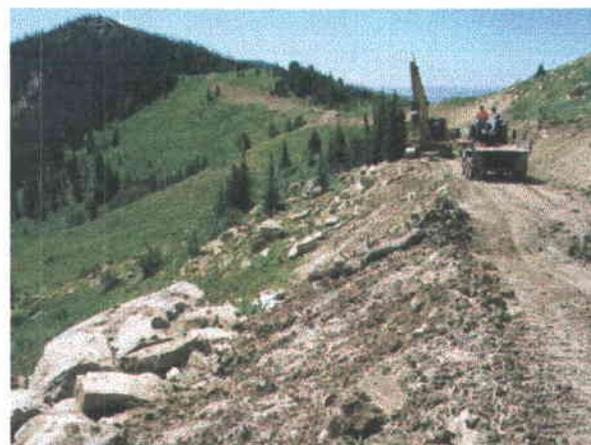
condition of road outslope at end of inspection

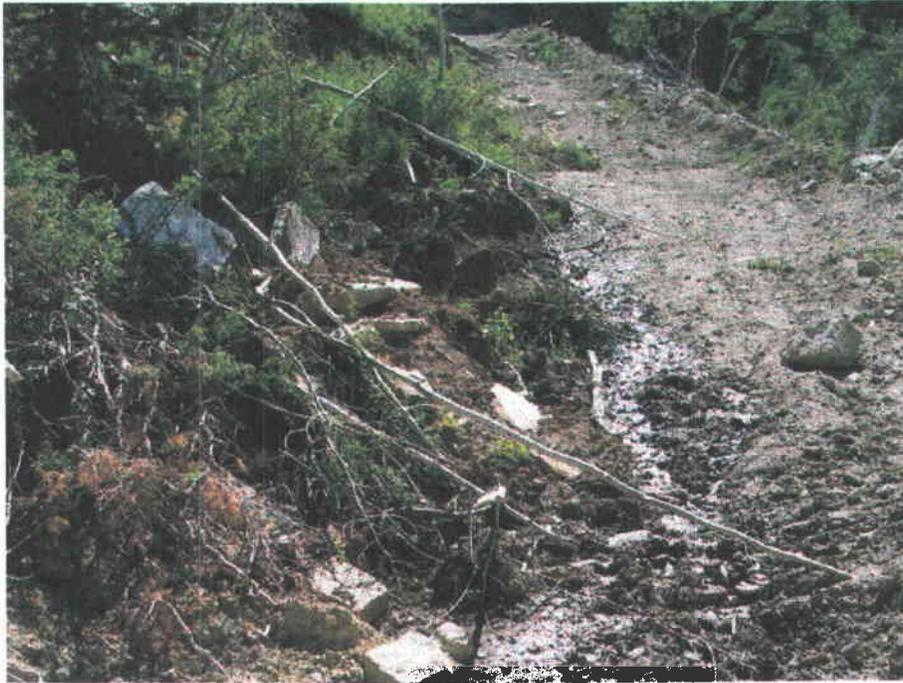
There has been a failure of the slope in the location of the spring on the access road to pad #3. Placement of a drain in the vicinity of this spring is part of the reclamation plan. A second spring was noted about 75 feet above this spring along the access road. (A drain should be placed in this location as well.) The second spring was estimated at about 1 gal/ 5 min. (I will bring a bottle and stop watch next inspection). Photographs attached.

Slump near spring on access road to pad #3

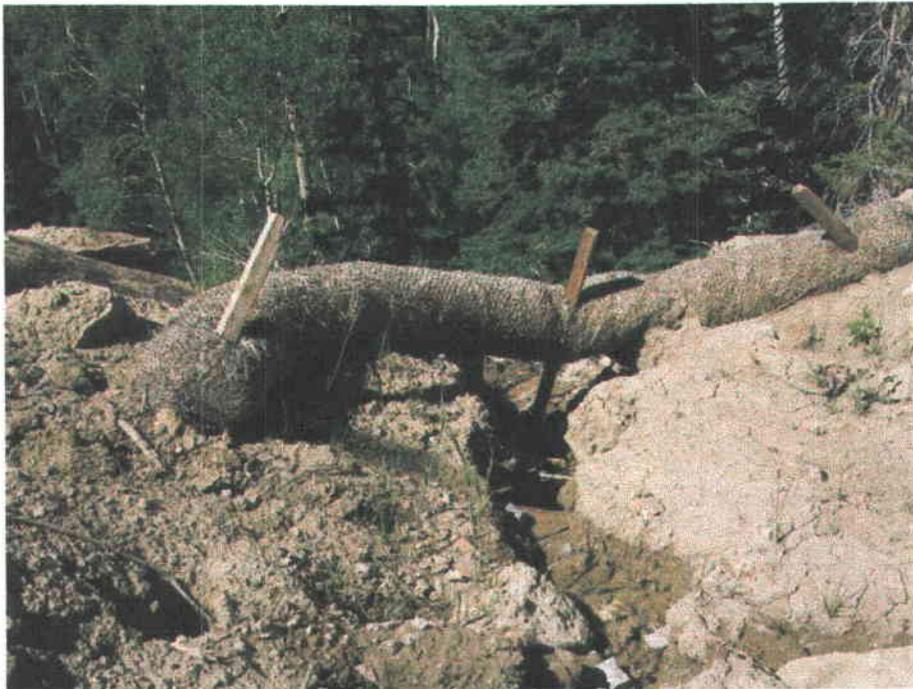
excelsior log "treating" spring flow on access road to pad #3
