**RE: Abatement Plan – Division Order DO-09A, Genwal Resources, Inc.  
Crandall Canyon Mine, C-015/0032**

## PETERSEN HYDROLOGIC

At your request we have performed an investigation of iron concentrations in mine discharge waters from the Genwal Resources, Inc. Crandall Canyon Mine. Specifically, the purpose of this investigation is to evaluate historical iron concentrations in the mine discharge waters and to provide projections of likely future iron concentrations in discharge waters from the now sealed Crandall Canyon Mine.

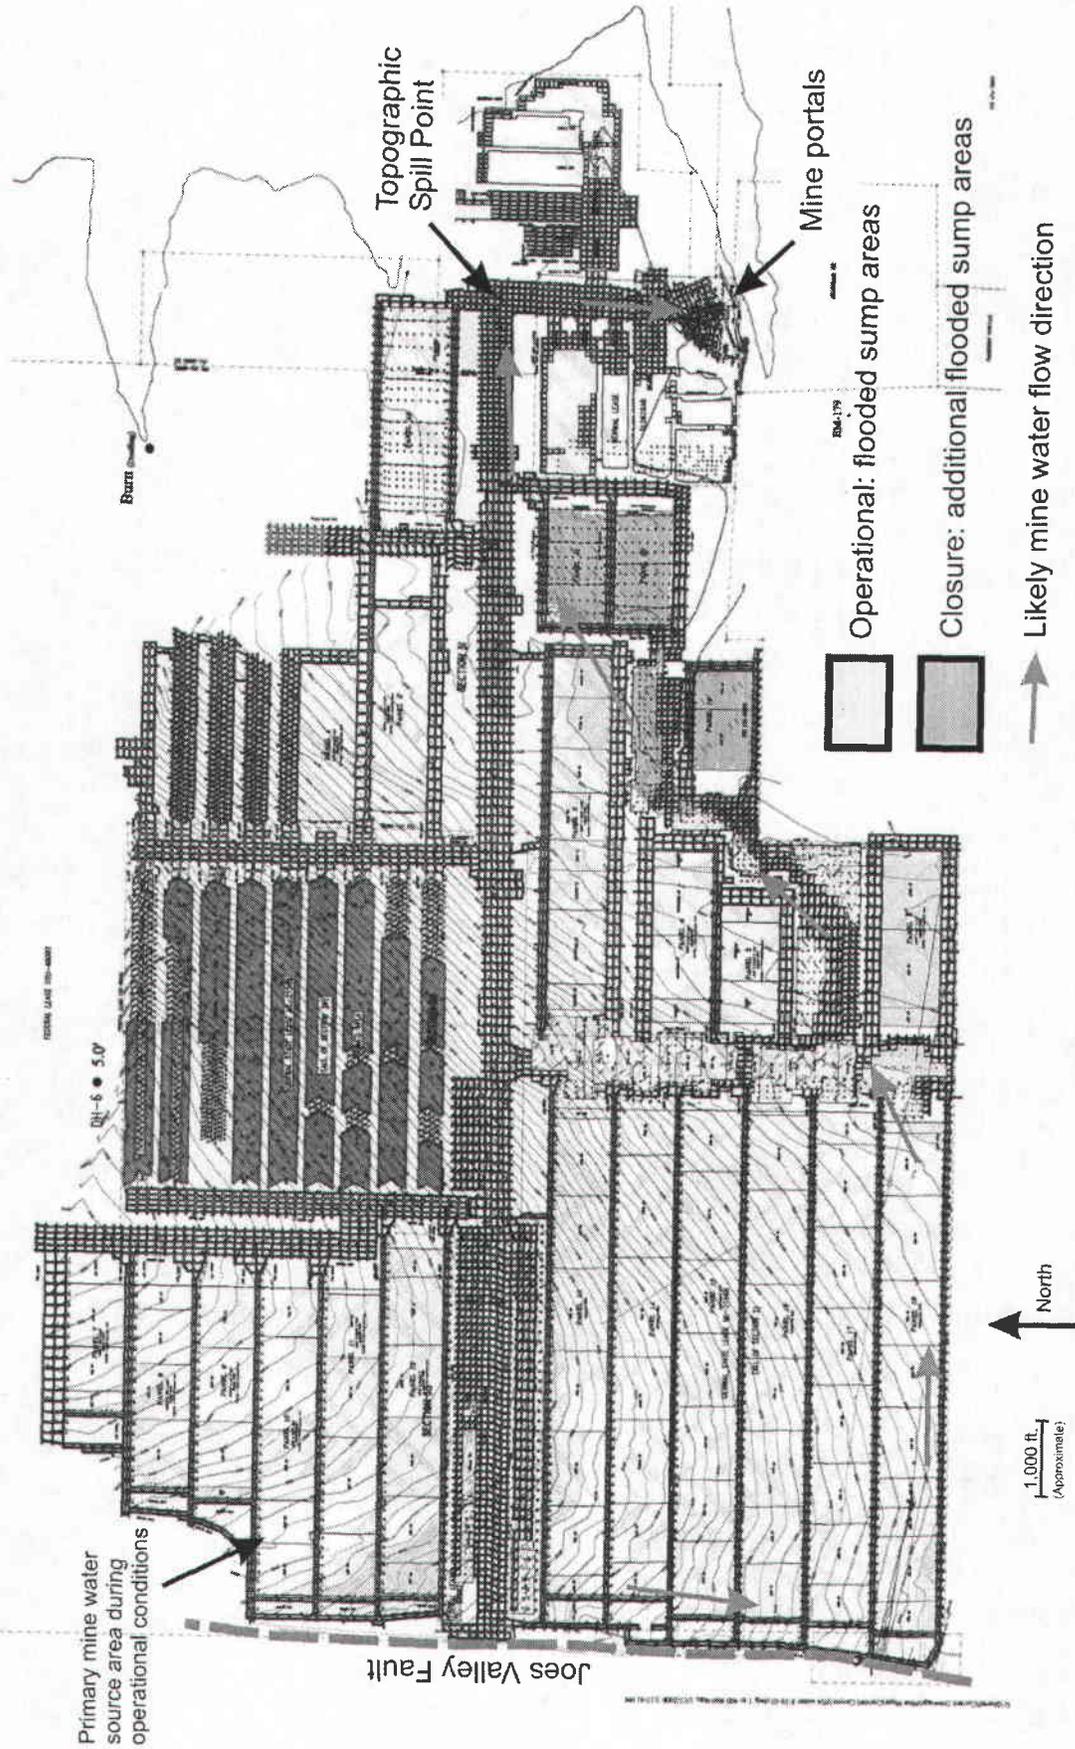
As indicated on Figure 2, subsequent to the cessation of mine-water pumping, portions of the mine workings that were previously not flooded (under operational conditions) became flooded as rising mine waters inundated these areas. Accordingly, un-oxidized pyrite minerals in the newly flooded areas likely came into contact with oxygenated mine waters, resulting in pyrite oxidation and the resultant liberation of iron into the mine waters. Additionally, as a result of the mine bump/bounce event, freshly broken coal debris was likely emplaced in mine entries, which may have resulted in increased potential for interactions between mine waters and freshly exposed pyrite minerals. It is my professional opinion that the observed increases in iron concentrations in mine discharge water subsequent to the gravity discharge of mine waters to the surface likely occurred under these geochemical conditions.

Figure 2 Map of the Crandall Canyon Mine workings with the likely routing of mine water to the surface indicated by red arrows. Areas shown in green are mined areas flooded with water during operational conditions. Areas in red indicate recently flooded areas of the mine. The red areas together with those in green indicate likely flooded mine areas in the current closure condition.

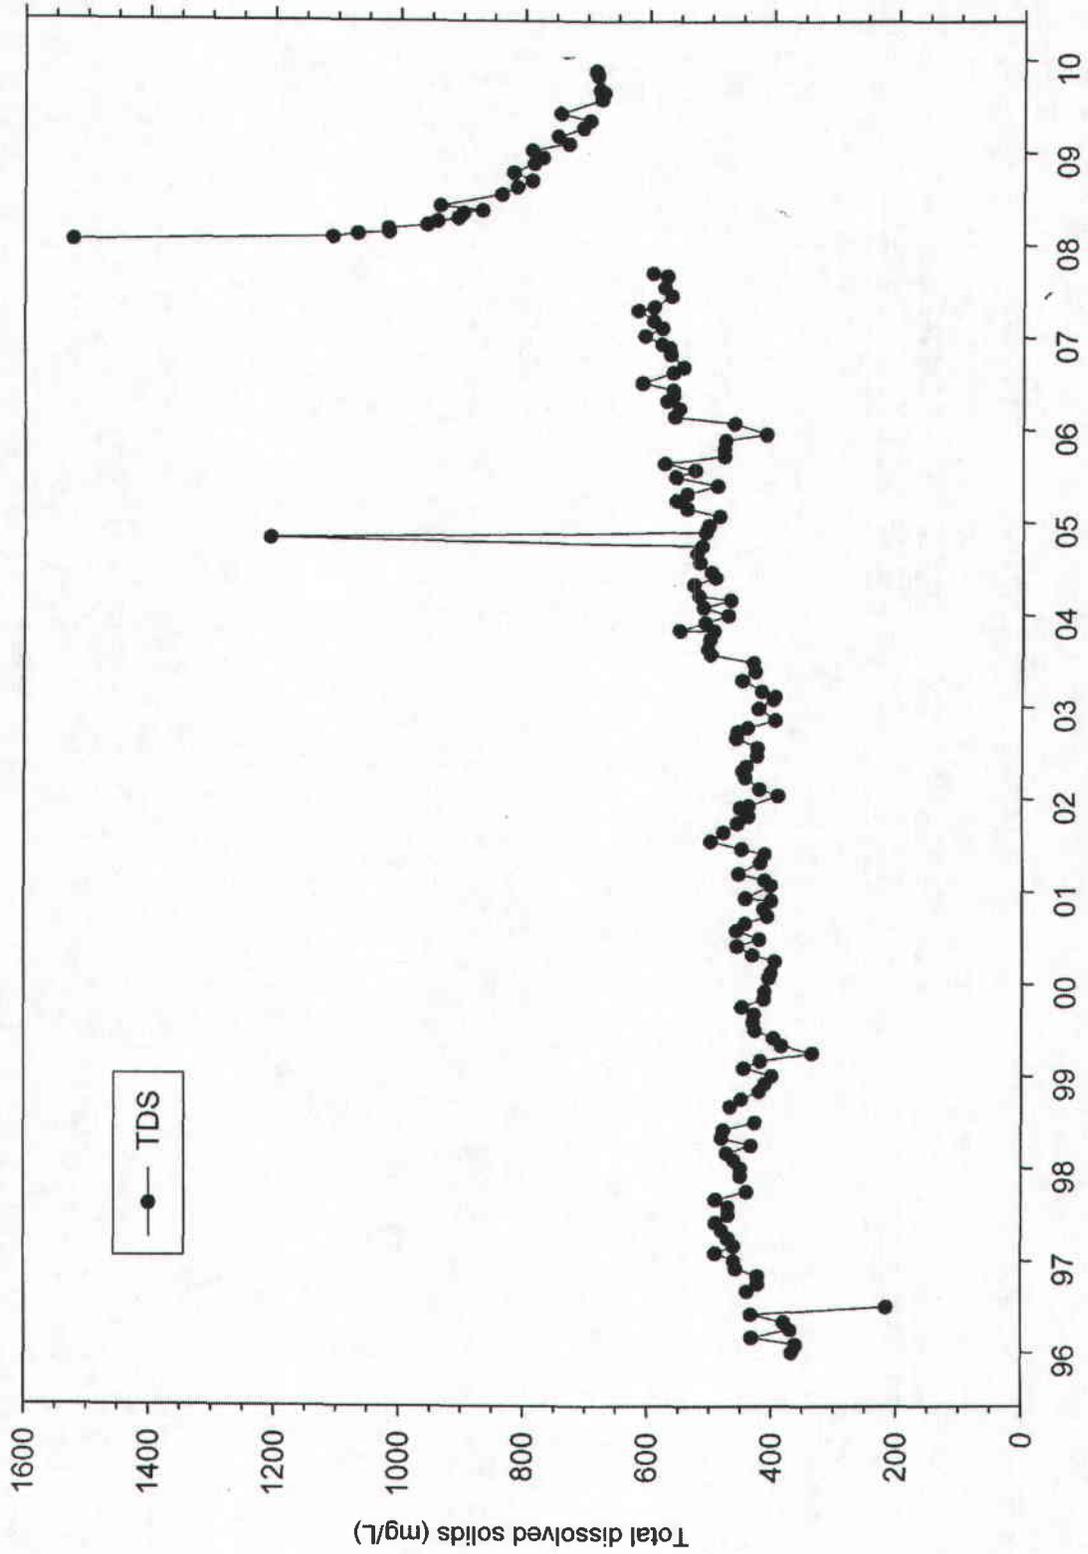
It is apparent in Figure 3 that the TDS concentrations of mine discharge water rapidly spiked relative to previous levels as the first groundwater spilled from the sealed Crandall

Canyon Mine in early 2008. The TDS concentrations of mine discharge waters sampled after this initial occurrence steadily declined. By late 2009, the TDS concentrations of the mine discharge waters were gradually approaching those observed during the operational phase of the mine. This TDS spike likely resulted from the effects of the flushing of soluble minerals or other materials present in the old mine workings as these areas were flooded for the first time (see Figure 2). After these materials were flushed and gradually removed from the recently flooded mine workings, elevated TDS concentrations declined accordingly.

- The initial spike in TDS concentrations observed in the gravity discharge from the Crandall Canyon Mine in early 2008 is likely attributable to the dissolution of soluble minerals or other matter in inundated portions of the mine. Upon flushing of these materials from the flooded mine areas over time, the TDS concentrations of mine discharge water are gradually returning to near-previous levels.

Figure 3 Total dissolved solids (TDS) concentrations of Crandall Canyon Mine discharge waters.

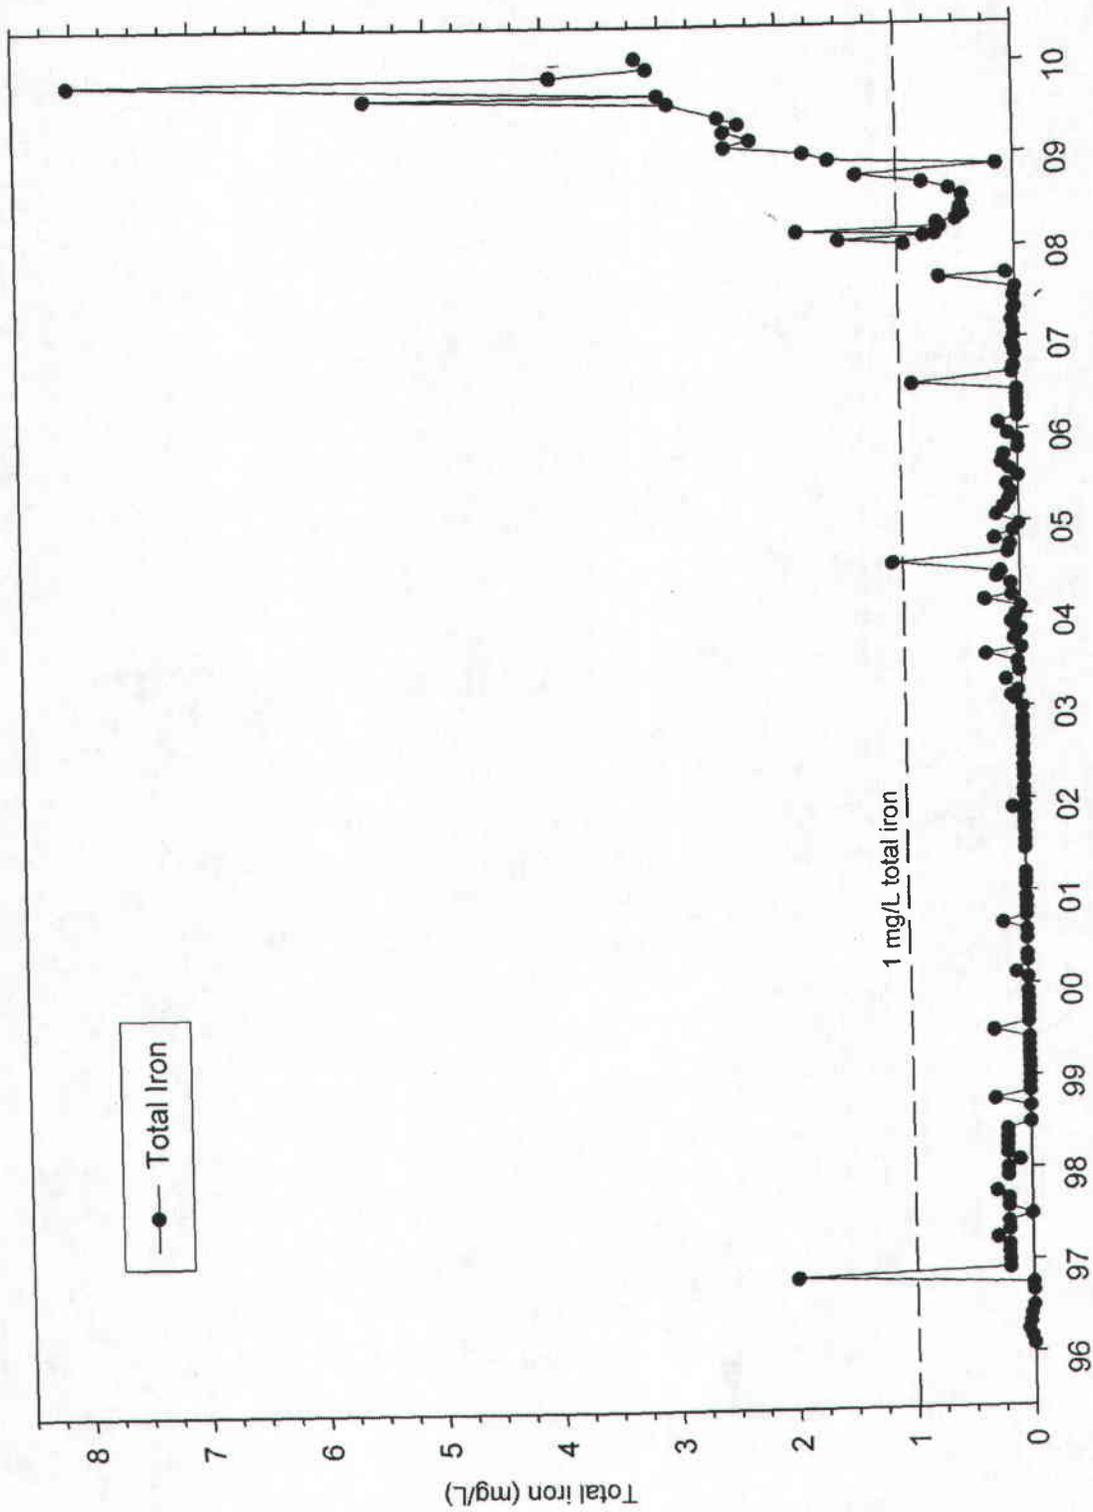
Total iron concentrations in Crandall Canyon Mine discharge waters were typically low prior to the mine bump/bounce event (Figure 4). This conclusion is of particular importance to this investigation. The previous lack of appreciable iron in mine discharge water is likely attributable to the removal of pyrite from the mine environment that was in contact with mine waters through oxidation reactions (i.e., the available pyrite was likely consumed). Accordingly, elevated iron concentrations did not occur in mine waters that flowed over the pyrite-depleted materials during operational conditions.

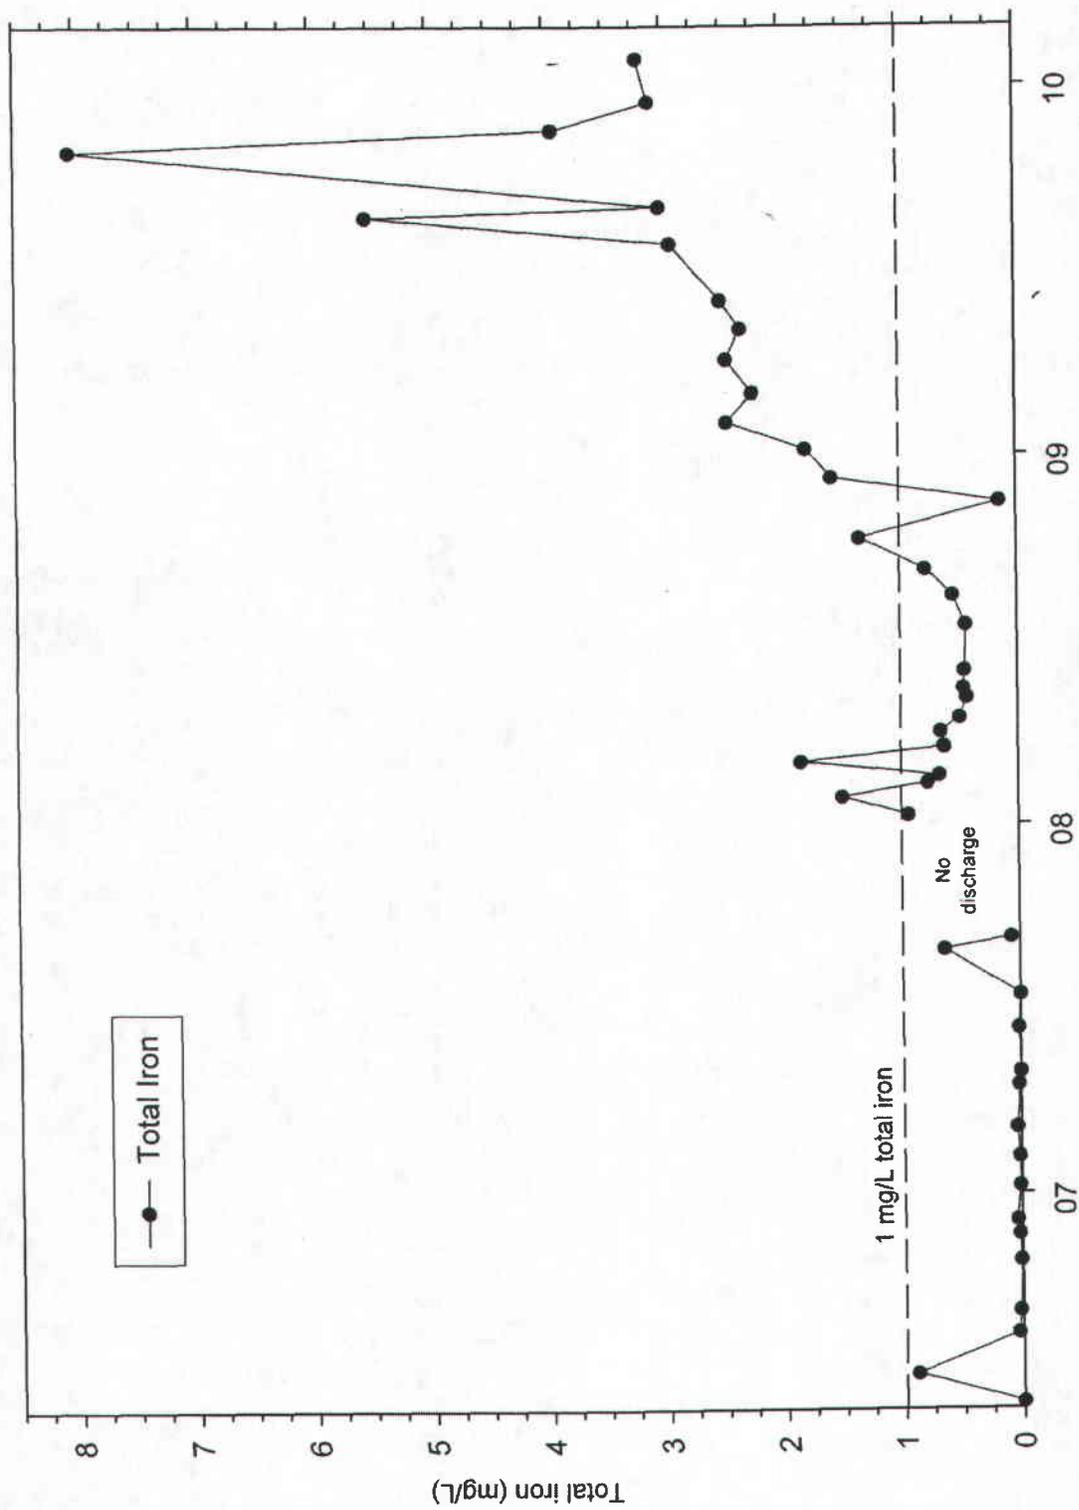
Beginning in late 2008 and early 2009, total iron concentrations in the mine discharge water began to increase, with concentrations rising to approximately 3 mg/L, and temporarily spiking to about 8 mg/L in late 2009. The most recent two samples from the mine discharge water were slightly above 3 mg/L total iron. The observed increased total iron concentrations are likely attributable to the oxidation of pyrite or other sulfide minerals as described above.

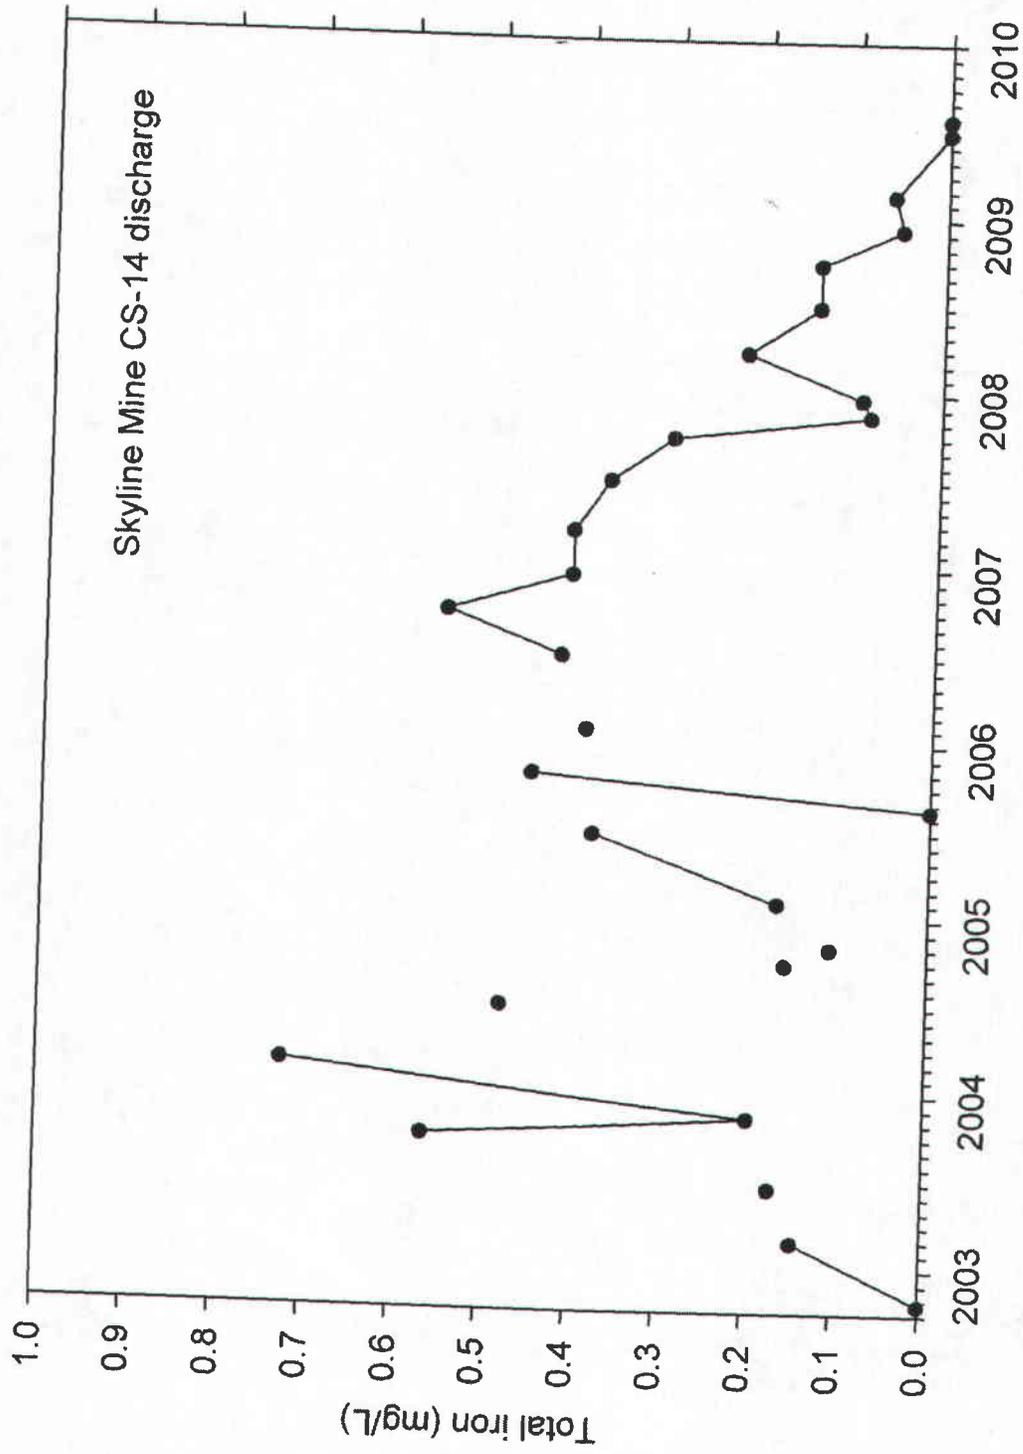
While not all characteristics of the physical or chemical regimes of these two mines are the same, the overall hydrogeochemical environment is believed to be generally similar. As shown on Figure 6, after some initial variability in iron concentrations in 2004 and 2005, the total iron concentrations in the mine discharge water began a fairly uniform decline in 2006 that continued until there was eventually an essentially complete absence of total iron present in the mine water discharge. It seems likely that, in a similar manner, the concentrations of iron in the Crandall Canyon Mine discharge water should gradually moderate over time as the chemical reactants are removed from the system. The time required for the iron concentrations to decline to levels less than 1 mg/L cannot be determined with certainty, as the physical mine environment is not accessible for inspection. However, based on the declines observed at the Skyline Mine CS-14 location, it seems likely that declines in iron concentrations to levels less than 1 mg/L will likely occur within a few years.

Figure 6 Total iron concentrations in mine discharge waters pumped from the down-dip flooded mine workings in the southwest portion of the Skyline Mine at monitoring point CS-14 (DOGM, 2010).
